Dowally Burn, Pitlochry ***Perth and Kinross***

Archaeological Evaluation: Jan – Feb 2011
Report

R G Parkins and Partners Ltd
on behalf of Blair Castle Estates

(project AA. 1909)

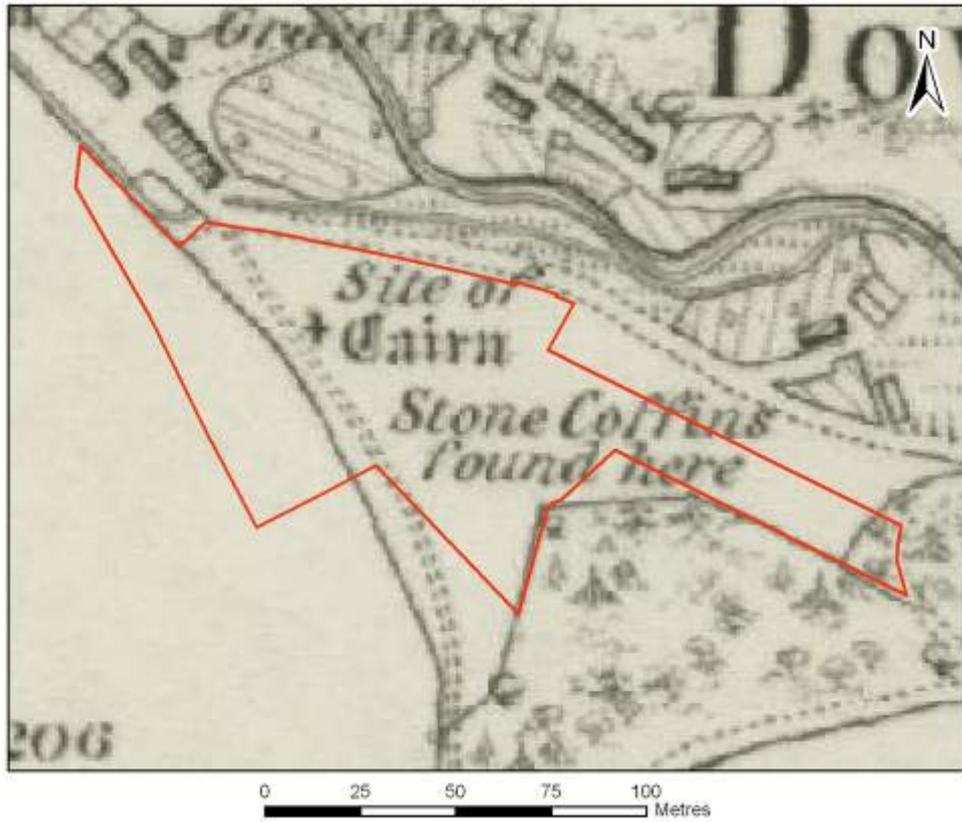
Figure 5. 1st edition 6-inch OS map showing site outline and trench locations. (NLS)

The site of the cairn and cist had been recorded by The National Monuments Record of Scotland (NMRS) as NMR – NO04 NW3. The NMRS records that the New Statistical Account (NSA) states that a cairn measuring 9m (30ft) in diameter and 1.8m (6ft) in height was removed in the 19th century, revealing a stone coffin full of black earth. It was reported that other ‘stone coffins’ were located within the vicinity, but exact locations are not given. No upstanding remains of this site are visible today and the site is classed as being of local importance (Environmental Appraisal, Atmos Consulting, 2010). The site of the cairn and stone coffins has been recorded on the OS 6-inch (*figure 5*) and OS 25-inch 1st edition maps (*figure 6*).

In total twenty linear trenches were laid out across the site which ensured a good spatial coverage for testing the survival of archaeological remains (*figure 4*). A greater density of trenches were placed in the central/central west portion of the field in an attempt to target the area most likely to contain archaeological remains, namely the area around the recorded cairn seen on the OS 1st edition maps (*figures 5 and 6*).

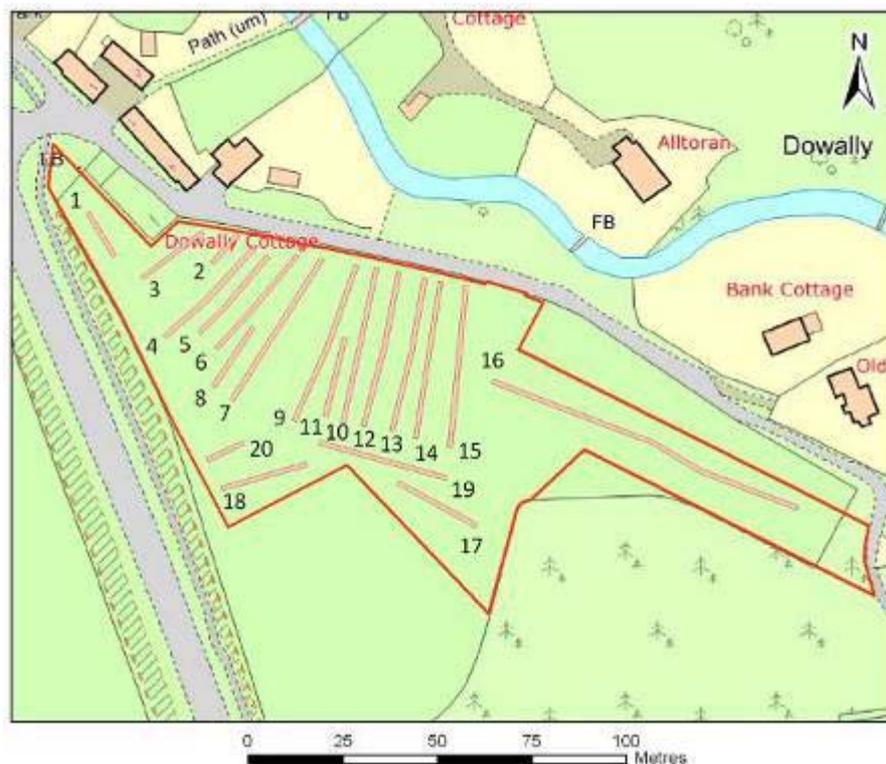
The evaluation trenches and the features revealed were surveyed using a Leica TCR805 total station. This survey data was then transferred to AutoCad to produce a digital plan of the site which was geo-referenced to the British National Grid (*figure 7*).

Figure 7. Trench location plan with site outline in red.

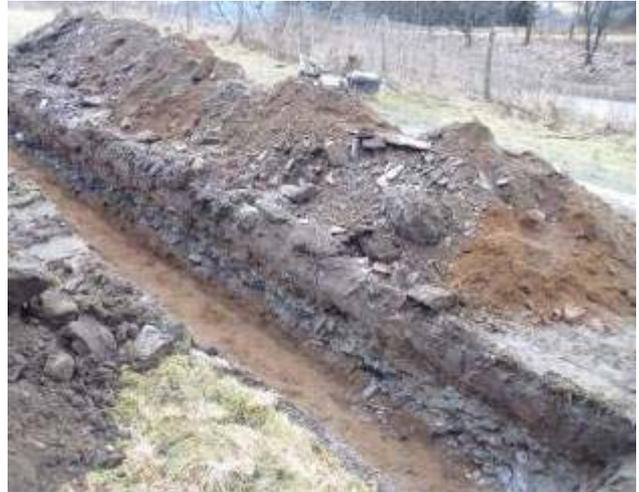
Plate 1. Trench 1 view from the N.

Topsoil (001), a mid-dark brown sandy soil, was frozen and compact and was found to a depth of 30cm. Modern material including concrete, plastic and fencewire were present. Removal of topsoil revealed a spread of broken rock (002) upto 25cm thick, with no cultural material present.

This has been interpreted as a hardstanding for a site compound relating to the construction of the A9 road which runs directly to the west of the site. This hardstanding (002) is found in several other trenches and the possible extent of the site compound has been plotted (*Appendix A*).

Below (002) was a homogenous mid orange sandy silt (003) which was very clean and was interpreted as natural. Natural was encountered at a depth of 55cm. A test slot was placed through (003) at the NW end of the trench and it was found that it continued to at depth of at least 1m.

Approximately 5m to the SE a light to mid brown mixed stony soil deposit was discovered between (001) and (002), becoming thicker further upslope. Modern debris was frequently found within this deposit (plastic, ceramic pipe fragments, fencing wire, curb stones).

(004) and (001) are presumed to be landscaping deposits following the shutdown of the A9 compound.

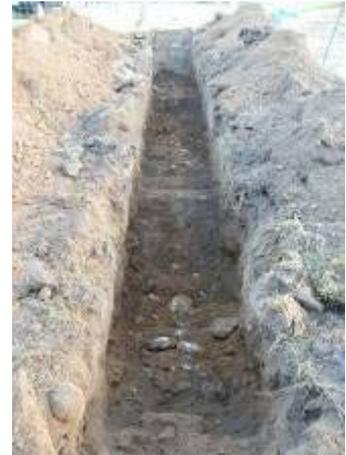
Plate 2. Trench 2 view from the NE.

This trench was 11 m in length, 1.2m in width and was aligned roughly NE-SW.

Topsoil (005), a mid-dark brown sandy soil, was again frozen making initial excavation difficult and measured 30cm in depth.

Below this a moderately compacted mid orangey brown fine sandy silt (006) was discovered which was 20cm in depth.

Underlying (006) was a layer of mixed and mottled dark brown-black silt (007) which was 40cm thick and continued to a trench depth of 90cm before stony natural gravels (008) were reached.

No artefacts or features were discovered within this trench.

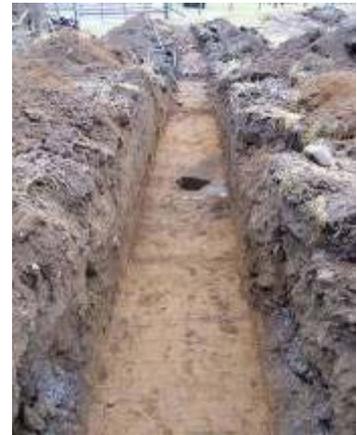
Plate 3. Trench 1 view from the NE.

This trench was 21 m in length, 1.2m in width and was aligned roughly NE-SW, 7m NW of trench 2.

Topsoil (005) ranged from 20-30cm in depth and overlay (006) which reached a maximum thickness of 35cm but was approximately 25cm thick at the northern end of the trench.

Halfway along the trench a slight break of slope occurred within the field, resulting in the southern end of the trench being approximately a metre higher than the northern limit. As the trench reached the break of slope both the topsoil (005) and (006) reached their maximum depth. Deposit (006) overlay natural gravels (008).

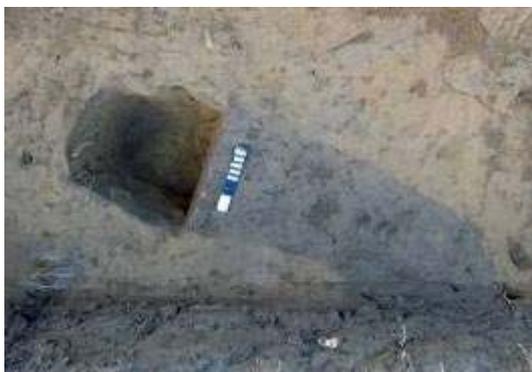
At 4m from the southern limit of trench 3 a linear pit feature [009] was encountered cut into (006). The feature was orientated ENE-WSW and was 1.3m in length by 0.5m in width. The southern end of this feature was excavated revealing a U shaped profile and a depth of 0.25m. Within the dark sandy silt fill (010) a silver plated fork (find no.1) was retrieved. As a modern date for this feature was established, excavation of the feature ceased.

Plate 4. Feature [009] half sectioned.

Features [009], [015], [017], [020] were all very modern in date. Excavation of the linear pit [009], in trench 3, was abandoned when a silver plated fork was found. Linear features [015] and [017] both contained wire and cigarette packet foil, whilst linear cut [020] contained a modern orange plastic field drain.

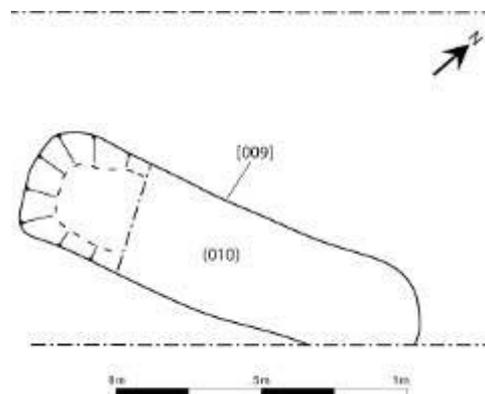
Figure 8. Plan of feature [009].

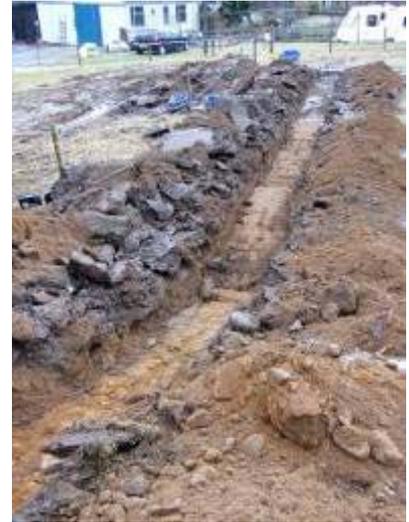
Plate 5. Trench 4 view from S.

This trench was 34m in length, 1.2m in width and was aligned roughly NE-SW.

Throughout this trench topsoil (005) was a consistent depth of 30cm. Below topsoil was (006) which was 20cm in depth but this increased in the central part of the trench to 30cm, where the break of slope in the field was encountered (as in trench 3).

Below (006) in the northern end of the trench was stony natural (008), whilst in the south sandy natural (003) was encountered.

At the southern extent of the trench hardstanding (002) and (004) were encountered. As with trench 3 it was decided to terminate the trench at this point.

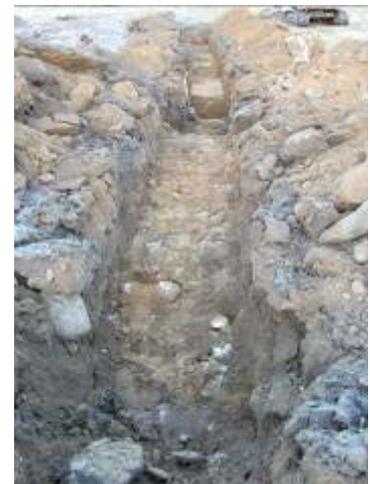
Plate 6. Trench 5 view from NE.

At a distance of 15m from the northeastern end of the trench, just north of the field's break of slope, the remains of a car were found. The car appeared to be orientated NW-SE, perpendicular to the trench. Whilst much of the car was corroded it does appear that the entire vehicle was present. However the number plate on the front (VES 216) did not match that on the rear (LSN 810).

The car has since been identified as a Wolseley, most probably the 1500 model.

A cut [022] for the pit containing the car could be seen in section. The sides were steeply sloping with a sharp bottom break of slope. The fill of the pit was a dark brown sandy silt (023).

According to one local, the car, which has since been identified as a Wolseley (probably model 1500), was buried by nearby residents immediately prior to the A9 road construction when the car was found abandoned.

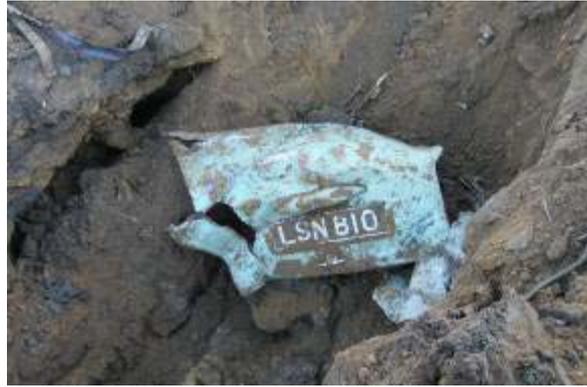
Plate 7. Rear of excavated car in trench 5.

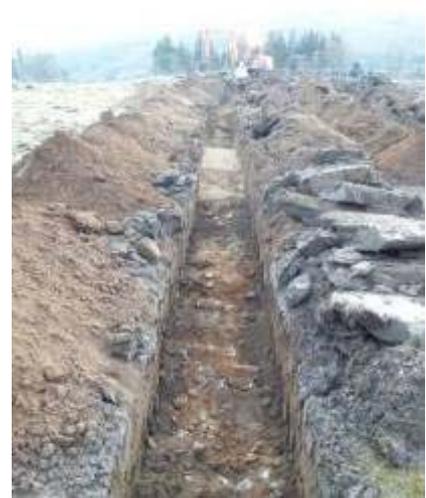
Plate 8. Trench 6 view from NE.

Topsoil (005) was found to a depth of 20cm, below which sandy silt (006) was 55cm thick.

Natural gravels (008) were revealed beneath (006) in the north, with sandy natural (003) revealed towards the south.

No artefacts or features were discovered within this trench.

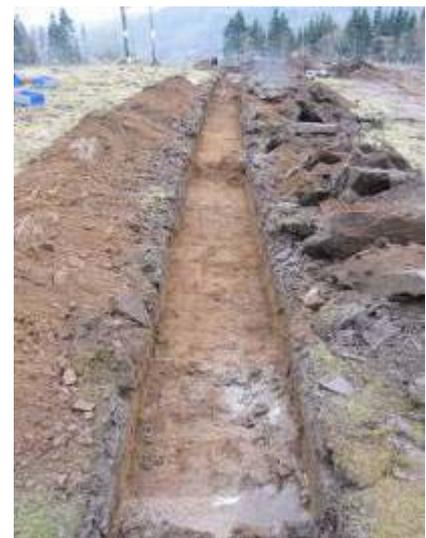
Plate 9. Trench 5 view from NE.

Topsoil (005) was found to a depth of 20cm but this reduced to 15cm in the south. Below this was sandy silt (006) which was 20cm thick.

Natural gravels (008) were revealed beneath (006) in the north, with sandy natural (003) located towards the centre of the trench before the presence of natural gravels again at the southern end.

No artefacts or features were discovered within this trench.

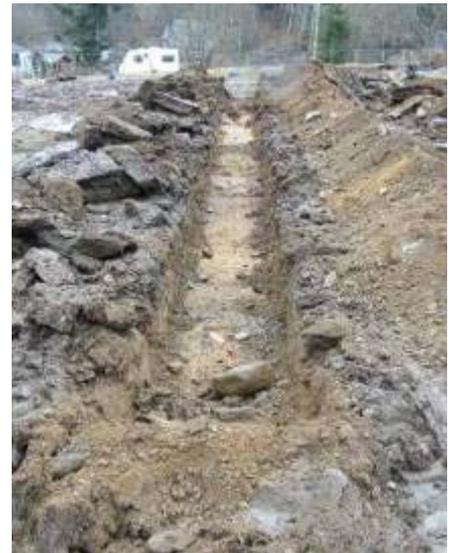
Plate 10. Trench 8 view from NNE.

In trench 8 topsoil (005) was found to be 25cm in depth but this reduced to 20cm in the south. Below this was sandy silt (006) which was 15cm thick.

Natural gravels (008) were revealed beneath (006) in the north, with sandy natural (003) towards the southern end.

At a distance of 10m from the northern end of the trench feature [017], a gravel filled drain, was revealed running WNW-ESE. This feature was 35cm in width and was half sectioned and recorded. The upper fill of this drain consisted of coarse grey gravel (018), 5cm in depth. Fencewire and the remains of a cigarette packet were found within the lower fill, a mid brown mixed sandy silt deposit (019) which was 12cm deep.

A further 2m south of this drain was linear feature [015] which was orientated E-W. At a width of 25cm it was narrower than linear [017] and did not have the same coarse gravel upper fill. The fill was a mixed mid brown sandy silt deposit and again foil from a cigarette packet was found along with a modern nail. This linear feature was 10cm in depth and was most likely a modern field drain.

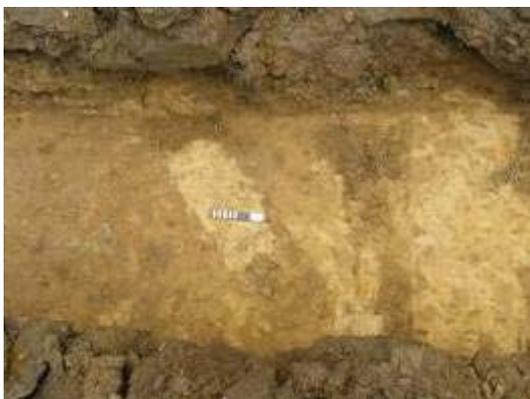
Plate 11. Pre-ex shot of feature [015].

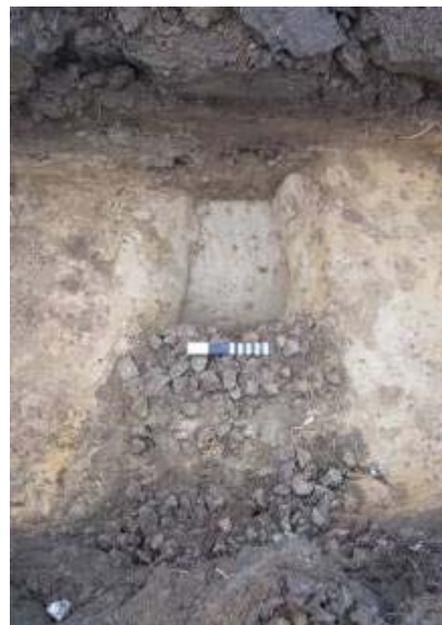
Plate 12. Mid-ex shot of feature [017].

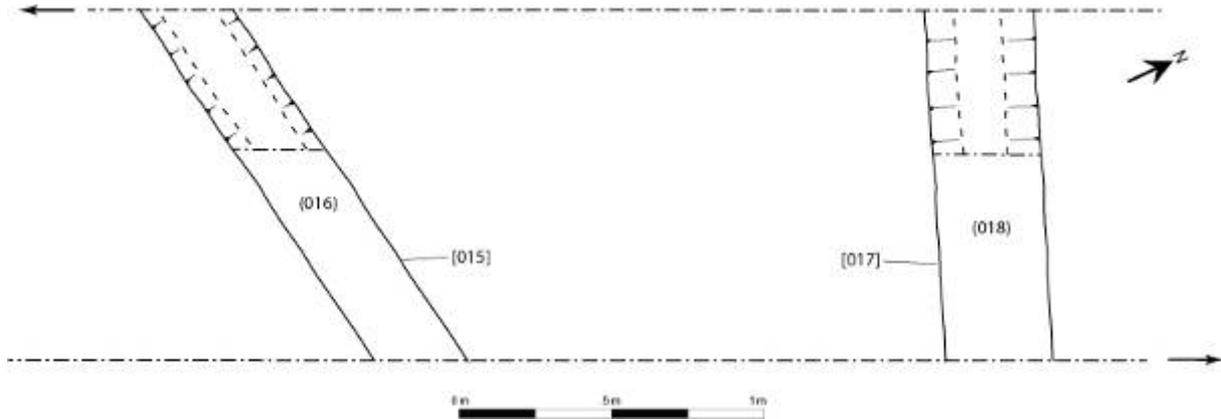
Figure 9. Plan of features [015] and [017].

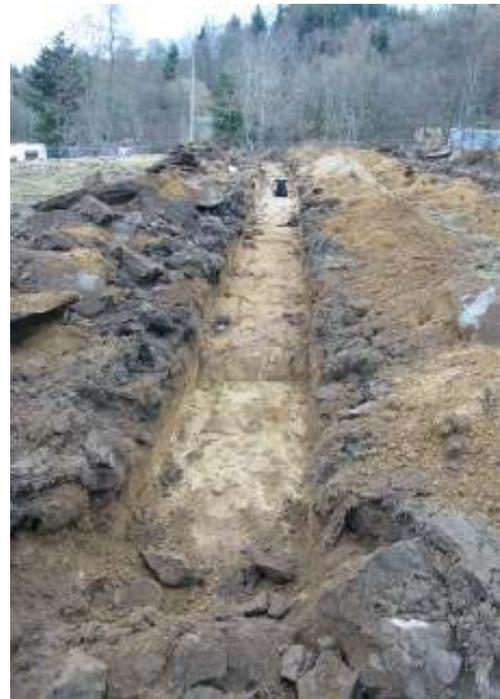
Plate 13. Trench 9 view from the SSW.

Topsoil (005) was found to be 25cm in depth but this reduced to 20cm in the south. Below this was sandy silt (006) which was 15cm thick.

At a distance of 29m from the northern end of the trench feature [011] was revealed, a linear ditch 1.6m in width. This feature was half sectioned and was found to be comprised of one fill, a loose mixed mid-dark brown sandy silt (012) which was 23cm in depth. This feature was cut through topsoil, and had very straight side with a sharp bottom break of slope suggesting it was most likely the result of modern machine (JCB) works.

Modern wire was found within the fill of this feature.

No artefacts or other features were discovered within this trench.

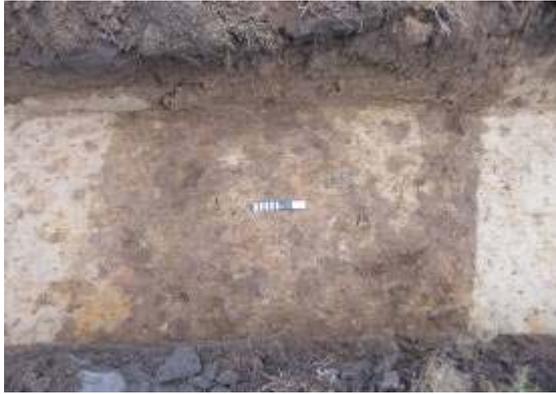
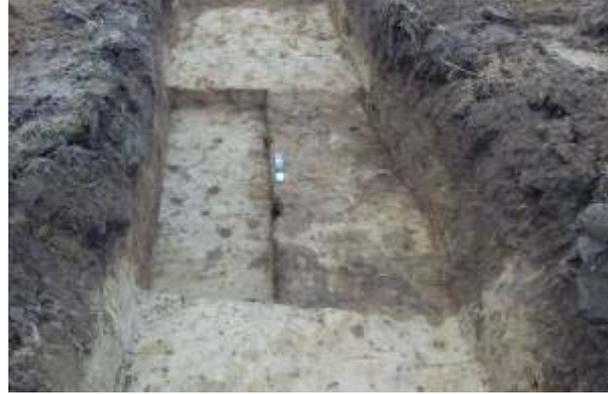
Plate 14. Pre-ex shot of feature [011].

Plate 15. Mid-ex shot of feature [011].

Trenches 9 and 10 contained features [011] and [013] respectively, which appeared to represent a linear ditch running through both trenches. However, when trench 11 was opened up between these trenches no evidence for a ditch was revealed. At approximately 1.6m in width it is possible that these straight sided features, with only single fills, are the result of relatively modern activity by a JCB or similar excavating machine.

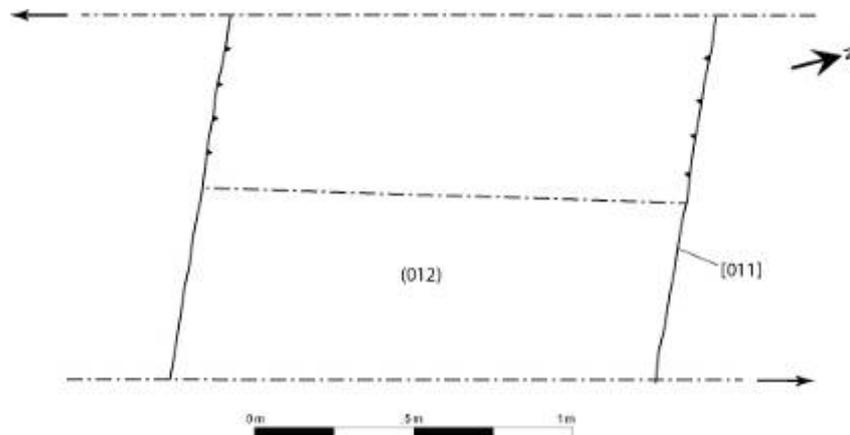
Figure 10. Plan of feature [011].

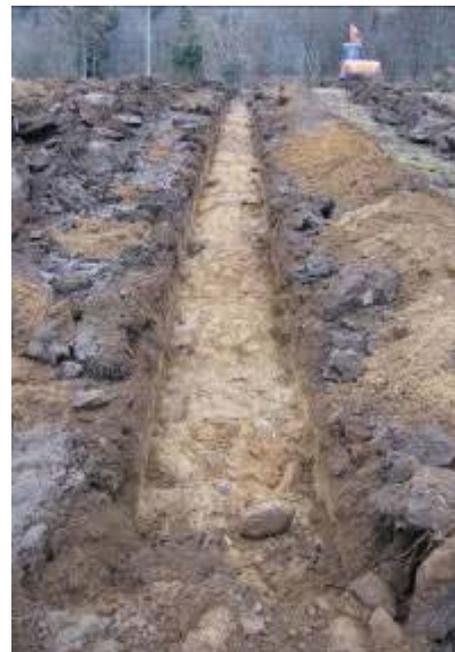
Plate 16. Trench 10 view from the SSW.

Topsoil (005) was found to be 15cm in depth but this increased to 20cm in the south. Below this was sandy silt (006) which was 10cm thick.

Natural gravels (008) were revealed beneath (006) in the north, with sandy natural (003) towards the centre and natural gravels again at the southern end.

At a distance of 31m from the northern end of the trench feature [013] was revealed, a linear ditch 1.6m in width, very similar to feature [011] found in trench 9. This feature was half sectioned and was found to be comprised of one fill, a loose mixed mid-dark brown sandy silt (014) which was 45cm in depth. This feature, like [011], was cut through topsoil, had very straight sides and a sharp bottom break of slope, again suggesting it was the result of modern machine (JCB) works.

No artefacts or other features were discovered within this trench.

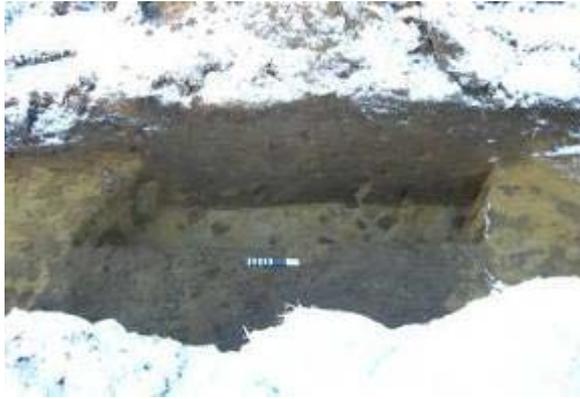
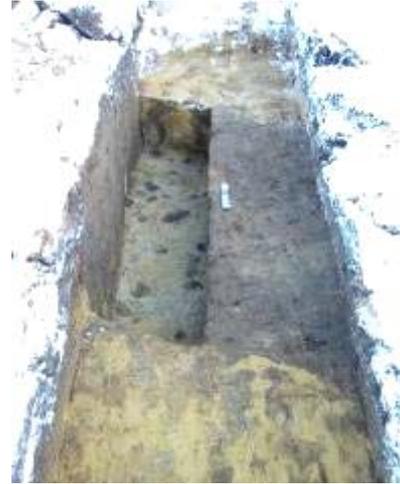
Plate 17. Mid-ex shot of feature [013].

Plate 18. Mid-ex shot of feature [013].

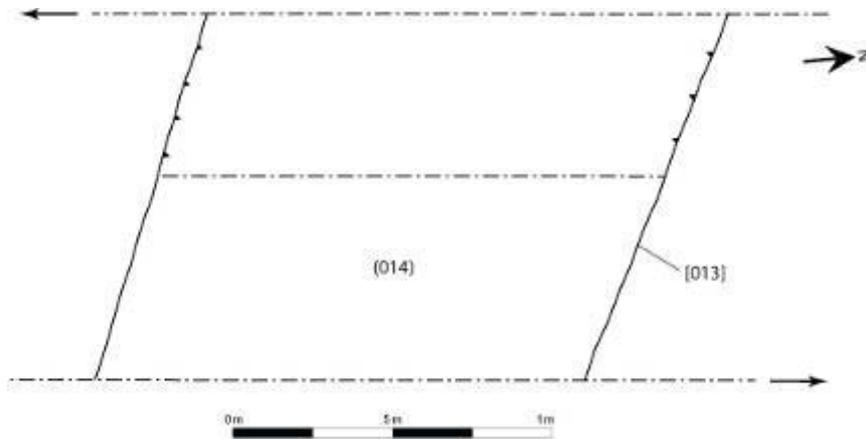
Figure 11. Plan of feature [013].

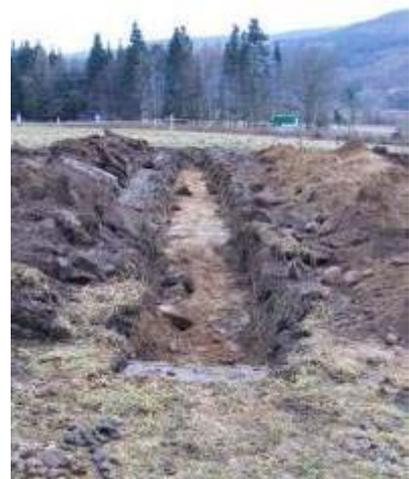
Plate 19. Trench 11 view from the N.

Sandy natural (003) was revealed beneath (006) in the north, with natural gravels (008) found at the southern end.

No artefacts or features were discovered within this trench.

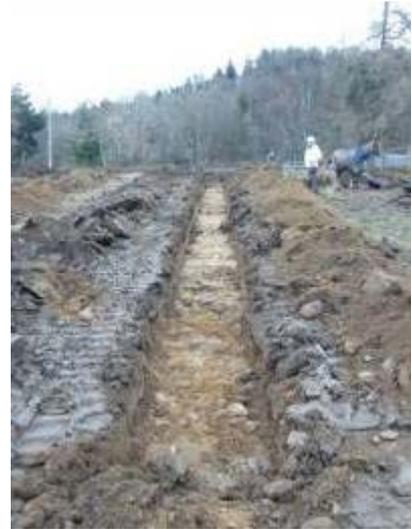
Plate 20. Trench 12 view from the N.

Natural gravels (008) were revealed beneath (006) in the north, with sandy natural (003) towards the centre and natural gravels again at the southern end.

No artefacts or features were discovered within this trench.

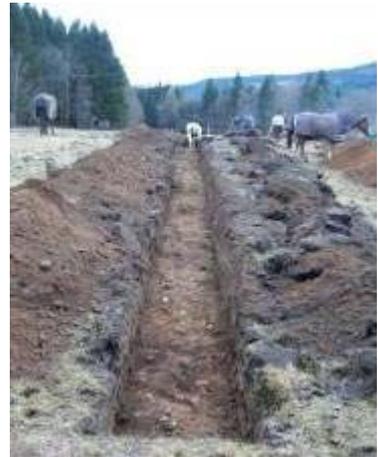
Plate 21. Trench 13 view from the N.

Natural gravels (008) were revealed beneath (006) in the north, with sandy natural (003) towards the centre and natural gravels again at the southern end.

No artefacts or features were discovered within this trench.

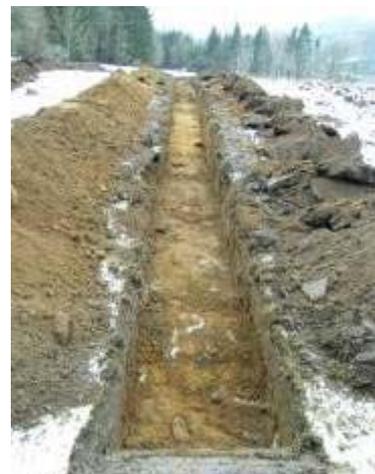
Plate 22. Trench 14 view from the N.

Natural gravels (008) were revealed beneath (006) in the north, with sandy natural (003) towards the centre and natural gravels again at the southern end.

No artefacts or features were discovered within this trench.

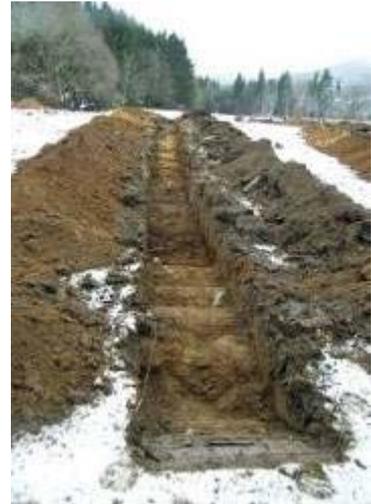
Plate 23. Trench 15 view from the N.

Natural gravels (008) were revealed beneath (006) in the north, with sandy natural (003) towards the centre and natural gravels again at the southern end.

No artefacts or features were discovered within this trench.

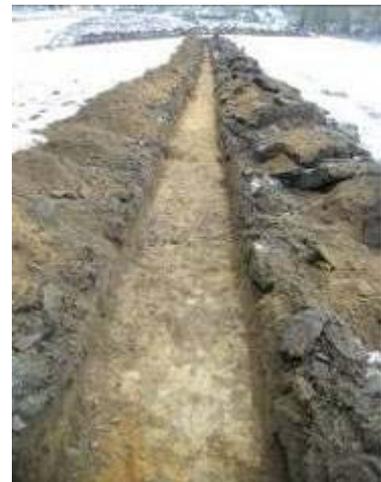
Plate 24. Trench 16 view from the ESE.

Below (006) in the majority of the trench was orangey sandy natural (003). However a patch of gravelly natural (008) was encountered at a distance of 35m from the eastern end of the trench, which continued for 11m.

No artefacts or features were discovered within this trench.

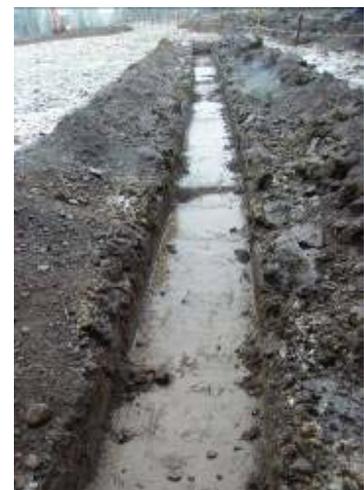
Plate 25. Trench 17 view from the SE.

Topsoil (005) was 20cm in depth, below which was (006) which was 10cm thick. This came down onto sandy silt natural (003).

No artefacts or features were discovered within this trench.

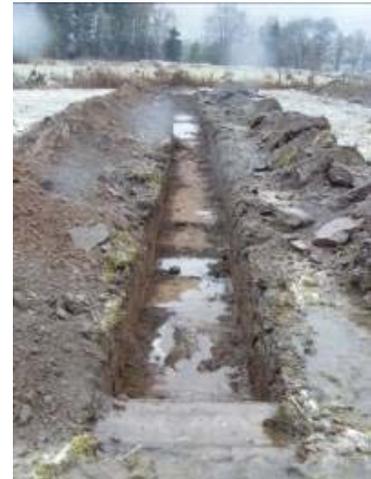
Plate 26. Trench 18 view from the ENE.

Topsoil (005) was 20cm in depth, below which was (006) which was 15cm thick. This came down onto sandy silt natural (003).

No artefacts or features were discovered within this trench.

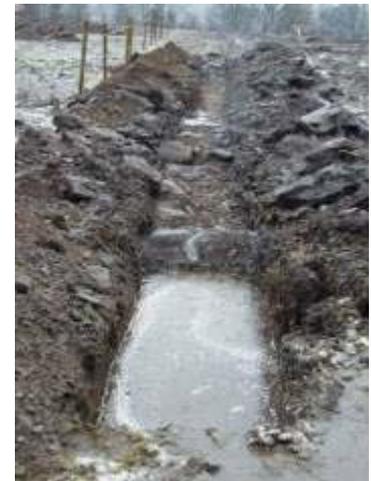
Plate 27. Trench 19 view from the ESE.

Topsoil (005) was 20cm in depth, below which was (006) which was 10cm thick. This came down onto natural gravels (008).

No artefacts or features were discovered within this trench.

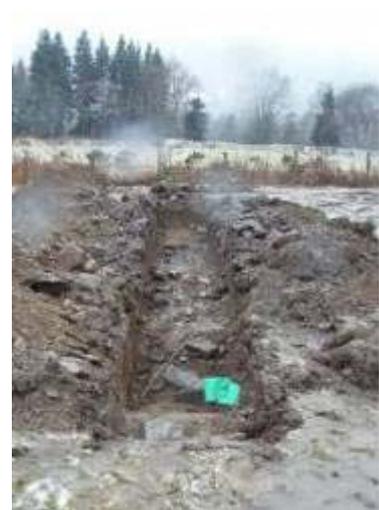
Plate 28. Trench 20 view from the NE.

A modern field drain [020] was located at the eastern end of the trench. The cut for this orange plastic drain measured 40cm in width and was filled with a dark brown sandy silt (021).
