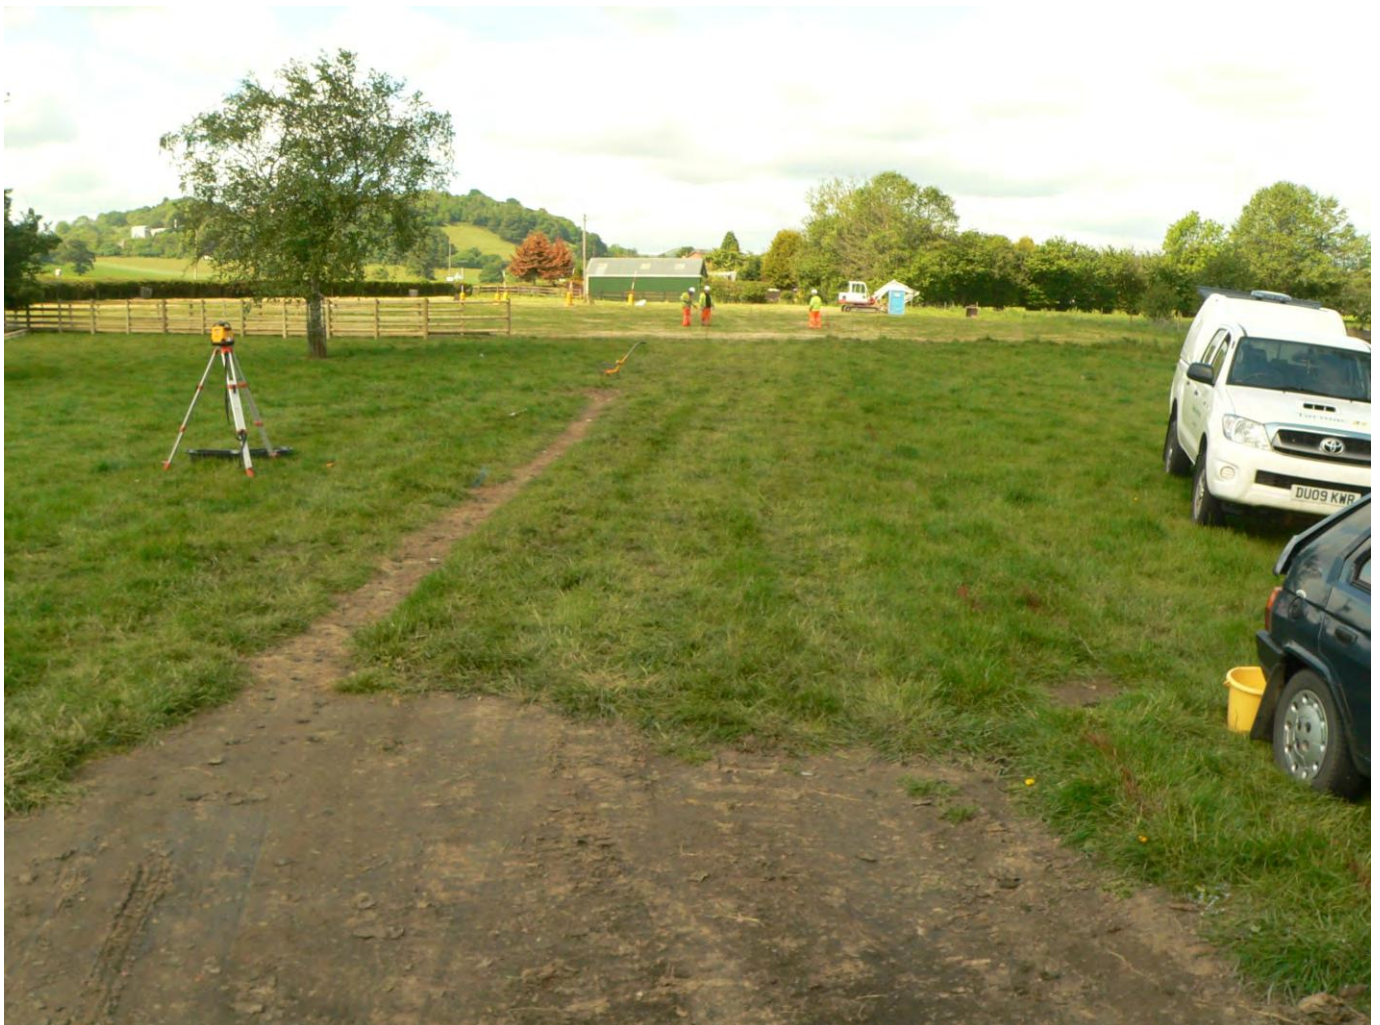
Plate 2 View westwards across the east field from a point in the middle of Plate 1

5.2.2 In the eastern field, the formation level failed to bottom a topsoil profile formed in alluvium undoubtedly deposited by the nearby stream (Plates 7 & 8). No features cut this alluvium apart from a post-medieval field boundary ditch [502] c.

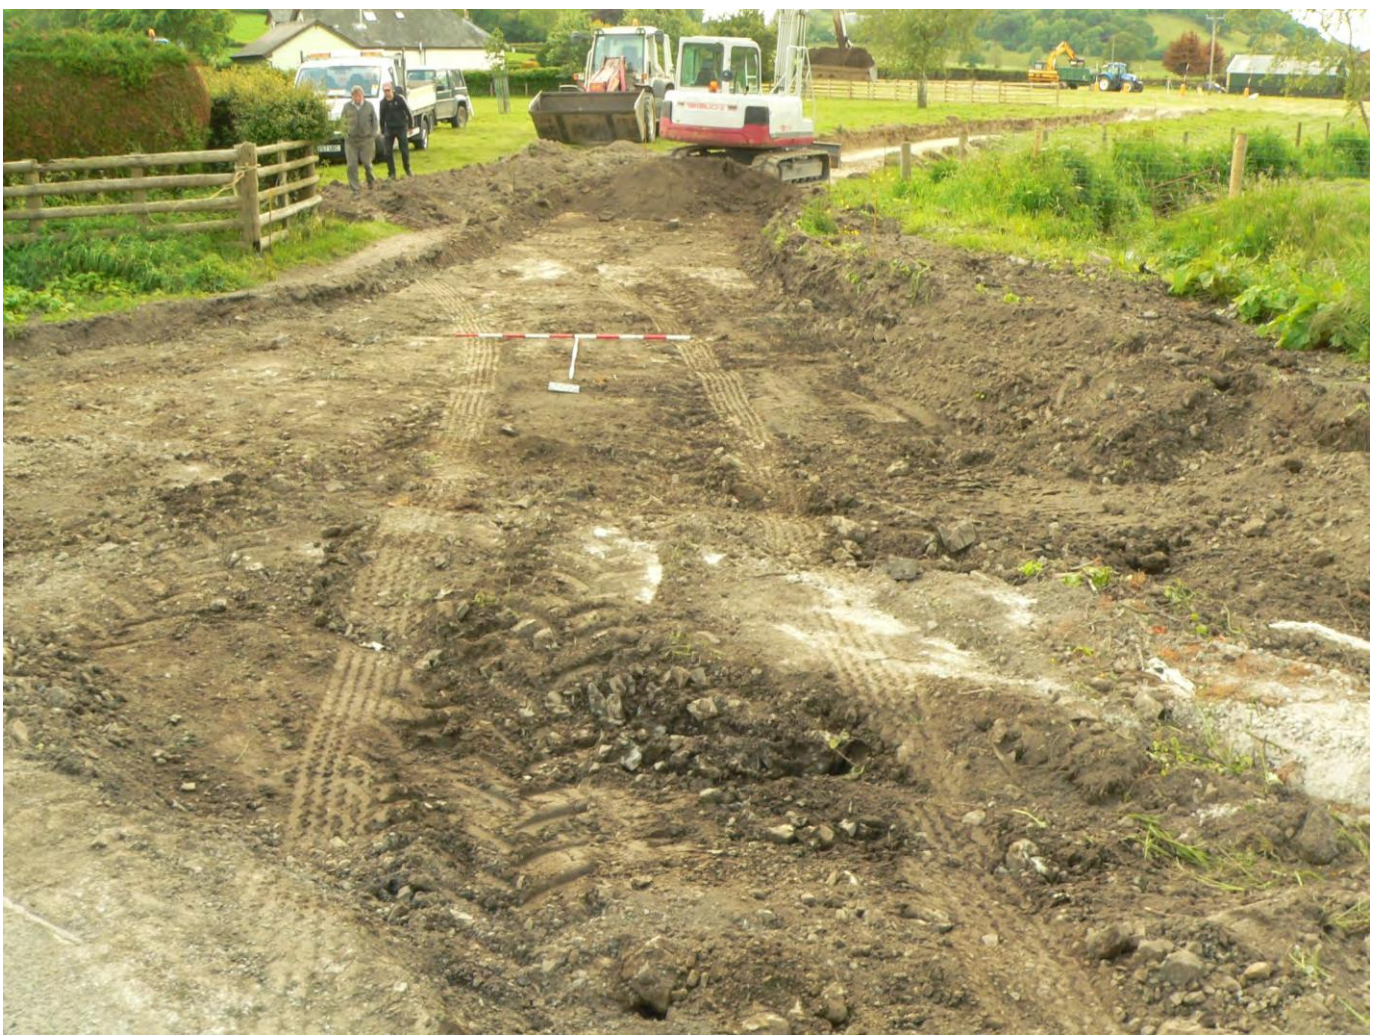
**Plate 5 Splay / junction at the far east end of new road showing the intended formation level .
The trench shown on Plate 6 is just to the right of the scales**

5.2.1 The conclusions about the depth of machining (para 5.1.5 above) proved to be true except at the east end of the corridor alongside the stream (Plate 5). Here, a small trench was dug through soft peaty ground to find something firmer (trench shown as dark grey on Fig. 3 and see Plate 6). Various jam jars, bottles and part of a WW II gas mask were found at the base of the ground works. The dig was then widened to take out all the peaty material (extent shown in light grey on Fig. 3). The peaty deposits would seem merely to have been part of the pre-1989 stream course.

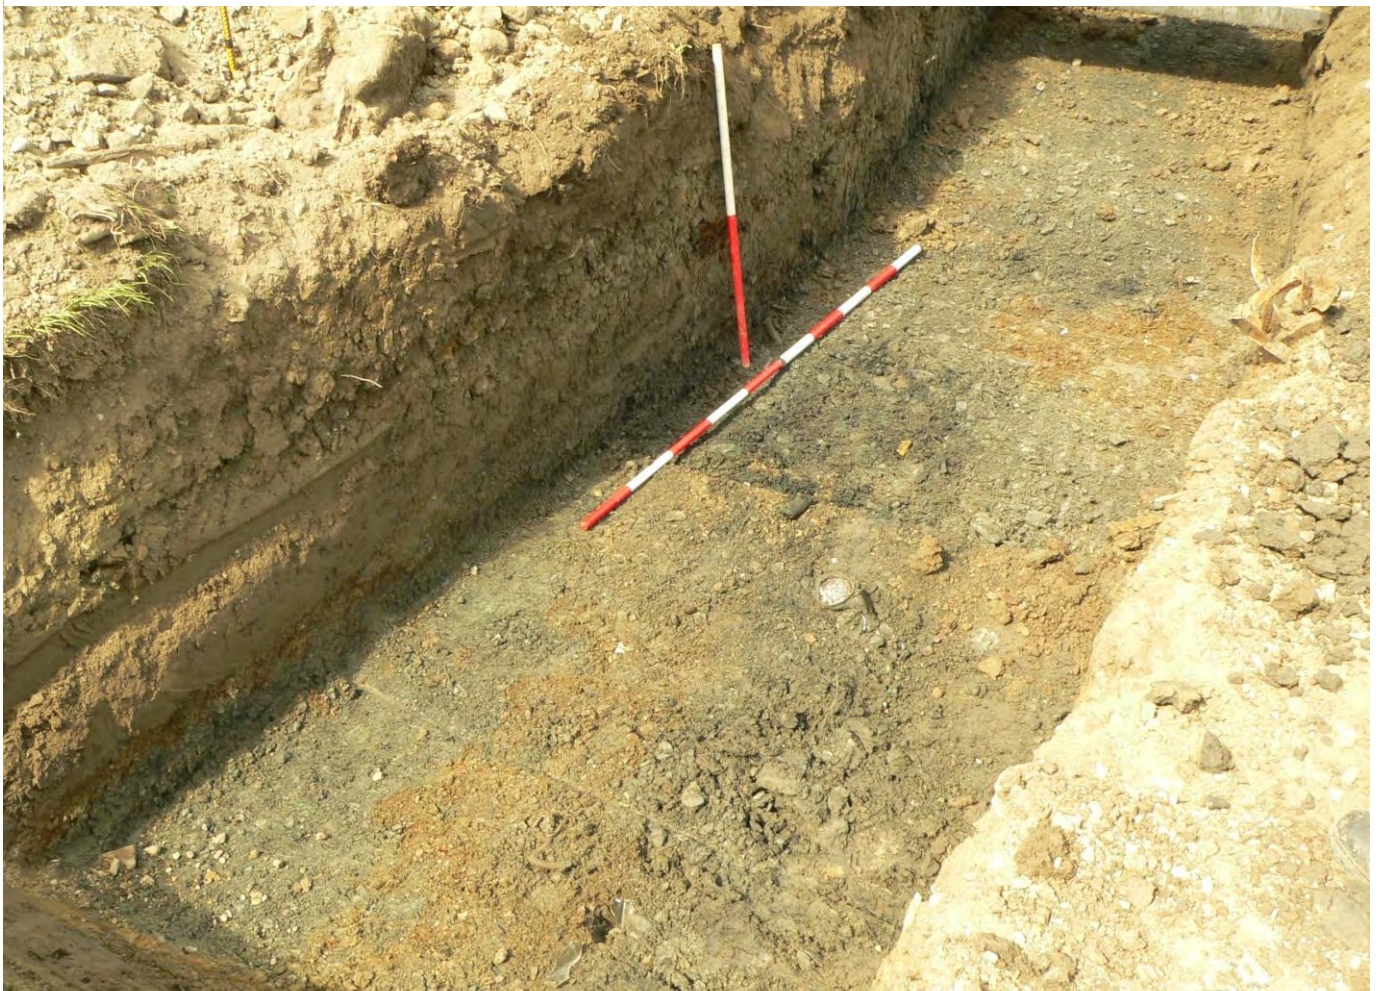
**Plate 6 Test trench to examine old stream bed.
Jam jars and parts of a Second World War gas mask were found at the base of the trench**

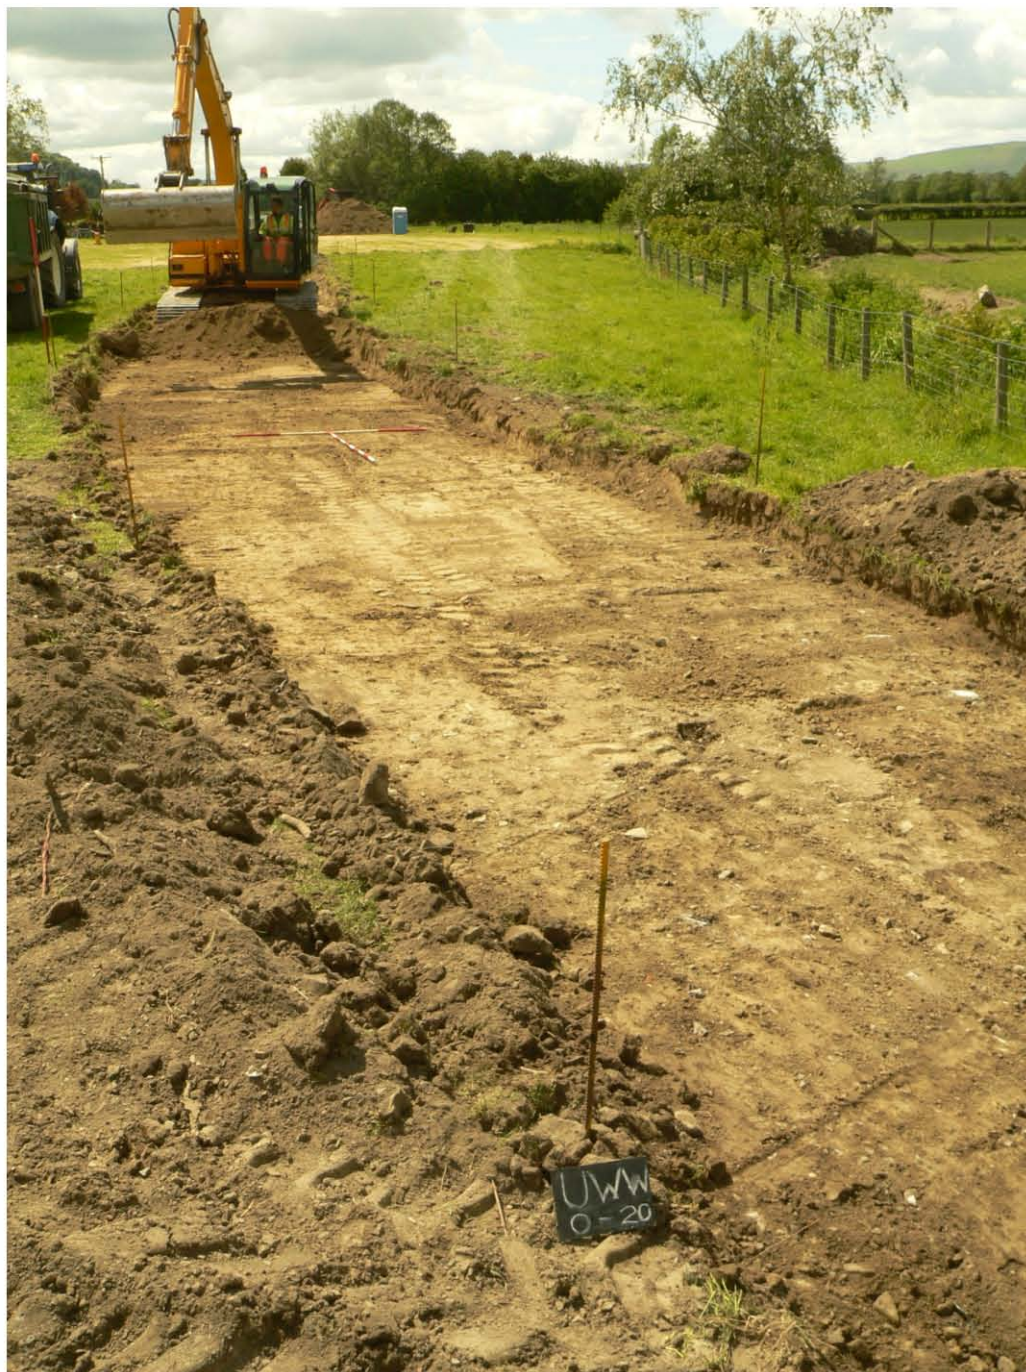
**Plate 7 East field, east part - formation level from Zero to 20 metres (west)
note the base of machining is still very much in alluvial topsoil**

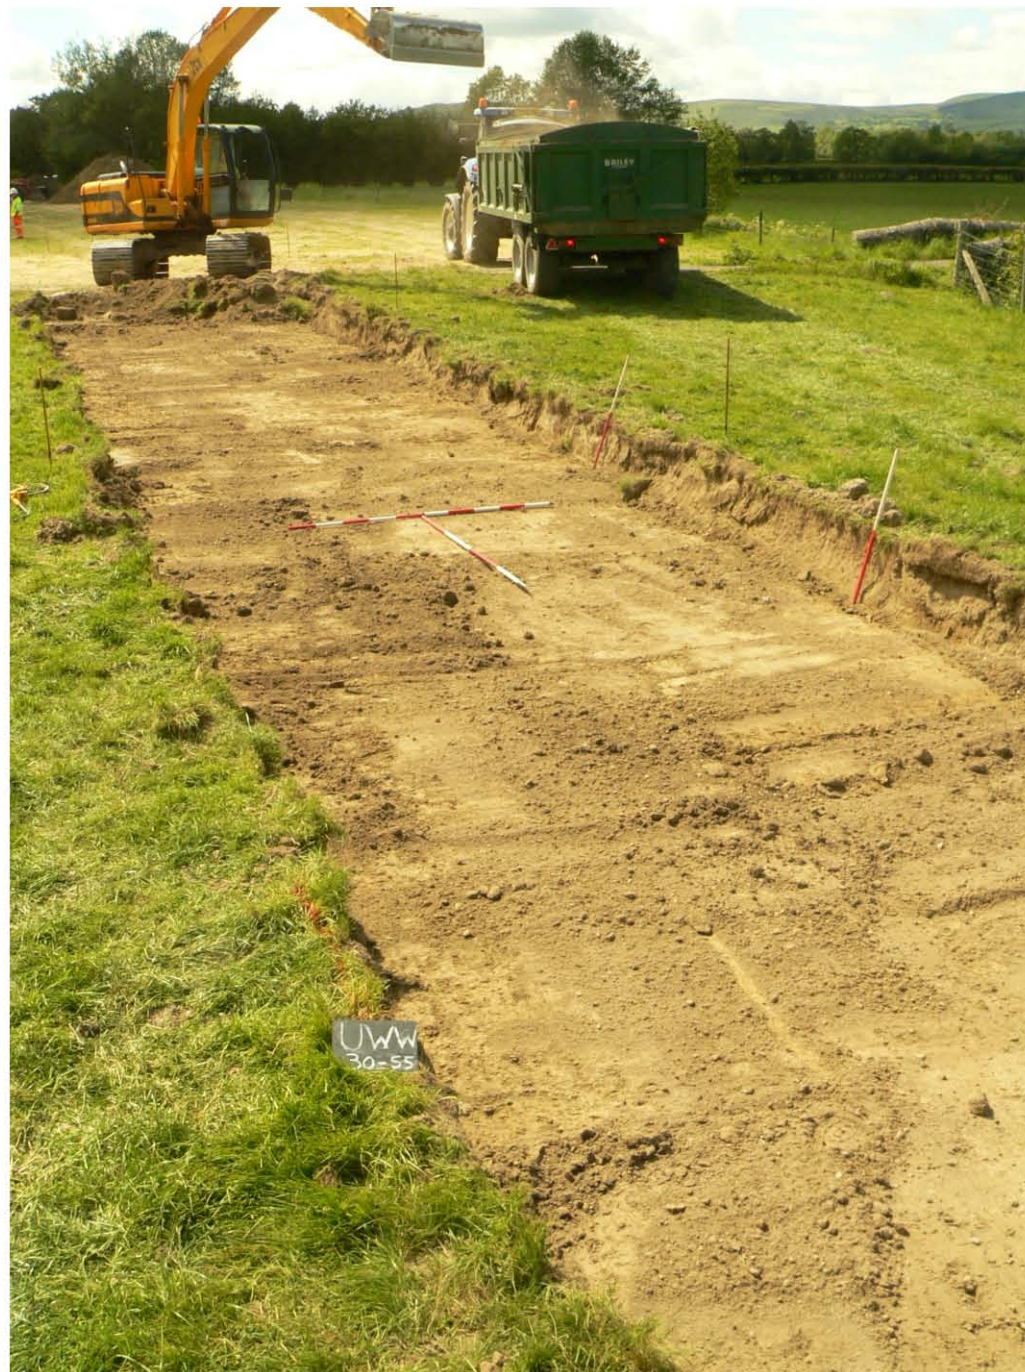
**Plate 8 East field, west part - formation level from 30m to 55 metres (west)
again, note that the base of machining is still very much in alluvial topsoil**

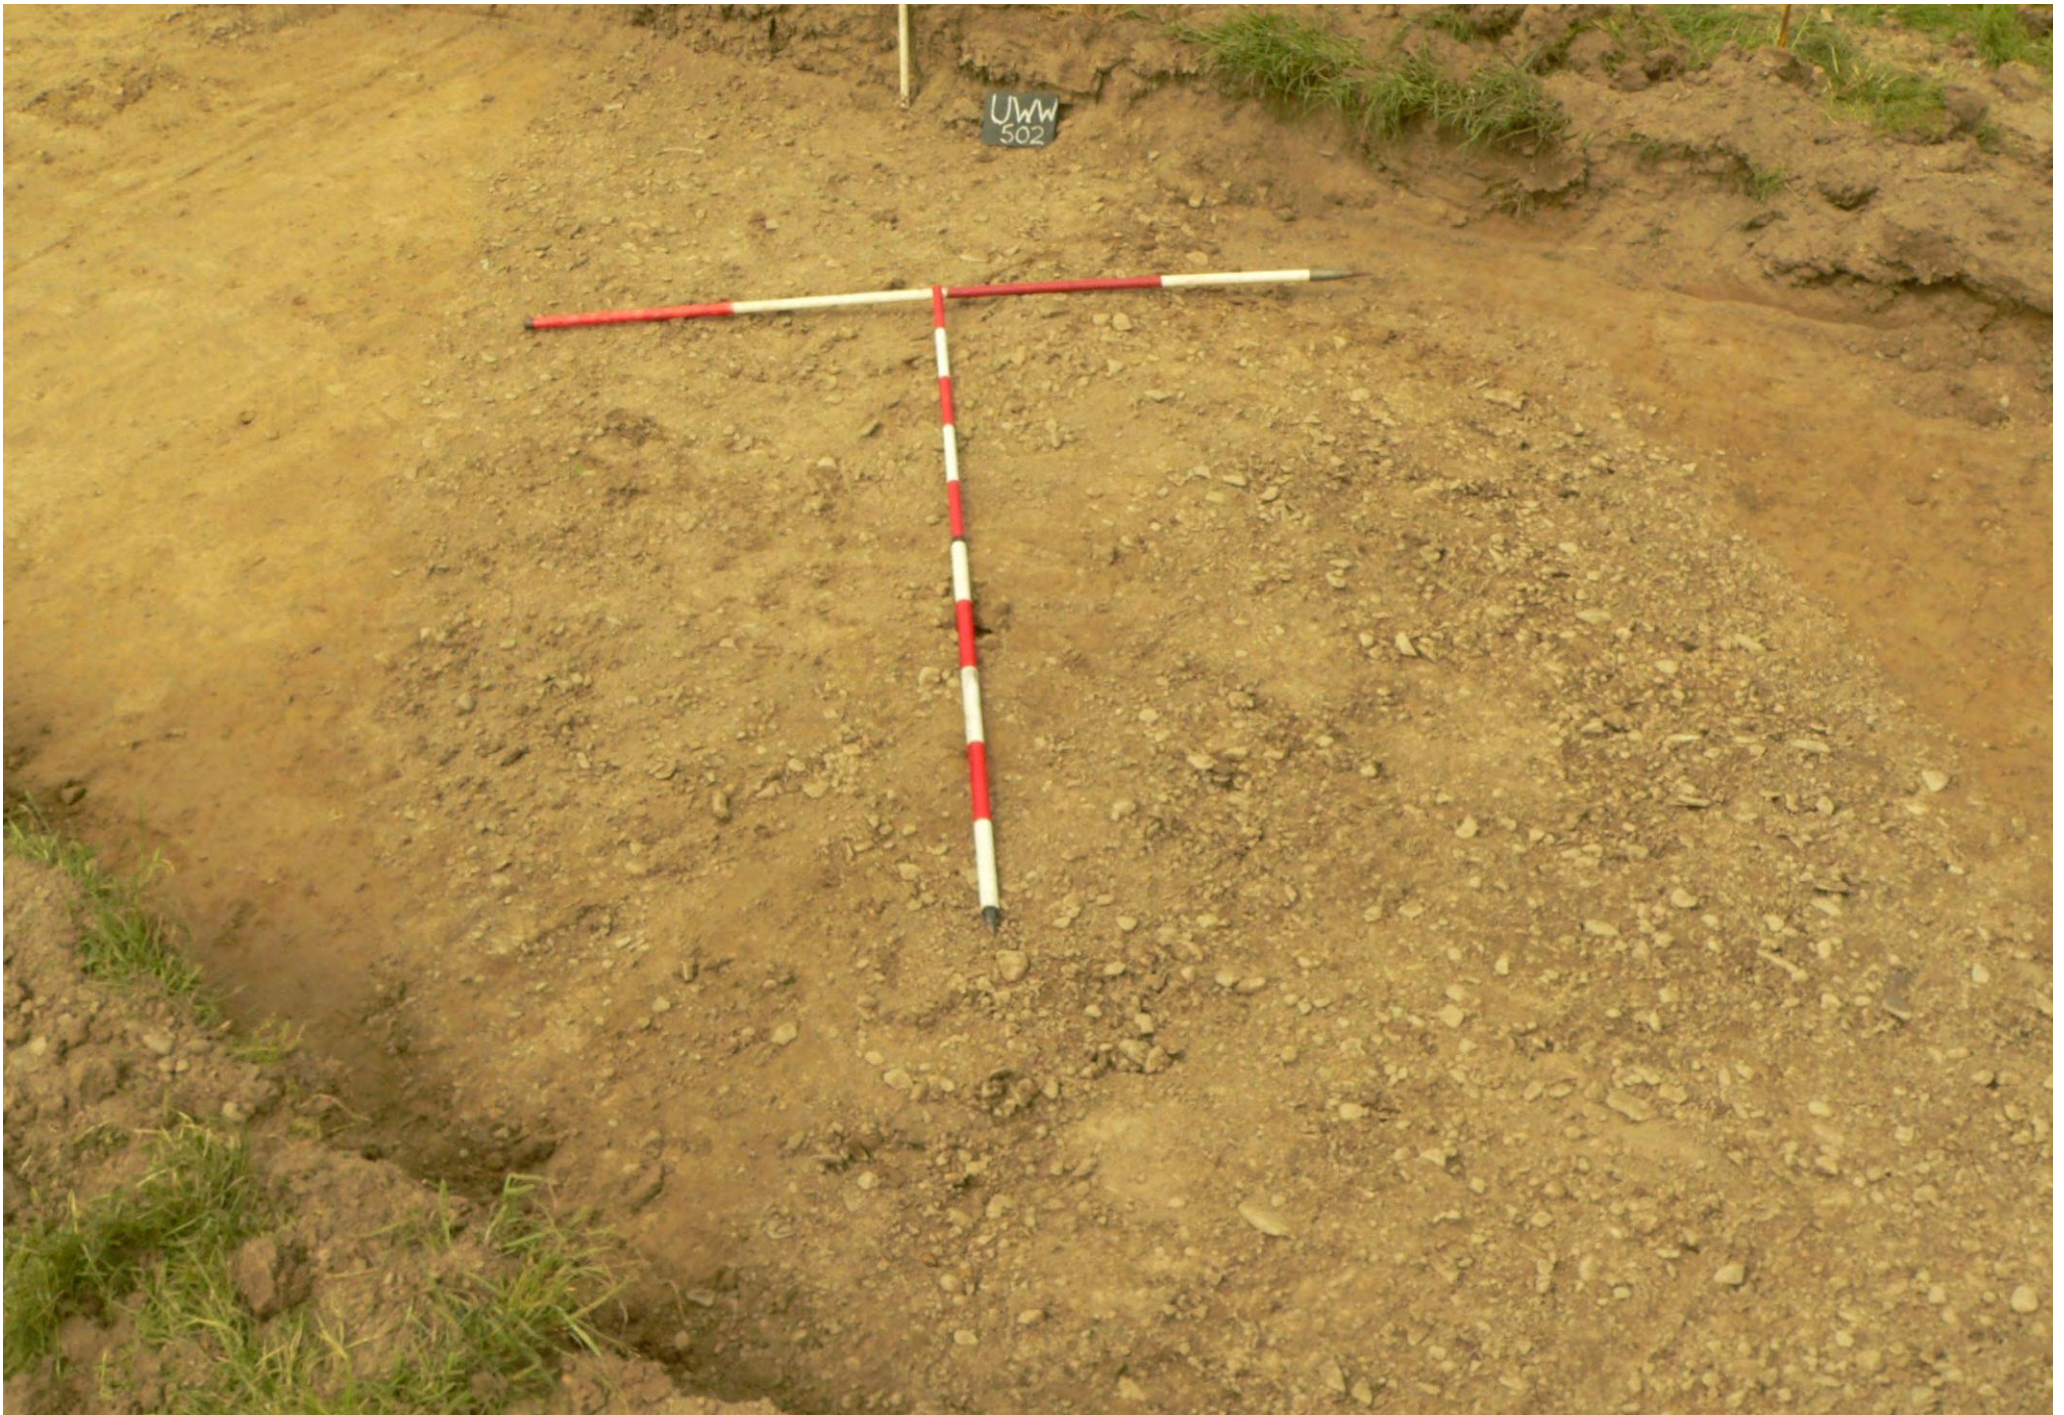
**Plate 9 East field, mid part - recent ditch [502] cutting topsoil at formation level at c. 30m (west)
note that the base of machining to either side of [502] is still very much in alluvial topsoil**

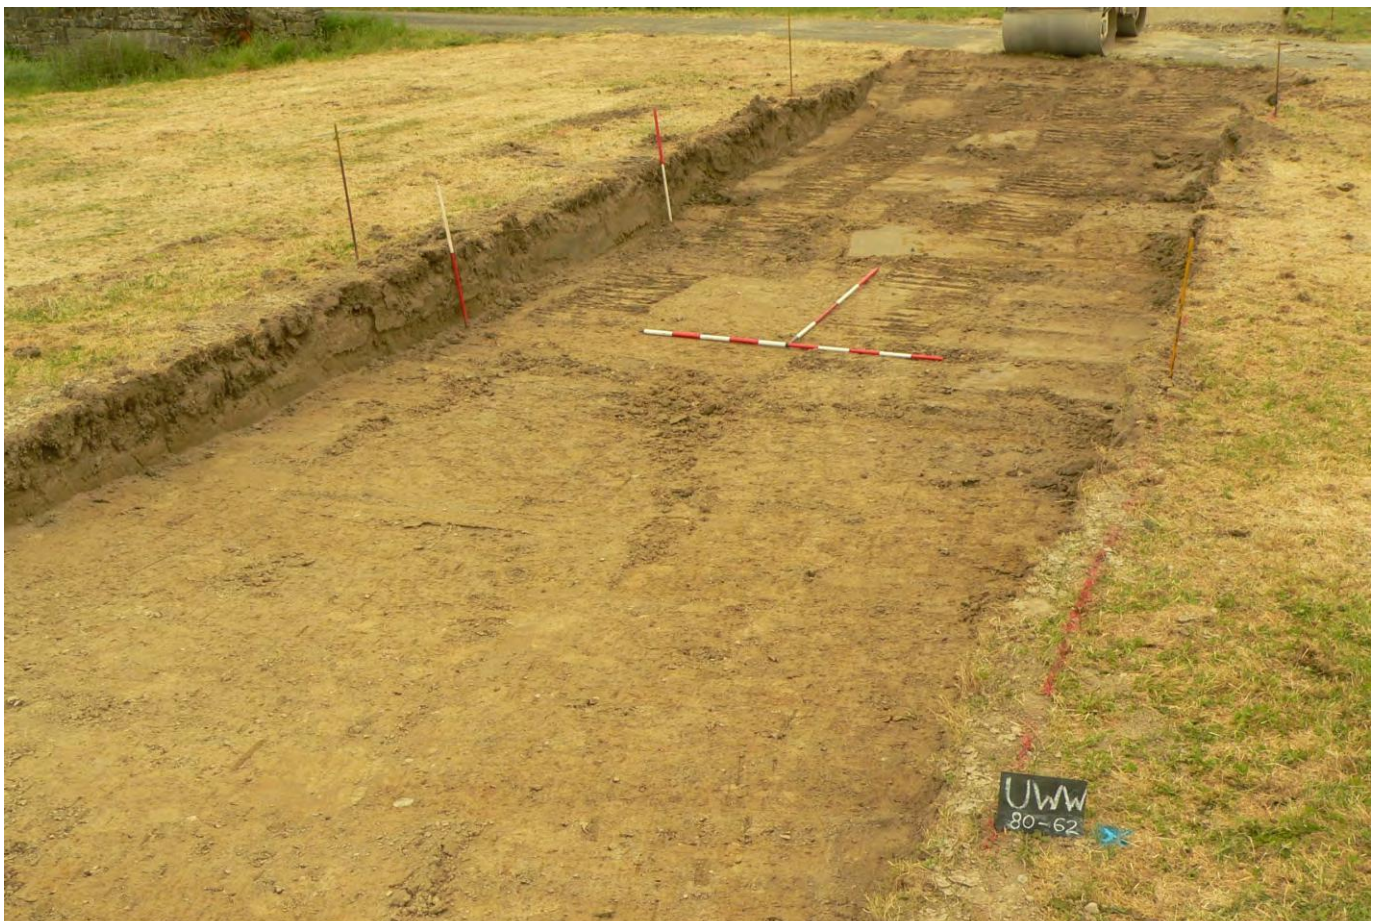
Plate 10 West field - finished formation level from 80 eastwards back to 62 metres west showing largely alluvial topsoil in base of roadline (the roller is sitting on the school driveway)

5.3.1 The alluvium extended to the west of the central driveway (leading to Womaston School) into the west field for about c. 35m. (Plates 10 to 12). Just before this, a ditch [504] was found cutting the lower alluvium. It showed clearly as a pit on the south side of the trench becoming a damp patch on the east side (Plate 13). It was undoubtedly the fairly recent ditch still open in 1962 (Fig. 4) but filled in by 1972 (Fig. 5)

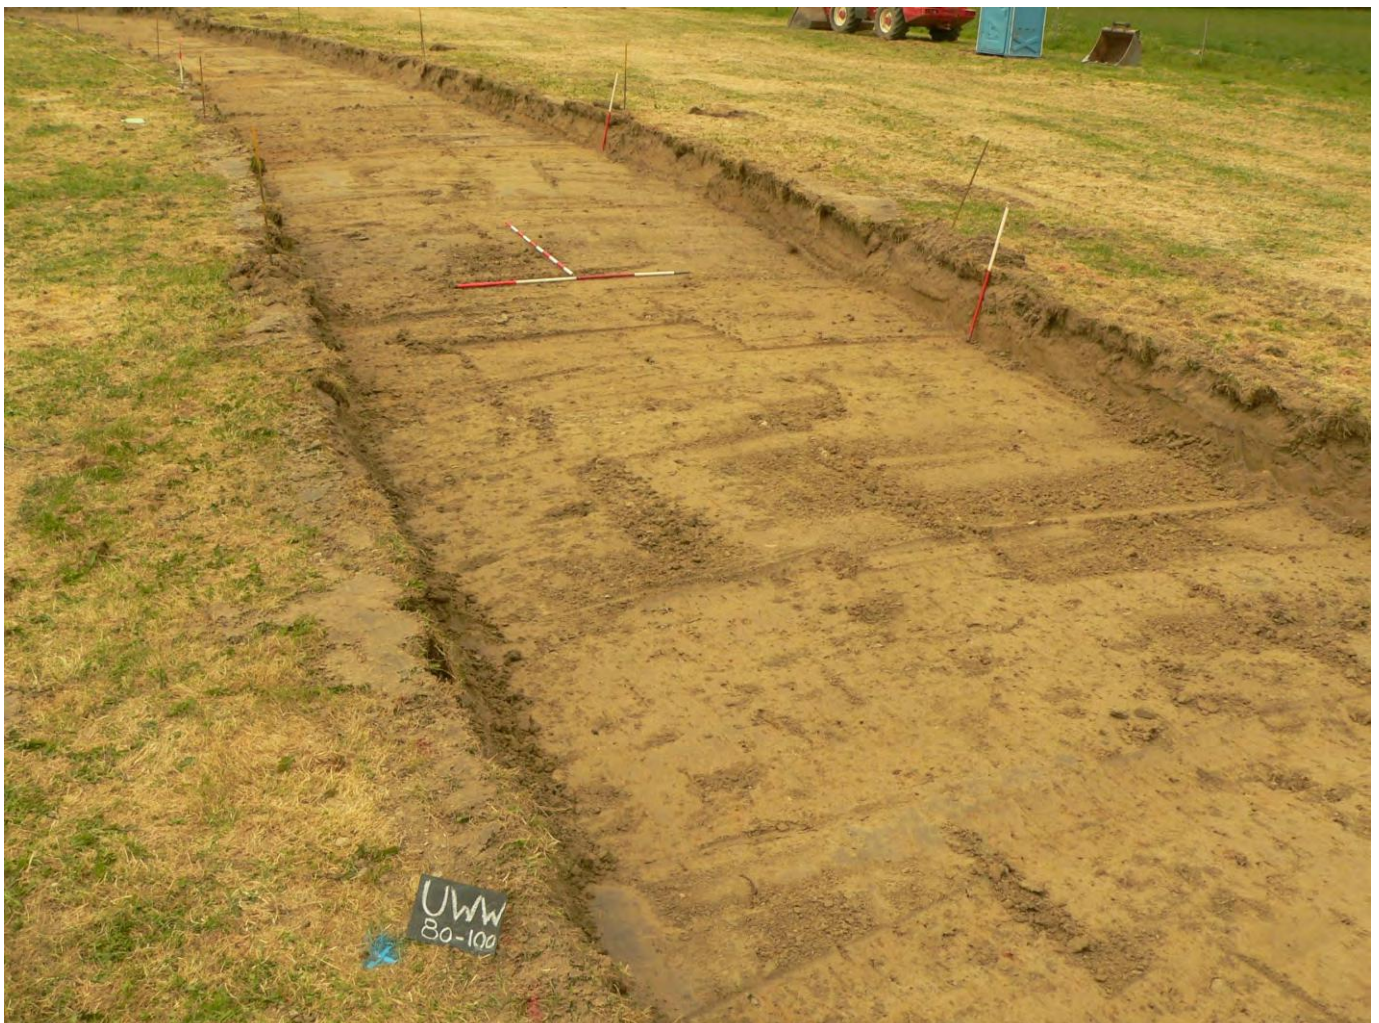
Plate 11 West field - finished formation level from 80 to 100 metres west showing largely alluvial topsoil in base of roadline - pit f 504 (see Plate 12) is framed by the photo scales

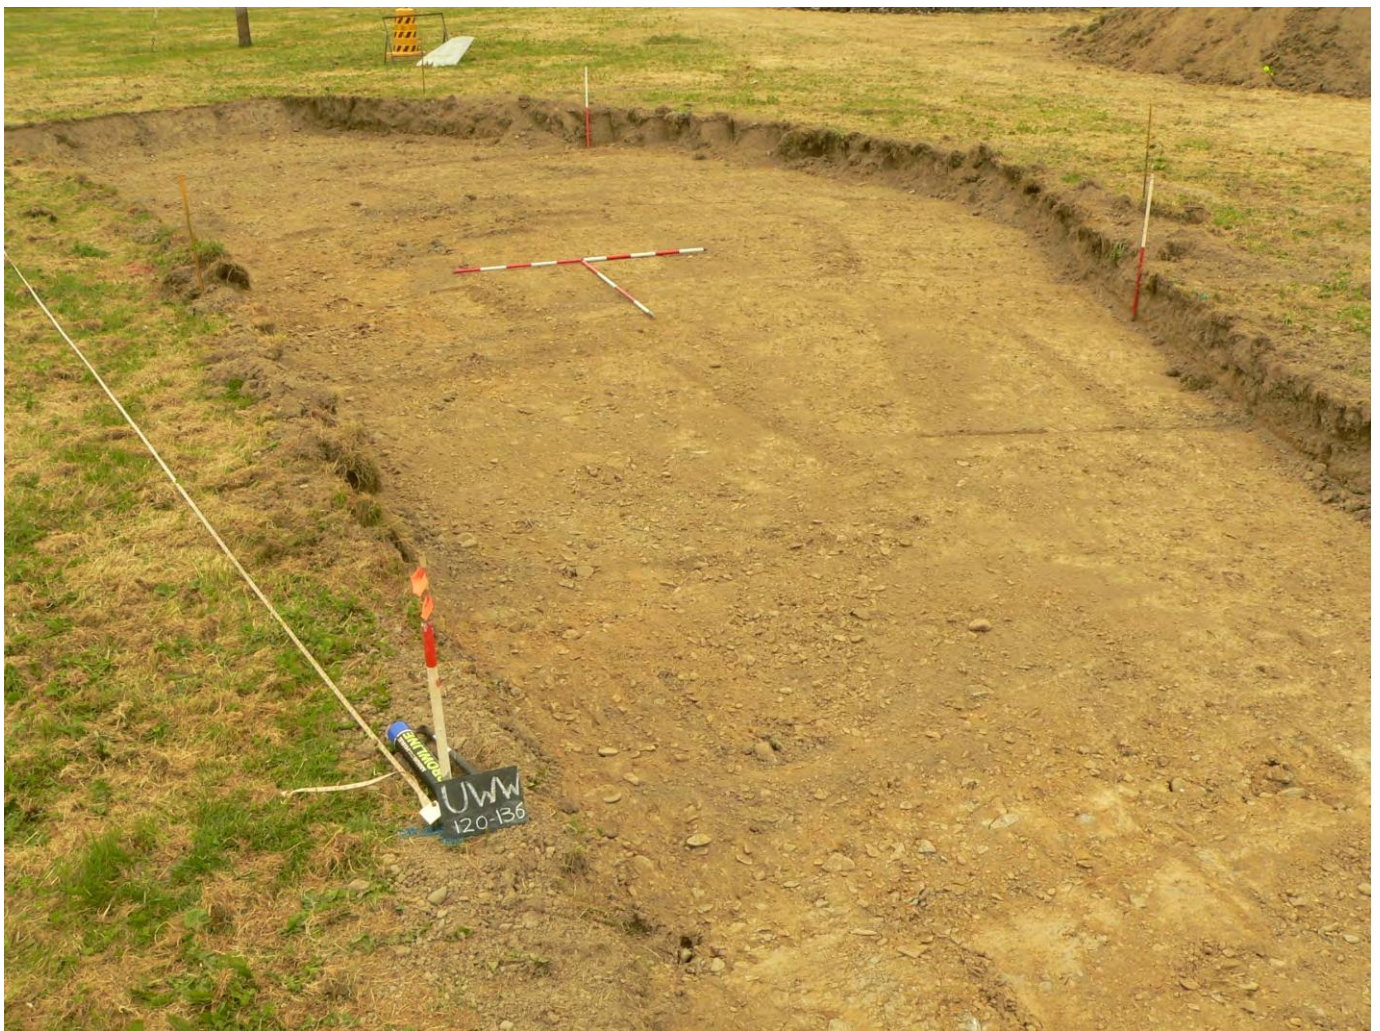
Plate 14 West field - finished formation level from 120 to 135 metres west base of trench again largely alluvial topsoil except for a small area of gravel subsoil in mid foreground

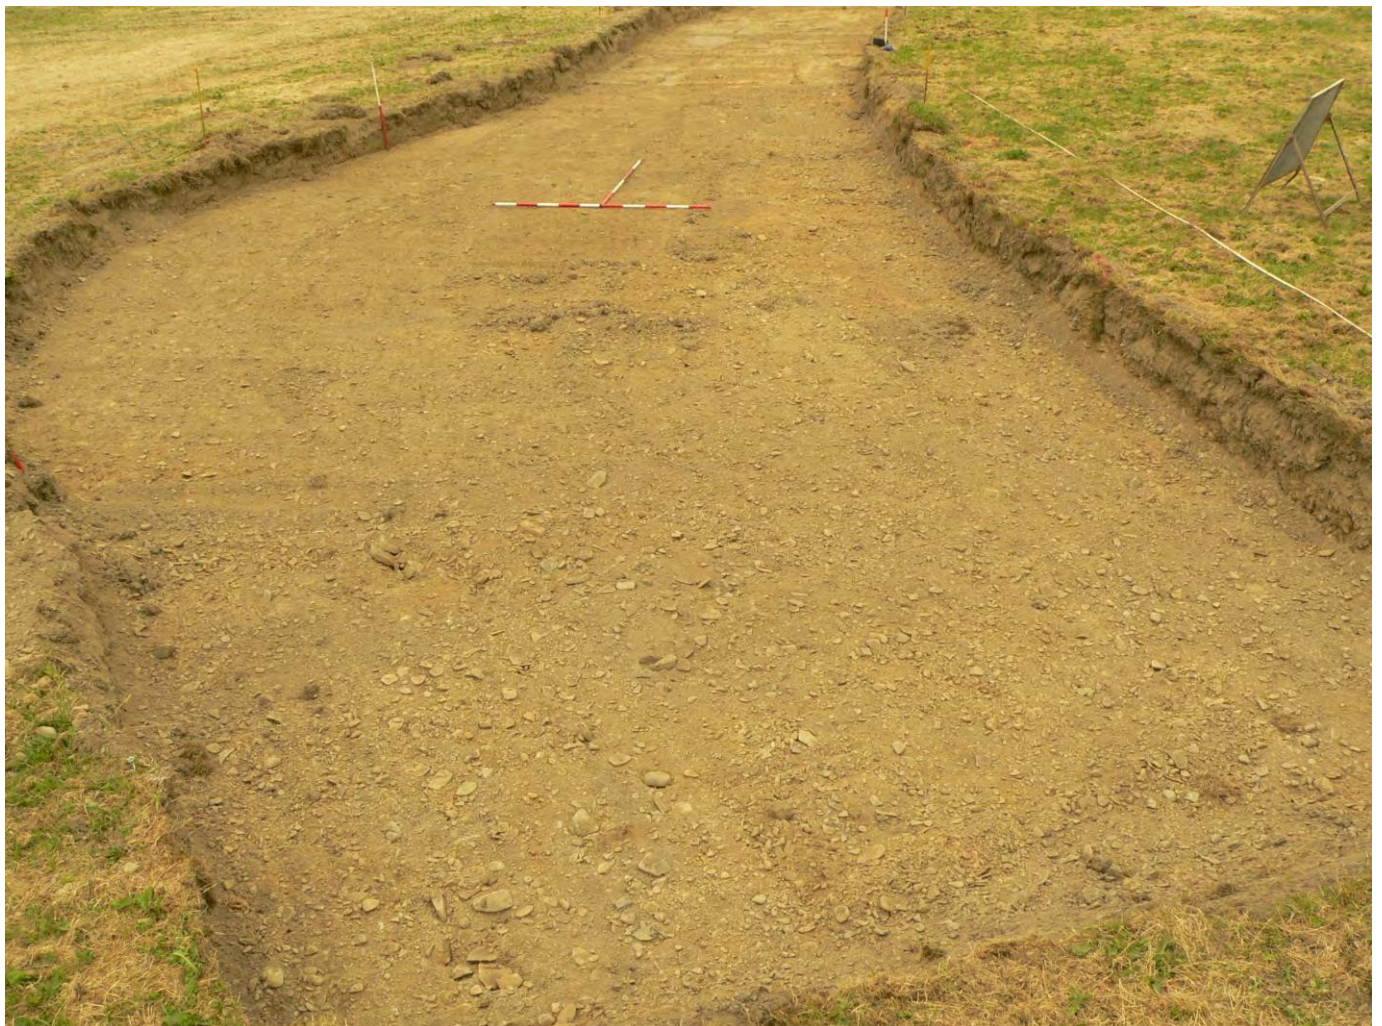
Plate 15 Same area as Plate 14, but the reverse view from 135m west to 120 metres showing a patch of orange subsoil to the right of the photo scales and only alluvial topsoil elsewhere

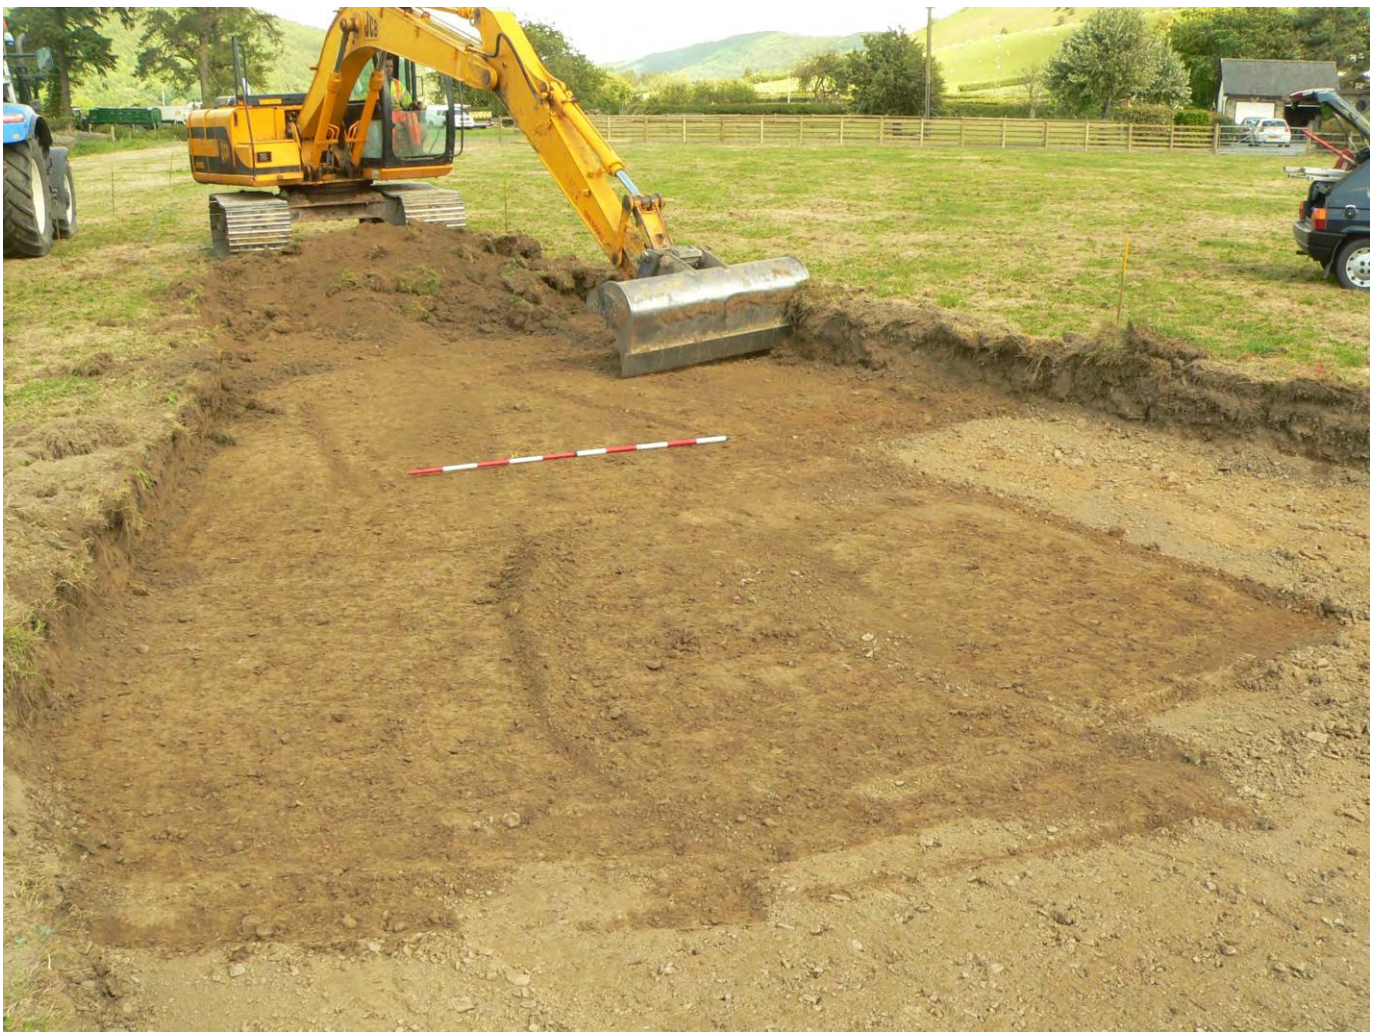
Plate 16 West field - finished formation level from 160 back to 135 metres west base of trench now largely still well within the lower part of the ancient cultivation topsoil

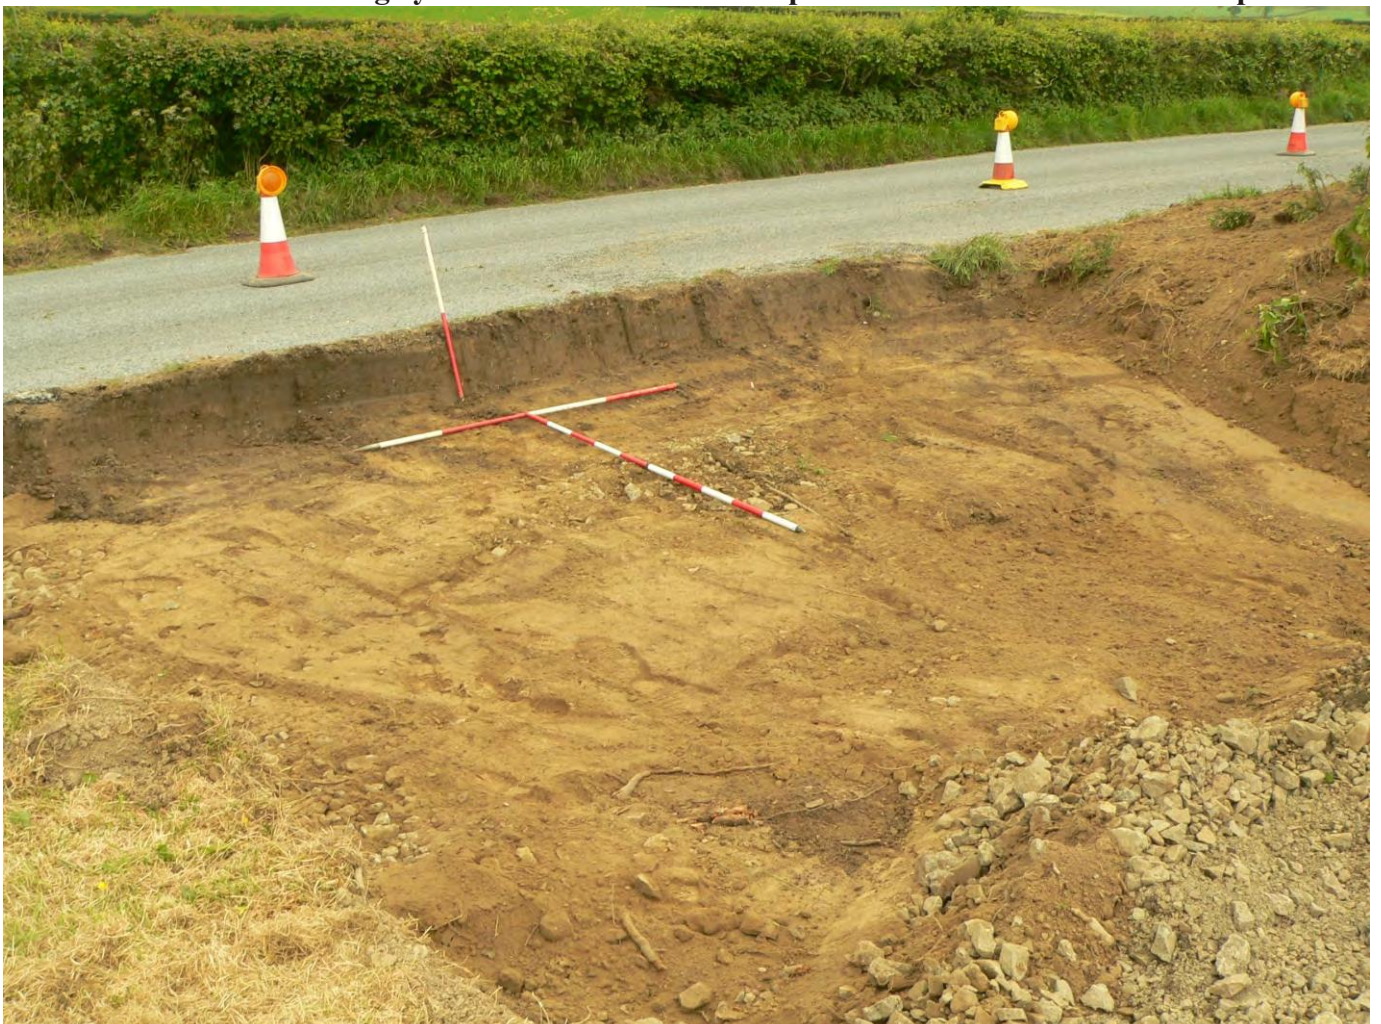
Plate 17 The western entranceway onto the B (1 metres to 1 metres west) base of trench still very much within the ancient cultivation topsoil profile

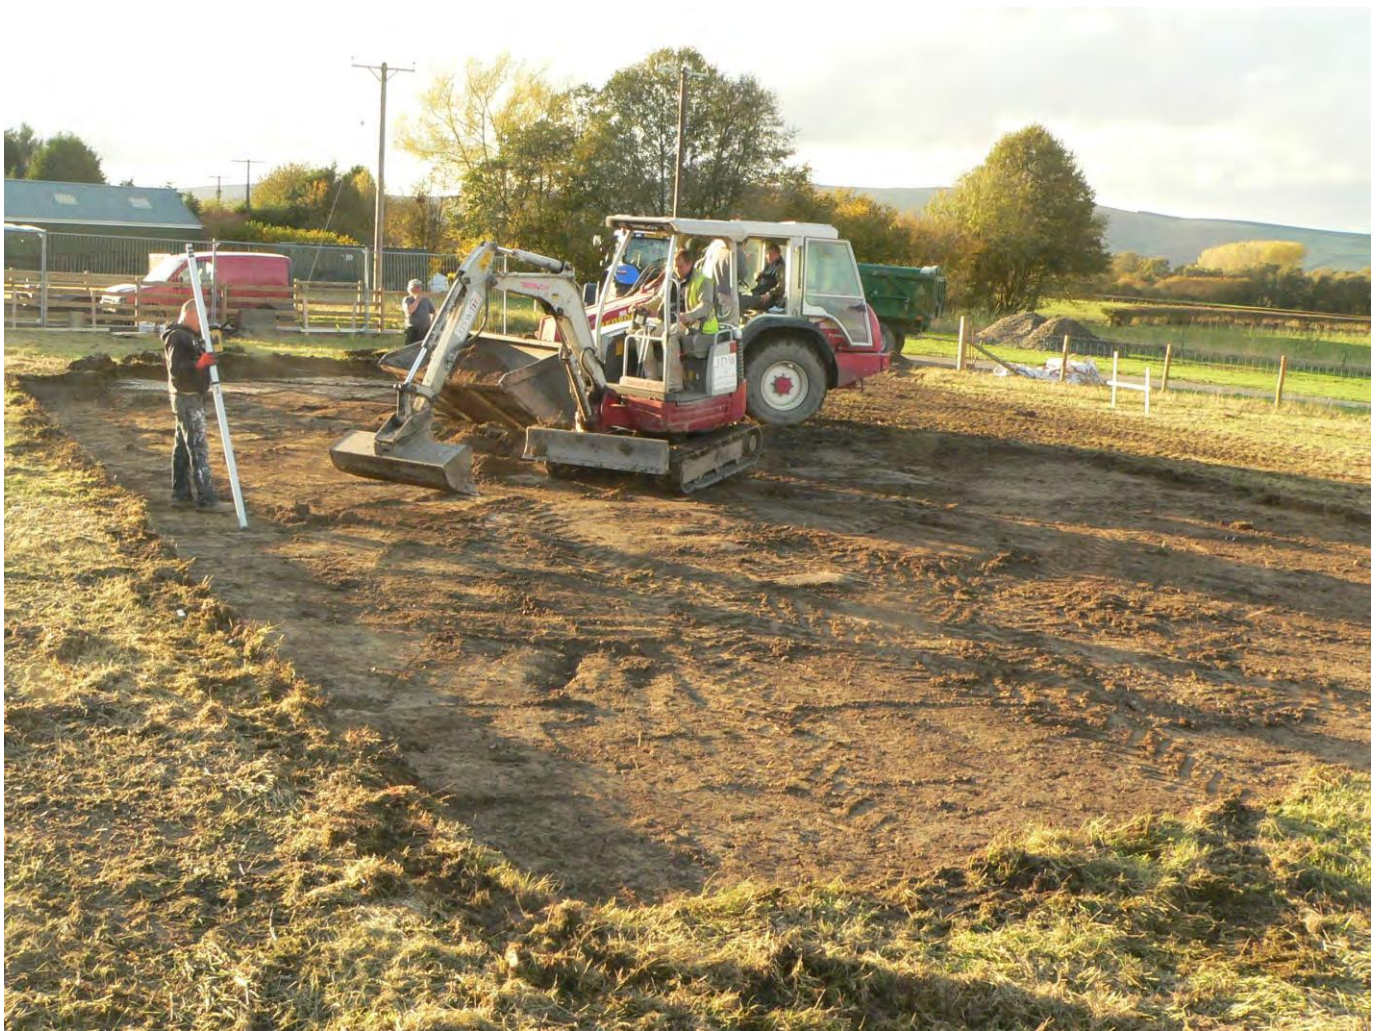
Plate 18 House 1 footing being topsoiled

5.3.3 Nothing of any significance whatsoever was revealed in the ground works for the two new houses (Plates 18 to 21).. Again, these rarely reached the subsoil.

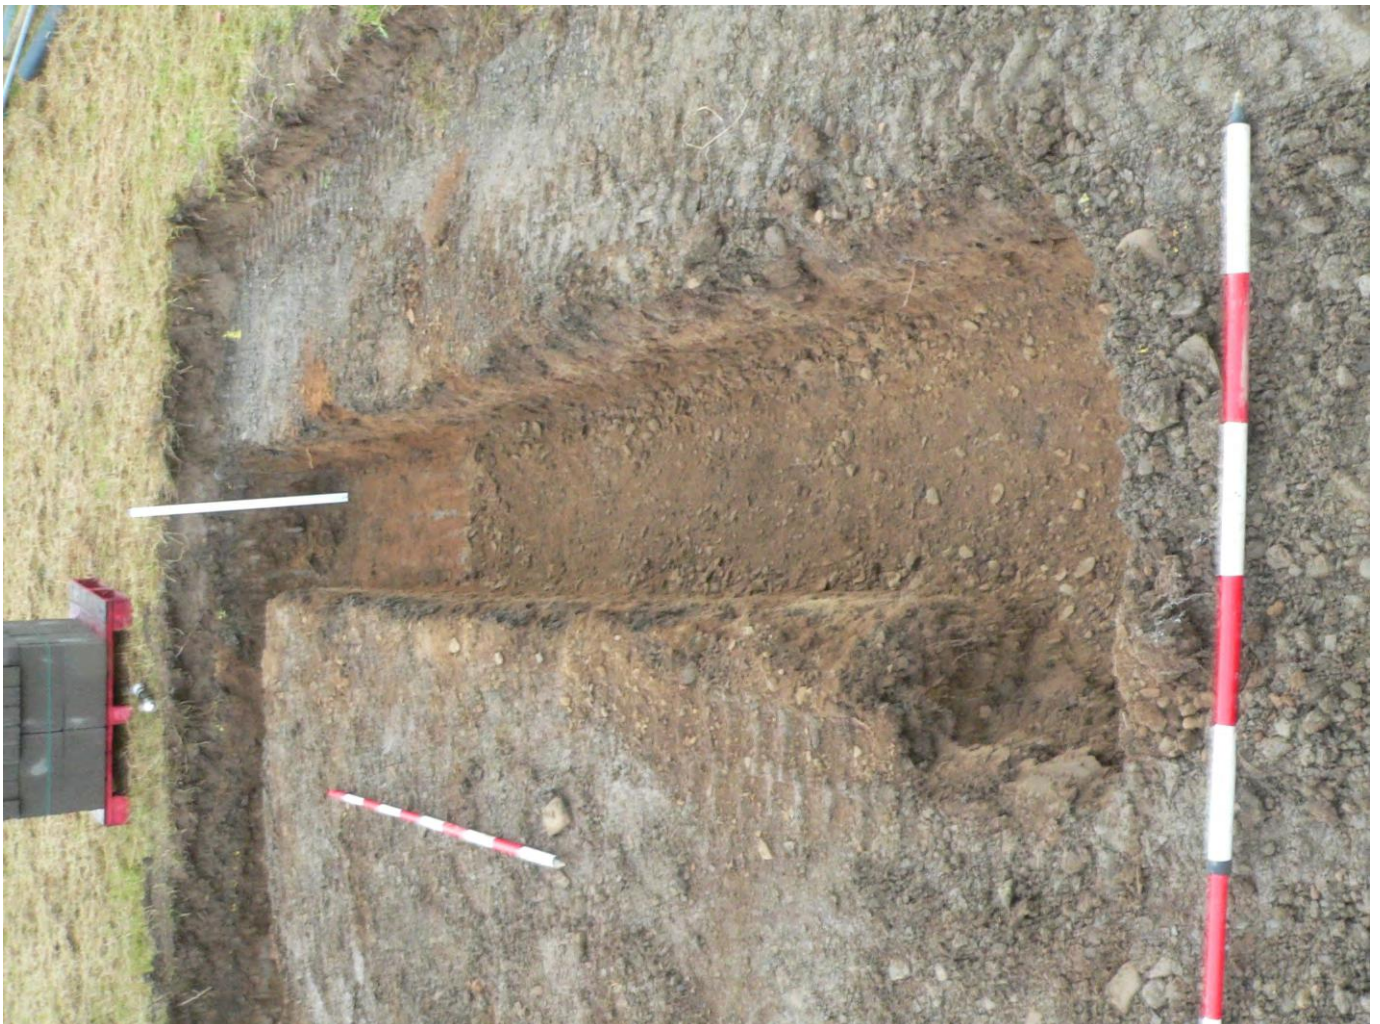
Plate 19 House 1 footing - east side, showing medieval cultivation soil in base
