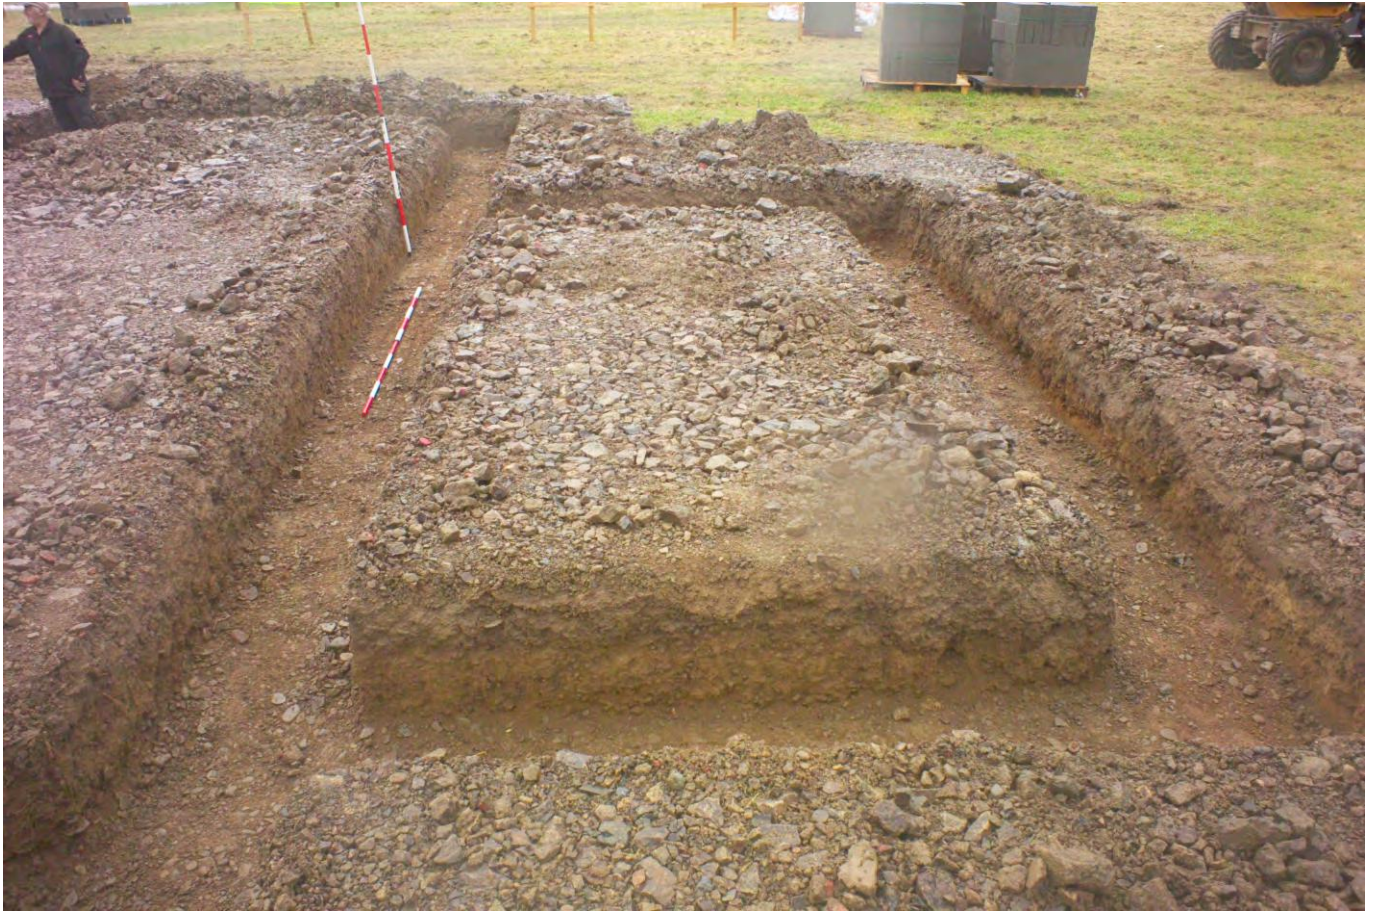
Plate 20 House 2 footing - east side, again showing only medieval cultivation soil in base

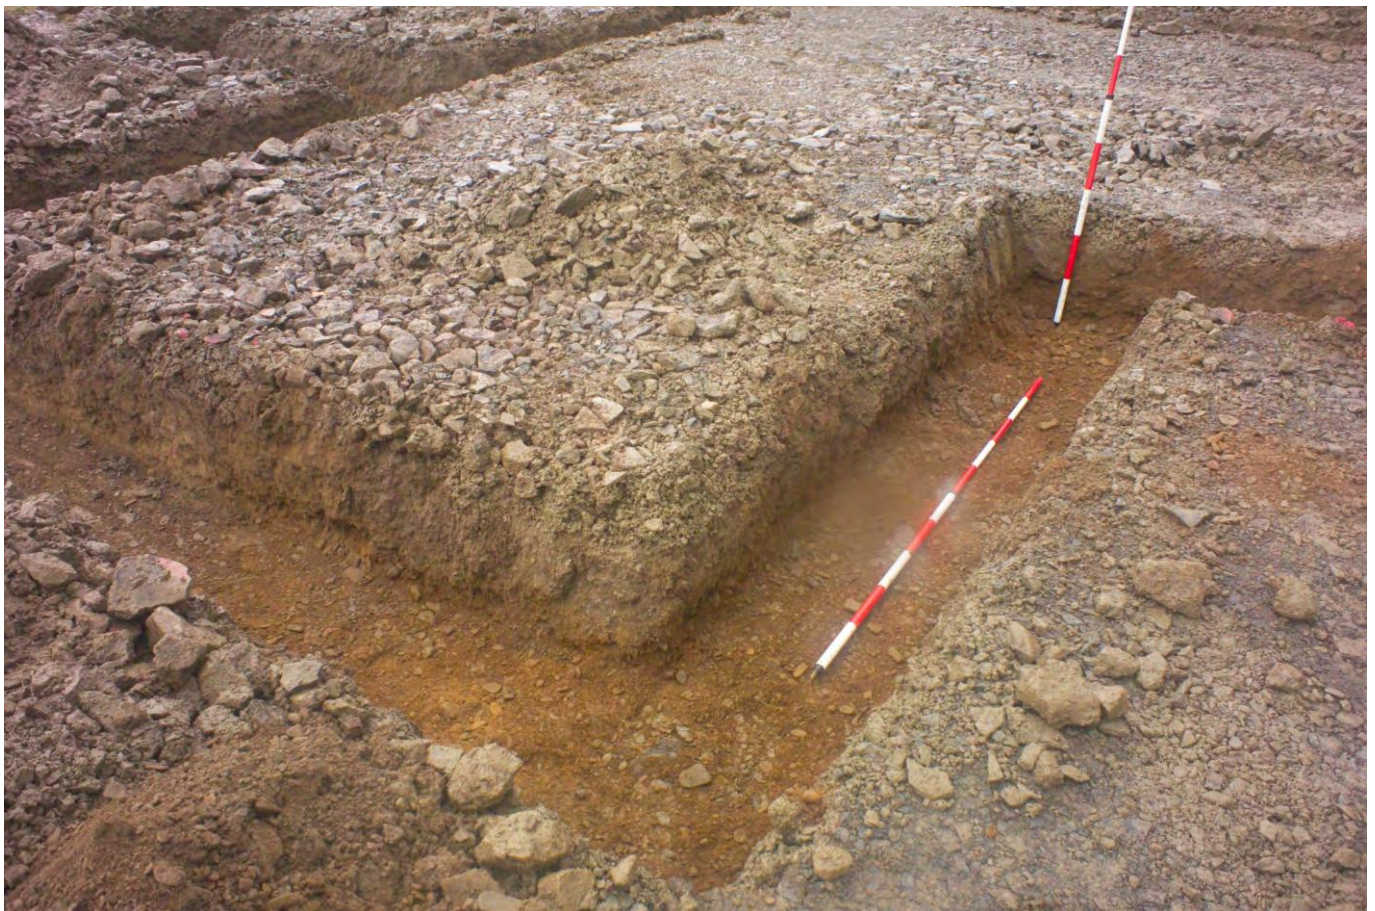
Plate 21 House 2 - mid part showing some clean subsoil in base
