ARCHAEOLOGICAL EVALUATION

INNS COURT, KNOWLE WEST, BRISTOL.

Housing Services Directorate, Bristol City Council.

BA/F323

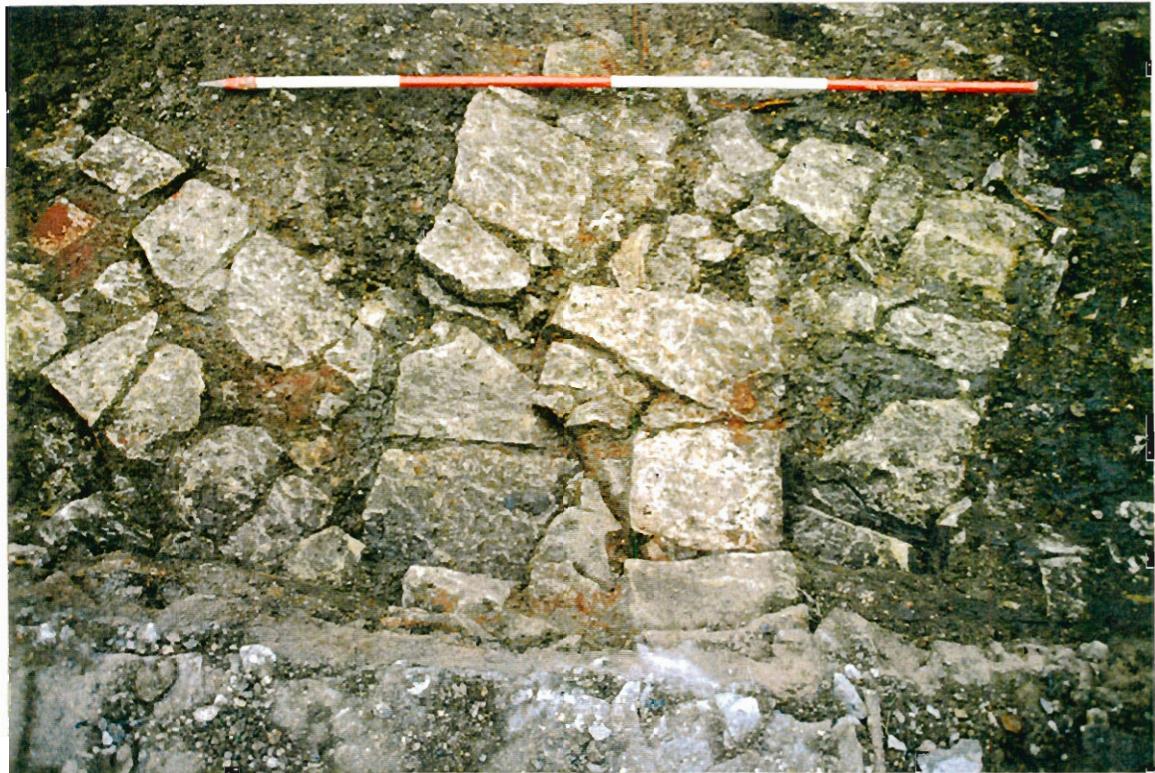
Plate 1 Trench 1 - wall 111 and the corner of walls 112 and 113, looking east

An east/west wall (111; 57.20m OD) survived in the west half of the trench but appeared to have been destroyed to the east by modern cut 107. Wall 111 was bonded with light brown or red clay and had an offset on its north side. A sherd of 14th century pottery was contained within the clay bonding of the wall. The wall was sealed below layers 102 and 103 while the construction trenches for the wall (119 & 121) cut layer 105 and the underlying Roman layers 115 and 116. A layer of brown, gritty clay containing many Lias limestone fragments (118) abutted the wall to the north, was sealed by layer 103 and in turn sealed foundation trench 119 and may have been the construction layer for wall 111. Layer 118 contained a sherd of 17th century Wanstrow pottery. It seems likely that wall 111 was post-medieval in date and may have been constructed in the 17th century.

Wall 111 had been built partly through and partly over the corner of a building which was on a completely different alignment to the medieval and post-medieval structures of Inns Court. The foundations (walls 112 & 113) of this earlier building were made of Lias limestone bonded with a reddish to light brown clay, and were approximately 0.6m wide. Wall 113 terminated, apparently intentionally, some 1m to the south-east of the corner of the building.

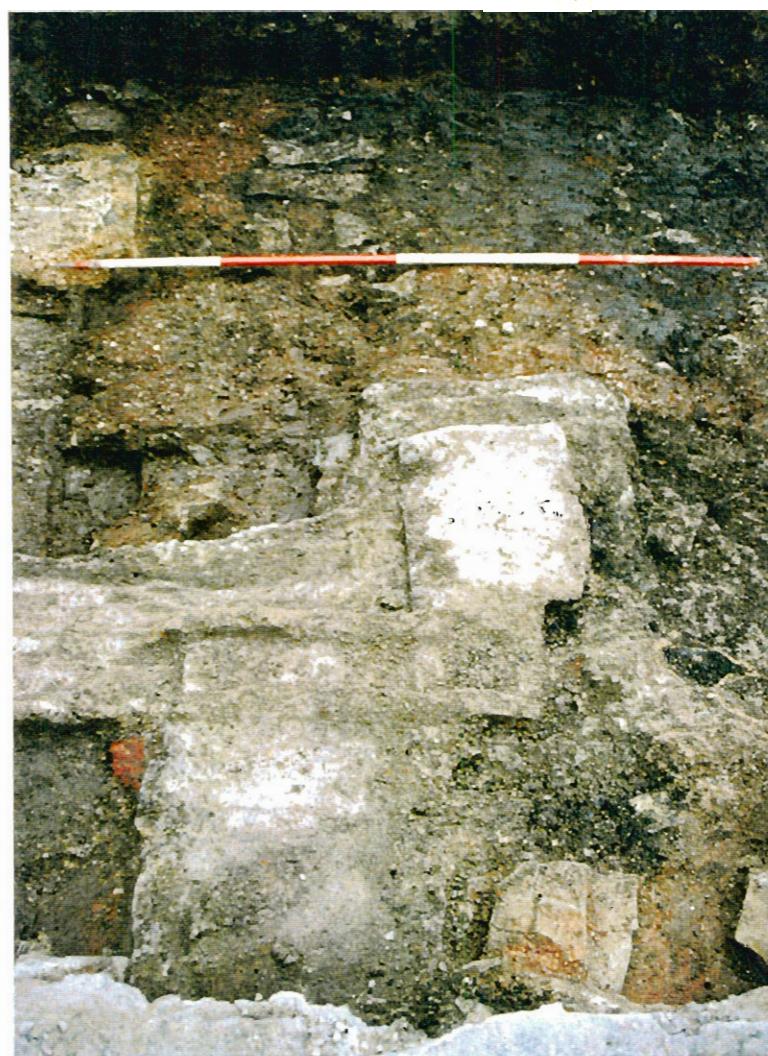
Plate 2 The corner of wall 110 (bottom, right), feature 114 (top, centre) and the area of concrete foundation 106, looking west

The possible south-west corner of the Inns Court manor house was represented by wall 110 (57.10m OD), built of Lias limestone bonded with a friable pinkish/red mortar, and without any apparent foundations, being built directly on the underlying Roman occupation. This wall turned north along the east section of the trench where it had been damaged by the modern pipe trench 109. There was no direct dating evidence for this wall although the mortar appeared to be the same as that used in the standing south wall and stair turret of the manor and therefore most likely dates to the 15th/16th century.

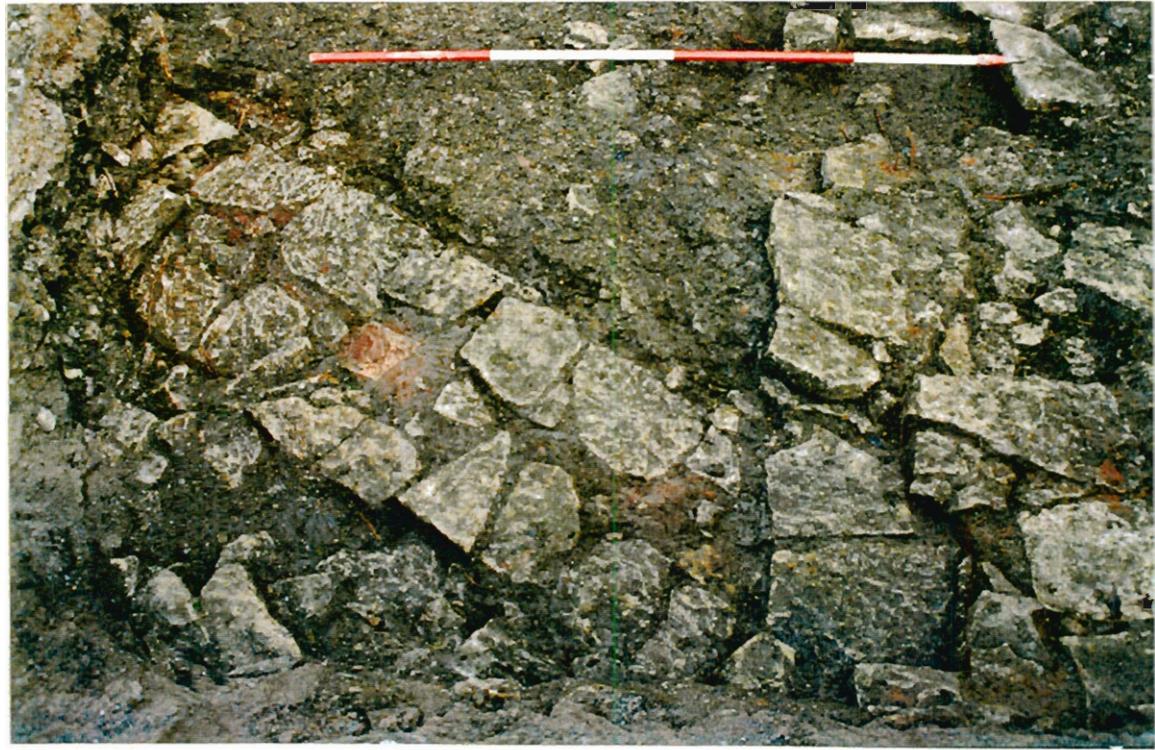
Plate 3 Trench 1 - wall 112 and wall 111 (on right of photograph), looking east

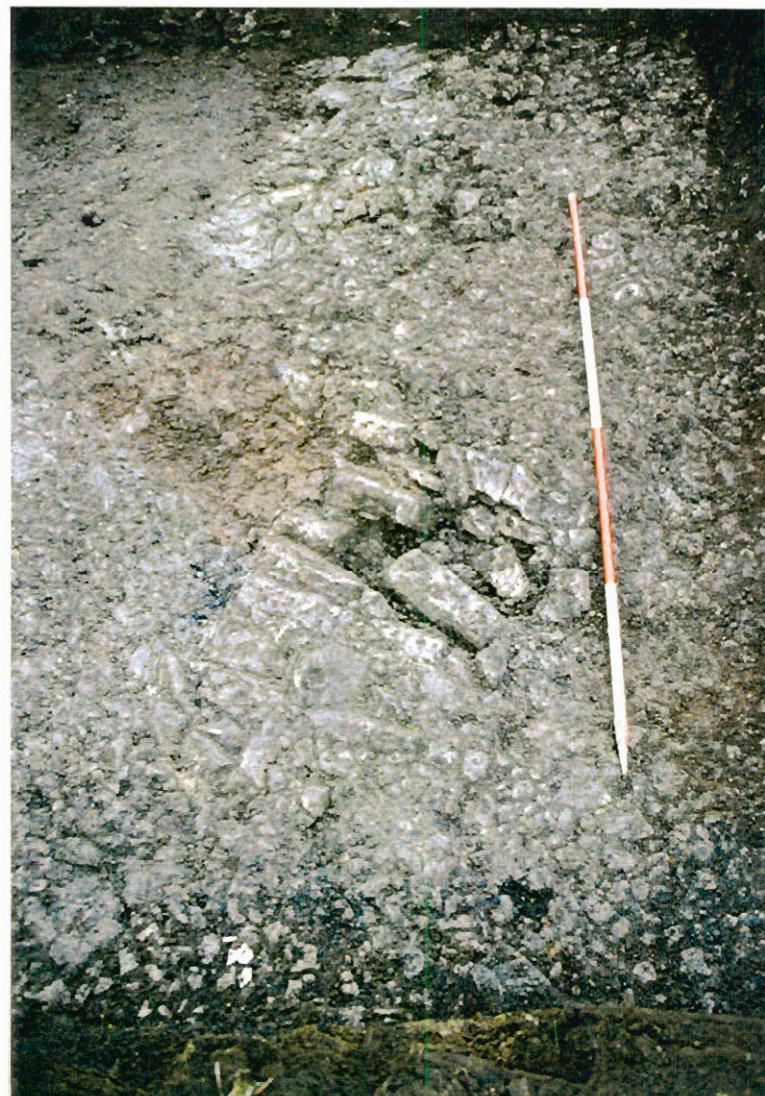
Plate 4 Trench 2 - the area of pitched stones and cobbles (206), looking east

At the south end of the trench was an area of large pitched stones surrounded by packed stones or cobbles (206; 56.19m OD). The top of this stone surface had post-medieval and modern debris pushed into it, including fragments of brick and tile, but a small section through 206, in the south-east corner of the trench, produced some iron slag, animal bone and Roman pottery from immediately below 206 where it overlay the natural (207). It seems likely that this stone feature originally spread further to the north, where it had been cut by the modern road, and may be Roman in date despite the post-medieval material in its surface caused by later disturbance.

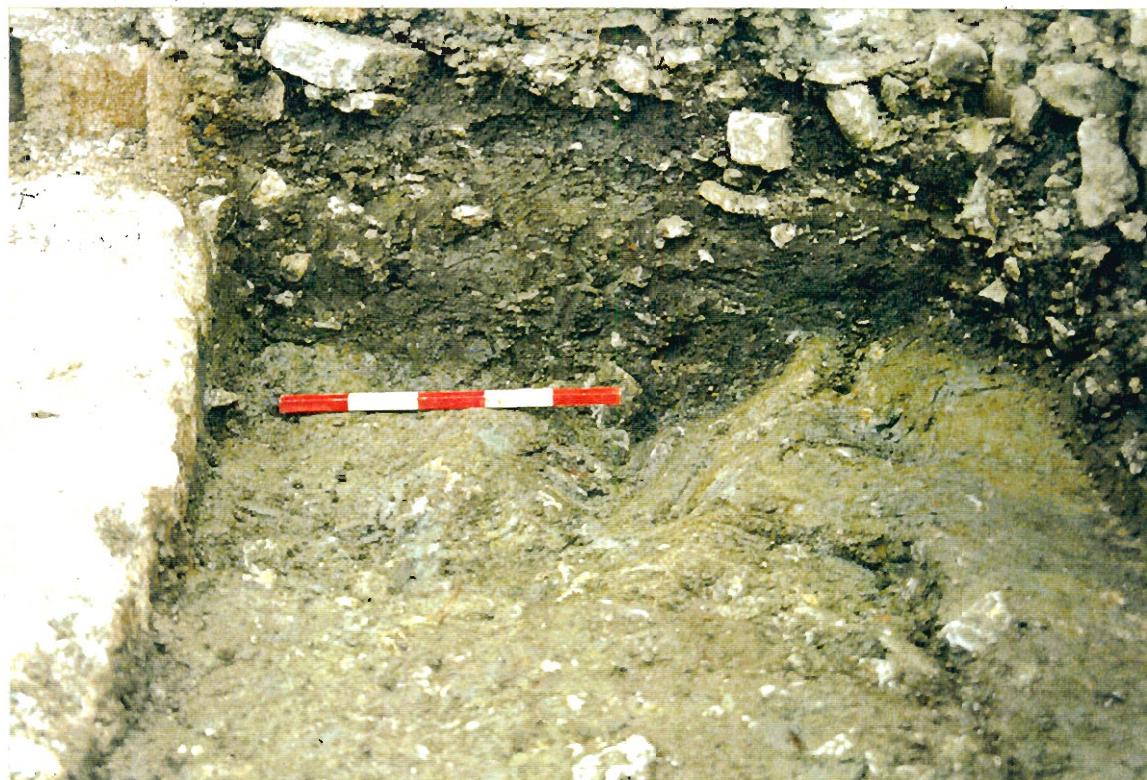
Plate 5 Trench 3 - showing pit 316 sectioned, looking north

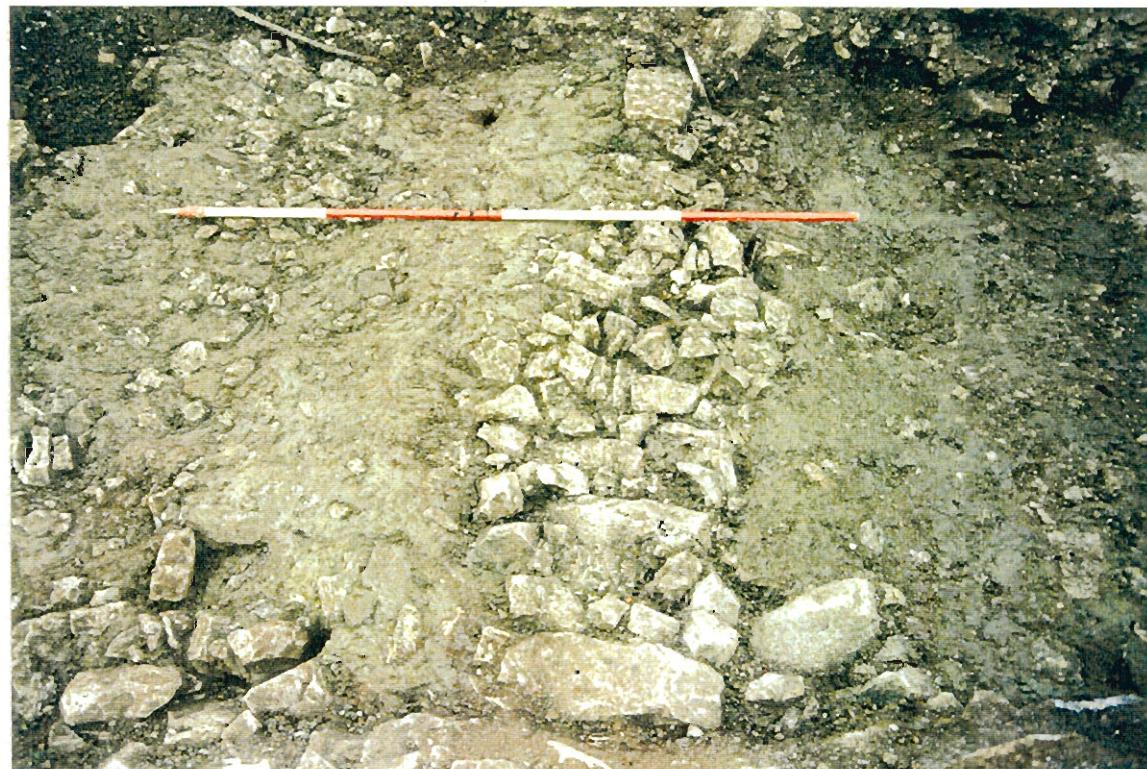
Plate 6 Trench 3 - the stone-lined linear feature (318), layer 320 to the east and layer 325 to the west, looking north

West of pit 316 was an area of grey/green clay containing lumps of brown clay, charcoal flecks and small pieces of Lias limestone (320; 56.15m OD). This produced sherds of 2nd to 3rd century pottery and an iron knife blade (SF 3; Fig.8). Cut into 320 was what appeared to be a linear feature (318) aligned approximately north/south which contained large stones either lying flat or pitched at angles into a dark brown heavy clay (319). This produced 2nd to 3rd century pottery. On removing layer 325 to the west of 318 it was found that the stone-filled feature extended west under 325. Another stone-filled feature (323) ran east/west against the south section of the trench although it had been obscured and partly damaged by the concrete pipe 318.

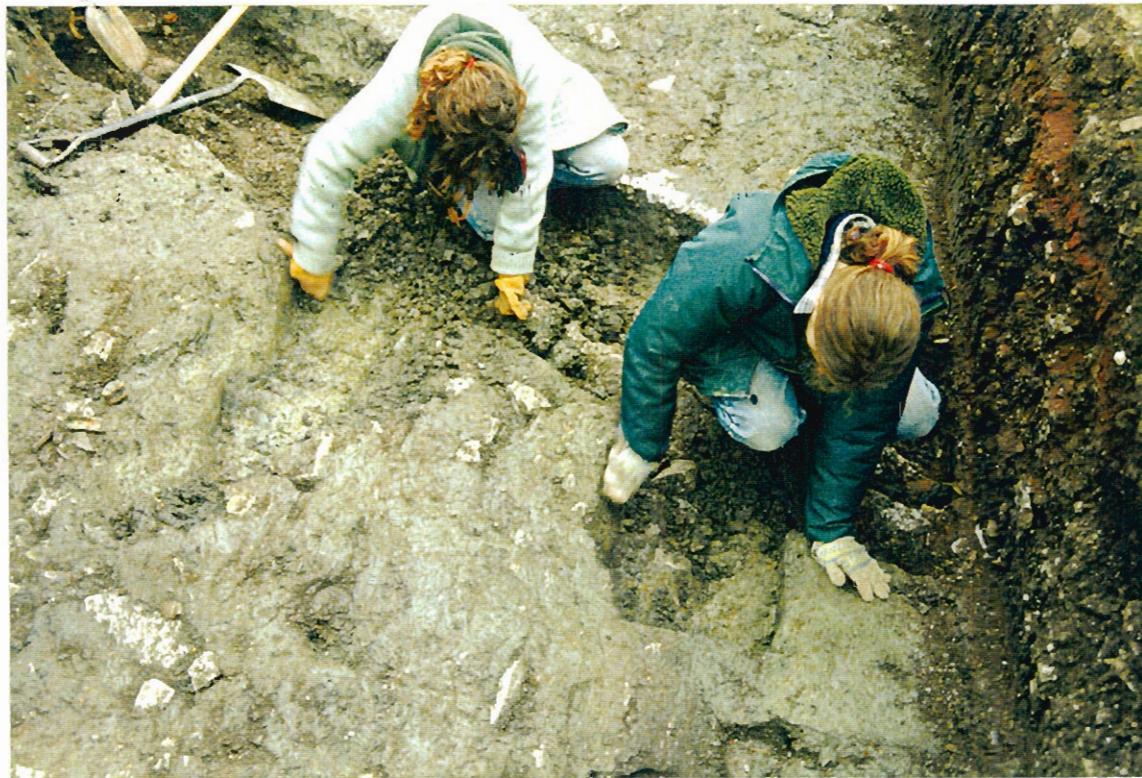
Plate 7 Trench 4 - showing the excavation of slots 407 and 419, looking approx. south

North of the modern sewer pipe (403), layer 405 was sectioned in order to determine its depth and to investigate two possible slots or small ditches which appeared in the side of the cut for the sewer. The removal of layer 405 in this area revealed two shallow, steep sided, linear features (407 & 419) aligned approximately north/south, and cut into the natural clay. These were 0.40m and 0.80m wide respectively, and were 0.20m apart. They were about 0.20m deep and were filled with a dark brown clay, similar to 405, but containing charcoal flecks and the occasional pitched limestone fragment. The base of these slots was at 55.20m OD although they sloped down to the south. Both these slots could be seen continuing south on the other side of the cut for the modern sewer although their southern limit was not determined. Slot 407 appeared to turn at right angles to the west before it reached the north section of the evaluation trench. On the ridge separating the two slots there was a small, circular posthole (422).

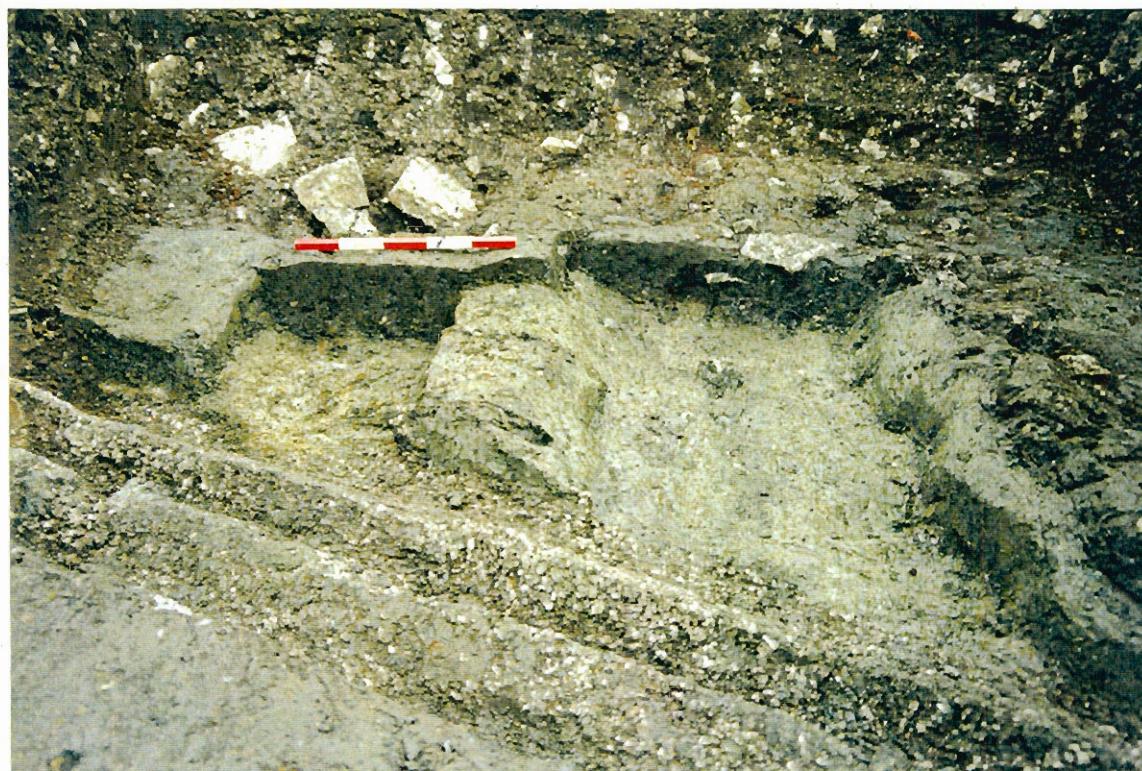
Plate 8 Trench 4 - the section excavated through the slots 407 and 419, looking north

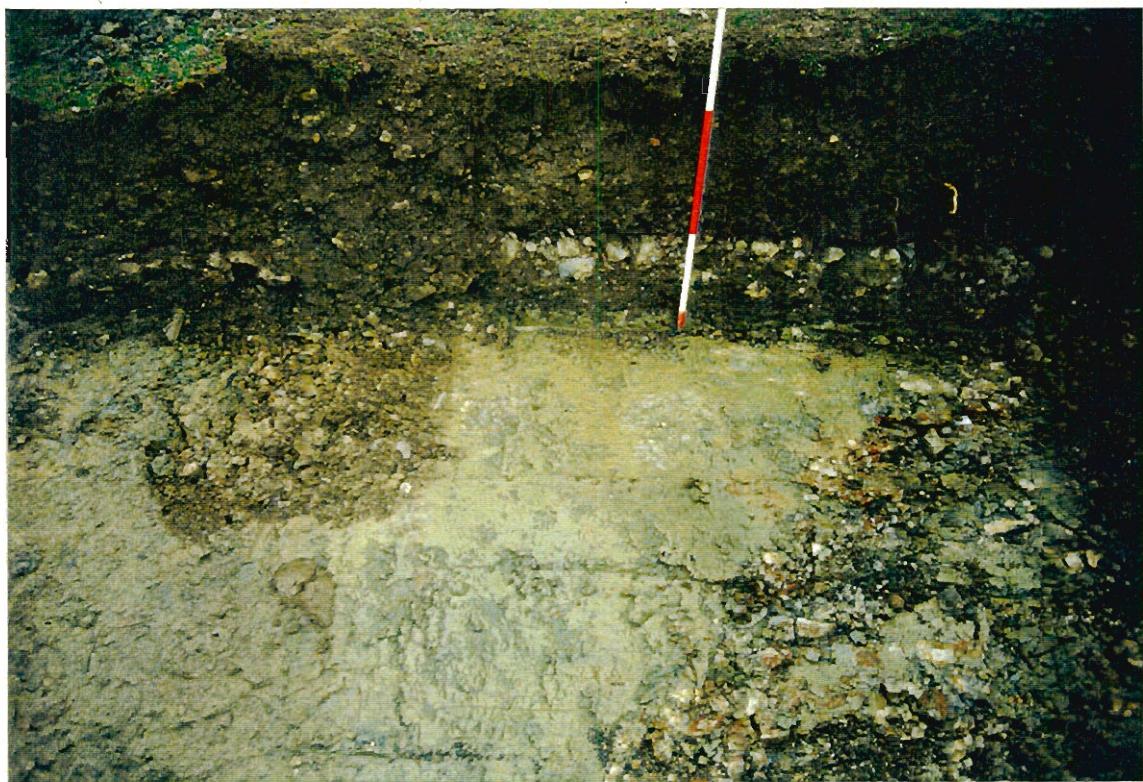
Plate 9 Trench 7 - the modern road surface overlying natural. The engineer's test pit can be seen cutting natural to the left centre of the photograph, looking north

The whole area of this trench was occupied by the former road which had been broken-up and then covered with deposits of clay and topsoil (701-703) in order to landscape the area. The road had removed any archaeological deposits and had been constructed directly on the Lias limestone and clay natural at approximately 57.20m OD. A linear feature running east/west, and cut through the natural, produced modern brick and was presumably a pipe trench, although it was not completely excavated. The engineer's Test Pit 2 was encountered adjacent to the north section of the trench.

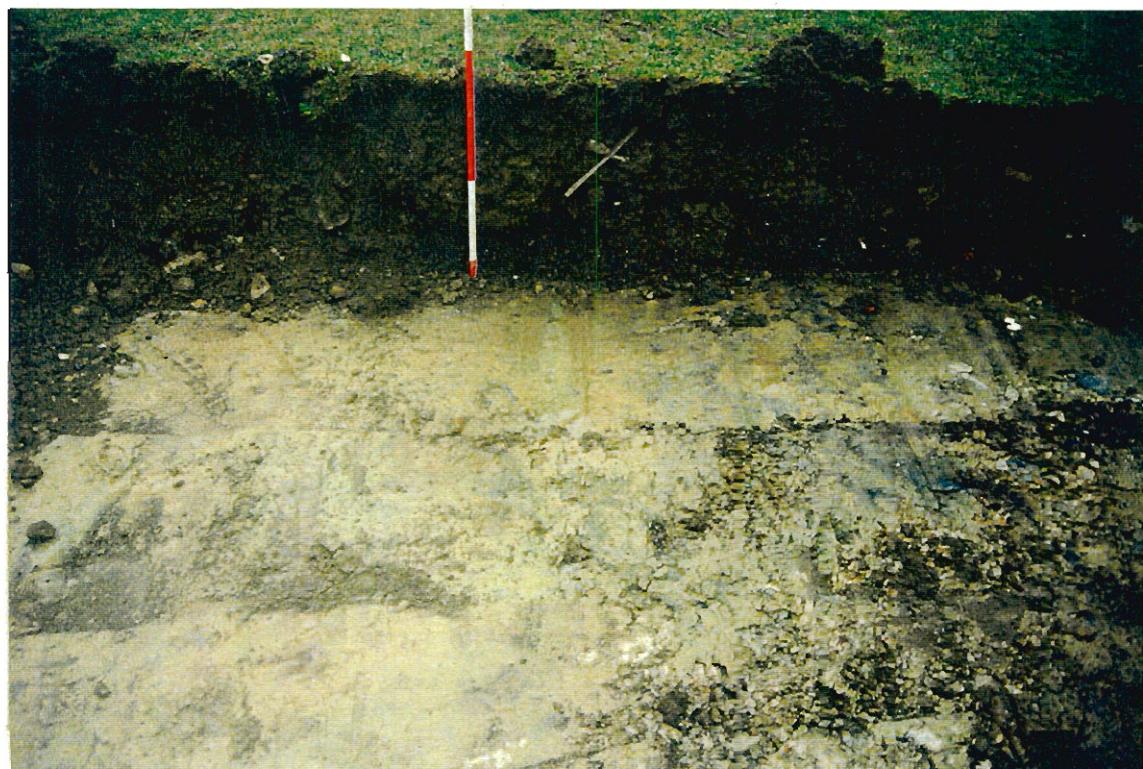
Plate 10 Trench 8 - the modern road debris overlying natural, looking south

The whole area of this trench was occupied by the former road which had been broken-up and then covered with deposits of clay and topsoil (801-803) in order to landscape the area. The road had removed any archaeological deposits and had been constructed directly on the Lias limestone and clay natural at approximately 56.35m OD

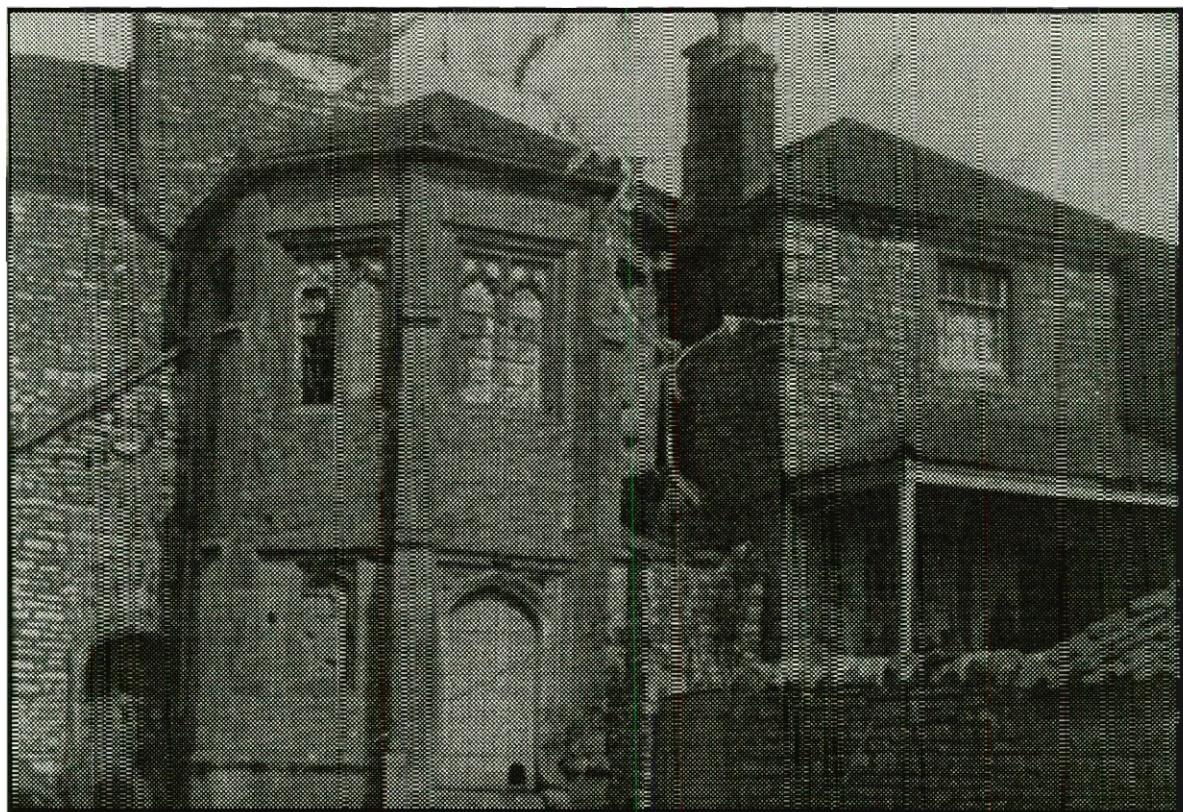
Plate 11 The 16th century stair turret before demolition of the farmhouse in 1951

- 3.6 The antiquarian J. Collinson writing in 1791 noted that in Bishopsworth was '*an ancient house called Inyns Court which in 1353 belonged to John Onewyn. Sir John Inyn was owner thereof and died in 1439*'. Nineteenth century illustrations of Inns Court show that a significant portion of the 15th/16th century house was still standing at that time. The surviving stair turret is probably 16th century in date (Plate 11 shows the stair turret before demolition of the farmhouse).
