HENDRE GAEROG, LON PARC, CAERNARFON

ARCHAEOLOGICAL EVALUATION (G1870)

Report number : 589

Gwynedd Archaeological Trust has been requested by Ap Thomas Partnership, to carry out a program archaeological field evaluation work in advance of development at Hendre Gaerog, Lon Parc, Caernarfon (SH 4829 6244). A brief for the work was provided by Gwynedd Archaeological Planning Service (D959) and a project design was produced by Gwynedd Archaeological Trust.

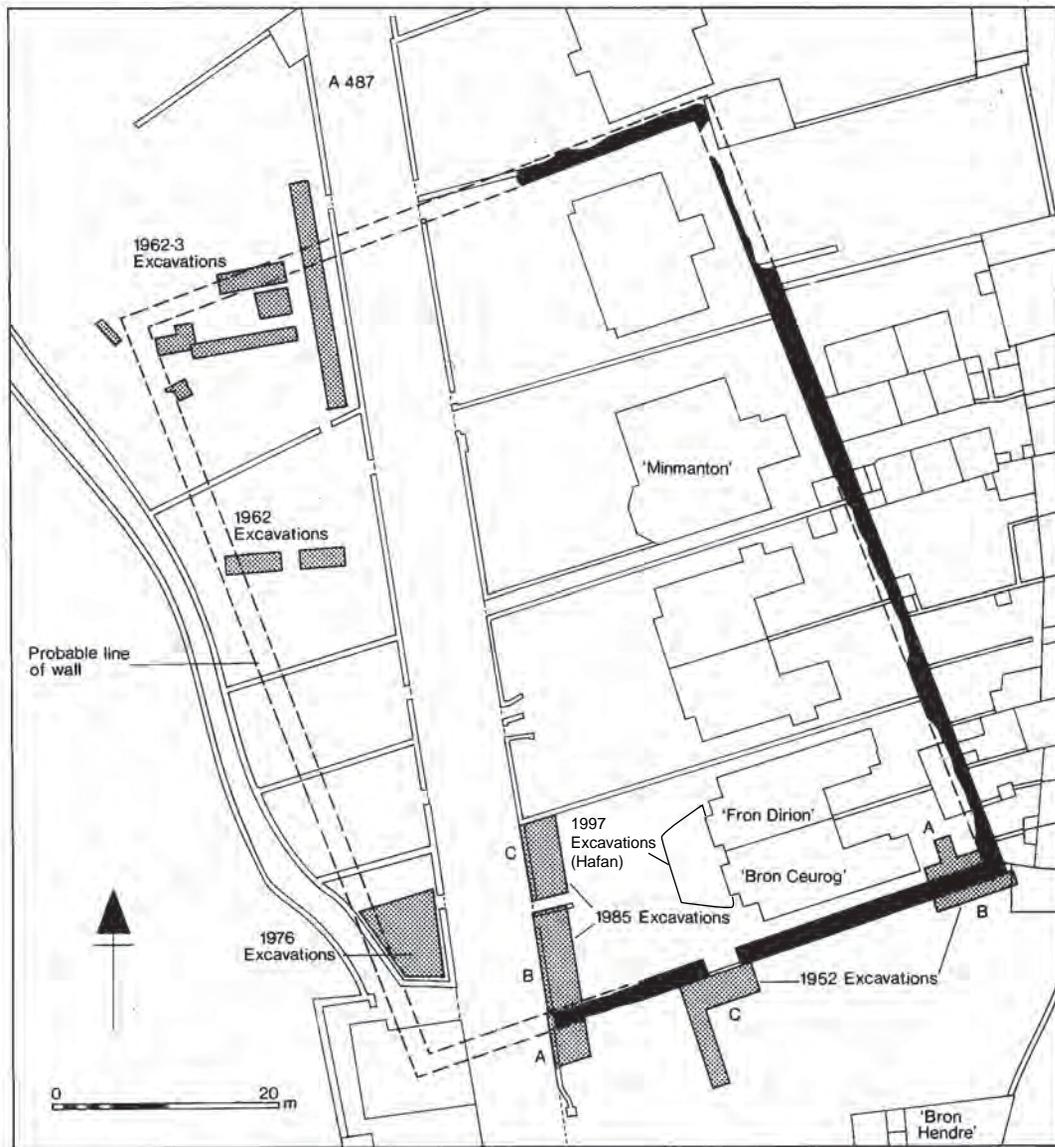
Fig. 2 Excavations within Hen Waliau 1952-1997 (after Boyle 1991)

The area close to the development has been fairly well-sampled. A total of sixteen trenches have been excavated in Hen Waliau (Fig 2). A further eight were excavated during road improvements immediately to the north of the enclosure (Fig. 3). Wheeler carried out excavations within Hen Waliau in the 1920s, dating it to the 4th century, and recorded the local tradition of a road and well in the gardens of Bron Hendre and Mimanton to the south of the site. A cobbled surface to the south of the walls was dated to no later than the mid second century. Further excavations were carried out here in 1952, 62, 63 and 85. These are summarised in Boyle (1991). The excavations demonstrated traces of activity on the site in the later first and early second centuries. There then appeared to be a hiatus until the walls of Hen Waliau were constructed in the 4th century. The function of the enclosure is not entirely clear but the best interpretation seems to be as a storage depot. No other Roman activity was identified in this area until a series of excavations were carried out by Richard White in advance of improvements along Newborough Road. These excavations revealed widespread Roman activity in two phases from the late first to the mid second centuries. A ditch and two wells were identified along with evidence for light industrial activity including leather and metalworking. All the evidence thus points to fairly widespread activity in the area to the west of Segontium and around Hen Waliau particularly in the early years of the Roman Occupation. A watching brief was carried out 45m to the north of the present site but no Roman stratigraphy was found possibly due to a previous truncation of the deposits.

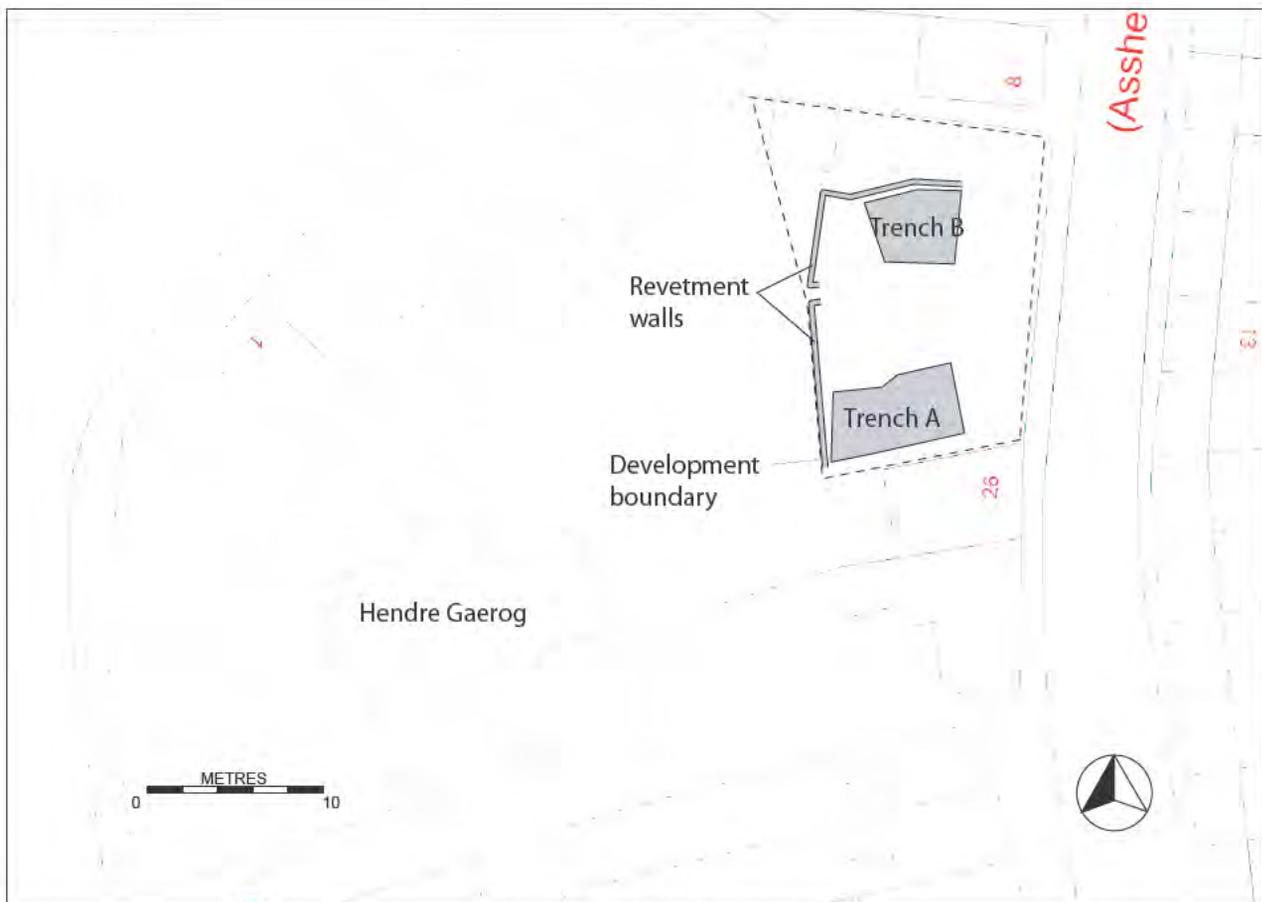
Fig. 7 Trench locations

The evaluation was therefore undertaken using trial excavations in the form of two trenches within the site. The area is bounded on two sides by a tall stone wall and on one side by a house. The site is part of the garden of Hendre Gaerog and has been terraced into the natural hillslope forming two raised beds and, for the most part is bounded on the western side, by a revetment wall. The proposed development extends a few metres beyond the revetment at the north. Two 18m x 2m wide trenches running across the entire evaluation area were originally proposed. This was, however found to be impractical due to the presence of trees and shrubs on the site and also the problem of the positioning of spoil heaps within the limited area available. Two subrectangular trenches were excavated with dimensions of 7m x 4m and 5m x 4m (Fig 7).

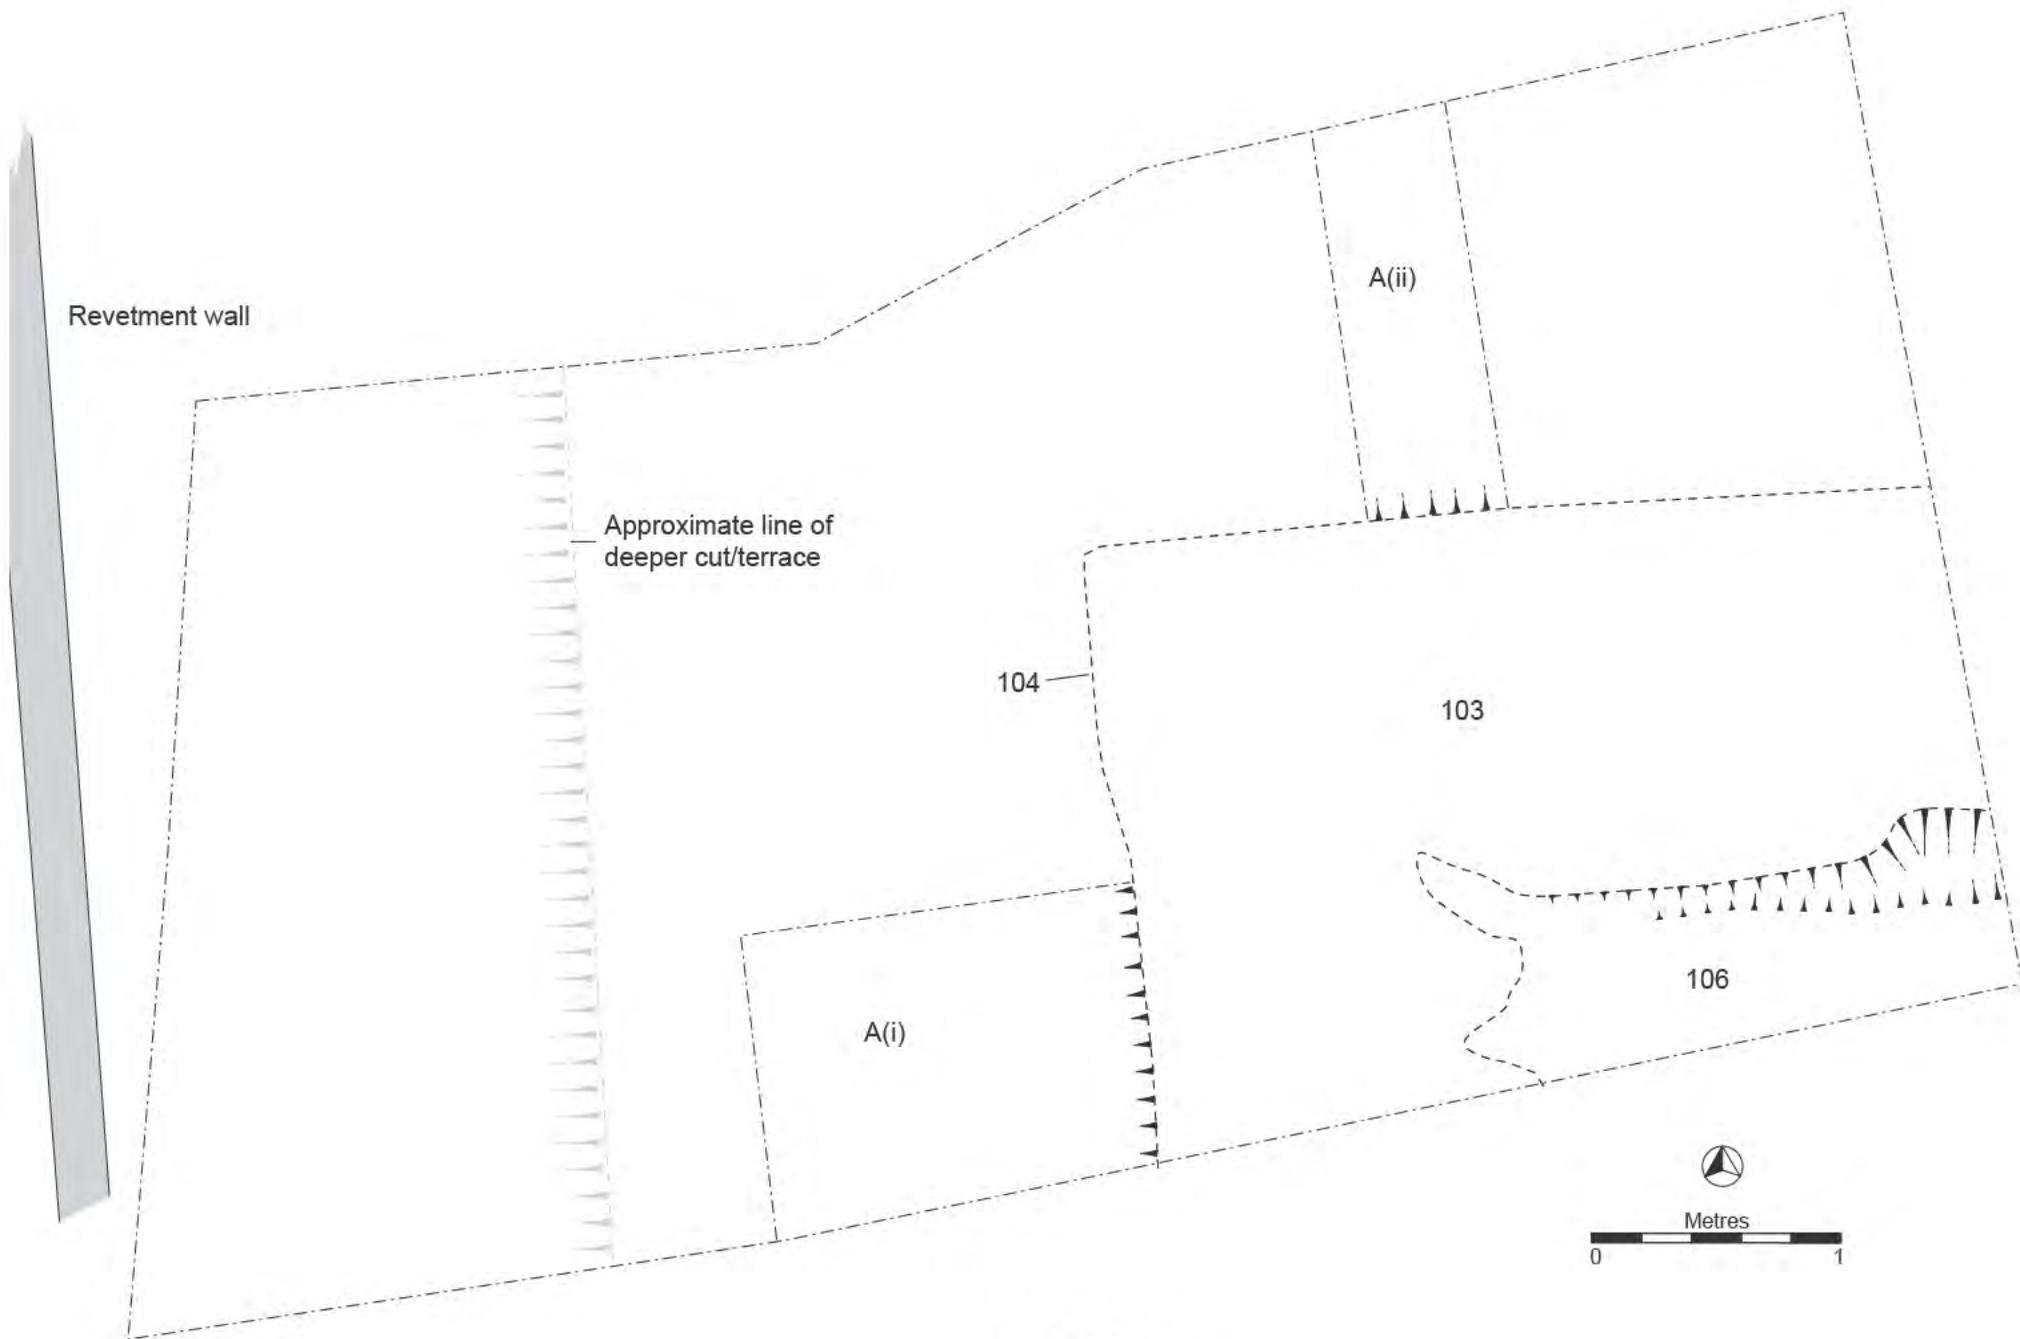
Fig. 8 Trench A

This topsoil was removed using a minidigger. This was 0.5 to 0.75 m deep across the majority of the trench. This revealed a square of natural subsoil (103) cut away to the north and west (104). The fill of the cut features (102) appeared to be a single deposit and contained large amounts of early 20th century pottery and fragments of mortar but no other building debris. An attempt was made to remove the modern fill starting at the west side of the site. This was excavated down to a depth of 2m. Modern pottery was still present at the bottom of the trench. The natural subsoil appeared to have been cut away about 1.5m from the end of the trench. No further excavation was possible for health and safety reasons and this part of the trench was partially backfilled. The modern deposits were sectioned on the west and north sides of the trench (A(i) and A(ii), Fig 8). The section on the west side (A(i)) revealed a vertical cut into the natural subsoil to a depth of 0.7m. The subsoil had then been terraced at the same level until it reached the deep cut revealed by the minidigger. A further vertical cut, this time 0.5m deep was revealed by the section at the north (A(ii)). The natural subsoil had again been cut away at this level as far as the edge of the trench. A shallow scrape (106) into the surface of the subsoil appeared to be the base of a modern rubbish pit and was filled with cinders and broken pottery.

No Roman material was recovered from any of the contexts in this trench. The rectangle of subsoil (103) in the south-east of the trench appeared to be undisturbed but no features earlier than the 20th century pit (106) were visible. The stratigraphy in the rest of the trench had been heavily truncated and only substantial deeply cut Roman features would be expected to survive here. There was no sign of any such features in the two sections cut through the modern deposits. It therefore seems safe to assume that there are no surviving features earlier than the 20th century terracing within this trench. The 20th century features comprise an L shaped (in plan) vertical cut into the subsoil forming a terrace about 2.2m wide at the west and in excess of 1.5m wide at the north. This was a further steep cut to depth in excess of 2m at the western edge of the trench. A revetment wall stands in front of this and the area had presumably been infilled sometime in the mid 20th century. The exact function of the terracing is somewhat unclear but it presumably relates to landscaping of the garden when the structures shown on the 1888 and 1918 OS maps were demolished. It should be noted that the current revetment wall follows the same line as largest enclosure shown on the 1888 map. The 20th century artefacts within the infill behind the wall suggest that it is probably not the same structure.

The areas that have already been evaluated (trenches A and B) require no further excavation or mitigatory measures.

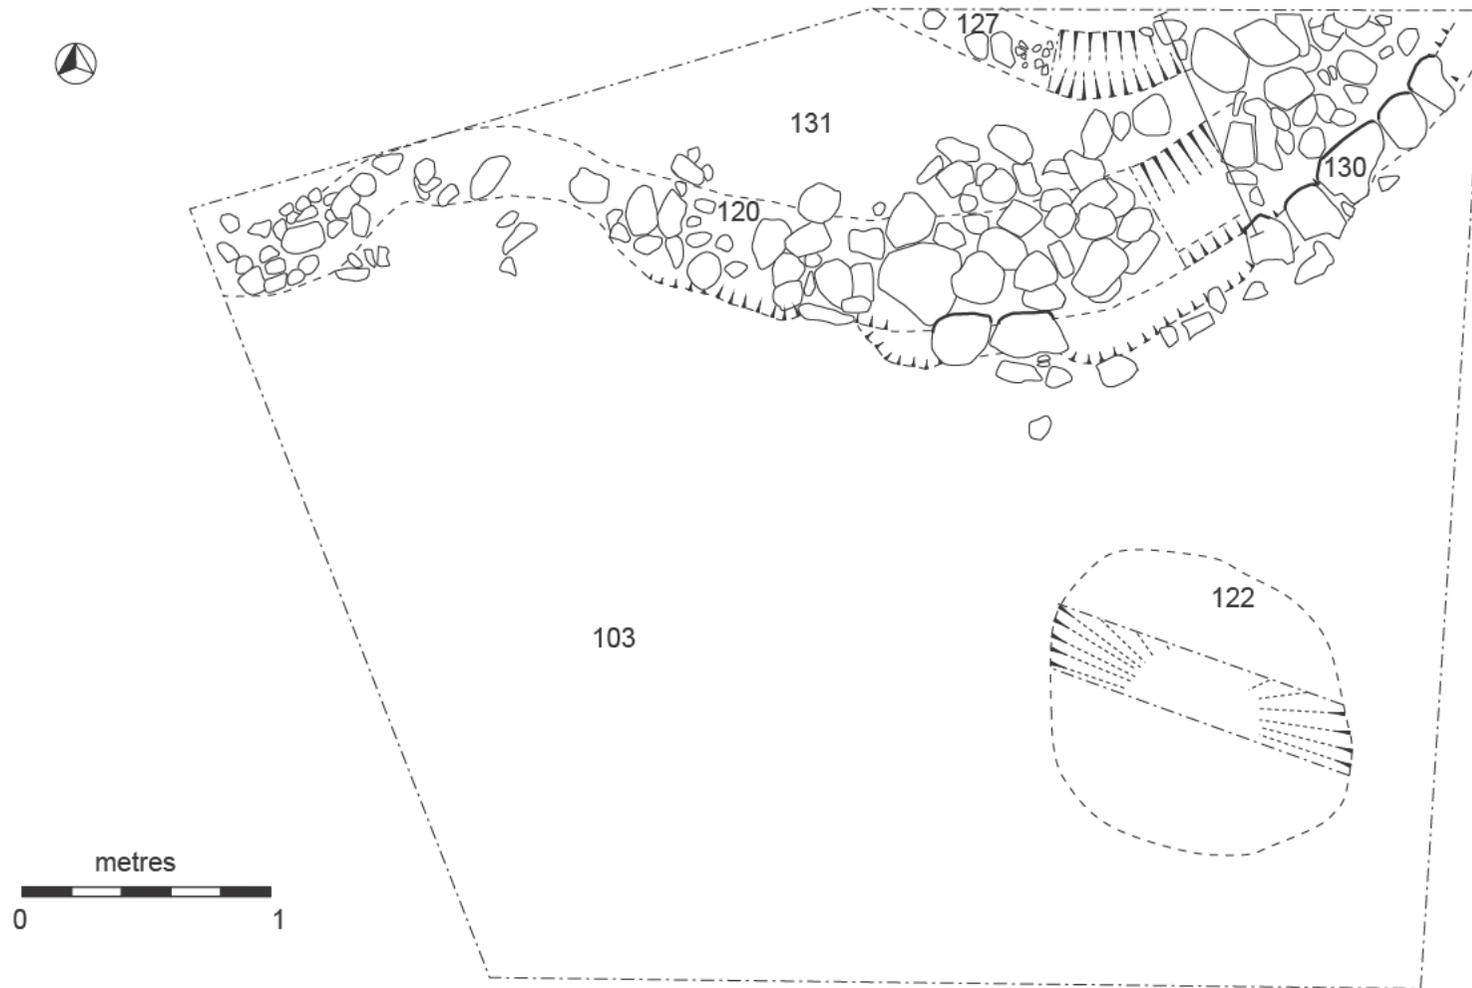
Fig. 9 Trench B

The topsoil (123) was excavated using the mechanical digger. It was a dark loam, 0.45m deep, containing frequent pieces of 20th century pottery. This revealed a deposit of brown loamy soil (124). This was sampled and found to contain mid 19th century pottery but none of the 20th century material that characterised the layer above. This deposit was also mechanically removed. It was found to be 0.55m deep and is best interpreted as being a buried topsoil horizon. The trench was cleaned by hand revealing natural yellowish orange subsoil, at a similar level to that in trench A, with two features cut into it. The most obvious was a somewhat meandering linear cut (131) filled with a deposit of very firm greyish brown silty clay (126). This extended southwards from the northern edge of the trench for a maximum of 1.4m. There were occasional larger stones protruding through the deposit and the edge was defined at the eastern end by a line of large natural stones (130). It was excavated and found to contain occasional sherds of Roman pottery and none of the later material that characterised the topsoil layers thus suggesting an early date. Three fairly large sherds of coarseware, two conjoining, were recovered along with some small fragments of tile. The feature appears to be a wide hollow extending beyond the edge of the trench. Two roughly parallel drains (120 and 127) running along the bottom of the hollow were revealed when the upper deposit was removed. The southernmost was a shallow

meandering channel (120), running along the edge of the hollow. The line of stones (130) running along the edge of the hollow and drain could be traced for 2.8m. A small shelf cut into the subsoil to accommodate the stones indicated the extent of the feature even though most of the stones had been dislodged. The drain itself was 40cm wide and 10cm deep and was cut asymmetrically. It was steepest on the south side and roughly U shaped in section. It was filled and partially covered with varying amounts of large stones in a matrix of fairly soft silty clay (128).

Only a short length of the northernmost drain (127) fell within the excavated area. This was sectioned and found to be 25cm wide and 14cm deep. It was roughly U shaped in section the northern side having been cut somewhat more steeply than the southern. It was packed with rounded stones in a matrix of soft clayey silt (129). A single large unabraded sherd of a decorated samian bowl was found between the stones. There were several large stones overlying the drain that could be interpreted as a crude capping.

A patch of small angular stones (122) apparently in natural subsoil proved to be on closer inspection the fill of a shallow pit (122). This was 1.0m in diameter and 0.25m deep with a shallow V shaped cross section. It was filled with well mixed redeposited subsoil containing a small amount of humus. No finds were recovered from this feature so its function and date could not be determined.

The two drains (120 and 127) are relatively slight and sit within a larger hollow (131). The stone edging (130) at a relatively high level indicates that drain 120 was probably at one time an open channel, with the stones preventing erosion to its steepest side. The stones within and over the drain are untidily heaped and do not give the impression that they were part of the original construction. It therefore appears that the drain was filled with stones at a later date and that it silted up with the stones within it, hence the soft matrix within the cut. Drain 127 was a discrete feature deliberately packed with small stones that did not extend above the cut. The soft clay matrix indicates that it also silted up. Its stone filled constriction and possible capping stones suggest that it was designed to be a covered drain perhaps functioning as a buried land drain. It therefore seems that drain 120 was originally open and running along the edge of a wider hollow, either draining the hollow itself or taking runoff from higher up the slope. Drain 120 was then partly back filled with stones and silted up. Covered drain 127 may have been cut at about the same time as 120 was backfilled. The crude capping seems to be of a similar character to the stone dumped in the open drain. It then seems the area was backfilled with firm clayey soil, perhaps to form a level surface.

In all, four reasonably large sherds of Roman pottery were recovered from hollow 131 and the associated drains. The piece of samian ware from drain 127 was very sharp and unabraded suggesting that it was freshly broken when it was deposited. This can be taken as a good indication that the feature is of a Roman date. The sherds of coarseware in the upper fill of the hollow were the only datable finds in the context and again suggest a Roman date for the infilling of this feature. The pottery will be sent to the National Museum of Wales for more precise dating; the samian sherd should be closely datable.

The northern 6m of the development (Fig. 10) area has a higher potential for the survival of Roman archaeology. The features discovered in trench B clearly extend into this area and may indicate the limit of a wider area of Roman archaeology. It is therefore recommended that full excavation should precede any disturbance deeper than 0.5m.

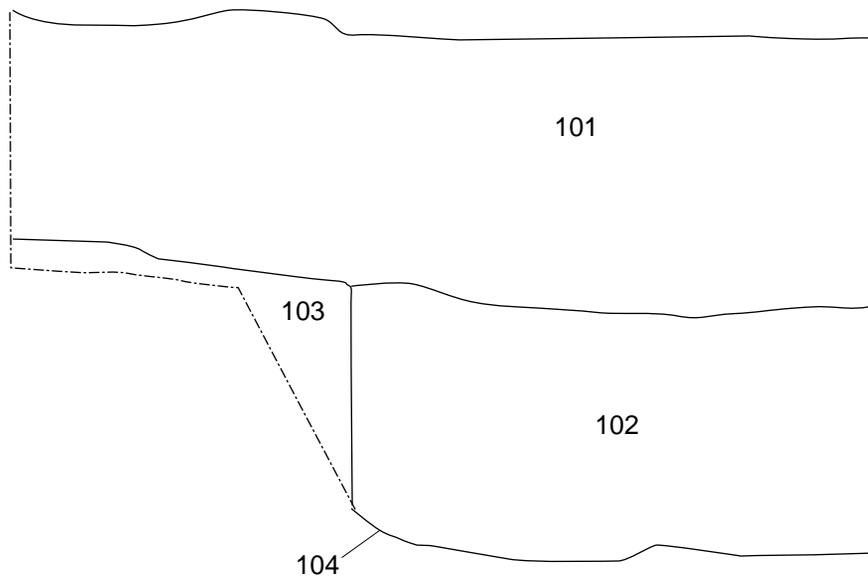
(a) Terrace 104 - east facing section

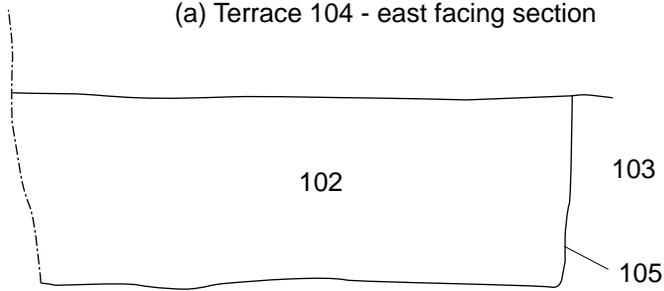
(b) Terrace 105 - west facing section

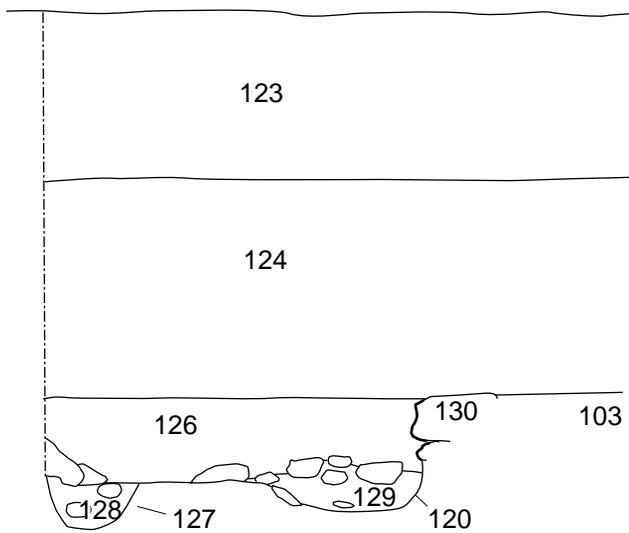
(d) Hollow 131 and drains 120 and 127 south-west facing section
(123 and 124 projected levels only)

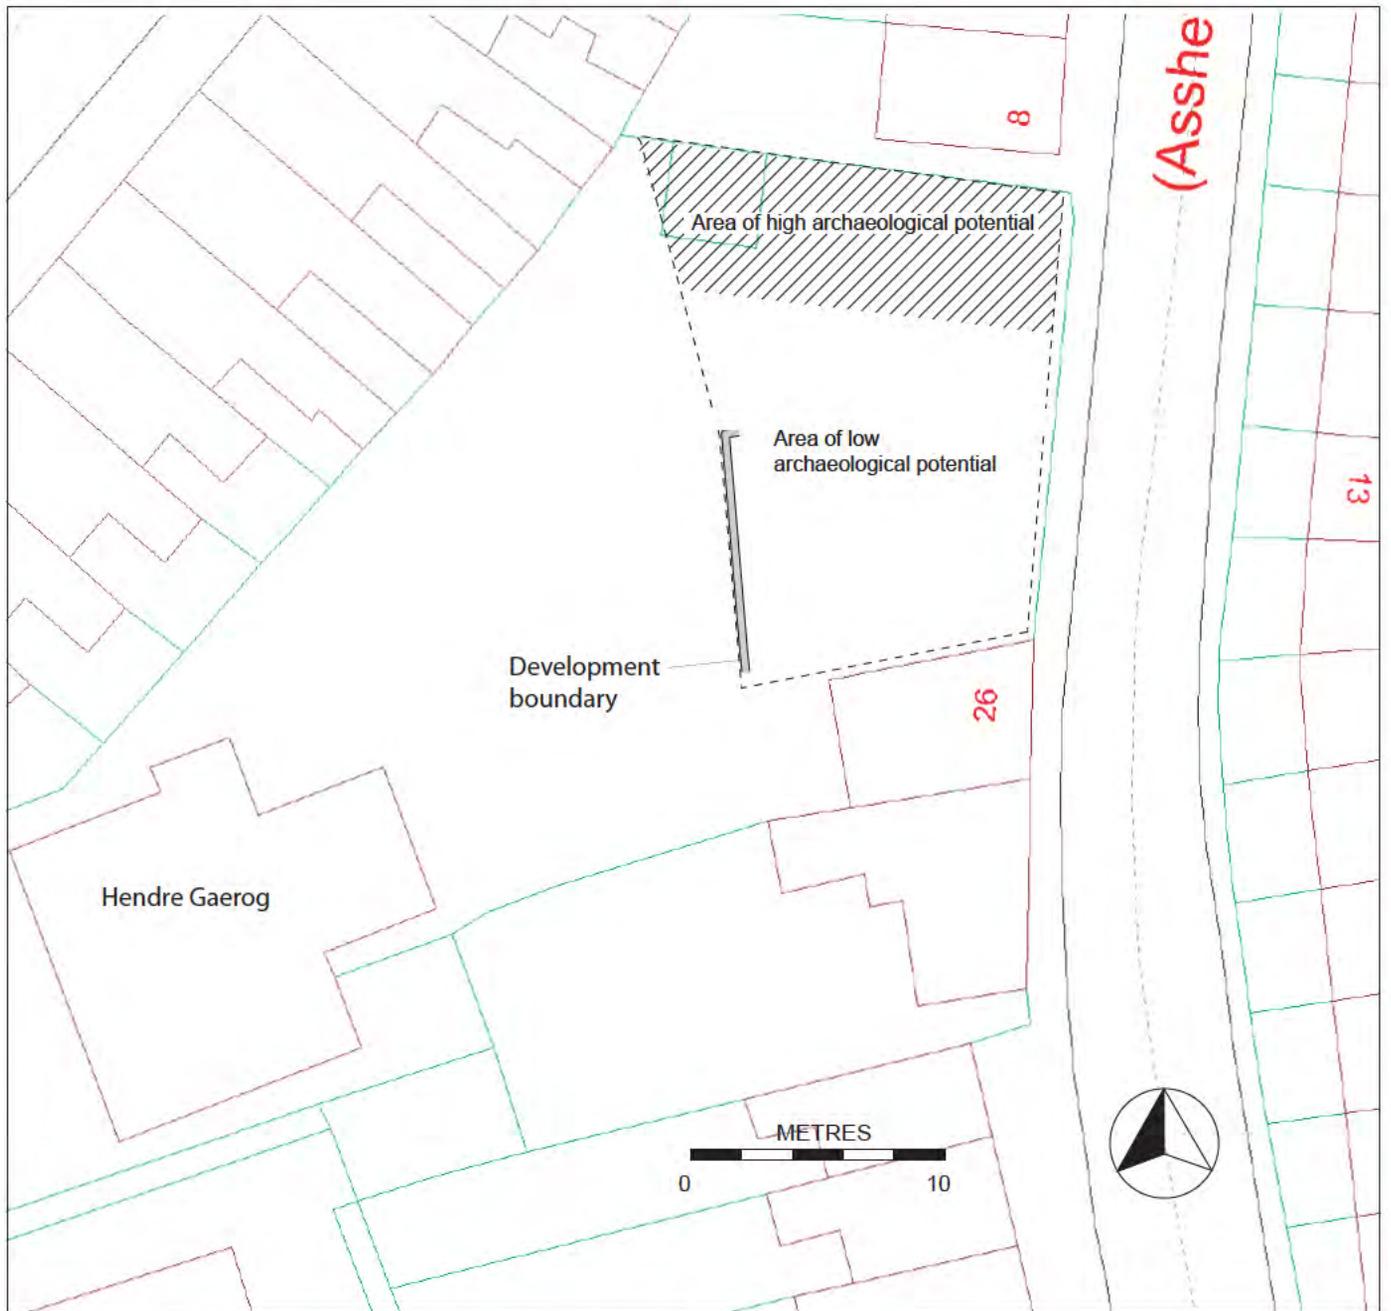
Fig. 11 Development area showing areas of high and low archaeological potential

The potential for the survival of significant Roman or other early remains is low across all but the northern 6 metres of the development area (Fig. 10). There may, however, be minor features present in the area of lower potential that did not fall within the evaluation trenches. A watching brief is therefore recommended for any disturbance deeper than 0.5m below the current ground surface. Any disturbance above this level will be within the 19th/20th century deposits, will not affect the earlier archaeology and therefore requires no mitigation.
