Land to the North-West of Tremadog (Lidiart Yspytty)

Archaeological Assessment

GAT Project No. 1736 Report No. 546 October 2004

ARCHAEOLOGICAL EVALUATION (G1736)

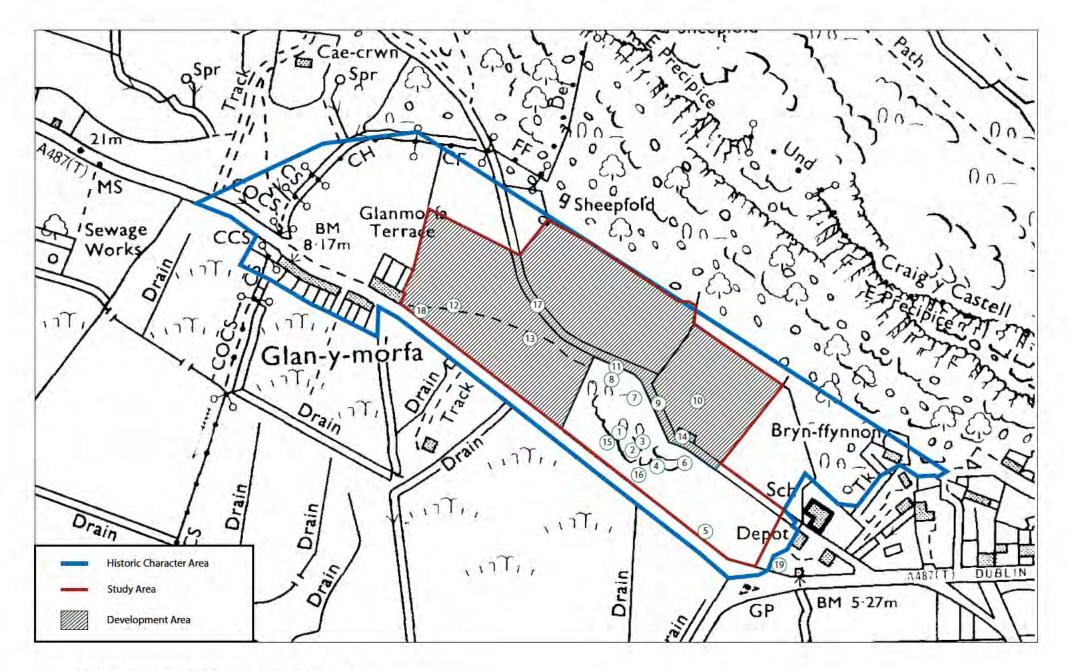
Figure 1. Development Area, Historic Charecter Area and sites of interest.

Capita Symonds has asked the Gwynedd Archaeological Trust to undertake an archaeological evaluation in advance of a proposed development at Tremadog, Gwynedd on behalf of North Wales NHS Trust. The proposed development is centred on SH 557402 and the affected area is indicated on the site plan (Figure 1). This constitutes the study area of the present document. The development area contains remains of ironstone mining, possibly of Roman origin and significant road and railway remains. Adjacent to the site is a Roman bathhouse (now buried beneath the garden of the adjoining house), and finds of Mesolithic/Neolithic date were recovered west of the A487 during trial excavations in 1995. The development area falls within a designated Landscape of Historic Interest (HLW (Gw) 7 Aberglaslyn) and within Historic Landscape Characterisation Area 35, Llidiart Yspytty (GAT Report 519).

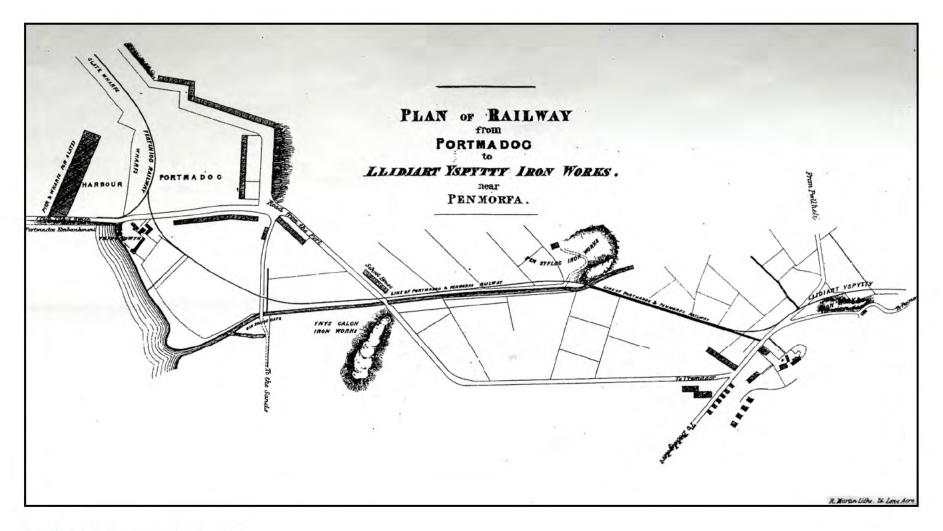
Figure 2. Plan of railway from Porthmadog c. 1848

An indication of the line of the road is given on a semi-diagrammatic plan of the railway from Porthmadog to Llidiart Yspytty of 1848 (fig 2). It is also clearly marked on the Penmorfa tithe map of 1840 (copy in Caernarfon Record Office). The majority of the road is still visible. It can be traced up the slope from Glanmorfa Terrace to the top of Lyddiart Yspytty as a 5 to 6m wide grass-covered terrace above a dry stone revetment. The revetment wall is now partially collapsed in places. The line of the road at the top of the slope is shown running just to the north of the old quarry on the OS map of 1887. The quarry has since been filled in and a short stretch of the road can no longer be traced. The road and the tramway must have run side by side for a few metres at the north of the quarry before diverging close to the eastern end of the shallow railway cutting. They must have run through a very narrow corridor and this may explain why the turnpike was rebuilt on the alignment of the present road in 1845. The line of the earlier turnpike is currently marked in the east of the development area by a track running to the south of a disused agricultural building and then as an access to the school. It should also be noted that it is probable, given the presence of the Roman bath house (see GAT Report 519), that a Roman road runs through the study area, and the line of the turnpike is a possible route for this, being the most obvious access between the former coastline and the cliffs.

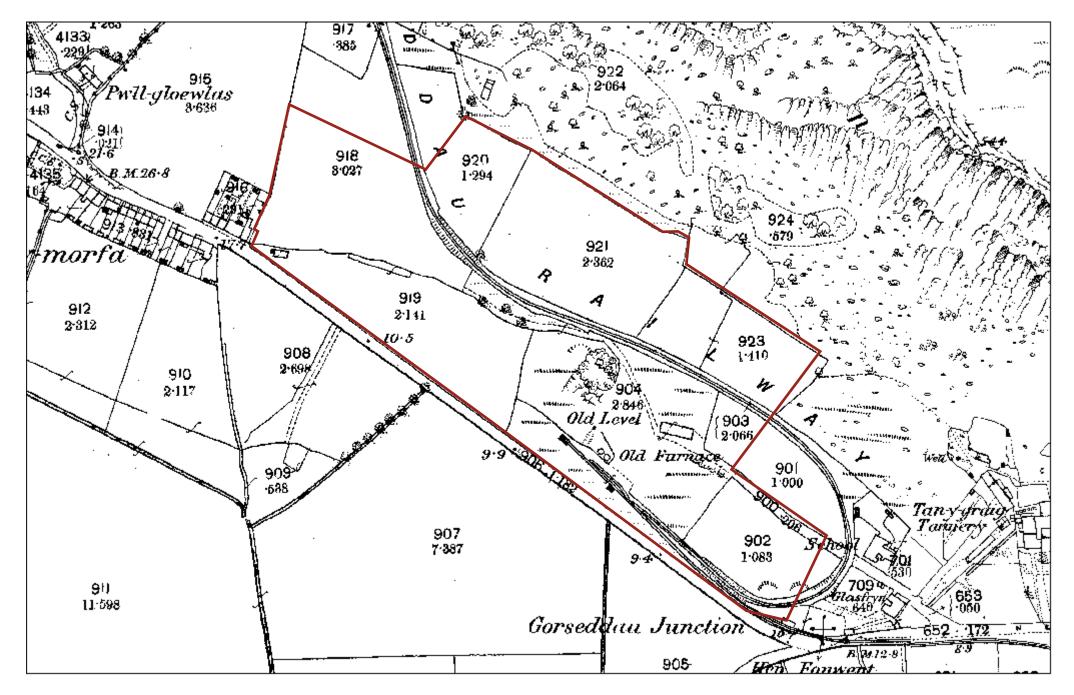
The tramway and part of the road are shown on the 1887 25" OS map (Carnarvonshire XXXIV.11 – see fig 3). The 1915 edition shows some areas of rock that could correspond to the rock cut feature but it is not depicted as continuous (fig 5). Both editions show a long narrow enclosure of unknown function that is no longer visible, and through which the ditch appears to pass.

Trench 1 measured 8.00 m x 3.25 m (l x w) and was located in the north-east corner of the evaluation area in an attempt to locate the remains of a building identified on the 1887 Ordnance Survey Map (Figure 3). The trench was orientated east west with an additional "spur" added to examine the rock cut channel and to establish the relationship between the building and the channel.

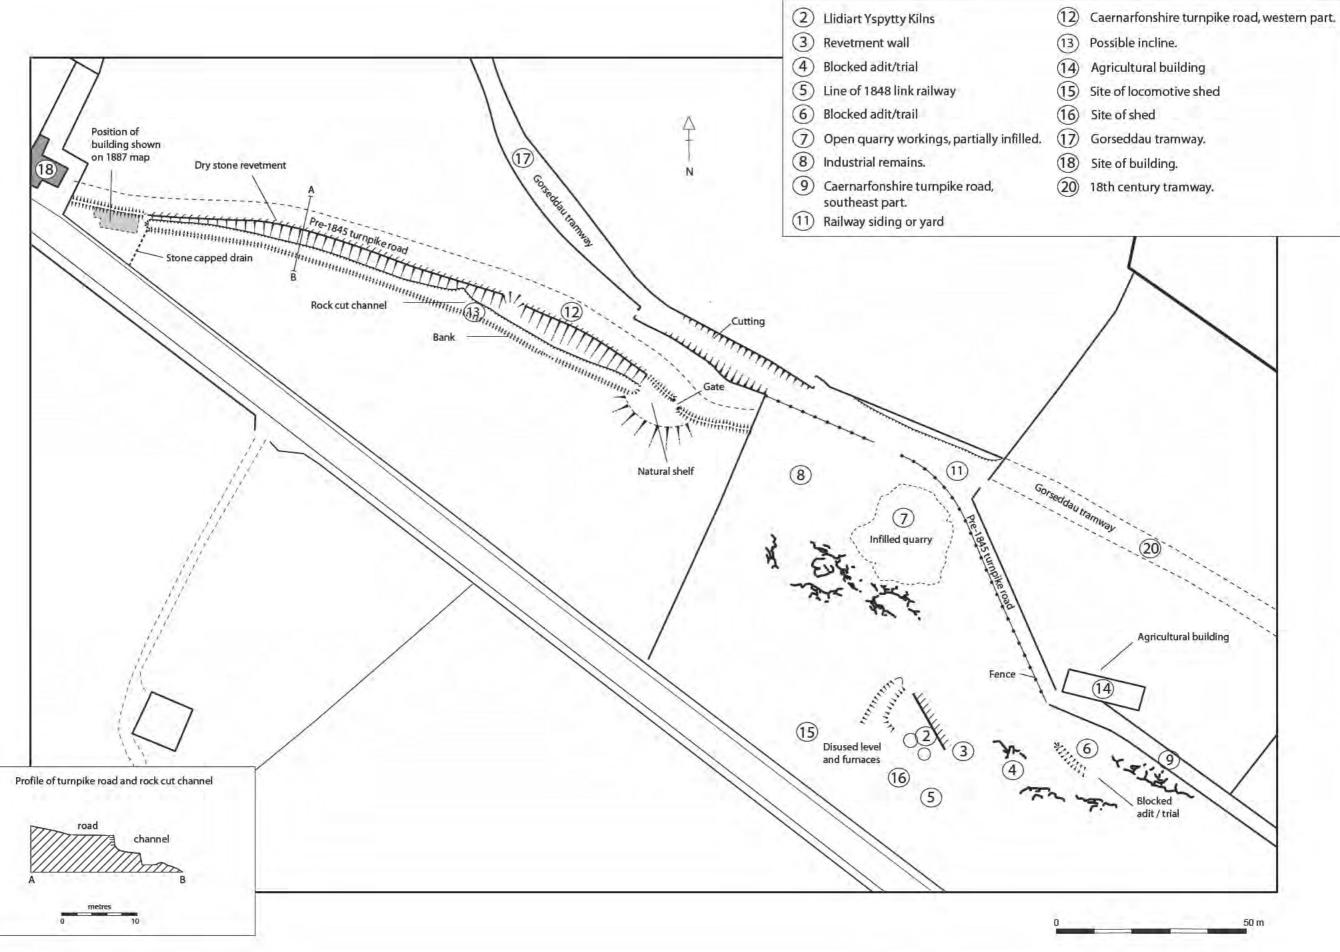
The individual features are described below, and the results shown on fig 6.

The bed of the tramway is extant and runs through the centre of the development area. It enters the area at the north as a raised track bed flanked by mortared stone walls. This is still in use as a public footpath. It then passes through a shallow cutting. The bed of the railway is 4m wide and the sides of the cutting are sloping rock faces. Beyond this, the tramway is visible as a terrace, initially cut into the rock at the north before being partially blocked by a field wall. It can then be traced as a grass-grown terrace in improved pasture before being lost in the school grounds to the east of the development.

A ditch, much overgrown by vegetation, is visible a few metres down -slope of the turnpike in the western part of the development area. Closer inspection shows this to be a well-engineered rock-cut feature. It consists of a 3m to 3.5m wide terrace cut into the slope, with a 1.2m wide earth and stone bank on the outer edge of the terrace for most of its length and a 2m wide channel. A stone capped drain, apparently leading from the western end of the channel can be traced south across the field. The eastern end of the feature is relatively well defined but heavily overgrown. It appears to start on a natural shelf below the turnpike road. This area is very overgrown and there has been some erosion of the slope above the shelf. The turnpike runs above an earth and stone bank at this point. A 2. 2m wide gate with extant gateposts leads from the road to the shelf but no further structures are visible. The function of the channel is not entirely clear, but there may have been other, now lost or obscured, structures associated with it. It is too narrow to be an incline and in its present form, with an outer bank, it appears to be a watercourse. It is rock cut and is thus likely to be associated with the ironstone mine and quarry as opposed to being of agricultural origin. The 1887 25-inch OS map shows a building at the bottom of the channel, close to the current stone capped drain. It is possible that the feature was providing water for industrial use in this building, probably as a power source for machinery. Unfortunately, there is no sign of a water source at the upper end of the channel. The nearest sources of water are several hundred metres to the east and west and there are no extant leats. It is possible that some kind of industrial process connected with the mine was carried out on the natural shelf at the top of the channel, the gate indicates that access was necessary. The position of the gate a few metres away from a fairly steep drop suggests that it was not for agricultural use. In conclusion, we do not have enough information to assign a definite function to the channel but it appears to be a leat or drain, and may have been used to supply water to the former building next to Glanmorfa Terrace, or as a drain to take surplus water away.

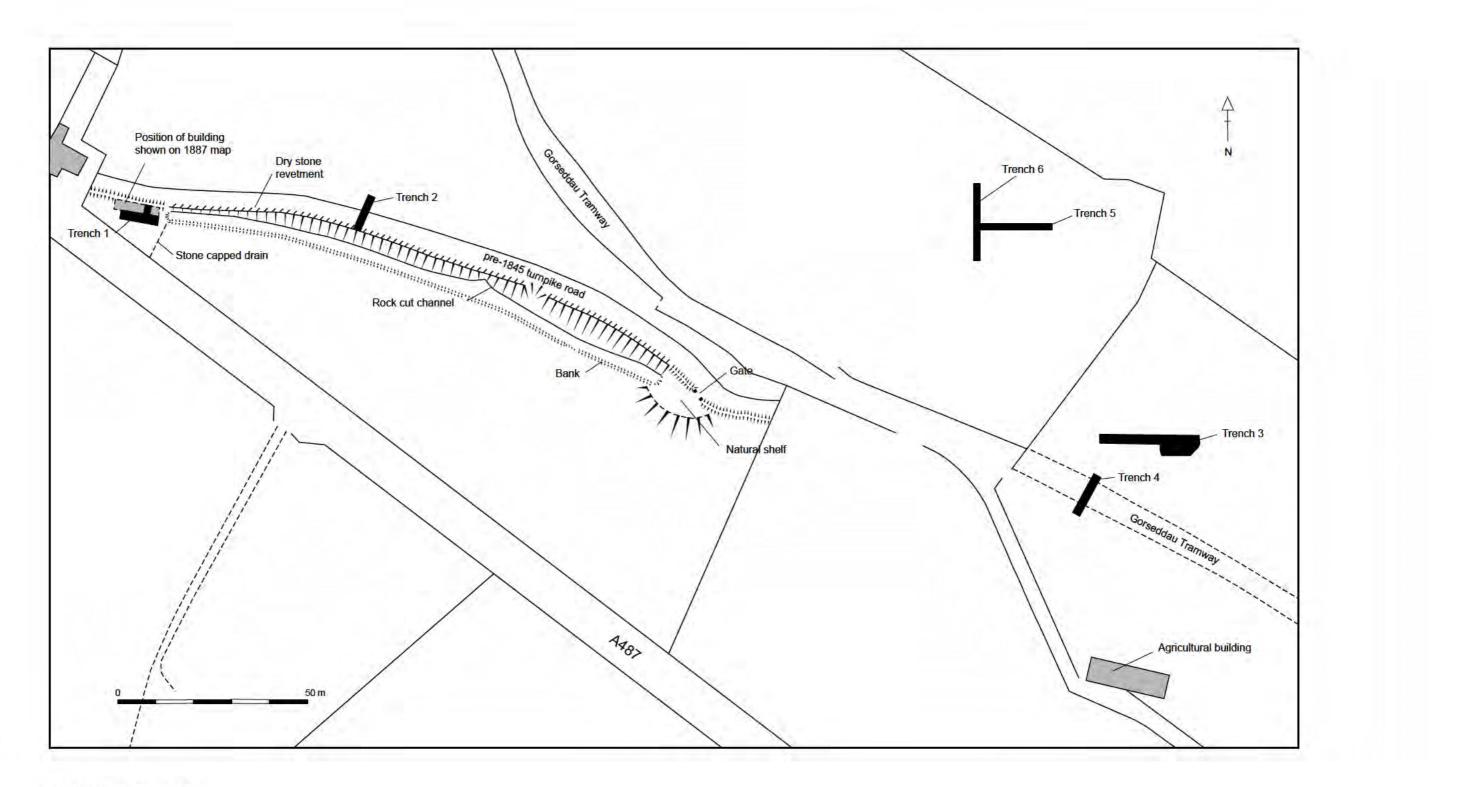
Figure 7. Trench location plan

Each trench is described separately. Archaeological deposits are numbered within rounded brackets, and archaeological cuts within square brackets. The location of the trenches is shown on fig 7.

Trench 2 was located in the north west section of the evaluation area (see fig 7). It measured 8.50 m x 1.80m (l x w) and was inserted in attempt to identify the remains of the pre-1845 turnpike road and investigate any evidence for earlier phases.

Trench 3 was located at the eastern end of the evaluation area, at a point where the natural slope flattened slightly below a rocky outcrop to form a small terrace. It thus lay between the remains of the Gorseddau Tramway to the south and field boundaries to the west and north (fig 7).

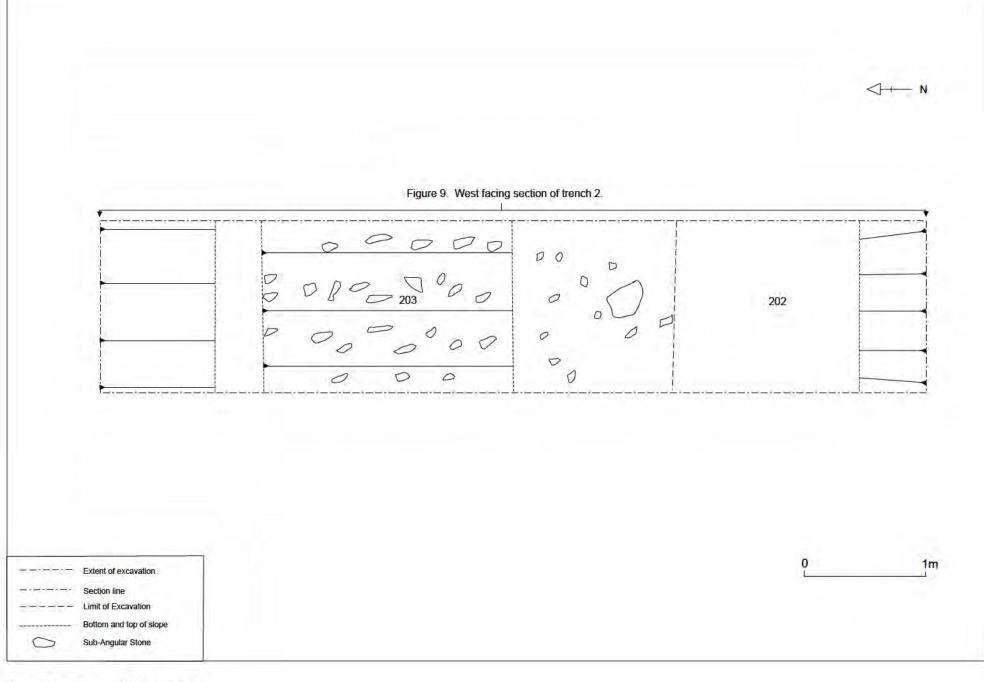
Figure 8. Post excavation plan of trench 2.

The trench was inserted through the topsoil, context (201), which measured an average 0.26m in depth. This context sealed context (202), a red-brown deposit of sand-clay-silt, which measured 4.60m in width and 0.70m in depth (maximum). This deposit was provisionally identified as the surface of the turnpike road. It was in fact a thick deposit of colluvium that had build up against the slope of the hillside, sealing orange, shale-rich subsoil, context (203). The turnpike appeared to have been created by terracing context (202) to create a flat tractable surface (see fig's 8 and 9; Plate 3).

Evaluation Trench 2 confirmed that the pre-1845 turnpike road had been constructed by terracing the natural colluvium. There was no evidence for a pre-turnpike road, and none for a road of Roman date. **Recommendations:** It is unlikely that further evaluation or excavation will help understand the function of either site 18, the rectangular building, or site 13, the rock cut feature. The impact upon these two is likely to be relatively slight, and the upper north-east end of the leat/drain, which may be of greatest interest, is presently not going to be disturbed. Should clearance or construction take place at this end then a comprehensive watching brief, with time for recording, should be undertaken. A watching brief should also be maintained when the access road cuts through the leat and turnpike road, and time allowed for cleaning and recording a section.
