# Balfour Beatty Jones Brothers Joint Venture A487 Porthmadog, Minffordd and Tremadog Bypass

Report on archaeological mitigation (GAT report 1065)

## A487 Porthmadog, Minffordd and Tremadog Bypass

### Report on archaeological mitigation

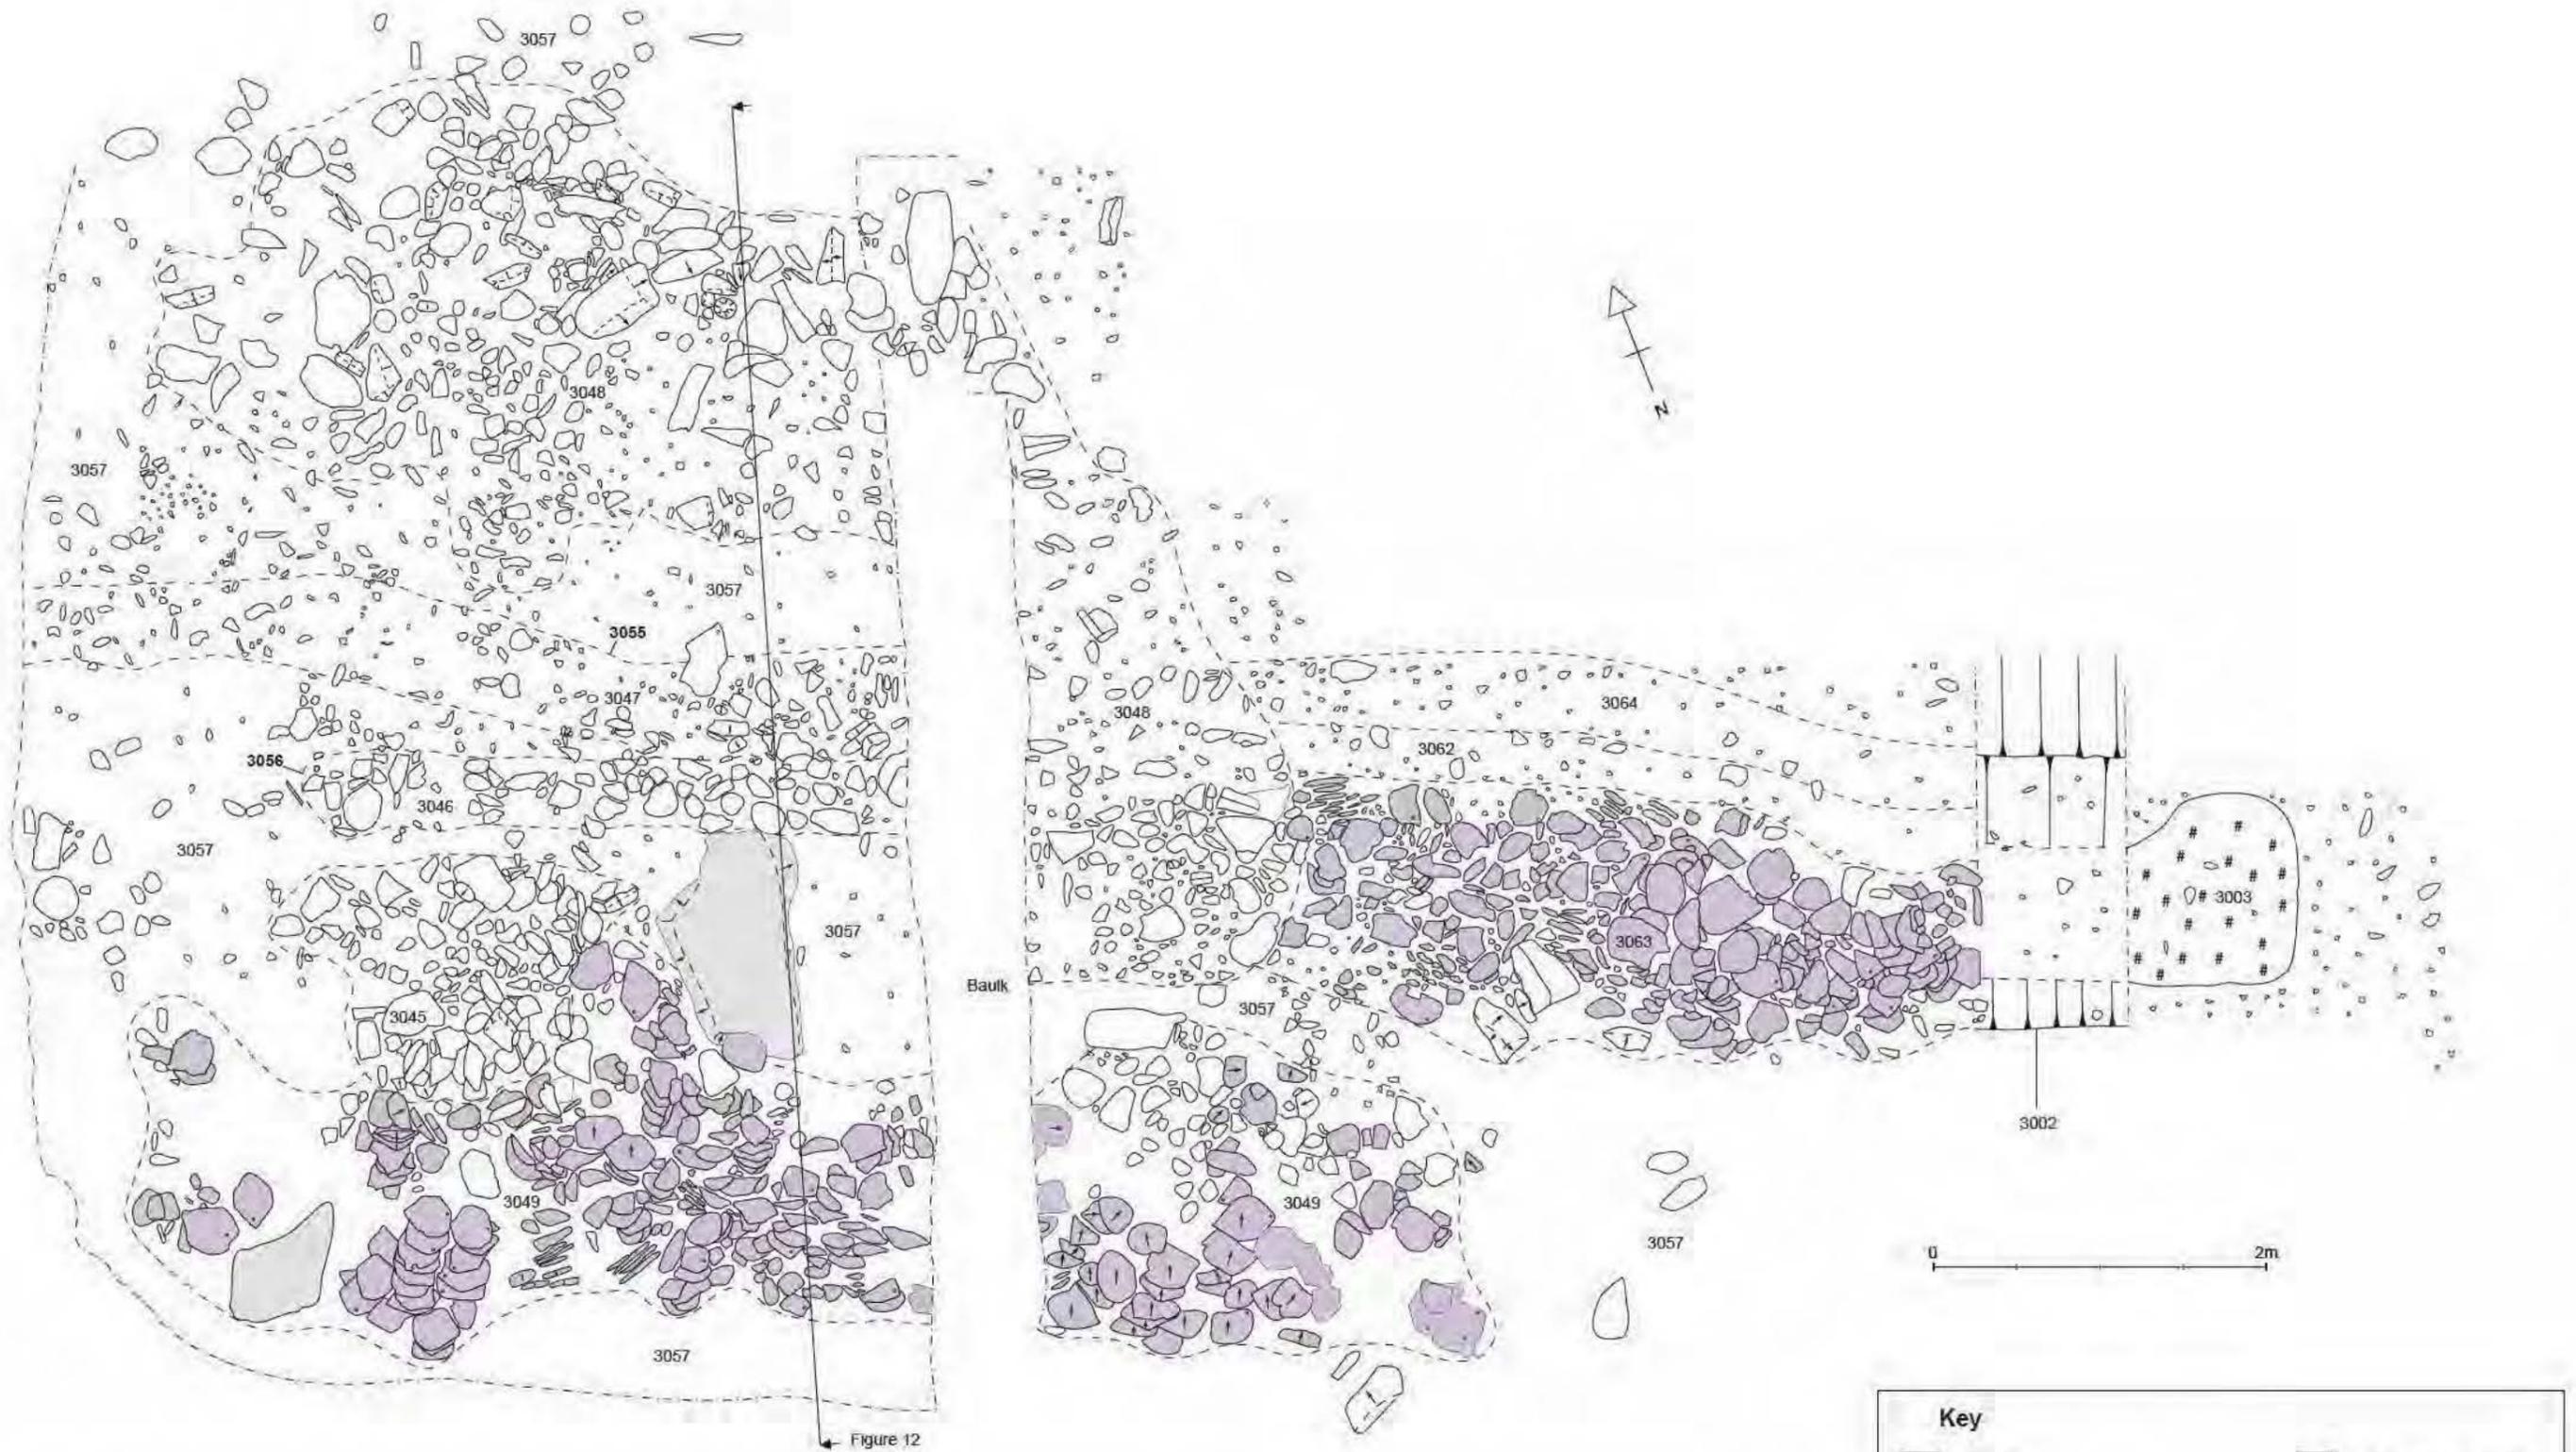
Figure 14. Plan of roofing slate area, showing concentrated areas of purple roofing slates with dumping deposits to the north. This area sloped down from south to north.

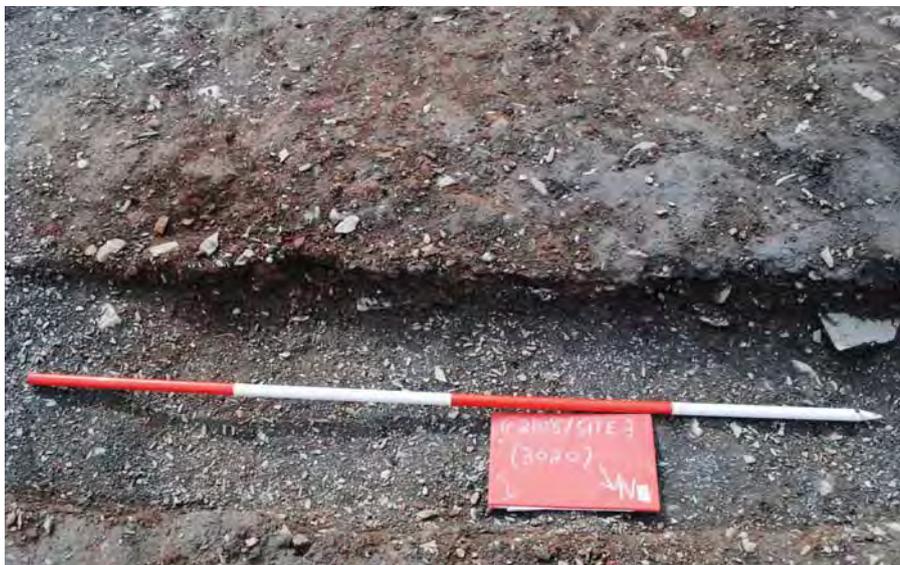
Plate 9: Section through burnt clay deposit (3020)

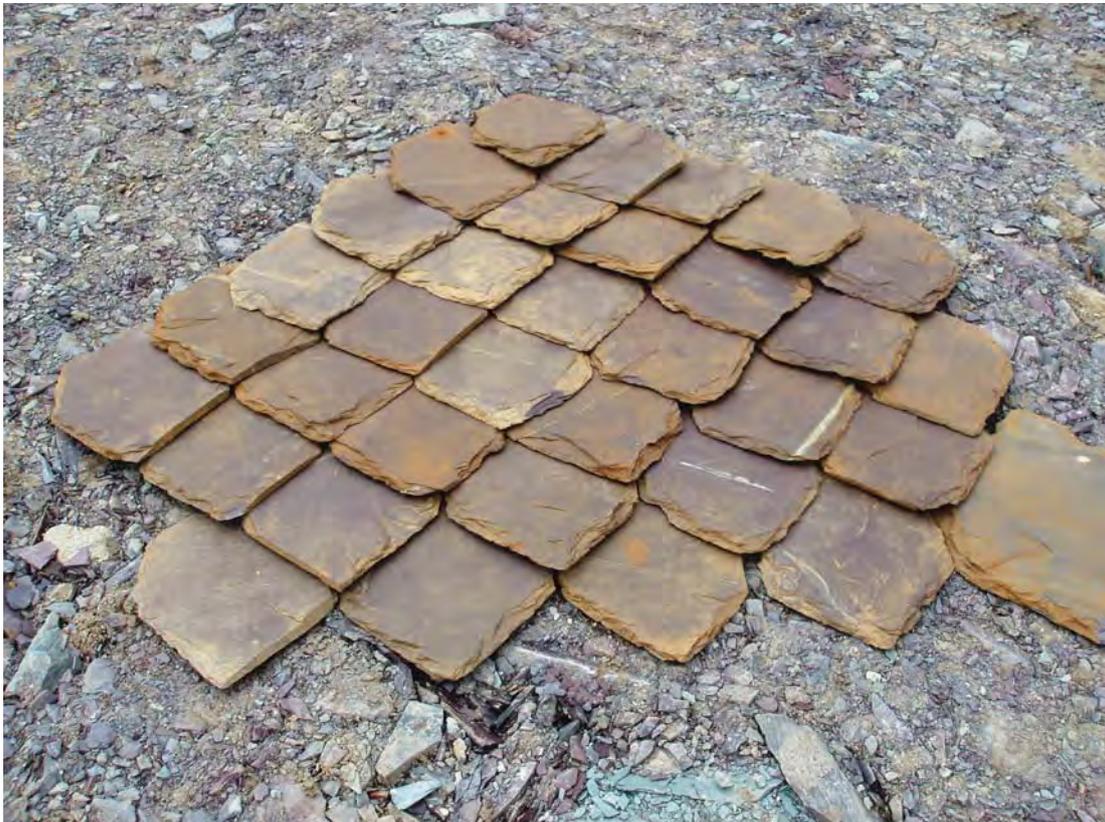
Plate 12: Slates laid out to indicate how they would be hung on the roof (photograph by Bill Jones)

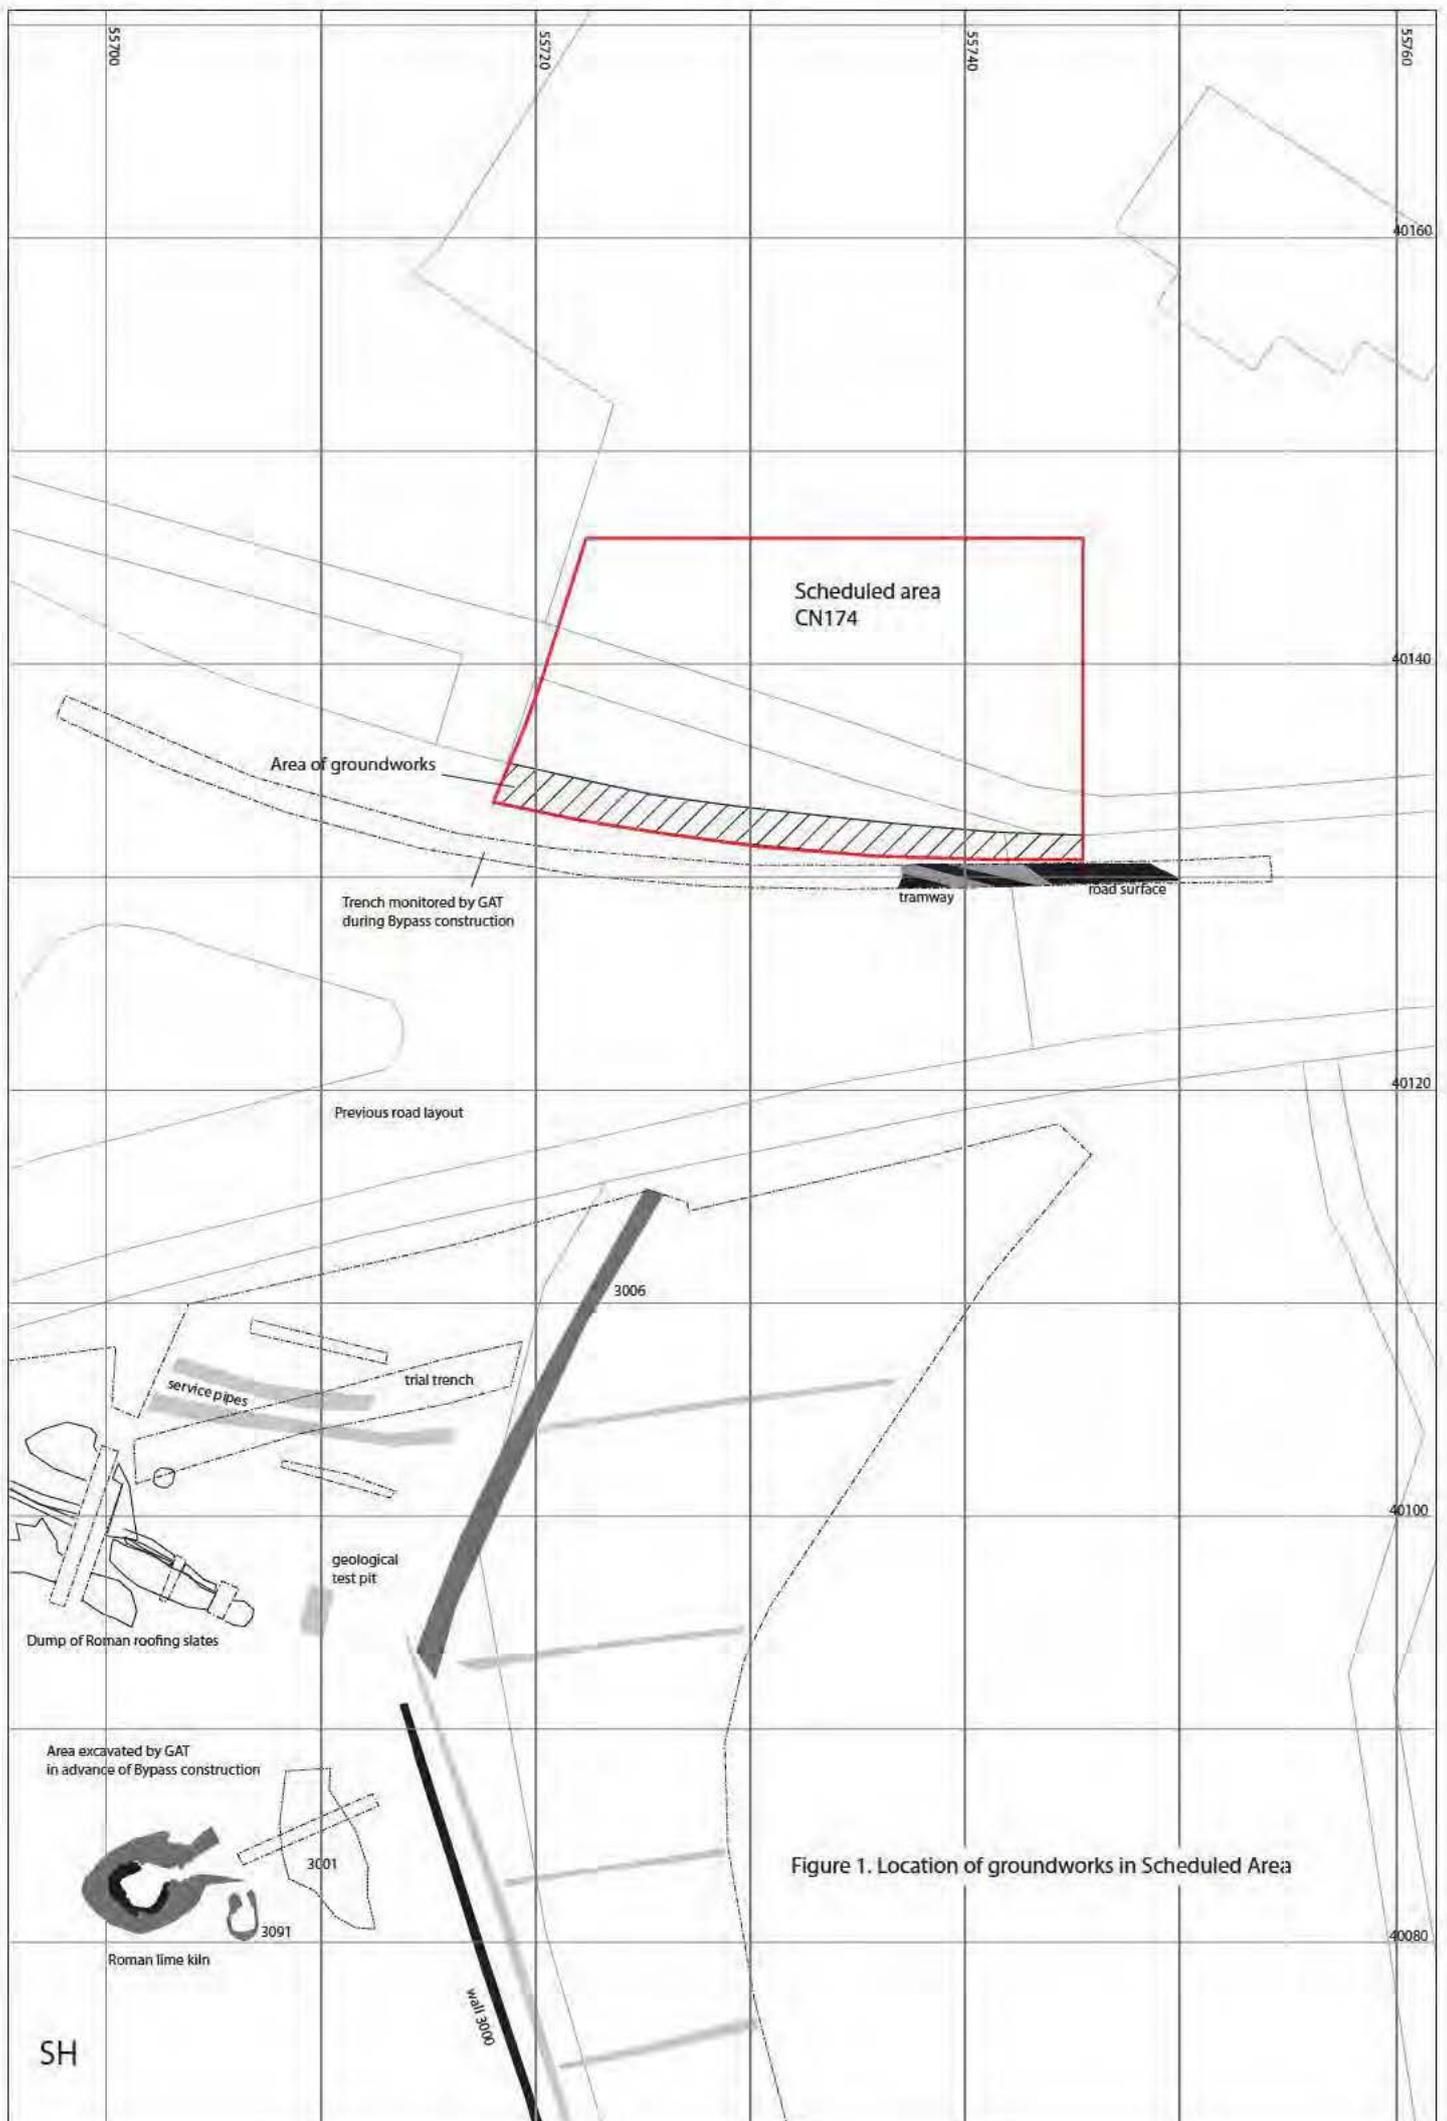
Figure 1. Location of groundworks in Scheduled Area

At the back of the existing verge an 8m section of the existing footway surfacing within the Scheduled Area will be removed with a planner to a depth of approximately 100mm, in order to tie in the overlay surfacing of the new footway which runs behind the new kerbline to the west. New edging kerbs will be hand laid along southern edge of the footway
