# **Lancaster City Centre**

## **An Archaeological Assessment of The Market Hall and Damside Street**

**LANCASTER  
UNIVERSITY  
ARCHAEOLOGICAL  
UNIT**

**March 1991**

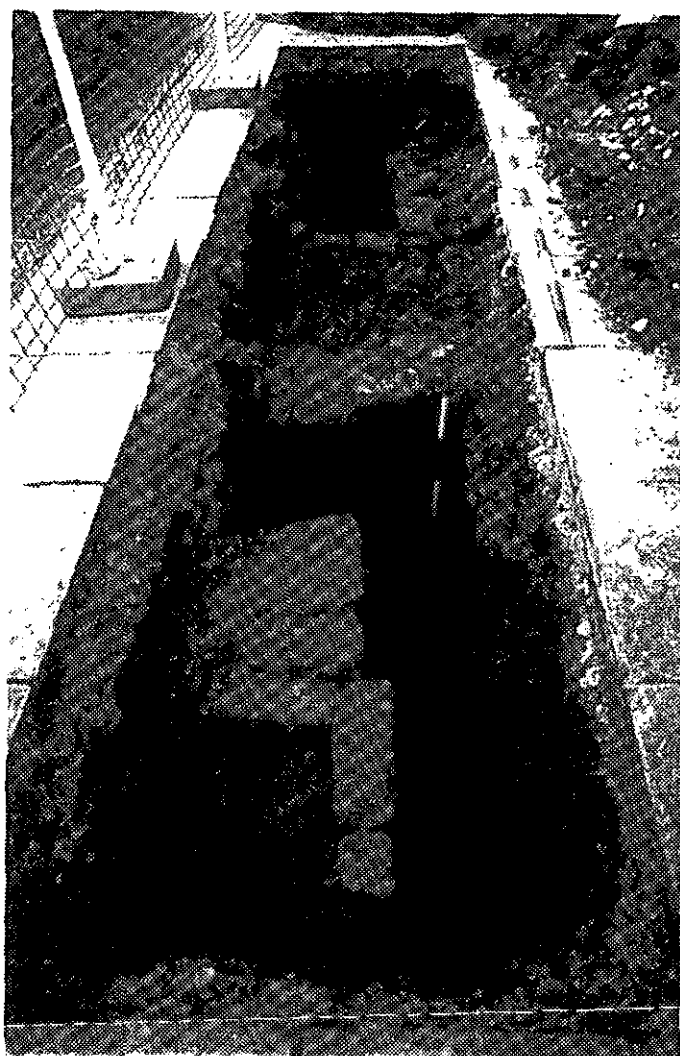
Plate I: Market Hall, Trench 2, from the east showing the cellars and the surviving archaeology (centre of trench)

Trench 2 was located to the north of the Market Hall, on the paved ramp, adjacent to Barrows Yard electricity substation. The trench measured 6.80m by 1.20m, with its long axis orientated east-west. The upper levels were made up of hardcore (0.10m deep) topped with bedding sand (0.09m deep) and the surface was made of 0.60m square pre-cast paving slabs (0.065m in depth). The removal of the modern surface revealed building debris and two separate cellars which had possibly cut through any archaeological deposit; however, a narrow strip between the cellars appeared not to have been disturbed and this was investigated more closely (Plates I & II).

The layers described above were truncated to the east and west by cellar walls (19 & 16); however, no foundation trenches were observed for these although it should be noted that the walls were not exposed to their full depth. It would appear that the cellar was constructed by means of building immediately against the cut made to accommodate the cellar; certainly both outer faces of the exposed walls were irregular. All other material post-dated the construction of the cellars and was part of the processes of building demolition and levelling.
