**AN ARCHAEOLOGICAL ASSESSMENT AT  
CHURCH FARM, BIDSTON  
1992 (SITE 31)**

**September 1992**

Field Archaeology Section,  
Liverpool Museum,  
William Brown Street,  
Liverpool L3 8EN  
Tel: 051 207 0001 x260

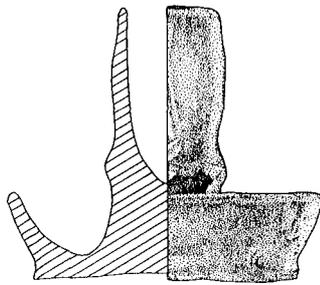
Fig. 15. Pottery from Church Farm, Bidston, 1992

The finds from Church Farm represent an interesting cross-section of the occupation history of the site. By far the largest category of find was pottery. In total 63 pottery sherds were recovered. The earliest sherds were three of Roman date, comprising a rim sherd of Gillam form 219 black-burnished dish (BB1, Fig. 15.1) of the period AD 125-150, a rim sherd of a jar in a slightly micaceous sandy orange fabric, which may be Severn Valley or Cheshire Plains fabric (Fig. 15.2), and a small body sherd in a light orange-brown sandy fabric.

As usual on farm or village sites, the great bulk of the finds date to the post-medieval and later periods (16th to 20th centuries) when the use of pottery became firmly established (58 of 63 sherds). A small number of dark-glazed sherds representing four or five earthenware storage vessels of 16th and 17th century date, together with three fragments from different self-coloured ware bowls (dating to the 17th century) is followed by the usual explosion of pottery use in the 18th century. The principal form remains the storage vessel but a small number of thinner walled sherds in black wares are evident. The rim of a trailed slipware dish, of a type dated 1660 to 1720 in Stoke-on-Trent, but not necessarily a Staffordshire product (31.11), along with a single body sherd of agate-bodied ware (31.4), a rather superior earthenware which had a *floruit* in the period 1740-70, represent the only relatively sophisticated vessel in the collection. An unusual find was a candlestick with a very carefully applied dark brown glaze over a fine dark red body which probably dates to the 17th century (31.22, Fig. 15.3).

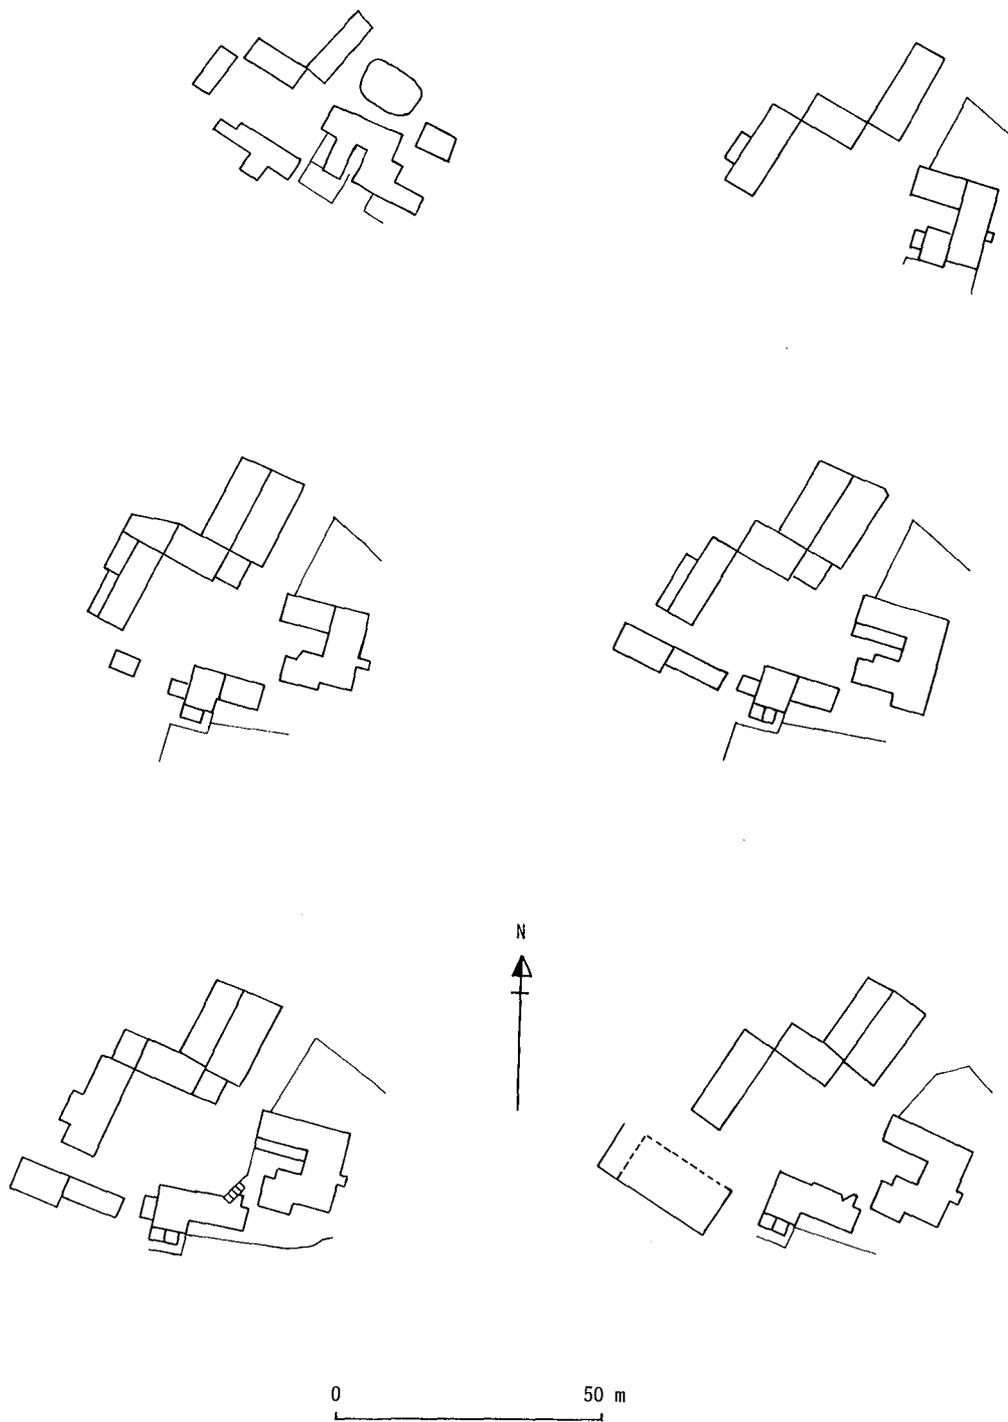
Fig. 16. The map evidence for the Church Farm buildings, a: 1842, b: 1875, c: 1911, d: 1935, e: 1954, f: 1990

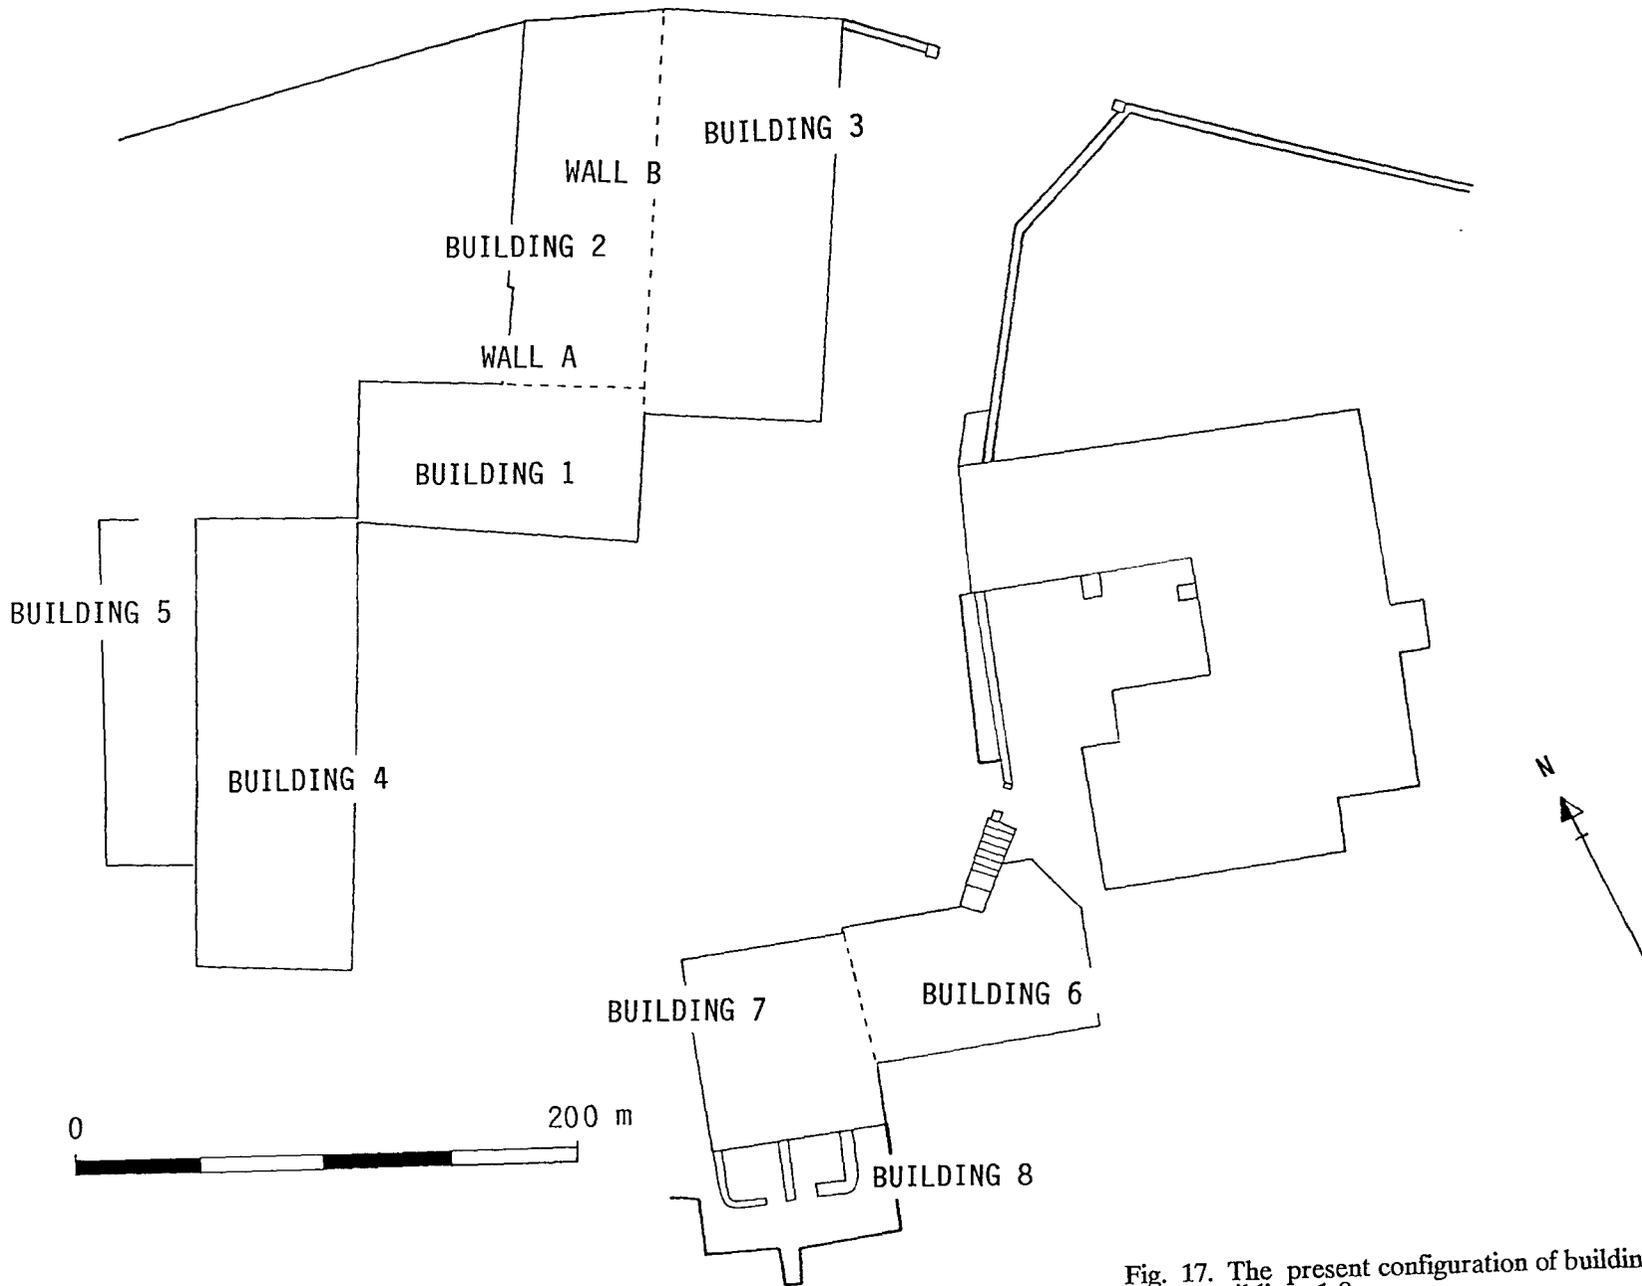
Fig. 17. The present configuration of buildings, showing the location of Buildings 1-8

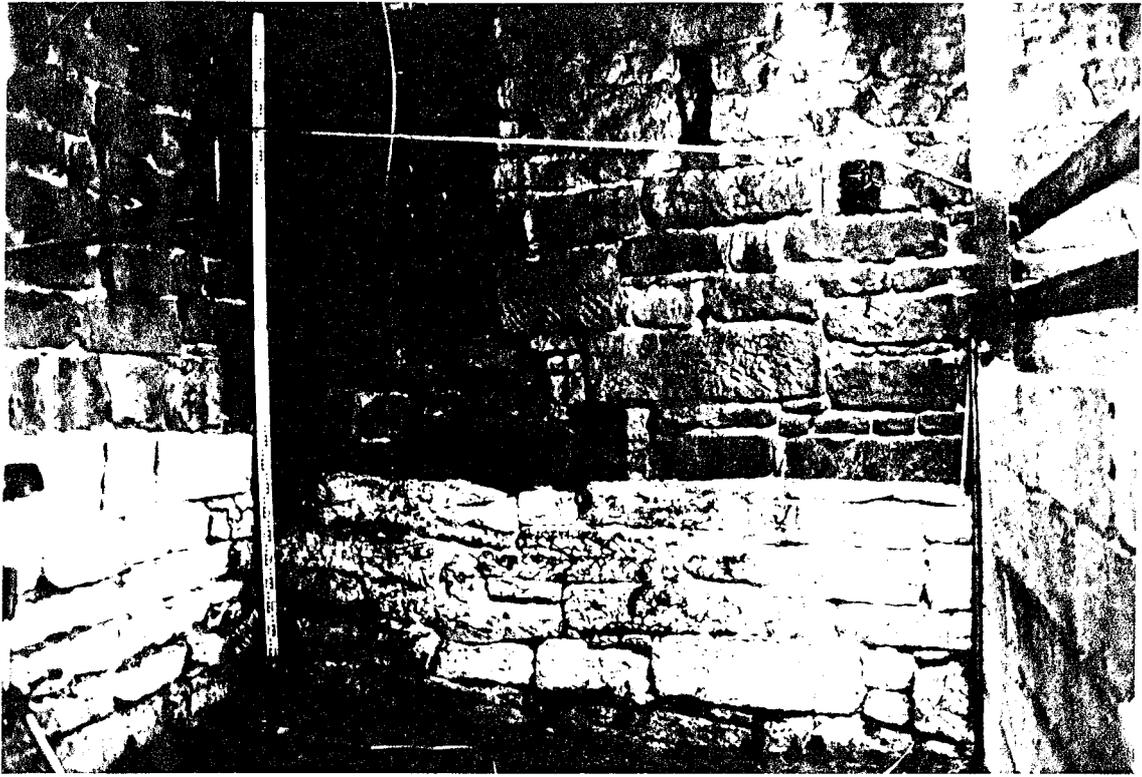
Ia The interior dividing wall (Wall A/B, Fig. 17) of Building 2

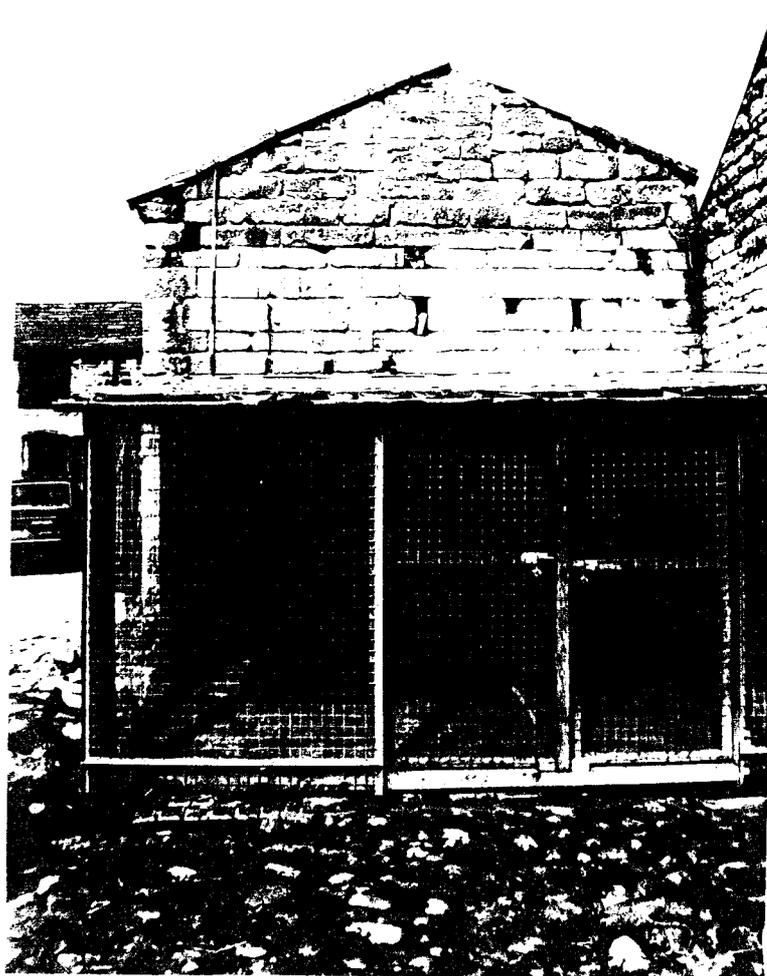
Ib The eastern gable end of Building 1

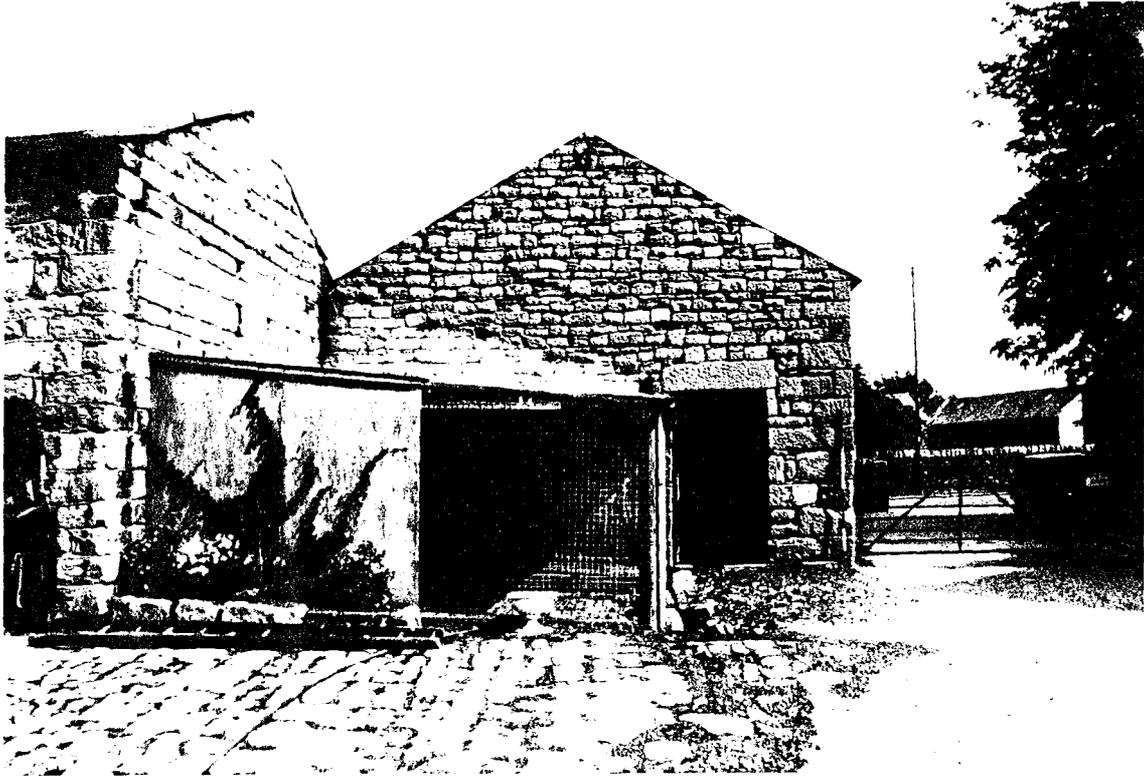
IIa The southern gable end of Building 3

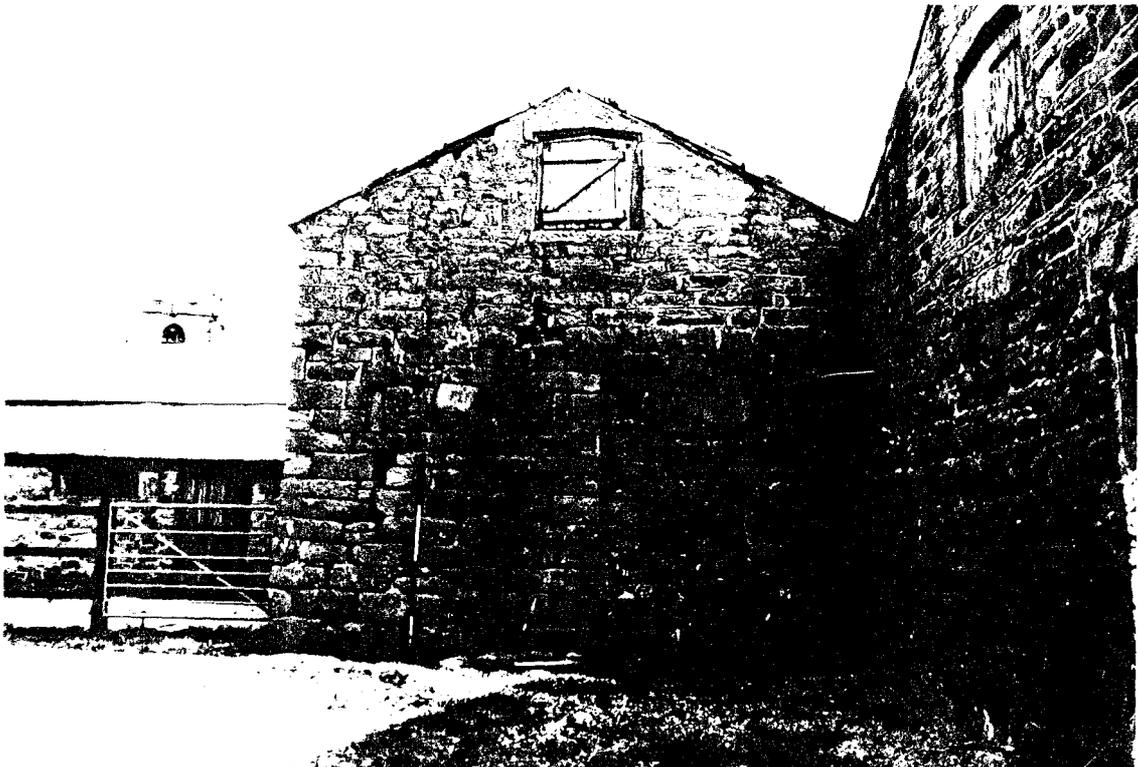
IIb The western gable end of Building 1

Again, as in the case of the eastern gable end of Building 1, the western gable end has three evenly spaced, but blocked ventilation holes. There is also an opening in this apex, but unlike the opposing gable opening it has a moulded surround, a sill, a lintel and a fitted wooden door with cross and diagonal battens visible from the exterior. The southern edge of the western gable lacks well shaped quoins, and, as in the case of Building 1 and Building 3, there is no apparent attempt to key Building 1 in with Building 4.

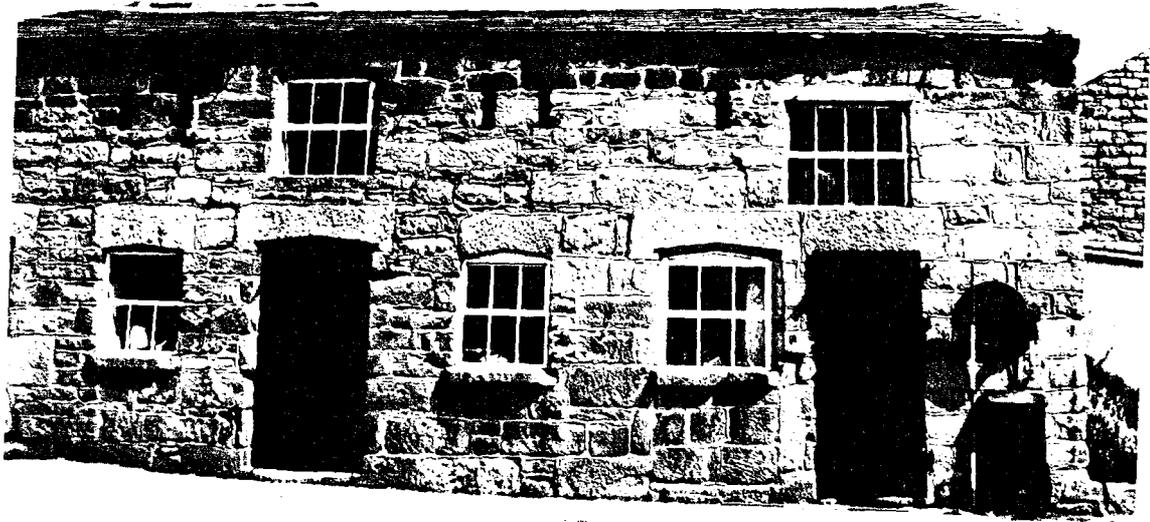
IIIa The south facing elevation of Building 1

The southern elevation of Building 1 (Photograph IIIa) originally had alternating doors and windows on the ground floor level but they have subsequently been altered. From the western end of the building moving eastward, there is a blocked doorway, (now a window), one unaltered window, one stable door, one unaltered window, one blocked doorway, (with a layer of white angular gravel stones set in the bottom of a step, 20 - 30 mm thick), and finally at the eastern end, one stable door. Each window is a sash window with a moulded surround and a large carefully finished ashlar block as a lintel. Each of the ground floor windows has a large sill which projects from the wall by approximately 0.15 m.

The eastern most door and window on this elevation are not as evenly spaced apart as those further along the elevation, or those on the east facing wall of Building 4 (Photograph IIIb). The window above this doorway also has a different appearance in that it has no sill, and has a modern rectangular concrete block as a lintel.

The first floor level has, from west to east, a pair of rectangular ventilation holes, a window (which previously had a wooden door similar to those on the eastern elevation of Building 4 (I. Ross pers. comm.)), a pair of rectangular ventilation holes, a single ventilation hole and the afore-mentioned window with a concrete block lintel.

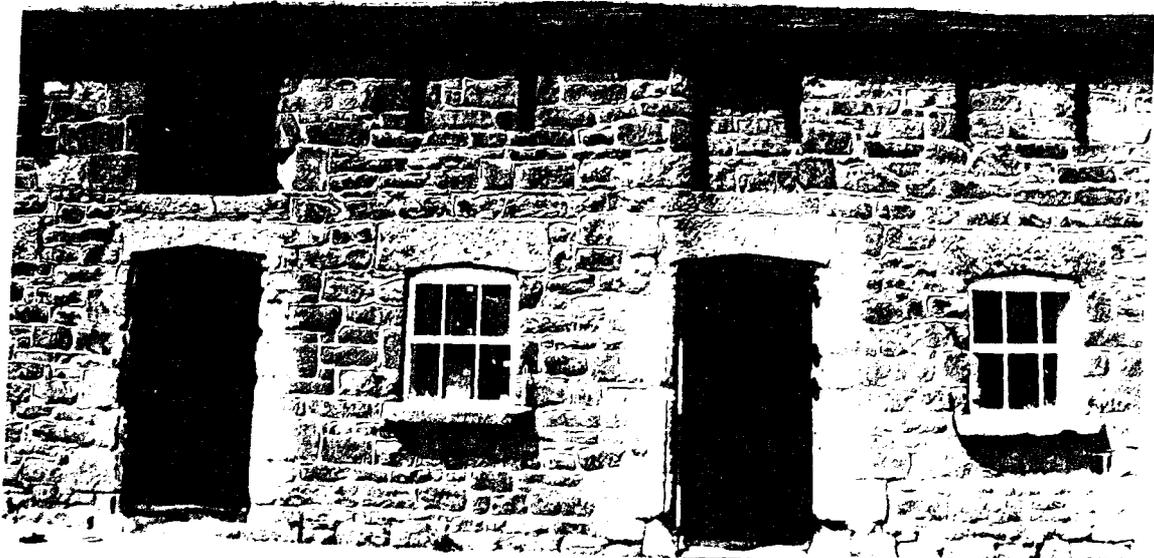
IIIb The eastern elevation of Building 4

The appearance of this elevation compares well with the eastern elevation of Building 4 (Photograph IIIb). Here the air vents form matching pairs, suggesting that Building 1 has lost an air vent in order to accommodate an additional window. On the ground floor of Building 1, during the same stage of reorganisation, a window has been blocked and an extra door 'squeezed' into the remaining space at the eastern end. This may also have been the phase when a brick wall was added to the interior of the eastern gable, between the fourth window and the added door, to form a small loose-box, tack room or quarantine at the eastern end. The present owners constructed a secondary floor to this room for use as a bird loft, but originally the added window on the first floor would have provided the light for the room.

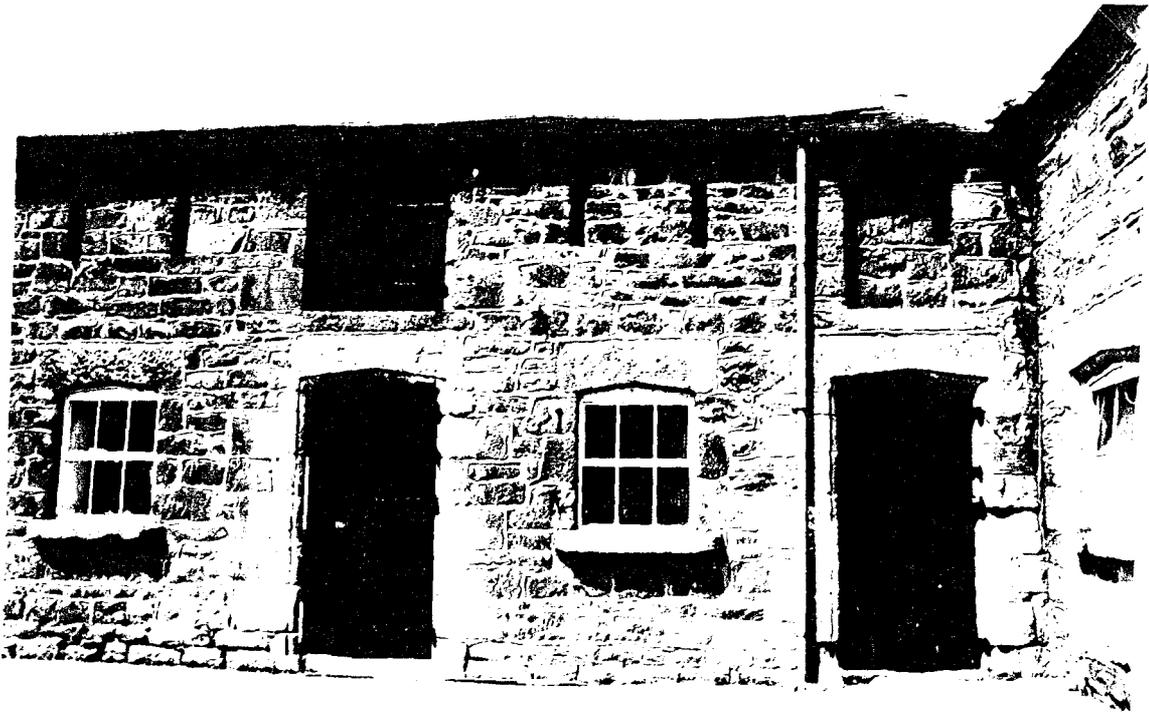
Va The northern end of the east facing elevation of Building 4

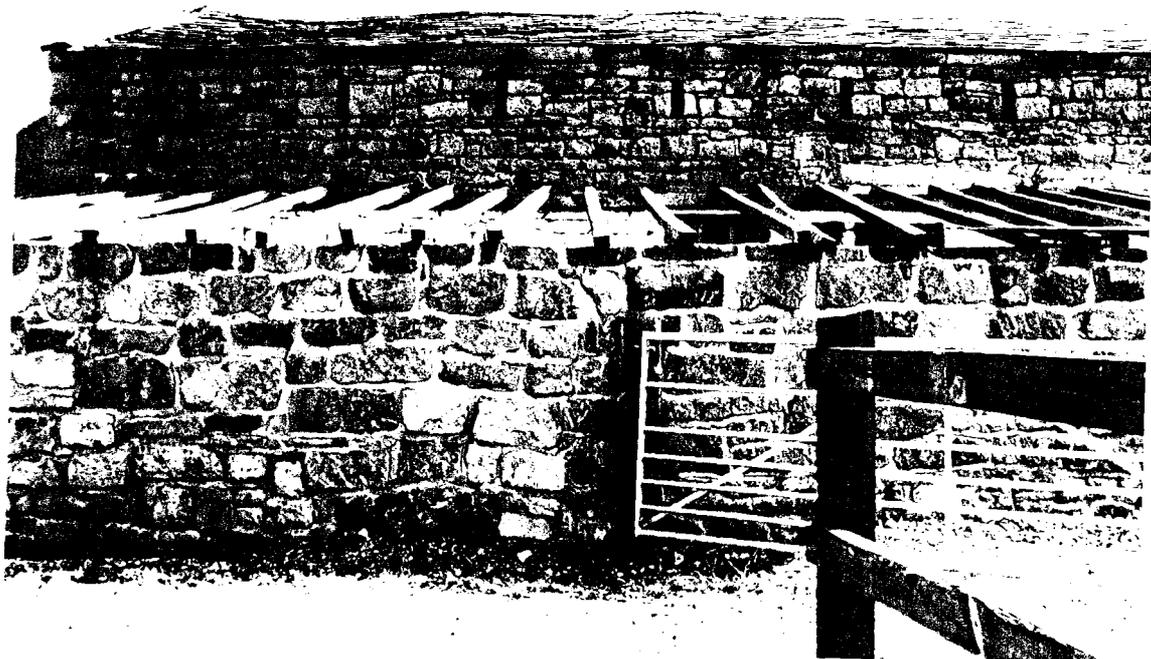
Vb The western elevation of Building 5

This block is a modern feature which remains unfinished (Photograph Vb). Again the construction is one of squared built to courses, and again, a lime based mortar has been used. At present the building has no roof. The incomplete nature of the building provides a good illustration of the way other buildings within the farm complex have been altered in the past. It can be seen from the map evidence that a smaller extension has existed at this point until the mid 1980s. The present structure makes use of the southern wall of this extension.

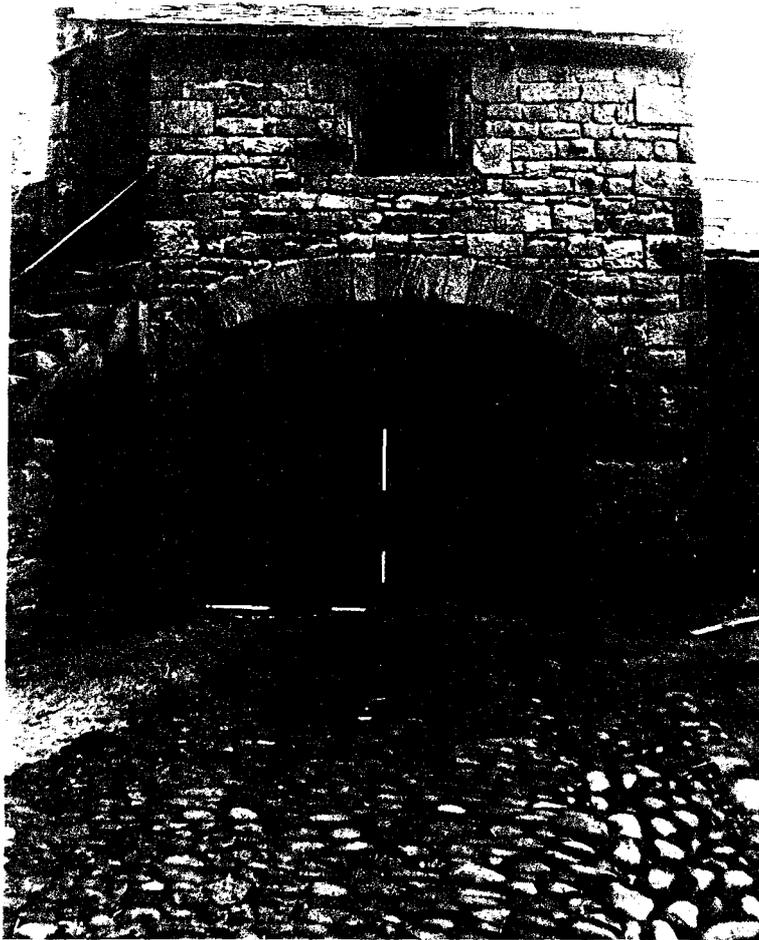
VIa The north facing elevation of Building 6

The granary at Church Farm is of a common arrangement, built over the cartshed, and measuring 16m by 6m including the adjoining shed. The two functions complement one another, as the granary needed to be raised from the ground, and the cartshed required an open-fronted roofed structure. The Church Farm example has a shallow arched lintel formed by a series of wedge-shaped stone blocks. Now complete with a shed door, it may have originally been open-fronted. It has a brick floor with an area of cobble stones in the entrance. This particular arrangement has external stone steps with an extended wall to accommodate a built-in dog kennel beneath (Photograph VIa).

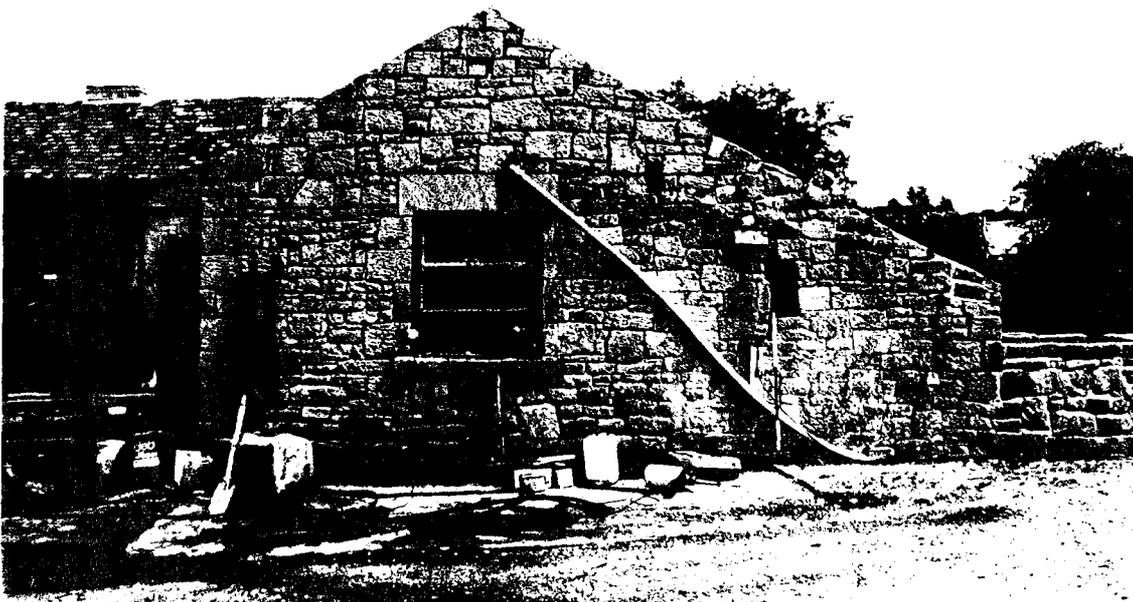
VIb The western elevation of Building 7

The northern corner of this elevation has a well built alternating quoin, but the southern corner (which is in fact the corner of the pigsty wall) has no such feature (Photograph VIb).

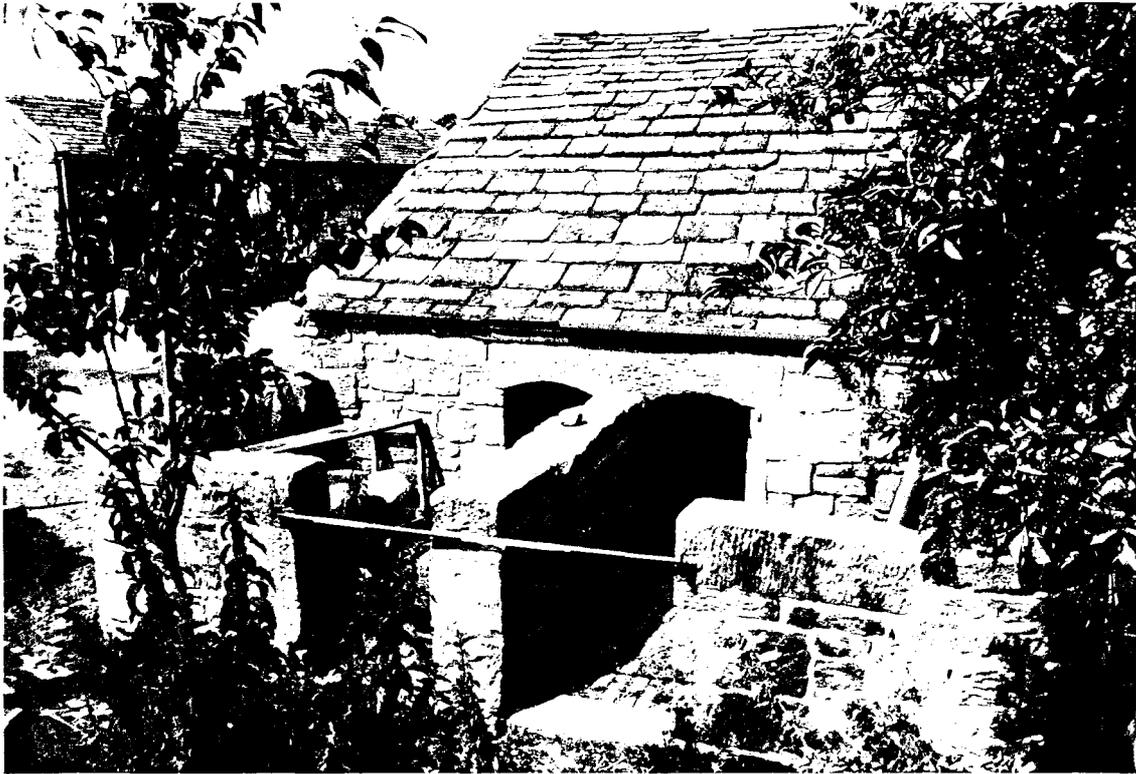
VII Building 8, the pigsty
