*An Archaeological Evaluation on the site of a  
Proposed New Building  
at*

Box House, BOX  
WILTSHIRE

WITHIN SAM 30299

March 2008

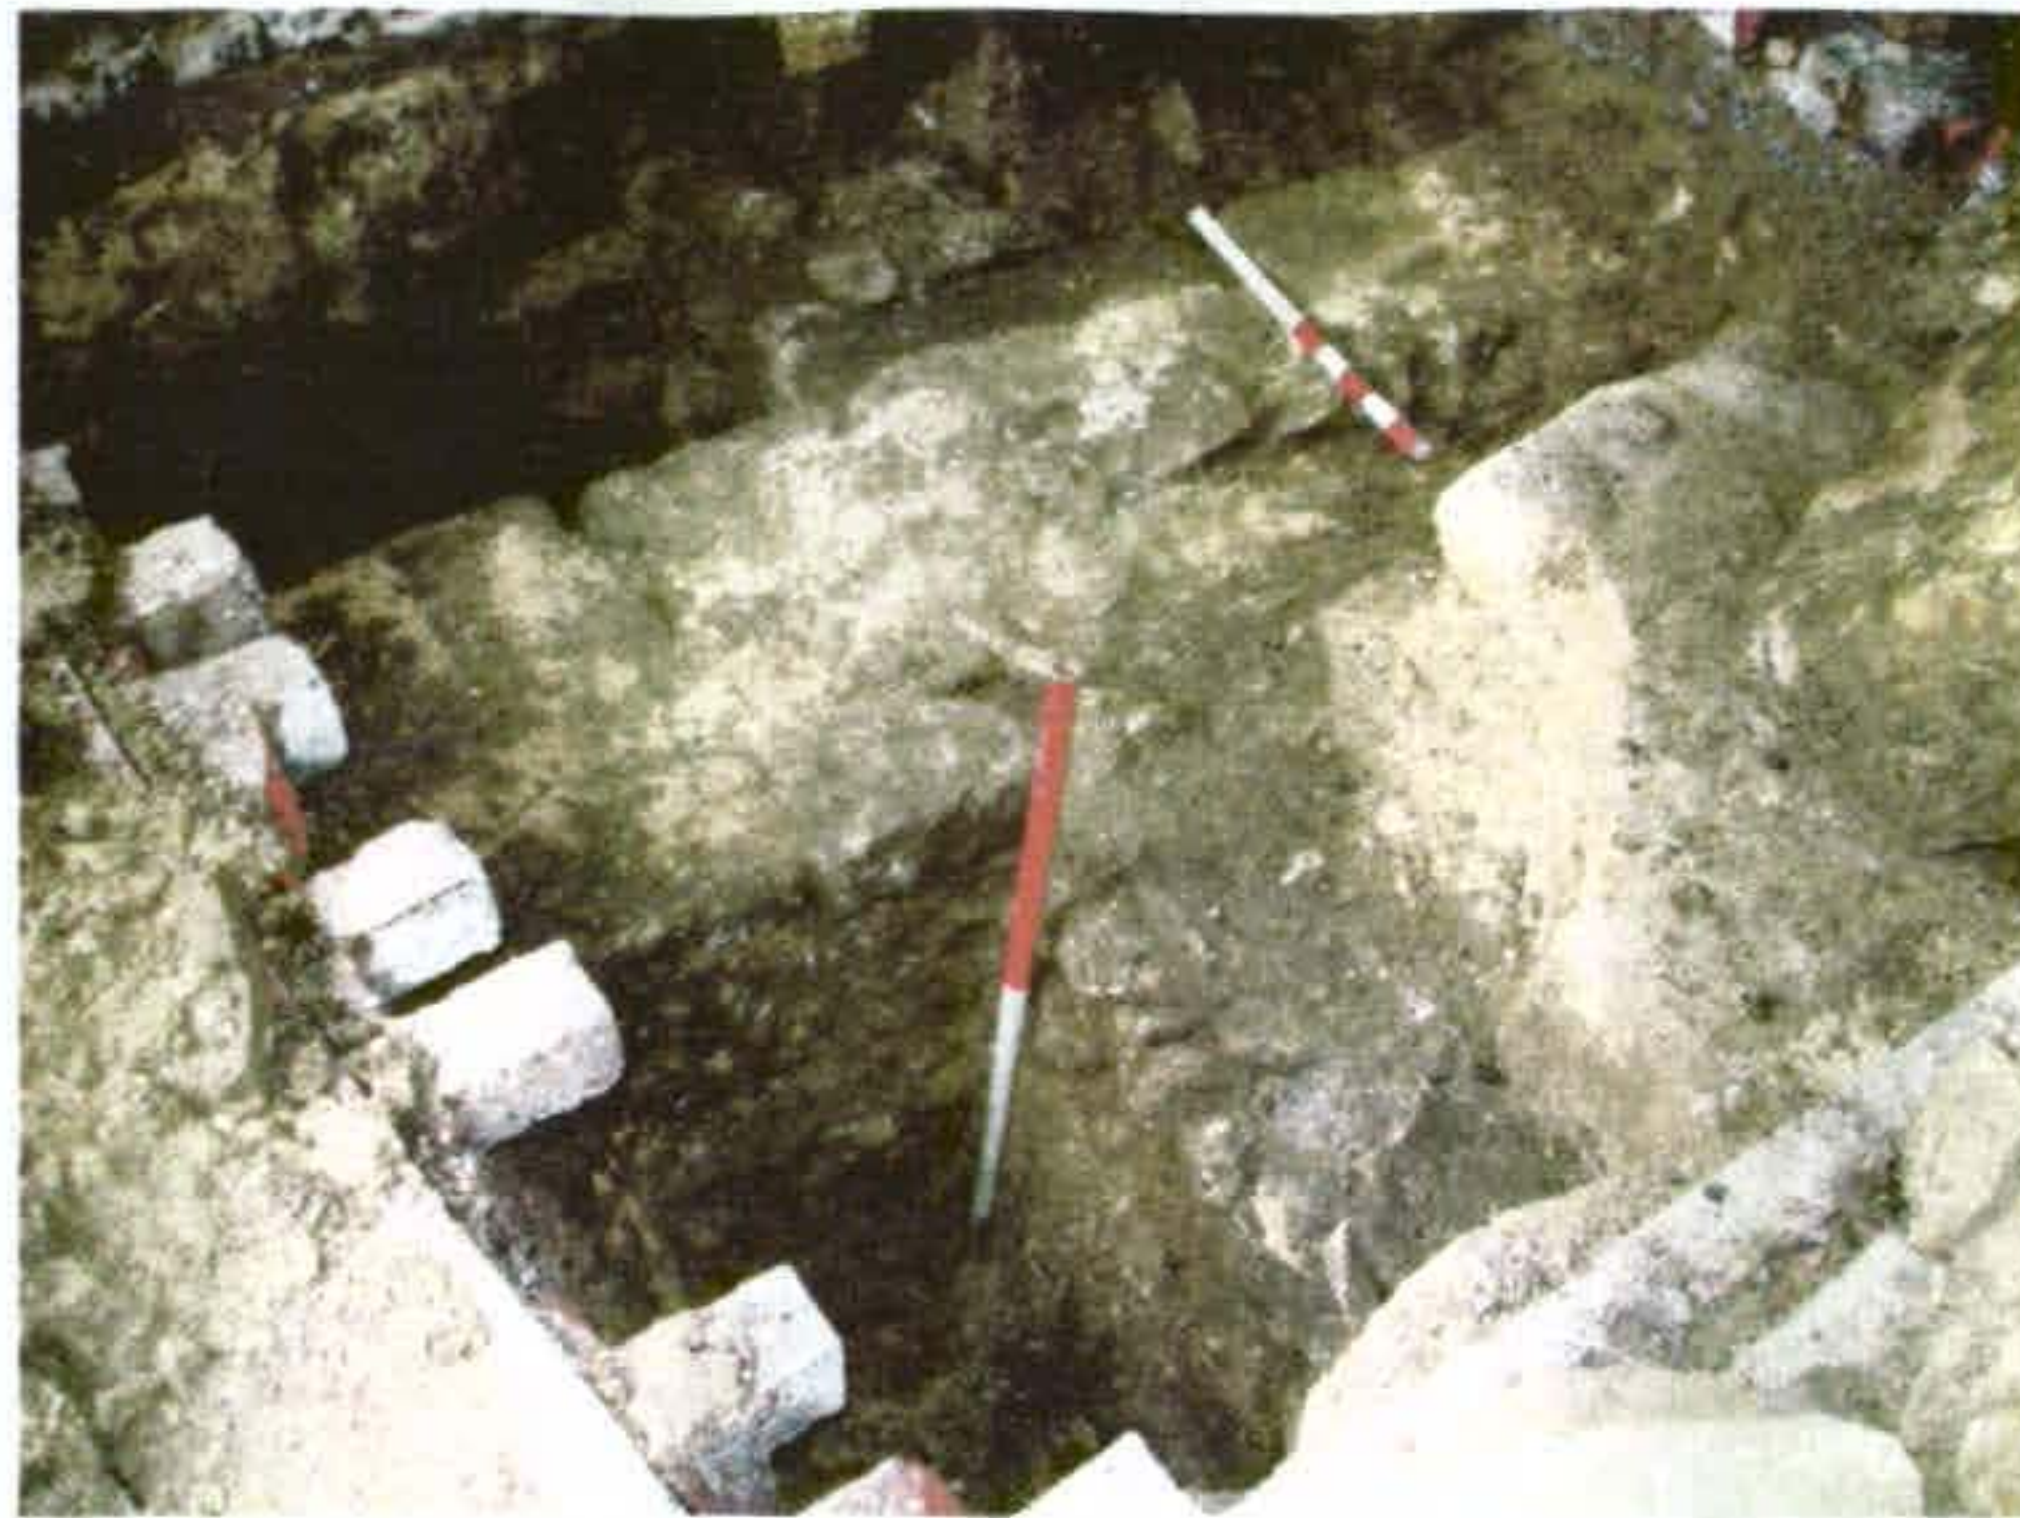
- 6.1.1 This trench was 2m by 2m and was hand dug through the concrete Coach House floor to an average depth of 0.46m. This revealed the top of a wall (112) at a depth of 0.4m. The wall was 0.59m wide and running on an east north east by west south-west alignment. It was neatly constructed from large subangular limestone blocks on both faces of average depth 0.09m, with a smaller rubble infill, bonded with a hard creamy white lime mortar. On the northern side a sondage revealed that the wall (112) was abutted by a loose gritty light grey layer of decayed limestone and silty clay with occasional rubble (113). The top of this deposit was at 42.98m AOD (Above Ordnance Datum). The base of this layer was not found but it continued to a depth of over 1.4m below floor level and contained no dateable artefacts. Overlying this was a layer of compacted mid brown silty clay 0.4m deep (111) which contained common inclusions of pennant tile fragments and moderate to small subangular limestone stone rubble but no other dateable artefacts. The wall was abutted in the south-western corner of the trench by a compacted mid brown silty clay with occasional rubble (115), which was not excavated but similar to (111). This layer had been cut in the south-eastern corner of the trench by a 19<sup>th</sup> century feature [105] which was filled with loose dark brown soil containing occasional pieces of 19<sup>th</sup> century china (109). A sondage revealed that this later feature was over 0.62m deep and the base was not found. The sondages also revealed that the wall survived to a depth of over 7 or 8 courses and continued to a depth of over 1.4m below floor level, approximately 42.44m AOD.

Wall of Romano-British date

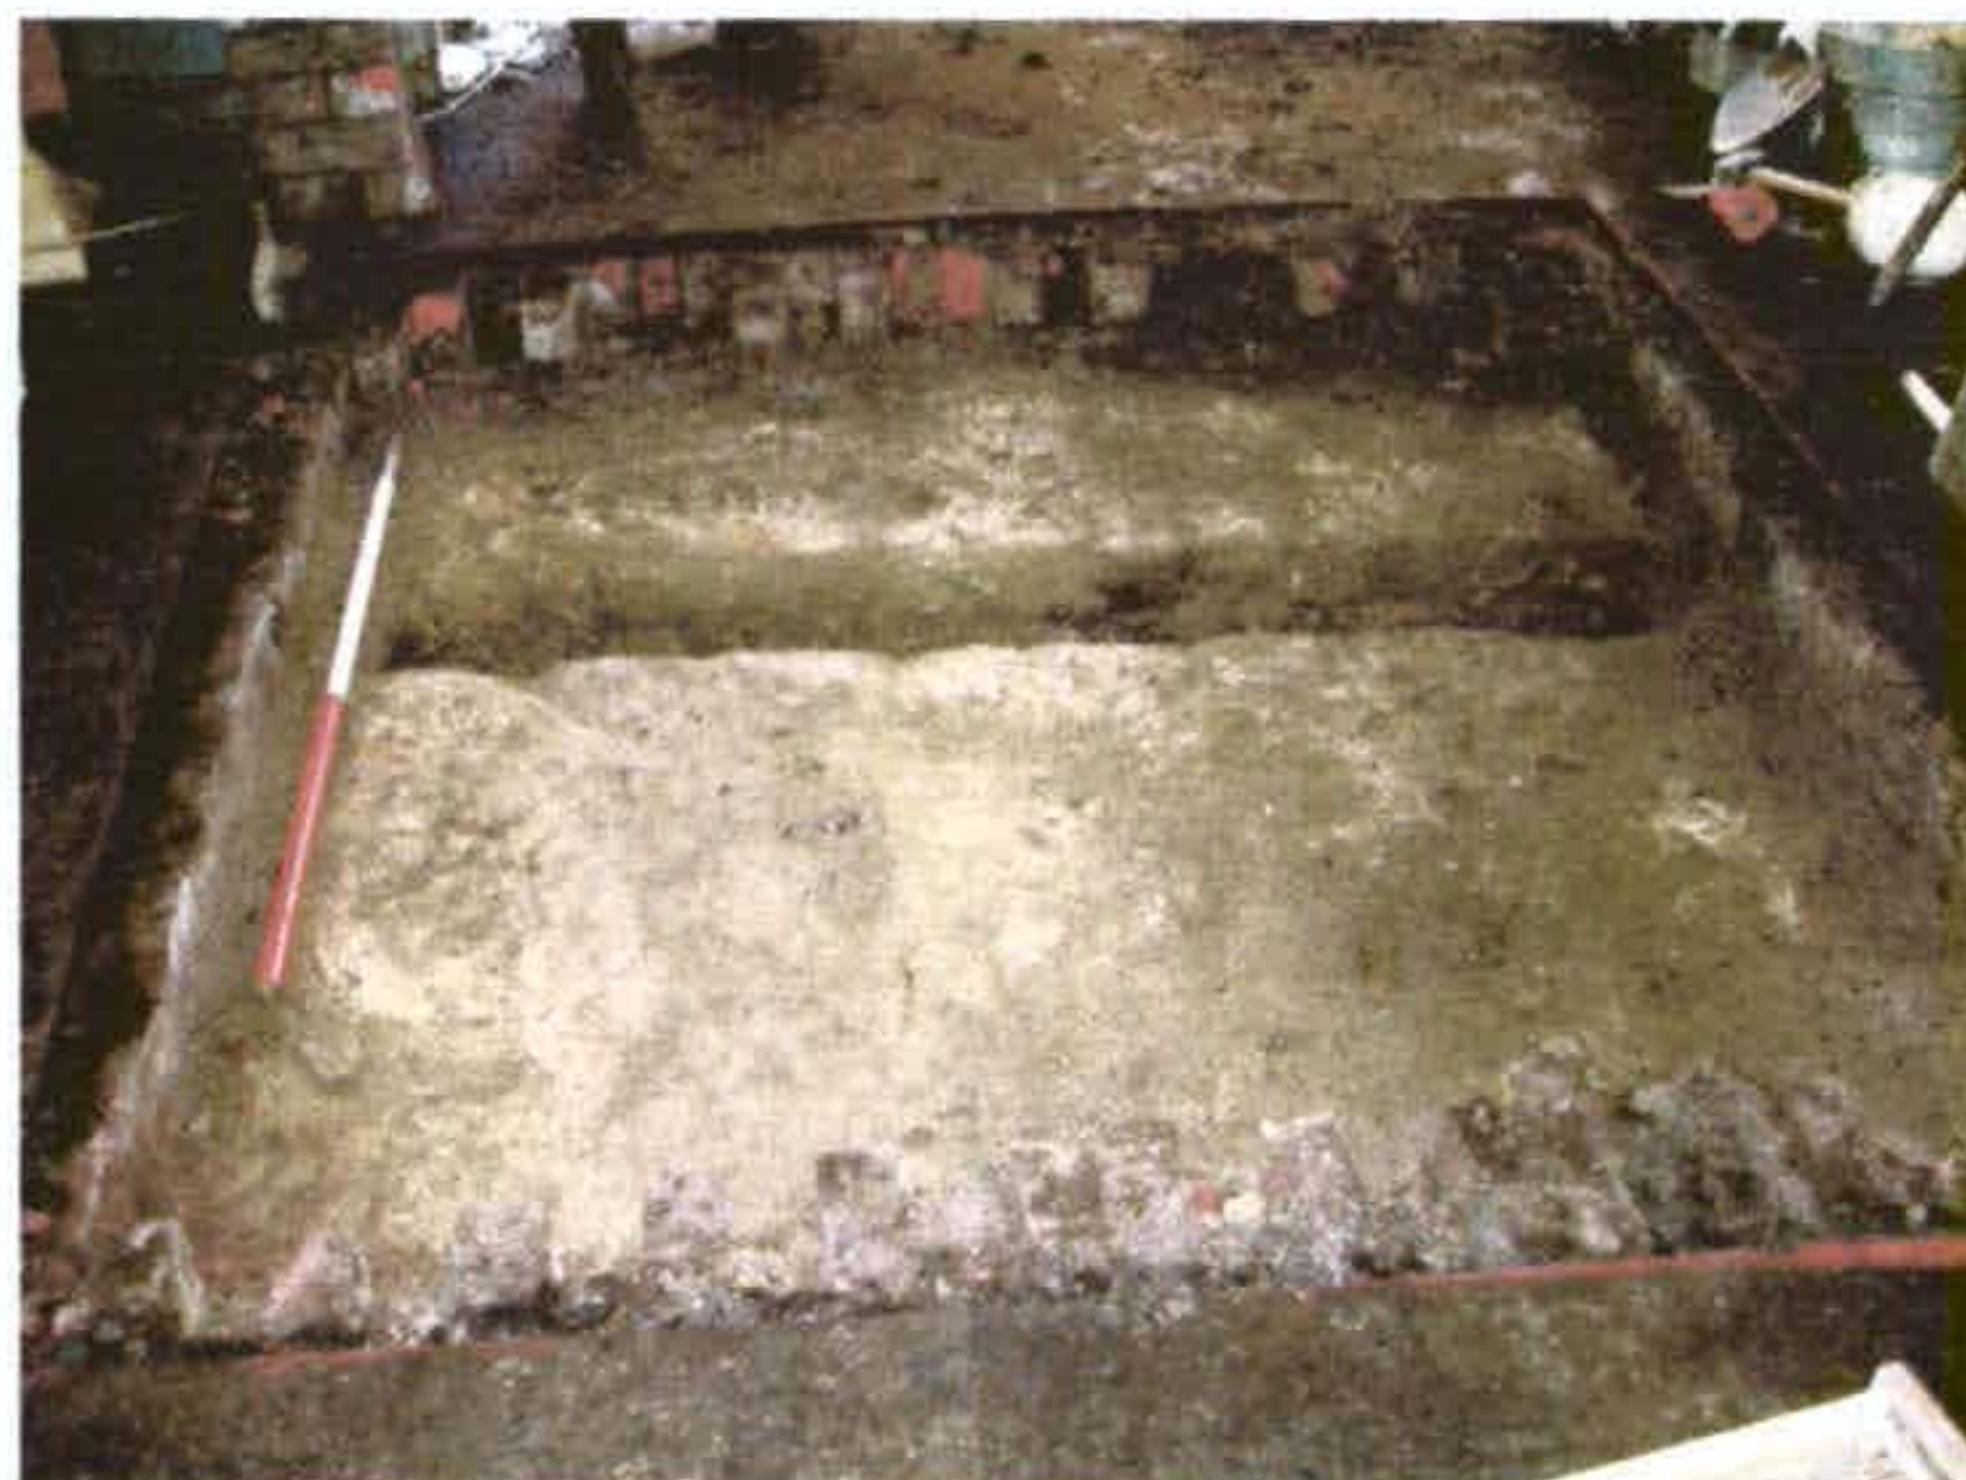
- 6.1.2 The upper part of the wall (112) and abutting layers had been truncated by a 19<sup>th</sup> century floor level which stratigraphically overlay the fill of cut [105]. This 19<sup>th</sup> century building phase (group context 102 including (103) (106), (107) and (108)) was comprised of several components and its base was at approximately 43.38m AOD (see Fig 5). There was a straight stone built channel (103), 0.27m deep and 0.2m wide running parallel to the front wall of the Coach House building with a flat flagstone base (107). At the northern end of the trench the sides of the channel were formed by two large limestone blocks (106). These were abutted to the south by a compacted mid greyish silty clay soil which contained occasional Post-medieval pottery (108). The sides of the channel in the southern half of the trench were constructed from small subangular limestone blocks and abutted the compacted earth layer (108). The channel was filled with a loose brown soil containing 19<sup>th</sup> century glass and ceramics. The channel and associated contexts were then overlain by a thin layer of compacted soil (116) with occasional stones and 19<sup>th</sup> century ceramics up to 0.1m deep. Above this was a mortar bedding layer with a brick floor on top overlain by a later concrete scree surface.

Surface of 19th century date with channel and stone pads (on left hand of picture)

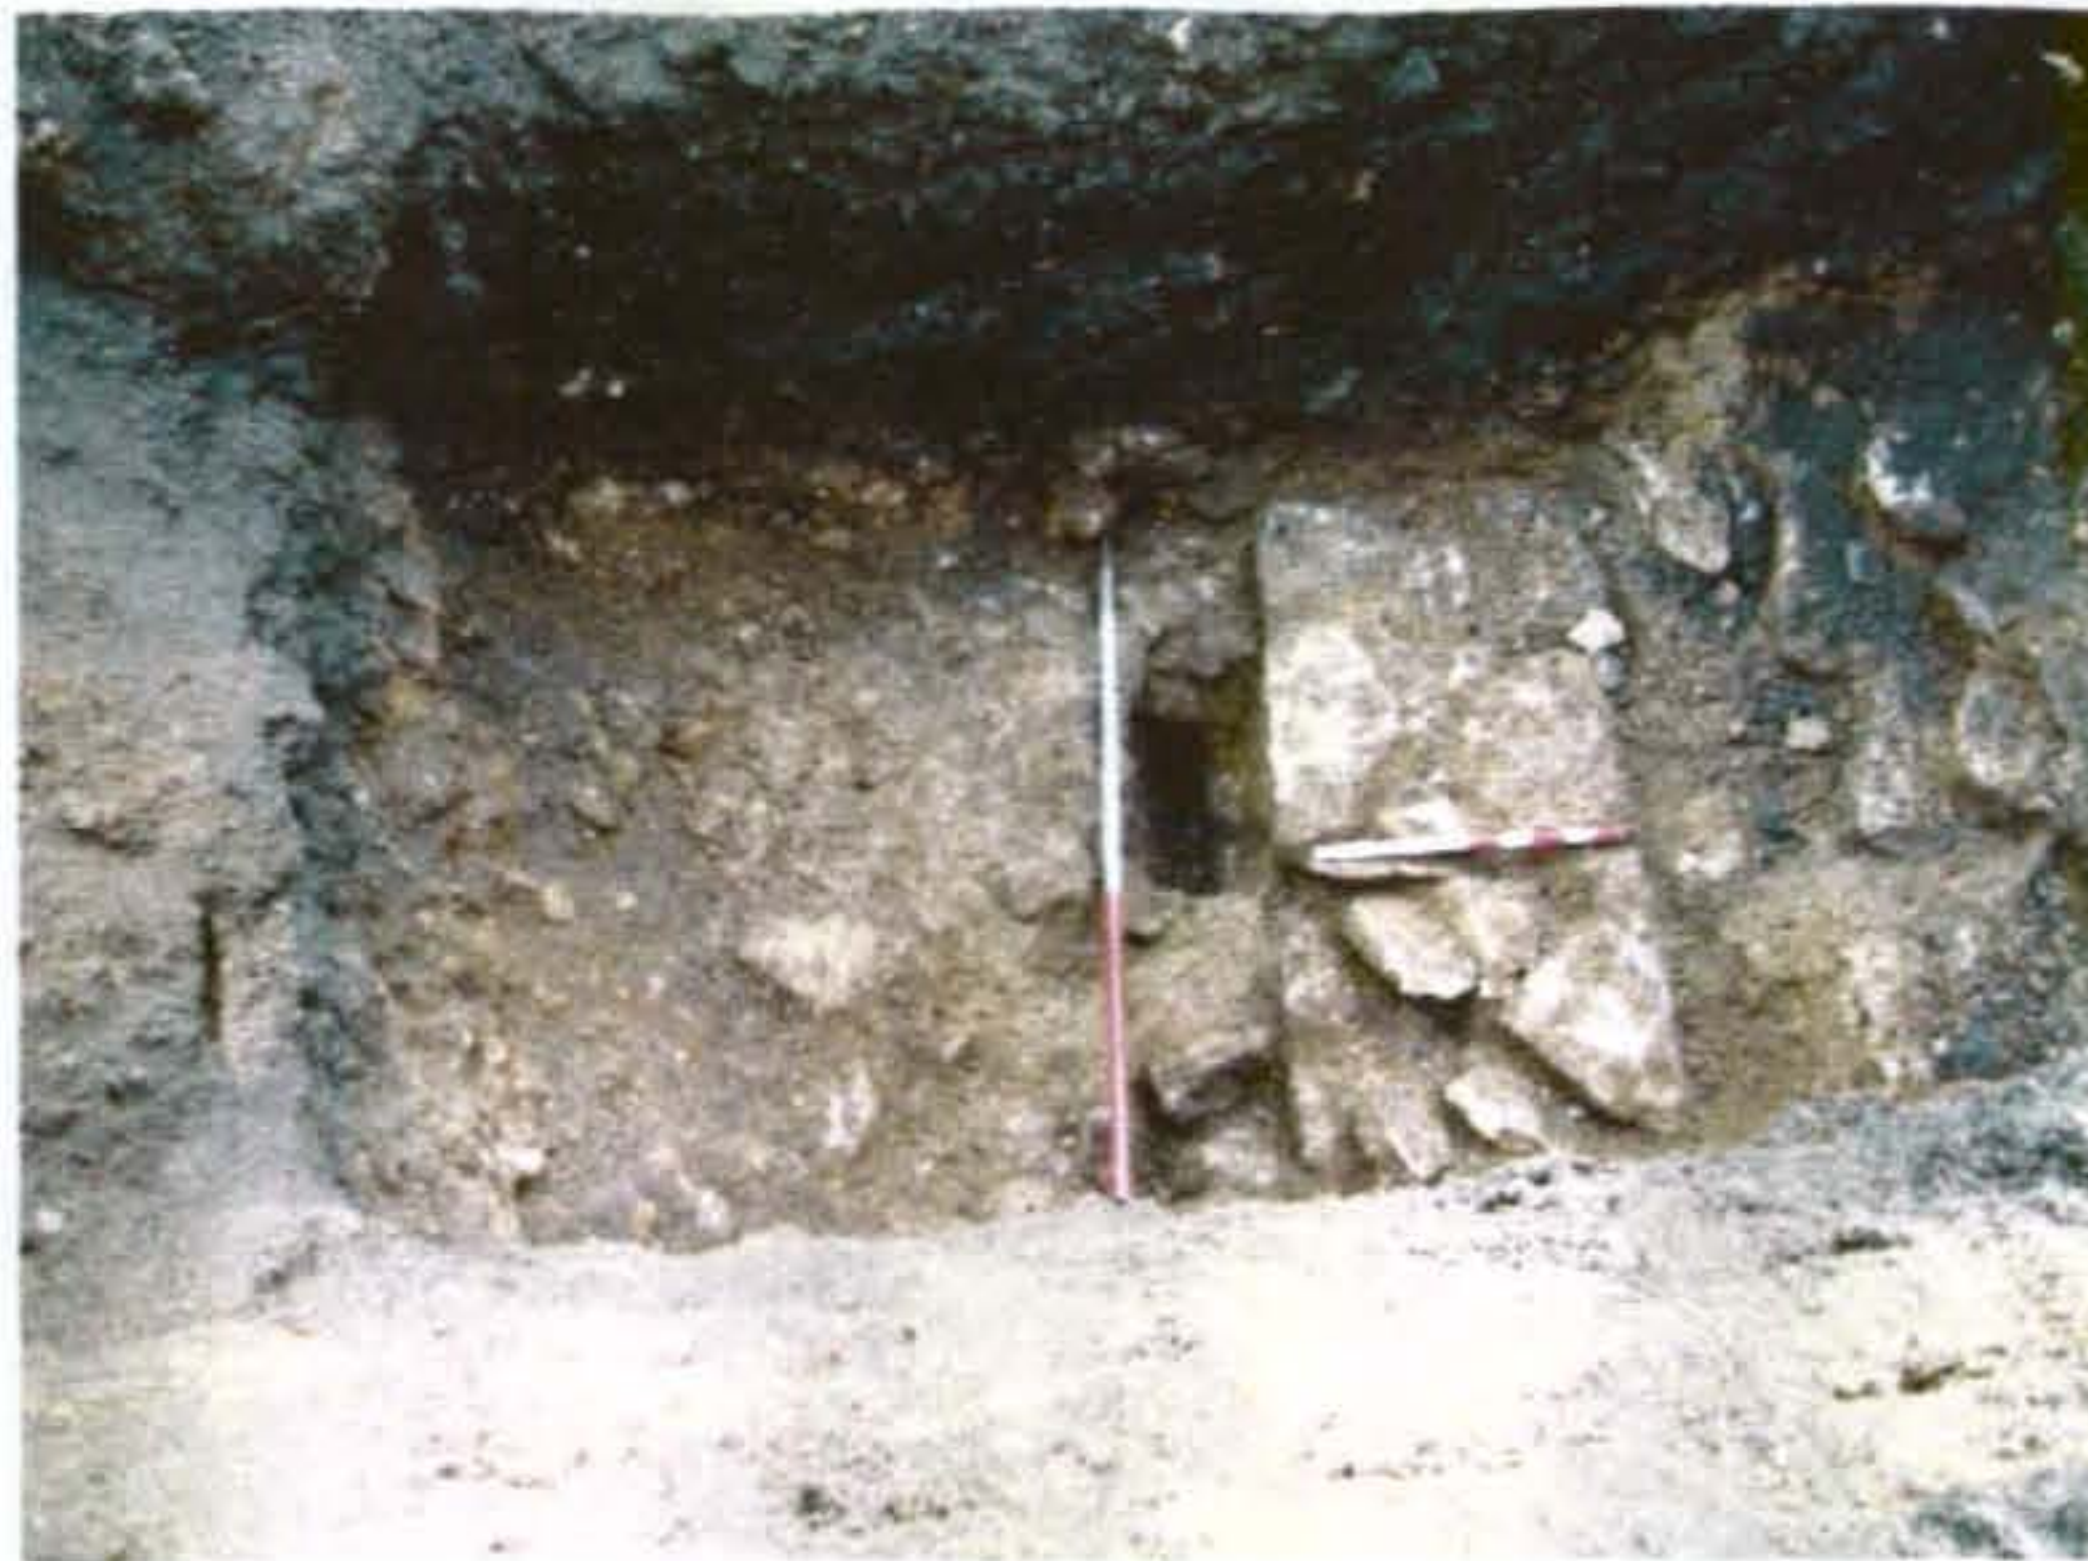
- 6.2.2 Context (215) had been cut by a vertically sided straight edged cut [209], the foundation cut for a wall (206). The cut was over 0.44m deep with no obvious base found and contained a wall (206), of which the base was at approximately 41.99m AOD. At the base the southern side of the wall was abutted by a loose light greyish brown stony fill (210) with a high decayed limestone component which produced no artefacts. The southern face of the wall at this level was relatively crudely faced and constructed from subangular limestone blocks of average 0.15m depth, with smaller rubble infill. On the northern face the wall was not excavated but appeared to be of similar construction. There were traces of a pale creamy orange fine gravely material with occasional peagrit forming an ephemeral bonding matrix. The wall was 0.59m wide and orientated east north-east by west south-west and the top of the surviving courses was 2.32m below current ground level at 42.59m AOD. The lowest three or four courses had survived with the bottom course stepped out by 0.1m on the southern side. A further context (207) within cut [209] partially overlay fill (210) in the eastern half of the trench. This consisted of a finely crushed deposit of cream coloured limestone, possibly from construction of the wall. It contained an unabraded Romano-British tile fragment and lenses of loose stone rubble. Later disturbance appeared to have significantly truncated this context.

Wall in Trench 2 looking westwards
