ARCHAEOLOGICAL EVALUATION
BLUE BRIDGE LANE
FISHERGATE, YORK

EVALUATION REPORT
MARCH 2001

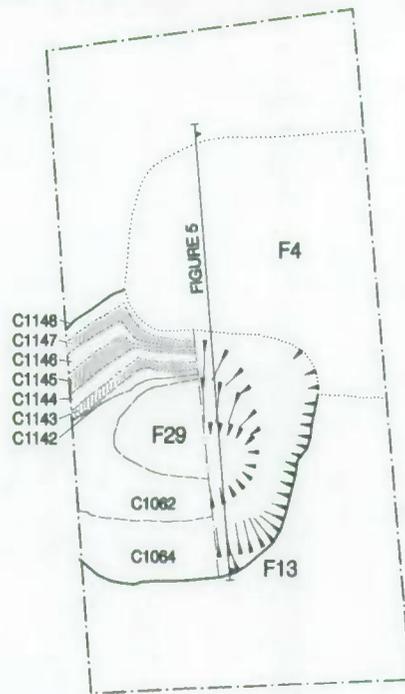
Figure 5

Intervention 1 - plan of pit F13

In plan the earliest backfills of F13 were located in the western half of the feature. They comprised a series of charcoal rich, ashy layers separated by alternate layers of brown silt which tipped steeply into the pit from the west (C1142-C1148). These contexts were not sampled during the evaluation as they did not continue through into the excavated eastern half of the pit. This sequence appears to represent the disposal of primary waste possibly associated with metalworking or cooking. C1143, C1145 and C1147 all contained a high incidence of charcoal and burnt clay pieces within an ashy silt matrix. Further investigation will be required to provide a firm interpretation of this feature. It is possible, however, that the process which created this material was being undertaken close by, and F13 may be indicative of the presence of structures and buildings.

The remaining deposits within F13 also require further investigation. In plan and section it appears that F13 may be cut centrally by a later feature. This takes the form of a vertical shaft 0.5m in diameter

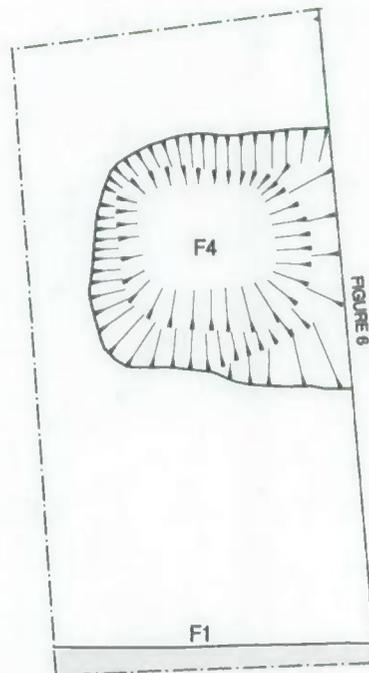
Figure 6

Intervention 1 - plan of F1 and F4

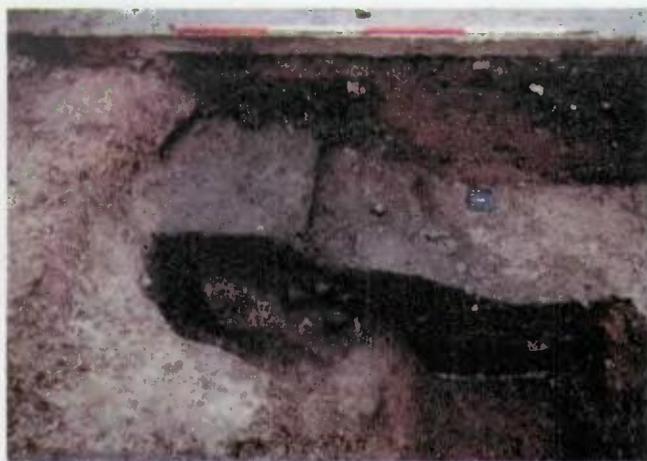
Plate 1 East facing section of F4 and F13

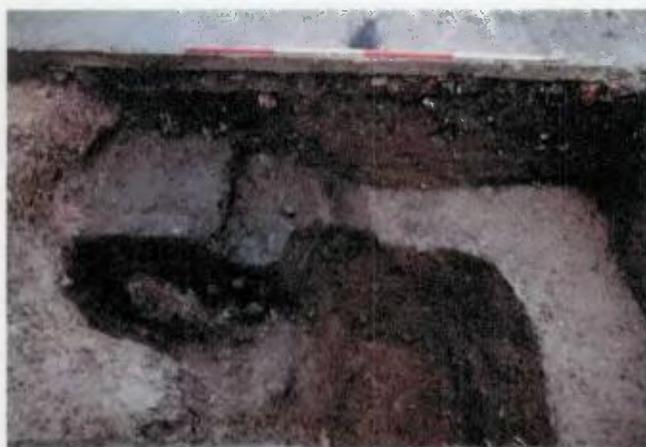
Plate 2 F4 post excavation

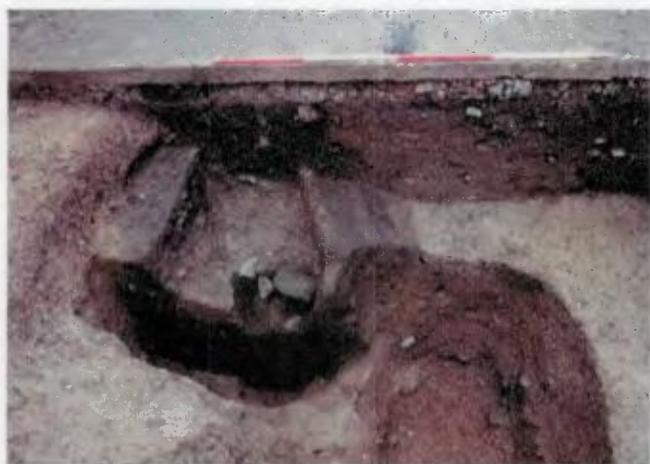
Plate 3 East facing section of F13 post excavation

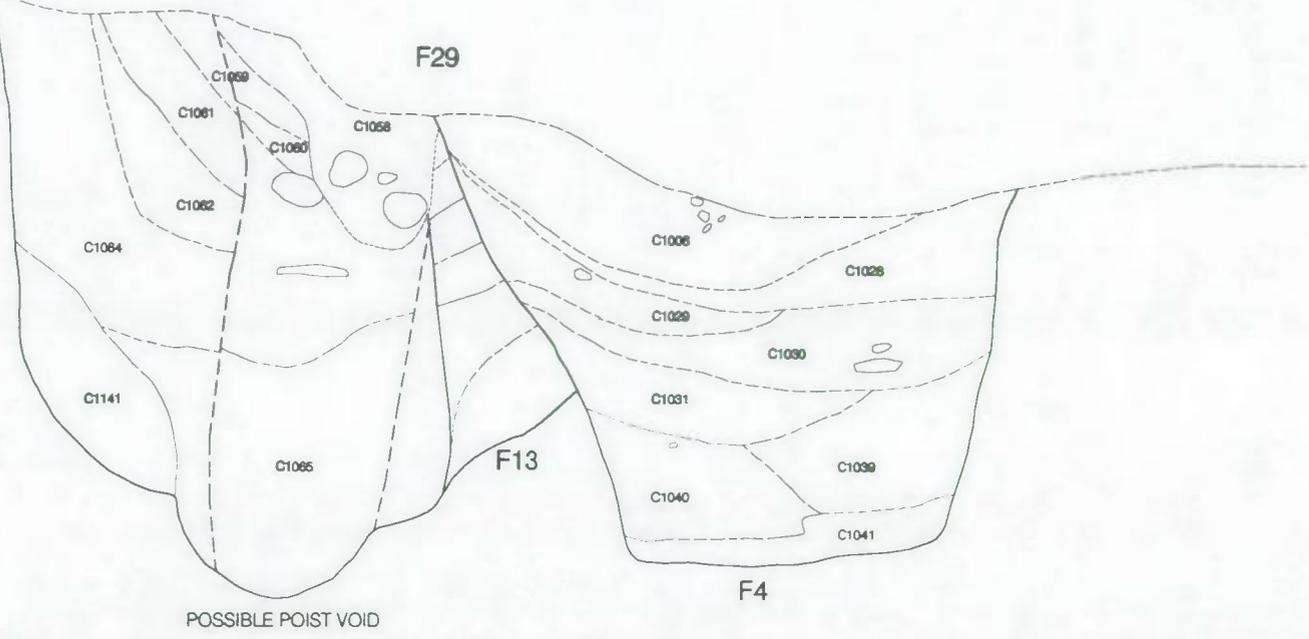
Intervention 1 - F4 and F13 east facing section

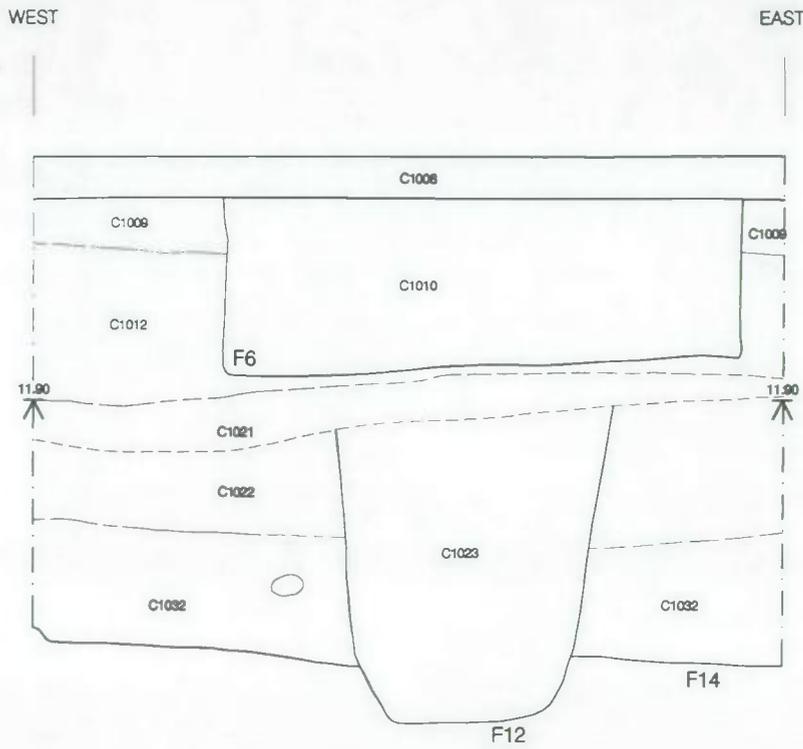
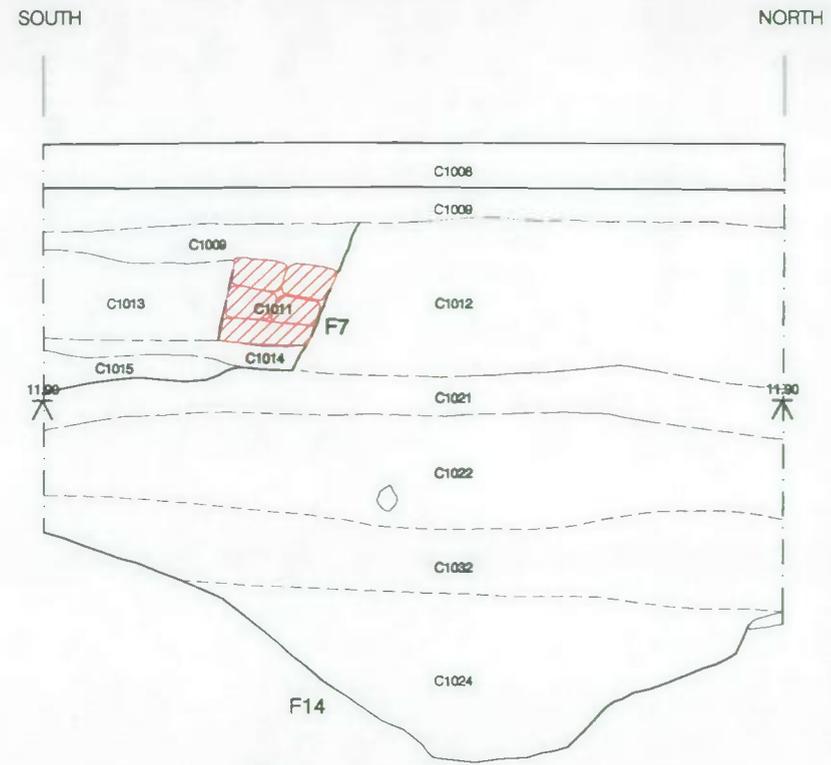
Figure 10

Intervention 2 - south facing section

The earliest deposits contacted within Intervention 2 comprised the single backfill (C1024) of an east-west aligned ditch (F14) running through the centre of the excavation (Fig.10). This feature was 1.6m wide, cut to a depth of 0.5m and had a variable U-shaped profile, well defined against the surrounding sand and gravel subsoil (C1159) (Fig.11). Its backfill consisted of a slightly mottled grey brown silty sand from which pieces of animal bone and pottery were recovered. The pottery from F14 was a mixed assemblage containing a single sherd of Stamford ware, five sherds of Yorkshire Gritty ware and a single piece of 13th century Humber ware. In addition to this two fragments of tile and a piece of brick were also recovered which appear to date between the 14th and 16th centuries. There was

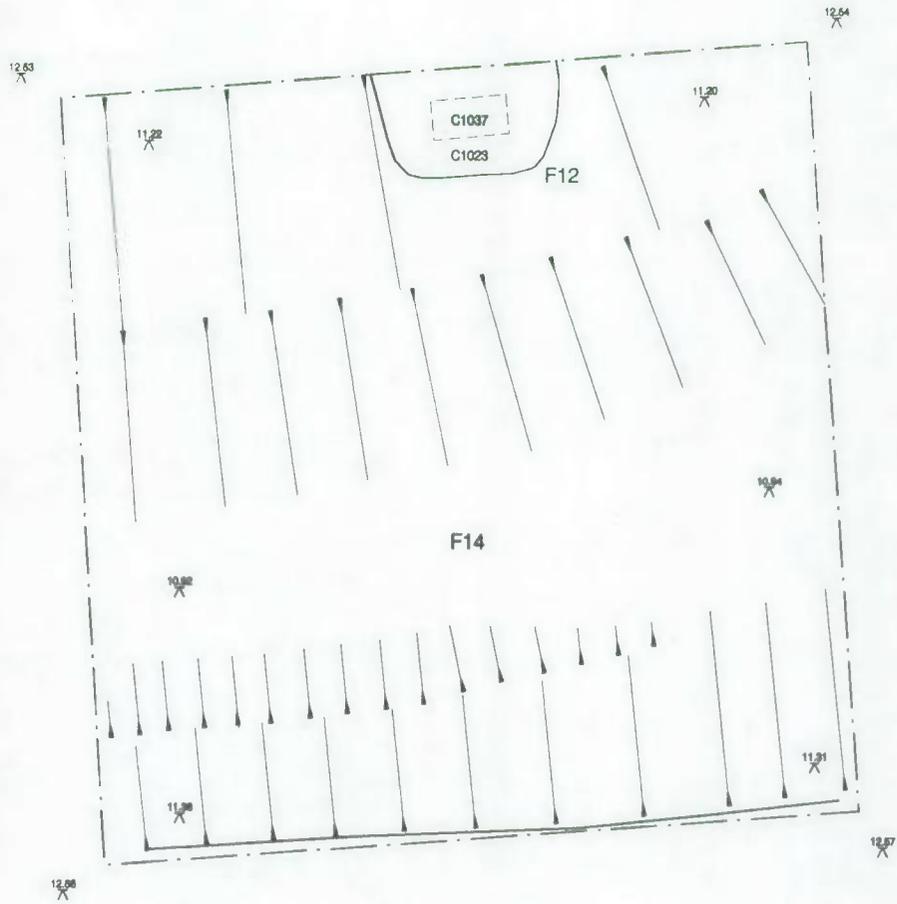
Intervention 2 - post excavation plan

Intervention 2 was excavated by machine to a depth of 0.4m below the present ground surface. At this point a square posthole (F12), located against the northern limit of excavation (Fig.9), was identified and excavation was continued by hand.

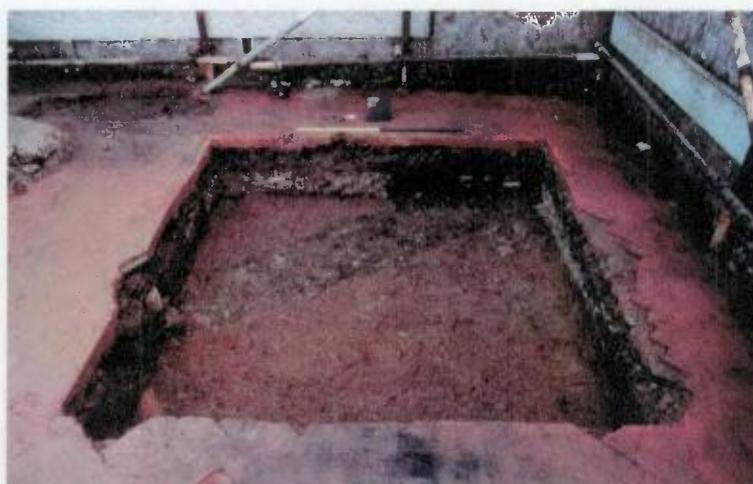
Plate 4 Intervention 3 looking east

Within Intervention 3 boulder clay subsoil was exposed at (12.81m AOD) only 0.2m below the present ground surface. This trench was characterised by a series of modern features including a large sewer pipe (F10) running along a NW-SE alignment and a regular mortar filled scoop (F11). These features were sealed by a layer of reinforced concrete and tiled floor. No earlier archaeological features or deposits were identified within this trench (Fig.12).

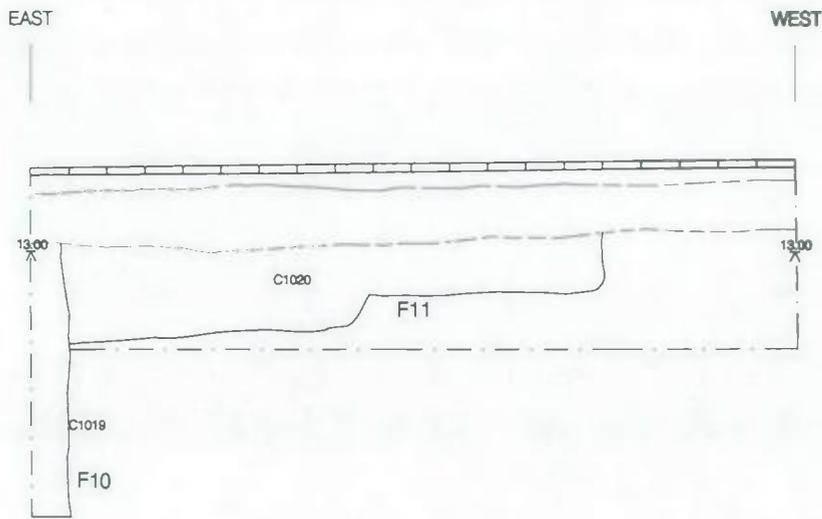
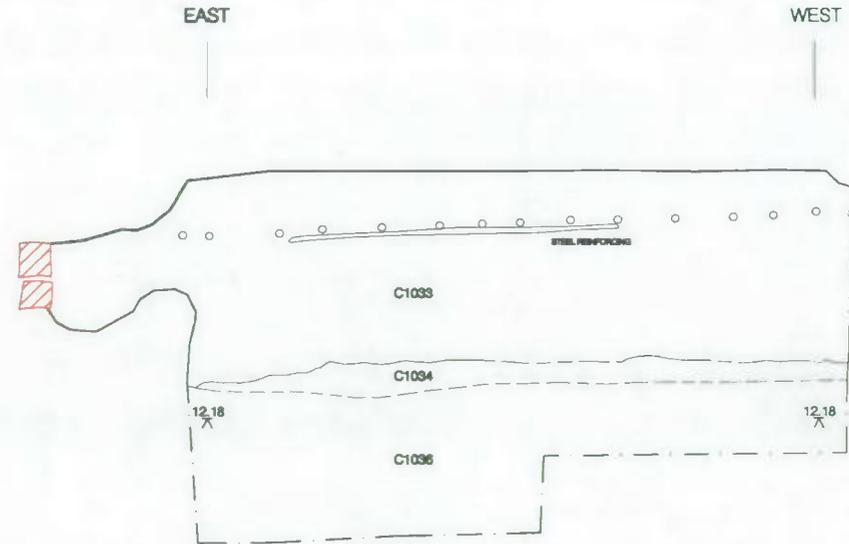
Intervention 3 - north facing section

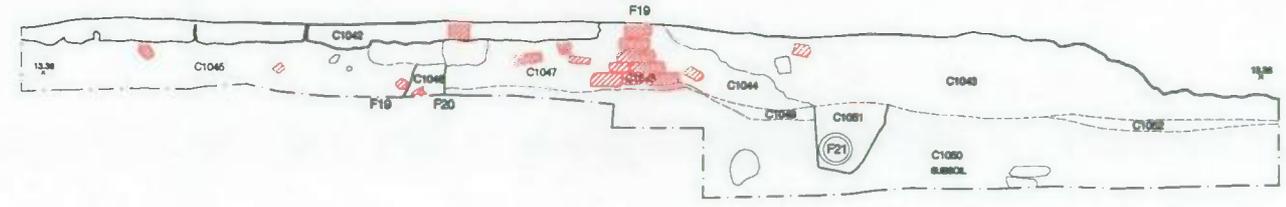
Intervention 5 - east facing section of excavation

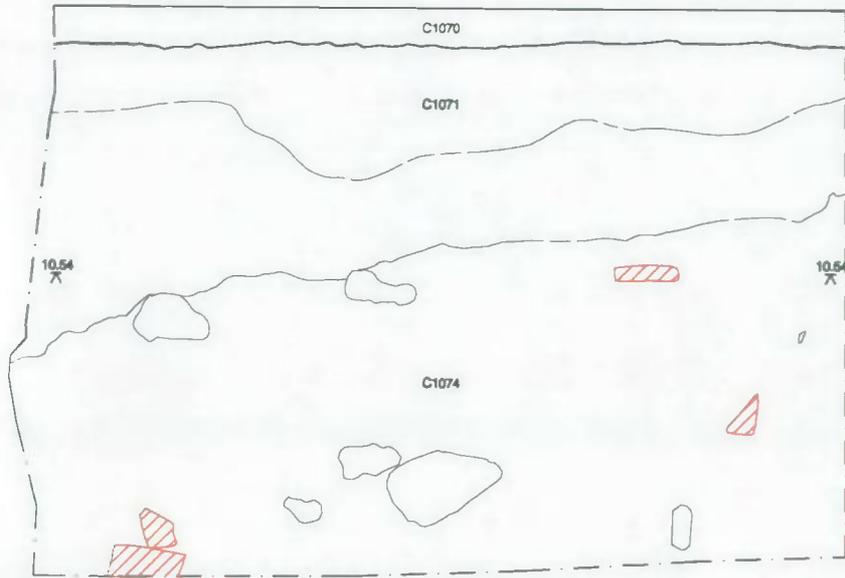
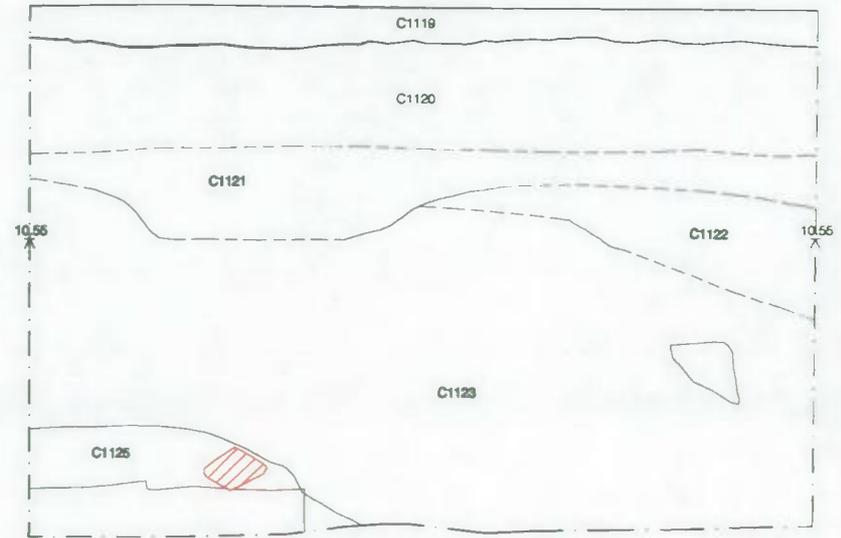
Intervention 7 - south facing section

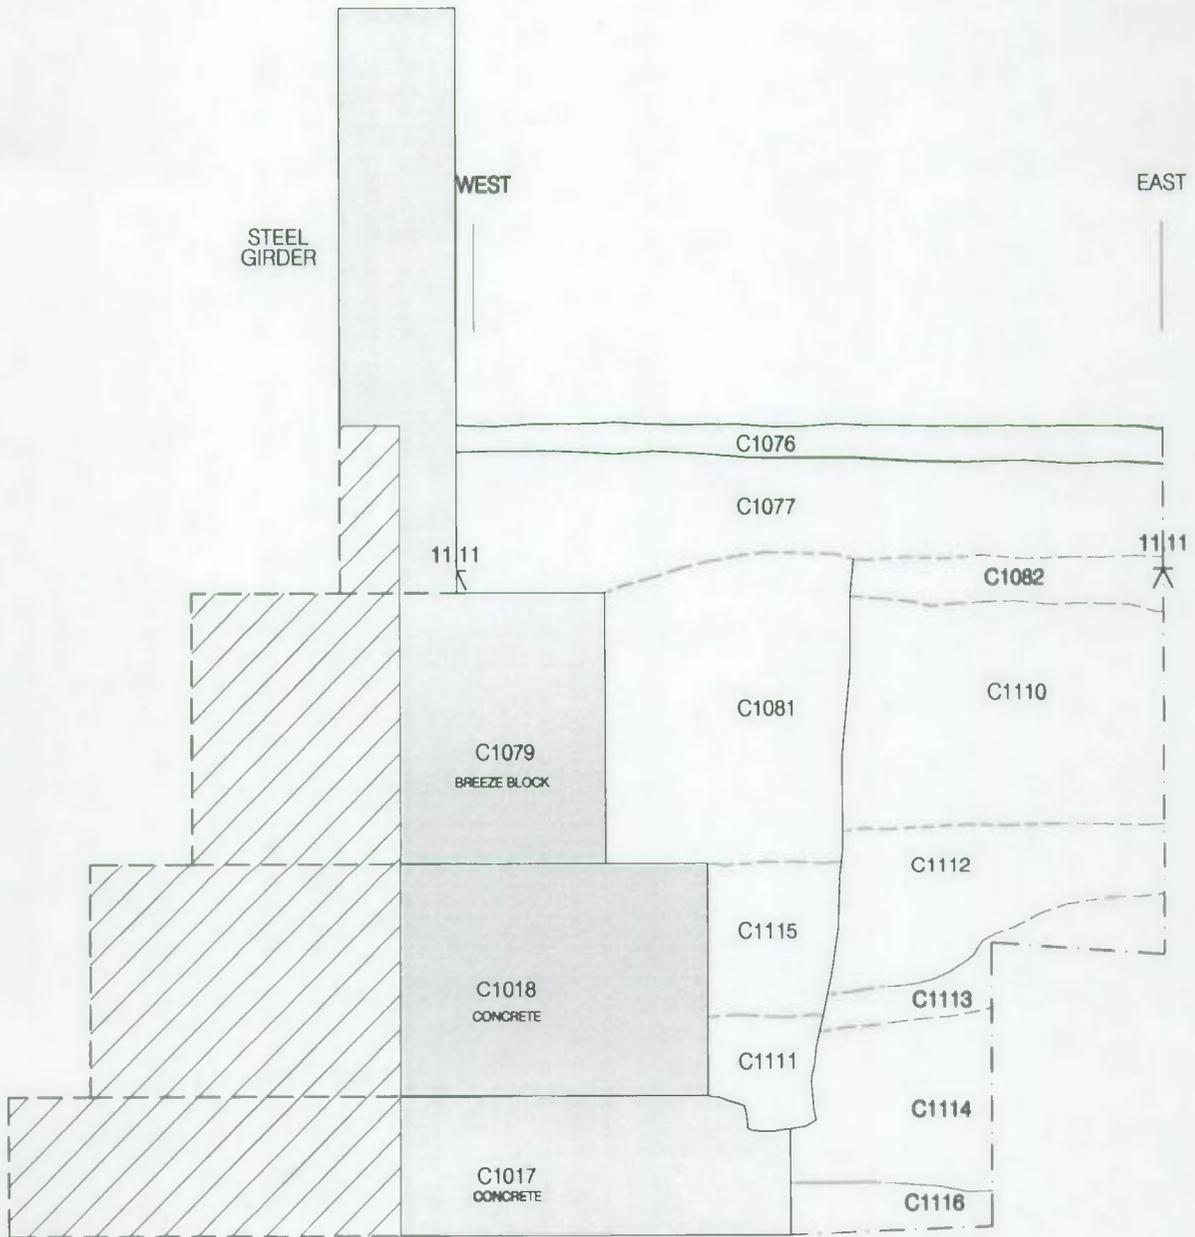
The steel pillar was found to sit on a square concrete platform 1.6m across and 0.9m thick (C1077, C1078) (Fig.17). This platform appeared to be cast *in situ* within a 3m square cut (F27), excavated to a depth of 2.2m (9.37m AOD) from the present car park surface. The base of the pillar was encased in 3 courses of breeze blocks (C1079). The construction cut (F27) had been backfilled with a sequence of sandy clay (C1111), sand (C1115) and limestone hardcore (C1080). The form and scale of this construction appears to be consistent with the other pillars observed in the evaluation of the car park. Each of the 56 steel pillars in the car park area is assumed to sit within a foundation cut measuring approximately 3.0m square and cut to a depth of at least 1.6m.

PROJECTED WESTERN HALF OF PILLAR SUPPORT

The results from Intervention 9 show that the construction of the car park has caused a high degree of disturbance. Each of the 56 steel pillars is set within a cut of not less than 3m x 3m which has been excavated to a depth in excess of 1.5m. Considering their tight spacing this has caused a considerable

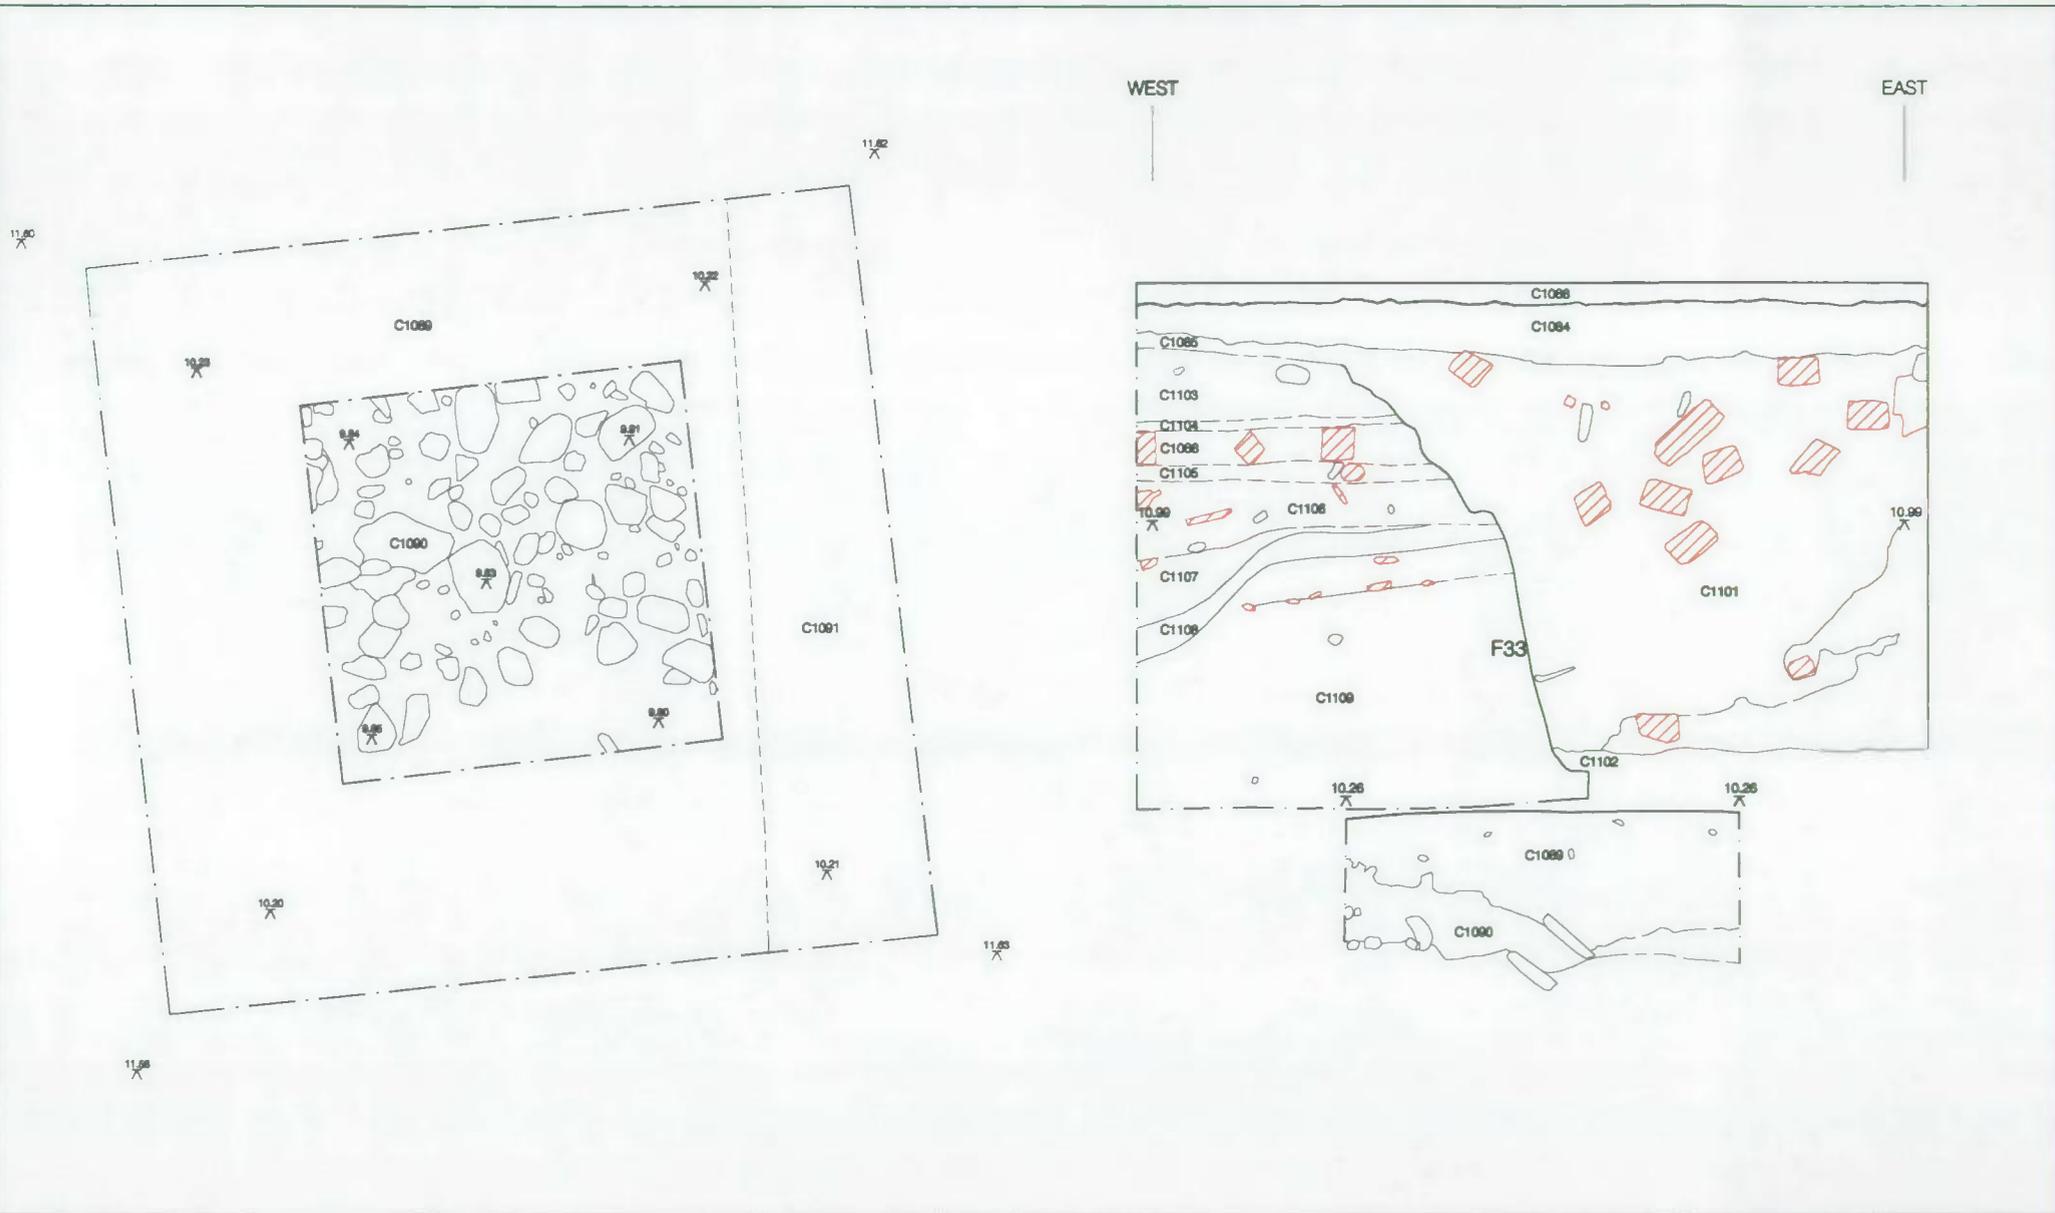
Figure 18

Intervention 10 - post excavation plan

Intervention 10 was excavated to a depth of 1.4m (10.05m AOD) from the present car park surface before being stepped in and excavated a further 0.3m. This trench was significantly different from any of the previous interventions within the car park area. Instead of being dominated by modern levelling and destruction there was a discrete and intact sequence of earlier deposits (Fig.18).

The earliest archaeological deposit encountered within Intervention 10 comprised a layer of rounded cobbles set within a yellow brown clay matrix. (C1090). This surface or dump was, in many respects similar to C1114 recorded in Intervention 9 and lay at a height of 9.8m AOD. C1090 was sealed by a slightly mottled deposit of sandy clay silt with occasional charcoal inclusions, 0.3m deep (C1089). Six abraded sherds of Romano-British pottery were recovered from this context.

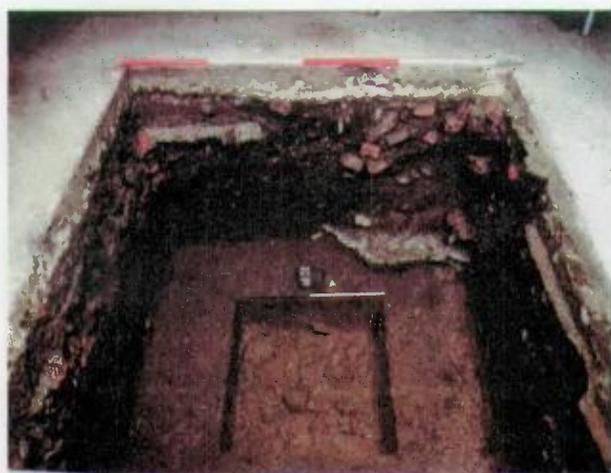
Plate 5 Intervention 10 south facing section
and cobbles C1090

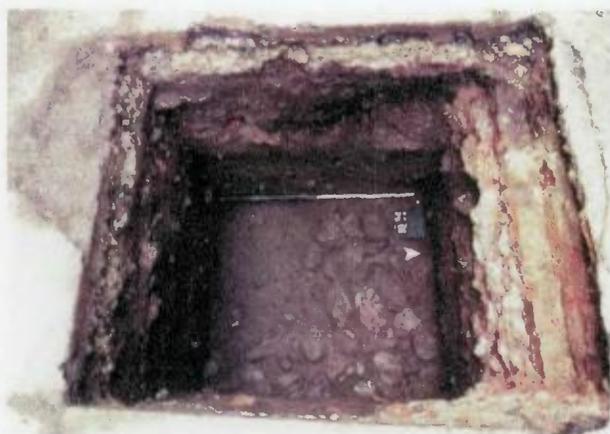
Plate 6 Intervention 11 looking west with cobbles C1099, F31

was exposed which appeared to form the remains of a surface or road (C1099, F 31). In addition to a single fragment of 13th century tile, a sherd of York Gritty ware (1050-1250AD) and a sherd of Pingsdorf-type ware (1000-1200AD) were recovered from amongst the stones.

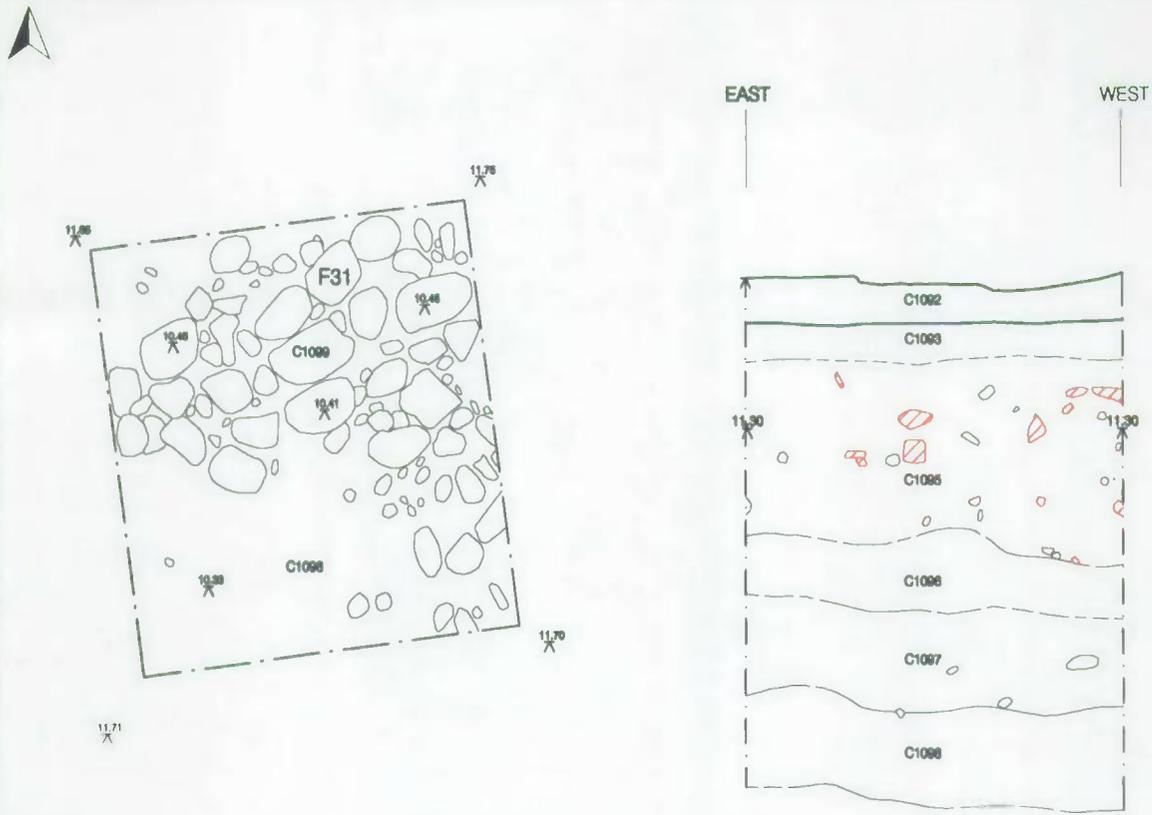
Figure 19

Intervention 11 - C1098

The excavation of Intervention 11 did not expose subsoil. Instead a similar sequence of deposits to those recorded in Intervention 10 was observed. Intervention 11 (Fig.19) was hand excavated to a depth of 1.4m below the present ground level (10.35m AOD). At this level a layer of rounded cobbles

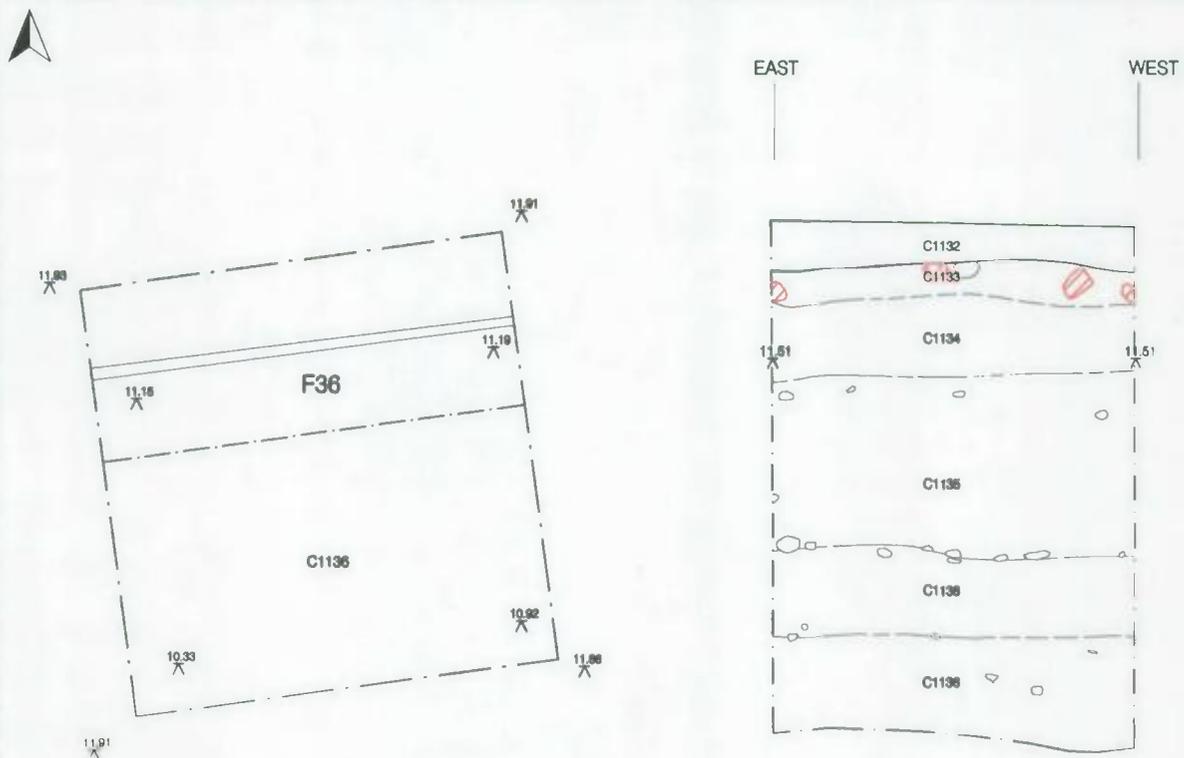
Intervention 12 - post excavation

The excavation of Intervention 12 (Fig.20) revealed a similar sequence of deposits to those recorded in Intervention 11. The earliest archaeological deposit within this trench was C1136. This was a mottled, slightly variable layer of dark brown sandy clay, 0.4m in depth, from which two pieces of Samian, a sherd of Ebor ware and a large chunk of mortaria were recovered. The top of this deposit was exposed at a depth of 1.1m from the present ground surface (10.80m AOD). All of the pottery appeared to be abraded but the size of the sherds suggests that C1136 may be from an intact Romano-

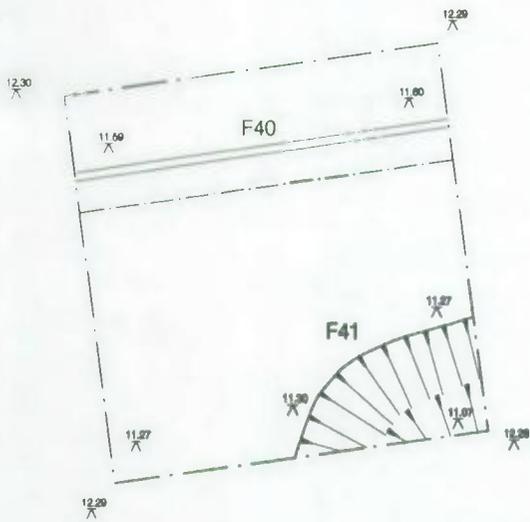
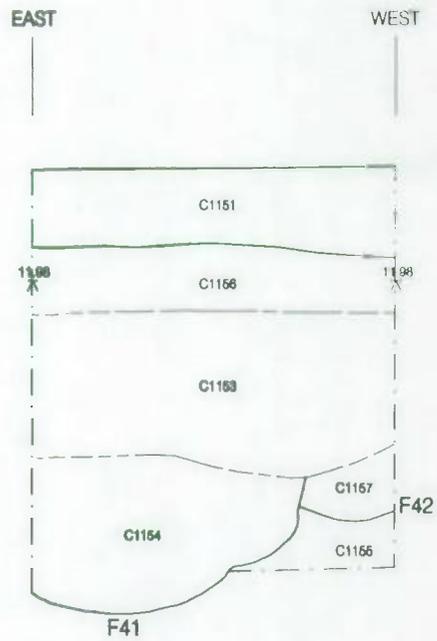
Figure 21

Intervention 13 - F41

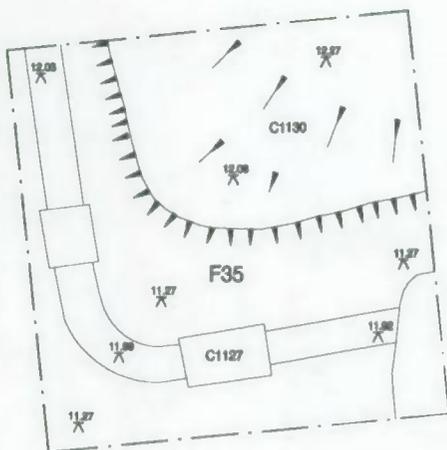
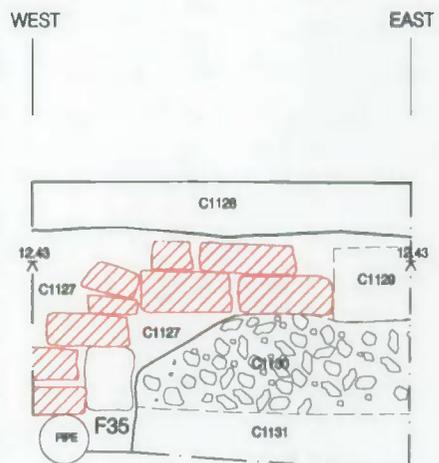
Intervention 14 - post excavation

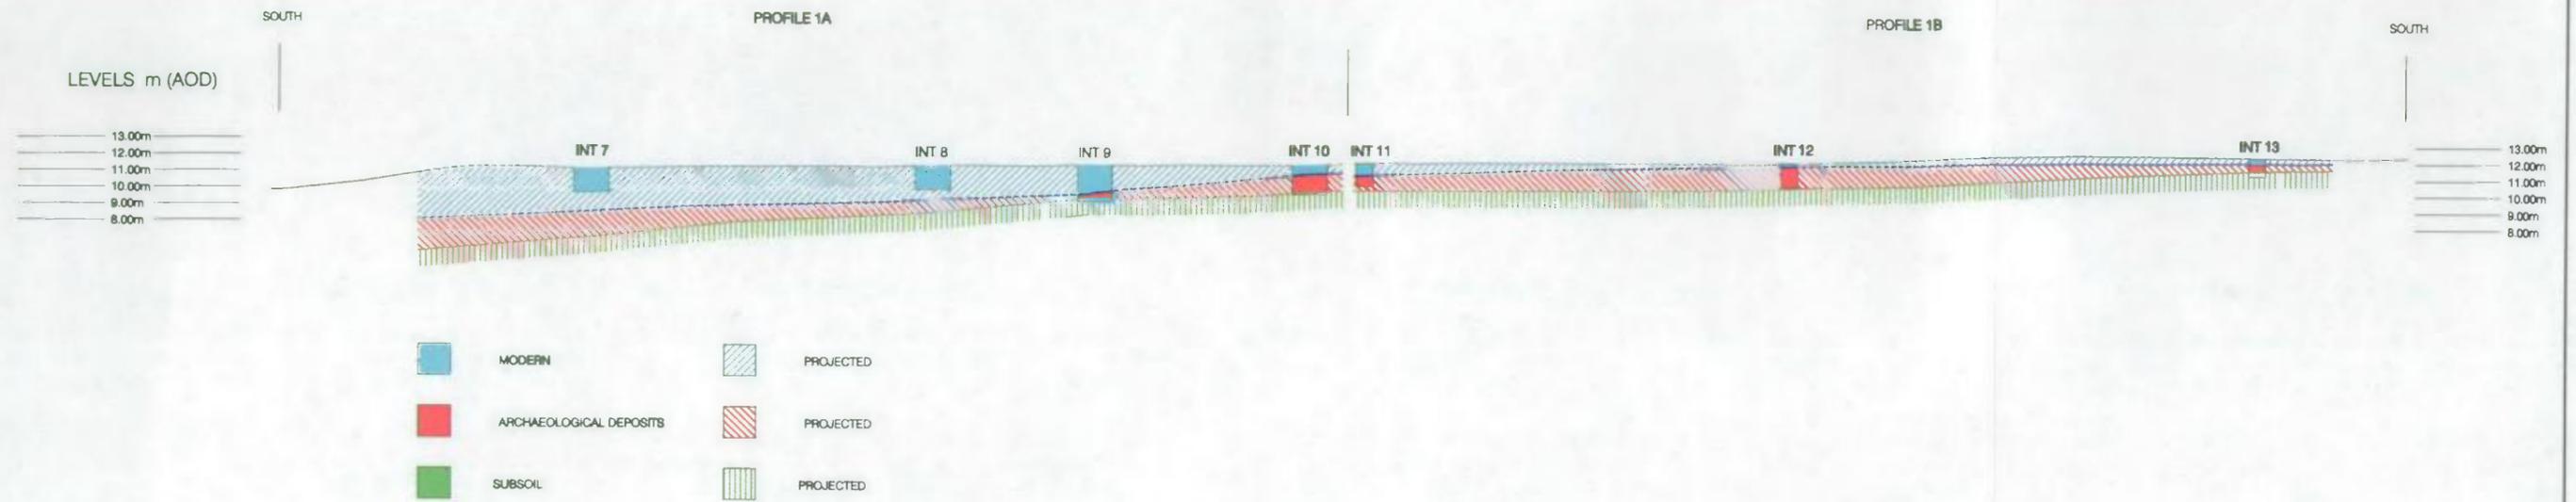
Figure 24

Profile 1a and 1b - based on levels from Interventions 6 to 13

The natural topography slopes from south-east to north-west away from Blue Bridge Lane towards the River Foss. The depth of subsoil recorded on Interventions 1, 3, 4, 5 and 14 is on average less than 0.3m from the present ground surface (Fig.26). Furthermore there is evidence that the south-eastern corner of the site has undergone a degree of truncation within the last two hundred years. Any archaeological features substantial enough to survive in this area (Fig.26, highlighted) would be encountered immediately below the modern concrete and overburden which, in some places, is as shallow as 0.2m. The absence of any pre-modern archaeological features in Interventions 3, 4 and 5 may be more a reflection of this truncation rather than a real distribution. This notion is supported by the quality and quantity of archaeological deposits exposed elsewhere at deeper levels across the site (Intervention 1).

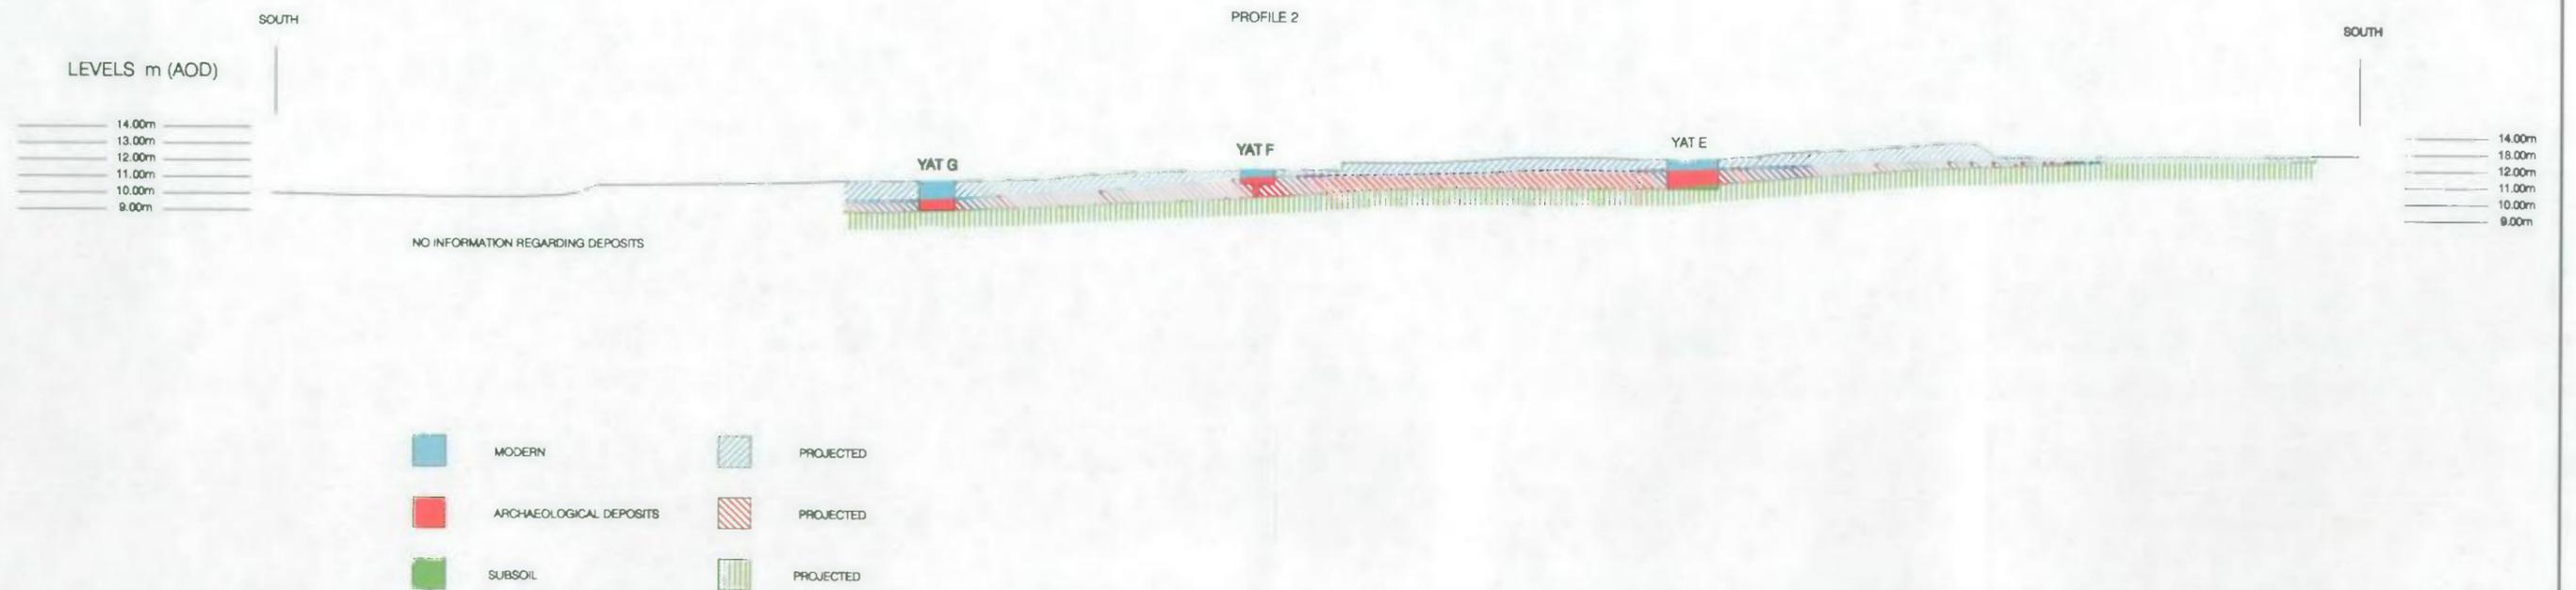
Figure 25

Profile 2 - based on levels from YAT trenches E, F, G, FAS survey and Interventions 1 and 4

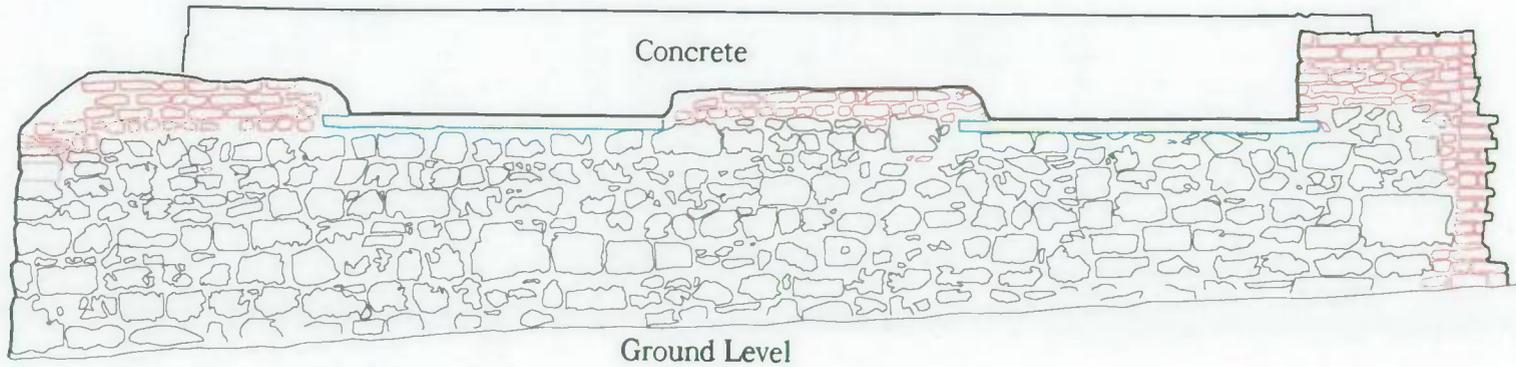
South elevation of section of wall, north side of Blue Bridge Lane, York

Before further disturbance to the wall fabric is contemplated the existing survey record should be enhanced in detail. It is clear that the total removal of the rear (north) modern fabric of brick and breeze blocks would result in the disintegration of the remaining wall-core and possibly the wall face. This should therefore not be contemplated until there is a detailed archaeological record of the structure.

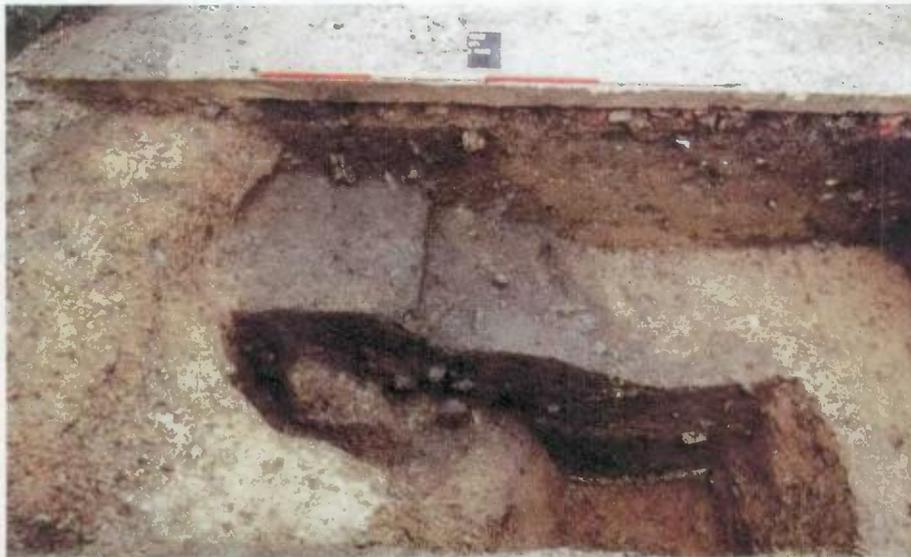
Plate 1: Intervention 1, section through F4 and F13

Subsoil was exposed at a depth of (12.45m AOD) 0.2m below the present ground surface immediately under a layer of concrete. At this level several features were defined and excavated. The latest features comprise two shallow scoops or pits (F38 and F39) which were probably post-medieval in date. F38 and F39 cut through two clearly medieval features. The first of these was the construction cut (F1) for an east-west aligned wall, still standing as part of the present site boundary which is considered to be the precinct wall of St. Andrews priory. The second feature appears to be a substantial sub-rectangular pit (F4) some 2.0m x 1.5m, cut to a depth of 2.1m with steeply sloping near

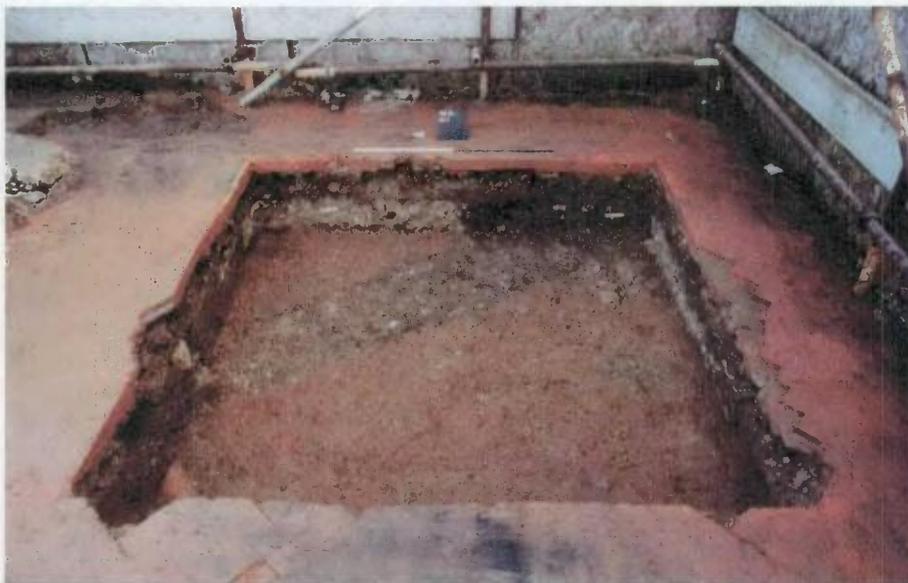
Plate 2: Intervention 3 looking east

Boulder clay subsoil was exposed at only (12.81m AOD) 0.2m below the present ground surface. Intervention 3 was characterised by a series of modern features including a large sewer pipe (F10) and regular mortar filled scoop (F11).

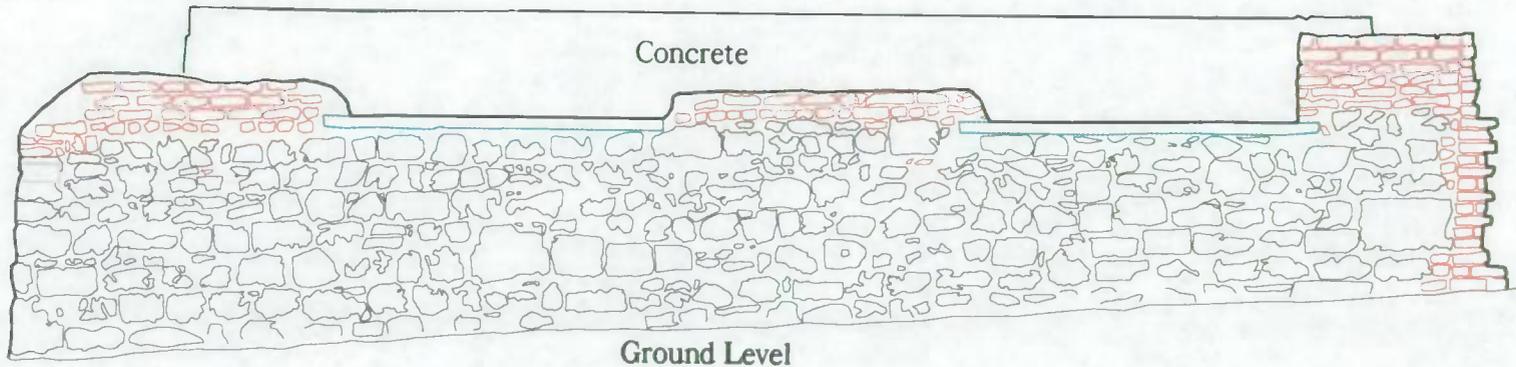
South elevation of section of wall, north side of Blue Bridge Lane, York

Before further disturbance to the wall fabric is contemplated the existing survey record should be enhanced in detail. It is clear that the total removal of the rear (north) modern fabric of brick and breeze blocks would result in the disintegration of the remaining wall-core and possibly the wall face. This should therefore not be contemplated until there is a detailed archaeological record of the structure.

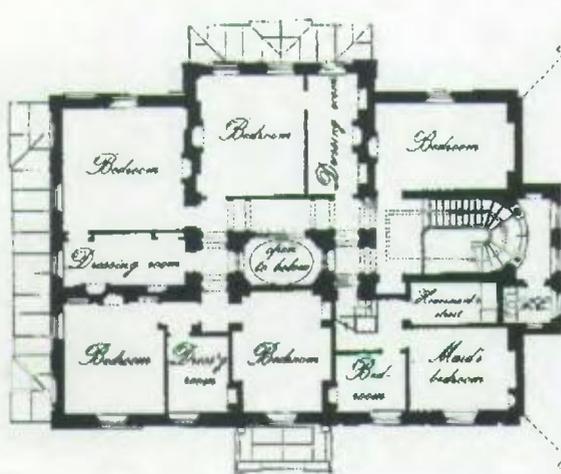
Chamber floor plan

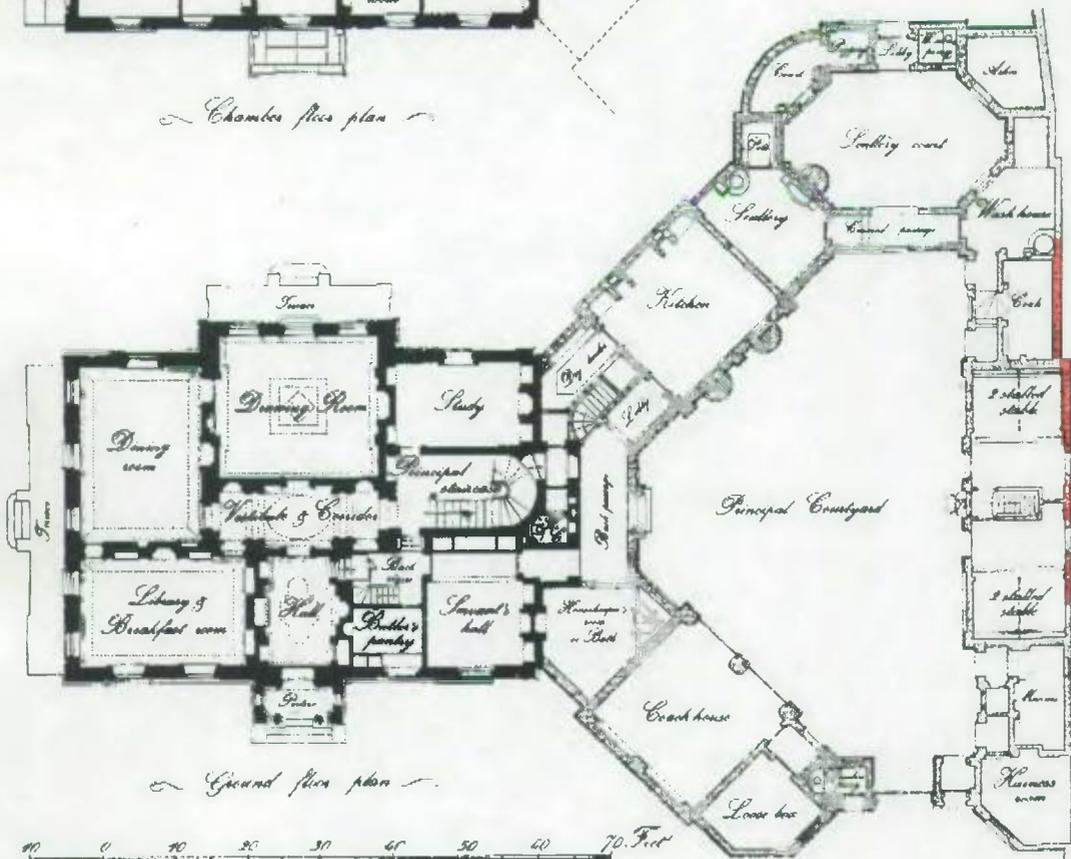
Fig. 66.

Ground floor plan
