Laurel House, Church Street, Welford-on-Avon, Warwickshire

Archaeological Watching Brief

Report No 1205
February 2012

Project Report No. 1205

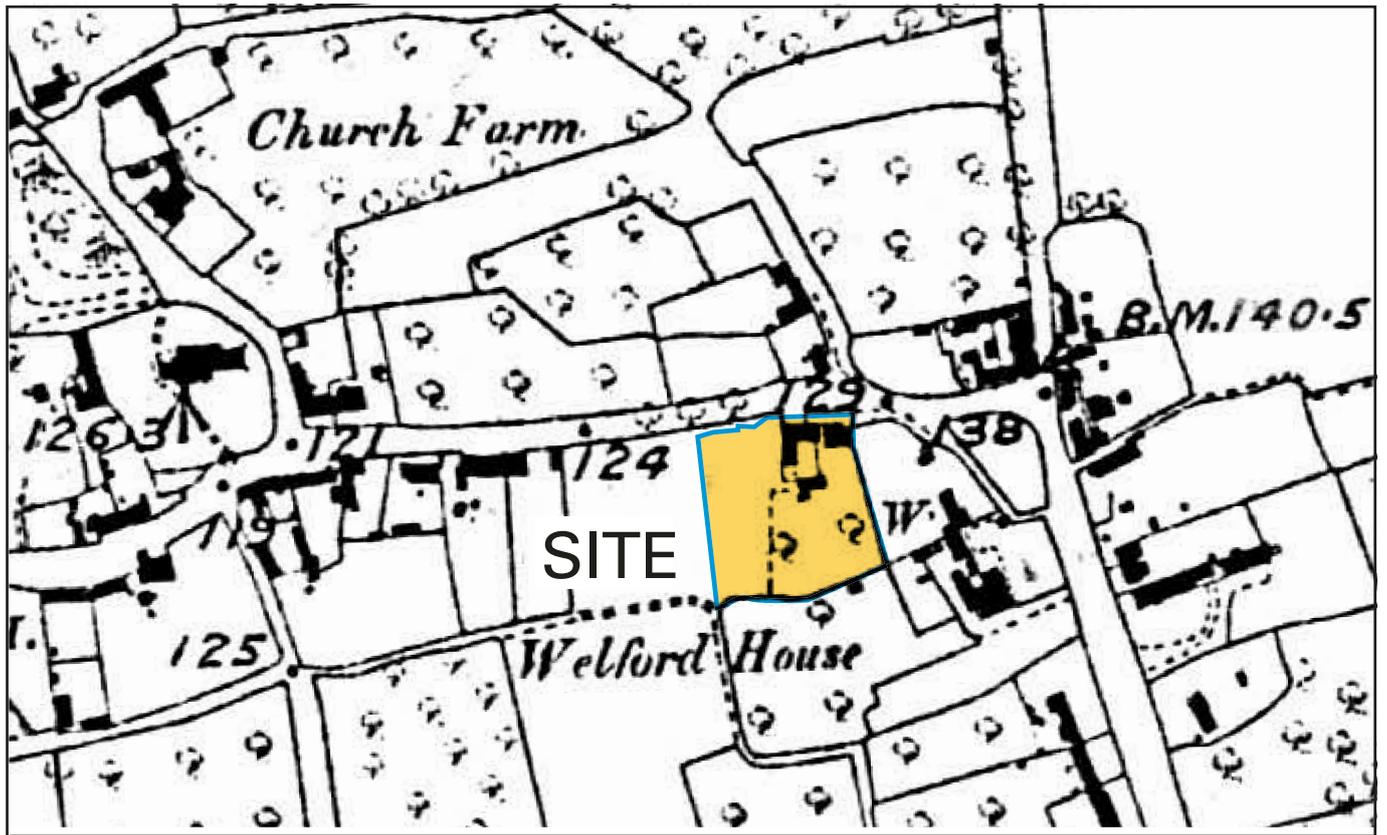
4.8 The 1834 Ordnance Survey does show the site as part of a narrow strip of cottages on the west side of the High Street. The 1884 First Edition Ordnance Survey map shows some of the cottages that now make up Laurel House and several associated outbuildings to the rear. By the time of the Second Edition map of 1901 many of these outbuildings had been removed and replaced by a more extensive group which includes the current store and garage with dovecote. A few more buildings had been added by the time of the Third Edition map of 1923. All of the outbuildings to the east of the garage/dovecote have since been demolished.

Fig 2: Detail from First Edition Ordnance Survey map of 1884

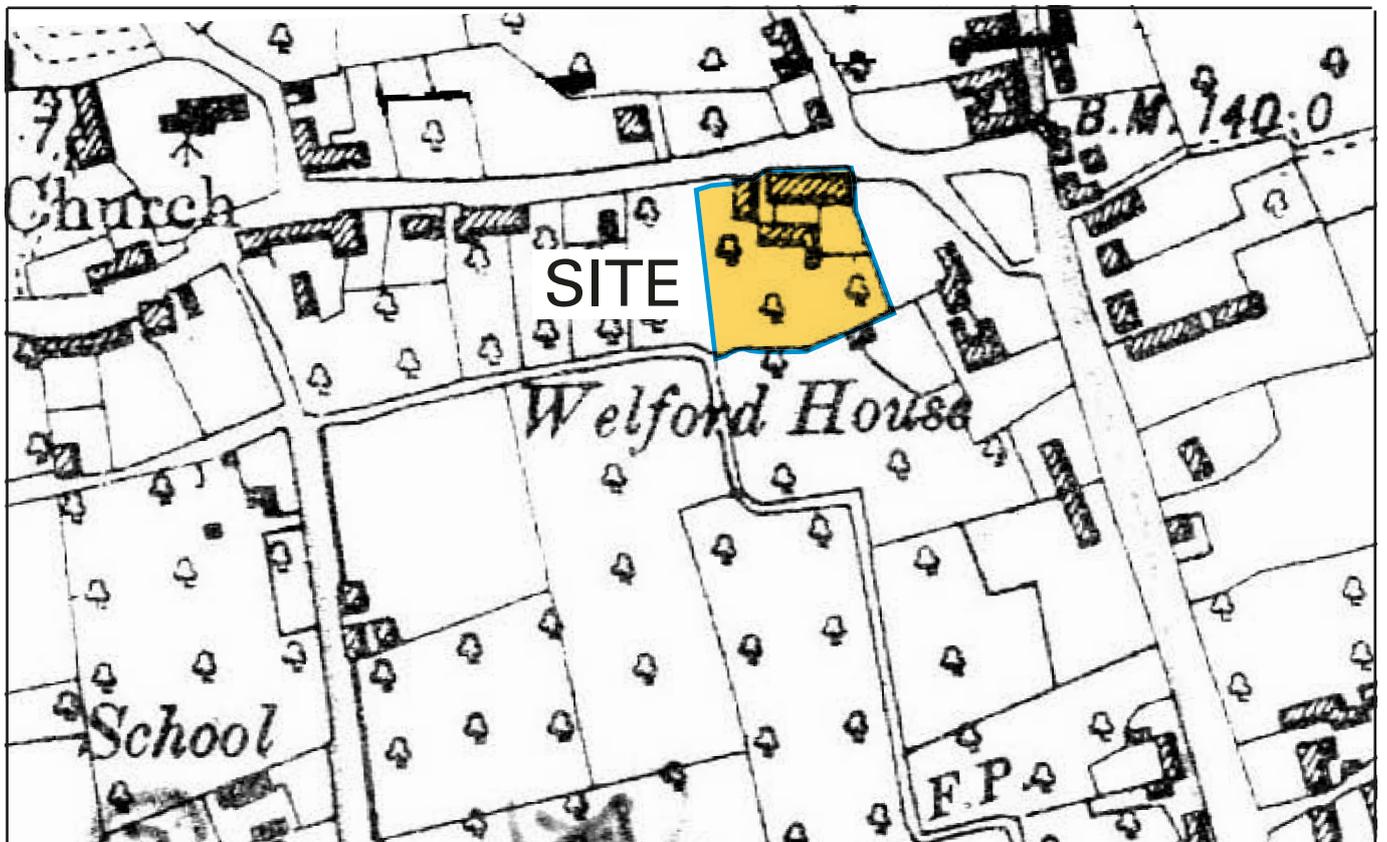
Fig 3: Detail from Second Edition Ordnance Survey map of 1901

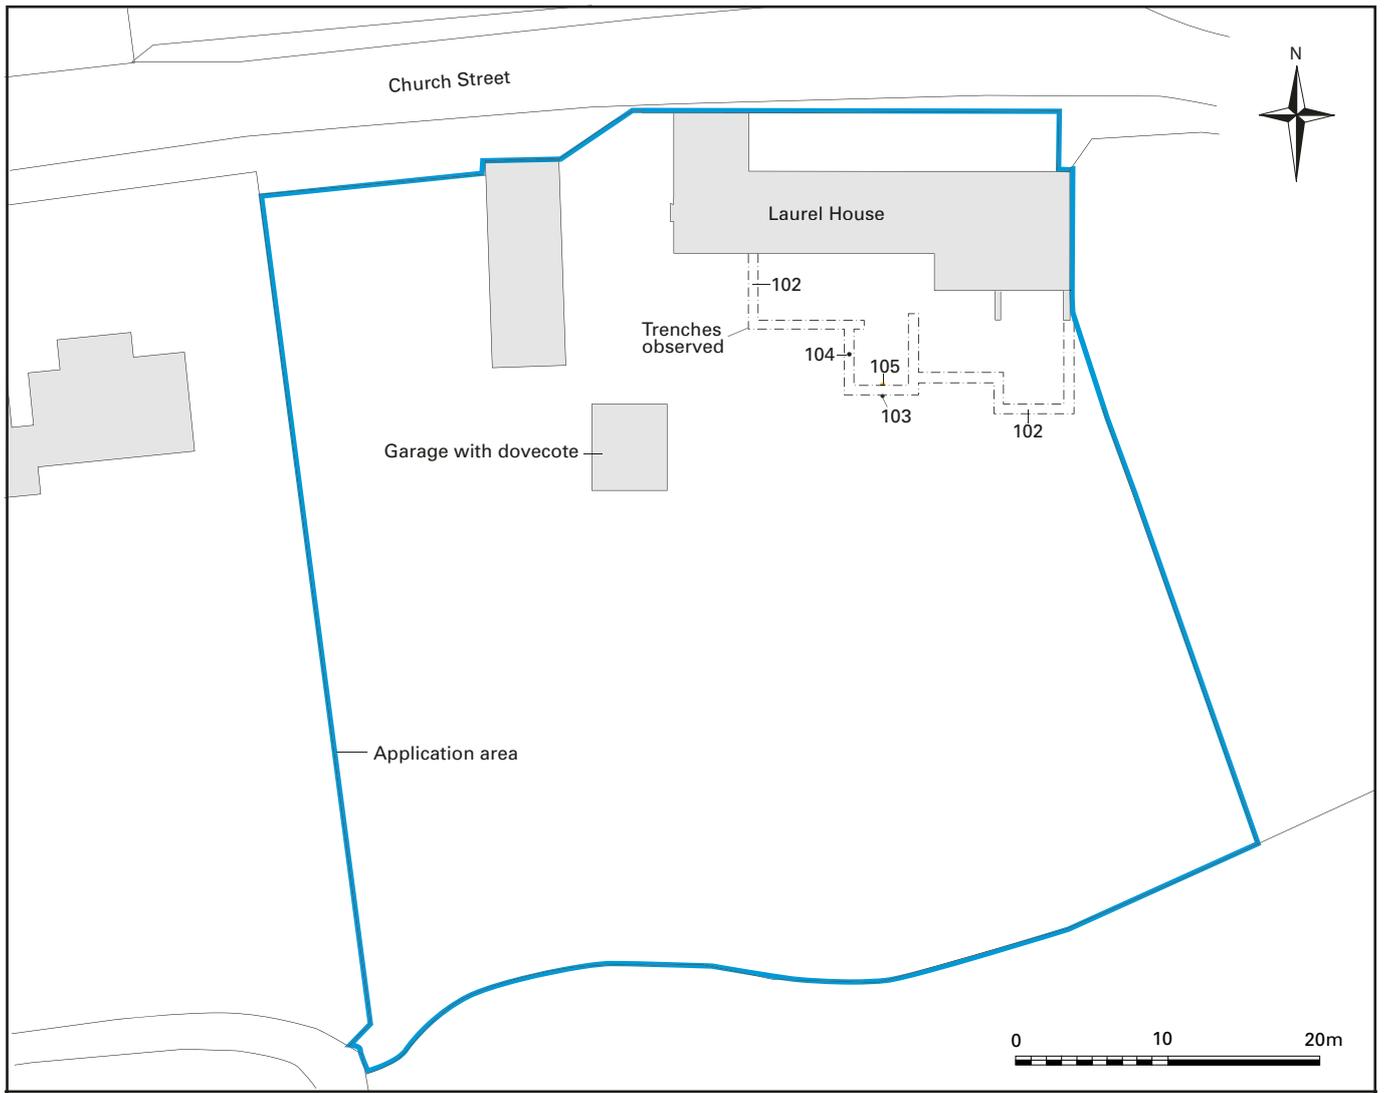
Fig 4: Trenches observed

5.1 An extant conservatory had recently been demolished to ground level before the site was visited but this involved no groundworks. Trenches for the new extension were then excavated using a tracked machine with a 0.6m toothless ditching bucket. All trenches were 0.6m wide and were all excavated down into geological natural greenish clay (102). At the eastern end of the site the trenches were 1.7m deep but for most they were only 1.2m deep.

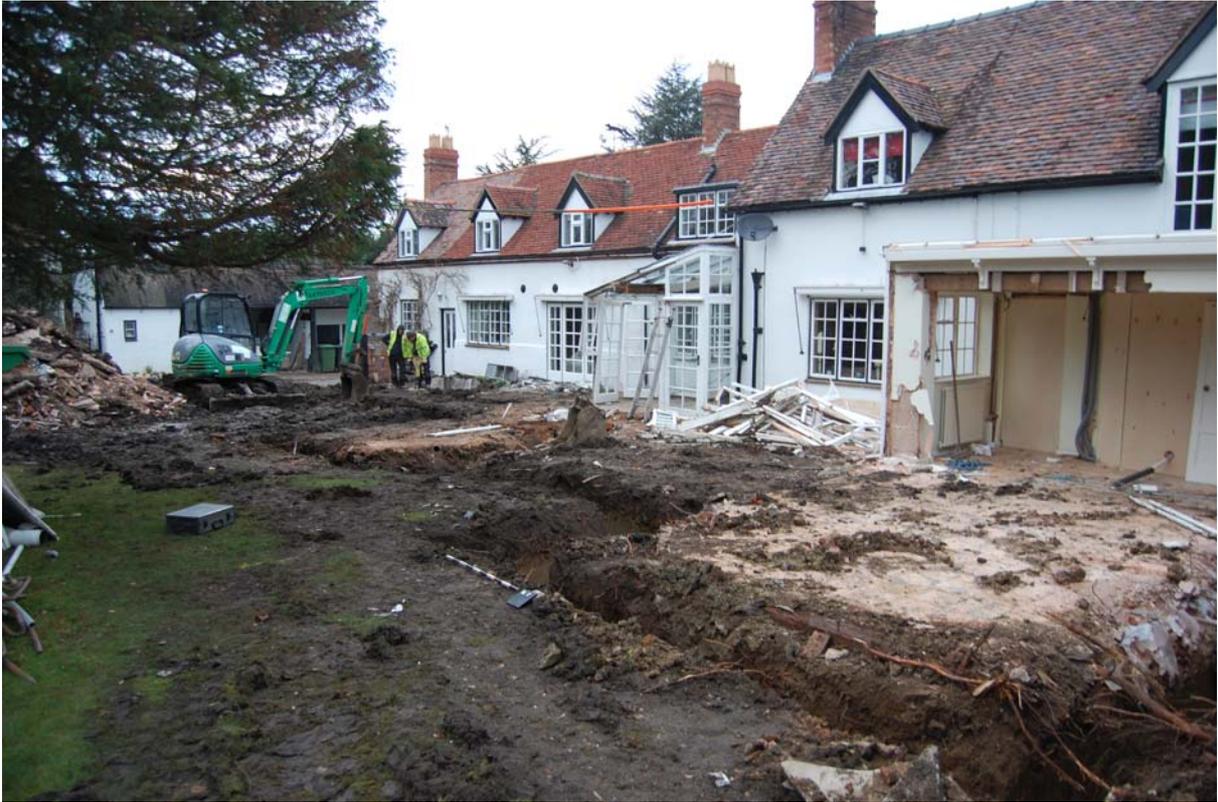
Fig 5: General view of the foundation trenches approaching completion

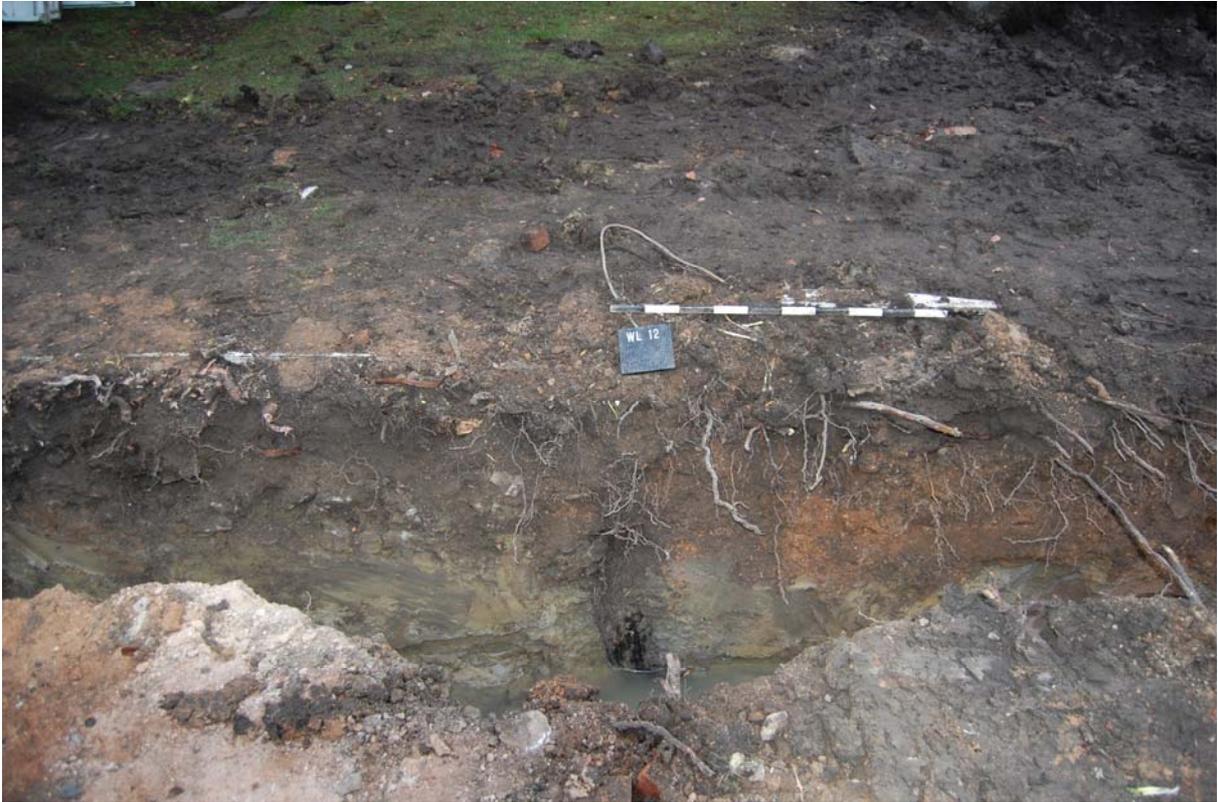
5.2 Geological natural clay was reached at a depth of 0.4m at the eastern end of the trench and but was overlaid by an increasingly deep layer of soil (106) the further west the trenches were excavated. Two wooden posts (103 and 104) were visible driven into the clay (102). Post 103 was large and rounded and had a diameter of 0.2m whilst post 104 was roughly squared and 0.15m in diameter. Part of a brick wall (105), only 0.2m wide, was also observed. All were covered by layer 106, a greyish brown sandy loam ranging in thickness from 0.1m at the eastern end of the site and 0.5m at the western end of the site. It contained frequent fragments of brick along with occasional roof tile and other building debris. Fragments of 19th and 20th century pottery were also recovered from this layer. These

Fig 6: Section showing wooden post 103 and the typical make-up of the site

included part of a saucer made by 'E Asbury & Co, Longton'. This firm operated between 1875 and 1925 (potteries and ceramics website). No early features were exposed and no pottery earlier than the 19th century was found. Layer 106 was overlain by 0.2m of dark greyish brown sandy loam topsoil (100). At the far eastern end of the site was a layer of modern disturbance (101) associated with the construction of the recently removed conservatory.
