# Longbridge Manor, Stratford Road, Warwick, Warwickshire

## Archaeological Evaluation

Report No 1201  
January 2012

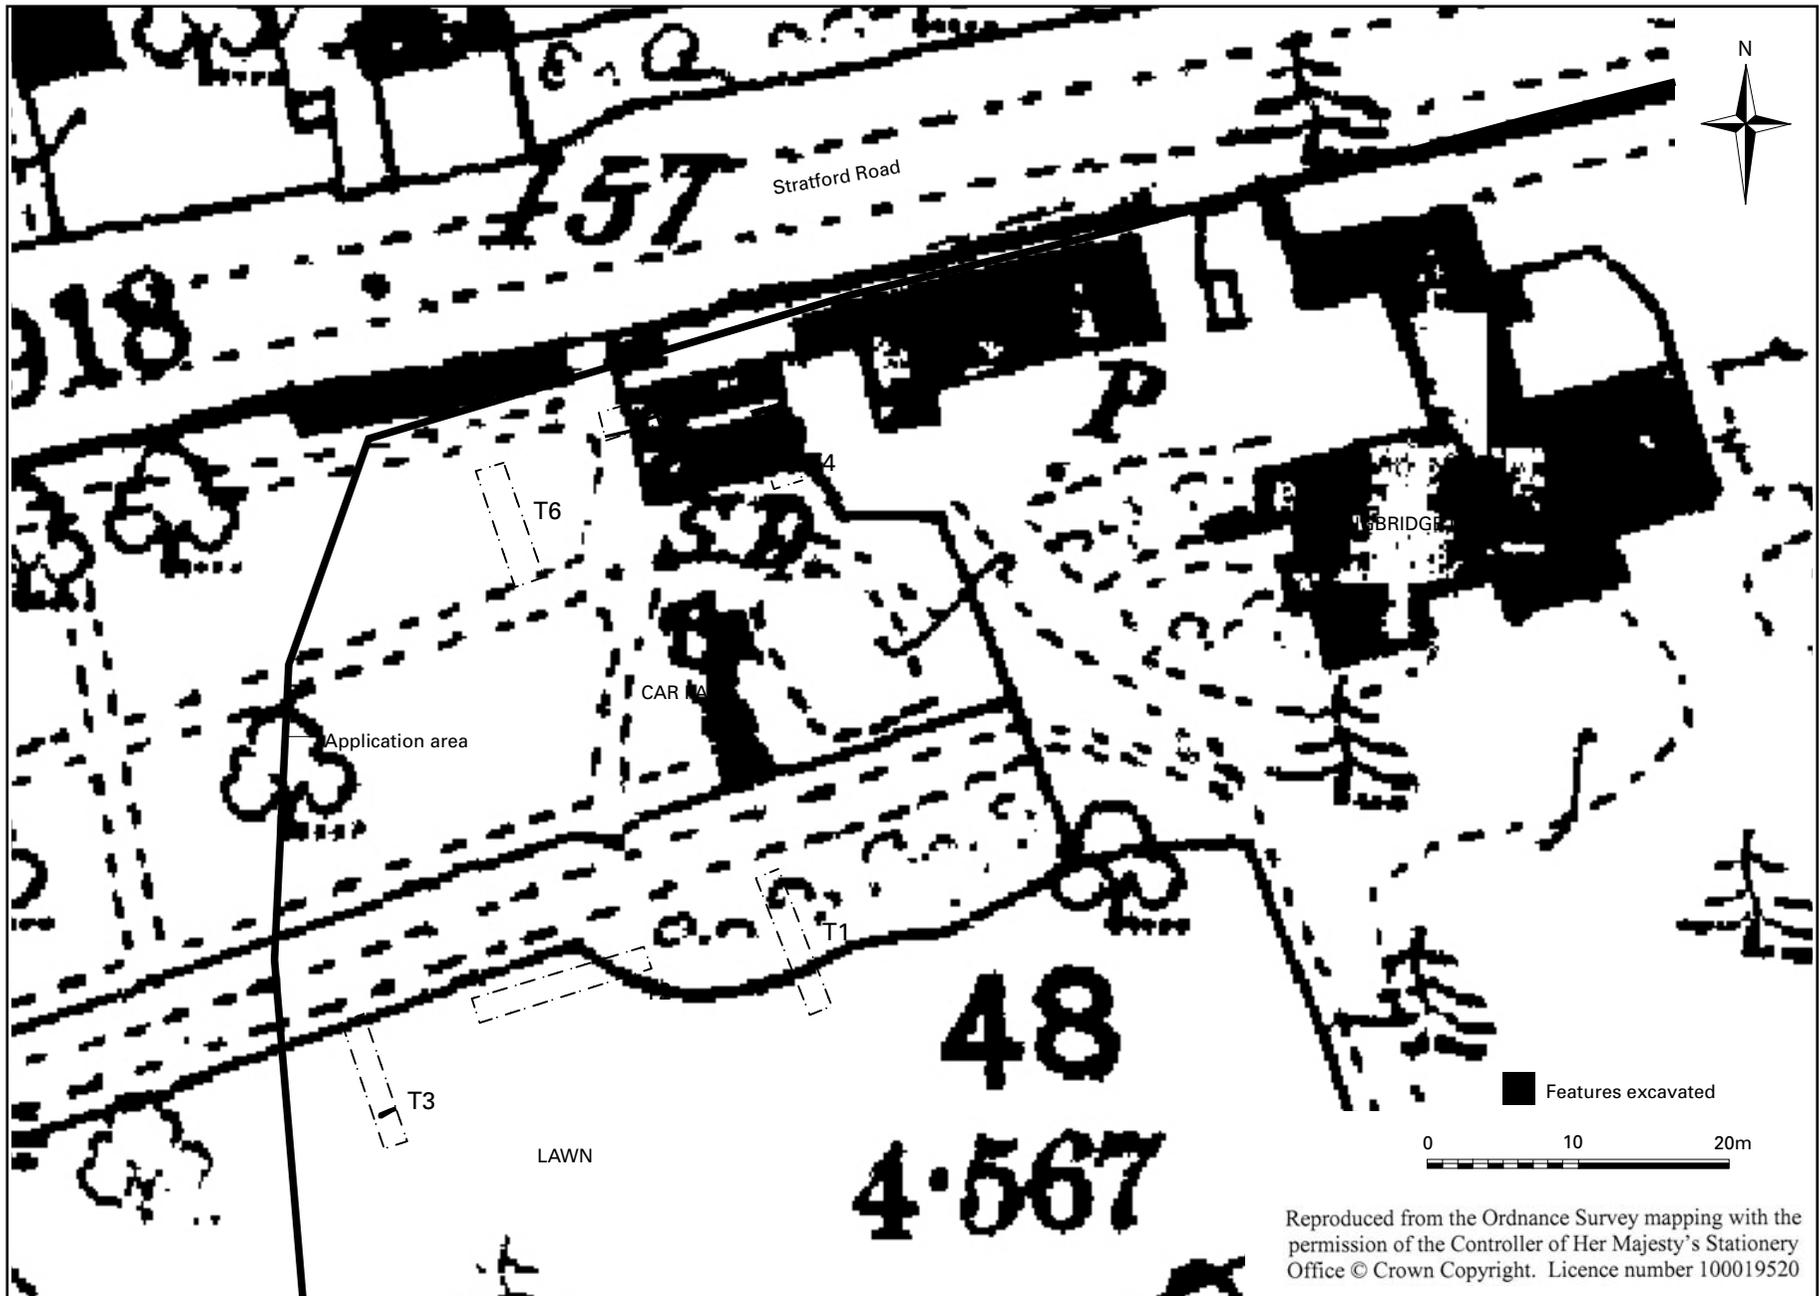
Fig 2: Location of evaluation trenches superimposed on First Edition Ordnance Survey map of 1887

Trenches 1 to 3 were excavated within existing lawns, on the south side of Longbridge Manor (Fig 2).

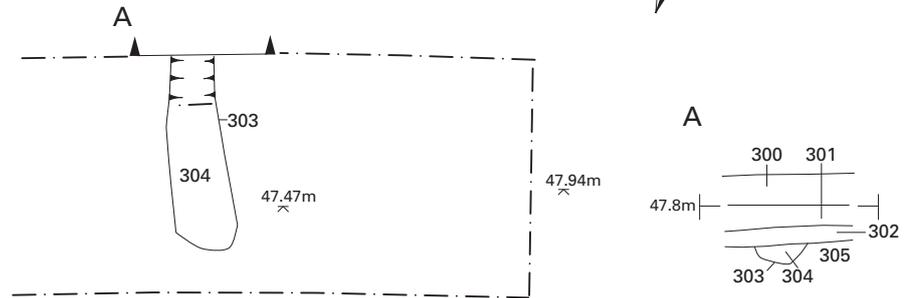
### TRENCH 3

5.3 This was 9m long and 1.8m wide. At the southern end the geological natural was reached at a depth of 0.31m whilst at the northern end it was 0.57m below the ground surface. Close to the south end of the trench a narrow gully (303, Figs 3 and 7) running in an approximately east-west direction, up to 0.40m wide and a maximum depth of 0.17m deep was exposed. The gully was filled by a grey sandy loam (304) with very occasional charcoal flecks (Fig 3, section A). A single fragment of animal bone and a single fragment of fired clay were recovered from the fill. It seemed possible that the fired clay fragment was prehistoric in date. The geological natural (305) and gully fill 304 were overlaid by up to 0.2m of a brownish grey sandy loam (302). This was covered by up to 0.17m of strong brown sandy loam (301) which contained occasional charcoal flecks. Above this was up to 0.21m of greyish brown sandy loam topsoil (300).

6.1 The earliest possible archaeological feature exposed during the evaluation was a small gully (303) in Trench 3. This contained a single fragment of animal bone and single fragment of fired clay. This had not been fired to a high temperature and so was relatively soft. Such a find cannot be easily dated but as 30 fragments of fired clay were found in Iron Age features in the archaeological evaluation just to the west in 1997, it seems an Iron Age date for this fired clay is possible. The fill of the gully itself was a grey sandy loam (304), such a fill being common in older archaeological features where a long period of leaching has removed much of its colour.

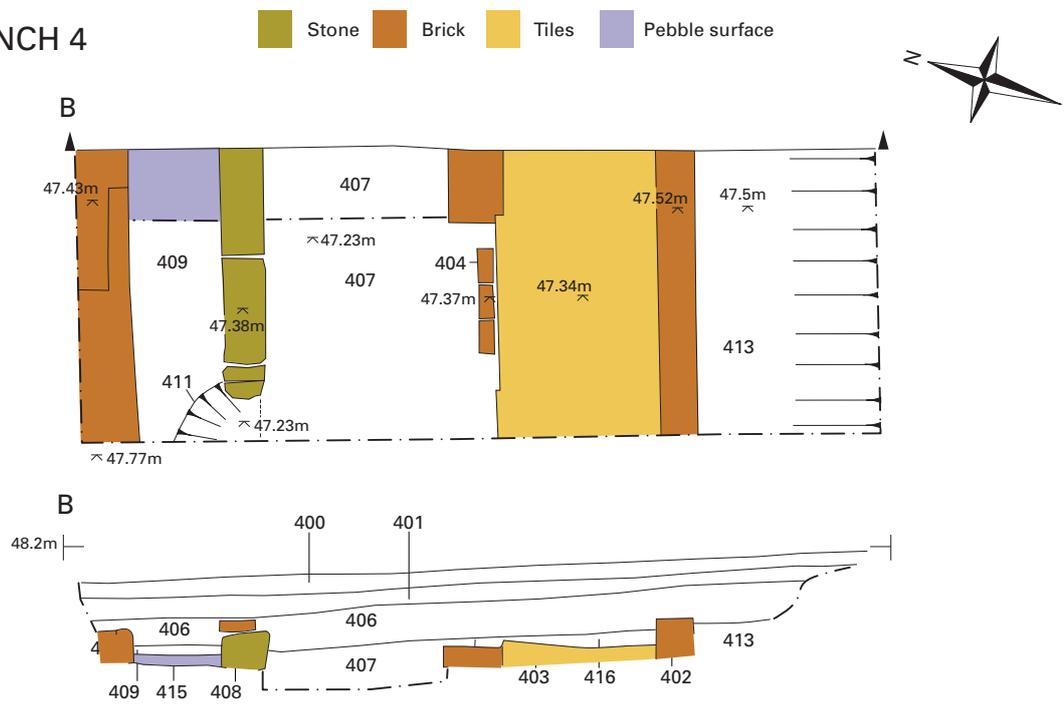
### TRENCH 4

5.4 Trench 4 was 5.5m long and 1.8m wide. It contained a large number of archaeological layers and features (Fig 3). Geological natural was not exposed in this trench. A number of walls and a tiled floor were exposed and cleaned by hand. At the north end of

the trench a brick wall (410) running in an east-west direction was exposed. The full width of the wall was not exposed, although it is unlikely to have been very much wider. Two courses of wall remained and the visible piece within the trench was 1.8m long, 0.4m wide and up to 0.22m high. It was constructed from machine-made bricks which were bonded with a white mortar. To the south of this was a sandstone wall (408) up to 0.3m wide, 1.65m long and 0.25m high. It was constructed from neat blocks of green sandstone and was bonded with a white mortar. A single brick on top of the sandstone wall and only visible in section (Fig 3, Section B) suggests that this stonework may have formed the footing for a brick wall. To the south of this two brick features; the remains of a wall (404) and a possible step (405), were exposed. These butted up against a floor (403) of large ceramic tiles, each 0.37 by 0.35m in size. The southern edge of the floor was defined by another brick wall (402) 0.23m wide and two courses in height. The space between brick wall 410 and sandstone wall 408 was partly excavated and revealed a pebble surface (415). This appeared to butt up to wall 408 and wall 410 may have been cut through it. It was covered by a layer of off-white mortar containing frequent small pebbles (409). Both this and wall 408 were cut by a relatively modern pit (411) which was filled with a greenish brown clay loam (412). To the south of wall 408 the lowest layer reached was a dark greyish brown clay loam (407). Brick feature 405 and tile floor 403 were overlain by a layer of mixed clay loam and brick (416), clearly a layer associated with the demolition of the buildings, whilst all of these layers and walls were overlain by a layer very dark greyish brown clay loam (406), again mixed with frequent broken brick fragments and again associated with demolition. Layer 406 was overlaid by a layer of grey hardcore (401) which was covered by 0.1m of modern tarmac surface (400).

6.3 Two of the three trenches within the existing car park exposed remains of brick and stone structures. The brick structures must be those shown first shown on the 1886 Ordnance Survey map as greenhouses. The stone wall (408) may well have always been part of these greenhouses although its different method of construction and the apparently associated pebble surface (415) might suggest an earlier date. It is just possible that this is part of an earlier building shown on an estate plan of the site in 1815 (Hodgetts 2011, fig 6). This is also shown a tithe map of 1849 (Hodgetts 2011, fig 7) but had gone by 1886 and is likely to have been either demolished to build the greenhouses, or just possibly incorporated into them.

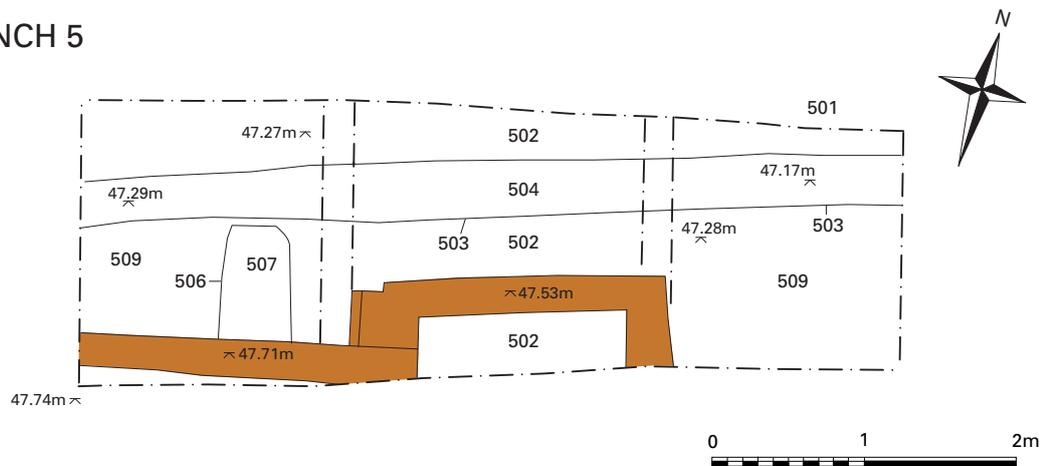
### TRENCH 5

5.5 This was 5.5m long and was excavated down to geological natural sand and gravel (509) at its northern and southern ends. A live sewer pipe trench (503), filled by grey hardcore (504), ran the length of the trench, cutting the natural sand and gravel. Geological natural was also cut by a sub-rectangular pit (506) which was filled by a dark greyish brown clay loam. This fill contained occasional fragments of tile and a single piece of flower pot and was not excavated due to its relatively modern date. The natural gravel was also cut by two associated brick walls (505 and 508). Wall 508 appeared to form part of a tank and consisted of at least four courses of blue 'engineering' brick bonded with a hard white mortar. Attached to wall 508 was a further length of wall (505) which was made of red brick and was 0.45m high and 0.24m wide. The two walls had clearly formed part of the same structure and were late 19th or early 20th century in date. The structure had been demolished and the area levelled up using the demolition rubble mixed with dark grey clay (502). This was covered by a layer of modern grey hardcore (501) above which was the current tarmac car park surface (500).

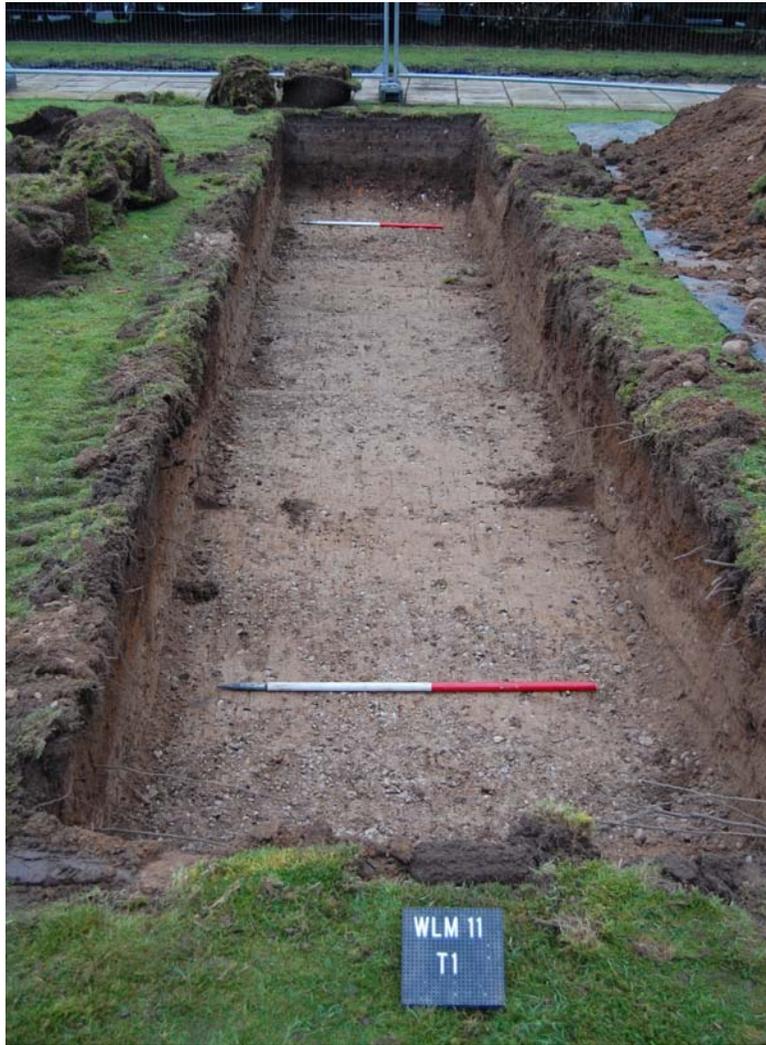
Fig 4: Trench 1, looking north

5.1 This was 9.6m long and 1.8m wide. Geological natural (103), a pale brown sand and gravel, was exposed at a depth of 0.81m at its northern end but only 0.6m at its southern end. At the northern 3m of the trench natural layer 103 was overlaid 0.28m of grey sandy loam (102) which contained a single fragment of 13th- to 14th-century pottery and occasional fragments of 18th- or 19th-century pottery and glass along with fragments of ceramic tile and brick. Layer 102 was covered by 0.32m of brownish grey sandy loam (101) which was covered by 0.21m of greyish brown topsoil (100). At the southern end of the trench, where layer 102 did not exist, the natural was overlaid directly by 0.40m of layer 101 which was covered by 0.20m of topsoil (100).

6.2 In Trench 1, a layer above the geological natural, within the area of existing lawn, contained a few sherds of pottery, mostly of 18th- and 19th-century date but also a single medieval sherd dating from the 13th or 14th century. The medieval sherd is most likely a residual find from the nearby medieval hamlet. A fragment of hand-made brick, also from Trench 1, was probably later 17th century in date and appeared similar to those from which part of the Longbridge Manor is built.

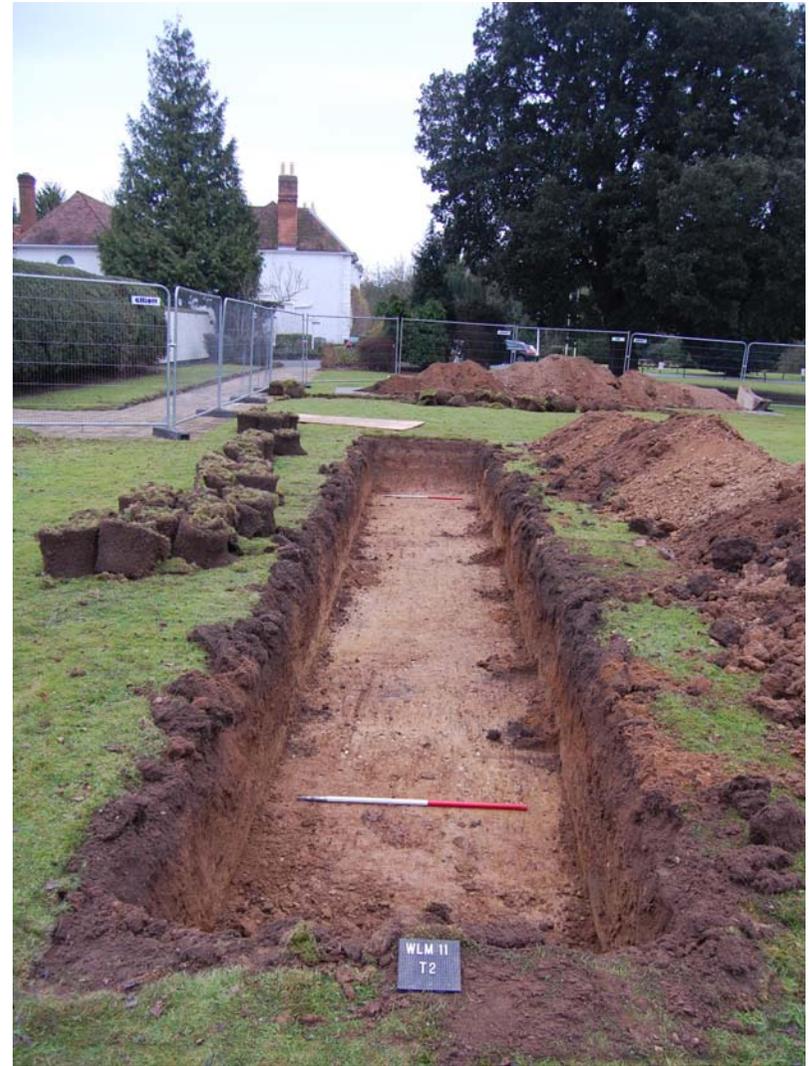
Fig 5: Trench 2, looking east

5.2 This was 12m long and 1.8m wide. Geological natural was reached at a depth of 0.64m in at the eastern end of the trench and 0.69m at the western end. It was overlaid by a layer of 0.30-0.49m of brownish grey sandy loam (201). This was covered by 0.20-0.30m of greyish brown sandy loam (200). No archaeological features or finds were recovered.

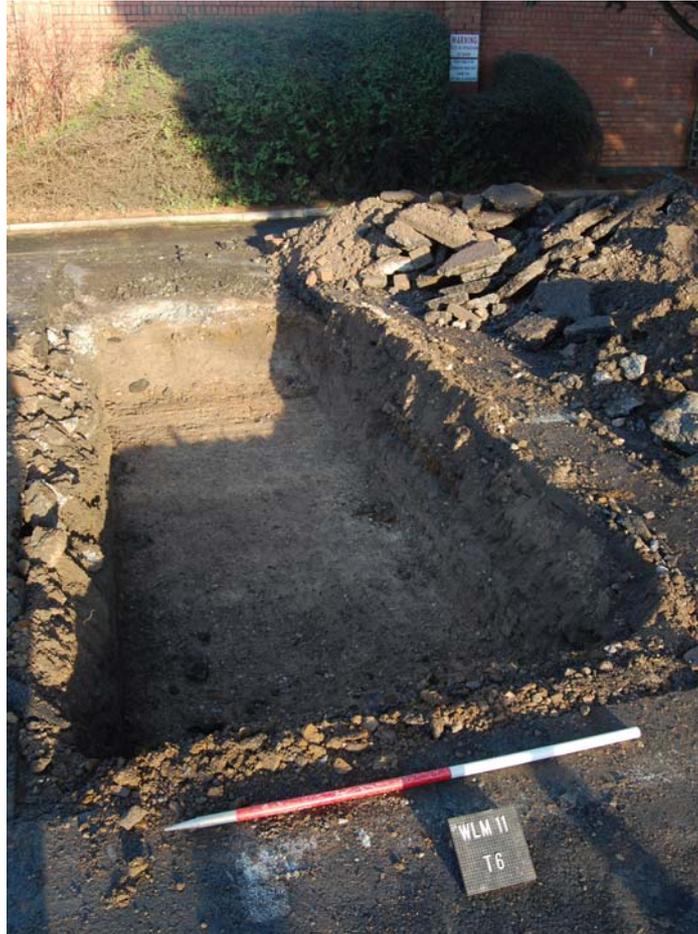
Fig 10: Trench 6, looking north

5.6 This was 8m long and was excavated down to geological natural sand and gravel (606) which was reached at a depth of 0.71m at the northern end of the trench and 0.76m at the southern end. This was overlaid by 0.20-0.23m of a grey sandy loam layer (604) which was covered by either 80mm of steel re-enforced concrete (602) or an associated layer of yellowish brown hardcore (603). These layers were covered by 60-80mm of modern grey hardcore (601) which was overlaid by 0.17-0.18m of tarmac.
