# Bowhill

The archaeological study of a building under  
repair in Exeter, Devon, 1977–95

*The archaeological study of a building under  
repair in Exeter, Devon, 1977–95*

Published in association with Exeter Archaeology as Volume 5 in the  
Exeter Archaeology Reports series

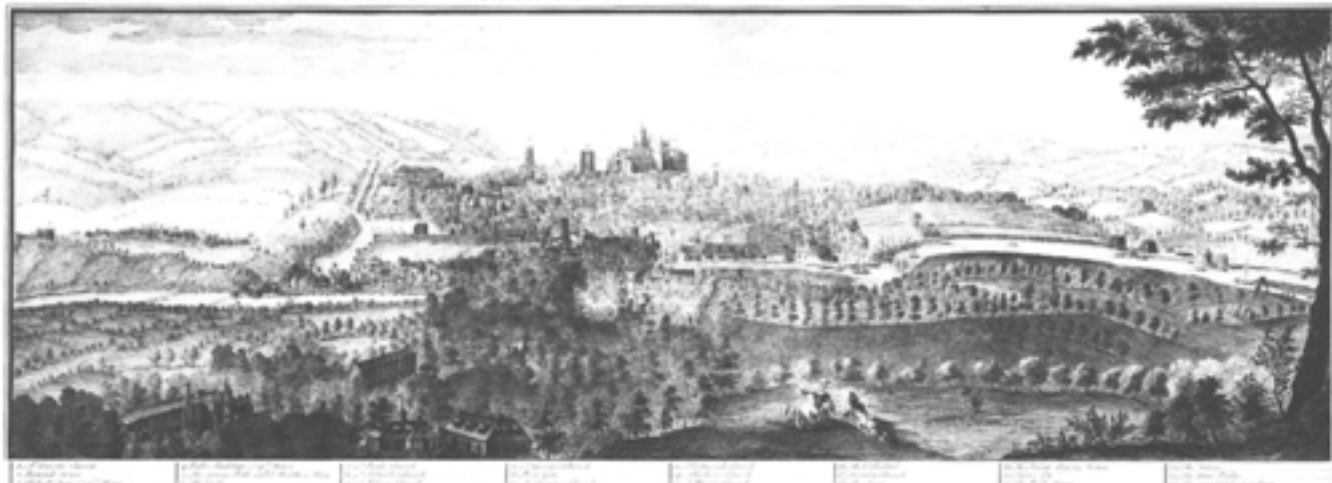
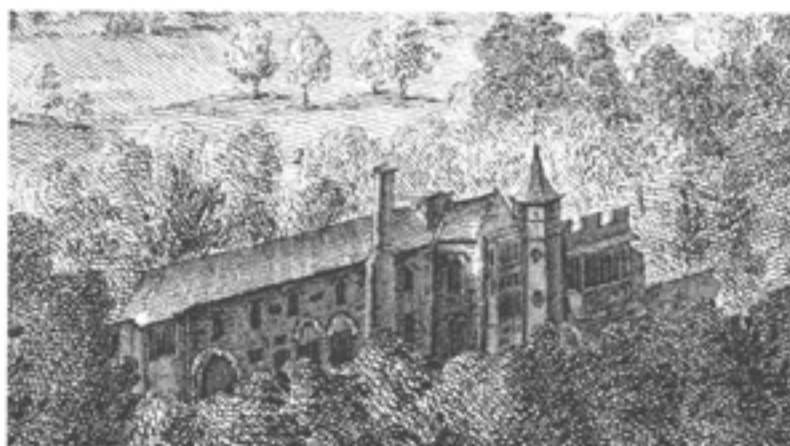
*Figure 2.1*

*The South West Prospect of the City of Exeter by Samuel and Nathaniel Buck, dated 1736: note, in the centre, the second Botshill House, Franklyn (= Franklin in Fig 2.2) House, and the parish church (EMAFU 1863/1); detail of Botshill (lower left in main view) (EMAFU 1863/2) (photograph by Gary Young) (source: Exeter Archaeology, photograph © Exeter Archaeology).*

Bowhill appears in the lower left-hand corner of the large copper-plate engraving entitled 'The South West Prospect of the City of Exeter' in the series of views of English towns and cities by Samuel and Nathaniel Buck (Fig 2.1).<sup>2</sup> Considering the fact that it forms a minor detail in a corner of the general view of the city (albeit in the foreground of that view), the house is depicted with some care,<sup>3</sup> but the view is not without problems of interpretation.

Chief among such problems is that none of the rear ranges appears, although the archaeological evidence shows that these were still standing at the time (along with the south-east range that is shown here). The house is depicted as if it consisted only of the south and south-east ranges, with dense tree growth against the rear of this rather shallow building.<sup>4</sup> Further vegetation obscures the base of the southern wall. Second is the strange square element on the roof masking the junction of the roofs of the south and south-east ranges. These problems may have arisen from the way in which the engraving was compiled. Most of the Bucks' town prospects were drawn from a fixed (and often elevated) position.<sup>5</sup> Separate drawings were sometimes made of individual landmarks for inclusion in the foreground and the views of the three houses (the two Bowhills and Franklyn) along the lower edge of the Exeter view would be strong candidates for being recorded in such sketches.<sup>6</sup> If the artist who sketched Bowhill had done so from the road to the south, the most obvious aspect of the building, he might have omitted details of the rear ranges, or merely noted their existence. The engraver (or compiler of the draft)<sup>7</sup> might then have overlooked these aspects of the sketch. The solution to the second problem, that of the roof lines, probably lies in confusion over the structure itself (perhaps this again reflects a tentative aspect of the sketch). Two separately roofed structures, adjoining at the corner, must have been roofed by means of leaded valleys, a junction that is unusual and thus may not have been rendered by the draughtsman in an intelligible form. The engraver, again, may have adopted a solution that seemed sensible to him, but which bore no relation to the actual arrangement.

the detail (see Fig 2.1) with the south elevation of the south range as recorded in 1987 (see Fig 5.8) shows that every feature of the engraved view mirrors windows and doorways exactly, relieving arches where such were employed and even smaller apertures between the first-floor windows of the south range, where there are putlog holes. With this level of reliability where fabric survives, it is suggested that the features shown in the vanished parts of the building should be taken seriously as a faithful record of the south range prior to the extensive demolitions of c 1800 (phase 8, see below).<sup>8</sup> There is evidence in the fabric for the oriel window at the west end of the range, although in reality this was a corbelled-out structure at first-floor level only, rather than the full-height structure shown here, and for the walls of a south-east range (Chapters 5 and 8). Some of the architectural fragments recovered from the site also probably came from this building and add another dimension to the testing of this view.<sup>9</sup> Since the existence of the range is demonstrated by evidence in the fabric, it is suggested that the details of the Bucks' view should be accepted as the basis of a reconstruction (see Fig 12.5). Further discussion of the structures of the south-east range appears in Chapter 8.

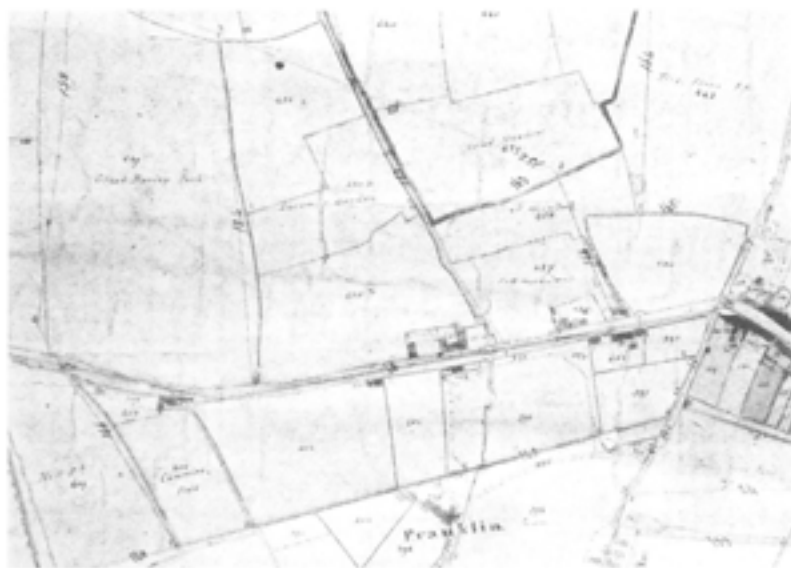
Figure 2.3 (above)  
Detail of the immediate area of Bowhill from the PRO copy of the tithe map dated 1839. Bowhill is just below centre, numbered 431/431a; note also the three fields of 'Lucombe's Garden', numbered 430, 430a and 430b (see Fig 3.1) (reproduced courtesy of the Public Record Office IR 30/9/407).

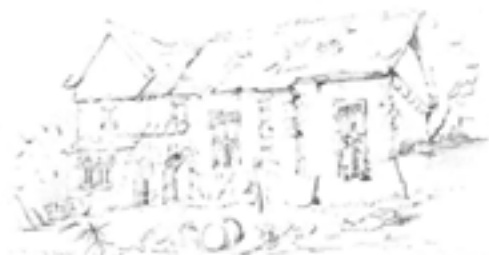
Figure 2.4 (top, right)  
Mid-19th-century pencil drawing by George Townsend showing Bowhill from the east (photograph by David Garner) (reproduced courtesy of the Wiltshire Studies Library, Exeter).

Westcountry Studies Library at Exeter and the other two, by F W L Stockdale, are in the Royal Institution of Cornwall at Truro.<sup>13</sup> Of the Townsend drawings, one seems to be a copy of the other (and may not even have been drawn by Townsend himself); many details are repeated (such as the barrel in the foreground), but in a simpler or cruder fashion.<sup>14</sup> Since the second version adds nothing informative to the first, it is not illustrated here. The view (Fig 2.4) is of the east elevation and shows the building pretty much as it survived at the time of the earliest photographs, with thatch on the hall range, but the oversail and south range still slated. The porch, east gable of the south range, hall chimney stack and northern bay of the east range are all missing.

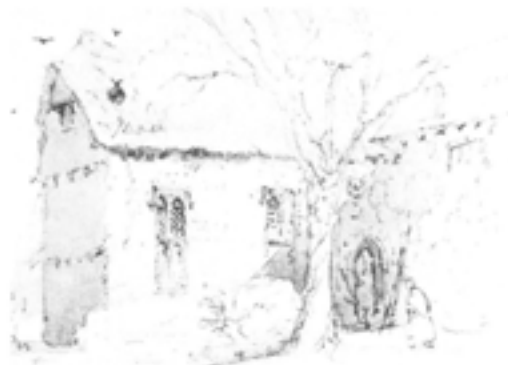
Figure 2.5 (centre, right)  
Mid-19th-century pencil drawing by F W L Stockdale, showing the courtyard looking south-east (photograph by David Smart) (reproduced courtesy of the Royal Institution of Cornwall).

The drawings by Stockdale show different views.<sup>15</sup> One (Fig 2.5) shows the interior of the courtyard looking south-east. Again the hall range is thatched, with the remainder of the roofs slated and there is a large tree in the centre of the courtyard. The north gable of the east range is shown free of attached structures (although this may represent some tidying up by the artist, as derelict structures are known to have survived in this position). A chimney is shown in the roof of the south range.<sup>16</sup> The second drawing (Fig 2.6) shows the west elevation of the house. Here the general configuration is much as it survived in the 1970s, except that a smaller structure is shown attached to the south-west corner of the building in the position of the later 'annexe' and roofed on an east-west axis. There are windows on ground and first floors of the western gable, the first-floor window of the west range is shown blocked (although the sill is articulated) and there is no doorway through the western boundary wall into the courtyard.

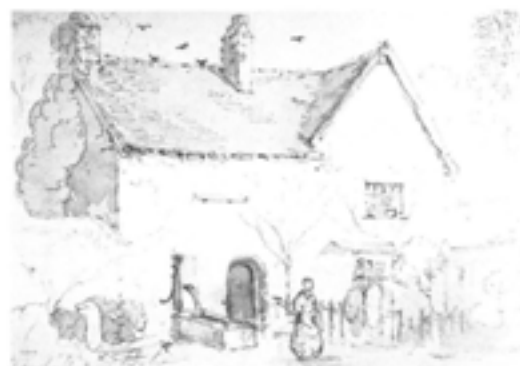
Figure 2.6 (bottom, right)  
Mid-19th-century pencil drawing by F W L Stockdale showing the house from the west (photograph by David Smart) (reproduced courtesy of the Royal Institution of Cornwall).

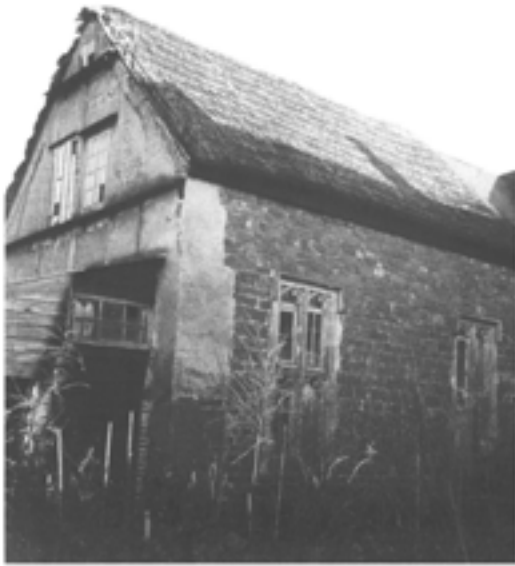
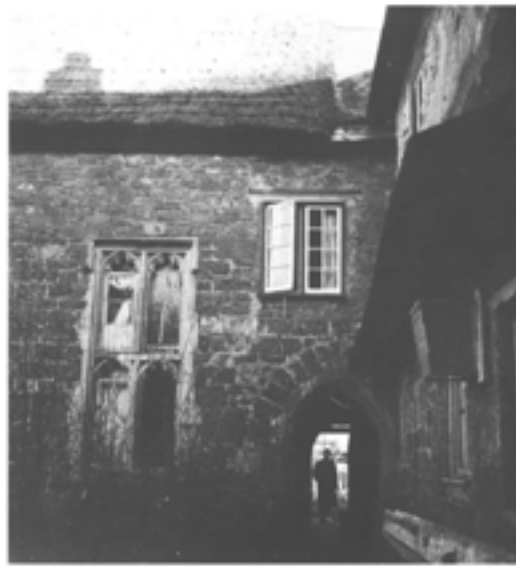
*Figure 2.7*  
Anonymous photographs,  
labelled and dated 'Bowhill,  
Exeter, 30.xii.1936',  
possibly by A W Everett:  
(left) the hall range  
showing the thatched roof;  
(right) detail of the screens  
passage (EH B960392-3).

The views reproduced here (Fig 2.7) are dated 30 December 1936 but are otherwise unprovenanced and represent the only pre-war views known to the author other than Fig 3.3 and the two photographs published by Everett.<sup>18</sup> They are useful in showing the thatched east range, the nature of the northern gable of the hall, the remnants of early ridge tiles on the junction of the roofs of the east and south ranges and the generally dilapidated condition of the building at this time (*see*, for example, the randomly glazed windows of the hall). Later photographs by the NMR/RCHME (and others) of the 1950s and 1960s provide a valuable record of the building before the destructive alterations of the restaurant period (Figs 2.8–2.28).

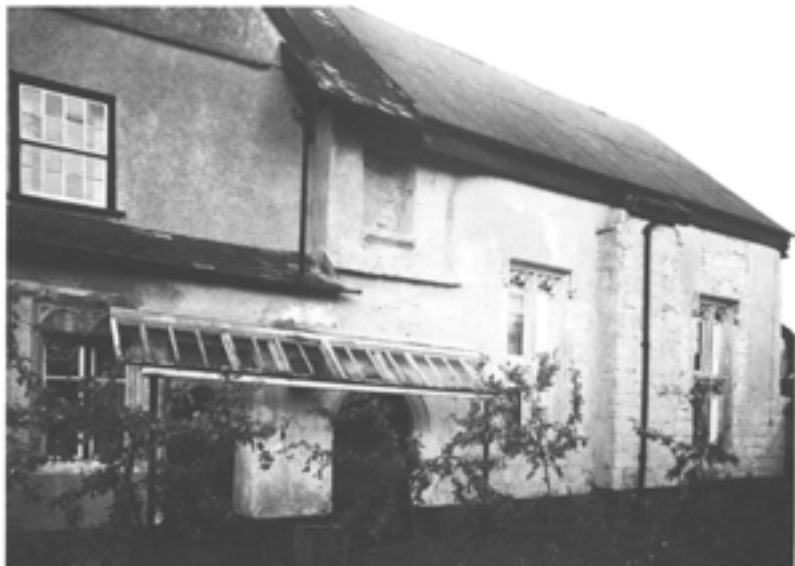
*Figure 2.8*  
The east elevation in the  
1950s. Note the corrugated  
roof of the hall and extent  
of cob walling, detectable by  
smooth texture beneath  
render (NMR AA  
57/144).

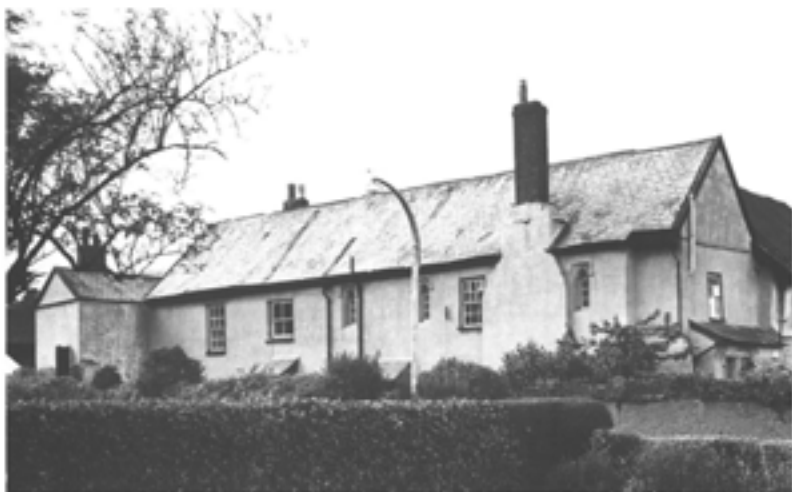
Figure 2.10  
The south elevation in the 1950s from the opposite side of Dunsford Road. Note especially the glimpse of the cob boundary wall, which had been demolished prior to any later photographs (NMR AA 57/139).

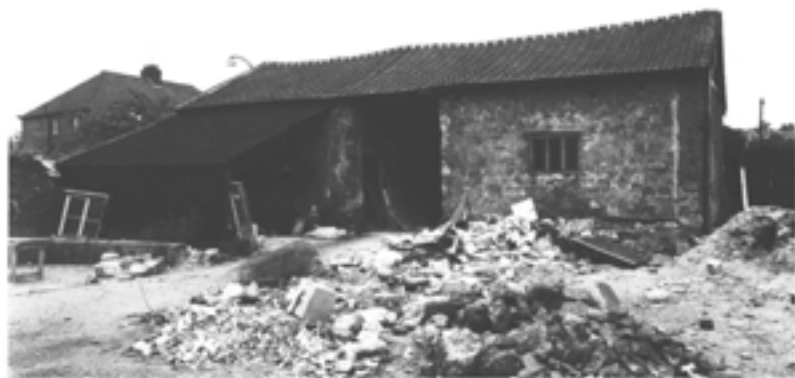
Figure 2.15  
The east elevation of the barn in 1969. Note the three-light window (RCHME BB69/5022).

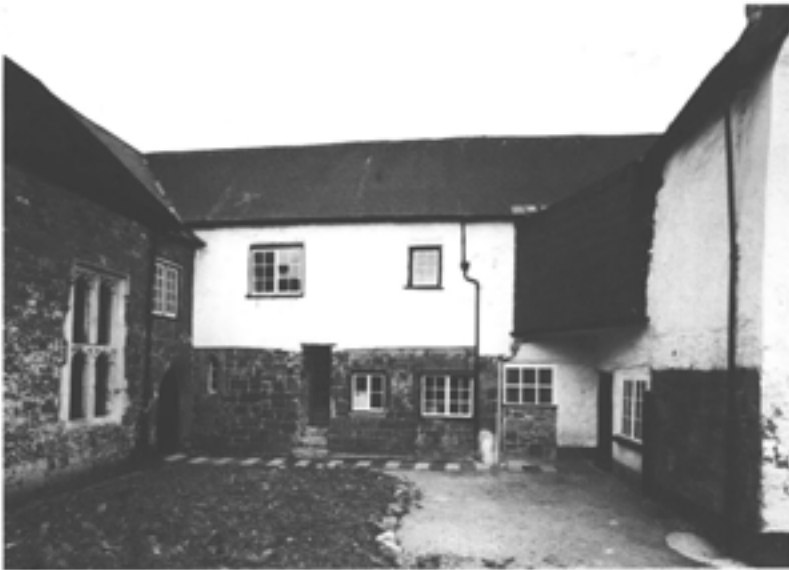
Figure 2.18  
The north elevation of the south range in 1969. Note the 'bridge' in the corner (RGHME BB69/5015).

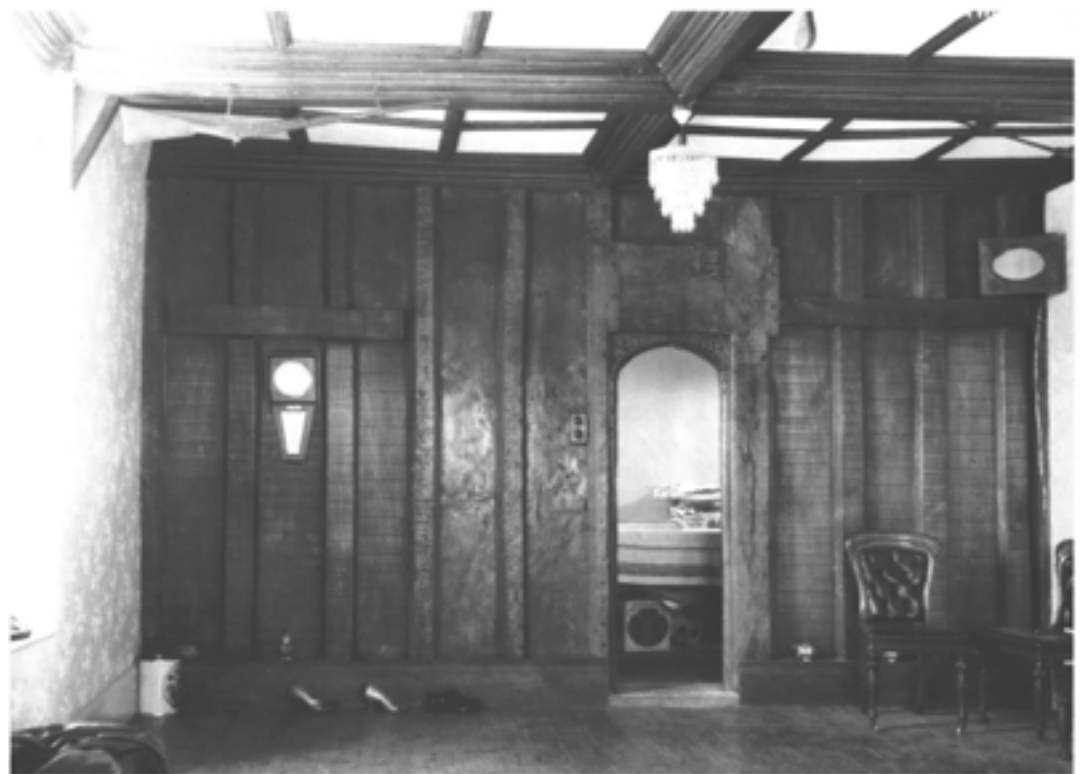
*Figure 2.24  
The interior of the parlour  
in the 1950s. Note the  
screen in position beneath  
beam 5. The head of the  
curved post/brace that was  
inserted to support the south  
end of beam 4 on the  
removal of the screen from  
its original site is visible on  
the left (photograph by  
A W Everett; NMR AA  
69/1757).*

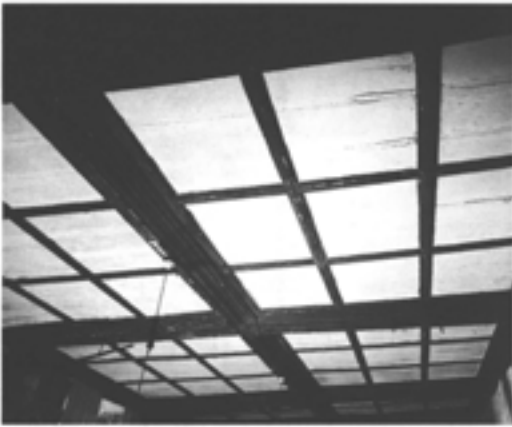
Figure 2.25 (above, left)  
 Detail of the parlour ceiling in the 1950s, looking west, bays 2 (in foreground) to 4. Note the detail of the mouldings of the panels. The later shallower form is otherwise recorded only in a sketch (NMR AA 57/171).

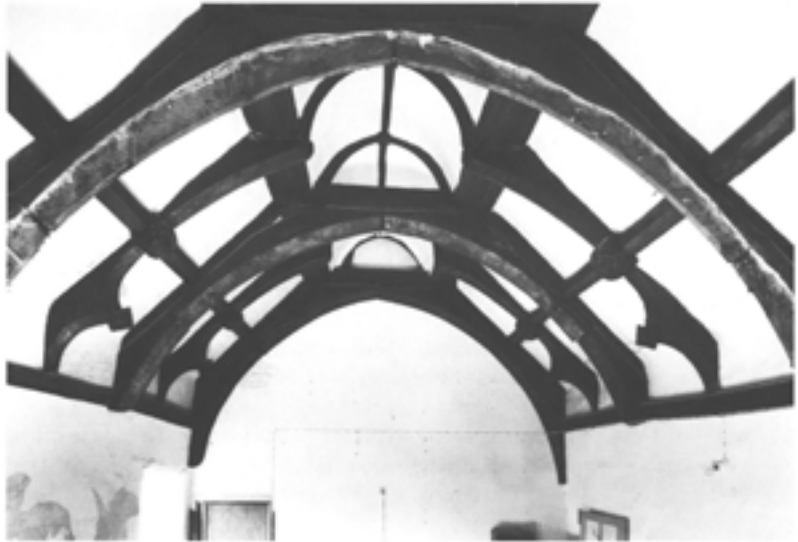
Figure 2.27  
 The great chamber roof in 1969, looking west. Note the plaster ceiling and line of the partition on main truss III in foreground (RCHME BB69/5029).

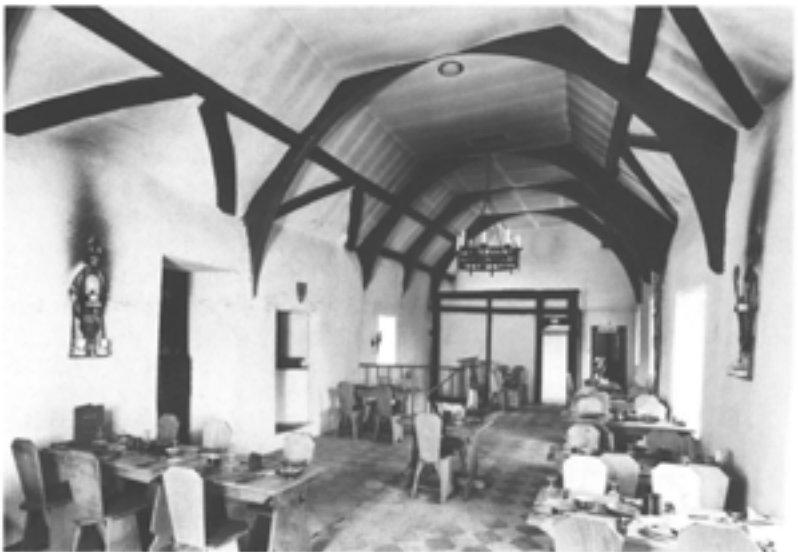
Figure 2.28  
 The first floor of the south range in 1969, looking east. Note the cross wall has been removed. (RCHME BB69/5038).

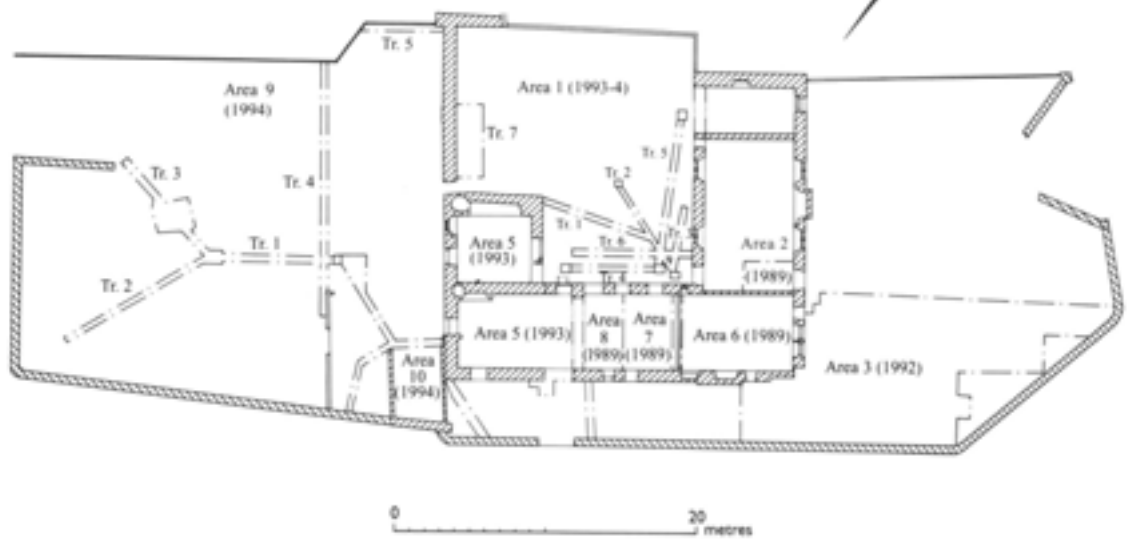
Figure 4.1

Key to areas excavated 1977-94 (scale 1:500) (line drawing by Tony Ives).

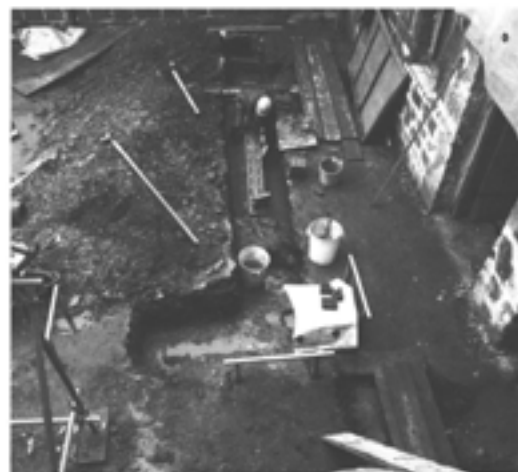
Figure 4.2  
The footing trench for the reconstructed pentice in the central courtyard in May 1994, looking east  
(photograph by David Garner; EH B942060)

As the repair programme drew to a close, many trenches were excavated for services, drainage, the insertion of ducting for cables and the footings for the new pentice (Fig 4.2). Thus, between November 1993 and March 1995, the work concentrated on the recording of archaeological strata exposed by the works programme: the observation of drainage trenches in the western courtyard (see Fig 4.1; Area 9); the excavation of an area within the building footprint of the annexe at the south-west corner of the building when it was rebuilt in July 1994 (Area 10); further observations of service and foundation trenches in the central courtyard (Area 1) at various dates between November 1993 and October 1994; and observation of trenches dug for new drainage in the area to the south of the south range (Area 3). In the central courtyard the

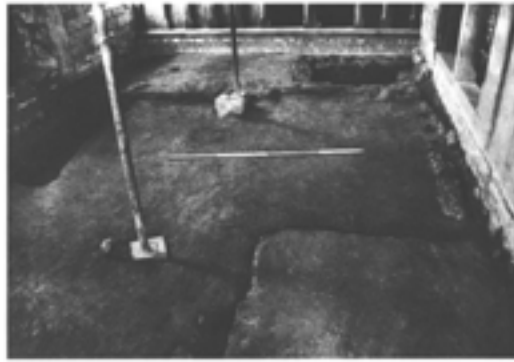
Figure 4.5  
The early building beneath the parlour (phase 2) under excavation in 1989, looking west. Note the wall bases and the wardrobe pit at rear right. The vestigial nature of the structures is shown by the height of the wall bases (photograph by Stuart Blaylock; EMAFU 1581/11).

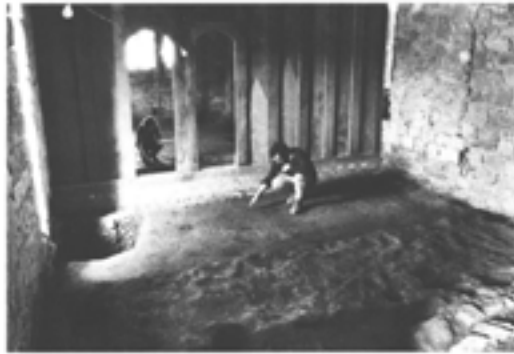
Figure 4.6  
The phase 2 building beneath the service rooms, looking east (photograph by Stuart Blaylock; EMAFU 1589/31).

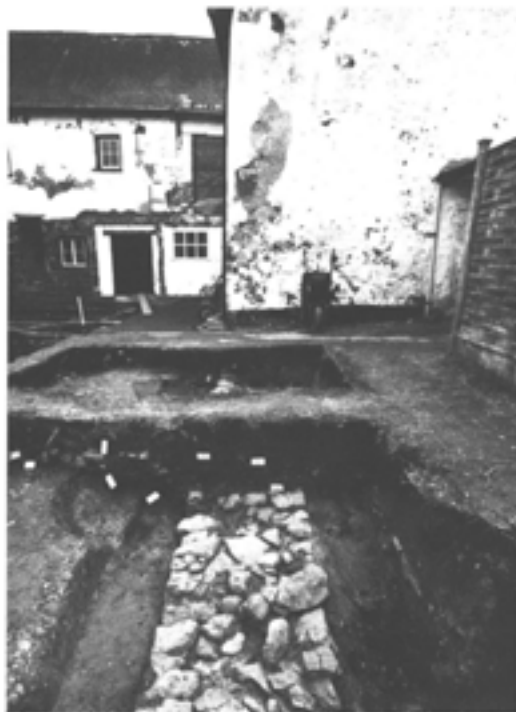
Figure 4.8  
The 1977 excavations in the courtyard showing the excavated wall footings of the west range, looking south to the standing west range (EMAFU 1988/35) (source: Exeter Archaeology; © Exeter Archaeology).

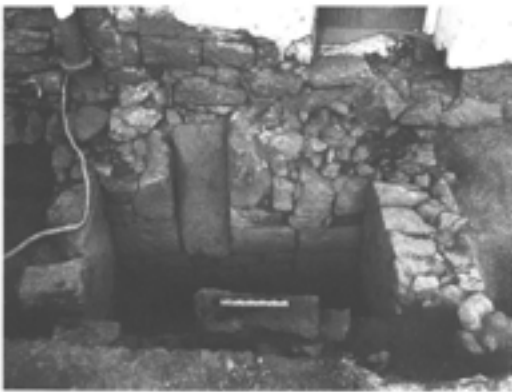
Figure 4.9 (left)  
The garderobe pit and the chute in Area 3 (to south of the south range), looking north, excavated in 1978 (photograph by Stephen Dummore; EBO78/BW4/3).

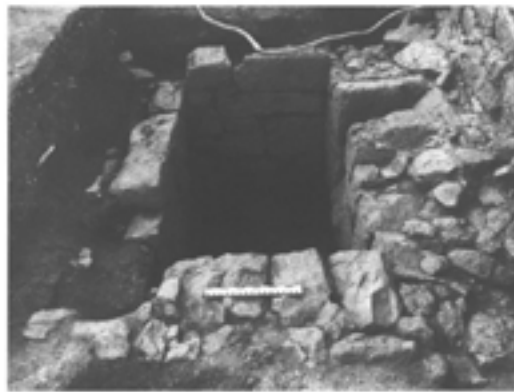
Figure 4.10 (right)  
As Figure 4.9, looking west (photograph by Stephen Dummore; EBO78/BW4/11).

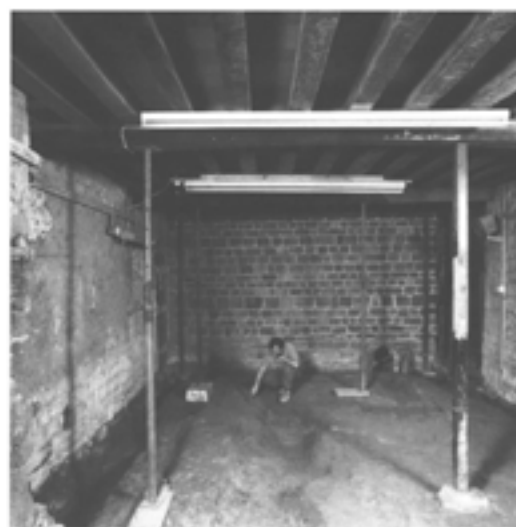
Figure 4.11  
Excavation of the west service room of the south range in September 1993, looking east. Note the foundation trench to the left and the rebuilt stone cross wall in the background (photograph by David Garner; EH B934821).

Traces of a primary clay makeup or floor layer, were recorded over approximately half of the area of the room (see Fig 4.7, 1508 and 1570), running directly over the fills of the foundation trenches (Fig 4.11) and up to the walls; in the north-east doorway the equivalent deposit formed a threshold of cobbles (see Fig 4.7, 1600 and 1674). This probably represented the bedding for a paved floor. There is also a strong possibility

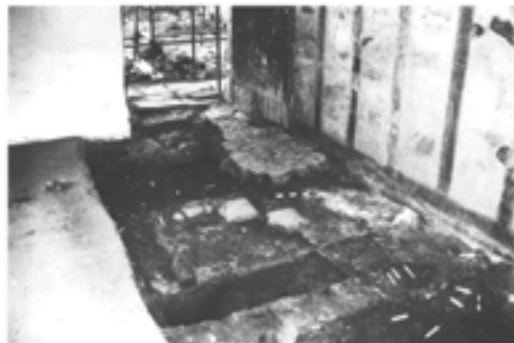
Figure 4.12  
Excavation of the screens passage in 1989. Note two paving slabs *in situ* (centre) and 19th-century cobbled floor above (photograph by Jenny Norton; EMAFU 1651/14).

Surviving primary flooring in the east half of the screens passage comprised a trodden clay surface and a mortar bedding layer, for a stone pavement, of which remnants survived *in situ* (Fig 4.12; see also Fig 4.18, section 13, 838 and 806). To the north a slot preserved in the floor layers marked the position of the screen – a rectilinear base (with some evidence of more than one position), with a square terminal, stopping 0.3m short of the central axis of the hall. This indicates that the screen possessed a central opening, although *c.* 0.6m seems rather narrow. Presumably the slot represented the sleeper beam for the screen (extending partially under the central opening), rather than the superstructure of the screen itself. The floor makeup layers accumulated against the base of the sleeper beam, that is, they were deposited once the screen was in position. These layers contained late sherds and clay-pipe material (including joining sherds of a mid- to late 17th-century tin-glazed jar),<sup>35</sup> indicating that the floor had been disturbed, perhaps because the volcanic-stone paviments were re-laid in the late 17th or 18th century (therefore in phase 7?).

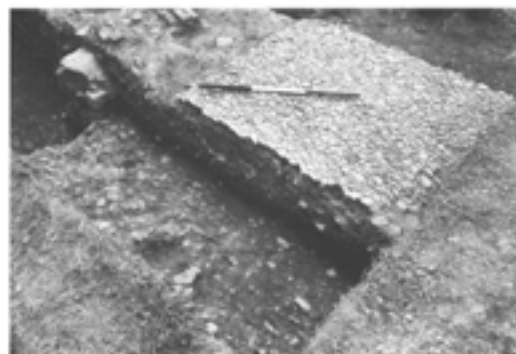
*Figure 4.13*  
The north-east corner of the courtyard looking south-west. Detail of courtyard surfaces, with phase 3 pebbled surface below and phase 8 cobbled surface within new kitchen above (photograph by Stephen Dunmore; EBO77/BW2(3)).

The new kitchen received a floor of neatly laid cobbles (Fig 4.22; see also Fig 4.19, 2065). The exterior yard surfaces were treated in the same way (see Fig 4.13), with pitched cobbled surfaces incorporating drainage gullies around the building and leading off to the south-east. The cobbling ran over the site of the east wall of the former west range and in part extended northwards to the boundary wall of the site. A further drainage gully ran directly south above the interior face of the former wall of the west range (see Fig 4.19, 2173). The cobbled surfaces were well preserved around the new kitchen and in the northern half of the courtyard, but deteriorated towards the south, where later activity had disturbed the

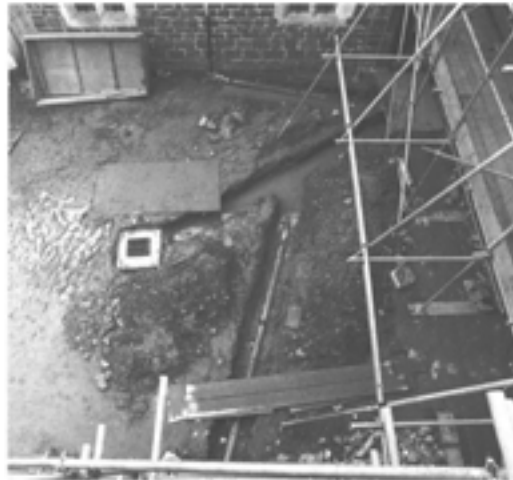
Figure 4.14  
Service trenches dug for drains in the central courtyard, December 1993, looking east (photograph by David Garner; EH B936795).

The excavation of service trenches in 1993–4 gave another opportunity to observe the sequence of pebbled surfaces in the southern half of the central courtyard (Fig 4.14). This confirmed that the stone-lined drain or conduit (see Fig 4.7, 2150) was a primary feature of the courtyard and coeval with the courtyard surfaces. Further areas of pebbled surface were recorded in trenches 4 and 5 (see Fig 4.1), where they had survived in the unexcavated baulks of 1977. A clean clay layer within the accumulation of pebbled surfaces was re-examined and interpreted as the product of cob mixing.

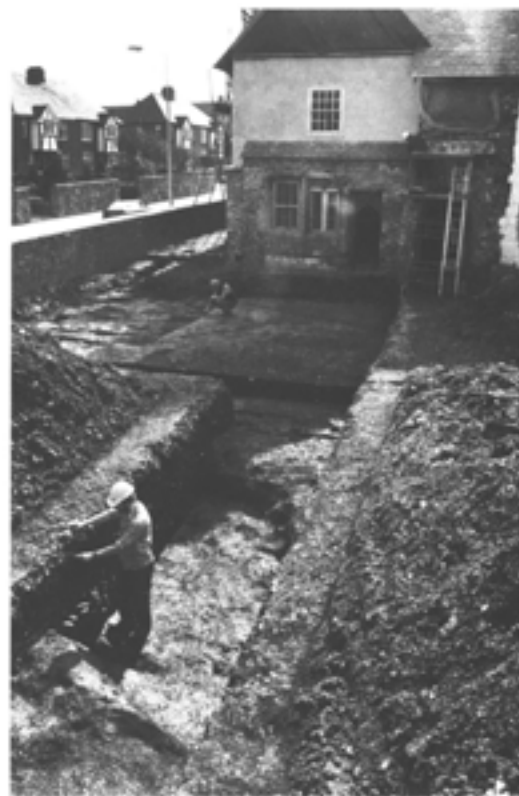
Figure 4.16  
Excavation of the eastern courtyard in 1992; the terminal of the Civil War ditch in foreground, looking west (photograph by Peter Stead; EMAFU 1988/22).

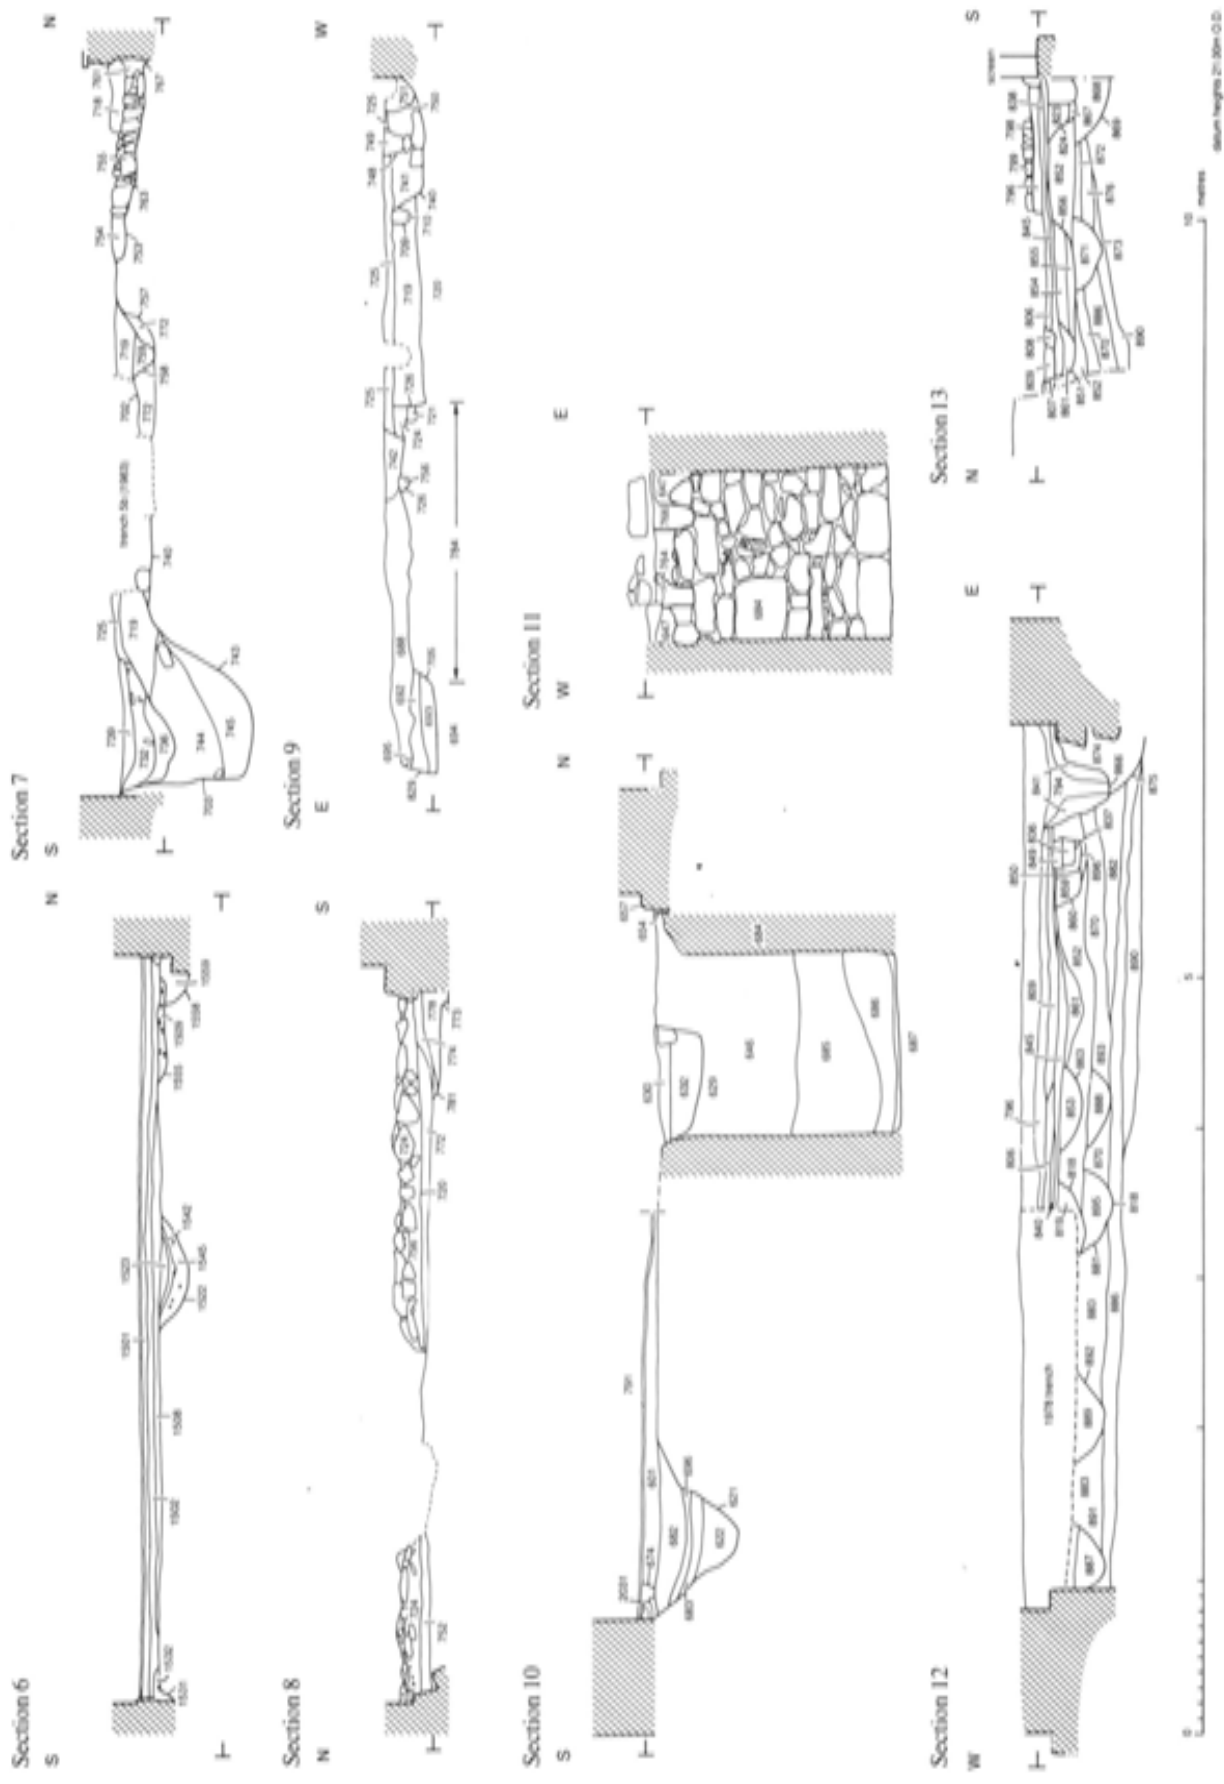
Figure 4.16  
 Selected sections 6-13 (scale 1:50) (line drawing by Tony Irce).

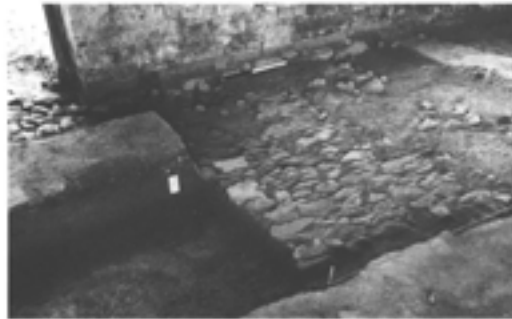
Figure 4.20  
Cobbled surface in the hall  
(detail) (photograph by  
Stephen Dunmore;  
EBO78/BW3/5).

1. A patch of cobbled floor immediately within the south-western door with a straight southern edge, where it was laid up to the north face of the screen (Fig 4.20; see also Fig 4.19, 2133).
2. Patches of mortar and clay flooring in the northern and central parts of the hall.
3. A rough surface of loam and mortar, with a make-up layer of red clay overlying the earlier cobbles. Another equivalent deposit had lime or mortar in its surface.
4. Isolated individual stones of a paved floor (of volcanic trap) lying on the combined makeup layers of 2 and 3 (2036).

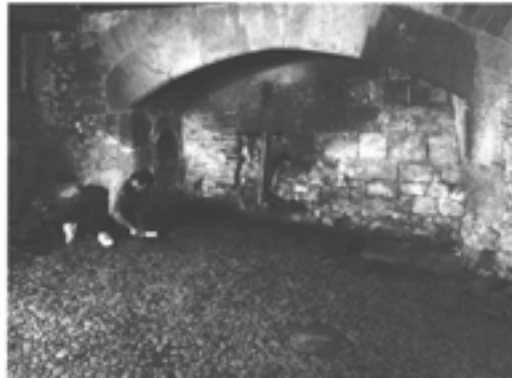
Figure 4.21  
The kitchen in 1993, with  
cobbled floor of phase 8  
(photograph by David  
Garner; EH B934831).

A well-preserved floor of tightly laid cobbles bedded in clay survived over two-thirds of the room including the fireplace and was revealed on the removal of the modern cement floor (Fig 4.21; see also Fig 4.19, 1664).<sup>67</sup> The floor was of similar style and composition to the cobbled surfaces in the central courtyard and so it was assigned to phase 8. One large area of patching was noted inside the east window (see Fig 4.19, 1658), as well as other smaller repairs. Excavation was halted at this level rather than destroy the floor.

pavement.<sup>71</sup> Traces of the cobbling to the west (see Fig 4.19, 1768) show that the surface once ran up to the western boundary wall, but the site of the north range was excluded from the cobbled area (see below). The cobbled work was very similar to the floor in the kitchen (see Fig 4.21).

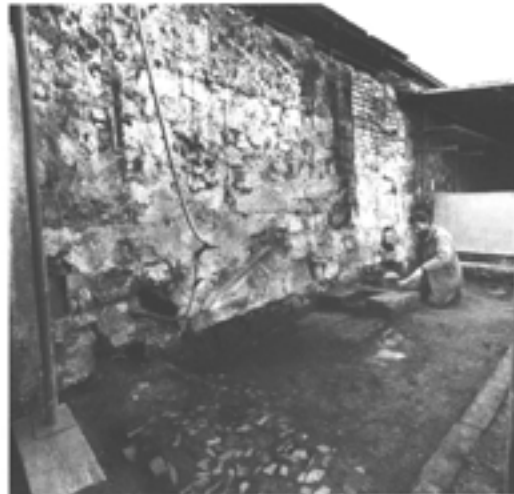
*Figure 4.24*  
Excavation of the phase 9 building on the site of the west range in October 1994, looking north-west (photograph by David Garner; EH B945339).

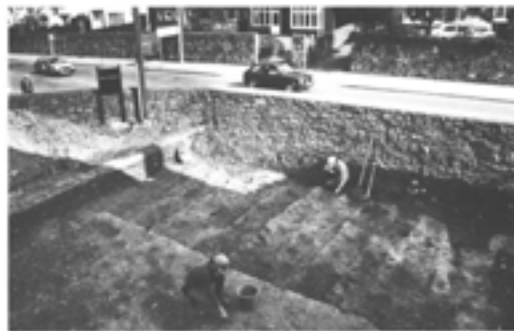
*Figure 4.25*  
The eastern courtyard excavation 1992 – 19th-century cultivation trenches, looking south-east (photograph by Peter Stead; EMAPU 1988/32).

A series of closely spaced parallel trenches, 0.7m wide on average, were cut into the natural subsoil over much of the excavated area (Fig 4.25; see also Fig 4.23). They had wholly removed the earlier levels, such as wall footings or other structural traces of the south-east range, and even traces of the demolition activity of phase 8. Most of the trenches had a primary fill of white lime/lime mortar that may have been deliberately used for its value as a soil improver. The main fill of the features was garden soil.

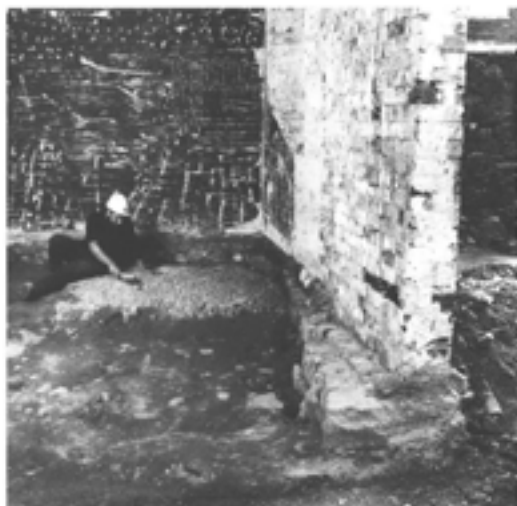
*Figure 4.26*  
Excavation within the annexe in July 1994, looking south. Note the two walls on different alignments (photograph by David Garner; EH B943785).

constructed with wall footings of volcanic stone on an orientation square onto the Dunsford Hill frontage. This building had a cobbled interior surface (Fig 4.26; see also Fig 4.19, 1732 and 1723).

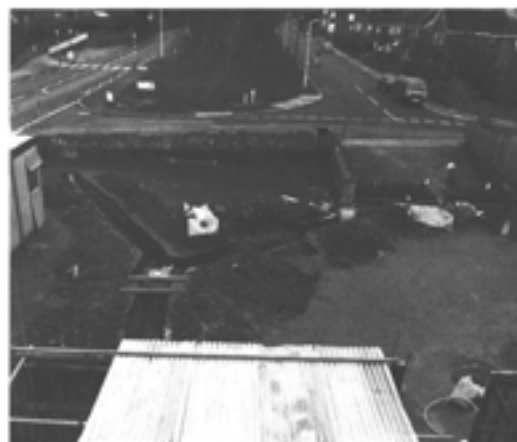
*Figure 4.27*  
Service trenches dug for drains in the western courtyard, December 1993, looking west (photograph by David Garner; EH B936794).

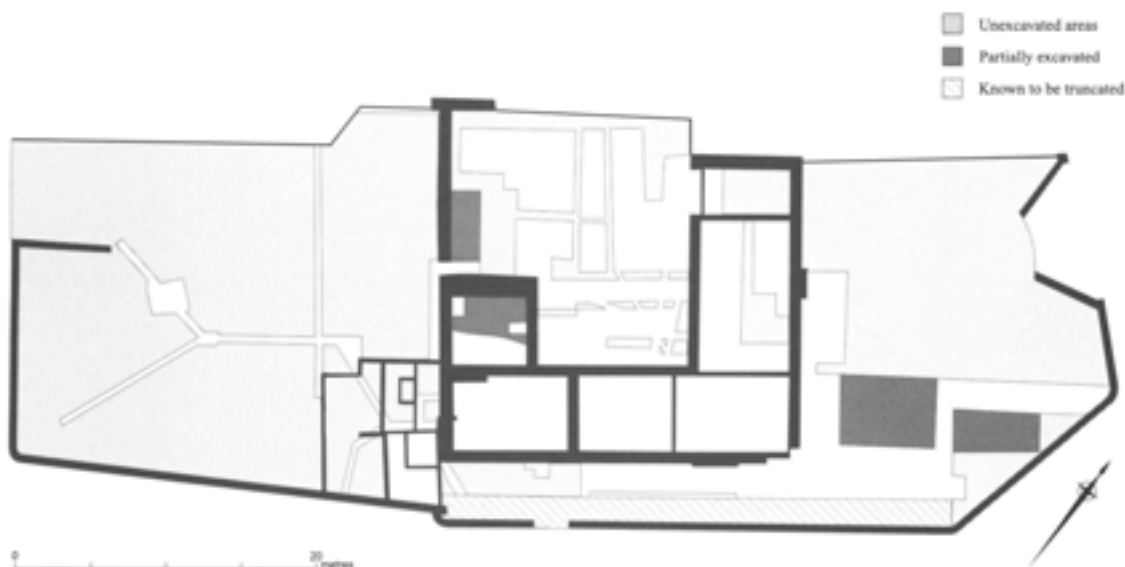
Figure 4.28  
Plan of the site showing unexcavated areas to illustrate the section on the 'Archaeological implications for the future management of the site' (scale 1:500) (line drawing by Tony Ives).

Although much of the site has been archaeologically examined it cannot be assumed that Bowhill is now 'cleared' of its archaeology. Several areas remain almost wholly unexcavated (such as parts of the east and west courtyards) or retain unexcavated baulks running across them (such as the central courtyard). Within the building several areas remain unexcavated, including most of the northernmost bay of the east range and some areas of the great hall. The extent and position of unexcavated parts of the site are summarised in Fig 4.28, from which it will be seen that unexcavated areas account for some 60 per cent of the area within the boundaries. Although this

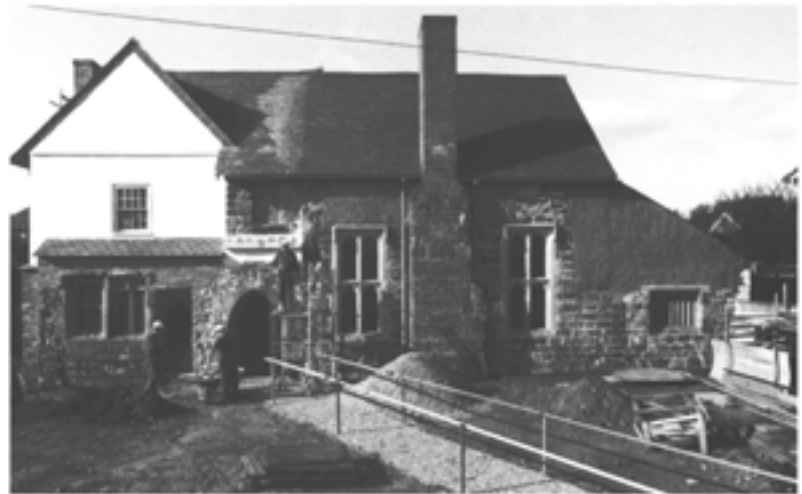
*Figure 5.2 (below)*  
General view of the east elevation when stripped for re-rendering in May 1993 (the earliest available general shot) and thus after repairs in masonry and cob (photograph by David Garner; EH B930369).

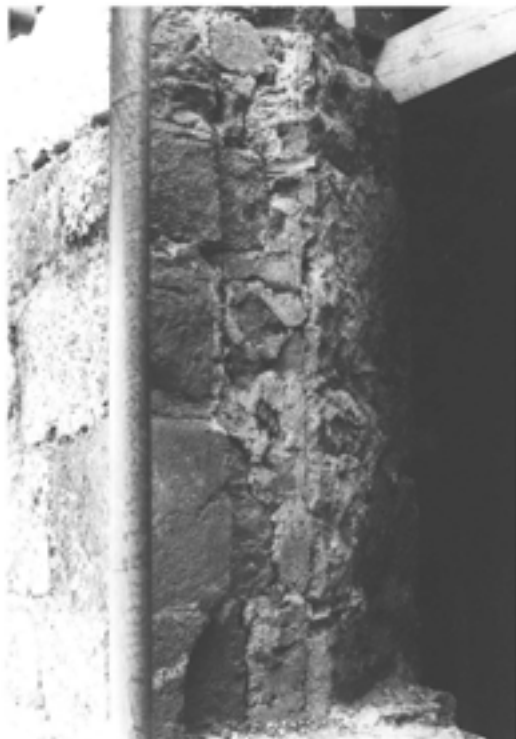
*Figure 5.3 (left)*  
The reveal of the east window of the hall store. Note the inner splay and the chase for a timber frame, looking south-west, 1985 (EH C850070).

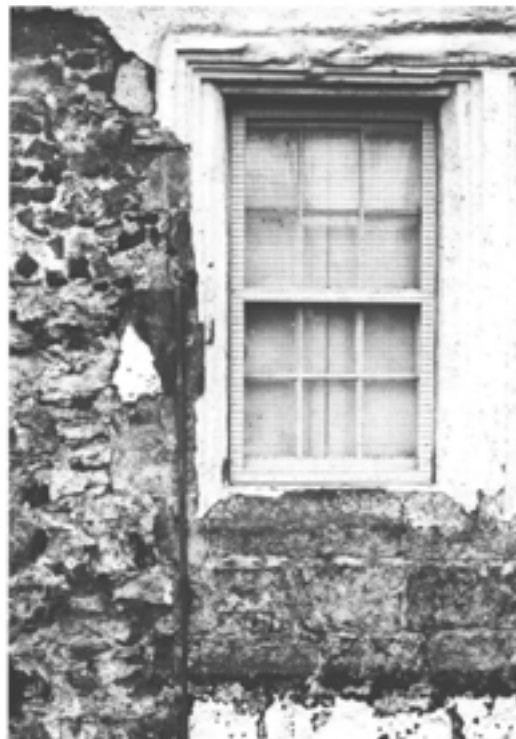
*Figure 5.4 (right)*  
Detail of the scar of the north wall of the south-east range. Note the conflict with the label of the window (DoE unnumbered, c 1981; EH B960399).

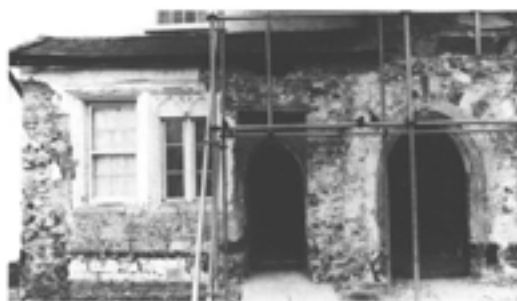
Figure 5.5  
The east elevation of the parlour, showing scars for the porch and the stair door (DoE unnumbered, c 1981; EH B960396).

Immediately to the south of the site of the porch was a narrow arched doorway set in the eastern wall of the parlour (Fig 5.5; see also Fig 5.1, 84) and cutting the interior facework (see Fig 6.2). The frame was of coarse breccia with a chamfer and simple stops set flush with the inside face of the wall; a rebate showed that the door opened outward (to the east). The embrasure was heavily disturbed and most of its superficial fabric belonged to the phase 8 alterations – principally the facing-up in brick of removed wall scars and rebuilding above the lintel after the removal of the gable, again in brick (see Fig 5.1, 83). Despite the disturbances the door appeared to have survived in its intended position and the large blocks of the facework and the frame of the parlour window forming the southern reveal showed signs that they had been dressed off (suggesting that originally they formed an inner quoin). The arrangement of the parlour window, squeezed into the available space between this door and the return wall of the south-east range, showed that this space was so occupied from the first.<sup>15</sup>

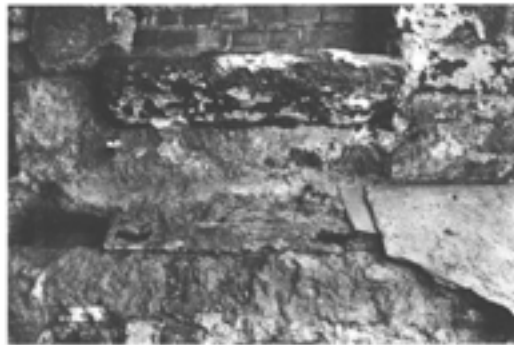
*Figure 5.6*  
Detail of the breccia block reused as a window sill above the porch (*see Fig 5.2*), August 1991 (photograph by Stuart Blaylock; EMAFU 1843/15).

The fabric of the porch was removed, the wall scars were refaced and the sockets for the roof timbers were blocked in. The first-floor stage of the wall was rebuilt with blocks of breccia containing a window (*see Fig 5.1, 94*). This fabric incorporated as the sill of the window a large fragment of a breccia block with a hollow order on its lower edge, returning onto one end (*Fig 5.6*). This fragment can plausibly be interpreted as one of the corbel blocks from the base of the oriel window in the south elevation, cut down and reused here after the destruction of the oriel window (*see pp 81–2*). The other blocks of breccia used here could have been reused from this source. Mortar types suggested that the insertion of the window took place in the same programme of work as the removal of the oriel (phase 8), coinciding with the evidence of extensive alterations to the door to the stair turret at this time. The blocking of the beam sockets contained mortar of the ubiquitous and distinctive composition of phase 8. At a still later point, new cob work was laid above and to the south of the primary cob (*see Fig 5.1, 91*) and this became the base for a slated offset. The area is seen in this form, with the window open, in the mid-19th-century drawings by Townsend (*see Fig 2.4*); the window was blocked by the mid-20th century.<sup>17</sup>

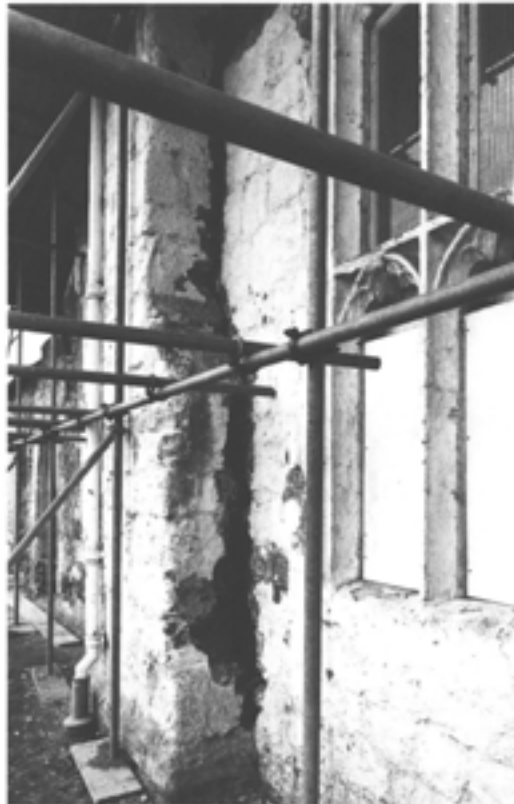
*Figure 5.7*  
Detail of the hall chimney stack, showing the straight joint with the hall fabric, January 1981 (DoE J11/2/81).

3. When the wall had reached a height of *c.* 2.5m, the stack was commenced and the gap to each side filled with mortared rubble.
4. Above this height the construction of wall and stack proceeded in parallel, although the neat, straight join with the wall at the top of the stack (see Fig 5.7) shows that they continued to be built as separate structures.
5. Once the masonry was complete, the roof was raised and the wall-top cob added around the trusses, running up to the masonry of the stack.<sup>34</sup>

The same variation in material and breaks in masonry were visible in the wall to either side of the stack, approximately to the level of the transoms of the windows (2.4–2.9m above present ground level; *see Fig 5.1*). The masonry of the upper half of the stack seemed to bond with that of the adjacent wall, when examined after the works were complete in 1987. Photographs taken during the works in 1981, however, appear to suggest that the structural break continued, albeit in a tidier fashion, with the masonry of the stack butting against that of the wall (*Fig 5.7*). None of the courses matched from stack to adjacent wall. The impression is very much that the chimney stack (and, therefore, the fireplace within) were additions to the east range.<sup>19</sup>

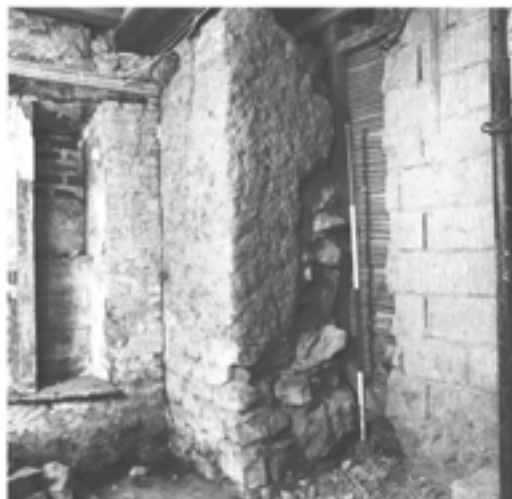
Figure 5.9  
Southern end of the surviving west gable wall of the south range, showing original stone footings and cob wall and stone refacing of exterior face (right), looking south-west (photograph by David Garner; EH B940374).

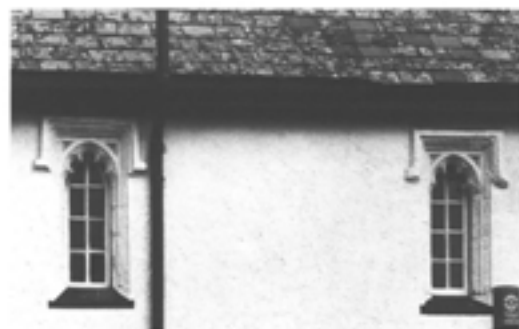
Figure 5.11  
Two lancet windows  
photographed in 1969  
(RCHME BB69/5014).

The south elevation preserved something of the original appearance of the building, especially through the survival of several primary, cinquefoil-headed lancet windows. Three windows on the first floor were complete, although weathered (Fig 5.11); the ground floor retained one near-complete
