# Bowhill

The archaeological study of a building under  
repair in Exeter, Devon, 1977–95

*The archaeological study of a building under  
repair in Exeter, Devon, 1977–95*

Published in association with Exeter Archaeology as Volume 5 in the  
Exeter Archaeology Reports series

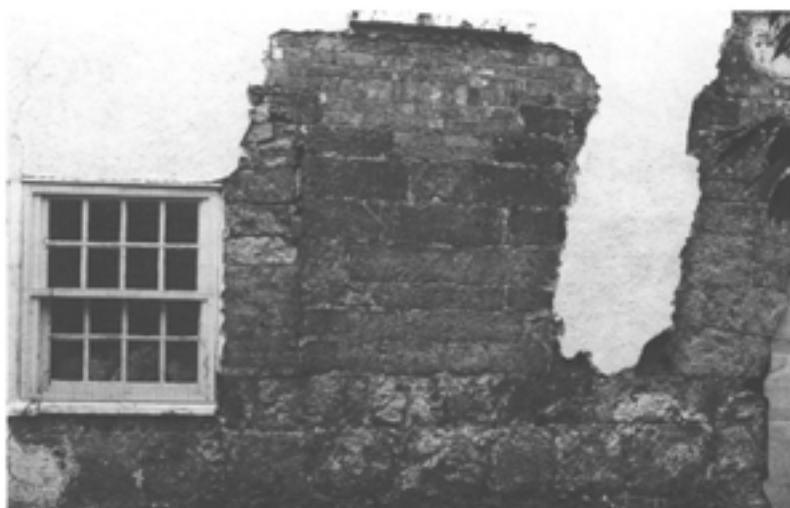
Figure 5.13 (above, right) Volcanic stone footings (see Fig 5.8, 3) and breccia base for oriel window (49) when first stripped c 1981 (DoE unnumbered print).

The evidence here deserves individual description. An area of breccia ashlar in pristine condition formed an outer skin to the cob wall (Fig 5.13; see also Fig 5.8, 49), bearing on the volcanic stone footings (see Fig 5.8, 3) 1.5m wide and six courses (1.2m) high. A small circular depression on the central axis of the uppermost course

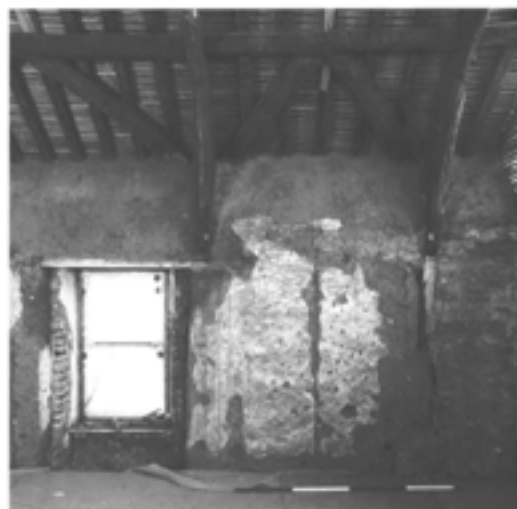
Figure 5.14  
South elevation of the oriel chamber, showing position of the oriel (see detail in Fig 6.69), the foot of truss X bearing on the window lintel and the foot of truss XI bearing on cob. The brick facing of phase 8 post-dates the removal of cob west gable (extreme right) (photograph by David Garner; EH B931152).

lintel (Fig 5.14; one of the few not carried onto stone), showing that the assembly could not have been secondary. Within the reveals the splays were cut away on both sides less than halfway through the wall. Above only the inner lintel survived (? of three). On the outside face, post-demolition brick fabric filled voids left by the removal of the oriel (see Fig 6.68). Inspection of the voids in the east reveal (when stripped in 1992) showed a series of cavities of varying depth within the cob, possibly formed by the moulding of cob around the tails of stone blocks. This provided some evidence that the structure of the oriel was of stone (as opposed to, say, timber).

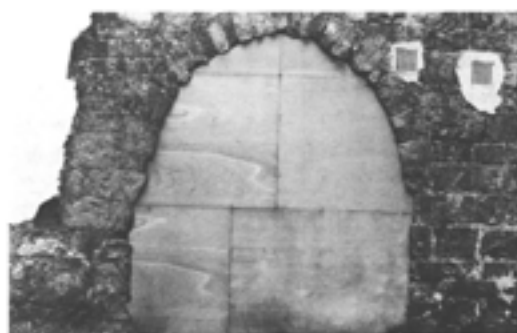
Figure 5.15  
The relieving arch for the through passage c 1981 (DoE unnumbered print).

The surviving arch was c 2.5m wide and represented the outer limit of a stone frame (Fig 5.15; impressions of the blocks were noted in the core).<sup>33</sup> The inner opening was narrower at 1.9m and spanned by a timber lintel rather than an arch (see Fig 6.22, 343). The grand arch was substantially larger than other arched doorways in the building at approximately 1.62m wide and 2.46m high. It was blocked and replaced by a small single doorway in the alterations of c 1800.<sup>34</sup>

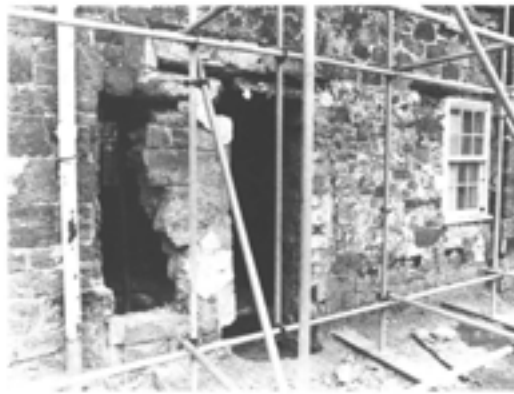
*Figure 5.16*  
The south range, exterior, detail of the south wall of the parlour/service rooms in August 1985, before commencement of rebuilding: pair of windows of phase 7 and blocking of phase 8, doorway of phase 9 (EH F850039/3).

*Figure 6.40*  
The south wall of the service rooms after stripping, but before any masonry repairs in 1985 (*see* exterior view of the same, Fig 5.16), with window of phase 7 (for enlarged parlour), blocked in phase 8 and doorway of phase 9 (EH F850039/5).

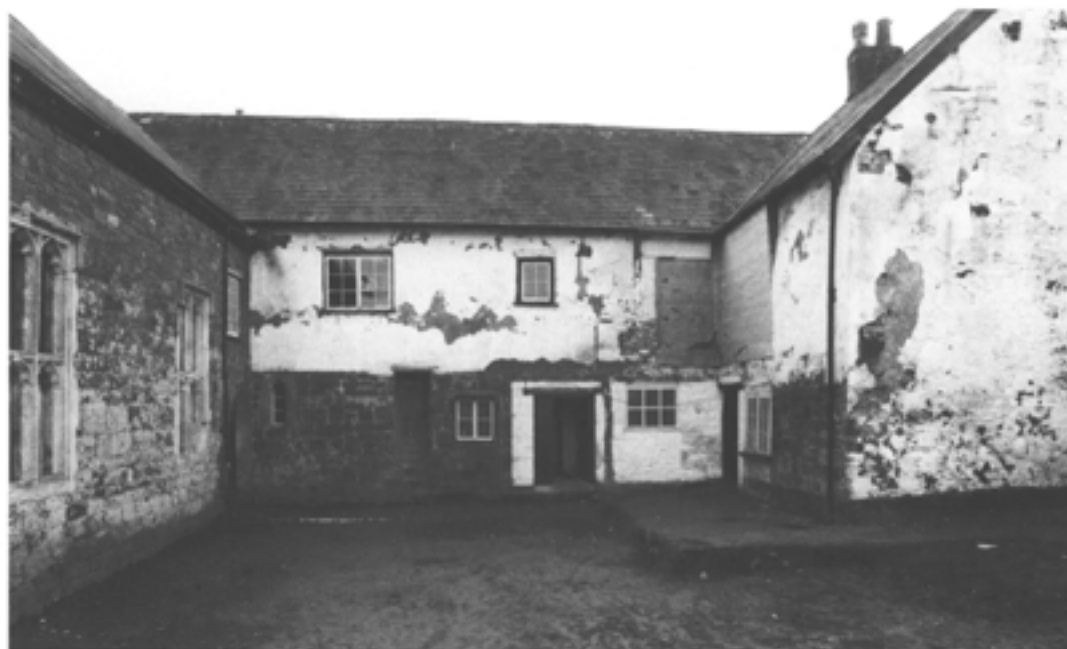
Figure 5.18  
The north elevation in 1978, after the backfilling of excavations (DoE J10/3/78).

The elevation was constructed of stone to first-floor level and of cob above (Figs 5.17 and 5.18). The main timbers of the pentice roof were lodged on the top of the stone (as were the floor beams and roof trusses inside). Primary lime-mortar rendering on cob was recorded at the top of this elevation, where it had been protected by the eaves of the roof, the only instance where this was observed at Bowhill (described in Chapter 10). Here the material was a white lime mortar, very similar in appearance to the mortar seen throughout the masonry of the primary phase.

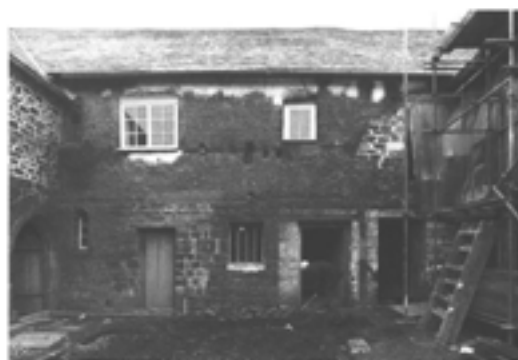
Figure 5.19  
The north elevation of the south range in February 1994, showing the wall stripped and partially repaired. Note the sockets for the roof of the pentice (cf elevation Fig 5.17, 346–7; this was the only occasion that the elevation was free of scaffolding, when any of these features were visible) (photograph by David Garner; EH B940403).

Extensive evidence for a covered walkway connecting the kitchen with the hall/screens passage was recorded in the north elevation (Fig 5.19; see also Fig 5.17). Three components of the roof had survived: beam sockets at 'wall plate' or 'tie beam' level (regarding the roof structure here in conventional terms); a range of rafter sockets further up the wall; and a horizontal chase or weathering, perhaps for bedding of flashing for the roof.

which this structure was built was clear, despite interruptions from later scars for the enlargement of the first-floor windows (344, 348 and so on). In detail the pattern failed to align precisely, especially in the matching of 'principal rafters' with the beams below. The central beam socket (351) aligned directly with the rafter above, but those to east and west, above 350 and 352, were set slightly 'inward' of their correct position.<sup>40</sup>

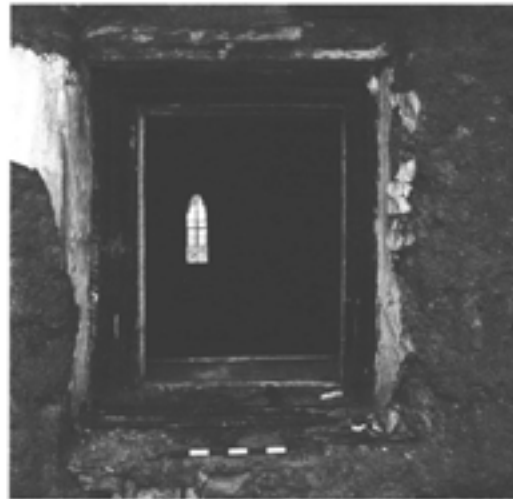
Figure 5.20  
Detail of window 137  
showing the inserted  
moulded frame and the  
original lintel (photograph  
by David Garner; EH  
B934812).

This window was unique to the building, and in its surviving form was probably a later assembly or reuse (Fig 5.20; *see also* Fig 6.53). Mortices and peg holes survived in the head and sill for two closely set mullions suggesting a three-light window, with lights between 150 and 180mm wide. There was no evidence of glazing in the mouldings, such as a rebate or sockets for glazing bars. The haphazard nature of the assembly was emphasised by the mouldings on the interior of the west jamb, where the head and east jamb had none. The reveals were certainly secondary, roughly cut

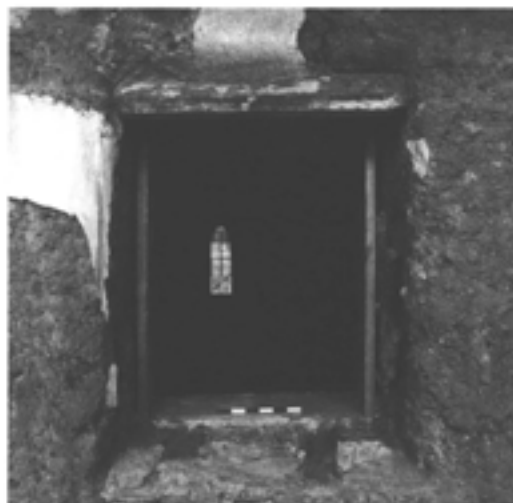
Figure 5.21  
As Figure 5.20, with the  
frame removed, August  
1993 (photograph by  
David Garner; EH  
B934815).

into the cob and did not retain primary plaster. The sill was replaced (with a scratch moulding and so presumably of 17th-century date), but the lintel, although cut back to its limits, was undisturbed. The sill was set in position with speckled mortar of the phase 8 type (Fig 5.21). It is proposed that the window had an origin in phase 5 and was placed in this embrasure after the removal of the pentice and associated features in phase 8. Similar windows are to be found, in undisturbed form, in alterations of the same period to the former guest hall of St Katherine's Priory, Polsloe, now in the eastern suburbs of Exeter.<sup>48</sup> Other examples in Exeter houses of the 16th and 17th centuries are listed by Portman.<sup>49</sup>

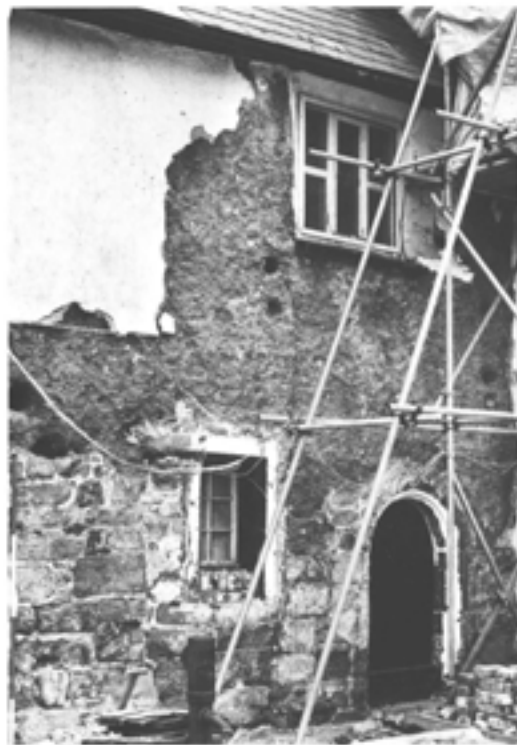
Figure 5.23  
The west elevation stripped  
in August 1988 (photo-  
graph by Keith Westcott;  
EMAFU 1497/13).

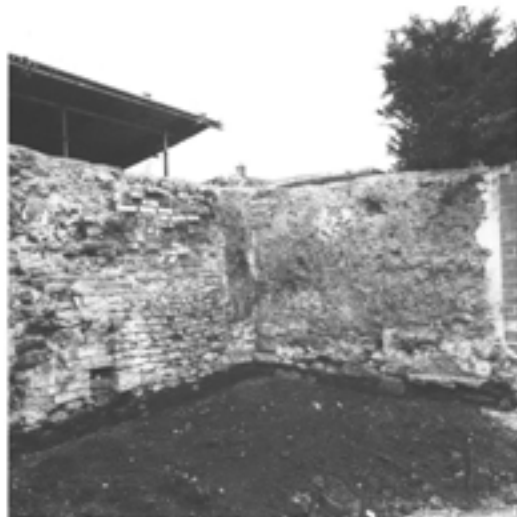
Figure 5.24  
The north-west corner of  
the courtyard in November  
1994, originally the interior  
elevation of the west/north  
ranges. Note the primary  
cob and stone footings  
(photograph by David  
Garner; EH B945706).

The nature of the demolished part of the west range was shown by the lower stage of its west and north walls, which survived as the boundary wall of the central courtyard. Although heavily obscured by repair and later alteration, the core of this wall was of original cob (Fig 5.24; cf Fig 6.45, 1794) on low stone footings (Fig 6.45, 1778, 1786 and 1796), in which breccia was freely mixed with volcanic stone. This supports the observation that the west range was built in conventional cob-building fashion (see above). Details of the west (outside) elevation of the courtyard wall were not seen, because no

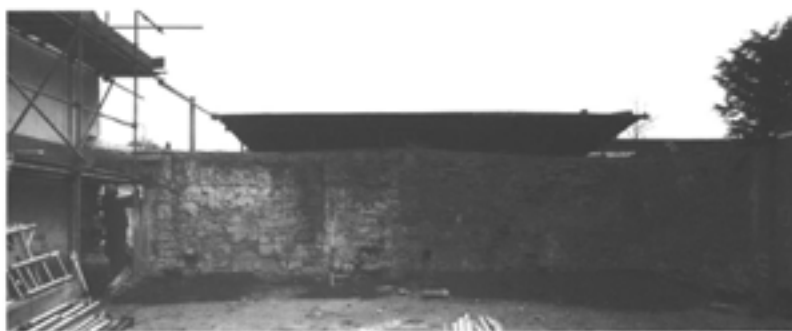
Figure 5.25  
The interior elevation of the west boundary wall of the courtyard in November 1994. This was originally the interior elevation of the west range (photograph by David Garner; EH B945704).

The standing fabric of the west wall (Fig 5.25; see also Fig 6.45) contained many later builds post-dating the demolition of the west range in phase 8, including refacing the cob in a mixture of stone and brick and adding a doorway midway along the wall (subsequently blocked). The fabric to the north of the doorway (see Fig 6.45, 1782 and 1792) contained numerous fragments of the Normandy tiles familiar in contexts associated with phase 8 elsewhere (Chapter 9).

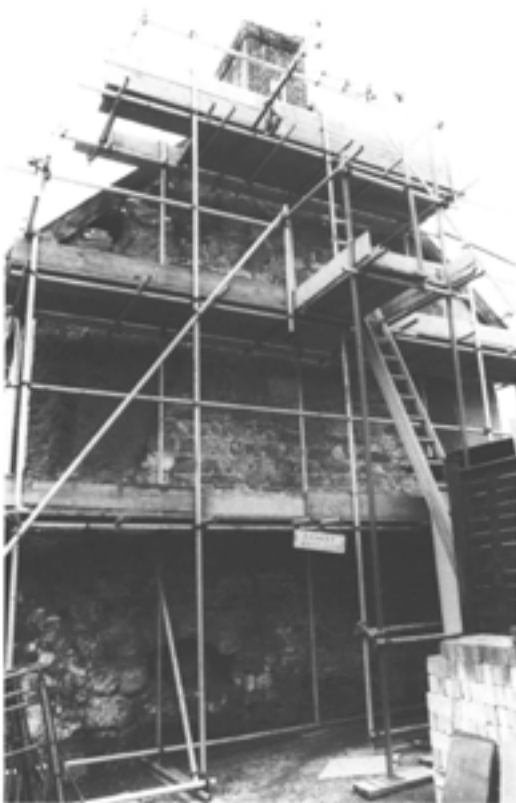
Figure 5.26  
The north elevation of the west range stripped and undergoing repairs in 1981 (DoE unnumbered print; EH B960397).

This elevation was repaired and rendered in 1981 and was not subsequently accessible for examination. The description is based on photographs (especially Fig 5.26), an outline elevation drawing and some post-repair re-survey to establish an accurate outline (done 'through' the modern rendering, Fig 5.27). The elevation was dominated by the masonry flue of the huge

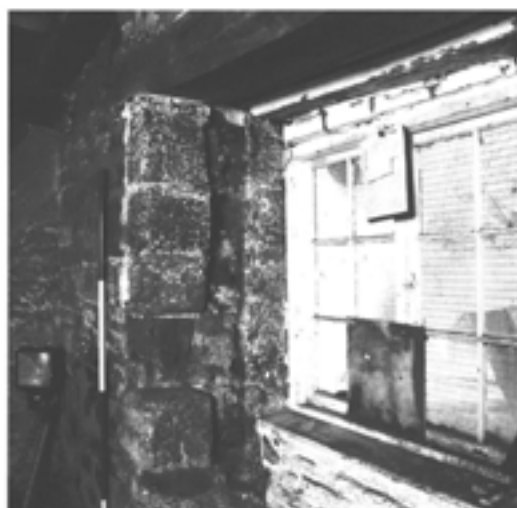
Figure 5.29  
Detail of window reveal  
360, looking north-east and  
showing the slot for the  
window frame (photo-  
graph by David Garner;  
EH B942026).

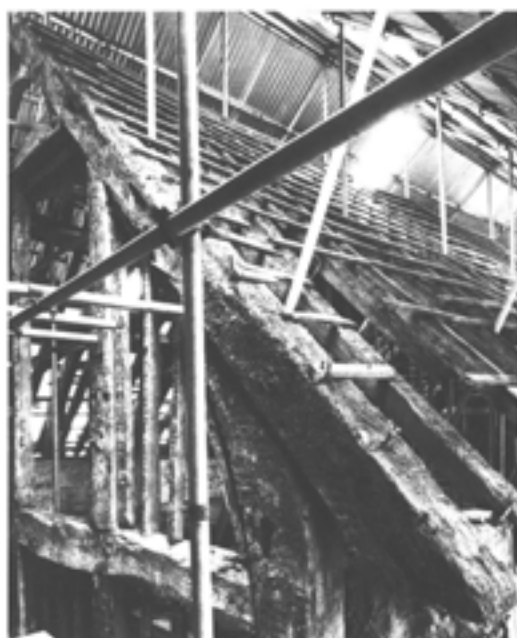
Figure 6.3

Partition at the north end of the hall in 1980, with the west post of truss II in the foreground. Note the blind rear face to the timbers, the mortices for purlins and plates of bay I and the studs of infill exposed (DoE J114/1/80).

ornamented carpentry of the reception rooms to the south of the hall and suggests that, notwithstanding its location in the traditional position of a solar or chamber, the room was not intended to provide important accommodation. An additional mortice in the north face of the western post of truss II (see Fig 6.3, bottom edge) may represent the head of a doorway in the western wall of the room at the head of the external stair.

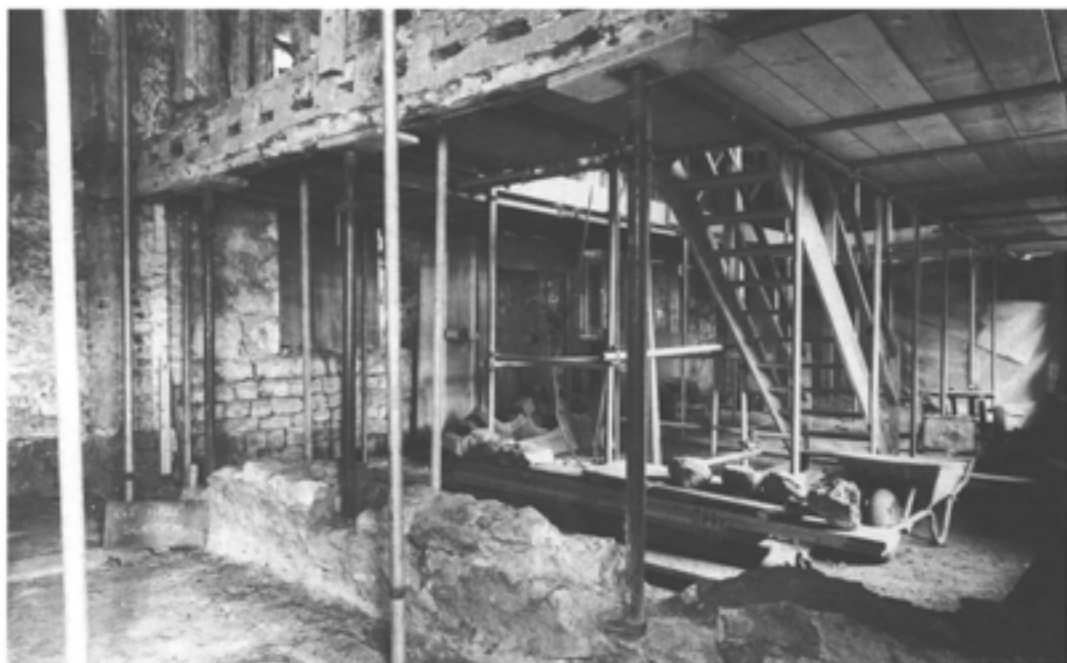
Figure 6.4

The east range, interior of the storeroom, with screen at north end of hall, north side, looking south-east. Note mortices for the floor joists, November 1983 (DoE J538/7/83).

The headbeam of the ground-floor screen provided evidence for the missing elements:<sup>3</sup> a run of mortices for the floor frame in its north face; a chamfer on the lower edge; and mortices on the soffit for the studs and plank filling of the partition (Fig 6.4). The south face of the beam bears interrupted chamfers on its lower edge, identifying the positions and form of the posts of the partition and showing that there was a doorway at the western end.

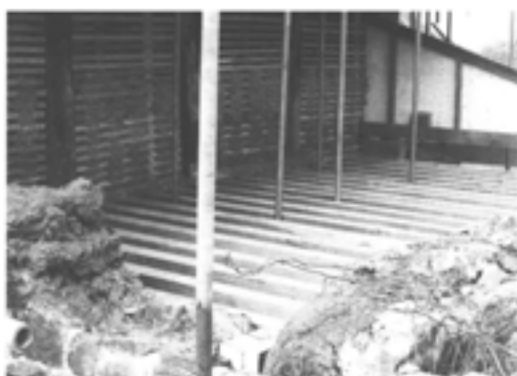
Figure 6.5 (left)

As Fig 6.4 at first-floor level with the joists restored, 1985 (EH C850070).

The east and north walls of bay 1 were stone to first-floor level and of cob above; a remnant of the cob survived (Fig 6.5). Footings of the north wall were seen in a trench dug in 1982 (see Fig 4.1), but no trace of the original floor of this room was seen. The west wall survived only as fragments in excavation (see Fig 4.7, 2273). The stone section of the walls contained evidence for two timber-framed windows. The frame of a window with very close-spaced, diagonally set square mullions was recovered from a blocked embrasure in the north wall; the window was set in the centre of the wall, with blocking in the outside half of the wall's thickness.<sup>4</sup> The character of the masonry and the position of the window is illustrated in Fig 6.6. The window has been replaced with a replica. The original is illustrated and described as a find (see Figs 9.23 and 9.24). In the east wall a larger embrasure, also set in the centre of the wall and with internally splayed reveals, had been disrupted by later alterations, but the southern reveal (see Fig 5.3) and part of the sill and north reveal had survived. This may have contained a similar window frame.<sup>5</sup>

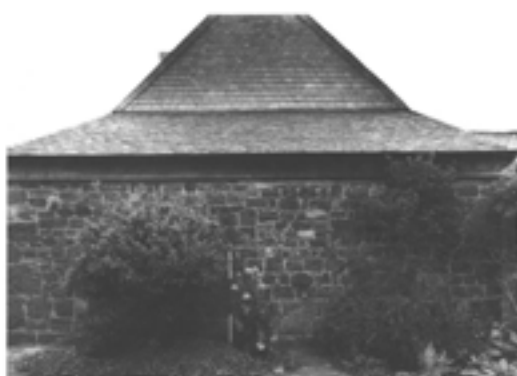
Figure 6.6 (right)

The north elevation of the east range in 1997 (after repair). Note the blocked window (no. 409), large quoins and uniform masonry style (photograph by David Garner; EH B970547).

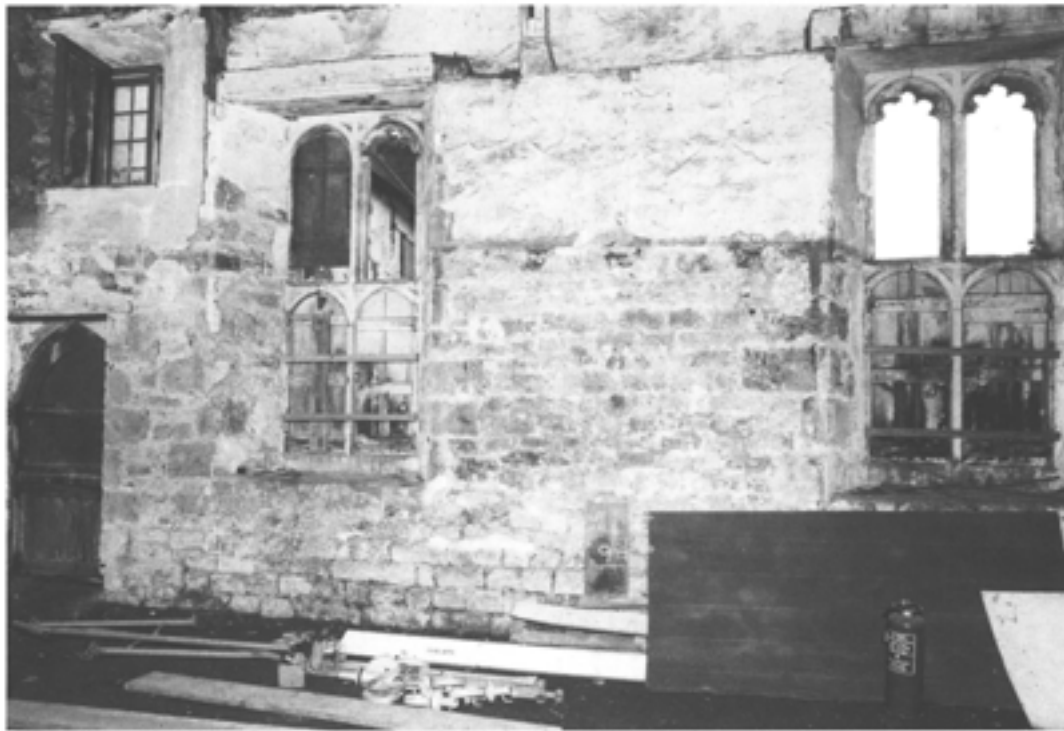
Figure 6.7  
Interior elevation of the west wall of the hall in 1978 (DoE J10/9/78).

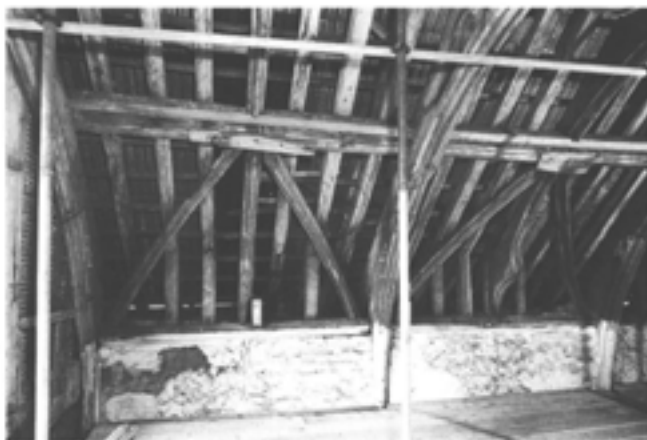
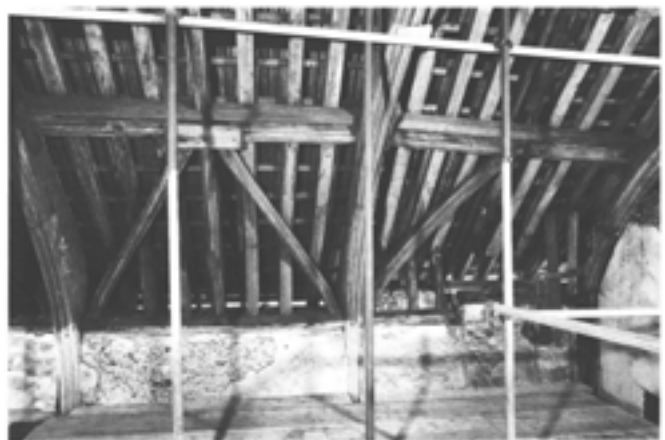
Figure 6.8 (below)  
Composite interior elevation of the east wall top of the hall prior to the removal of the roof for repair. These are important record photographs, since there is no other record of the cob (and stone patching) of the wall top, apparently butting the roof trusses (a northern half, trusses II–IV and b southern half, trusses IV–VI) (DoE J263/18/78 and J263/17/78).

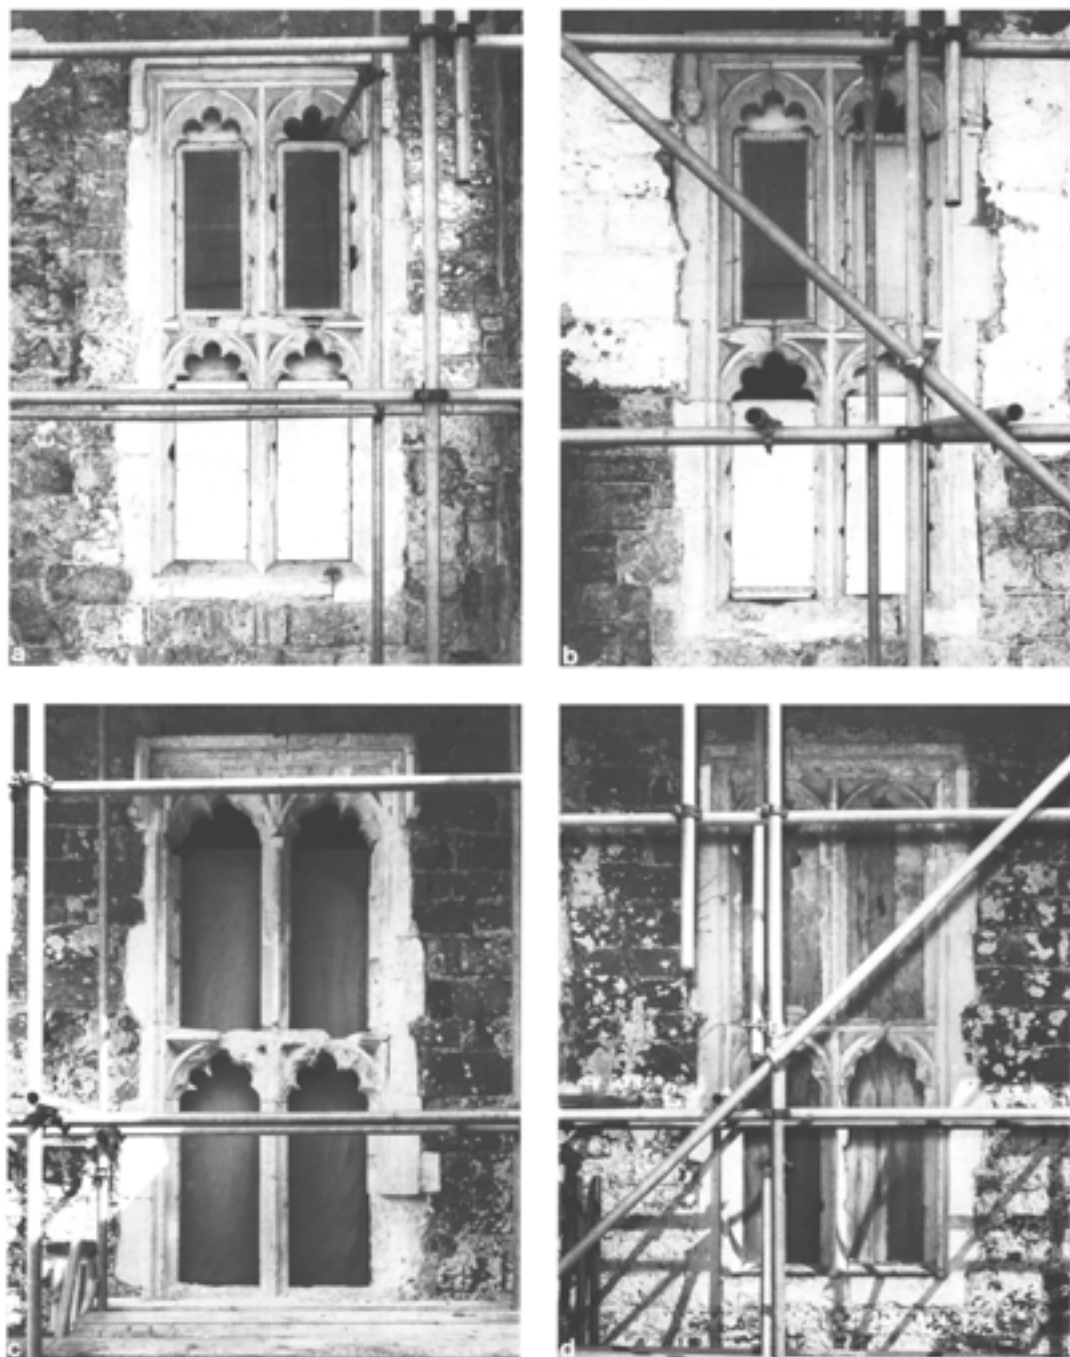
Figure 6.10  
Label stops of the east  
windows of the hall:  
a south window, south  
(EH B960557);  
b south window, north  
(EH B960556);  
c north window, south  
(EH B960555);  
d north window, north  
(EH B960554) (photo-  
graphs by David Garner).

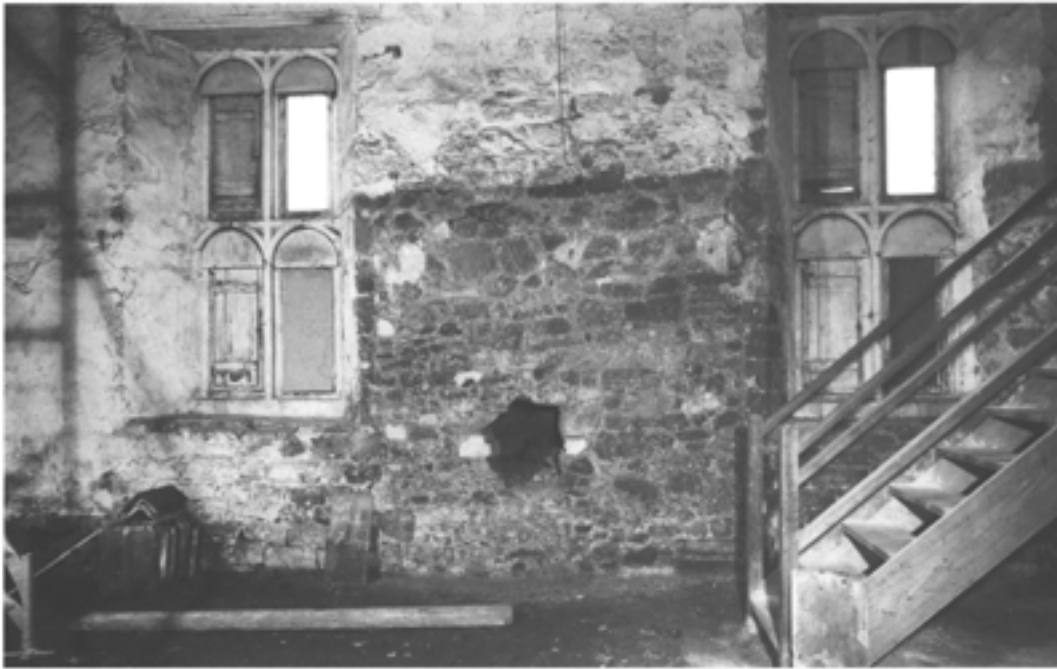
*Figure 6.11*  
*East wall of the hall,*  
*interior elevation in 1978*  
*before the removal of the*  
*masonry blocking the fire-*  
*place. Note the moulded*  
*block (catalogue no. 112)*  
*in infill (white stone to the*  
*left of the hole in blocking)*  
*(DoE J10/7/78).*

The fireplace, positioned between the windows on the east wall slightly to the south of centre, had been removed and blocked (see Fig 6.11). The fireplace and its stack are interpreted as an insertion contemporary with the construction of the building (Chapters 4 and 5). Evidence in the fabric is less clear inside than outside, although straight joints may be discernible on a photograph of the feature once stripped of its blocking (Fig 6.12). Again the material is

This description suggests that the final blocking took place in the phase of alterations of *c* 1800, in which a distinctive red white-speckled bonding material appears frequently (Chapter 10, class 7). A moulded Beer-stone block reused in the blocking (*see* Fig 6.11, and catalogue no. 112, Chapter 9) is consistent with this interpretation. Many such fragments derived from the demolition of this phase found their way into new masonry of the period (Chapters 4 and 12). Traces of the second phase were revealed in the excavation of the hall (Area 2, Chapter 4).

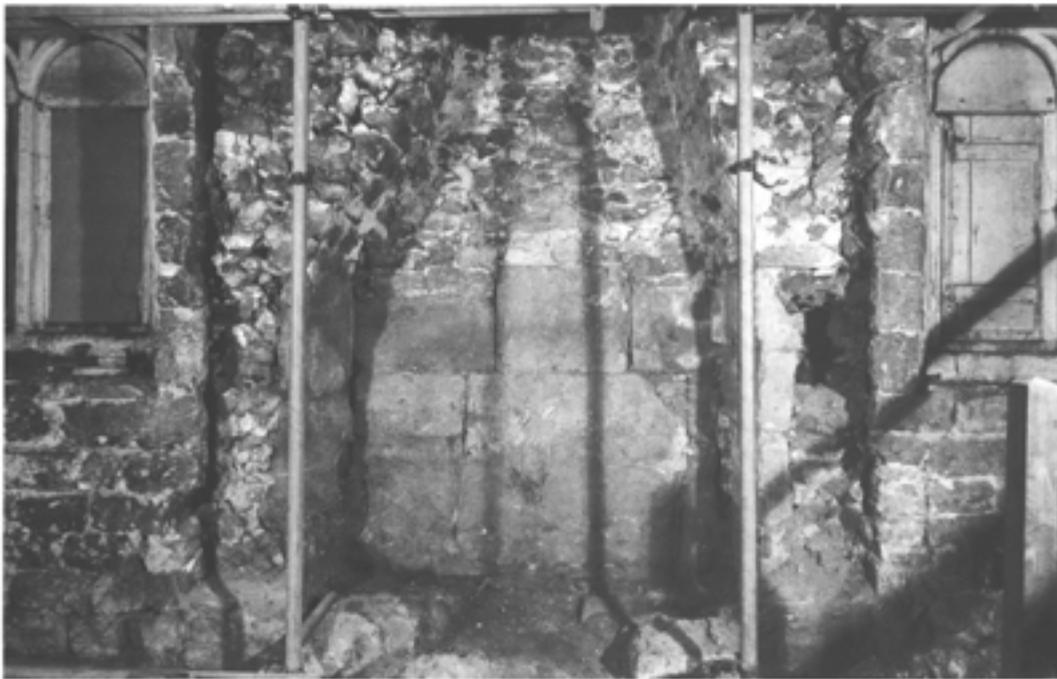
*Figure 6.12*  
*Detail of the fireplace in*  
*1981 after the removal of*  
*the blocking (DoE*  
*J11/5/81).*

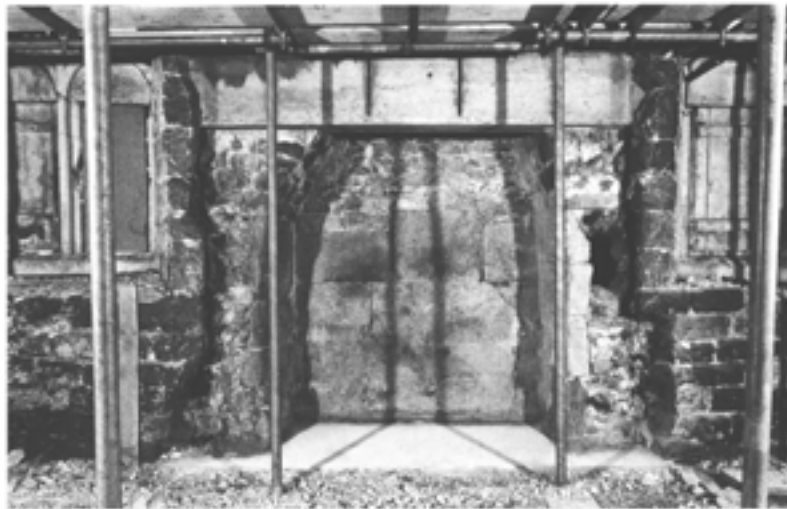
Figure 6.13  
The fireplace in 1982 after  
the construction of the new  
concrete lintel and hearth  
(DoE J8/2/82).

of 1982–9 (Figs 6.13 and 6.14; *see also* Fig 6.2). The sequence of blocking of the fireplace was observed by Dunmore:

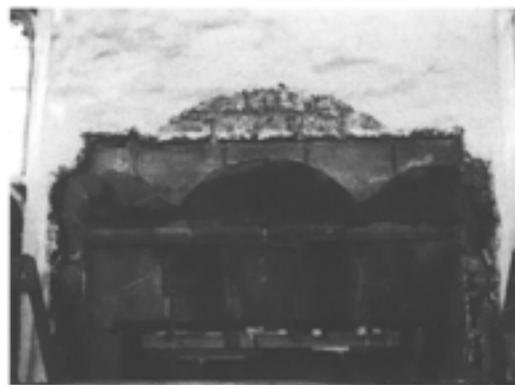
Figure 6.14  
The fireplace lintel and  
relieving arch during recon-  
struction in 1989. The  
central voussoir and the  
second block of the cornice  
from the left are originals  
(photograph by Stuart  
Blaylock; EMAFU  
1571/6).

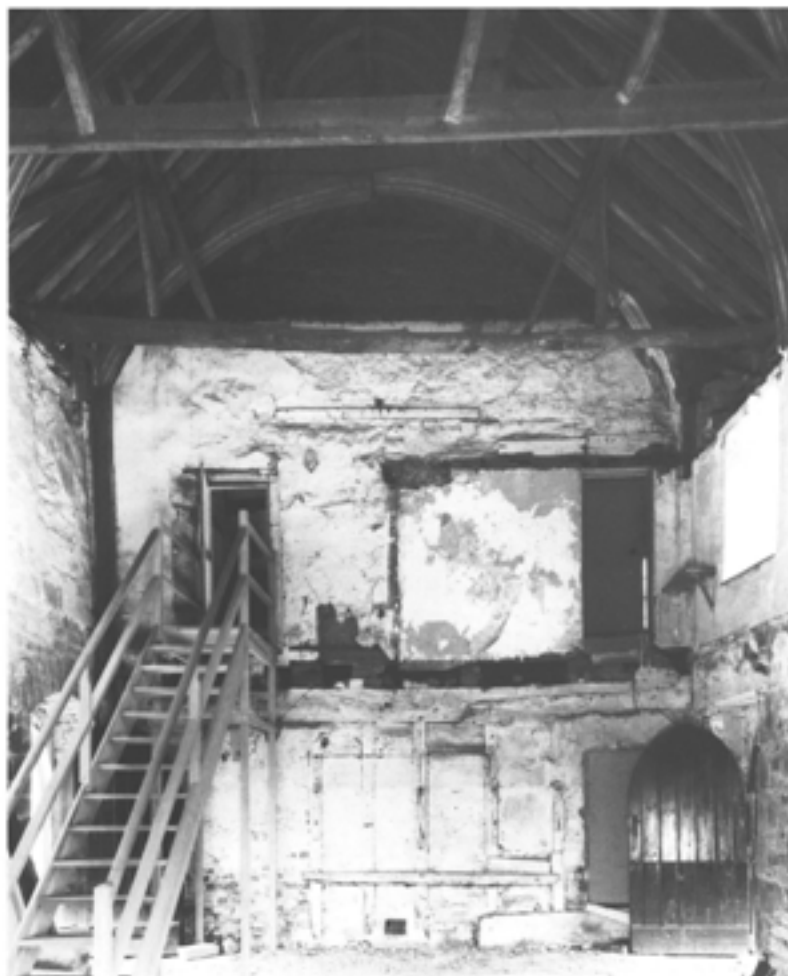
Figure 6.17 (below)  
The south partition of the hall in 1969 (RCHME BB69/5024).

softwood door-frame. The flooring of the hall has been assigned to the 19th century (phase 9) and could have been still later.<sup>14</sup> The floor was partly supported on beams lodged in sockets in the walls (a number of which were located in the west wall of the hall, see Fig 6.15), but additional support was given by props against the walls.<sup>15</sup> The floor was removed and burnt in 1967–8.<sup>16</sup> The extensive RCHME photographic survey of July 1969 shows that the floor lay at the height of the transoms of the windows and that the walls were plastered and lime-washed above this level (Figs 6.16 and 6.17; see also Figs 2.22, 6.7 and 6.11).

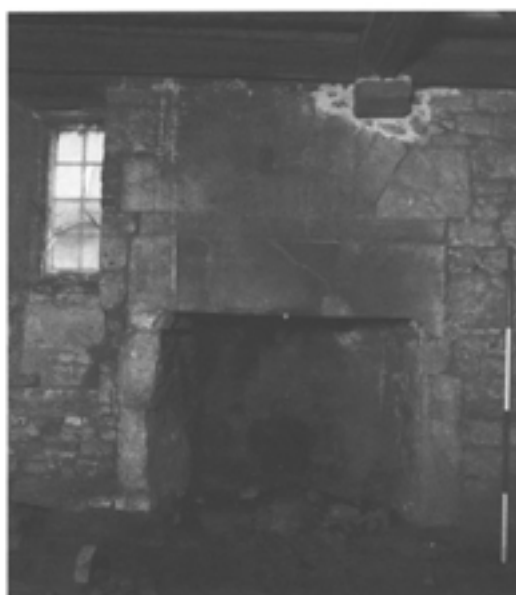
Figure 6.23  
Detail of the parlour fireplace (photograph by David Garner; EH B933127).

The fireplace in the south wall (Fig 6.23; *see also* Fig 6.22, 37) was of vesicular volcanic stone, built to the same general pattern as those in the great chamber and the hall and with the same diagonal tooling marks. The moulded mantelshelf was dressed off (possibly when the walls were panelled) and quite severe damage done to the jambs and lintel by the blocking of the fireplace and the insertion of a smaller hearth within it in the 19th century. A patch of 19th-century mortar and breccia blocking had survived from this. The massive lintel (of three blocks with joggled joints) was unmoulded and the jambs have a very badly damaged ogee moulding (as opposed to the continuous ogee moulding on jambs and lintel of the great chamber fireplace).

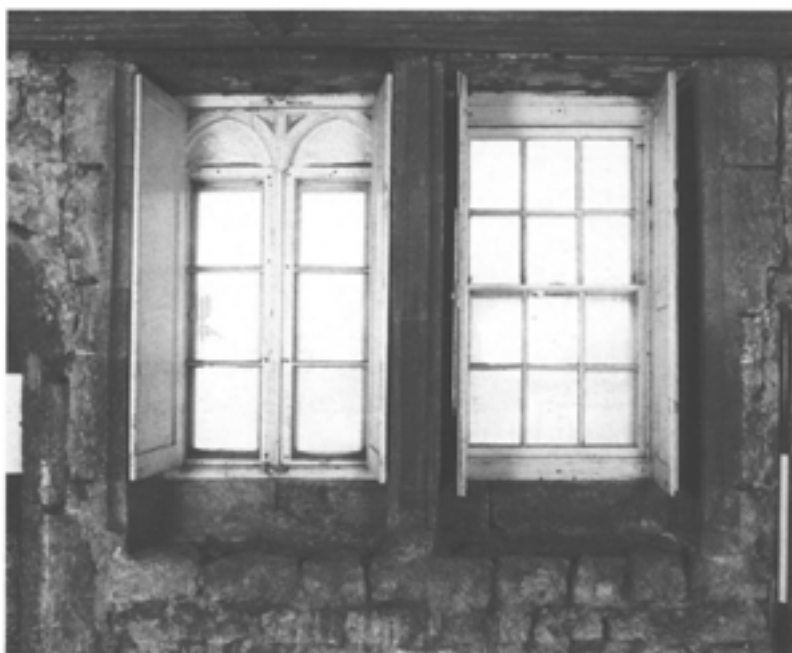
Figure 6.24  
Detail of the east windows of the parlour from within (photograph by David Garner; EH B933099).

Primary windows survived east of the fireplace (*see* Fig 6.22, 73), in the east elevation (Fig 6.24; *see also* Fig 6.2, 80 and 81) and in the north-west corner of the room (Fig 6.25, 261). Aside from modifications to the glazing and the universal removal of iron saddle bars, the principal alterations were to sills. The east window had a gently splayed sill, presumably of stone because the scars from its removal were still visible in the adjoining faces (*see* Fig 6.53). The king mullion spanned the full depth of the wall, its sides rebated for shutters (like the reveals). Foiled heads survived in the northern half of the window, although the dividing mullion was missing. To the south similar details were replaced by a sash in the later 19th century (the window was shown

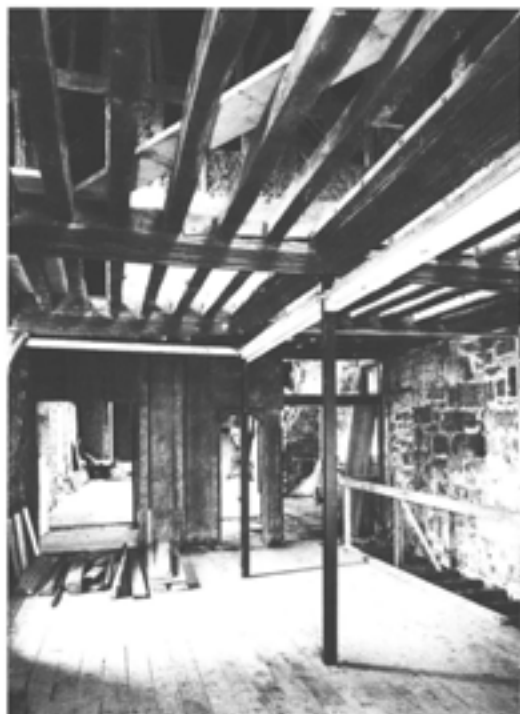
*Figure 6.26 (left)*  
*The interior of the parlour*  
*after further stripping in*  
*November 1979, southern*  
*half looking west. The*  
*photograph shows the*  
*subdivision of the ceiling*  
*removed and the surviving*  
*extent of the west partition*  
*(DoE J492/3/79).*

The screen dividing the parlour and the screens passage has been described above. The west wall of the parlour was formed by a post and panel screen whose surviving extent is well illustrated in photographs of 1979, albeit in its secondary position beneath beam 5 (Figs 6.26 and 6.27; see also Fig 2.24). The northern part of the screen had been completely removed. The central section was complete (comprising the southern of the two doorways, the mortice for the head of the northern door and two adjacent studs and panels of plank infill). Another large intrusion had cut away much of the remainder of the screen to the south, although the southernmost stud and some 0.6m of the intervening area at the top of the screen had survived (see Fig 6.15).

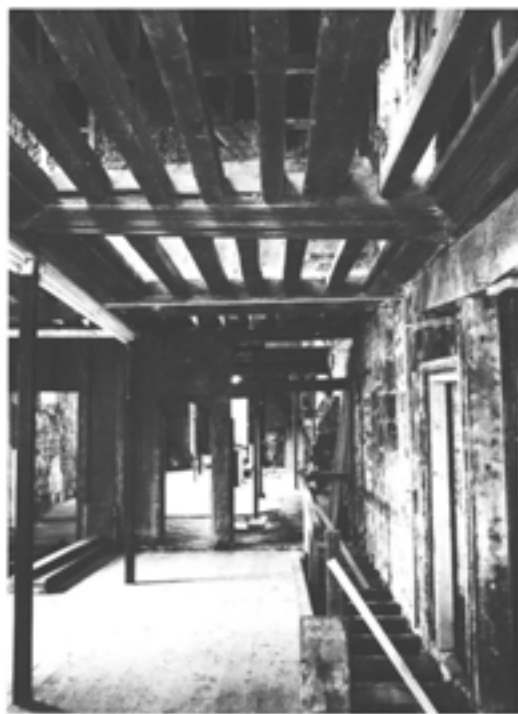
*Figure 6.27 (right)*  
*As Fig 6.26, northern half*  
*looking west, also showing*  
*mortices for timber pegs in*  
*the side of the post of the*  
*screen to the hall (extreme*  
*right) (DoE J492/4/79).*

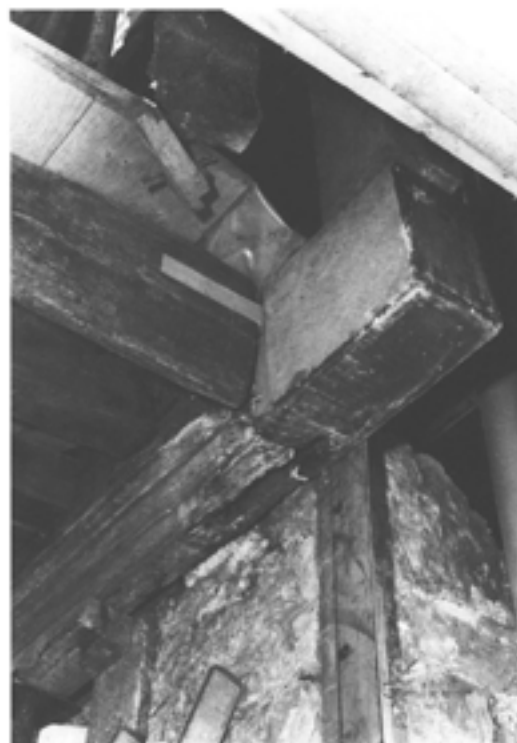
*Figure 6.30 (left)*  
Detail of the south-eastern corner of the parlour ceiling from below during repair (with resin repair to the terminal of beam 1). Also showing is the mortise for supporting the post in line with the quoin of the wall (photograph by David Garner; EH B905040).

The southern terminal of beam 1, at the junction of the south and south-east ranges, was originally not supported by masonry. A mortice was cut in the soffit of the beam, 530mm from its terminal, for a post that presumably served as a prop (Fig 6.30) and corresponded to a posthole directly beneath the mortice (see Fig 6.2, 606). The lack of support at this point is surprising, since this beam carries the full weight of the south-east corner of the roof of the south range (through the load on the post of truss 1 of the roof of the south range, see Figs 6.2 and 6.22). The southern terminal of beam 3 was lodged in masonry over the fireplace. Whether through lack of support, through decay or damage to the timber by heat from the chamber fireplace above, a corbel of breccia was cut into the masonry above and to the right of the relieving arch of the ground-floor fireplaces to provide extra support for the beam (see Fig 6.22, 22, Fig 6.20 and Fig 6.23).<sup>26</sup>

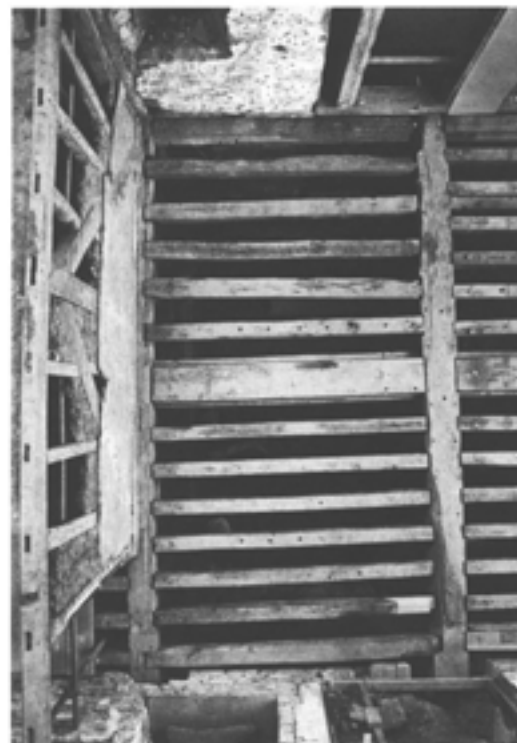
*Figure 6.31 (right)*  
Vertical view from above of the frame of the parlour ceiling, bay 3 (north at the top). Note the peg holes in the upper surface of the joists, purpose unknown, and mortises on the head-beam of the western partition (extreme left) (photograph by Keith Westcott; EMAFU 1380/5).

On the enlargement of the parlour into bay 4, the ceiling was furnished with additional timbers to imitate those of bays 1–3.<sup>31</sup> These comprised narrow timbers, with compressed versions of the original mouldings applied to the west face of beam 4 and the east face of beam 5 and broader timbers against the north and south walls of the bay. In the centre of the bay, a new axial joist with a direct copy of the original mouldings, rather than the compressed version of the other timbers, was inserted. Its upper surface was hollowed out to fit around an existing joist (*see* Fig 6.29, axial beam, bay 4). A softwood imitation of the earlier (oak) ceiling was erected throughout bays 2–4, probably at the same time as the extension of the parlour into bay 4. Dunmore recorded some oak planks among the softwood filling of bays 2–4.<sup>32</sup> This suggests that the softwood timbers were direct replacements of the earlier hardwood ceiling boards. The south flanking joist in bay 3 was also replaced with a timber with similar steep mouldings to those of bay 4 (*see* Fig 6.29, moulded joist, bay 3, south). This is identified by its thinner scantling, steep moulding profile, the absence of a groove for primary plank infill and the fact that it is placed in an *open* mortice in beam 4 to the west (Fig 6.34; *see also* Fig 6.31).

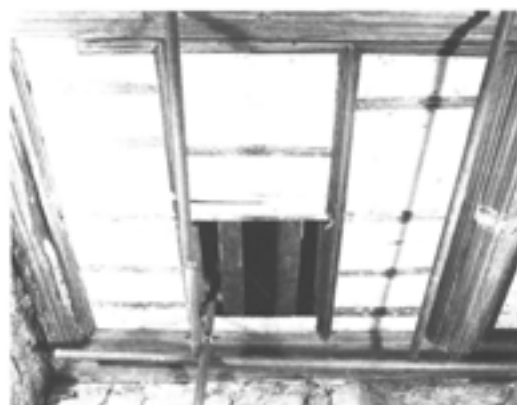
*Figure 6.32*  
The northern half of bay 1 of the parlour ceiling during dismantling, showing surviving ceiling boards and sub-ribs, looking east (EH F850039/11).

Applied timbers survived on the axial joists in all three bays, on the south sides of the northern peripheral joists and on a number of other joists, especially in bay 1 (see Fig 6.28, plan). A photograph shows the northern half of bay 1 during the removal of the boards in August 1985 (Fig 6.32). From this it can be seen that the applied timbers were used for fixing the planks of the infilling (three short planks north-south in each half bay - thus four applied timbers were needed). The planks (each spanning two joists) were then nailed to the soffits of the applied timbers and the east-west subsidiary mouldings fixed over the joins in the planks. Lastly short lengths of transverse subsidiary moulding were applied on the north-south lines. The edges of the planks were fitted together in simple V-shaped

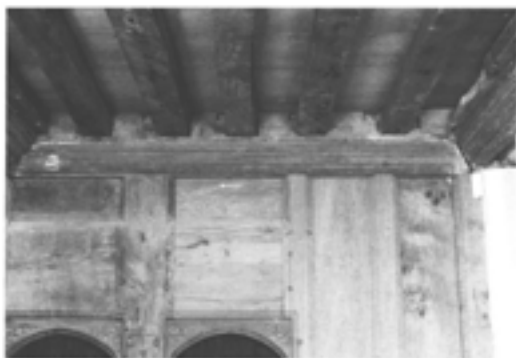
Figure 6.33  
Detail of the northern half of beam 4, showing filled and redundant mortices (photograph by David Garner; EH B990722).

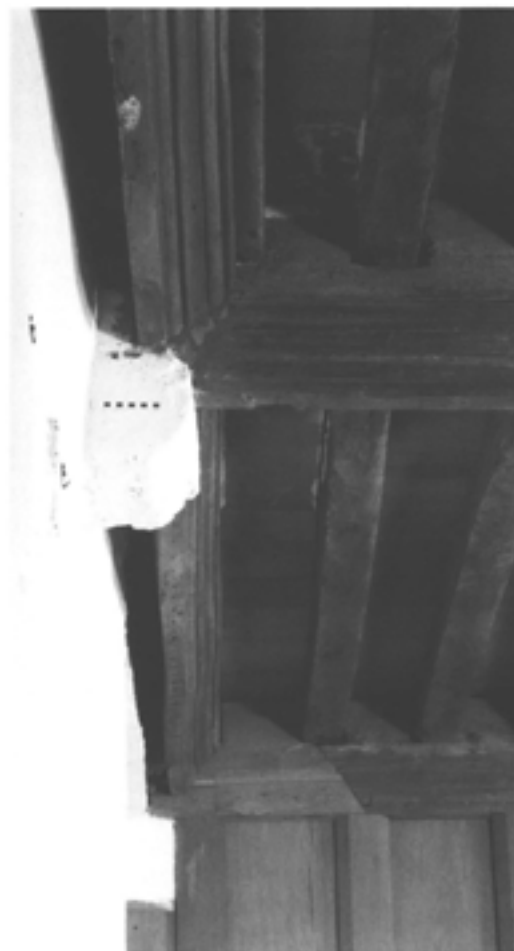
Figure 6.34  
Detail of the south flanking  
joist of bay 3, showing steep  
mouldings (compare with  
the joist of bay 2 in the fore-  
ground) (photograph by  
David Garner; EH  
B990721).

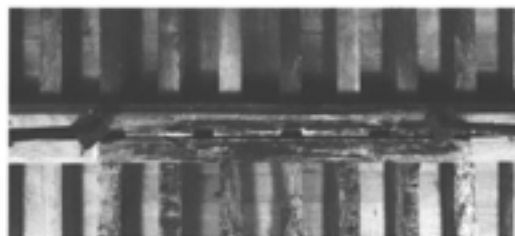
Figure 6.35  
Beam 6 seen from below, west at the top (restored to north and south), showing mortises for the posts of the partition and the slot for plank infill (photograph by David Garner; EH B933112).

The area between the parlour and the cross wall originally formed two rooms divided by a timber partition beneath beam 6 (Fig 6.35; see also Fig 5.30); both were probably further subdivided. When the parlour was enlarged into bay 4 in phase 7 (see above), the second partition was also removed, and the remaining space (bays 5 and 6) became a single room. Later alterations entailed further subdivision, especially in relation to new stairs from ground to first floor (Fig 6.36; see also Fig 12.2).

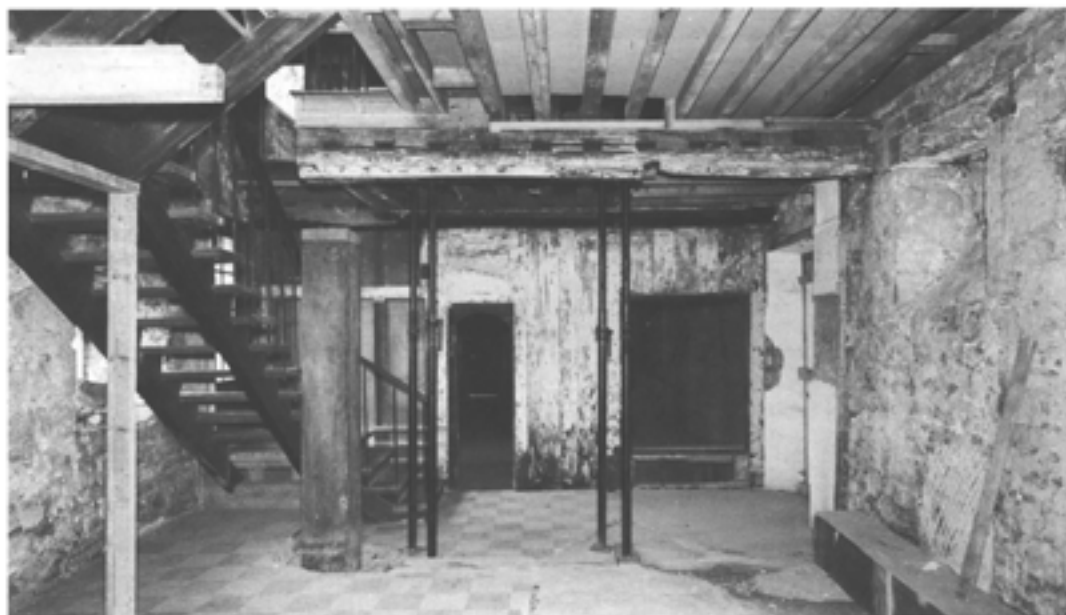
Figure 6.36  
Interior of the south range,  
showing the service rooms  
after initial stripping,  
looking east in July 1978.  
Note beam 6 in the fore-  
ground, cut away to the  
north (DoE J263/6/78).

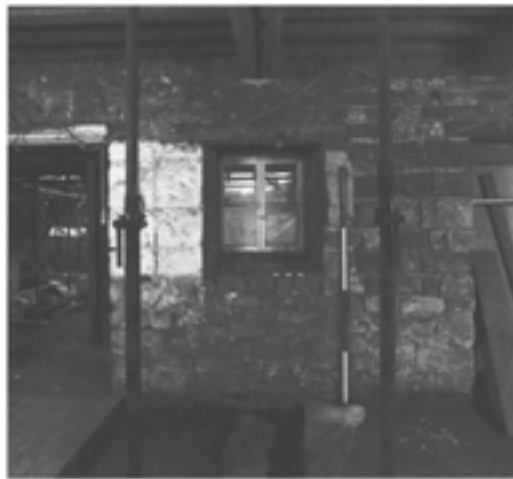
Figure 6.37  
North elevation of the service rooms in July 1993 (photograph by David Garner; EH B933570).

On the north wall the original door and window had survived (see Fig 6.25, 256 and 260), although the door had been blocked in a later phase. The north window (Fig 6.37) is noteworthy in that its light was shared between the two service rooms. The embrasure was of the standard form for doors and windows described above (Chapter 5), with the frame set midway in the wall, a chase left for it in the masonry and lintel timbers flanking the frame over the embrasure (Fig 6.38).<sup>41</sup>

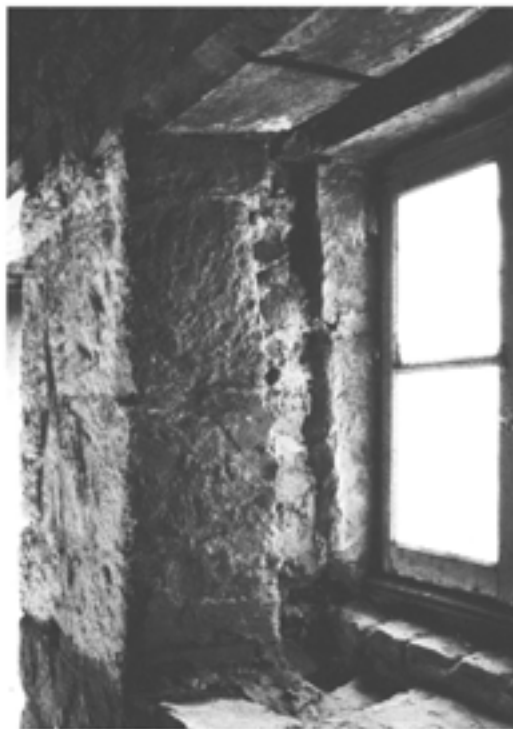
Figure 6.38  
Detail of window 256 looking north-west, showing the chase for the frame in the reveal and lintel and the slot for a partition in the inner lintel (photograph by Keith Westcott; EMAFU 1488/28).

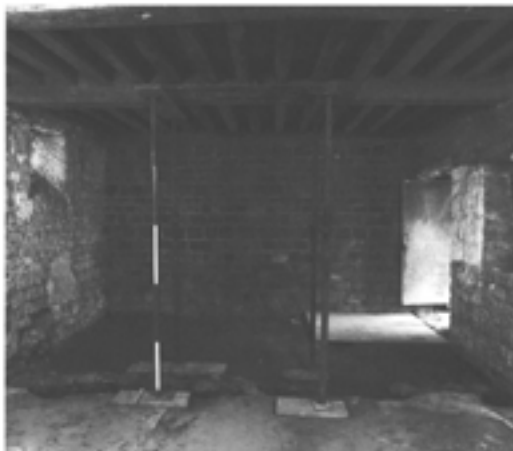
Figure 6.39  
The western service room, looking west to the rebuilt cross wall (on original footings) in July 1993. Note the sleeper wall for the screen (photograph by David Garner; EH B933566).
