# Bowhill

The archaeological study of a building under  
repair in Exeter, Devon, 1977–95

*The archaeological study of a building under  
repair in Exeter, Devon, 1977–95*

Published in association with Exeter Archaeology as Volume 5 in the  
Exeter Archaeology Reports series

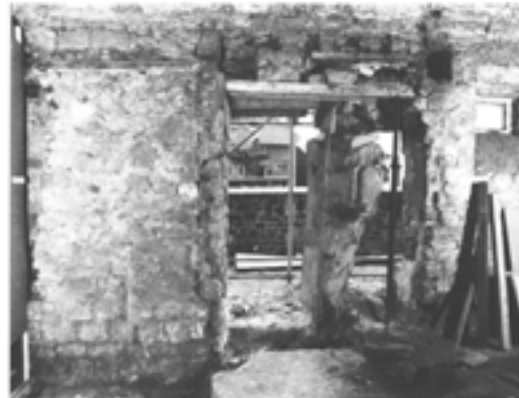
*Figure 6.40*  
The south wall of the service rooms after stripping, but before any masonry repairs in 1985 (*see* exterior view of the same, Fig 5.16), with window of phase 7 (for enlarged parlour), blocked in phase 8 and doorway of phase 9 (EH F850039/5).

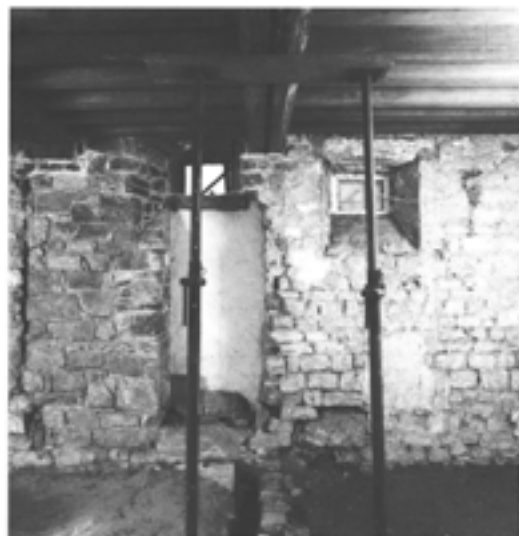
*Figure 6.41*  
A similar view to Fig 6.40 in 1993, after two phases of masonry repairs and excavation of the sleeper wall for the screen (bottom) (photograph by David Garner; EH B933571).

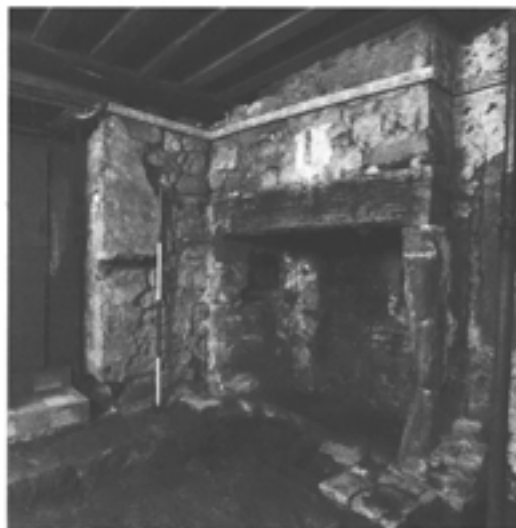
*Figure 6.43*  
The north-west corner of the west service room during excavation in 1993, showing the fireplace (see Fig 6.25, 262) and the paving slabs forming the remnant of floor (Fig 4.19, 1623) (photograph by David Garner; EH B934824).

The first and principal alteration to this room was the insertion of a fireplace and the construction of its associated stack in bay 10 of the north wall (Fig 6.43; see also Fig 6.25, 262 and 182). In the process the face of the wall was removed over the full width of the bay (although the rear face survived in the kitchen, see Fig 5.17). The fireplace was built against the west face of the post of truss x and underpinned beam 11 against the west wall (see Fig 6.25). It had reveals of large breccia blocks, spanned by a heavy timber lintel with chamfers and scroll stops. The rear was originally simply cut into the cob (part of the back is still just a cob face).

The lower part has been relined with brick (264). The oven in the western reveal was lined with breccia and floored with volcanic slabs (265). The facework of the stack above the lintel was of mixed volcanic and breccia masonry. From first-floor level the flue narrows and was built in a distinctive style of large face-bedded breccia slabs. A distinctive bonding material, a soft, yellow-brown mortar, was used throughout the fireplace and the stack. Similar material was used in the plastering of the wall to the east over the post of truss X, the adjacent cob walling and up to the soffit of beam 10. This was seen nowhere else in the building, although a similar (and possibly related) cob appeared in the filling of the scar of a stair in the south wall of the west service room (*see below*).

The excavation of 1993 revealed a number of volcanic stone pavements within and immediately around the fireplace (Chapter 4 and *see* Fig 4.19, 1623). Although these represented a later relaying of the floor, they might have originated in a paved floor of this phase or even in the primary floor of the room. The clay floor, found both in the passage (*see above*) and extending over much of the service room (*see* Fig 4.7, 1508 and 1570), could have been a bedding layer for such a pavement.

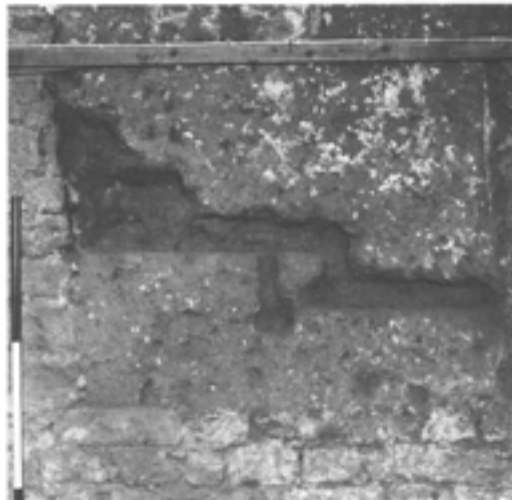
Figure 6.44  
Cob of the south elevation showing the secondary chase for a stair (*see* Fig 6.22, 342) at the junction of cob and stone walling (photograph by David Garner; EH B940402).

A further feature of this or another early period was a scar in the cob of the south wall of the room that had retained the outline of a stair (Fig 6.44; *see also* Fig 6.22, 342). The scar consisted of a well-defined lower edge in two horizontal steps separated by a possible socket. The upper edge ascended from west to east in four ill-defined steps, before disappearing against the masonry pier of the archway. The form, context and possible date of this stair were puzzling. If the upper limit of the scar is accepted as retaining the form of treads (at least roughly), then a

turning stair might be expected (the lower steps to the west appear longer than the upper, as if representing the turn of a dog-leg stair). If this was so, the feature could hardly have been earlier than the late 16th century and was probably later still. The position of the stair also counted against it as a primary feature, as there was already one stair ascending to the oriel chamber (*see above*) and this feature was placed directly beneath the oriel window, itself a primary element of the room above. Thus the feature is assigned (rather arbitrarily) to phases 5 or 7, since it was removed in the alterations of phase 8, which saw the construction of another stair in bay 8 (*see above*). The scar was filled with cob of a unique, yellowish mix (Chapter 10, class 4).

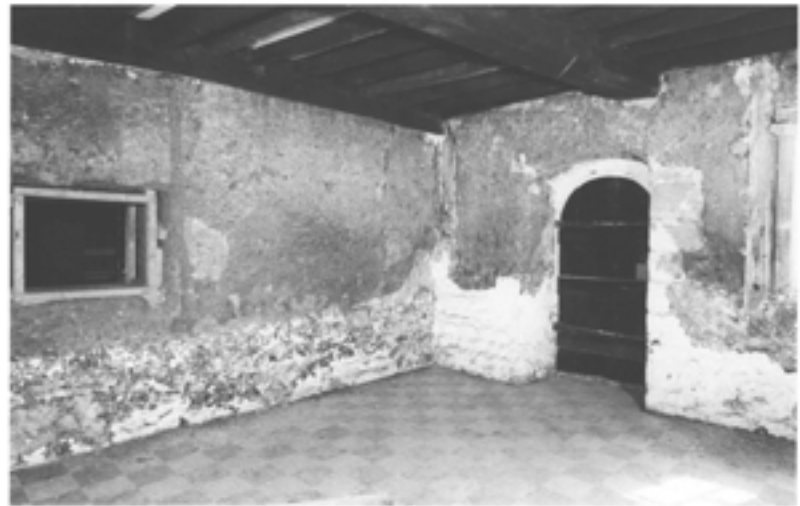
*Figure 6.46*  
The ground floor of the kitchen, looking south-west. Note the relative height of cob/stone footings, the door of phase 5 (cut into cob) and the inserted floor (DoE J263/3/78).

The south and west walls had low stone footings (c 0.9m high) and cob superstructure above (Fig 6.46; see also Figs 5.17 and 6.45). The east wall was built of stone to a slightly higher level. This was probably to provide direct support for the northern end of the lintels of the wide doorway/window giving onto the pentice, since the cob begins at the level of the lintel (Fig 6.47, 303, stone, and 218, cob). The north wall contained much more stone because of the massive chimney stack for the kitchen fireplace (Fig 6.48; see also Figs 4.21 and 6.47, 295 and 203). Nevertheless that part of the elevation not given over to the stack was of cob. The flanking parts to east and west have primary cob bearing onto or butting up to the masonry of the stack (see Fig 6.47, 202, 206 and 212).

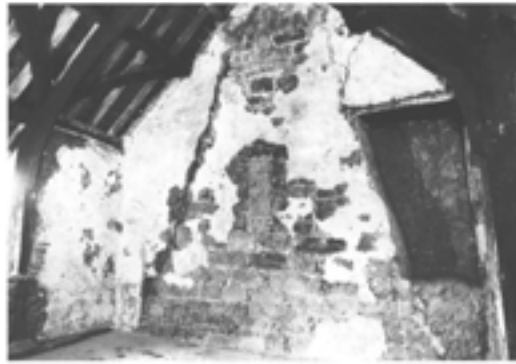
Figure 6.48  
The north elevation of the kitchen at first-floor level, showing the masonry chimney flue and cob walling to each side. Note the extent of surviving plaster at this time (July 1978; DoE J263/8/78).

A further puzzle was presented by a group of features in and against the northern wall: a niche high in the wall to the east of the chimney flue (see Fig 6.47, 211, and Fig 6.48); and sockets, apparently representing the positions of beams in the east and west walls at the same level as the threshold of the niche, but only in the northern half bay (see Fig 6.45, 244 and 246 and Fig 6.47, 220 and 224). The best interpretation of these features yet offered is that they represent some form of platform or possibly a 'smokehood' linked to the storage or curing of food.<sup>57</sup> Uncertainties concerning the phasing of the features,

(Fig 6.72; see also Fig 6.47, 204). The fireplace was removed and the cut filled with brick of later 19th-century type (see Fig 6.48; soot staining on the wall above the gap shows that the arrangement was defective).

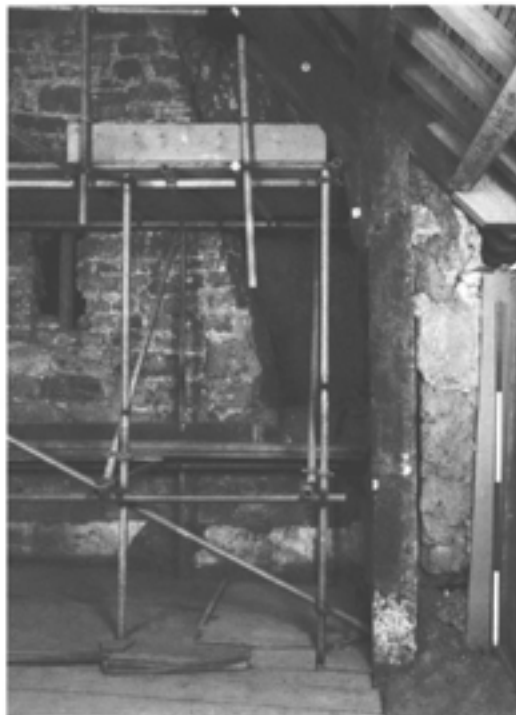
Figure 6.49  
The east post of truss II of the roof of the west range, showing the different treatment of this roof. Here the roof trusses were raised first and the cob wall built around them; in section this view shows a narrow gap caused by the shrinkage of the cob (photograph by David Garner; EH B933511).

The west range was built in a more conventional method than the south range, in that the posts of the roof trusses were raised before the cob walls were erected (Chapter 7). The principal evidence of the procedure in the fabric was that the cob ran up to the posts of the roof trusses, with only minimal shrinkage gaps (Fig 6.49; see also Fig 6.47, 400). Both western posts originally

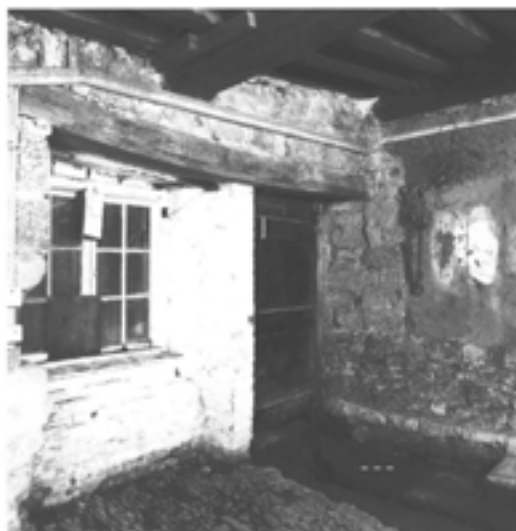
*Figure 6.52 (right)*  
Detail of window frame 238 and its embrasure, looking south-west (see Fig 5.2). Note the filled socket for the lintel at top centre and reveal cutting the primary plaster (photograph by David Garner; EH B943781).

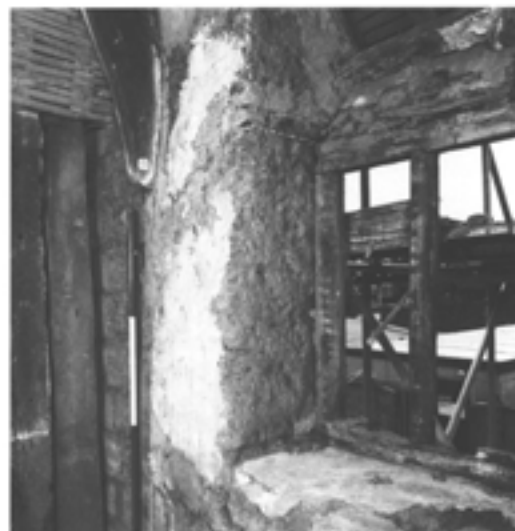
*Figure 6.53 (facing page)*  
Details of windows recorded in position: 137, moulded window frame of phase 5, reused in phase 8 in the north wall of the inner chamber; 238, chamfered window frame, perhaps of phase 3 or 4 from the west wall of the kitchen (first floor) (see the comparable frames in the collection of loose timbers, Fig 9.23); 80 and 81, sill of the east windows of the parlour, with isometric view and plan of the sills (the area occupied and obscured by modern frames indicated by dashed lines) (line drawing by Richard Parker).

The first-floor window had a timber frame of early style (Fig 6.53, 238) of the same type as two windows recovered from the barn in the 1970s (*see* Figs 2.14, 2.15 and Fig 9.23). The window was probably late 16th century in date, although reset in this position. It survived as two lights on the south side of the embrasure, cut to the north by a 20th-century window (Fig 6.54; *see also* Fig 6.45, 242, and Fig 6.52). The decayed sill timber was recovered with mortices indicating a further two lights and the placing of the window in fact suggests that it originally had five lights, occupying the space up to the south face of truss II. The frame had a simple chamfered profile, but was rebated for glazing. There were also single diagonally set vertical timber bars in each light (sockets in sills and lintels). Traces of red-lead colouring were observed on the timber. The placing of the window in this position probably occurred during the general reorganisation that took place after the demolition of the northern part of the west range and the insertion of a floor into the kitchen, c 1800 (phase 8). The pre-existing jambs were cut back quite substantially on the north side, in view of the evidence for the pier of cob to the south of the truss (*see above*). Short timber spurs were halved over the sill and set in the mortared outer sill, presumably to stabilise the window frame (*see* Fig 6.53, detail G). This work contained the ubiquitous red white-speckled mortar of phase 8. The window frame (along with those from the barn) may well have been reused from the demolished ranges to the north.

The north-western window has been described already (Chapter 5; Fig 5.17, 137, and Fig 6.53); it was made up of late 16th-century components, but probably not assembled in this form until a later phase. The north-eastern window (see Fig 6.25, 151) had a considerably enlarged embrasure and a replaced lintel (150), but retained an original external lintel. The reset internal lintel was set at the same level as those of the original lintels to either side (137 and 111), presumably reflecting the level of its predecessor. Traces of the eastern stop and the asymmetrical position of the enlarged embrasure suggest that the original window was central to bay 5 and may provide a clue to the width of an earlier embrasure. The bare cob of the widened embrasure retained traces of the very distinctive red heavily haired plaster, also seen associated with the late 17th-century partition to the east (and present throughout the inner chamber in traces over the primary plaster). This would suggest a context for the first enlargement of the embrasure in the same period as the renewed screen (phase 7?). The window is now fitted with a wide 19th-century casement.

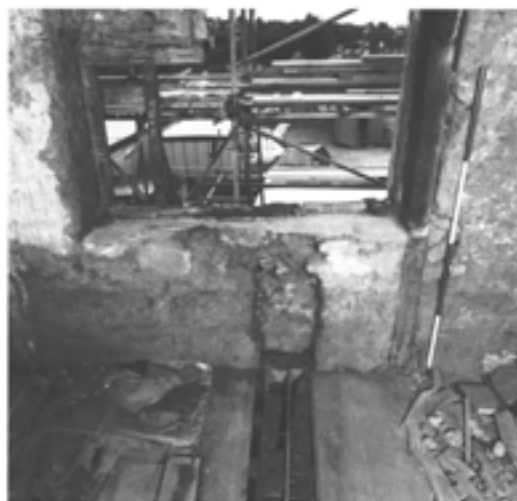
*Figure 6.54*  
The west elevation of the kitchen at first-floor level, showing the broad embrasure for window 238 and the slot (243) for insertion of the floor beam, during repairs in July 1994 (photograph by David Garner; EH B943775).

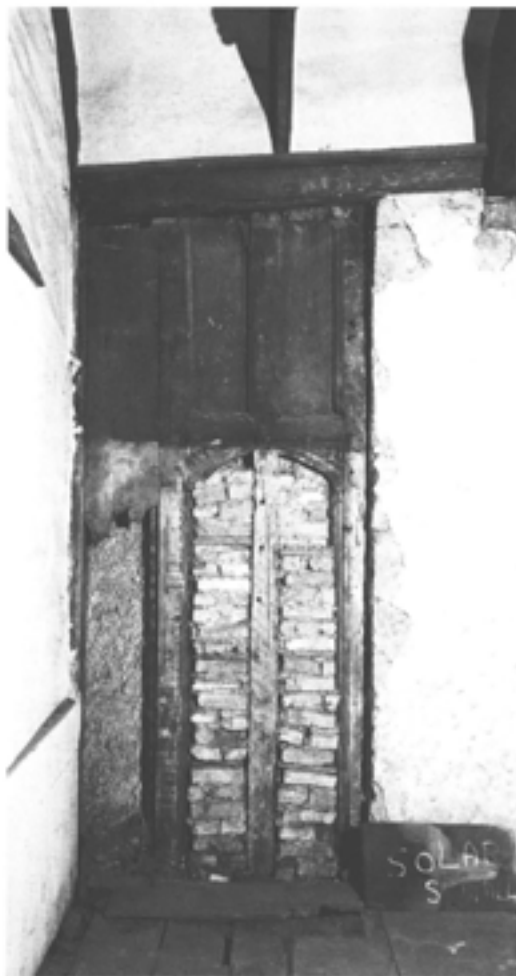
Figure 6.55  
Doorway in the south-east corner of the chamber (formerly leading to the south-east range), itself secondary (?phase) and blocked in phase 8 (DoE J263/16/78).

Another feature shared with the parlour was direct communication through the south-east corner of the room with the lost south-east range (see Fig 12.3).<sup>67</sup> This opening spanned the corner of the room and was framed to the east by the post of roof truss 1 (see Fig 6.22). The gap was filled by a section of partition of primary type, incorporating a low and narrow doorway of the same type as those of the screens in the hall and parlour below (Fig 6.55; see also Fig 6.22, 99, and ) and post and plank panelling above. The partition is unlikely to have been the original filling of this entrance, because although it was an authentic fragment of a primary screen typical of the building, in its

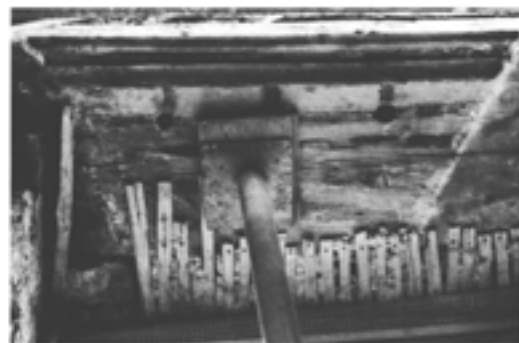
Figure 6.56  
Detail of the soffit of the  
lintel of window 17, south-  
west window of chamber.  
Note the moulding and  
outline of original splays  
(photograph by Stuart  
Blaylock; EMAFU  
1704/28).

In addition to windows in the gable wall (now missing), there were originally three windows in the great chamber. Two flanked the fireplace (see Fig 6.22, 17 and 69), while the third was in the north wall in the narrow

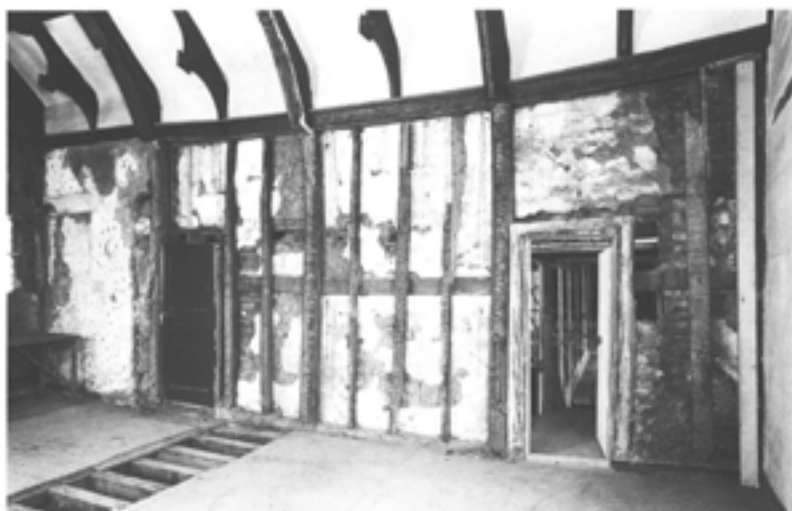
Figure 6.57 (top)  
The north elevation of the great chamber in July 1978, looking north-west, with later lath and plaster removed, showing the original plaster face and the posts of the roof trusses (DoE J263/14/78).

The structure of this partition has already been partly described in the context of the east range (see above, this chapter). The large-framed panels were formed within the posts of the roof trusses, the lower bressumer (or sill beam) timbers (halved over the main beams of the parlour ceiling below), middle rails and the cornice timbers. The filling comprised oak studs tenoned into the upper rails and sprung into grooves in the lower rails of each panel. The surface was then built up in oak laths on both faces of the partition and the void between the two layers of laths filled with daub. The daub extruded onto the exterior surfaces of the partition and was worked up into a bed layer which was subsequently plastered with a skim of white lime plaster (Fig 6.57).<sup>69</sup>

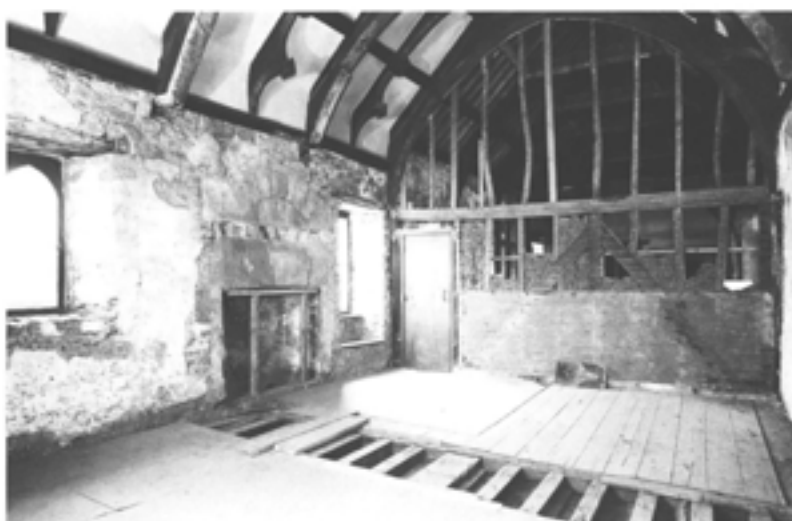
Figure 6.58 (bottom)  
The south elevation of the great chamber in July 1978, looking south-west. Note the fireplace and studs filling the area above the inserted screen (DoE J263/15/78).

Laths were applied to both sides of the screen as shuttering for the filling of the core with daub and to support the surfaces finished with heavily haired earth plaster, another late feature.<sup>71</sup> Half of the plaster surface survived on the east face of the screen (Fig 6.58). The second stage of the

partition (above the headbeam and filling the tympanum formed by the arch of the roof truss) was filled with a variety of timbers in a flimsy partition. Mortices survived in the headbeam for original (that is, 17th-century) studs (see Figs 6.15 and 6.31), which may have been more substantial, although those that survived in 1978 appear to be seated in the same mortices (see Fig 6.58). The door at the south end of the partition had retained its jambs, but had lost its head and been fitted with a modern frame and leaf (see Fig 6.58).

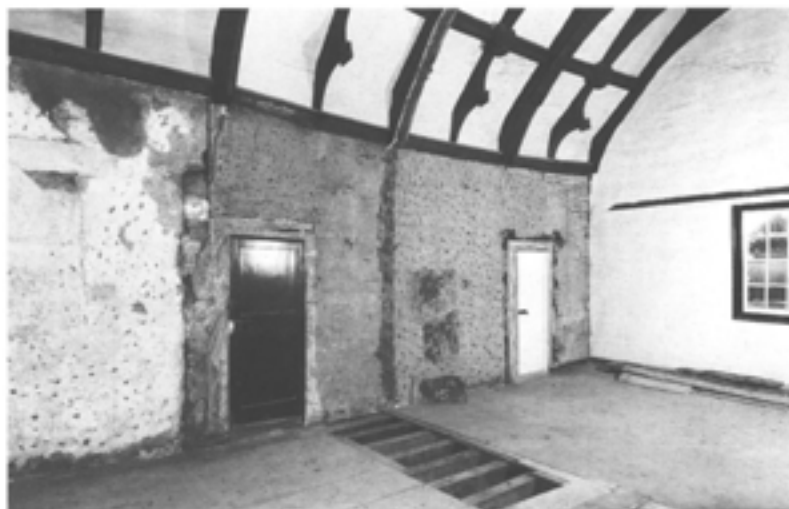
Figure 6.59 (top)  
The north elevation of the great chamber when first stripped in January 1978, looking north-east, showing new wall cladding of phase 8 and cut-in doorways of phase 9 (DoE J10/15/78).

Later alterations to the north partition involved the removal of the lowest section of the arch braces (below the cornice plates), in order to accommodate a new face of heavily haired plaster (on additional studs applied to the face of the screen, Fig 6.59; see also Fig 6.57) and the insertion of two doorways (one a reused 17th-century frame; see Fig 6.25, 113). These are clearly cut into the thickened wall (see for instance, Fig 6.59, showing lath and plaster infill around the western of the two doors cutting into the thickened wall). The insertion of doorways belongs to the phase after the construction of the first floor in the east range in the 19th century (see above, east range, the screens passage). Also at some point in phase 9, the south-west window was enlarged to accommodate a sash window. The reveals were rebuilt in stone and brick to eliminate the original splays and the sill lowered, widened and rebuilt in brick (see Fig 6.22, 106).

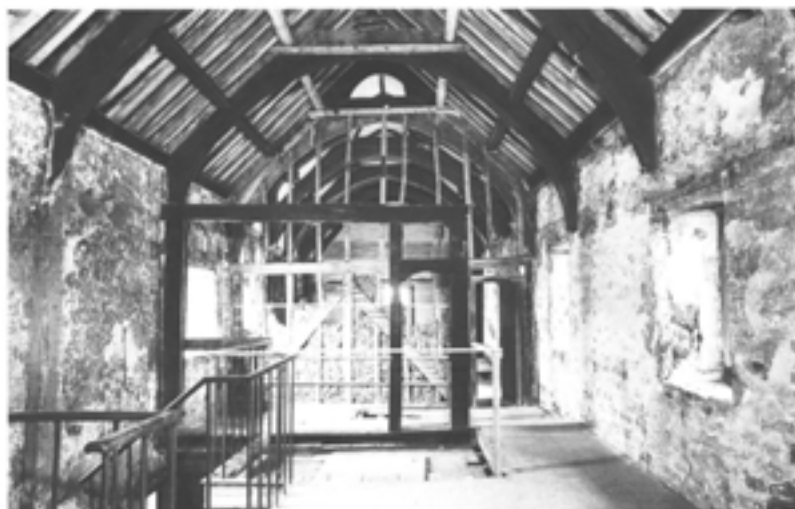
Figure 6.61 (top)  
The inner chamber looking east after first stripping in July 1978. Note the differential walling materials and 17th-century screen beneath truss VI (DoE 263/13/78).

At the time of the acquisition of the building the inner chamber was subdivided by a north-south partition on the line of truss VI. It was composed of an oak frame of substantial timbers incorporating a doorway with chamfered surround with diagonal stops and a four-centred head (see Fig 9.25). The partition may have been of primary character, although nothing else precisely like it had survived in the building. It could also, therefore, have been of later 16th-century date. The frame shared certain details of technique with the primary screens: the mortices for studding in the soffit of the headbeam; the continuous slot in the sill for the lower ends of studs (cut to a V shape) to be slid into position;<sup>77</sup> and the double chamfer and diagonal-cut stops of the door surround. The partition survived as a skeleton only and no studwork or infilling remained. A short length of east-west partition joined it to the west wall of the great chamber.<sup>78</sup> Both frames were dismantled when the building was stripped and have not been re-erected.

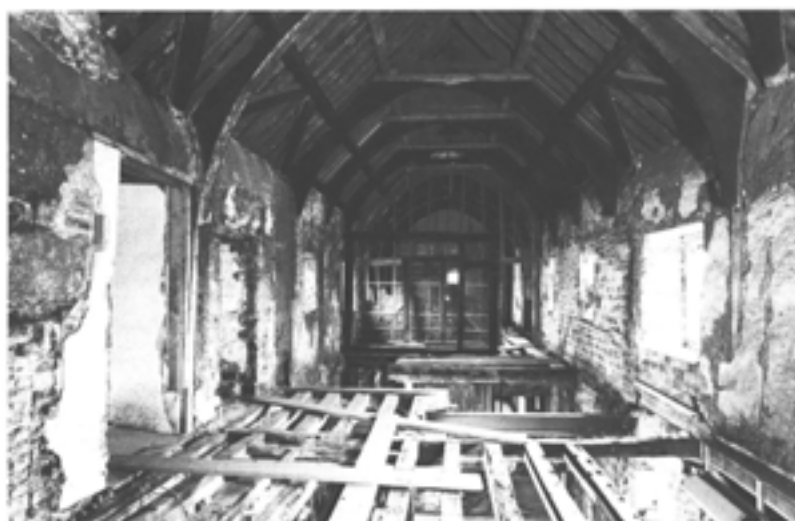
Figure 6.62 (bottom)  
Similar view to Fig 6.61 in November 1979, after removal of the floor boards and further stripping, with truss IX in the foreground (DoE J492/2/79).

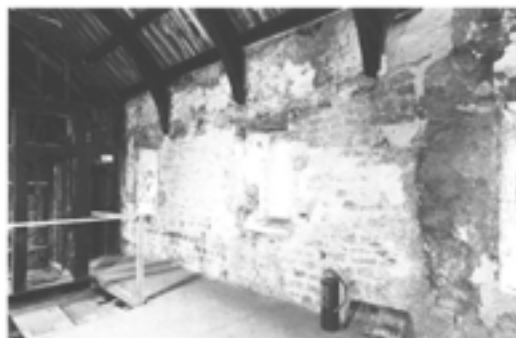
Figure 6.64

The interior elevation of the south wall of the inner chamber in July 1978 after stripping. Note the height of masonry, cob infill of wall tops, roof trusses cut off to fit the top of the stone wall and the scar of the cob cross wall west of truss VIII (extreme right) (DoE J263/11/78).

The wall was of cob above the first-floor level (the break in material occurred at the same level as in the north wall). Until it was rebuilt in 1990, the visible evidence for the wall comprised a scar in the cob of the south wall (see Fig 6.22, 127, and Fig 6.64), modern repairs of the scar in the cob (see Fig 6.22, 123), the full scar of the removed cob in the north wall (see Fig 6.25, 131, and Fig 6.65) and differential colouring of the timbers of the roof. The last was partly due to the staining/painting in successive layers of those parts of the timbers not concealed by the cob wall, as well as to discolouration by cob dust. This also showed that, as the wall rose into the roof, it narrowed from its full width of 0.85m to 0.6m (even less at the apex). The first-floor stage of the wall, as that of the north wall, was constructed before the addition of the roof, since its east face was cut for the insertion of the north post of truss VIII (see Fig 6.25, 134). The construction of the upper stage into the roof presumably post-dated the addition of the roof, and took place at the same time as the cob filling of the wall tops. The wall survived until 1969, although pierced by additional doors at ground level (see Fig 12.2, phase 10).<sup>84</sup>

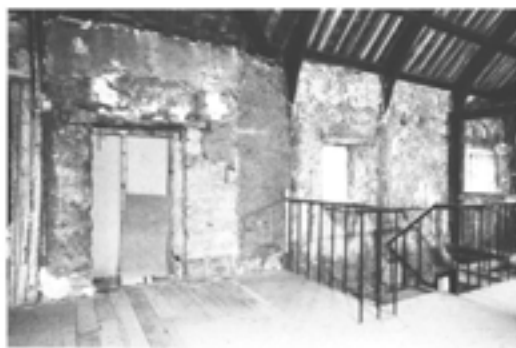
Figure 6.65

The interior elevation of the north wall of the inner chamber in July 1978 after stripping. Note the cob walling, the scar of the cob cross wall west of truss VIII (centre), the two windows in the inner chamber (right) and the position of the stair of phase II (DoE J263/12/78).

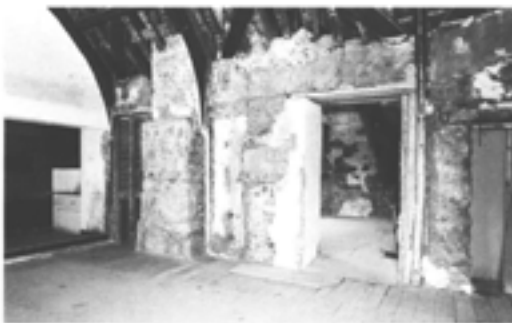
Figure 6.66  
The north elevation of the oriel chamber when first stripped, July 1978 (DoE J263/9/78).

This room occupied bays 8–10 of the first floor (Figs 6.66 and 6.67). It remained without subdivision from the primary phase 3 until it was incorporated into a larger room by the removal of the cross wall in the restaurant period alterations of phase 11 (1969 and onwards). The room was predominantly cob-walled (see Figs 6.22, 6.25 and 6.45). Even the flue of the fireplace in the north wall was formed of cob, the only instance of this to survive in the building.<sup>85</sup> Roof trusses were fitted into chases in the cob and carried down onto stone (although the southern posts of trusses X and XI were supported on a window lintel and bare cob respectively). Much primary plaster survived, running over the posts of the roof timbers, over the cob infill of the wall-tops and into the oriel embrasure (below). The floor level stepped up by 0.23m from that of the inner chamber to the east, a reflection of the rising ground level to the west. The level of embellishment of the roof (windbraces and bosses, Chapter 7) as well as the oriel window, show that this chamber was an important room.

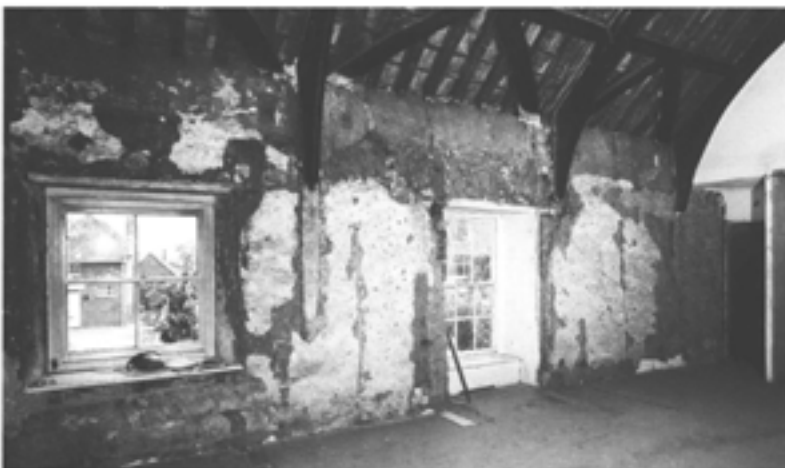
Figure 6.67 (below)  
The south elevation of the oriel chamber when first stripped, July 1978 (DoE J263/10/78).

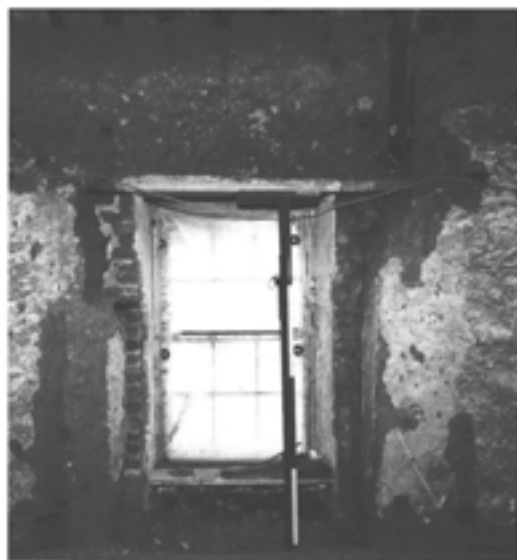
Figure 6.68  
Detail of the oriel window.  
Note the splayed reveals  
with primary plaster, later  
brick filling behind and the  
foot of truss X bearing on  
the lintel (photograph by  
David Garner; EH  
B930204).

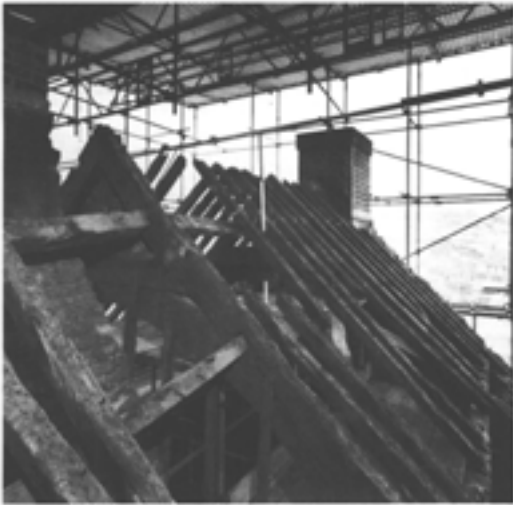
Figure 6.69  
General view of the roof of the west range when stripped in July 1992, looking north along the east side of the roof. Note especially the weathered area on the face of truss 1 representing the extent of the primary chimney stack (centre) (photograph by David Garner; EH B924255).

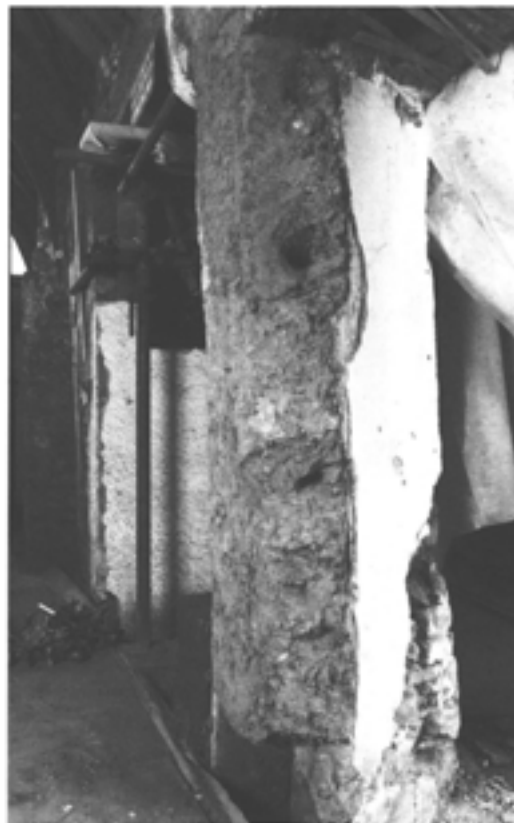
Figure 6.70  
The west reveal of door 200 formerly leading to the gallery, showing reverse splay, looking west (photograph by David Garner; EH B940400).

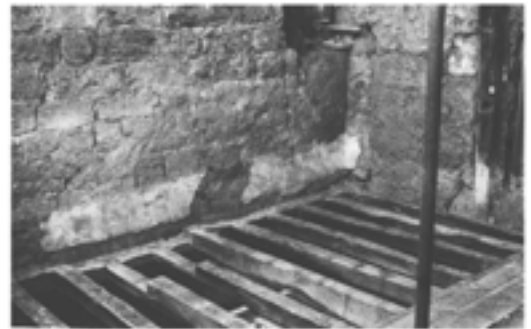
*Figure 6.71*  
West range, upper surface of the inserted first-floor frame, showing the rebate for a hearth slab and the extent of stone and cob (photograph by Stuart Blaylock; EMAFU 3000/3).

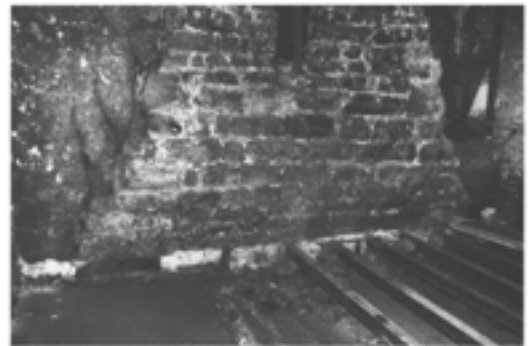
*Figure 6.72*  
As Fig 6.71, showing the later (19th-century) floor above being lifted (photograph by Aidan Matthews; EMAFU 1924/17a).

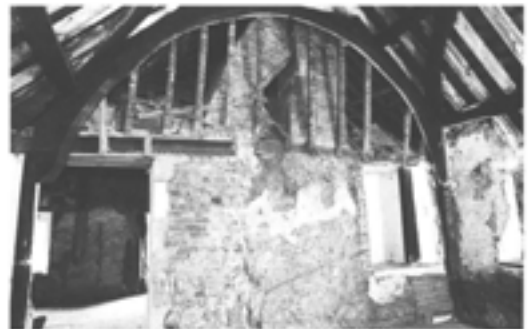
*Figure 6.73*  
The south elevation of the west range at first-floor level when first stripped in July 1978 (DoE J263/7/78).

In the south wall the principal later features related to the fireplaces of the oriel chamber (Fig 6.73), that is, the inserted 16th- to 17th-century stack to the west (see Fig 5.17, 235) and the brick back and flue of the phase 8 rearrangement of the primary fireplace (233 and 229). In the west corner a cupboard or closet was constructed in the space first employed for the niche facing into the oriel chamber (see p 141). The older doorway to the west of the stack (see Fig 6.25, 359) was blocked with studding and a new embrasure formed on the north side in brick and mortar of the phase of c 1800 (see Fig 5.17, 236 and 232). In turn a new cupboard was formed with newer studs and lath and plaster in the later 20th century.<sup>94</sup>

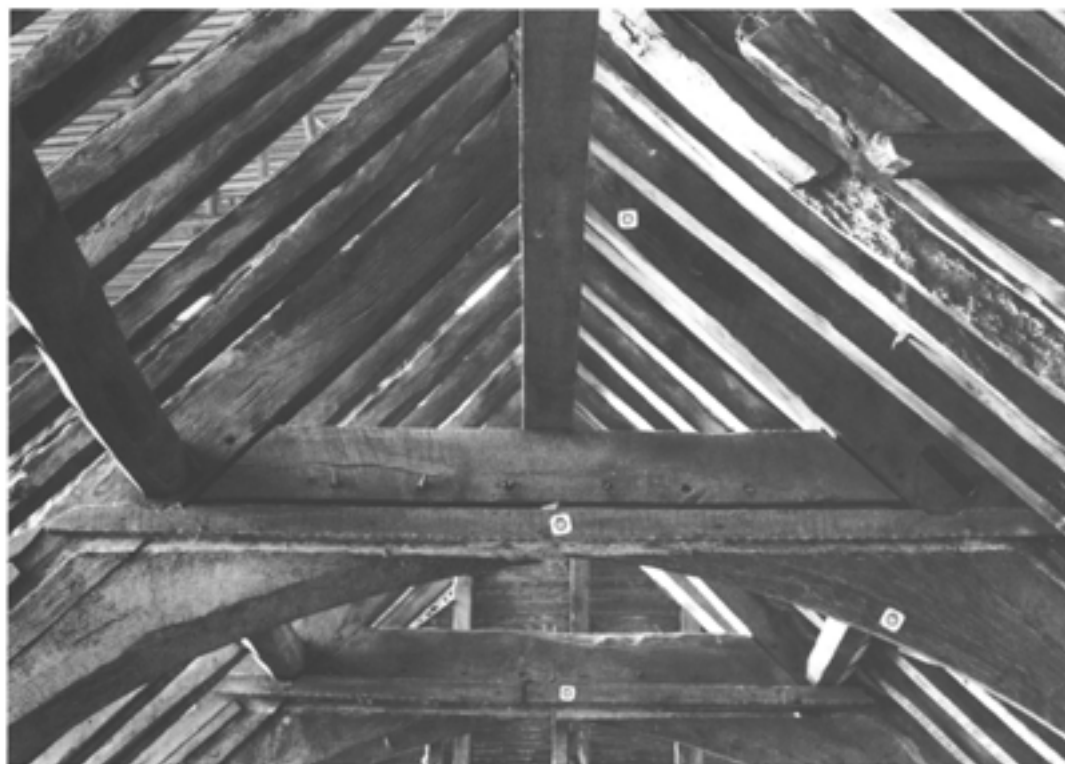
*Figure 7.1*  
The roof of the south range, trusses X and XI (showing protruding pegs) seen from the rear face (photograph by Stuart Blaylock; EMAFU 1924/1).

The roof of the south range was assembled from east to west, following the truss numbering which survived in a consistent series (1-X1), with multiple numbering on each truss.<sup>1</sup> The working faces of the timbers were to the west, since setting-out lines, assembly marks and numbers are invariably found on the west face of the timbers and the pegs were inserted from that direction (Fig 7.1).<sup>2</sup> On longitudinal timbers the number was usually inscribed at the east

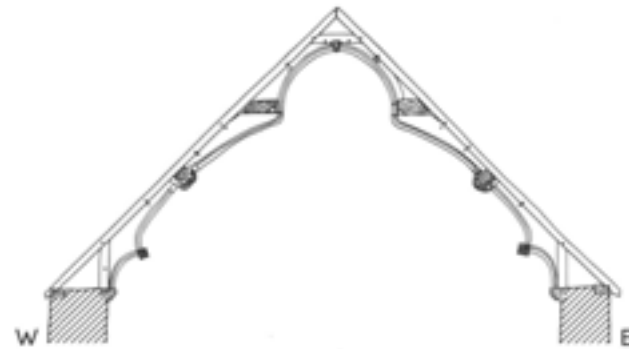
## Intermediate Truss V

Figure 7.2  
The roof of the east range  
(hall), specimen elevations  
of main and intermediate  
trusses (scale 1:100) and  
sections of timbers (line  
drawing by Richard  
Parke).

The roofs at Bowhill are variations of the jointed-cruck assembly. Essentially this consists of pairs of posts whose curved heads support the principal rafters (see Figs 7.2–7.3). These support four sets of purlins, the lowest set plate-wise to support the common rafters at the eaves and the next in line with the inner wall face. They are thus fixed to the posts/arch braces rather than the principals. There are no ridge pieces. The rafters, between five and eight per bay, are mostly butted at the apex and pegged. The variations both structural and decorative in the roofs through the building are the subject of this chapter. The hall roof is the largest, grandest and most highly decorated and formed the prototype for the remaining roofs. Both hall and great chamber follow essentially the same structural arrangement and use the same repertoire of joints,

The roofs were recorded in conventional truss elevations. These appear in the main elevation drawings of the building (Chapters 5 and 6), and in two detailed elevations (Figs 7.2 and 7.3). These have been augmented with 'exploded analytical drawings' of the hall, chamber, inner chamber and oriel chamber roofs that attempt to show how the carpentry is fitted together. The west range resembles the roof of the western bays of the south range, although with some variations. With the complex carpentry of the hall and chamber roofs, details of joints and the form of the timbers were best shown with whole bays pulled away from the assembled roof (*see Figs 7.6 and 7.13*). For the inner and oriel chambers, where a key aspect is the discrepancy in height between the two sides of the roof, one side is shown assembled, the other (with the taller posts) disassembled (*see Figs 7.27 and 7.29*).

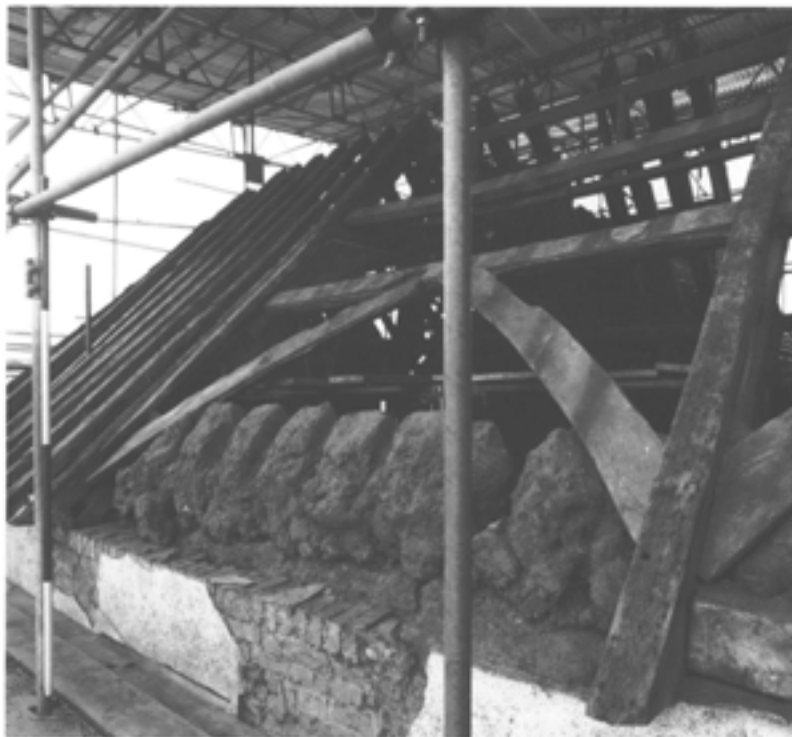
*Figure 7.4*  
The roof of the south range, bay 9 (south), with common rafters and eaves purlin removed in June 1992. Note the cob beam filling on the wall top with impressions of the common rafters and brick fabric on the site of the oriel window (phase 8) (photograph by David Garner; EH B923942).

The next stage of construction was the filling of the wall tops (the space of triangular section between the top of the wall proper, the wall face/cornice/lowest purlin, and the soffit of the common rafters/roof – a process called beam filling [Fig 7.4]).<sup>10</sup> This was carried out in cob above the stone as well as the cob walling. In the great chamber the face of the beam filling lay flush with that of the ashlar pieces and, presumably, was plastered over. In elevation the beam filling abutted the roof trusses and sometimes filled the upper parts of the chases described above as well. It was clear from this sequence that the finishing of the cob walling took place after the roof timbers had been positioned. Then the walls were plastered. Everywhere the primary white lime plaster of the interior of the building was recorded running over cob (and stone) walls, posts of the roof trusses (Fig 7.5),

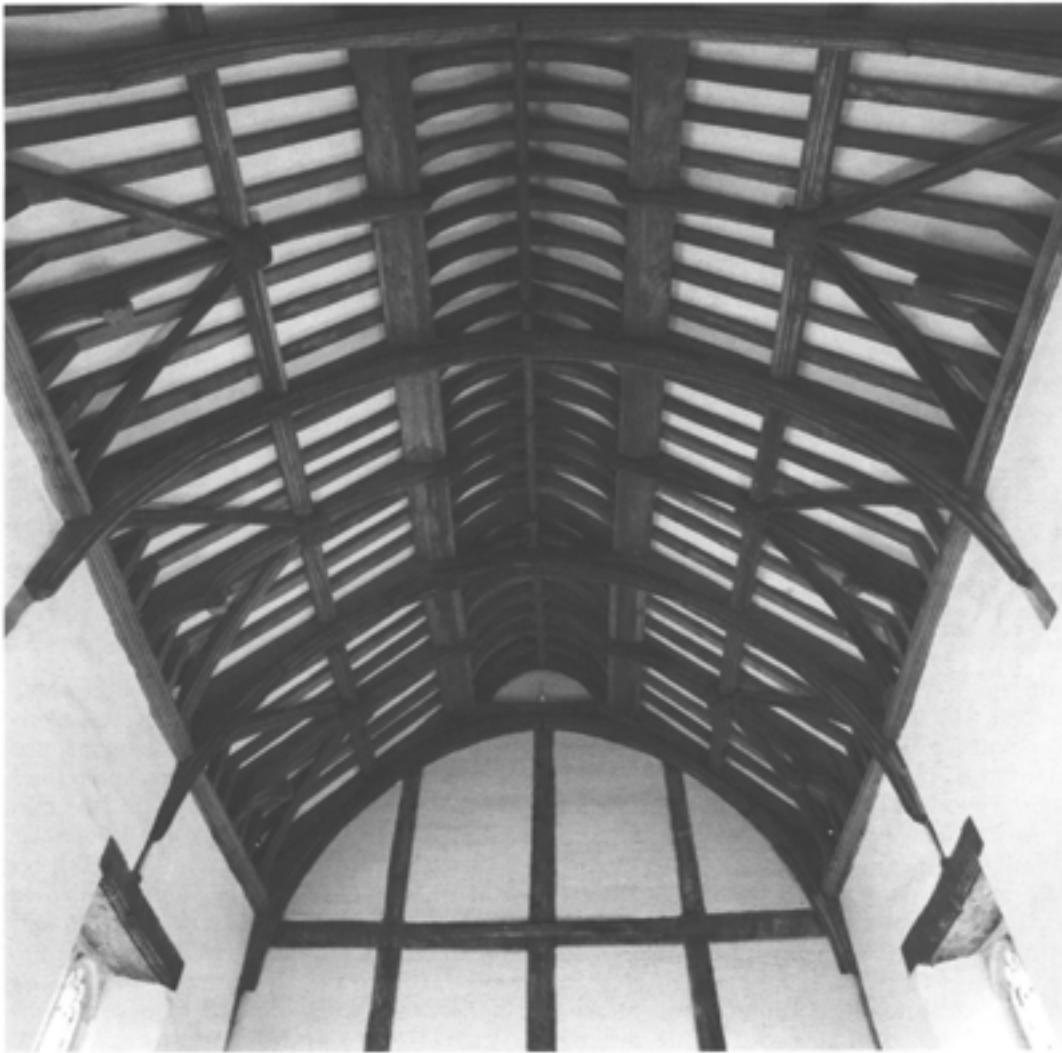
*Figure 7.7*  
The hall roof after repair,  
May 1995, looking north  
(photograph by David  
Garner; EH B953012).

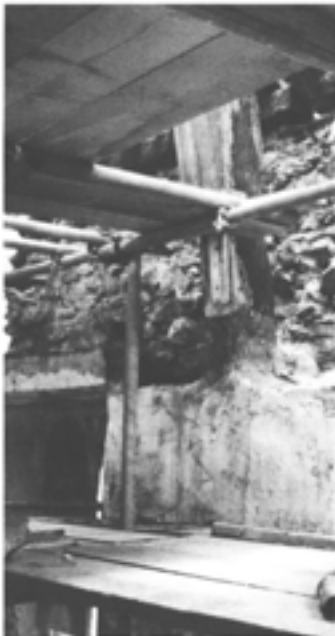
*Figure 7.8 (below, left)*  
The foot of the west post of  
truss IV of the hall roof,  
supported on a remnant of  
the cob wall-top filling  
(unnumbered DoE photo-  
graph of c 1980-1).

posts bearing on the stone wall top or on the lintels of windows, with the cob of the wall top built up around them (see Figs 6.2 and 6.15). The west posts of trusses IV and V did not sit neatly on the wall top. Truss IV, remarkably, appears to have been supported on cob, a small area of which survived under the foot of the truss (Figs 7.8 and 7.9; see also Fig 6.15); truss V is supported by a chock of timber.<sup>15</sup> In contrast to the south range, work on the walls and the roof of the hall appears to have been synchronised. Trusses II and VI are unmoored to the north and south respectively. Thus the northern cell, in bay 1, cannot have had any significant ornament (the space to the south of truss VI was occupied by the portion of roof oversailing the south range, discussed below).

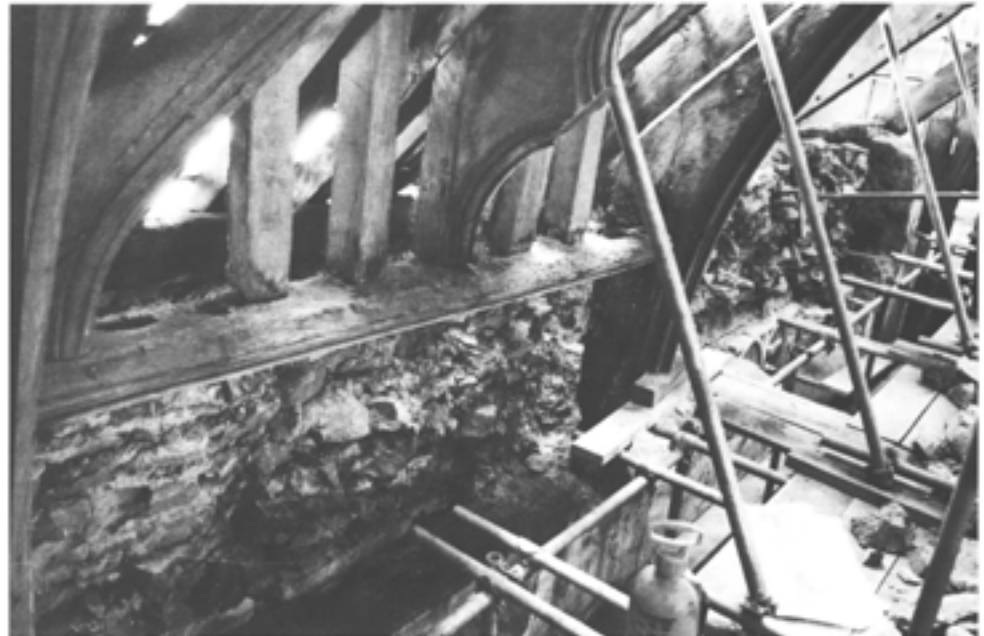
Figure 7.10  
The apex of trusses II and III in 1978, showing the coving and the structure where one cove brace is missing (right) (DoE J263/22/78).

mortice beneath the detail drawing of a corbel, which could have accommodated a figured corbel or similar feature, in the manner of the Guildhall roof.<sup>18</sup> The same source shows bosses at the intersections of the intermediate trusses and purlins and smaller bosses or foliage carvings in the coving at the apexes of the intermediate trusses. The bosses probably survived *in situ* until the early 20th century, but they had been removed prior to Everett's interest in the building in the 1930s.<sup>19</sup> The photographic record of the roof made during dismantling in 1978 shows that, despite some decay, the timbers had remained clean and showed no trace that they had been ceiled, other than between the common rafters. The whole timber structure, therefore, including common rafters, was intended to be seen within any ceiling (Fig 7.10).

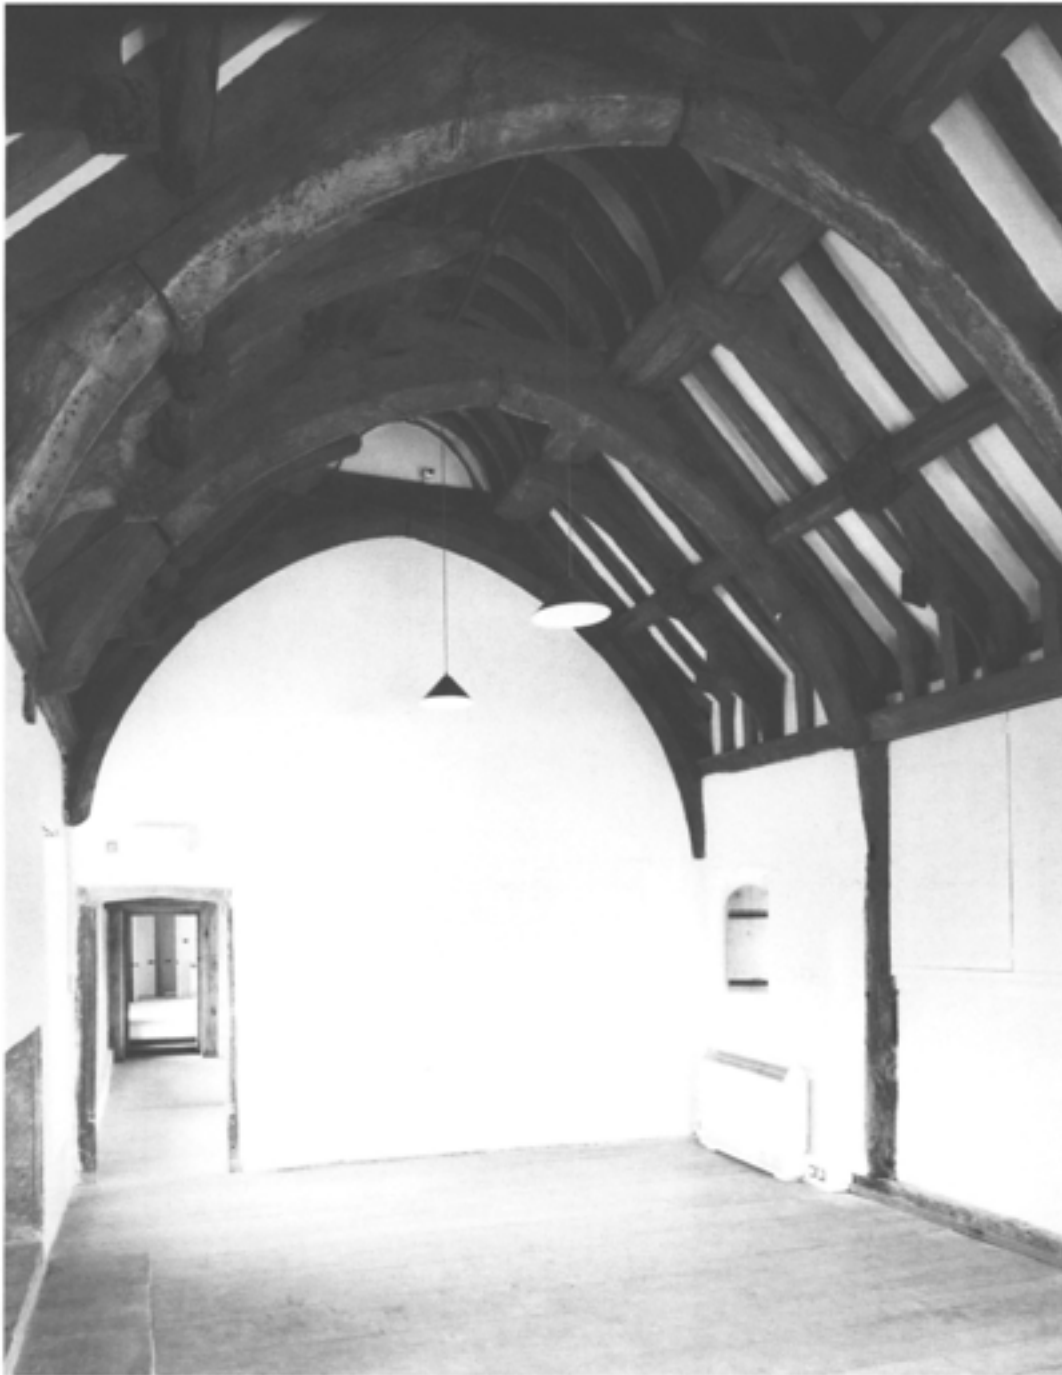
*Figure 7.14*  
 General view of the great chamber roof after repair, looking west, May 1995 (photograph by David Garner; EH A950713).

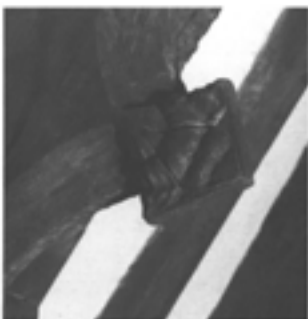
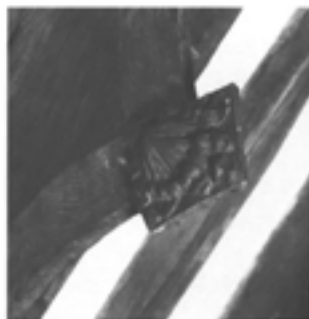
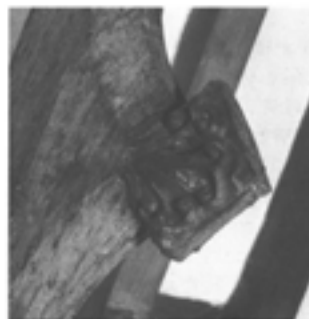
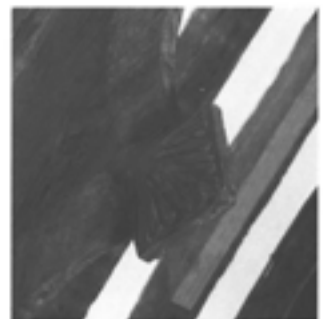
*Figure 7.15*  
 Foliage carvings on the cups of the intermediate trusses (IT) of the great chamber roof. Since the north and south cups bear the same carvings only one of each is illustrated: (left to right), IT I, N (EH B955479); IT II, N (EH B955480); IT III, S (EH B955484); IT IV, S (EH B955483) (photographs by David Garner).

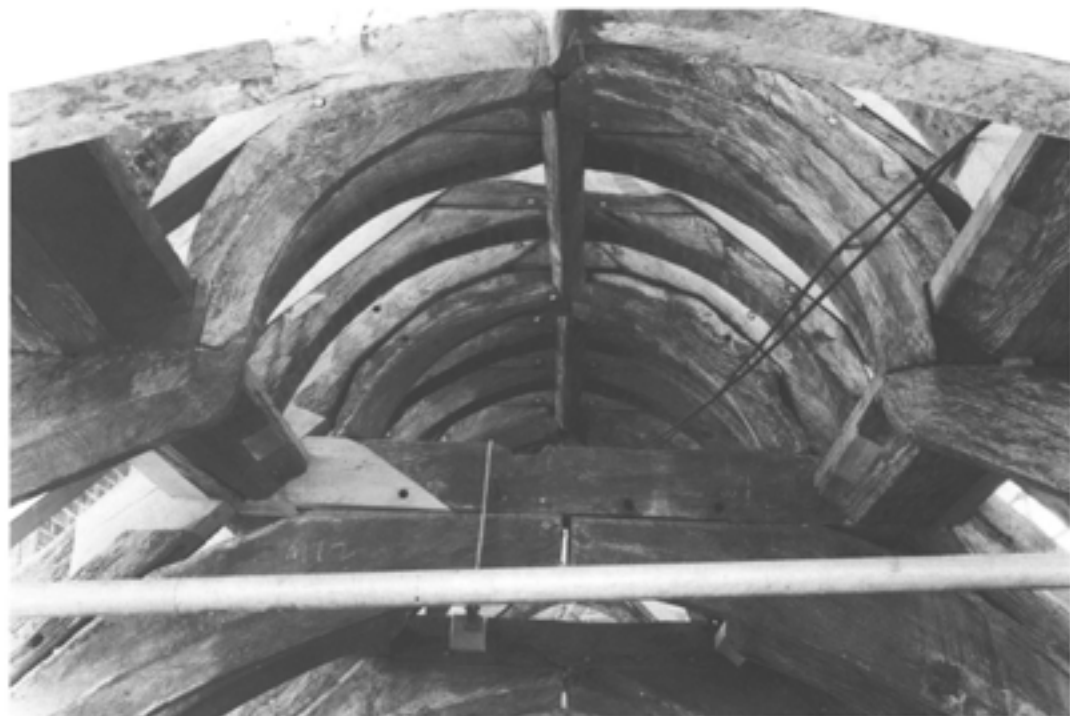
Figure 7.16

Detail of coving in bay 1 of the great chamber roof, looking west. Note the intermediate truss in the foreground, cove braces and axial cove purlin (photograph by David Garner; EH B891245).

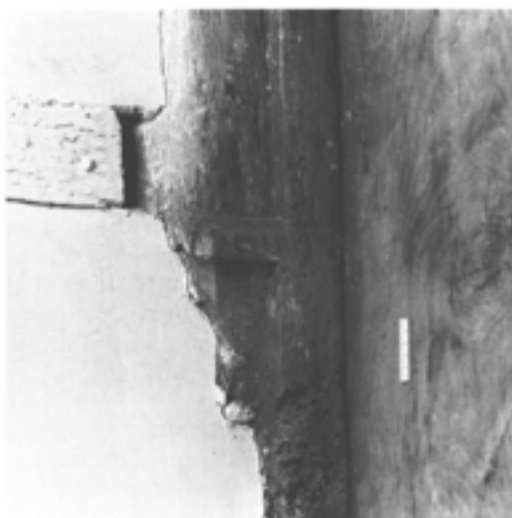
Figure 7.18  
Moulded capital at the base of the south arch brace of truss 1 of the great chamber roof, partly obscured by the modern east gable partition to the left (photograph by David Garner, February 2000; EH B000023).
