# Bowhill

The archaeological study of a building under  
repair in Exeter, Devon, 1977–95

*The archaeological study of a building under  
repair in Exeter, Devon, 1977–95*

Published in association with Exeter Archaeology as Volume 5 in the  
Exeter Archaeology Reports series

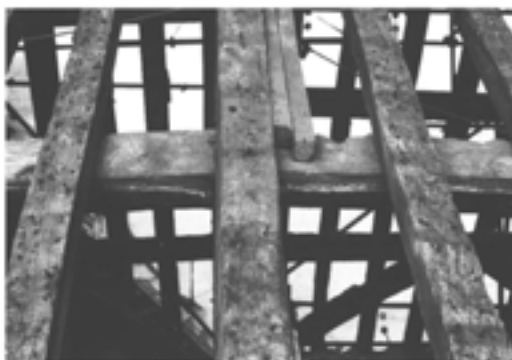
Figure 7.19  
Double-pegging of face-halved tenons, truss IX, south side (photograph by Stuart Blaylock; EMAFU 1803/18).

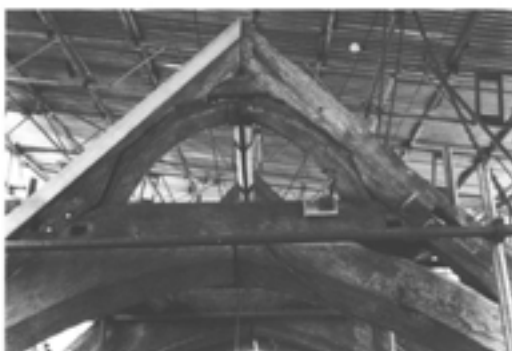
Figure 7.20  
Detail of truss IV when the rafters of bay 4 were dismantled in April 1989, looking east. Note especially the mortices for the upper purlin and cove purlin (EH B891266).

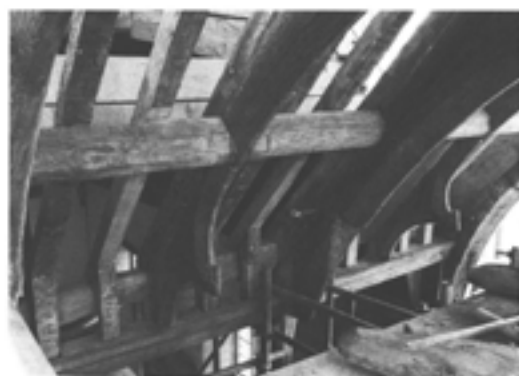
Figure 7.21 (top)  
The north side of the roof (bays 1 and 2) during re-assembly after repairs in April 1989. Note especially the ashlar pieces, wall-top assembly and purlin/intermediate truss junction with the bosses removed (EH B891255).

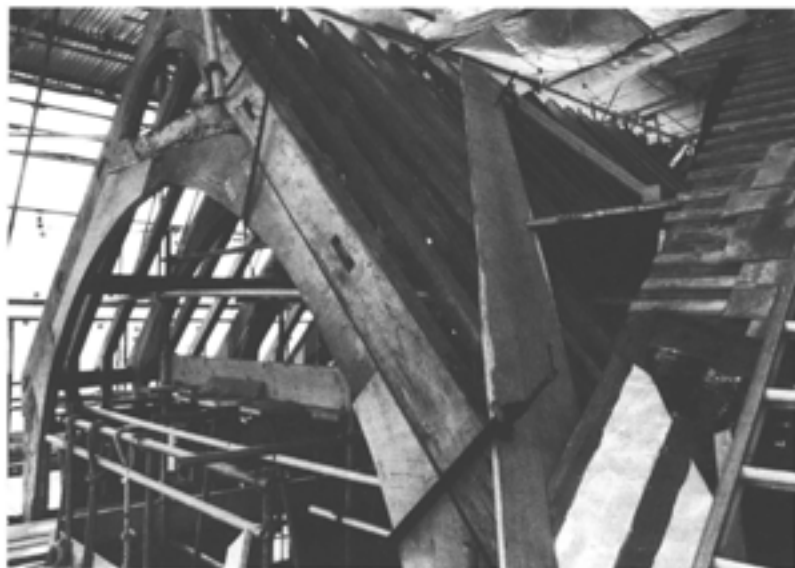
Figure 7.22 (bottom)  
The great chamber roof during reconstruction of the oversail of the roof of the east range in March 1990, looking south-west. Note the undecorated east face to truss 1 where it abutted the cob gable wall (photograph by Stuart Blaylock; EMAFU 1704/21).

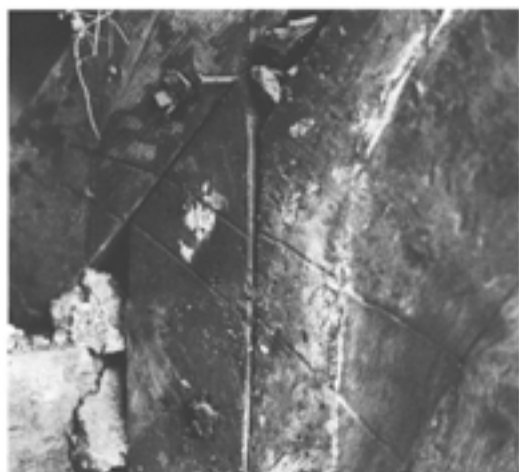
Figure 7.23 (top, left)  
Detail of the ashlar piece, common rafter and brace of intermediate truss II, north side. Note the assembly mark and the line of the (later) plaster ceiling (EMAFU 1423/29a).

number on the north side and a circular distinguishing mark (added to the last vertical stroke) on the south side. Inscribed numbers often run continuously across two or more timbers (a good example is Fig 7.23,

showing marks on intermediate truss II) or are inscribed at adjacent points on two timbers (Fig 7.24, on main truss III). Common rafter trusses have fewer marks, because they have fewer component timbers and seem to be numbered in a separate sequence. No marks are recorded on rafter trusses (RT) 1 and 2, but RTs 3 to 6 bear the Roman numerals III–VI in the correct sequence. From RT 7 onwards the numbering is confused: RT7, I; RT8, VI; RT9, V; RT10, IIII; RT11, III; RT12, II; RT13, VIIII; RT14, VIII (Fig 7.25, showing the south side of rafter trusses 14 (foreground) and 13); RT15, VII; and RT16, VI(I?). This is probably because the numbering was not adhered to in the original assembly. Although there is some evidence further west in the roof for rearrangement of rafter trusses during previous re-roofing, this is unlikely in the great chamber roof because of the large number of joints involved. In the central and western bays a muddling of the common rafters would have caused few complications, as each couple was only fixed at two points.

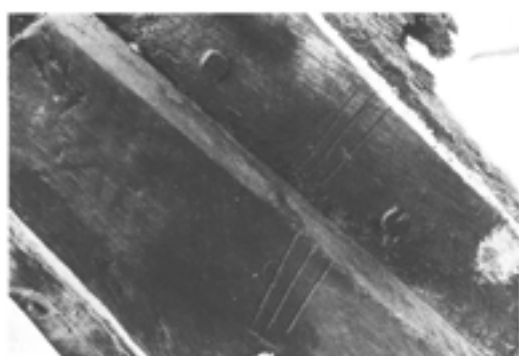
Figure 7.24 (centre, left)  
Detail of the assembly mark of main truss III, south side, with the arch brace (below) and principal rafter (above) (photograph by Keith Westcott; EMAFU 1404/34).

The principal trusses continue the numbering established in the chamber. Bold roman numerals are incised on the west face of the main timbers. These are plain on the north side of the roof, with an additional distinguishing mark on the south side (*see* Fig 7.24).<sup>31</sup> Within the bays common rafters were numbered, normally

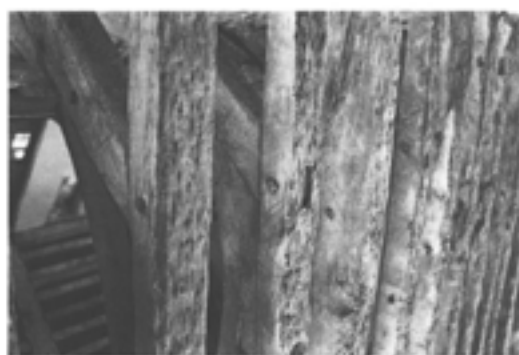
Figure 7.25 (bottom, left)  
Detail of the coving of the chamber roof from above, south side, looking north-east. Note the assembly marks (rafter truss 14 in the foreground) (photograph by Keith Westcott; EMAFU 1380/16)

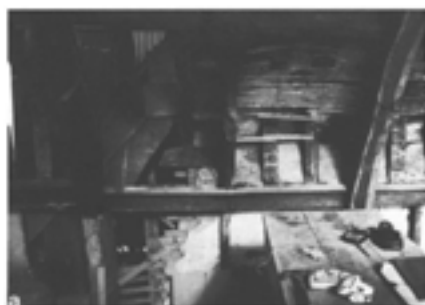
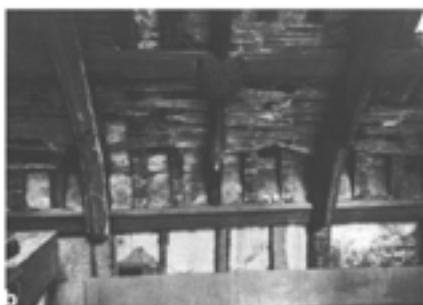
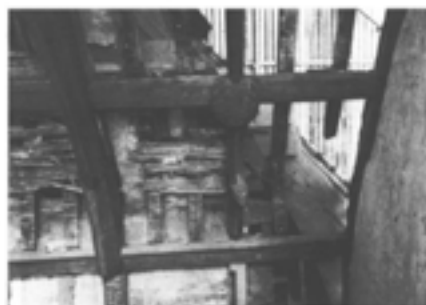
Figure 7.26  
Montage of three views of the north side of the roof before dismantling, c 1985–6: a bay 3; b bay 2; c bay 1. These unprovenanced prints record crucial information for two phases of plastered ceilings in the great chamber towards the outer face of the common rafters and on the soffits of the common rafters. Note also the 'beam filling' with sloping face between the ashlar pieces (copy negatives, EMAFU 3908/8–12).

Evidence for a primary ceiling was recorded in photographs of c 1985 taken during the dismantling of the chamber roof (Fig 7.26),<sup>28</sup> which show the remains of plaster behind the laths of a later ceiling near the outer face of the ashlar pieces and common rafters. This represents important evidence for the original appearance of the chamber roof (and, thereby, that of the hall as well) in that it shows that the lesser structural timbers were intended to be visible. Evidence for a later ceiling survived in the form of nail holes and staining from lath and plaster on the soffits of some timbers. This covered the common rafters, the ashlar pieces and the braces of the coving, that is, at this stage the chamfered timbers of the main and intermediate trusses were visible, but none of the plain-surfaced timbers (see Fig 2.27). This secondary ceiling,

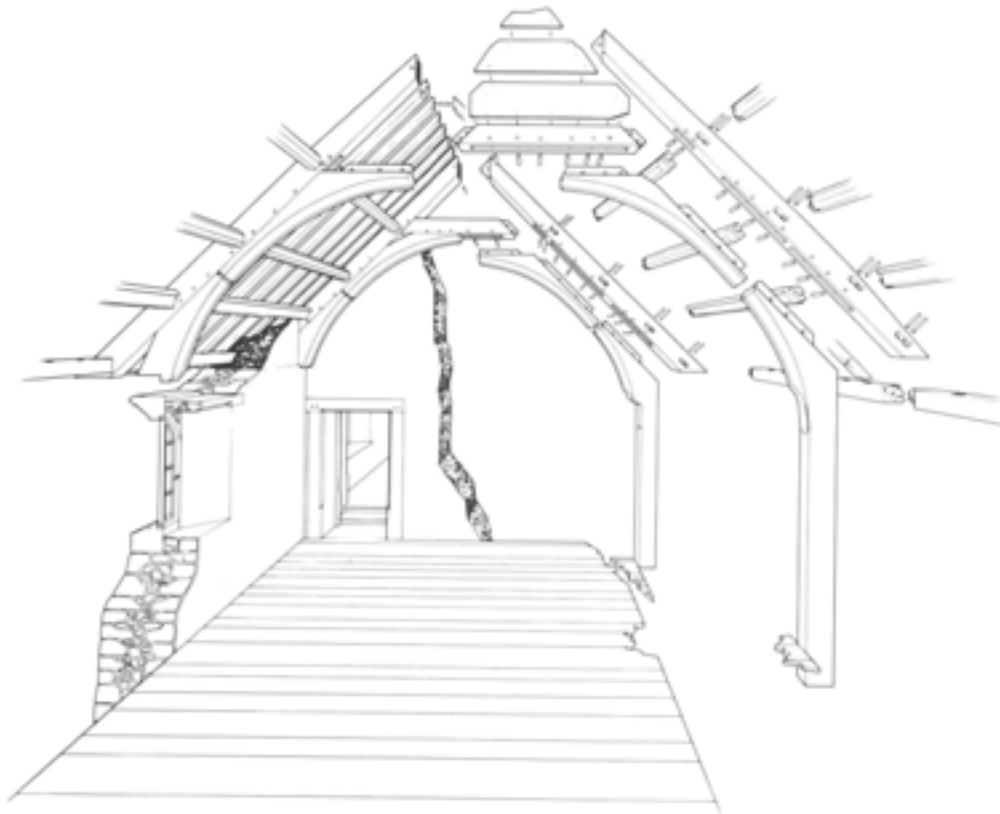
*Figure 7.27*  
Exploded analytical drawing of the roof of the south range (inner chamber), looking west, with truss VII in the foreground (not to scale) (line drawing by Piran Bishop).

The basic structure of the main trusses continues unchanged into the western part of the roof, but most of the purely decorative elements are now omitted (Fig 7.27). In consequence the roof of the inner chamber (bays 5–7; trusses V–VII) conforms more closely to the standard late medieval roof of jointed-cruck type. Again, the differential walling material (stone to the full height on the south, cob above floor level on the north) meant that the trusses on the south side were truncated and those on the north were left with long posts (Fig 7.28). The principal rafters are of the same design as those of the chamber, although the timbers are thinner and coving and yoke are omitted above the collar. The arch braces are cut to fit in the same manner as those of the great chamber, suggesting that they too originally bore pseudo-capitals or corbels as lower terminals. Again the final trimming may be related to the insertion of later ceilings, in this case the one represented by sockets in the south (*see* Fig 6.22, 125) and the north walls (*see* Fig 6.25, 144, 145, 147; Chapter 6). The common rafters are entirely plain without coving and are supported on the eaves purlin alone (plus pegs at the apexes in most cases). The three bays of this room have an average width of *c.* 1.97m (slightly <6'6") and each contains six pairs of common rafters, rather than the five of the great chamber roof.

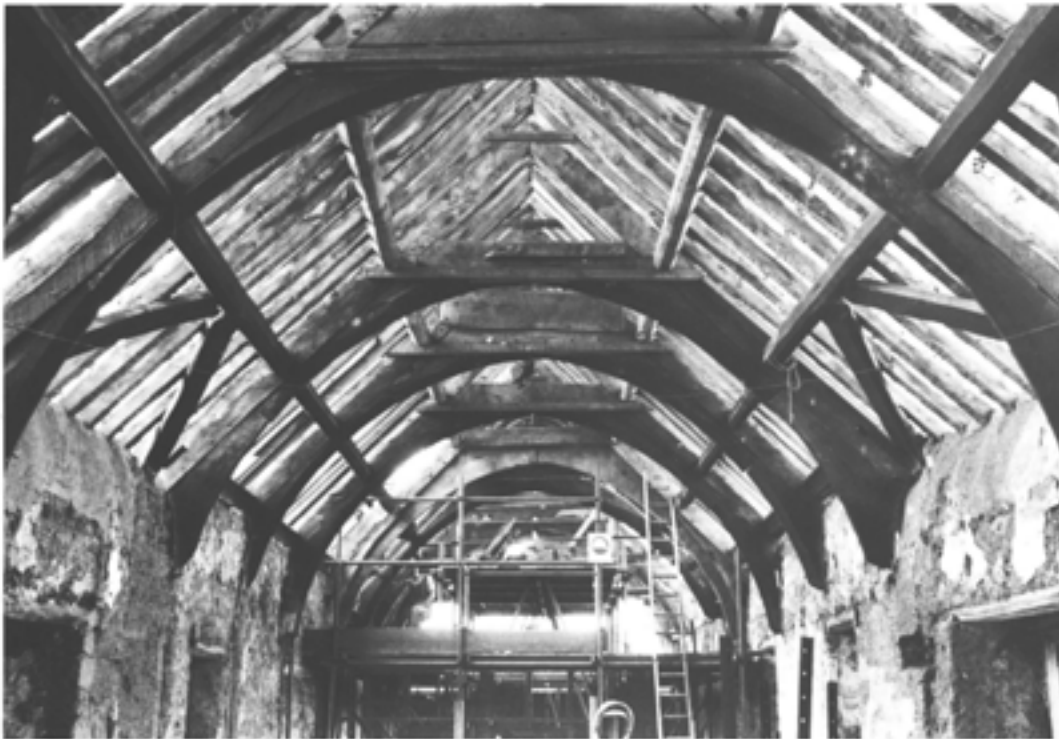
*Figure 7.28*  
General view of the roof of the oriel and inner chambers in May 1988, looking east, with truss IX in the foreground. Note especially the differential treatment of the feet of the trusses: those on the right (lodged on the stone of the south wall) are cut off at the base of the arch braces; those on the left (set in the cob of the north wall) have long posts stretching down to floor level (see elevation Fig 6.25) (photograph by Stuart Blaylock; EMAFU 1449/23a).

The common rafters and other timbers of the roof are free of nails and lath marks of ceilings, implying that this room was not ceiled in the early phases (torching between the rafters is possible, although unproven). Later 19th-century ceilings at a low level are described above from the evidence in the elevations (*see* Chapter 6, and Figs 6.22 and 6.25); these were replaced in phase 11 by a modern ceiling on the soffits of the common rafters and at the apex of the arch braces (*see* Figs 7.28 and 2.28).<sup>33</sup>

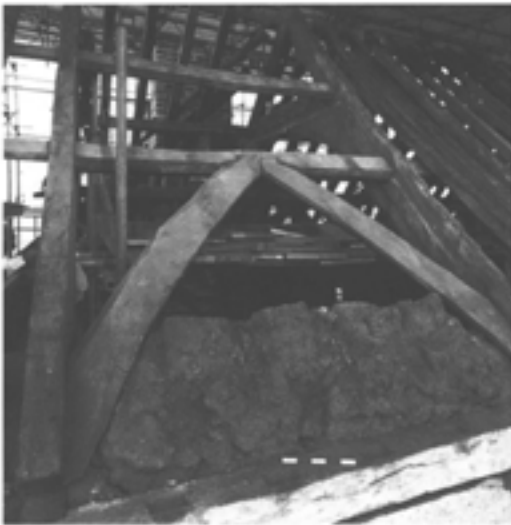
Figure 7.30 (top, left) Bay 10 (south) with common rafters removed in November 1992. Note the wall plate with mortices for the common rafters and the unpegged dovetails of the windbraces (photograph by David Garner; EH B926262).

chamber) was omitted in the oriel chamber and the cob infill of the wall tops now rose into the roof to the soffits of the rafters (Fig 7.29, see also Figs 7.4 and 7.30). The three bays of the oriel chamber have pairs of windbraces that strengthen the angle between principals and lower purlins at the same level as the middle purlins of bays 5–7. These elements are curved planks with chamfers on the lower edges secured to the principals by long soffit tenons (pegged) and to the purlins by bare-faced dovetail joints (unpegged; Figs 7.30–7.31; see also Fig 7.29, detail). At the apex of the windbrace assemblies in each bay, a gap of some 100–150mm is left between the terminals, matching a block of timber left unchamfered at the centre of the purlins. These are probably the seating for bosses (*cf* the unchamfered blocks left for the bosses on the intermediate trusses of chamber and

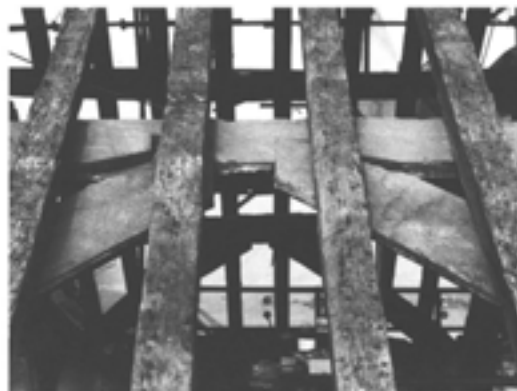
Figure 7.33 As Figure 7.32 from the outside, bay 8, south, showing the gap at the apex of the windbraces, looking north (photograph by Stuart Blaylock; EMAFU 1803/15).

hall roofs, above). The blocks have been removed in every bay, but evidence survives for their positions in the form of slight scars where the timber has been chiselled off or traces of cuts in the chamfers (Figs 7.32 and 7.33; see also Figs 6.25 and 7.29). It is not known whether bosses were fitted here and subsequently lost or were omitted as an alteration during construction.

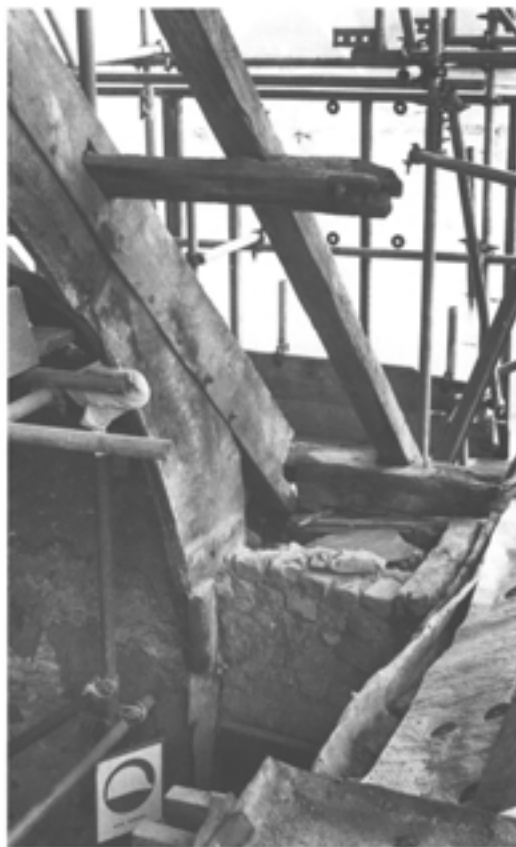
Figure 7.34

The west face of truss XI, south side, showing the extended purlins and wall plate carrying the common rafters over the west gable wall, September 1992. Note also the assembly marks and the blind rear face to the truss (photograph by Stuart Blaylock; EMAFU 3033/1).

abuted the inside face of the cob gable wall. The treatment of the lower terminals of the principals and the longitudinal members displays an unusual configuration related to the continuation of the rafters over the gable wall. The eaves purlins were continued across the line of truss XI by 0.75m and the lower ends of the principal rafters were cut to fit underneath the purlin in a halved joint (Fig 7.34, south, and Fig 7.35, north; see also Fig 5.22). The purlins of bay 10 were also carried across the line of the last truss by halving the thickness (to that of the tenon alone) and threading the resulting thinner timber through the mortice. The extended timbers supported two common rafter couples to the west of truss XI, of which one survived and one (no. 57) was missing (see Fig 7.34), as well as (presumably) an eaves assembly. This arrangement is of interest in its own right, but also because it gives some indication of how the roof might have been treated over the east and north gables, where no evidence had survived.<sup>36</sup>

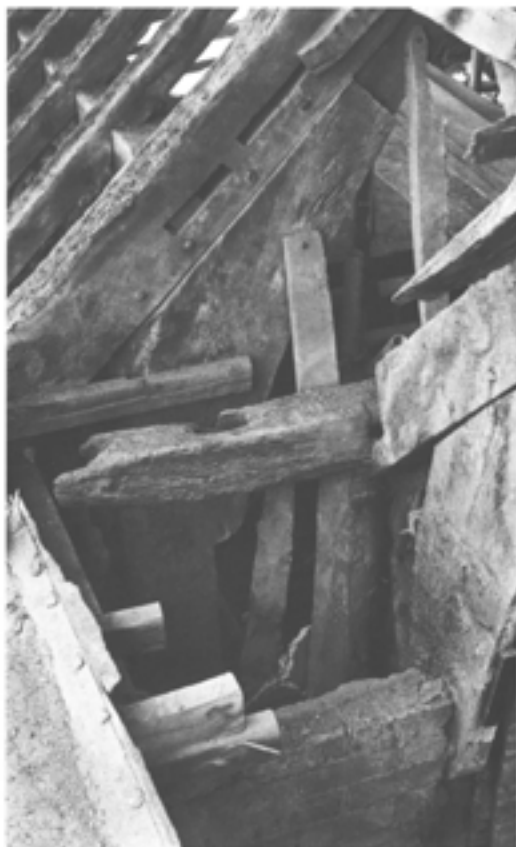
Figure 7.35

As Fig 7.34, detail on the northern side of truss XI. Here can be seen the top of the brick blocking of phase 8, inserted after the removal of the gable wall (bottom), and the western post of truss I of the west range behind (photograph by Stuart Blaylock; EMAFU 3025/31).

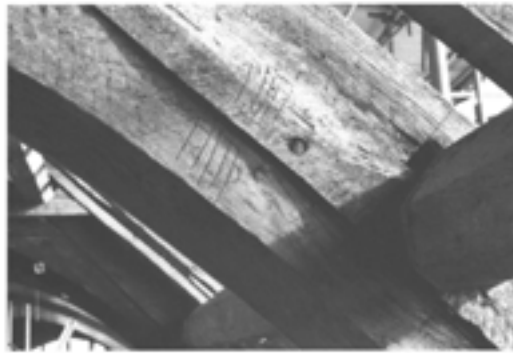
Figure 7.36  
Detail of assembly marks on truss IX, south side, principal rafter and arch brace (photograph by Stuart Blaylock; EMAFU 1803/2).

The numbering system continues (Fig 7.36, detail of marks on truss IX). The marks on common rafters continue in jumbled order in bay 8: RT 35, IIII; RT 36, II; RT 37, I; RT 38, V; RT 39, III; RT 40, VI; RT 41, VIII; RT 42, VII. In bays 9 and 10 the rafters survive in sequence and thus may not have been disturbed by past re-roofing activities (or were replaced with greater care). The rafters of bay 9 run in reverse sequence, VIII to I over common rafters 43 to 50; those of bay 10 are numbered I to V, RTs 51 to 55 (although the number III is missing on RT53). No numbers were observed on the two rafter trusses beyond the limit of bay 10 covering the western gable wall. Perhaps these were not prefabricated.

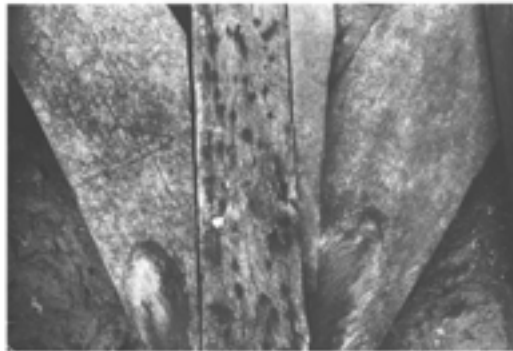
Figure 7.37  
The lower ends of windbraces in the oriel chamber, showing assembly marks, truss X, bays 9/10, south side (photograph by Stuart Blaylock; EMAFU 1803/21).

The purlins continue the numbering established from bay 5 (described above). The numbers IIII and V are marked on the eaves purlins and upper and lower purlins of bays 8 and 9 respectively, although no equivalent numbers (VI) were seen in bay 10. The windbraces are individually numbered (at the lower terminal of the upper surface) from east to west. Thus the windbraces of bay 8 are numbered I and II; bay 9, III and IIII; and bay 10, V and VI (Fig 7.37, showing the braces numbered IIII, right, and V, to either side of truss X, south side).

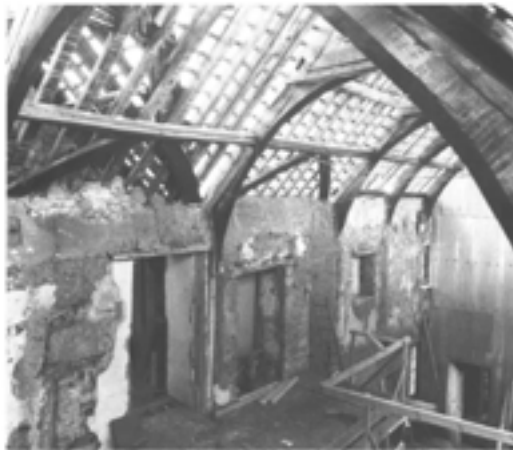
Figure 7.38  
Oblique view of the north elevation of the oriel and inner chambers, when the floors were removed in October 1985. Note the scar of the cross wall, right of centre, and traces of ceilings in oriel chamber (EH B850150/6).

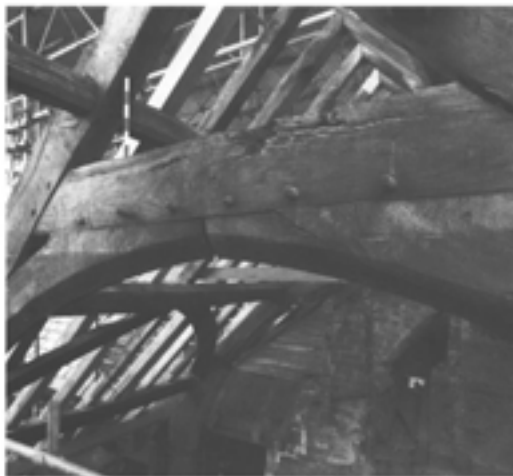
Figure 7.39  
General view of the interior of the roof of the west range, with truss II in the foreground, looking south. Note the protruding pegs (photograph by David Garner; EH B930166).

The roof has windbraces of similar form to those of the oriel chamber (see Fig 7.39). They are fixed with the same types of joint, but the dovetails on the middle purlins are secured by pegs, a detail omitted in the previous examples (Fig 7.41). The arrangement of windbraces shows that the filling of the northern half of bay 2 was accounted for in the design of the roof, as no mortises had been cut in the purlins in the northern side of the bay, where the timbers were obscured by the chimney (Fig 7.42). This represents another sign of better integration of the construction of walls and roof in the west range than elsewhere and supports the suggestion that the west range was built in a traditional structural sequence, perhaps after the other surviving ranges.

The principal trusses are numbered on their north faces starting from the south, indicating that the direction of erection was from south to north (this is confirmed by the pegs, which are all inserted from the north; see Fig 7.39). The two surviving trusses bear marks on all the main timbers (see Fig 7.39). The lower purlins bear the number of the bay/adjacent truss at their southern ends.<sup>40</sup> Some evidence of the numbering of common rafters was recorded, apparently continuous through bays 1 and 2, although the rafters were out of order (as in the south range) and some numbers were missing: RT 1, III; RT 2, III; RT 3, VII; RT 4, II; RT 5, V; RT 6, VIII; RT 7, I; RT 8, X; RT 9, XII; RT 10 (uncertain); and RT 11, XIII.

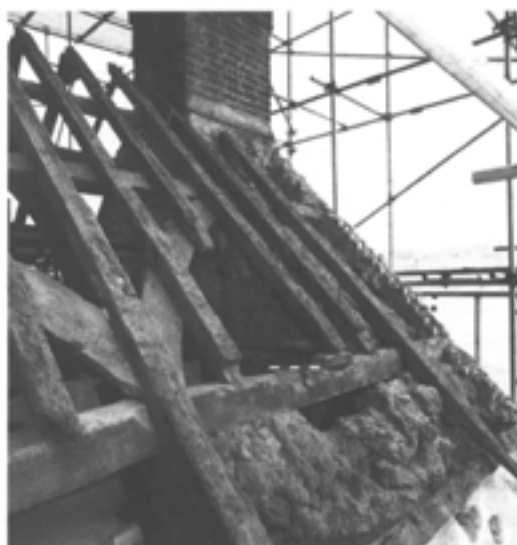
Figure 7.40

The east side of the roof of the west range when stripped in July 1992, with later rafters removed and surviving primary rafters in position. Note the rafters jointed into the cornice rather than the eaves purlin and the eaves purlin set diagonally (photograph by David Garner; EH B924254).

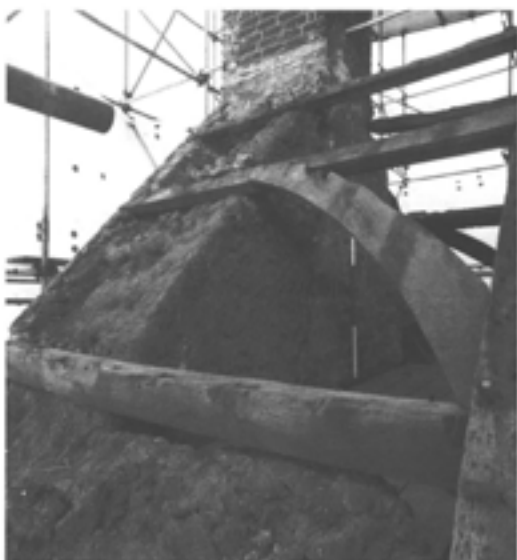
Figure 7.42

The west side of the roof of the west range in January 1993 after further stripping and removal of rafters, showing how the roof was carried over the gable wall (modern brick facing on the outside face). Note the absence of a mortise for the second windbrace (photograph by David Garner; EH B930171).

The purlins show another variant arrangement in which the lowest internal purlin is set at the top of the wall-top infill as a cornice, in the manner of the equivalent timbers in the inner chamber (see Fig 7.42). The timbers are chamfered in the same way as the other purlins, but are set square rather than diagonally and thus are strictly plates rather than purlins. Each bay originally had seven common rafters. The elevations (see Figs 5.22 and 5.27) show those which had survived (after the removal of later softwood additions; see also Figs 6.69 and 7.40). The common rafters are pegged to the middle purlins (on both sides of the roof), a detail not employed in the south range and suggesting that additional strengthening was necessary in this roof. Birds-mouth joints are employed to fix the common rafters, but they are fixed to the lower purlins (cornices) on both sides of the roof instead of the eaves purlins as in the south and east ranges. On the west side of the roof the rafters continue to eaves level nonetheless, but on the east side the surviving rafters terminate (or were cut off) at the cornice. This variation may have been determined by the need to provide for the roof of the gallery on the east side of the range.<sup>39</sup> Peg holes in the eaves purlin of bay 2 (east), at variance with the common rafters, may represent the positions of the extension rafters of a cat-slide roof over the gallery, overlapping the main common rafters (see Fig 5.27 and discussion of the evidence for a gallery in Chapter 5). No evidence survives in the roof of bay 1, as the eaves purlin was removed (with the rest of

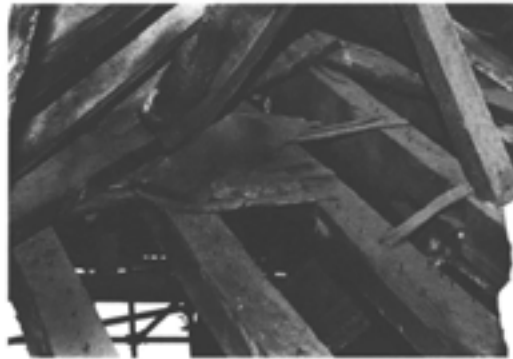
Figure 7.43

Detail inside the roof of the west range over the south range, showing the rafters of the roof of the south range, lath and mud-plaster covering south range, lay boards and chock for the purlin above laths (modern softwood rafters above). Note the lath nails in the common rafters (EMAFU 1984/26a).

on top of the laths; these served to support the south ends of the upper purlins where they met the roof of the south range (Fig 7.43) and show that the laths were applied to the roof of the south range prior to the construction of the roof of the west range (or at least the oversailing part of it).<sup>43</sup> Next the lay boards were positioned. The western board was halved under the eastern at the apex and both were oak planks, lengthened by simple edge-halved scarf joints.<sup>44</sup> Both lay boards were decayed at the eaves and the details of the treatment at this point did not survive. Evidence for the primary chimney rising through this part of the roof and abutting the unchamfered south face of truss 1 of the west range is discussed in Chapter 6.

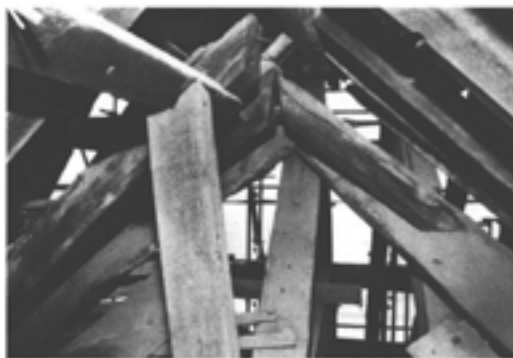
Figure 7.44

View inside the oversail of the roof of the west range, showing lay boards and jack rafters, looking south. Note the pegged joints at the apex (EMAFU 1984/33a).

pegged at the apex (Fig 7.44) and fixed to the lay boards with nails. One rafter survived on the west side and four on the east side (Fig 7.45). Once the roof was complete, the outside of the roof of the south range within the void was plastered with daub. Later softwood purlins supported a range of later common rafters and other inserted timbers from the re-roofing in phases 8 and 9. No original valley boards or other finishing timbers had survived.

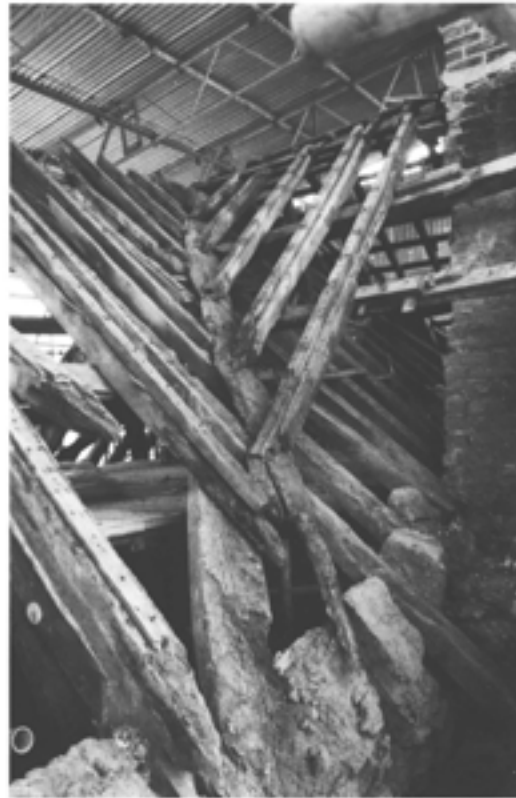
Figure 7.45  
 Junction of the roofs of the  
 south and west ranges,  
 showing the original lay  
 board and jack rafters, east  
 side, looking south-west  
 (EMAFU 1987/04).

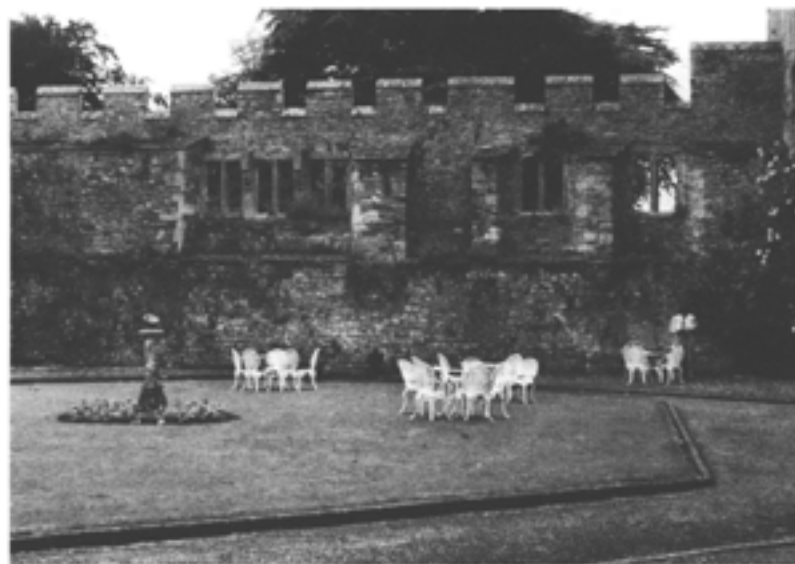
*Figure 8.3*  
 Thornbury Castle,  
 Gloucestershire, the stone  
 boundary wall of the  
 gallery around the Privy  
 Garden: (left) west wall,  
 interior (EA 3431/21);  
 (right) detail showing the  
 blocked doorway that gave  
 access to the gallery (via  
 stairs) from the first floor of  
 the adjacent range (EA  
 3431/34) (photographs by  
 Stuart Blaylock).

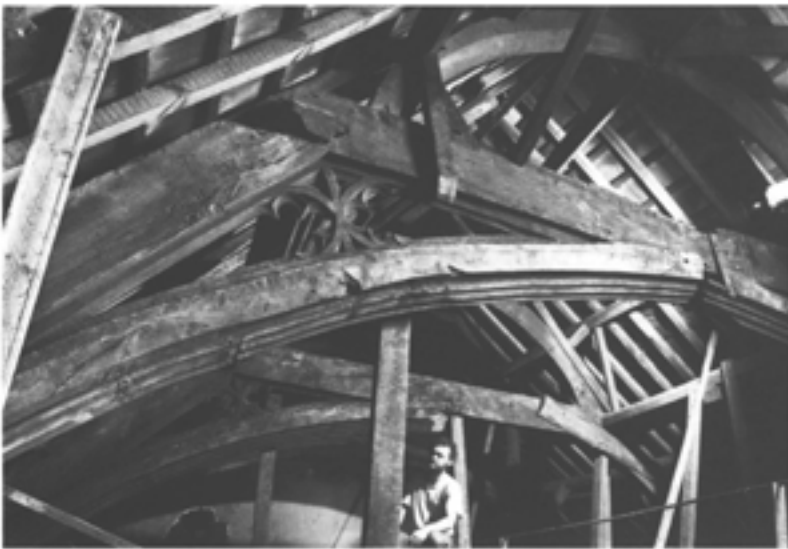
Figure 8.7  
Archdeacon of Exeter's House: short principal, collar and arch braces. Note the tracered spandrels and sawn-off upper purlin (photograph by David Garner; EMAFU 3326/12) (source: Exeter Archaeology; © Exeter Archaeology).

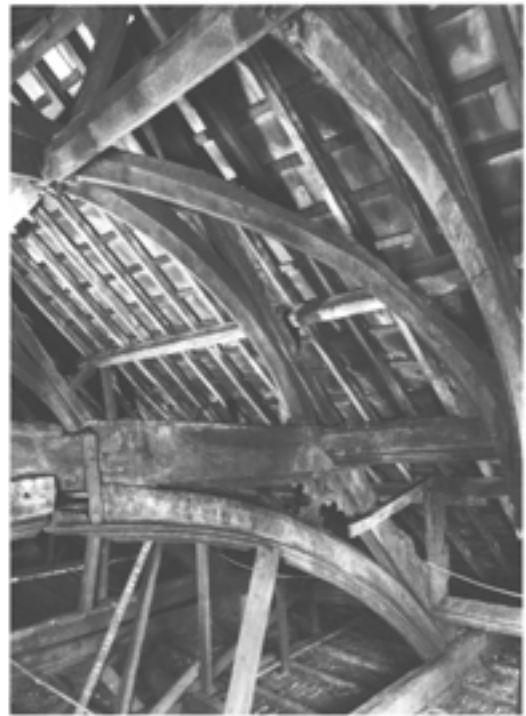
Figure 8.8  
Archdeacon of Exeter's House: purlins and 'vaulting' ribs (photograph by David Garner; EMAFU 3326/5) (source: Exeter Archaeology; © Exeter Archaeology).

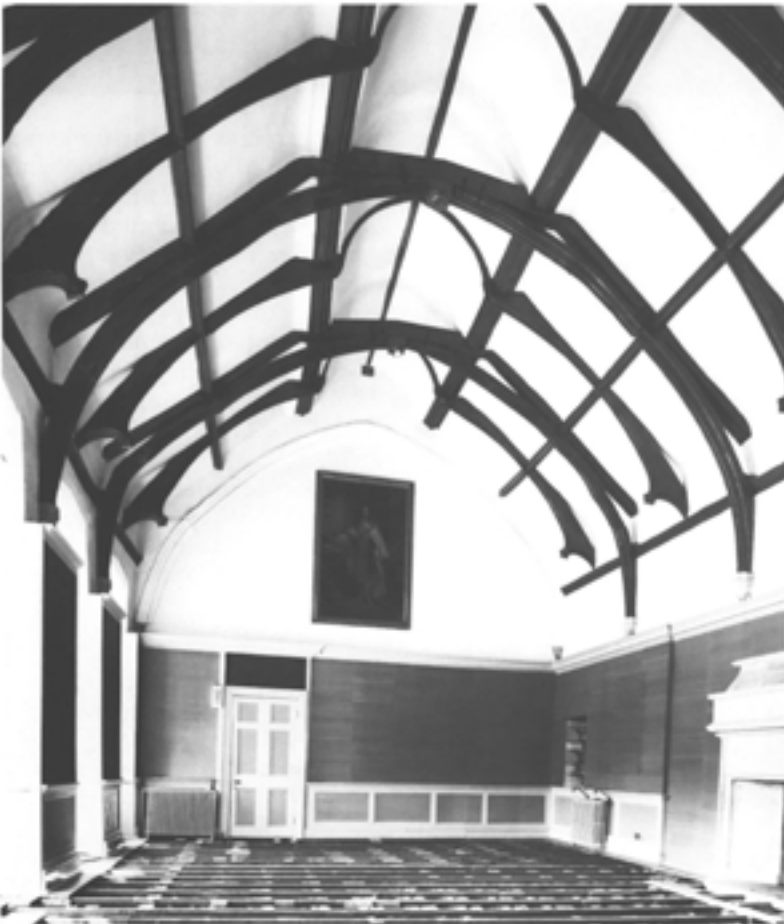
Figure 8.9  
The Deanery great chamber in August 1998, looking south-west (photograph by David Garner; EA 7058/2) (source: Exeter Archaeology; © Exeter Archaeology).

Some roofs omit certain features. The Deanery, for instance, has no windbraces (*see* Fig 8.9) and bosses have often been lost (as in the hall at Bowhill). The distinctive character of the group is evident, however, despite departures from the standard pattern.

The Deanery roof belongs to a building added to the 'lower' end of the earlier hall. This structure is of two storeys and accommodated a parlour on the ground floor, with a ceiling of intersecting moulded beams with large fleurons at the intersections, and a great chamber or first-floor hall above (see Fig 8.9).<sup>92</sup> It is possible that this work may have been inserted into an earlier building or at least that it incorporated earlier fabric. It is, therefore, difficult to judge whether the work represents a single programme of construction or whether the various elements could have been introduced piecemeal at different dates. The dendrochronology has suggested that the floor and roof were constructed at a similar date in the early 15th century (with estimated felling-date ranges of 1400–35 for the timbers of the floor and of

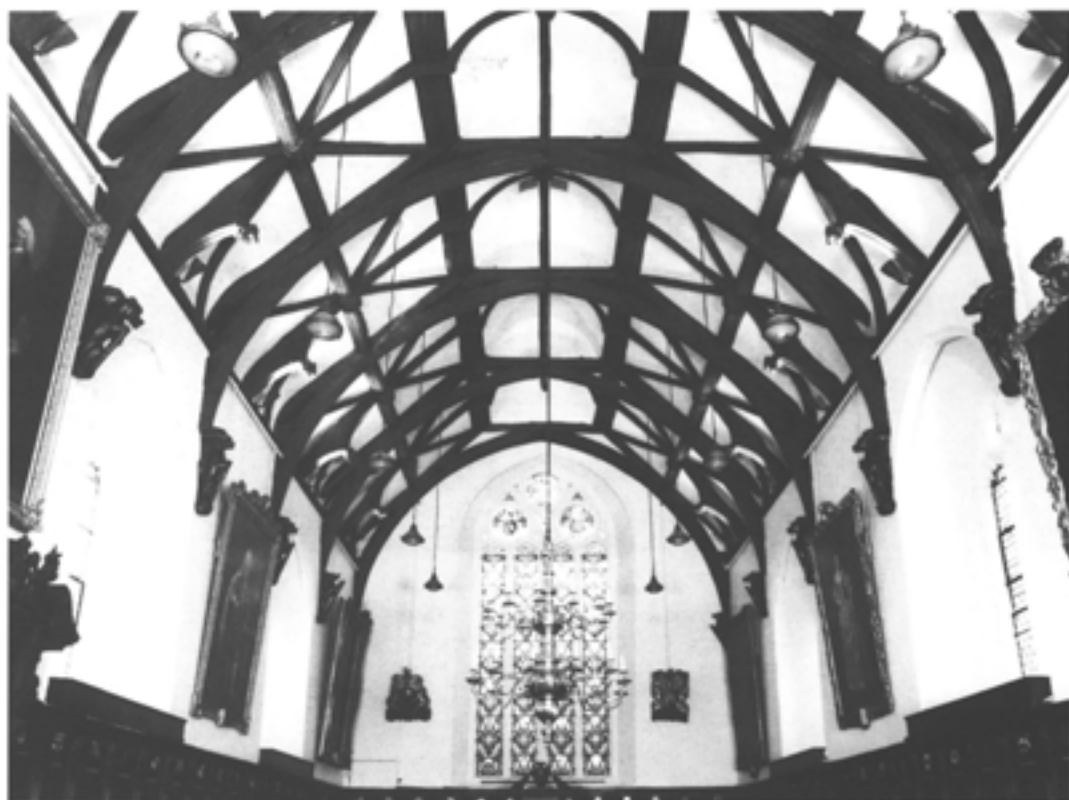
Figure 8.10  
Exeter Guildhall: general  
view, looking north (photo-  
graph by David Garner;  
EA 7419/1) (source: Exeter  
Archaeology; © Exeter  
Archaeology).

The combination of highly competent design and manufacture with a poor attention to detail in the fitting of the roof is one of the distinctive aspects of Bowhill. Similar infelicities appear at the Guildhall (Fig 8.10), where the lack of registration between the roof and the long elevation led to awkward relationships between the corbels and windows. These are the more surprising as the whole structure appears to be of one build.<sup>83</sup> Similar disregard for symmetry may have occurred in other buildings in the group, although the information available is often deficient.<sup>84</sup> It should be emphasised that the

Exeter's civic archives, principally the Receivers' accounts, suggest that the Guildhall was rebuilt in 1467–9. The roof probably (though not certainly) belongs to this campaign of work (see Fig 8.10).<sup>96</sup> The results of the dendrochronological analysis are consistent with this date bracket, suggesting a felling-date range of 1463–98 for the samples for the roof. Of the roofs that are dated with any certainty, therefore, the Guildhall is the closest in date to Bowhill (which was probably built in the last decade of the 15th or the first of the 16th century, with a possible shorter range of c 1500–6; see discussion in Chapter 12) of any building in the group. This seems to be supported by the evidence of mouldings (see above).

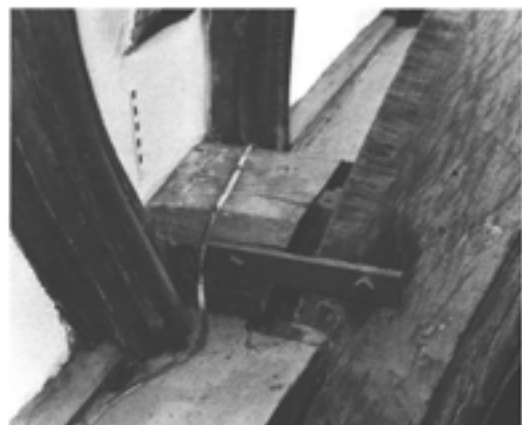
Figures 8.11 and 8.12  
Exeter Guildhall: (left)  
oblique view along the west  
side of the roof (bays 3–1),  
looking north, main truss III  
in foreground (EA 3620/16)  
(right) main truss IV, detail  
of wall-top assembly (EA  
3620/20) (photographs by  
David Garner; source:  
Exeter Archaeology;  
© Exeter Archaeology).

Comparison of mouldings enables some connections to be identified within the group (see Fig 8.5). The mouldings and carved details of the Guildhall roof (Figs 8.11–8.17; cf Figs 7.6, 7.7 and 7.13–7.17) provide the closest similarities to the roofs of Bowhill, although they are always more slender in scantling at Bowhill than in the Guildhall. The intermediate truss, lower

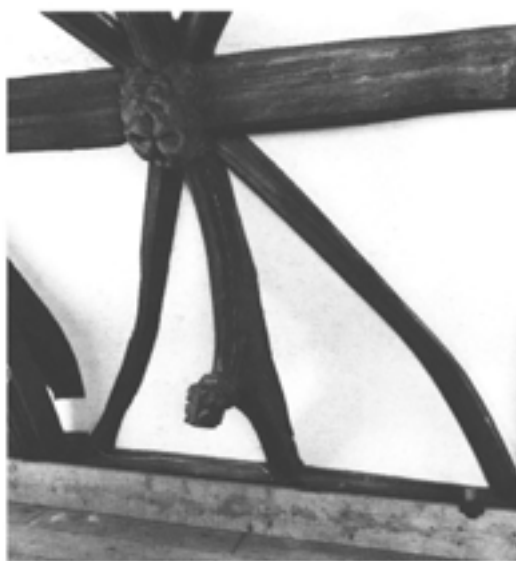
Figure 8.13  
Exeter Guildhall: detail of bay 1, looking west, showing the intermediate truss and windbraces (photograph by David Garner; EA 3621/01) (source: Exeter Archaeology; © Exeter Archaeology).

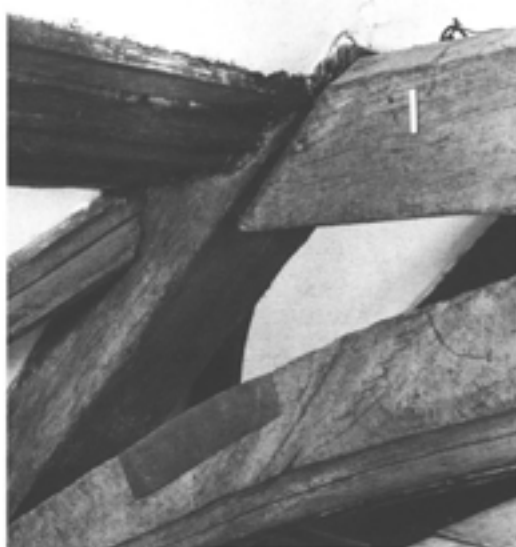
Figure 8.14  
Exeter Guildhall: main truss, detail of the collar/arch brace/upper purlin assembly (photograph by David Garner; EA 3620/07) (source: Exeter Archaeology; © Exeter Archaeology).

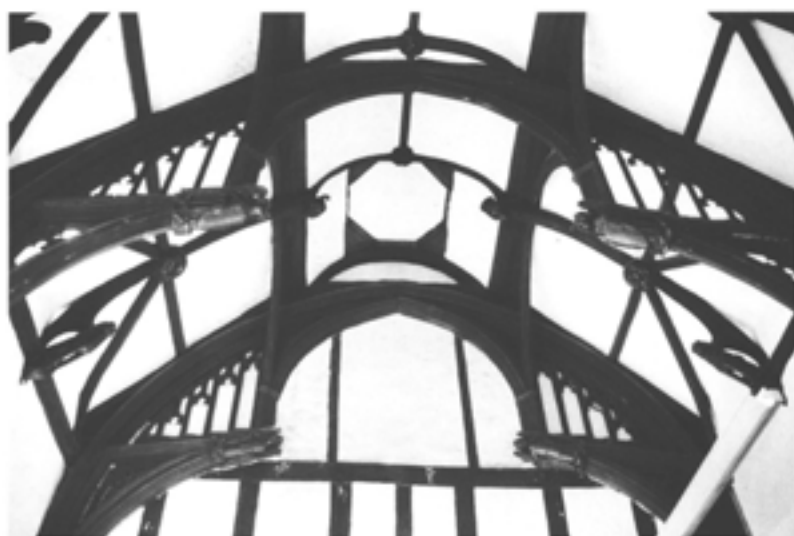
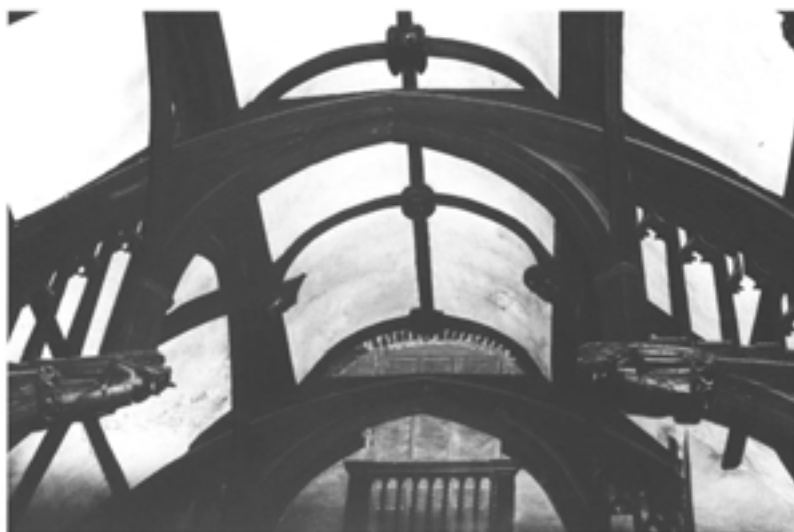
Figure 8.18  
The Law Library, no. 8  
The Close, Exeter: the roof  
looking south-east (photo-  
graph by Stuart Blaylock;  
author's own collection).

Figure 8.19  
The Law Library: detail of  
coving, looking north-west  
(EMAFU 955/9) (source:  
Exeter Archaeology;  
© Exeter Archaeology).

Another marked similarity occurs between the mouldings of the Deanery and The Law Library, although the matter is complicated by the additional timbers found in the more complex assembly of the hammer-beam roof (with fatter and more developed mouldings; Figs 8.18–8.19). Where the members are comparable there is a good match between the two. The main arch braces of the Deanery show the same basic moulding as the subsidiary braces of the roof at the Law Library,<sup>88</sup> composed of an ogee and a plain chamfer separated by a prominent quirk (a feature which also occurs in the Archdeaconry, *see below*). Subsidiary timbers in both roofs employ the simpler moulding of a hollow-fillet-roll-fillet profile on intermediate trusses, cove purlins and lower purlins throughout. The similarities extend to the more complex mouldings of upper purlins and cornices. The former are identical in the two roofs, the latter different, but similar in character (*see Fig 8.5*).

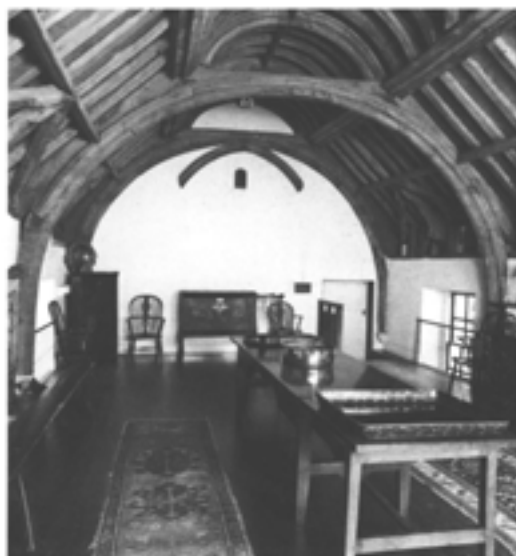
Figure 8.21  
Cadhay, the hall roof: bay  
elevations, looking south-  
east (photograph taken by  
David Garner with kind  
permission of O N W  
William-Povelett Esq;  
EH B960124).

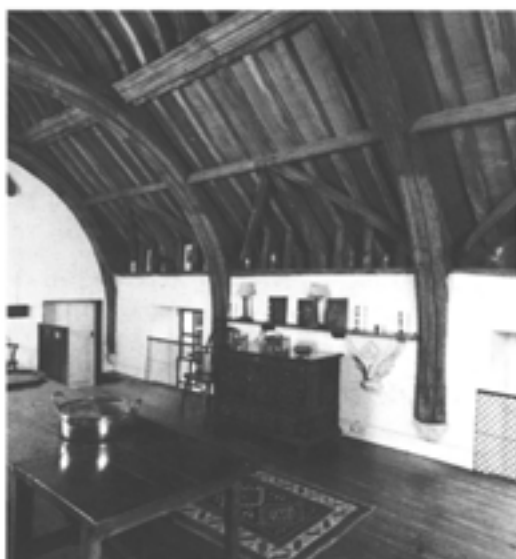
Figure 8.22  
Cadhay, the hall roof:  
detail of the coving, upper  
purlins and arch braces  
(photograph taken by  
David Garner with kind  
permission of O N W  
William-Povelett Esq;  
EH B960126).

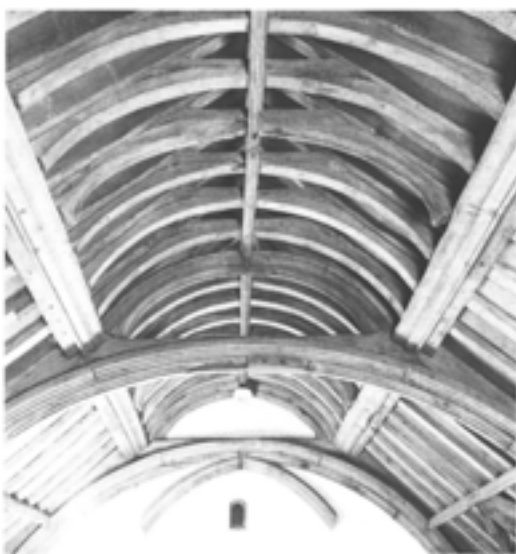
Figure 8.23  
Weare Giffard Hall: the hall roof in 1915, looking north-west (photograph from *Tipping 1915*, 21, fig 8) (reproduced courtesy of *Country Life*; © *Country Life*).

The second group of late medieval roofs is exemplified by Weare Giffard Hall. This building has a roof which is unparalleled in the exuberance and extent of its decoration (Fig 8.23), but which nevertheless has connections with a number of other, less ornate roofs in north and east Devon. Weare Giffard is probably to be dated between 1485 and 1503 on the grounds of allusions in the glazing of the dais window of the hall to Henry VII and John Fortescue (d 1503).<sup>111</sup> This roof and those others described below should strictly be termed

false hammer-beam roofs, as the hammer beams support arch braces rather than hammer posts.<sup>112</sup> The distinguishing features of the roof are heavily moulded hammer beams, multiple moulded wall plates or cornices (among other timbers) and arch-braced subsidiary or intermediate trusses within the main bays of the long elevation. The rhythm of main and intermediate trusses frames the division of each bay into panels by the purlins, the (apparently double) ridge pieces, the intermediate trusses and additional moulded sub-principals placed against each face of the (unmoulded) principals (and secured to them by lateral slip tenons). The resulting panels are richly ornamented with cusped diagonal windbraces.<sup>113</sup> Cusping and recusping is a feature of the principal rafters too. The only comparable example of this treatment in Devon is in Tuckers Hall, Exeter, where evidence for additional cusping survived in the form of long linear mortices in the soffits of the principals.<sup>114</sup> Weare Giffard also shares the detail of a double, or composite, ridge piece with Orleigh Court and West Challacombe (*see below*).<sup>115</sup>

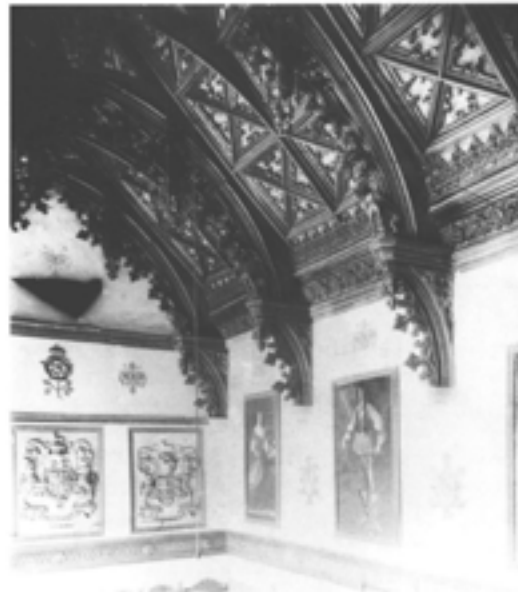
Figure 8.24  
Orleigh Court, Buckland Brewer: the hall roof (EH/NMR BB69/615).

Orleigh Court, Buckland Brewer, has a closely related late medieval roof in its hall. Although the ornament is generally simpler (Fig 8.24), the two roof structures share a number of decorative details, including moulded hammer beams, multiple cornice timbers and similar heraldic beasts.<sup>116</sup> Again each bay is divided into six panels by arch-braced intermediate trusses, purlins, double ridge pieces and moulded sub-principals. Here the panels are filled with cross braces set square and diagonally in alternate panels, with small central bosses.<sup>117</sup> The roof of the former open hall (now floored) at West Challacombe, Combe Martin, dated by dendrochronology to the third quarter of the 15th century,<sup>118</sup> has a very similar arrangement of moulded cornices and hammer beams, intermediate trusses, panelled bays with multiple windbraces (although a different pattern), double ridge pieces and moulded sub-principals (Fig 8.25).<sup>119</sup> The sub-principals are attached to the faces of the principal rafters by lateral slip tenons, providing a link in structural technique to Weare Giffard. A similar double ridge member to those of West Challacombe and Orleigh Court appears at South Yard, Rose Ash (although this is a single timber), in another highly decorated roof, albeit with a different emphasis and slightly earlier than the other examples (dated by

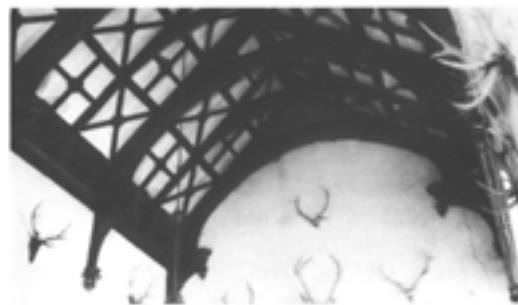
Figure 8.25  
West Challacombe, Combe Martin: the hall roof, looking west (photograph by David Garner) (reproduced courtesy of The National Trust; © The National Trust).

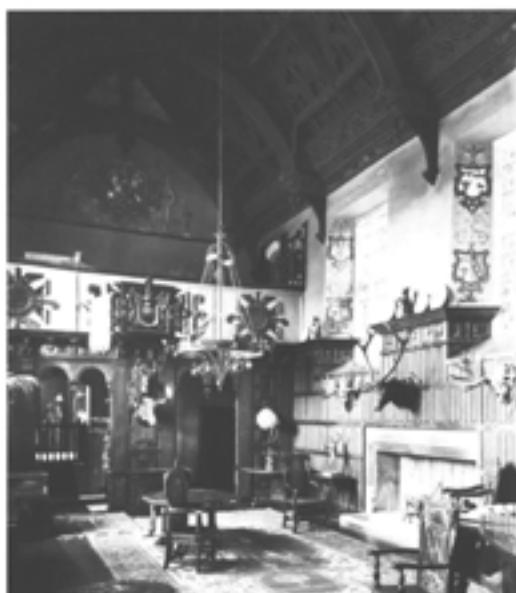
Figure 8.26  
Bradfield, Uffculme: the  
hall roof, looking south  
(EH/NMR CL L5096–  
5102) (reproduced  
courtesy of Country Life;  
© Country Life).

dendrochronology to 1447–8).<sup>120</sup> Lastly the roof of the hall at Bradfield, Uffculme (near Cullompton; Fig 8.26), displays similarities in its key elements – intermediate trusses, heavily moulded hammer beams and multiple cornice plates (although other aspects of this roof appear to be rather different again).<sup>121</sup> One further connection, although distant, is a false hammer-beam roof at Traymill Farm, Thorverton. This is almost wholly unmoulded (only the cornice timbers are moulded, here, very curiously, morticed into the ends of the hammer beams) and it has none of the elaborate ornament seen in the other roofs.<sup>122</sup>

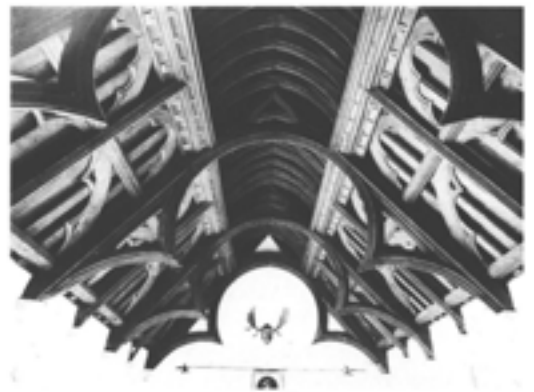
Figure 8.27  
Athelhampton Hall,  
Dorset: the hall roof,  
looking north-west. Note  
the square-set upper purlins  
and moulded cove braces  
(EH/NMR BB99/11093).

The roof of Athelhampton Hall, Dorset, displays the now familiar rhythm of main and intermediate trusses. Here the arch braces of the main trusses are extended in extraordinary large cusps, giving the roof a trefoil section.<sup>141</sup> The hall was built by Sir William Martyn, beginning after 1493.<sup>142</sup> It is thus very close in date to Bowhill, but also post-dates some buildings of the Exeter group. Aside from the general similarities of bay arrangement and moulded decoration at Athelhampton, one detail of the treatment stands out. This roof has a square-set upper purlin or plate richly moulded on its lower edge, that supports curved (and moulded) braces to each common rafter truss (Fig 8.27).<sup>143</sup> Although these braces form slightly pointed arches and have no longitudinal member (cove purlin), they form a coved upper stage to the roof very similar to the Exeter roofs. One notable difference is that at Athelhampton every brace is moulded, whereas in the Exeter group only those of the main and intermediate trusses are so treated. This shows that the braces of the coving at Athelhampton were exposed to view and could support the idea that the coving at Bowhill was ceiled (Chapter 7).

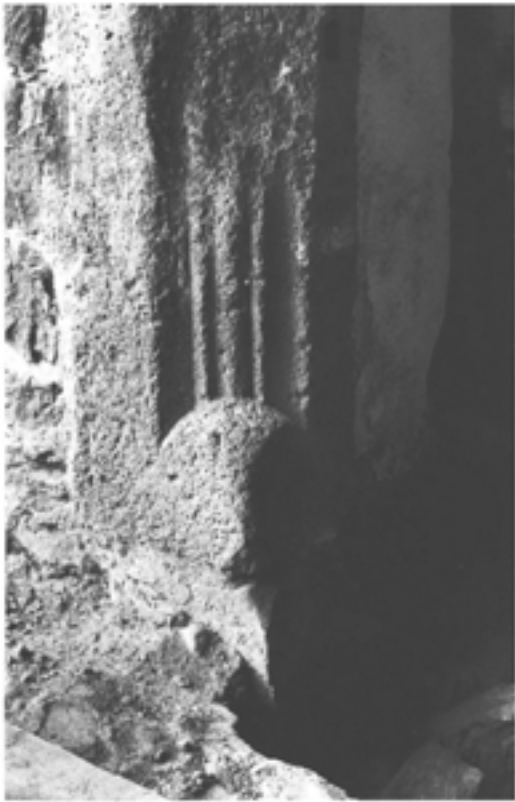
*Figure 8.30*  
Detail of the moulding and  
stop of the west door of the  
screens passage, north side  
(photograph by Stuart  
Blaylock; EMAFU  
1834/4).
