# Bowhill

The archaeological study of a building under  
repair in Exeter, Devon, 1977–95

*The archaeological study of a building under  
repair in Exeter, Devon, 1977–95*

Published in association with Exeter Archaeology as Volume 5 in the  
Exeter Archaeology Reports series

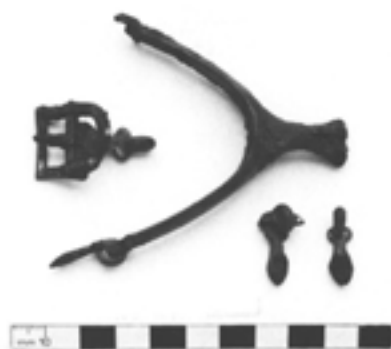
Figure 9.6  
Copper-alloy spur, catalogue no. 42 (photograph by David Garner; EH B960388).

bosses which hold the rowel pin. Only two points of a small iron rowel survive and they are rusted into the rowel box. Three rings of the spur terminals are damaged. The unbroken one holds a copper alloy attachment of slender lozenge shape, with two small bulges flanking the base of its ring. A rust patch shows that the missing stud that would have been pressed through a slit in the spur leather was iron. Two more stud attachments that are now detached but accompany the spur are of similar form and condition, one of them still held by the broken part of one spur terminal. The copper alloy buckle, now separate, has a D-shaped frame with central bar and an iron buckle pin. The rod within the bar also appears to be iron. The buckle plate is waisted with two projections flanking the base of its ring as on the attachments for the leathers. Those parts of the buckle frame and spur sides that are not covered in corrosion are very smooth, but traces of thin non-ferrous coating survive, especially on the buckle. L (overall, measured along neck to midway between terminals): 70mm; L (neck): c 22mm; span (between terminals): 67mm; buckle frame: 25 × 21mm; L (attachments) 22 and 23mm.

42. Rowel spur in copper alloy, with iron rowel, studs and buckle pin (Fig 9.5; see also Fig 9.6). Traces of non-ferrous coating. From context 2057 (small find no. 58).<sup>109</sup> Typologically the spur dates to  $c 1700$ .

The spur may have been made for a youth, but despite its small size it could have been worn by an adult. A small spur of this type is worn on the narrow part of the ankle above the heel in the painting of *King William Landing at Brixham, Torbay*, by Jan Wyck and dated 1688.<sup>110</sup> A pair of spurs of the same basic form are hallmarked 'London 1729'. They are silver with steel rowels.<sup>111</sup> The addition of iron parts to non-ferrous spurs was a fairly common practice.

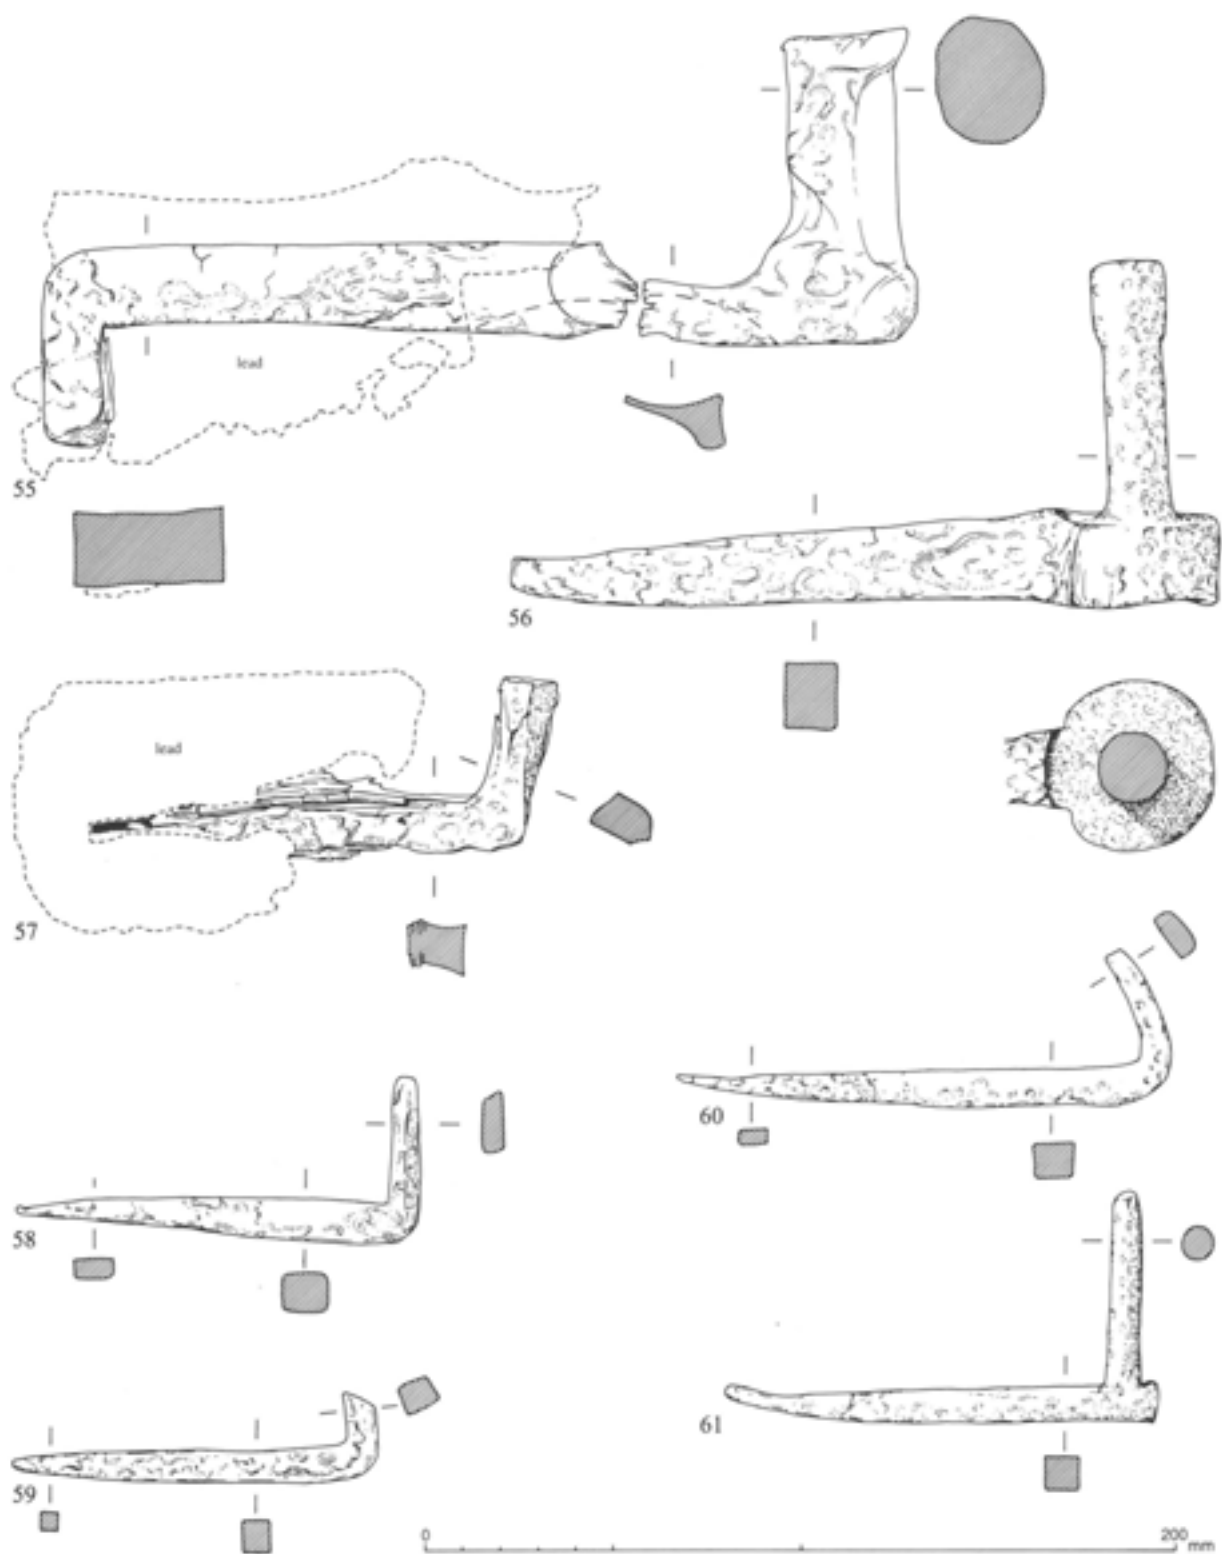
Figure 9.8  
 Architectural ironwork, catalogue nos 55–61; scale 1:2 (line drawing by Tony Ives).

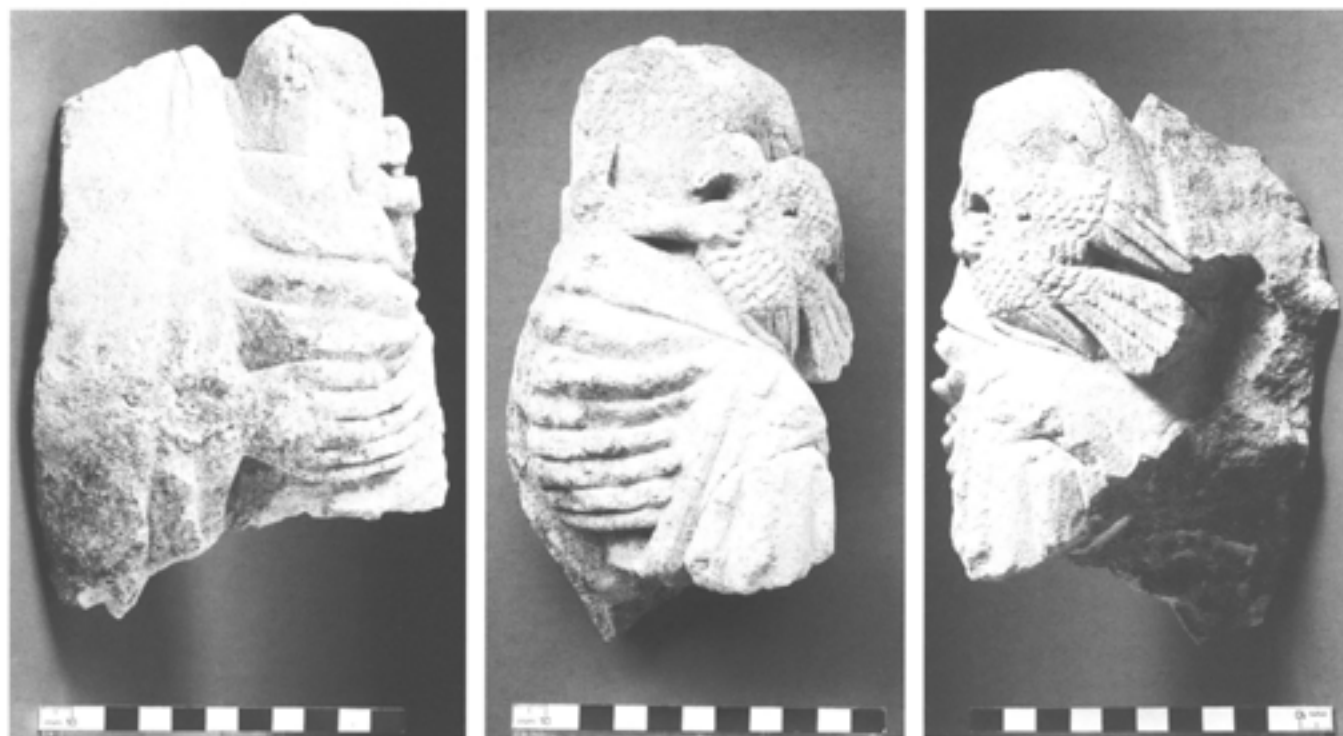
Figure 9.10  
Fragment of sculpture,  
catalogue no. 103: (left)  
side view (EH B960378);  
(centre) front view (EH  
B960380); (right) side  
view (EH B960379)  
(photo-graph by David  
Garner).

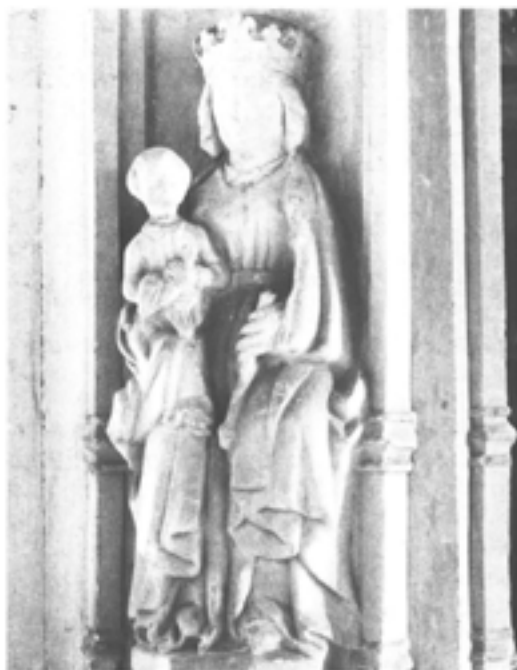
Figure 9.11  
Carving of the Virgin and Child (heads restored) on the tomb of Margaret Beaufort, Countess of Devon (d after 1449), Church of St Andrew Colyton, Devon (photograph by Stuart Blaylock; author's own collection).

The Bowhill piece is closely paralleled in several West Country sources. The first, conceivably a product of the same workshop (*see below*), is a carving of the Virgin and Child, holding a bird (Fig 9.11), on the west end of the canopy of the tomb of Margaret Beaufort, Countess of Devon (d after 1449), in St Andrew's Church, Colyton, Devon.<sup>158</sup> This is of similar size to the Bowhill fragment (*c* 200mm high, but 155mm without the head, which is remodelled in plaster) and may give a clue to its composition when complete. The second local parallel is a fragment of figure sculpture from Muchelney Abbey, Somerset, also of Beer stone, extraordinarily similar both in composition and extent of survival (Fig 9.12).<sup>159</sup> The accounts of its discovery, probably in the vicinity of the north choir aisle, suggest that more of the piece was present on first discovery than now survives and there is now little trace of the polychrome and gilding then described.<sup>160</sup> Little information is available on the context and date of the Muchelney piece, other than a vague suggestion of a 14th-century date (on the grounds of proximity to a tomb of that date);<sup>161</sup> it could be of almost any later medieval date. The subject also appears in 15th-century exterior sculpture on a number of east Devon church towers. Virgin and Child with bird groups appear at Clyst St Lawrence and Talaton, but at Plymtree no bird has survived, although the sculpture is heavily weathered.

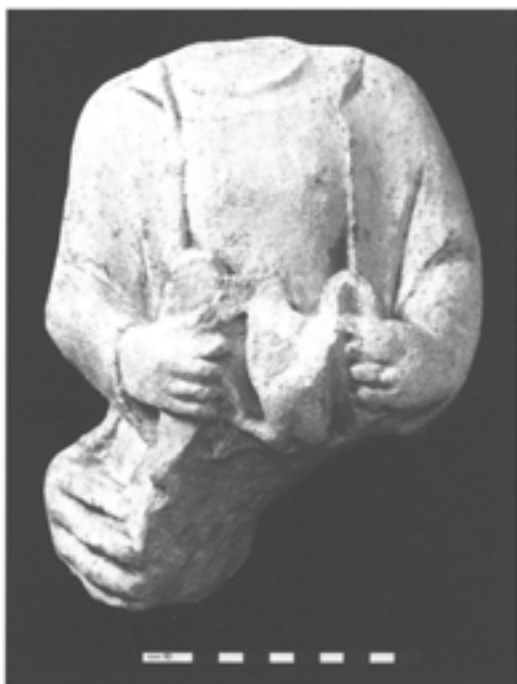
Figure 9.12  
Fragment of figure sculpture of the Virgin and Child from Muchelney Abbey, Somerset (photograph by David Garnstr; EH B990727).

Identification as a representation of the Holy Trinity is an alternative possibility, in which the hand of the large figure is a fragment of God the Father, the small figure represents God the Son and the bird the Holy Spirit (thus a dove rather than a goldfinch). Indeed the subject of the fragment from Muchelney Abbey quoted above, was originally identified as the Trinity.<sup>162</sup> Although this is a persuasive explanation of the fragment in some ways, it is not supported by any convincing iconographic parallels. The Trinity was often represented as a large figure of God the Father, with the figure of the Son either crucified at his feet, or as a smaller figure carrying a cross (the Holy Spirit represented by a dove above or elsewhere in the composition or sometimes omitted altogether and thus more strictly 'God the Father with the crucified Christ').<sup>163</sup> Late medieval alabaster carvings provide frequent examples of this.<sup>164</sup> There are sculptural parallels on roof bosses in the Lady Chapel at Chester and the choir at Lichfield<sup>165</sup> and similar treatments on monumental brasses.<sup>166</sup> Alternatively the

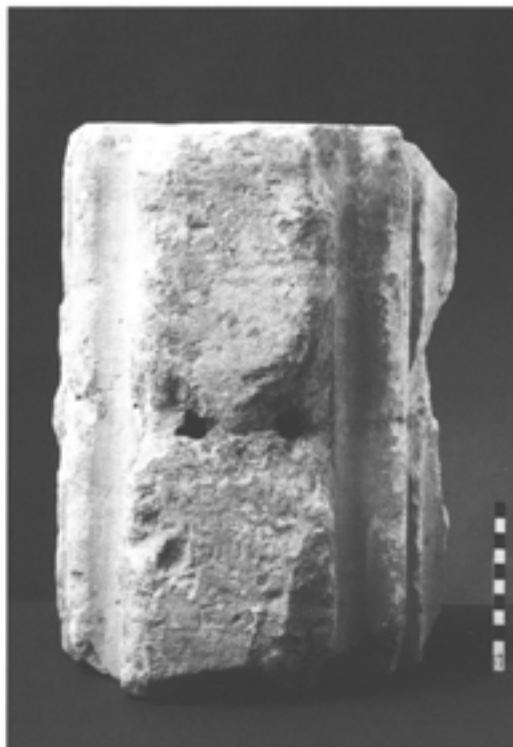
Figure 9.14 (facing page, top)  
Section of ornamented string course, catalogue no. 104 (photograph by David Garner; EH B960385).

Figure 9.15 (facing page, centre)  
Shaft section and moulded capital, catalogue no. 110 (photograph by David Garner; EH B960383).

104. Block from a string course; Beer stone; moulded front face with carved decoration on a deep hollow order, comprising a shield (blank) and a fragment of a carving, possibly a lion's mask (note the ear in Fig 9.14) if not a leaf or a 'fleur-de-lis'. One end survives, the other is broken; the top surface has been roughly re-dressed, and the rear face lime-washed, suggesting that the block was reused. Unprovenanced. L 370mm; W 265mm; Th 160–180mm.

110. Moulded shaft section and capital (Fig 9.15); Beer stone; shaft contained within a right-angled nook or rebate, perhaps from the inner angle of a window or door reveal? Original angle of 90° widened to c 115° by re-cutting the right-hand face (as drawn); limewash on this face suggests that this was a structural alteration rather than reuse of the block. Setting-out lines inscribed on top and bottom surfaces (the latter illustrated in Fig 9.13). Excavated find, from context 1025, the primary fill of the phase 6 defensive ditch (1024, see Figs 4.15 and 4.17, section 4), thus deposited in phase 7 or 8. L 315mm; max W 180mm; H 210mm.

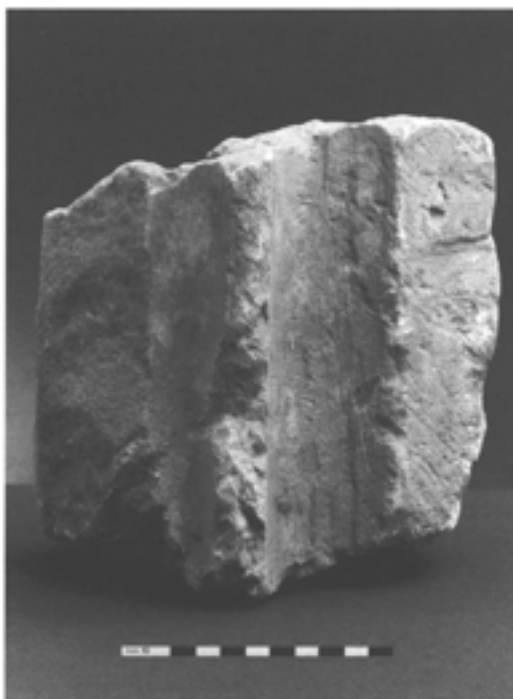
Figure 9.17  
Moulded rib or king mullion, catalogue no. 112 (photograph by David Garner; EH B960381).

Figure 9.18  
Moulded block, catalogue no. 116 (photograph by David Garner; EH B960382).

112. Moulded rib or king mullion (Fig 9.17); Beer stone; nearly symmetrical ogee moulding; centre line inscribed on each end; cross (?mason's mark) incised on one end; two holes 50mm deep in centre of front

116. Section of moulded block (Fig 9.18); Beer stone; fragmentary remains of three hollow mouldings and an edge; possibly a mullion or moulded rib if original axis is correctly interpreted, although form remains uncertain; the block was reused as a limestone trough by hollowing out the rear face. Excavated find, from context 2053, stone spread capping a pit of phase 9 (see Fig 4.19). L 190mm; max W 155mm; Th 150mm.

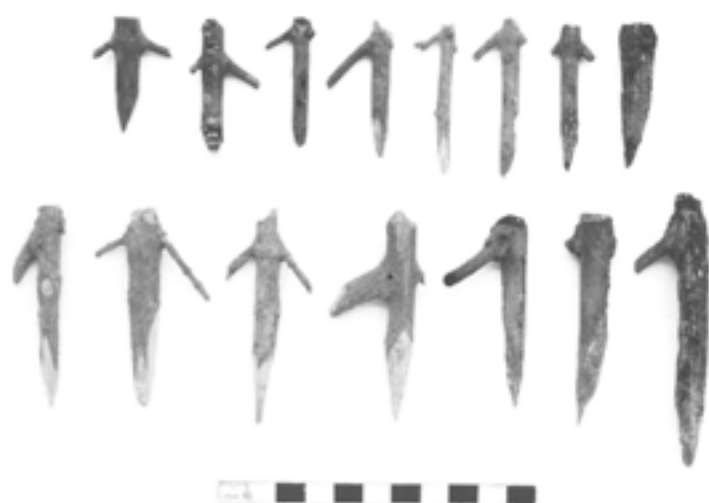
Figure 9.22  
Spurred pegs of unknown  
purpose, but possibly for use  
in vermin traps (photo-  
graph by David Garner;  
EH B960390).

The pegs vary in dimensions and in appearance (illustrated by the fifteen complete examples from context 376; Fig 9.22); most appear to be of elder (*Sambucus nigra*). A feature common to all is that twigs with one or two side shoots were selected which, when cut, provided the barb(s).<sup>217</sup> Typically the upper ends of the pegs are cut either in one stroke or cut around the circumference and snapped. The lower ends are sharpened to a point. Most were made from the full diameter of the twig. Some were split from thicker twigs, but this type has only one barb. The pegs range in length from 15–93mm<sup>218</sup> and from 4–14mm in thickness; some of the longer pegs are still very slender.

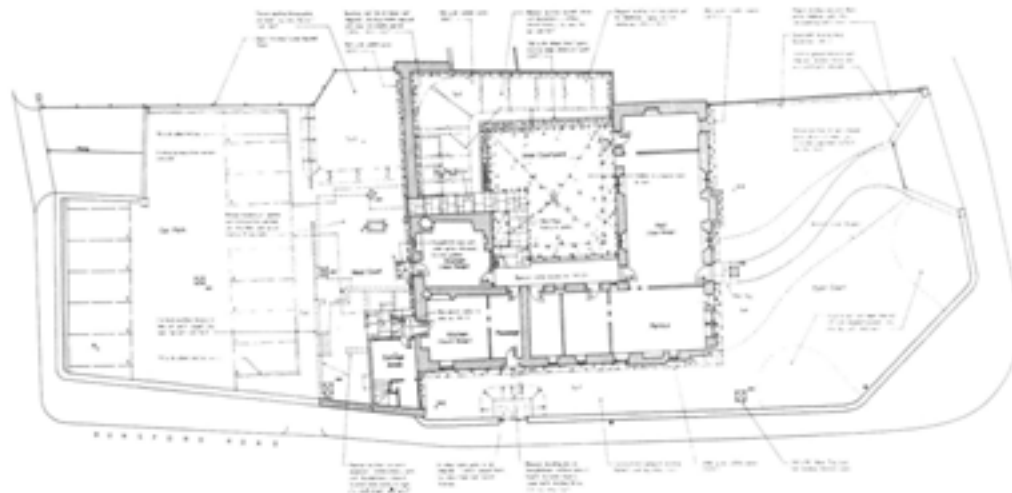
Figure 11.6  
Layout of the site and ground-floor plan of the house at the penultimate stage to completion, before the east car park was added. The west car park, with its double row of parking spaces, encroaches more on the building than the car park in Slade's original proposal (Fig 11.3). With the addition of the later eastern car park the building is surrounded. The main public entrance is now via the west service room from the west car park. The stairs in the south-west annexe are now the only means of access to the first floor. Note the lines of the missing north and west sections of the building set out in the inner courtyard (not to scale) (April 1994; AL/SK/03/A).

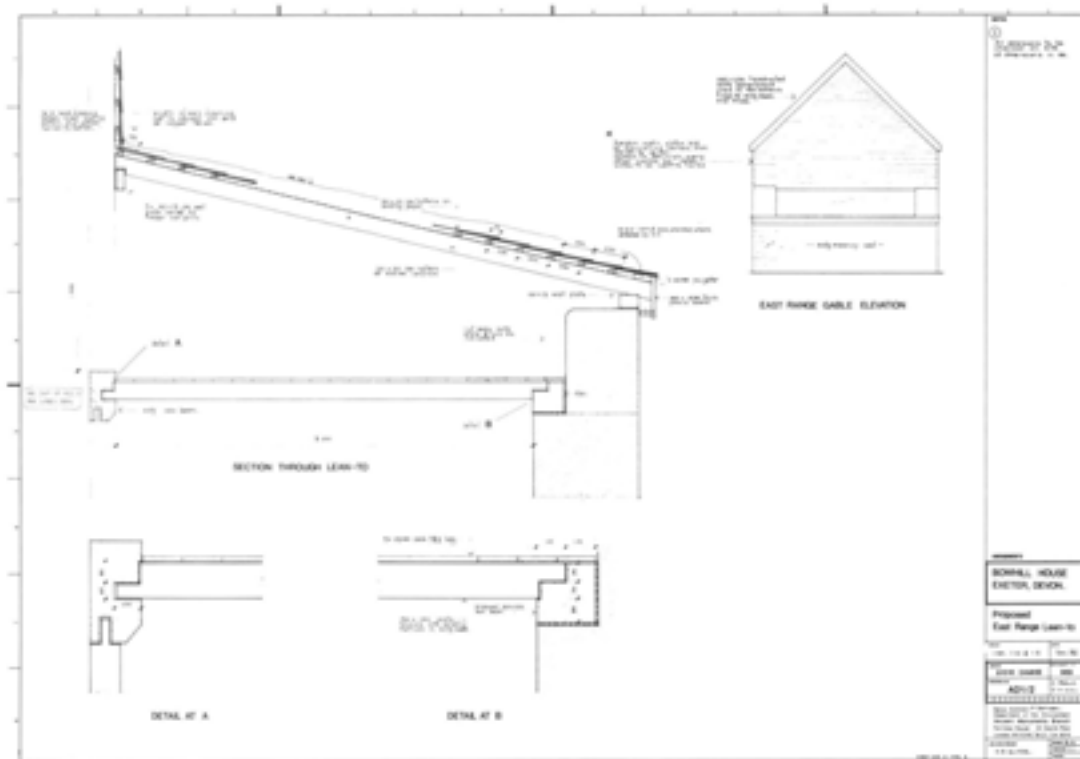
Figure 11.10  
Details of the original proposal for the roof of the hall store; slating laid at such a slack pitch is liable to leak (not to scale) (line drawing by 'G S', December 1982; ASI/2).

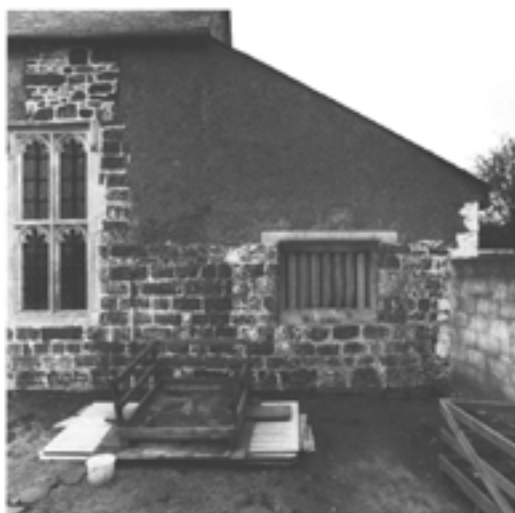
Figure 11.11  
The east elevation of the completed hall store; much of the cob walling above the window lintel is new (photograph by David Garner, April 1993; EH B931122).

Stage 1 saw the reconstruction of the dilapidated lean-to north extension to the hall (see Figs 2.7 and 2.9) with new cob placed wet in shutters. The plentiful use of dung and lime (on the advice of the internal research and technical advisory service led by the architect John Ashurst) emphasises the tentative use of cob at that time. For the west wall the cob was mixed 1:3 subsoil:French hydraulic lime. This set rock hard. Gradually the amount of lime was reduced until it was omitted completely for the east wall.<sup>31</sup> A modest reinstatement of the hall store was first intended (Fig 11.10). Later this developed into a virtually complete rebuild, with raised side walls in cob/lime under a new, steeper-pitched slated roof. The entirely new west wall, replacing a modern partition, followed the original foundation line. A loft floor was constructed to an heroic scale dictated by the original mortices in the hall screen headbeam (see below). The 'unhistorical' as-built roof and elevations reflect the 'improving' of a mutilated structure, employing 'matching traditional' (vernacular) wall and roof forms (Figs 11.11 and 11.12).

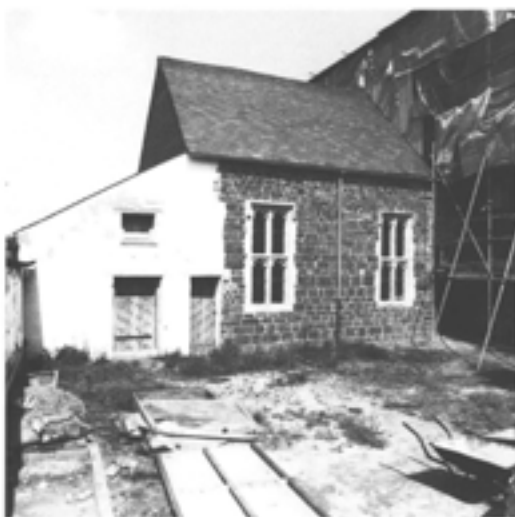
Figure 11.12  
The west elevation of the completed hall store; almost all the rendered walling is new (photograph by David Garner, July 1991; EH B917152).

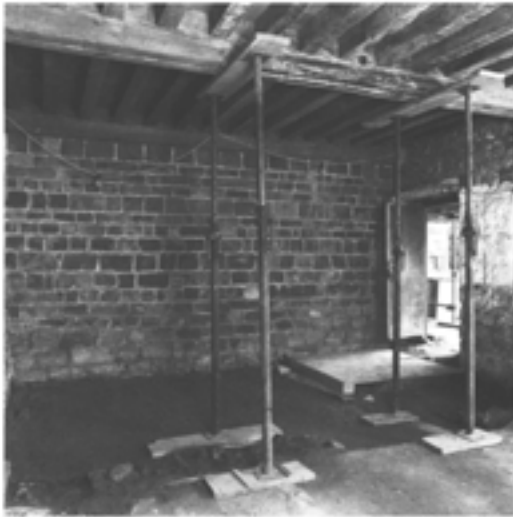
Figure 11.15 (top, left)  
The east elevation of the reconstructed stone cross wall in the south range in 1993 before plastering (photograph by David Garner, July 1993; EH B933548).

The reintroduction of the cross wall east of the through passage in the south range was undertaken in Stage 2 (Fig 11.15). The stone for the ground-floor stage was Carboniferous sandstone from Hayne quarry, Zeal Monachorum, Devon. The reconstruction of the first-floor stage of cob rising into the roof was a key element of Stage 2 (Fig 11.16; the evidence is summarised in Chapter 6; see also Fig 6.22, 127, and Fig 6.25, 131). The wall was rebuilt in cob (without dung) and included a doorway (from evidence). Cob blocks, which were easier to lay and consolidate in this position than cob, were used at the apex. The whole was subsequently lime plastered.<sup>39</sup> The policy of reconstruction using ‘original’ materials and techniques, even when these were to be hidden, was an important aspect of Stage 2.<sup>40</sup>

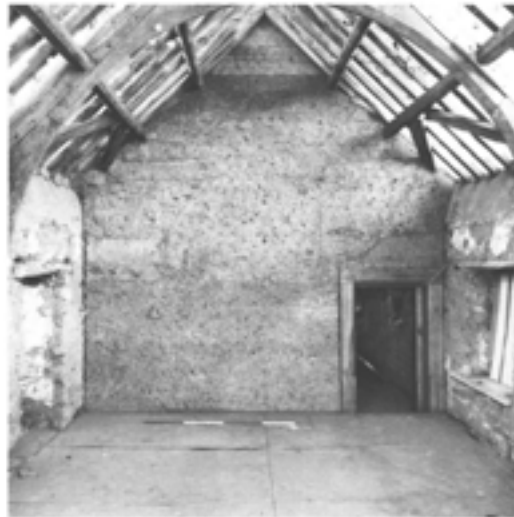
Figure 11.16 (top, right)  
The completed new cob cross wall between the inner and oriel chambers, looking east. The thickness of the wall was reduced on this side as it rose, in accordance with the archaeological evidence. The top was finished with cob bricks to manage potential shrinkage problems in this area (photograph by David Garner, December 1992; EH B926342).

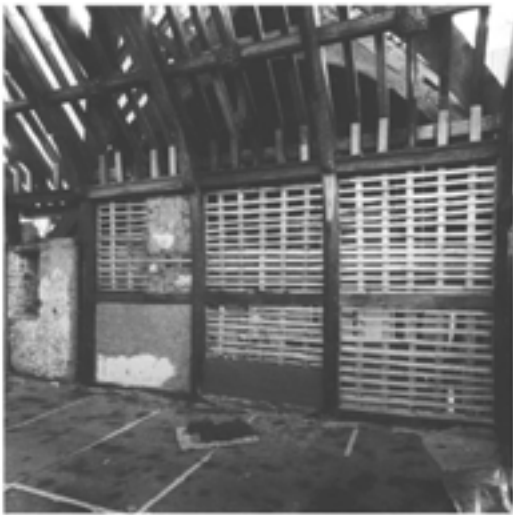
Figure 11.17 (below, left)  
The framed wall panel ('daub screen') between the great chamber and hall with most oak lathing reinstated in the early stages of being daubed, looking north (photograph by David Garner, October 1990; EH B906970).

In the south range, at first-floor level, the daub-filled partition between great chamber and hall (called the ‘daub screen’) was reconstructed (Fig 11.17; see also Figs 6.19, 6.57, 6.59, and Fig 6.25). By 1989 only a very small area of original daub infilling in this partition remained from what had been a considerable survival in 1976. Conventional repair to the main timbers, entailing the loss of original lath, daub, later doors and 17th-century door-framing, had taken place early in Stage 2.<sup>41</sup>

The lost armatures, consisting of vertical timber staves with horizontal gapped oak lathing nailed to each side were reinstated in the late 1980s around the fragment of original armature and daub, which survives to serve as a model for the new daub infilling work that followed in the early 1990s.<sup>42</sup> The framed west partition of the great chamber survived (called the 'daub partition'), but the upper area into the arch braces of truss V was missing (Figs 11.18, and 11.19; see also Figs 6.15 and 6.58). This was reformed with modern framing and lathed and plastered on both sides. There was inadequate evidence for its earlier form and the arrangement was chosen as being traditional and aesthetically satisfactory. The 17th-century lower section with daub infill, to be described later, needed less attention. It was stiffened by the reinstatement of its lathing and daub and the door-frame at the south end of the partition was reinstated (below). Repairs and

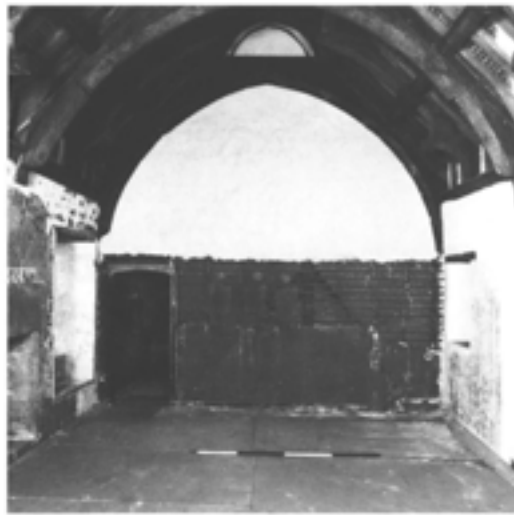
Figure 11.18 (below, right)  
The framed wall panel ('daub partition') between the great and inner chambers with timber, plaster and daub repairs complete and awaiting a section of new daub-plaster finish, looking west (photograph by David Garner, November 1992; EH B925482).

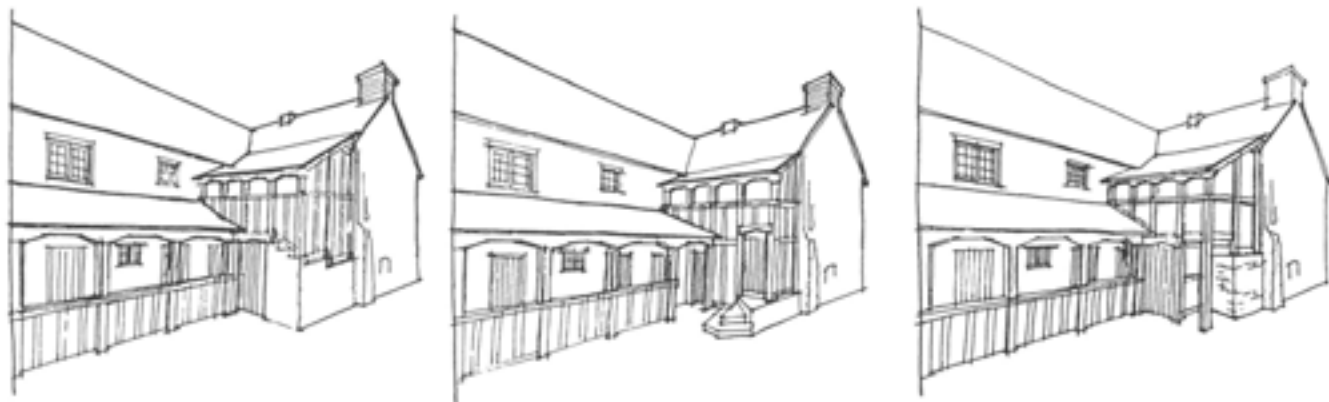
Figure 11.25 (above)  
Design proposals for the reinstatement of first-floor access via a partially reinstated gallery; key points are the roof pitches and the relationship between pentice and gallery, which was lost in the completed work (see Fig 11.24) where the open bay of the pentice is too wide (drawings by Mark Samwell, c January 1994).

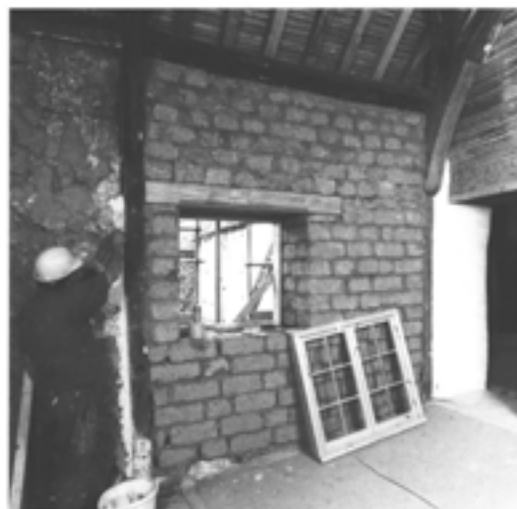
Figure 11.29  
Completed cob block reinstatement to the east wall of the kitchen chamber, including the new window. The window had no historic precedent and was introduced to bring extra light into the room (photograph by David Garner, July 1994; EH B943806).

There were no changes to the west range in plan and only one major change to the fabric 'as found' – the reinstatement of a substantial section of cob wall at first-floor level (Figs 11.29, 5.27, 389 and 6.47, 225). The large gap (created for access in phase 8) was initially intended to be rebuilt in cob, after the 'reinstatement like with like' philosophy of Stage 2. Cob block was eventually preferred, because of advantages in speed of

work and in minimising the shrinkage problems that arise with cob. A hollow-cored, double-skin wall of blocks was built to minimise load and as an experiment.<sup>46</sup> Two minor extensions to internal walling were carried out. The first, both an aesthetic and a structural exercise, reduced the width of the 1970s breakthrough into the oriel chamber (see Fig 5.17, 228) by reintroducing an eastern reveal abutting the end of the hollow-block wall described above. This was also (for reasons of time) carried out in

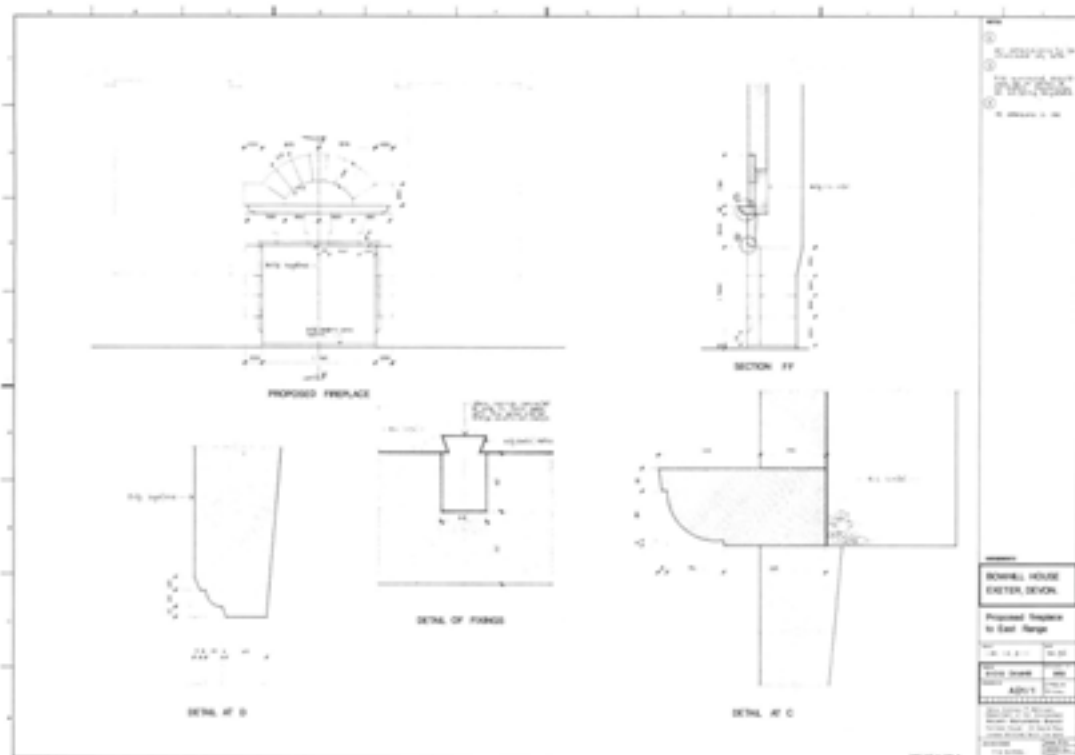
Figure 11.30  
Working drawing showing elevation, section, and details of the proposed hall fireplace (not to scale) (line drawing by 'G S', December 1982; AD1/1).

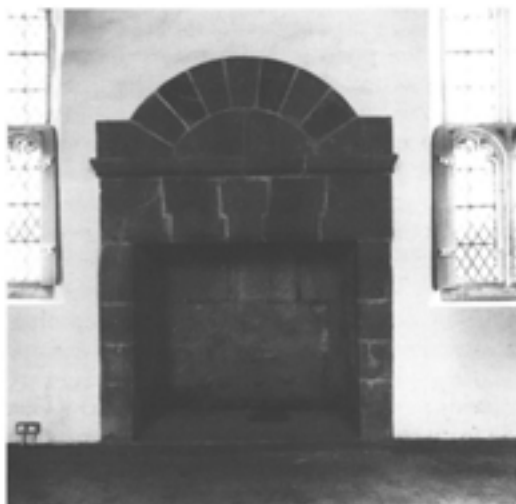
Figure 11.31 (left)  
The new hall fireplace as completed (photograph by David Garner, June 1995; EH B953011).

1. The hall fireplace was fully reintroduced (Figs 11.30–11.31; see also Fig 6.12), the design based on the surviving keystone and moulded cornice stone (Chapter 6) and on extant fireplaces in the parlour and great chamber (see proposal drawing, Fig 11.30 and Fig 6.23). The new lintel and relieving arch are supported by a concealed reinforced concrete lintel (see Fig 6.14). Stone from Raddon, near Thorverton, was used as the nearest matching material obtainable to the

original volcanic trap from Pocombe or Barley. The appearance is shown by comparison of old and new blocks (Figs 11.30 and 11.31; see also Fig 6.2, inset).<sup>49</sup> A concrete hearth was laid in place of hearth slabs (which could still be installed).

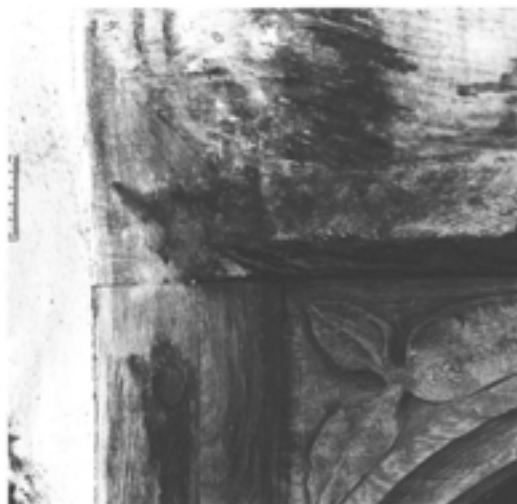
Figure 11.32 (right)  
New carved spandrel to the door-frame in the north partition of the hall (photograph by David Garner, May 1994; EH B942050).

4. New door heads were carved to complete missing panelling in the hall and parlour (Fig 11.32). Like the bosses, these were carved by the DEL carpenters. Most took as their model the surviving door head in the parlour partition, although the spandrels of the partition of the west service room were more elaborate than most. At least one carpenter involved in this work experimented with carving from life.

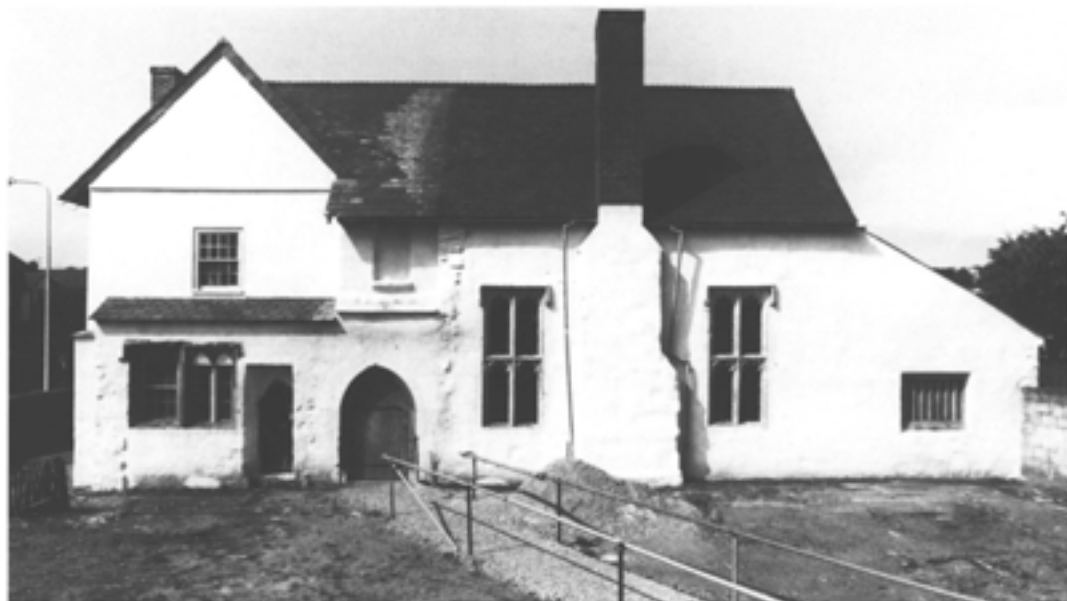
Figure 11.35 (centre)  
The east elevation after the reinstatement of the top section of the hall chimney stack (to an assumed design and height). The modern brickwork was subsequently limewashed to make the contrast between original and new less obvious (photograph by David Garner, June 1993; EH B933141).

The 1981 programme called for the reinstatement of the upper part of the hall chimney stack (Figs 11.35; see also Fig 2.9). The shouldered junction of the new stack with the original masonry build below was formed in moulded and coloured cast

concrete imitating Permian breccia. The new stack was of red hand-made brick, the top weathered by a sheet of Georgian wired glass (though vented, condensation still falls onto the hearth). Brick and concrete confirm the work as low-key reconstruction, in which detailed form and height are indicative only. The use of brick also echoes the historic secondary brickwork of the other chimney stacks. In Stage 2 both brick and stone sections were lime rendered and limewashed, as with the rest of the walls. Colour from the concrete offsets is now 'bleeding' through this render.

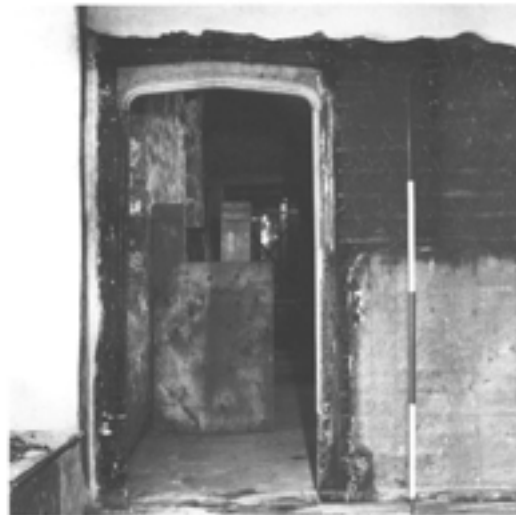
Figure 11.37 (top, right)  
The reinstated doorway between the great and inner chambers. The jambs are original, the head modern. Note the recently conserved lathed and daub-filled wall panel with heavily haired daub plaster intact and conserved (below) and new lath and plaster above (photograph by David Garner, October 1992; EH B926250).

Carved spandrels to partition doorways were reinstated, as in the Stage 1 works in the hall (above). An anachronistic arched head (to an earlier historic pattern) was introduced to the doorway in the west partition of the great chamber (Fig 11.37; see also Fig 6.15, 108), in part to improve headroom. The early door-frame in the south-east corner of the great chamber is also potentially confusing (see Fig 6.22, 99, and Fig 6.55). Although this was not the original location of the frame, it has been in this position since phase 8 or earlier; its presentation with recessed blocking was intended to indicate the former connection into the lost south-east range.

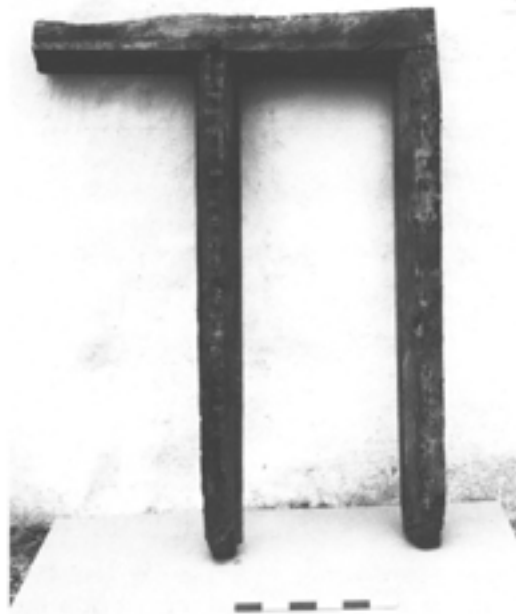
Figure 11.38 (below, right)  
Original fragment of a 16th-century window frame from the kitchen (scale: 300mm rule) (photograph by David Garner, July 1994; EH B943789).

Controlled opening up and recording of the secondary (16th-century) timber window in the west wall of the first-floor room in the west range led to its repair and reinstatement to its full dimensions (Figs 11.38 and 11.39; see also Fig 6.45, 238). This opening was occupied by a 20th-century two-light timber window cutting into one-and-a-half lights of a 16th-century timber window (Chapter 6; see Fig 5.22, 242 and 238) of the same type as two loose windows in store (Chapter 9, nos 136–7). It was decided to repair the historic fragment of frame. On the basis of evidence described above (Chapter 6), the modern window was omitted altogether and the

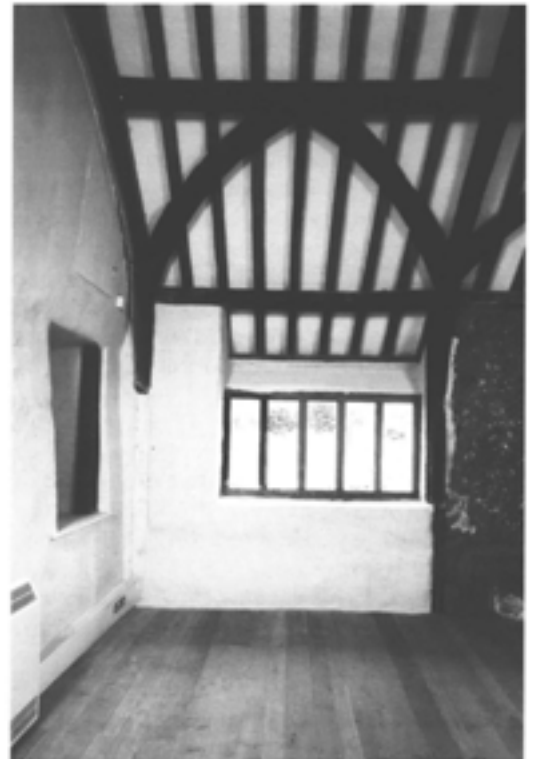
Figure 11.40  
The same window as in Fig 11.39, as finally reconstructed from all the evidence and from deduction (photograph by David Garner, June 1995; EH B953007).

window reconstructed to five lights as far as the nearby cruck post (Fig 11.40). The new window was glazed with fixed panes; red ochre paint identified on the historic frame was not repeated in the new work.

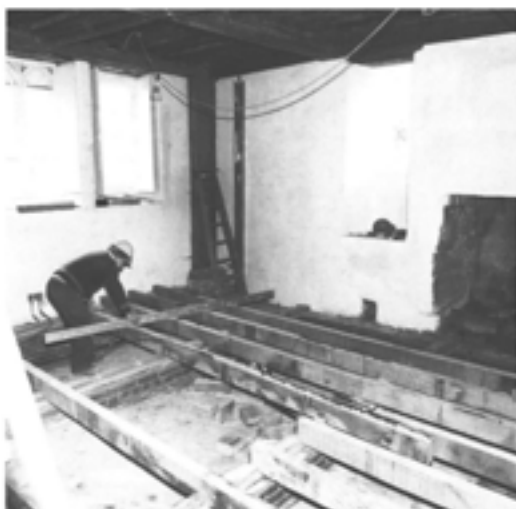
Figure 11.42 (above, right) The new timber suspended floor of the parlour under construction (photograph by David Garner, June 1994; EH B943757).

room, as far as it then remained, in accordance with less-interventionist policies. New suspended timber flooring was used, built off modern sleeper walls on slate damp-proof courses (Fig 11.42). The cavity beneath this floor (the result of the archaeological excavation of the parlour) was used to conceal services and the garderobe pit of the phase 2 building to house electrical gear. The floor of the adjoining service room was of earth, as in the great hall, formed in a cob/putty lime mix.

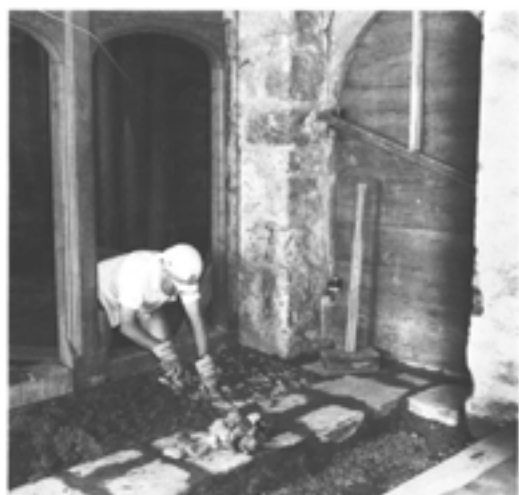
Figure 11.43 (below, left) Laying the floor in the screens passage: cobbles in a cob mix (photograph by David Garner, July 1991; EH B917144).

The flooring of the screens passage comprises a central run of stone flagging with bands of cobbles on each side, based on 19th-century evidence excavated in 1989 (Fig 11.43). The level is some millimetres below that of the lime/cob floor of the hall. Thresholds to the cross passage doorways were replaced in Devonian limestone ('Ashburton stone'). In the kitchen approximately half of a 19th-century cobbled floor survived running into the fireplace (see Fig 4.19). The missing section was re-laid in new cobbles to match (Fig 11.44).

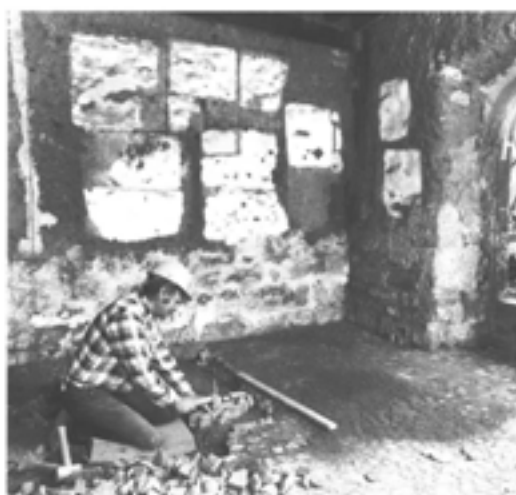
Figure 11.44 (below, right) Extending the surviving stone cobbling to the kitchen floor. Note the trial panels of daub on the cob wall in the background (photograph by David Garner, July 1994; EH B943801).

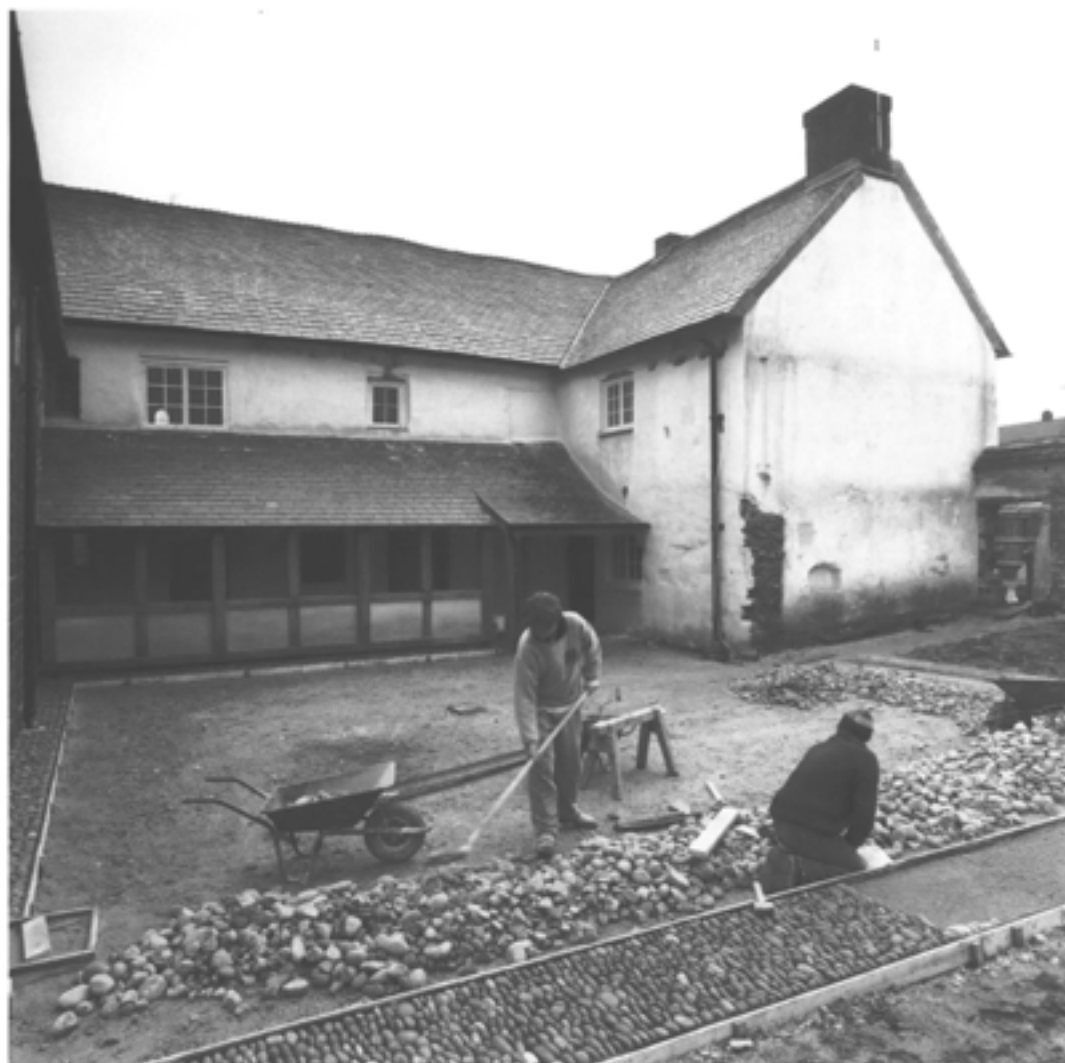
*Figure 11.46*  
View of the courtyard. Note the examples of 'didactic' display in the north gable of the kitchen (the scar of the wall of the west range and the chase of a door frame above) set into the modern render. In the foreground, the laying of stone pitching on the lines of the demolished walls is in progress, again didactic in purpose (photograph by David Garner, February 1995; EH B950948).

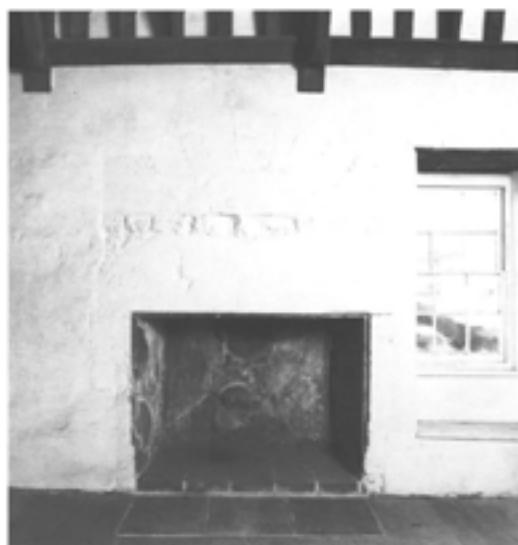
Figure 11.47

The fireplace of the great chamber on completion of conservation. Limewash is carried indiscriminately over all materials in the wall, as originally (note the effect in comparison to the exposed stonework in Fig 6.23) (photograph by David Garner, February 1995; EH B950947).

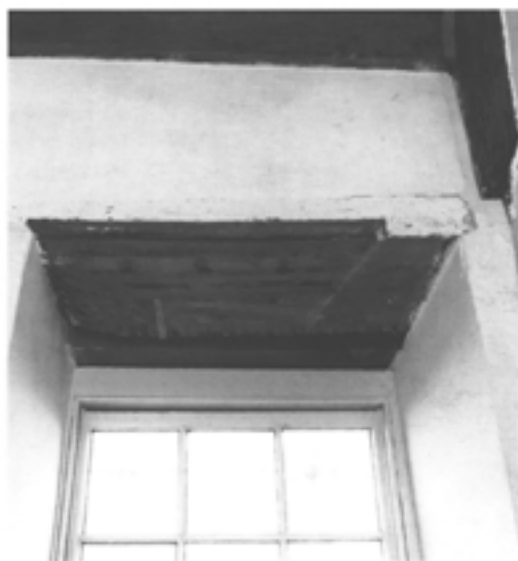
Figure 11.48

A didactic display – conserved window embrasure and lintel in the great chamber. The original lintel is intact, with reduced bearing on the right exposed when the embrasure was widened in the 19th century. Sockets for iron-work or timber of uncertain date survive in its underside. The lintel was preserved by the insertion of steelwork into the wall above (photograph by David Garner, February 1995; EH B950940).

4. Lintels of the south windows of the great chamber were decayed (Fig 6.22, 17 and 69). They were conserved *in situ* by taking down the masonry over the lintels and incorporating hidden stainless-steel supports in the rebuilding, thus retaining the evidence for window bars in the two lintels and allowing the evidence for two phases of opening to be displayed in the conserved work (Fig 11.48).

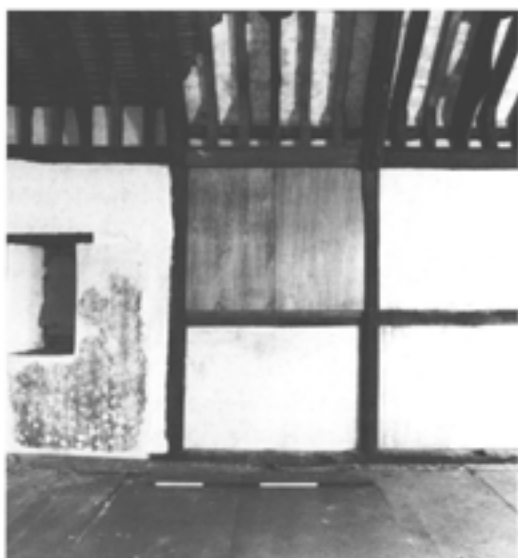
Figure 11.49

Protective hinged panels over the surviving area of original lath and daub in the great chamber/hall partition, subsequently painted (photograph by David Garner, September 1992; EH B925481).

- d. One panel of the north wall of the great chamber was left unplastered to display new and original daub side by side. This was protected by a hinged plywood cover board and, uniquely, remains accessible (Fig 11.49, see also Fig 11.125).

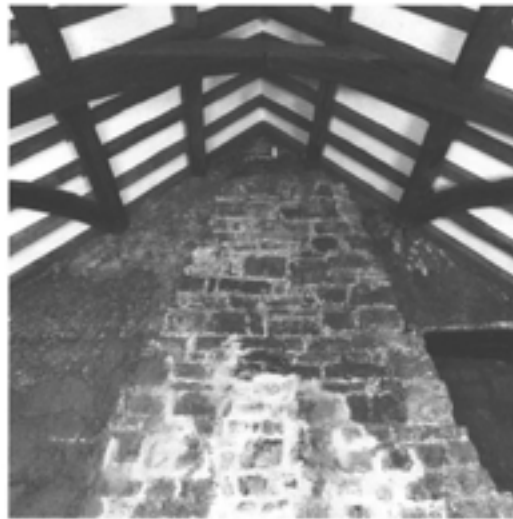
Figure 11.50  
The north wall of the kitchen (first-floor chamber) showing the display of repairs: various daubed wall surface repairs and cob/lime wall face rebuilding to the left; cob brick piecing in to the niche on the right; lime-mortar repointing to the stonework (photograph by David Garner, February 1995; EH B950937).

at first-floor level (north of truss II). This comprised the original cob walling to each side of the massive stone chimney flue, on which a series of repair types and solutions could be 'read' (Fig 11.50, and Figs 11.129–30).

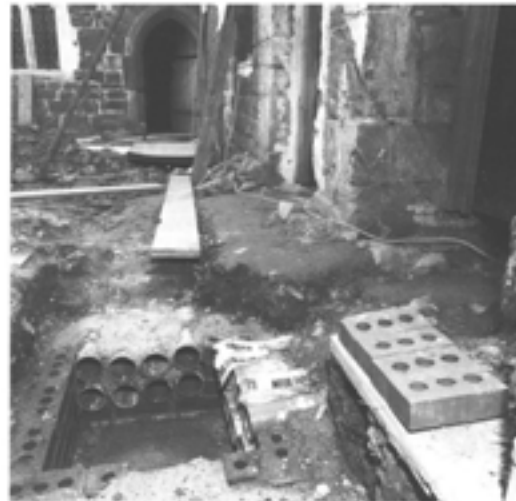
Figure 11.54  
The draught under  
construction below the floor  
of the pentice passageway  
(photograph by David  
Garner, March 1994; EH  
B940969).

Electricity supply was rated for use at higher loadings than were finally required. The main was brought in at the west end of the south range, formed within new work in the west gable (Fig 11.52). Ducts for wiring were run beneath ground floors through excavated areas (Figs 11.53 and 11.54). The edge of the hall floor was trenched for the ring main. Rising trunking was concealed within existing voids, where possible, or fixed to the walls in galvanised conduit (Fig 11.55). Historic work was treated as sacrosanct as far as possible, new work as sacrificial. Ring main trunking was laid in boxed-out timber skirtings on the first floor (as there were no floor voids; see Fig 11.119). Lighting wiring was placed so as not to be

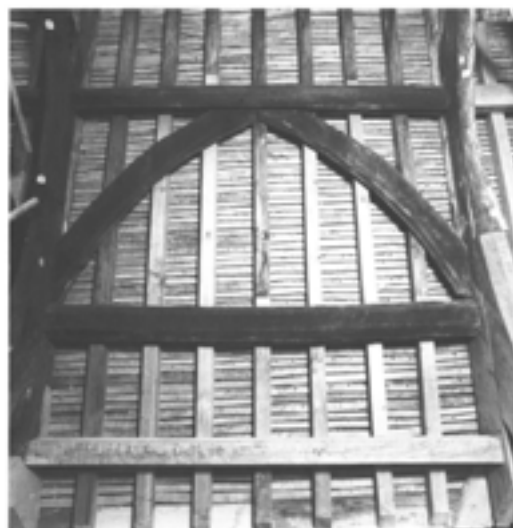
Figure 11.64 (right) Rafter and purlin reinstatement in the roof of the west range. Note the replacement jointed-cruck post supporting the original principal rafter on the right (photograph by David Garner, March 1993; EH B930332).

in phase 11 alterations (see Fig 5.17, unnumbered). This was replaced by an oak post with a curved head, bringing the structure into working order again (Fig 11.64). Because the roof timbers were in better condition in the west range, less rafter and purlin repair was needed here than elsewhere (Fig 11.65).
