# Bowhill

The archaeological study of a building under  
repair in Exeter, Devon, 1977–95

*The archaeological study of a building under  
repair in Exeter, Devon, 1977–95*

Published in association with Exeter Archaeology as Volume 5 in the  
Exeter Archaeology Reports series

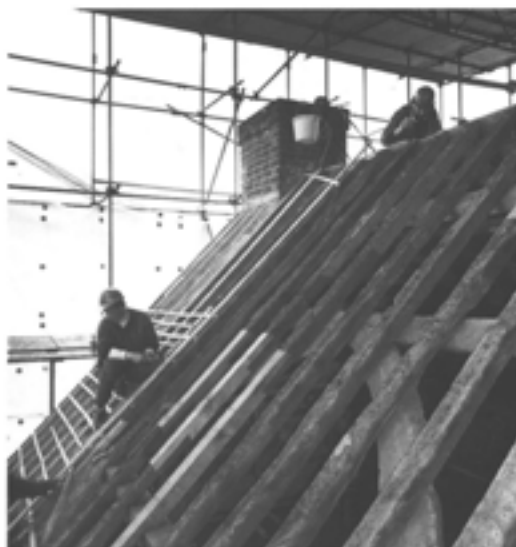
Figure 11.65

Rafter repairs in the roof of the west range (photograph by David Garner, March 1993; EH B930344).

in phase 11 alterations (see Fig 5.17, unnumbered). This was replaced by an oak post with a curved head, bringing the structure into working order again (Fig 11.64). Because the roof timbers were in better condition in the west range, less rafter and purlin repair was needed here than elsewhere (Fig 11.65).

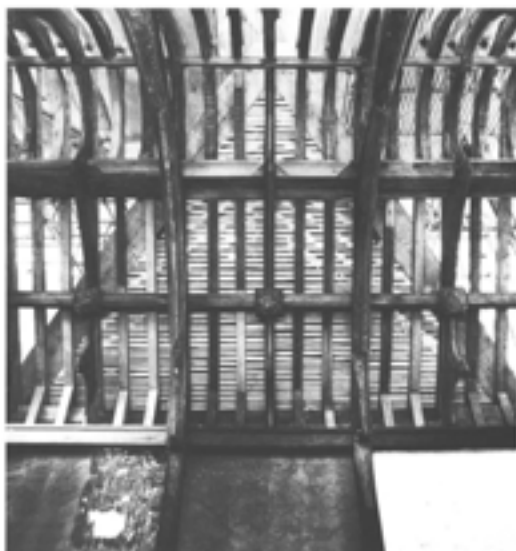
Figure 11.66

The underside of the reinstated ceiling triangle over the great chamber at the junction of the south and east ranges, before re-daubing (photograph by David Garner, January 1991; EH B910523).

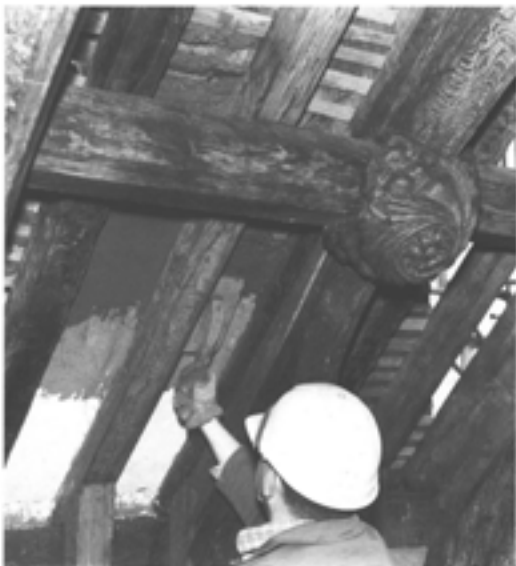
Figure 11.67

Ceiling daubing in progress in the great chamber (photograph by David Garner, May 1991; EH B916284).

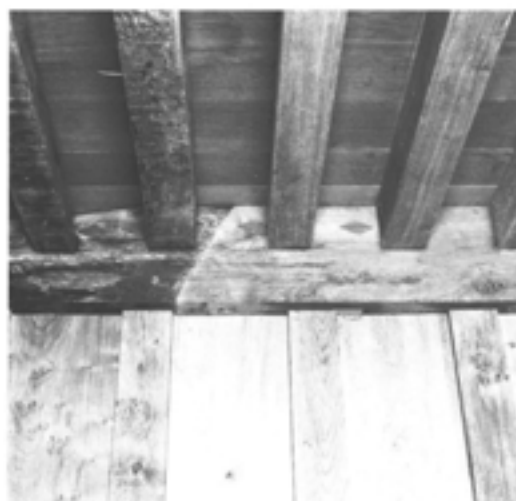
Figure 11.69  
The ceiling/first floor structure in the south range service room, with reinstated beam 6 doubling as headbeam to a new partition. Note the original (left) and reinstated (right) floor joists. The diamond-shaped timber pellets conceal the heads of bolts connecting a concealed metal fitch plate to the timber, a standard modern 'traditional' solution. The profile of the new timbers matches that of the originals (photograph by David Garner, April 1994; EH B942043).

No records of the timber repairs undertaken in Stage 1 were made other than that for the hall roof (*above*, p 289). Repairs seem to have followed traditional practice for the most part (Figs 11.69 and 11.70). One exception was the use of resin in the reinstatement of the post-and-plank partition at the north end of the hall and to consolidate and reform decayed ends of the headbeam at the external walls (Fig 11.71). Resin was again used in repairs to the beams 1–3 of the parlour ceiling, also carried out during Stage 1. The failed south ends of the beams (*see* Fig 6.28) were made up in resin to allow proper bearing on supporting elements (a new post for beam 1, seating in the walls for beams 2 and 3 and additional support from a new stone corbel for beam 3; *see* Fig 6.22, 22).<sup>77</sup> The beam-end repairs were reinforced with resin rods, drilled and resin-grouted in (typically where the timber had separated along a horizontal shake) and then concealed by continuous resin grouting set back within the shake. Practice in both cases followed that conventionally recommended – avoiding the use of resin in timber joints.<sup>78</sup> With regard to the ceiling boarding taken down at the stripping stage, the 1981 programme proposed replacing the moulded inner orders in the east bay (where original timber survived),<sup>79</sup> but plain boarding elsewhere. In the event the ceiling boards were not reinstated and remain in store.

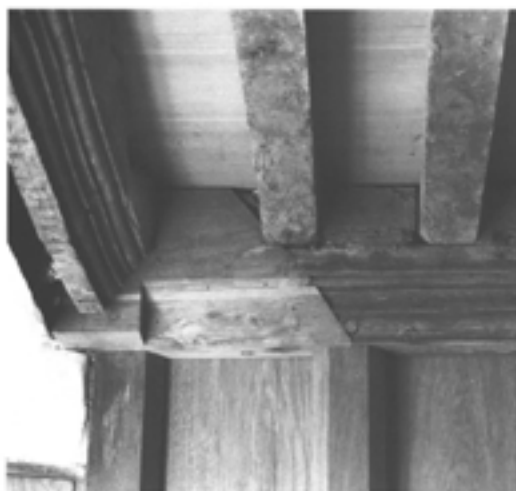
Figure 11.70  
The south end of beam 4 reinstated (south-west corner of the parlour). Here the profile of the new work is deliberately left un moulded to confirm the repair by more than just its newness. The lamination of timbers facing the repair suggests that it is in situ shuttering for a mass resin repair (photograph by David Garner, April 1994; EH B942038).

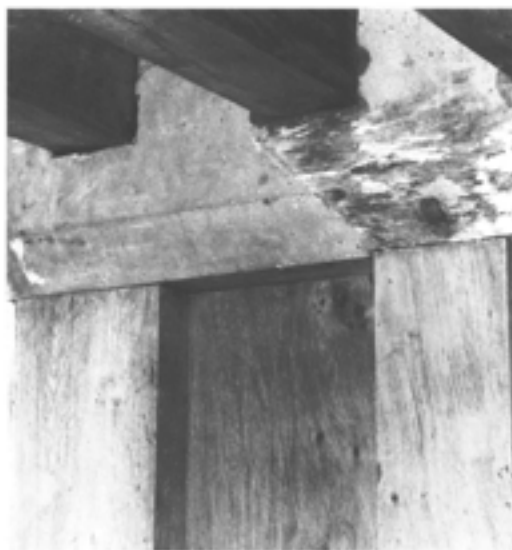
Figure 11.71

Mass-resin reinstatement of the east end of a beam in the north gable of the hall, looking south-east within hall store (photograph by David Garner, May 1994; EH B942053).

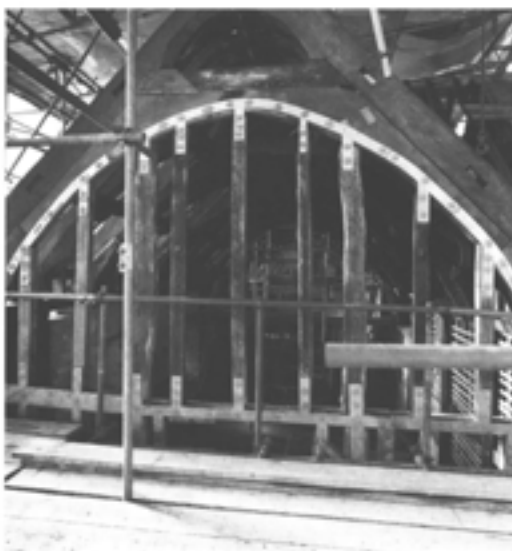
Figure 11.72

The east gable of the great chamber with the secondary timber frame re-erected and stainless-steel bracing in place (photograph by David Garner, November 1990; EH B906962).

In 1976 the upper part of the east gable of the south range was a timber structure of c 1800, lathed and plastered externally and internally. The 1981 programme had proposed its reconstruction in cob. By 1987 the lath and plaster finishes had been stripped and the timber framing of phase 8 dismantled and stored. In 1990, reinstatement of the timbers rather than reconstruction in cob was decided upon. The timber-framed structure was to be retained in the form in which it had survived until it was taken down and stored, although many of the historic timbers were very rough and ready. This was the first major departure from the 1981 programme. A frame of stainless-steel plating was made to hold the internal timbers together and to fix them to blades of the jointed-cruck truss 1 (Figs 11.72 and 11.73). The gable, incorporating the potential fire escape trap (*above*, p 287), was then (hardwood) lathed and plastered inside and out (without insulation) and lime rendered and limewashed.<sup>80</sup> Reinstatement included a

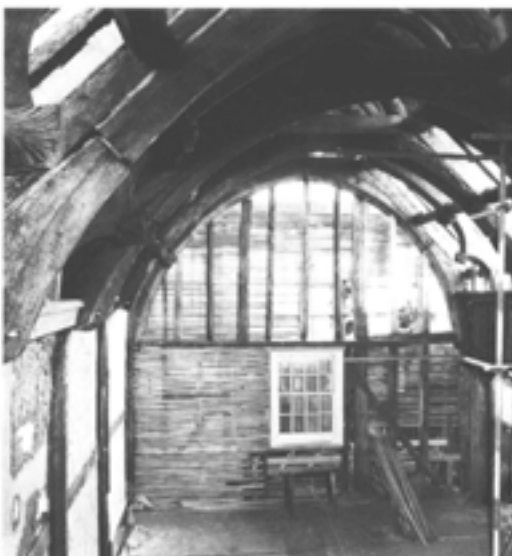
Figure 11.73

Internal view of the east gable of the great chamber, with lathing for lime plaster and with repaired window reinstated (photograph by David Garner, August 1991; EH B917212).

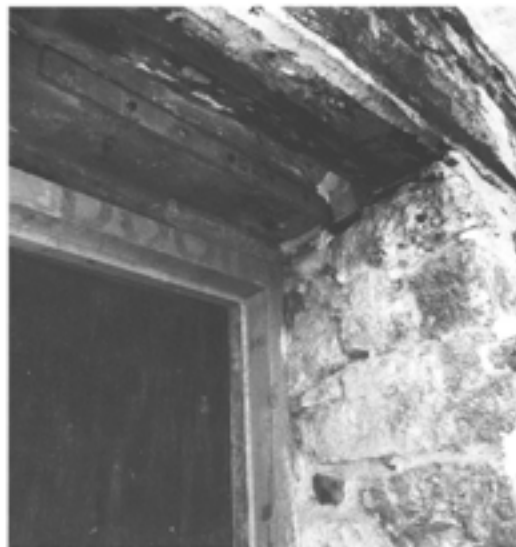
Figure 11.78

A decayed original timber lintel to the north doorway of the through passage in the south range, stabilised by a steel strap carrying its load into the stonework beyond the jamb (photograph by David Garner, September 1994; EH B945310).

No repairs were recorded to the hall window lintels. Elsewhere some timber lintels had deteriorated badly, requiring repair, support or replacement. The approach under Stage 2 was for retention wherever possible (Fig 11.78). Examples are: the lintel to the south-west window of the great chamber, where the outline of the medieval window reveals and laths from the plaster soffit of c 1800 were retained; and the inadequate lintel to a widened window opening in the north wall of the inner chamber, where a lining-board set against the interior window reveal was used to prop the lintel-end (Fig 6.25, 137). In the adjoining window, a cleat was used for the same purpose (Fig 11.79), similar in principle to historic (?phase 8) repairs to the roof to support the purlins. The original lintel of the north-west window of the great chamber was scarfed new to old, a classic timber repair. Lastly the later lintel of the south window of the west service room (see Fig 5.8, 332) was replaced by 'needling' with metal rods through the cob wall above the lintel, removing it and sliding in a replacement. The process was repeated for the replacement in new oak of crude 1970s lintels over the doorway from oriel chamber to kitchen chamber (Fig 11.80; Fig see also Fig 6.25, 228).

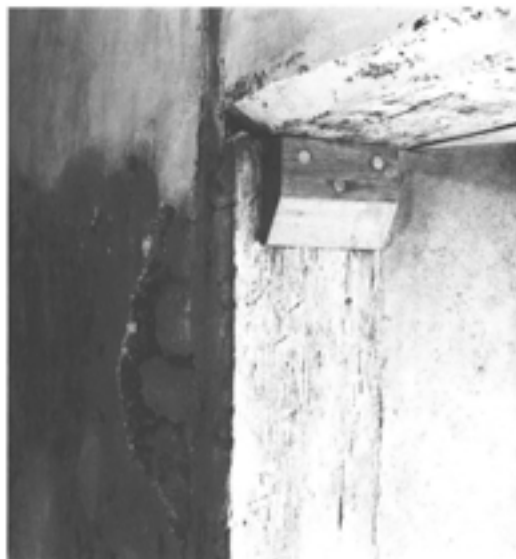
Figure 11.79

A small timber 'cleat' used to pick up the end of a lintel in the inner chamber, where its bearing had been removed (by widening the window). The heads of the fixing screws have been 'polished' to produce a tidy appearance. It is impossible to mistake this detail for anything other than a repair (photograph by David Garner, October 1993; EH B935838).

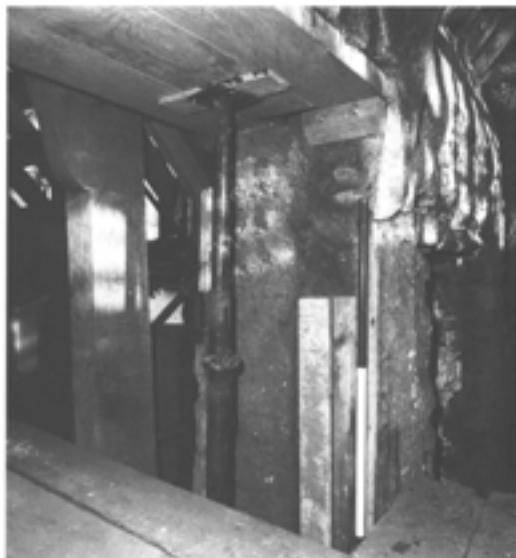
Figure 11.80

Larger-scale timber cleats used for the same purpose as in Fig 11.79. Here the cleats support the ends of replacement lintels, spanning the modern opening between the oriel and kitchen chambers (photograph by David Garner, December 1993; EH B926343).

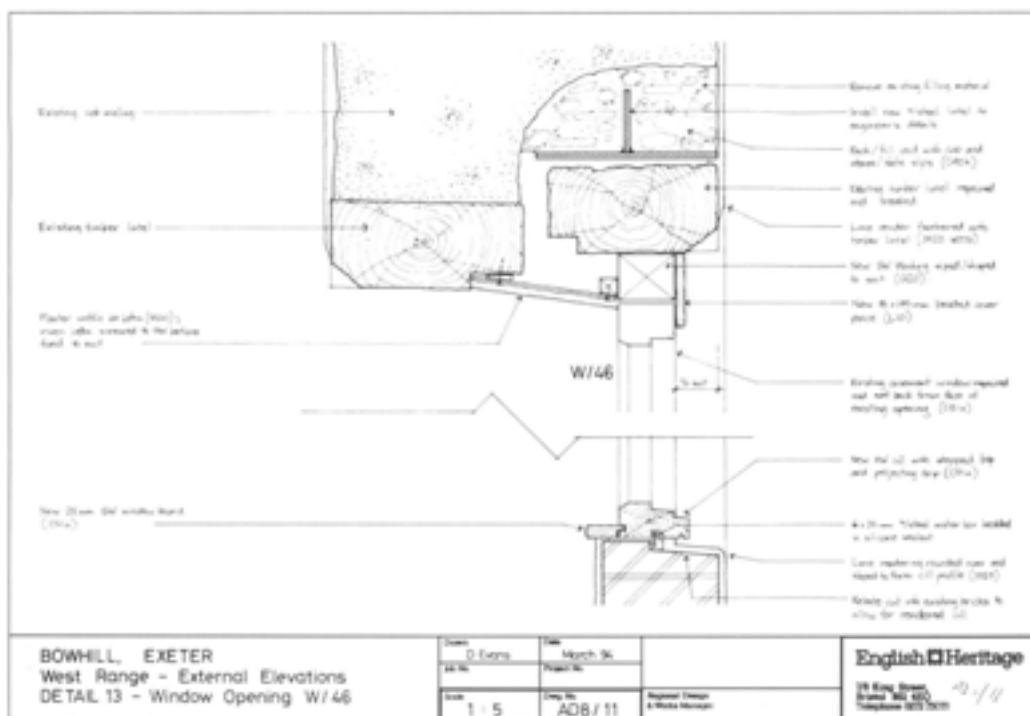
Figure 11.81  
Section through the lintels and wall in Fig 5.28b, showing the proposed inverted stainless-steel T angle to relieve the load on the original lintel (not to scale) (line drawing by Douglas Evans, March 1994; AD8/11).

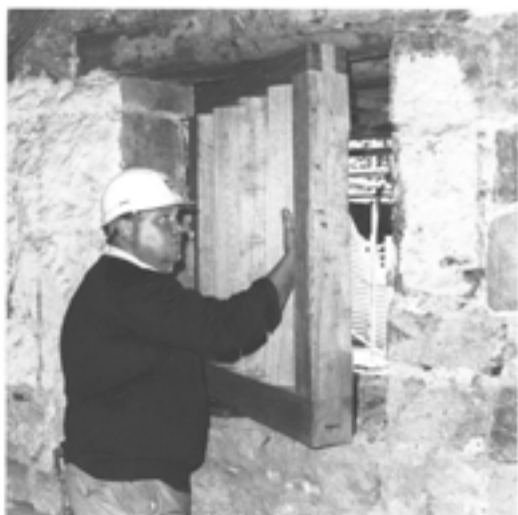
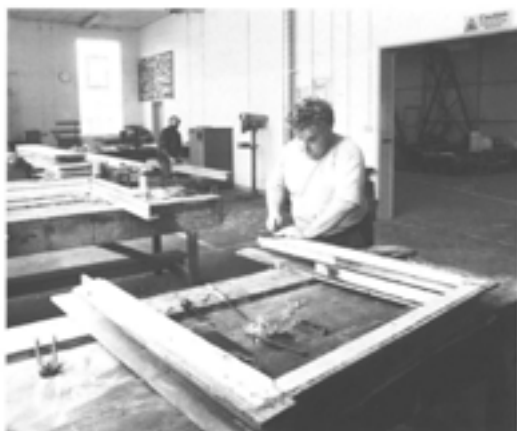
Figure 11.83 (centre, right) A minor 'piecing-in' repair to a 19th-century sash window (photograph by David Garner, October 1993; EH B935809).

Figure 11.84 (below, left) Fitting a new oak frame to the window serving the service room and store in the south range. Glazing set behind the bars was added to this window - pragmatic but anachronistic (photograph by David Garner, September 1993; EH B934872).

Timber windows were replaced in the hall store (above). Following the Stage 2 policy of 'treat as found', existing, invariably later, timber windows in the south and west ranges were mostly repaired and reinstated (Figs 11.83 and 11.84). Thus 19th-century timber casements were retained in the medieval cinquefoil-headed lancets. In the west range late 19th- to 20th-century windows in the east and west elevations were repaired as found and a new first-floor east window was provided to a modest design. Timber frames, sashes and casements were generally taken out and repaired on the bench (Fig 11.85).

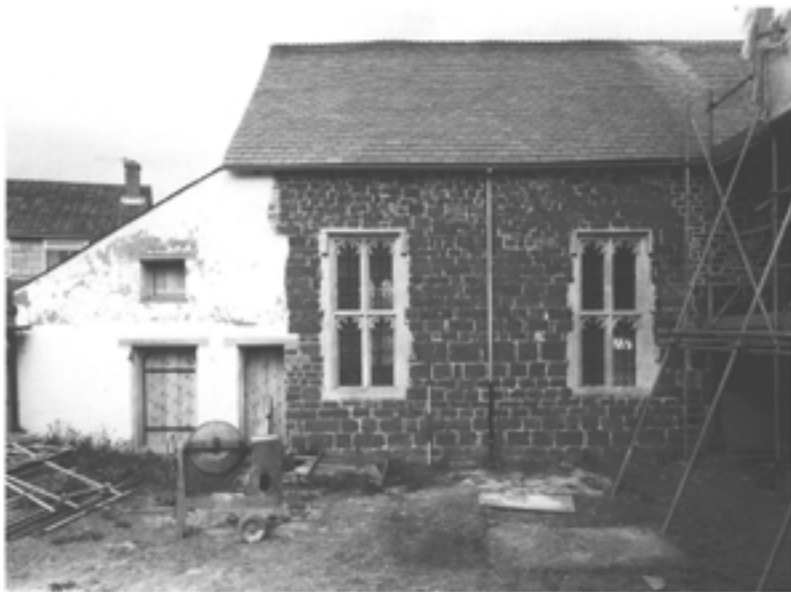
Figure 11.86 (above)  
The west elevation of the hall; the windows tracery has been fully reinstated and the secondary window removed and blocked (highlighted by the distinctively sized, coursed and pointed masonry at the upper right-hand side). Notice in the roof the 'pig'-course (sudden diminution) near the ridge. This mistake in laying out had to be perpetuated in the Stage 2 roofing of the south range (photograph by David Garner, April 1992; EH A920553).

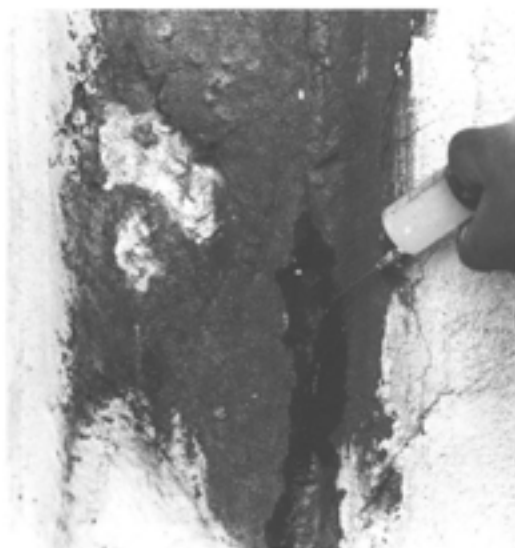
Figure 11.88 (top, left)  
Injection of ground trap as pozzolan in a lime grout into the stonework of the east window of the parlour (photograph by David Garner, October 1993; EH B935830).

Masonry elsewhere was generally in good condition. Other than occasional preparation by raking out loose mortar or dubbing out, little attention was needed. The repair of an oven surround in the kitchen, though of interest, is thus atypical (Fig 11.87). Where minor stabilisation of volcanic trap (original window surrounds) was needed, experiments were made with ground-up trap as a pozzolan in a lime grout, for injection into the fissures in the stone (Fig 11.88). This appears to have been successful. The existing, very exposed weatherings to the south range chimney stack were in poor condition and were consolidated where possible with some new Devonian limestone additions where necessary. Minor rebuilding of lost or poor modern walling for subsequent plastering was done in such a way to prevent mistaken identification in the future (Fig 11.89).

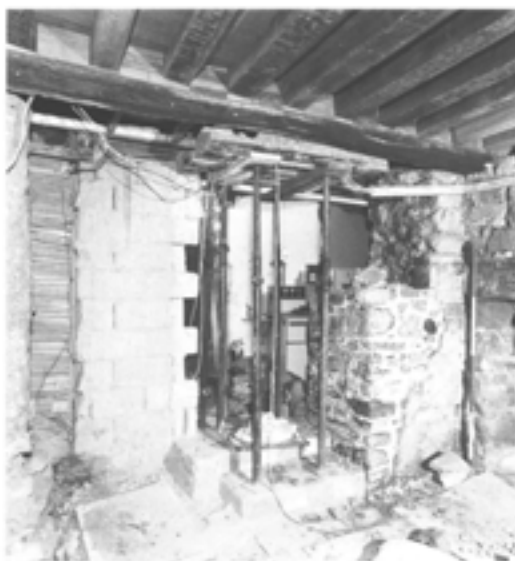
Figure 11.89 (centre, left)  
The interior of the west wall of the west service room, showing (left to right): a remnant of original cob; lathing exposed at the back of the 19th-century annexe; modern concrete blockwork; the former west doorway with original lintel; Stage 2 rebuilding in lime-mortared rubble; return in wall to historic, secondary fireplace. Subsequently the remaining concrete block was replaced with daub-filled studwork (see Fig 11.52) and the door opening was reinstated (photograph by David Garner, January 1994; EH B940372).

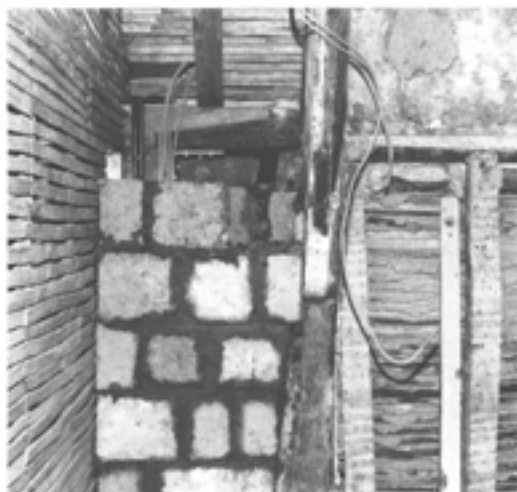
Figure 11.96 (top, left)  
Cob block 'blocking-up'  
around the repair area  
shown in Figs 11.74–75  
(photograph by David  
Garner, May 1994;  
EH B942058).

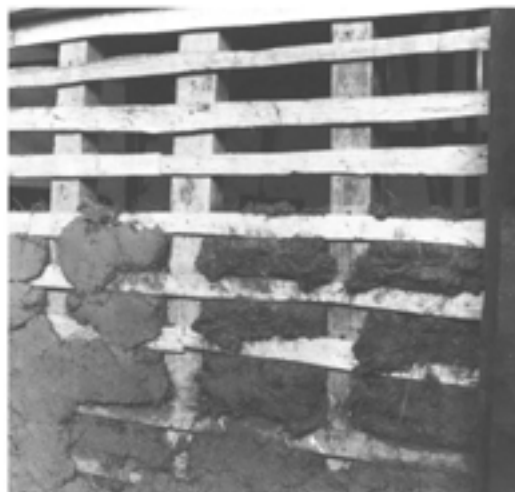
Figure 11.97 (centre, left)  
'Needling' to a remnant of  
cob wall surviving in the  
east wall of the west range,  
in order to allow the steel  
shown in Fig 11.82 to be  
slid into place (photograph  
by David Garner, June  
1994; EH B943742).

this fragment while inserting the lintel is examined elsewhere.<sup>89</sup> The socket was temporarily filled with polyurethane foam, needled below (Fig 11.97), then (under-built) rubble was removed, the lintel slid in and the wall 'stoned up' again under the cob.

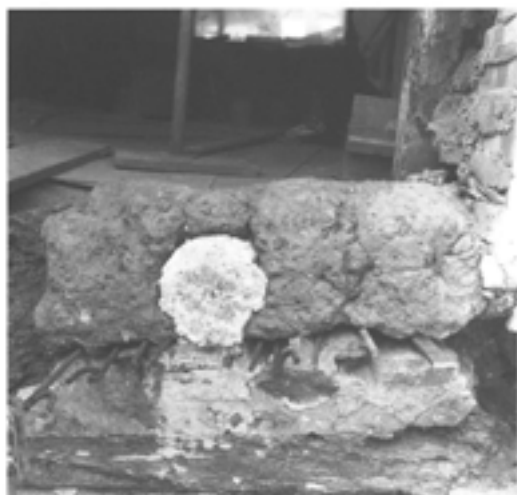
Figure 11.98 (below, left)  
Method of shuttering the  
cob infill to the ground-floor  
partition at the south end of  
the hall (undated photo-  
graph, c 1987) (reproduced  
courtesy of Larry Keefe;  
© Larry Keefe).

The filling with daub of the timber-framed panels of the north and south ends of the hall in Stage 1 has already been discussed. Nothing was recorded about this work. The bull's dung and subsoil used to fill the framed, double-lathed, north gable wall was free of lime as a result of experience with the new cob for the walls of the north extension.<sup>91</sup> Both were filled in stages using climbing shutters (above and Fig 11.98).

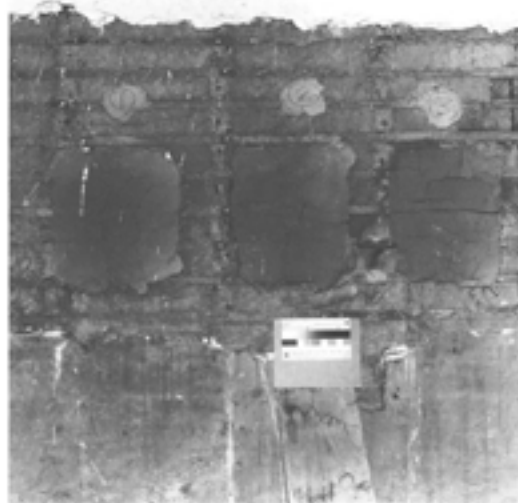
Figure 11.101 (below, left)  
Original plaster on the south wall of the oriel chamber; the edges of such areas were all filleted before new plaster was applied around them. Note the cob wall repair to the top of the window reveal (left) (photograph by David Garner, March 1994; EH B940989).

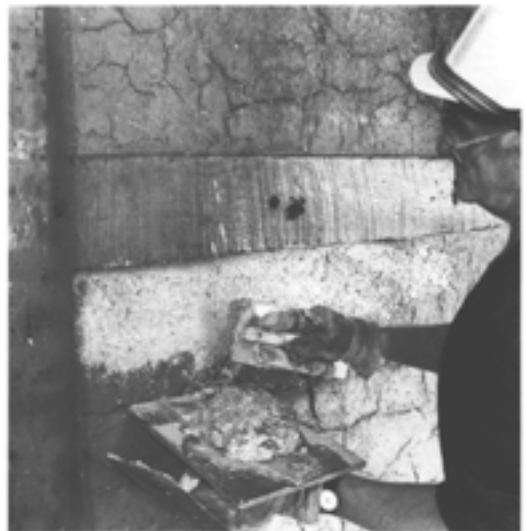
Figure 11.103 (below, right)  
Original and new plaster side by side, great chamber (photograph by David Garner, September 1992; EH B925480).

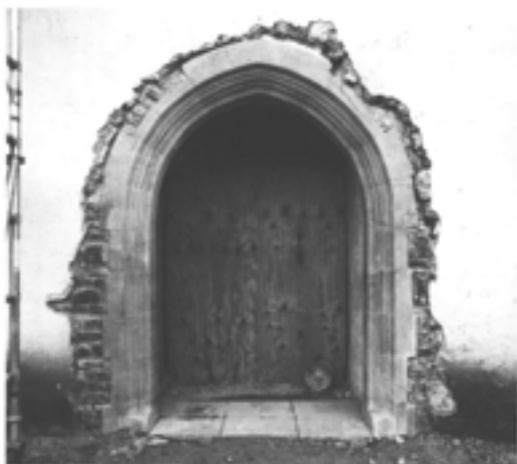
*Figure 11.112*  
*The restored arch of the through passage in the south elevation during insertion. For the final appearance see Fig 11.36 (photograph by David Garner, January 1995; EH B950929).*

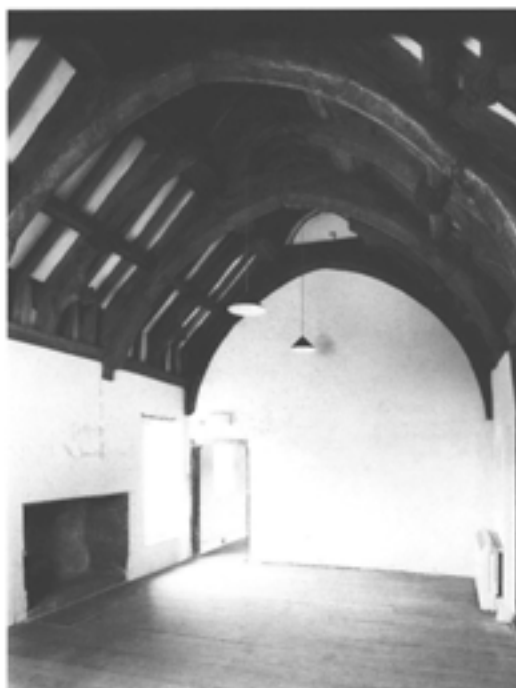
Figure 11.119 (top, right)  
The great chamber looking  
east. Note the skirting  
trunking for electrical  
services and electrical  
storage heater (photograph  
by David Garner, February  
1995; EH B950946).

seen by a standing individual. Lighting was by means of simple pendant bulbs and reflectors hung from the roof or floor structures. Heating by electric storage heaters set against walls was chosen as cheap and simple to install (see Figs 11.119 and 11.120).<sup>62</sup>

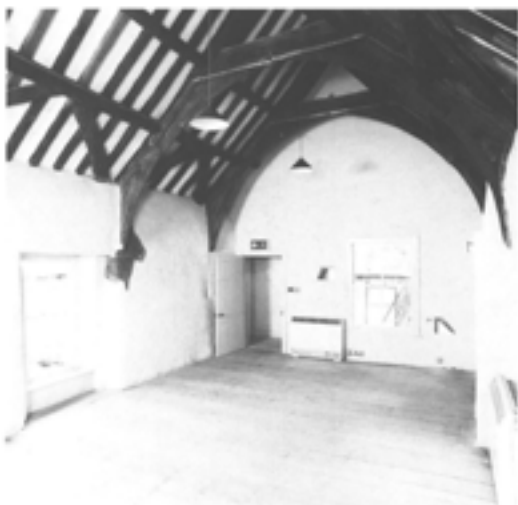
Figure 11.125 (top, right)  
A 'didactic window' in the north wall of the great chamber, showing the surviving section of the daub screen and repairs (photograph by David Garner, February 2000; EH B000019).

- d. One panel of the north wall of the great chamber was left unplastered to display new and original daub side by side. This was protected by a hinged plywood cover board and, uniquely, remains accessible (Fig 11.49, see also Fig 11.125).

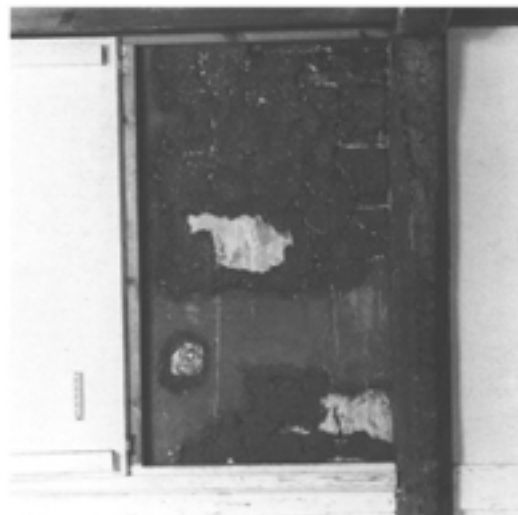
Figure 11.126 (below, right)  
A 'didactic window' in the north wall of the inner chamber showing a section of the north post of truss V of the roof of the south range, the broad cut in the cob for the insertion of the truss and the stone packing of the cut. Primary plaster survives partly over the cut up to and onto the roof truss; now plastered over (photograph by David Garner, February 1995; EH B950943).

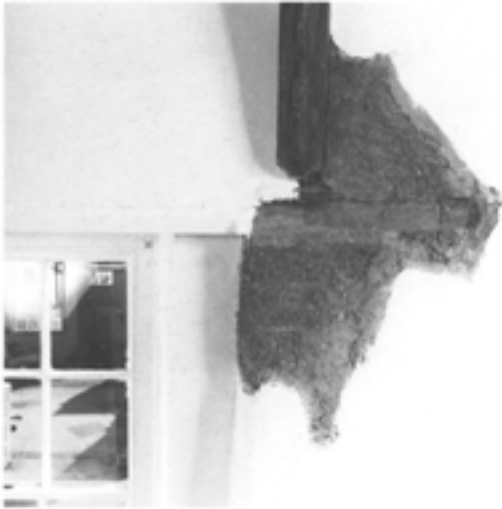
*Figure 11.127 (top, left)*  
A 'didactic window' in the south wall of the oriel chamber, showing the foot of truss X bearing on a window lintel and associated cob; now plastered over (photograph by David Garner, October 1996; EH B961847).

- c. In the south elevation of the oriel chamber adjacent to the oriel window showing repair of the cob work using cob blocks and truss x bearing on the extended window lintel (see Fig 6.22 and Fig 11.127).

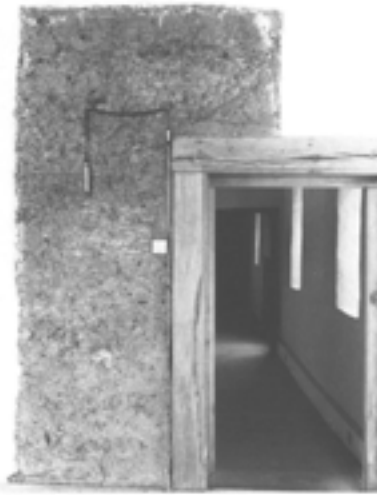
*Figure 11.128 (top, right)*  
A 'didactic window' in the east wall of the oriel chamber, with a section of the new cob cross wall exposed to show its composition and shrinkage, now plastered over (photograph by David Garner, October 1996; EH B961850).

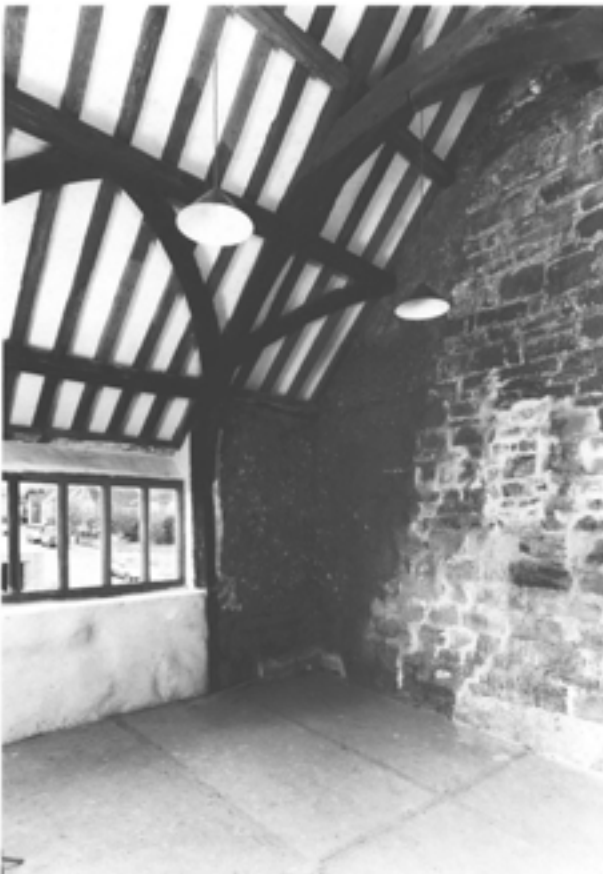
*Figure 11.129 (left)*  
The kitchen chamber, looking north-west and showing walling left unplastered, subsequently plastered over (photograph by David Garner, February 1995; EH B950936).

at first-floor level (north of truss II). This comprised the original cob walling to each side of the massive stone chimney flue, on which a series of repair types and solutions could be 'read' (Fig 11.50, and Figs 11.129–30).

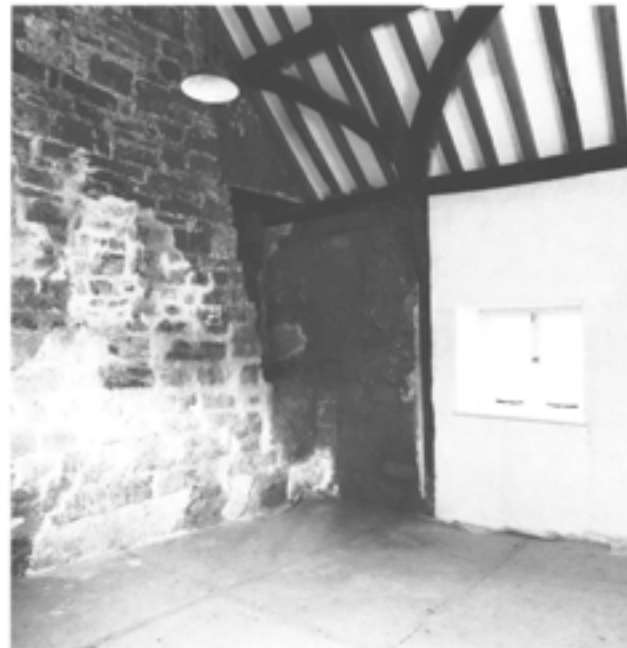
*Figure 11.130 (right)*  
The kitchen chamber, looking north-east and showing walling left unplastered, subsequently plastered over (photograph by David Garner, February 1995; EH B950938).

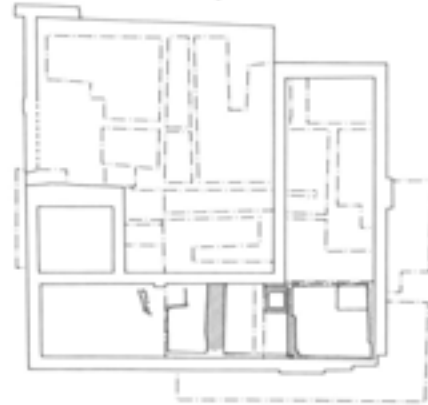
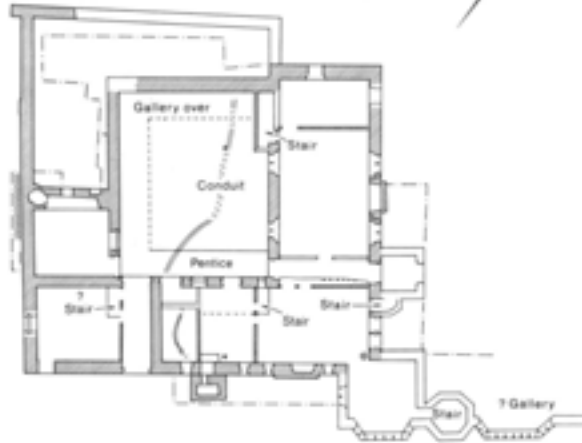
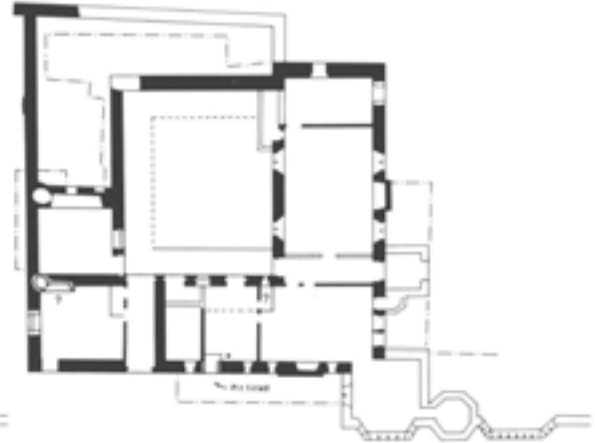
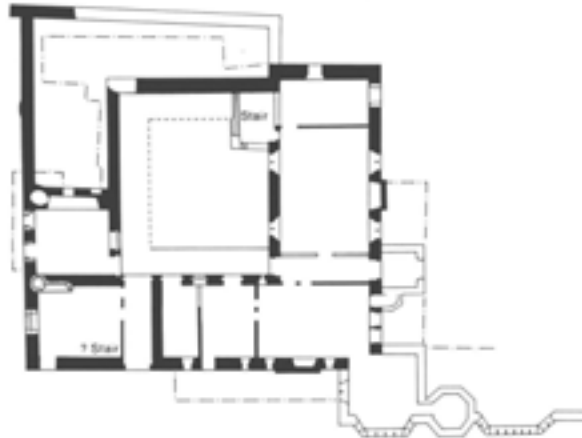
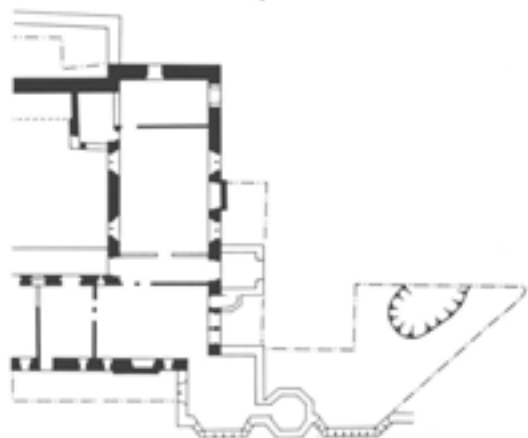
*Figure 12.1 (facing page)*  
Phased plans to illustrate the development of the site: ground floor, phases 1–6 (scale 1:500) (line drawing by Tony Ives).

The south and south-east ranges had a curious structural relationship: adjoining at a corner with the walls of the south-east range turning off from the main building some distance short of the corner; the resulting plan shows two rectangular rooms diagonally adjacent, overlapping at their corners (see Fig 12.1). Thus the parlour and chamber, on ground and first floors respectively, communicated with the rooms in the south-east range by means of a wide opening (framed by the post of the first roof truss of the south range and the post supporting the south-east corner of the parlour ceiling), which could have been filled with partitioning or could have remained open.<sup>79</sup> The two roofs must have been joined by valleys where they met (the Bucks' engraving gives a hint of the difficulties here).<sup>80</sup>

The principal excavated event in this phase was the rebuilding of the structure accommodating the stair in the north-eastern corner of the courtyard. The original stair was narrow and was contained partly within the thickness of the wall (and in view of the slight footings may have been of timber). No doubt it was inconvenient in use. The rebuilding was represented by a new wall, 2m out from the wall of the hall enclosing an area approximately 3.5 × 2m (see Figs 12.1 and 4.17, section 3, 2272).

These phases are characterised by relatively minor alterations and improvements to the fabric during the period when the building was in its heyday of occupation through the 16th and into the early 17th century (Fig 12.1). Perhaps the most widespread change of this period has left very little trace in the fabric: original and probably unglazed timber windows in the cob-walled parts of the building were replaced. Most windows in the stone-walled parts of the building were retained (although with some limited new glazing work, for example, in the lower lights of the hall windows). If the three timber windows described above (Chapter 9) are survivals from this programme of re-fenestration (and not themselves original windows altered for glazing), this work should probably be assigned to phase 4 (mid-16th century), that is, before *c* 1580, by which date ovolo-moulded window frames might be expected in a building of this calibre. The garderobe in the south wall of the south range was decommissioned at about the same time. One of the few good groups of stratified material from the site was recovered from its fill, dated with some precision to *c* 1550 (context 2307, Chapter 9). Perhaps rather later than this, the stair in the north-west corner of the central courtyard was rebuilt on larger footings, in a move to improve access from the high end of the hall to the north range and adjacent buildings. Since a larger stairwell implies a framed timber stair, which is likely to be rather later, this has been assigned to phase 5, probably late 16th or early 17th century. The west service room of the south range was improved in one of these phases, probably the later, by the addition of a fireplace and oven. A moulded window frame in the first floor of the south range (Fig 5.17, 137), was also introduced in phase 5, although in its surviving form it was the product of later alteration.

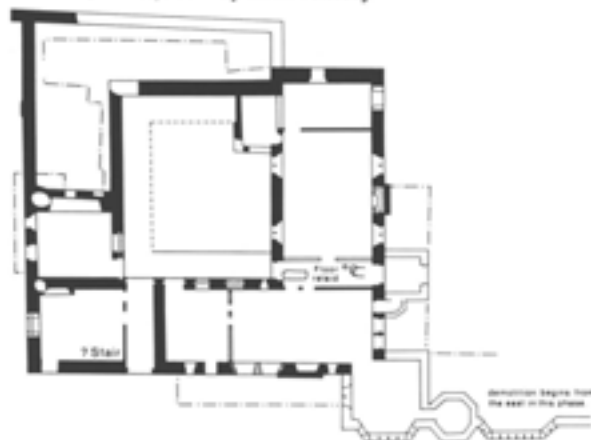
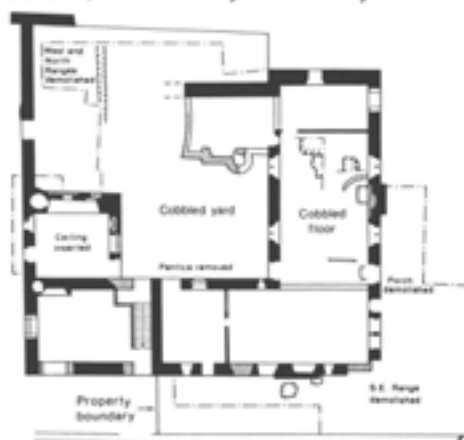
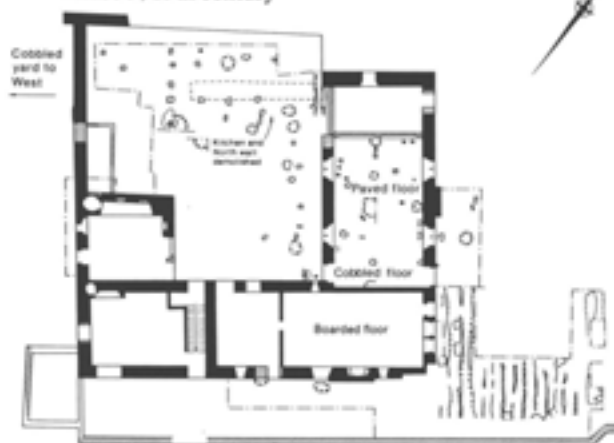
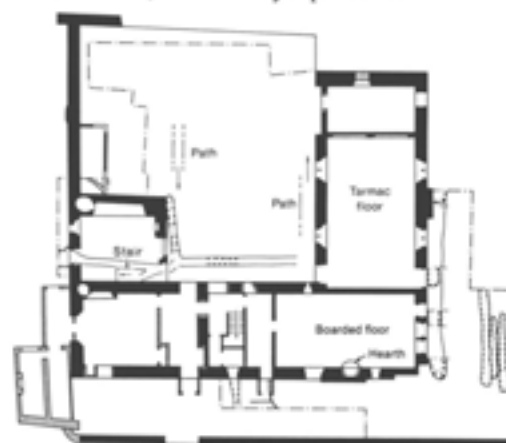
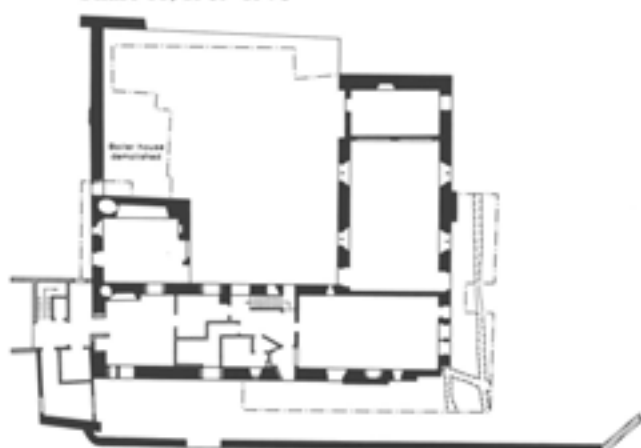
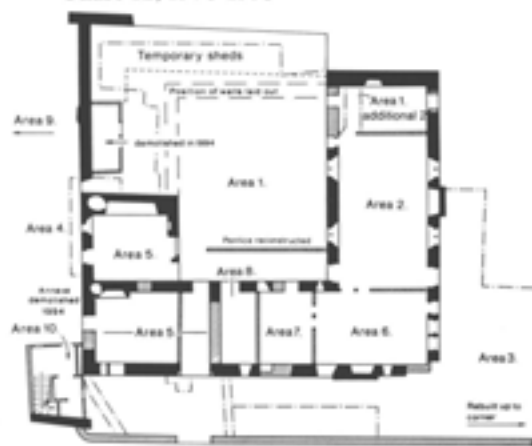
- New
- New secondary
- Retained from previous phase
- Conjectural or uncertain
- Edge of excavation trenches

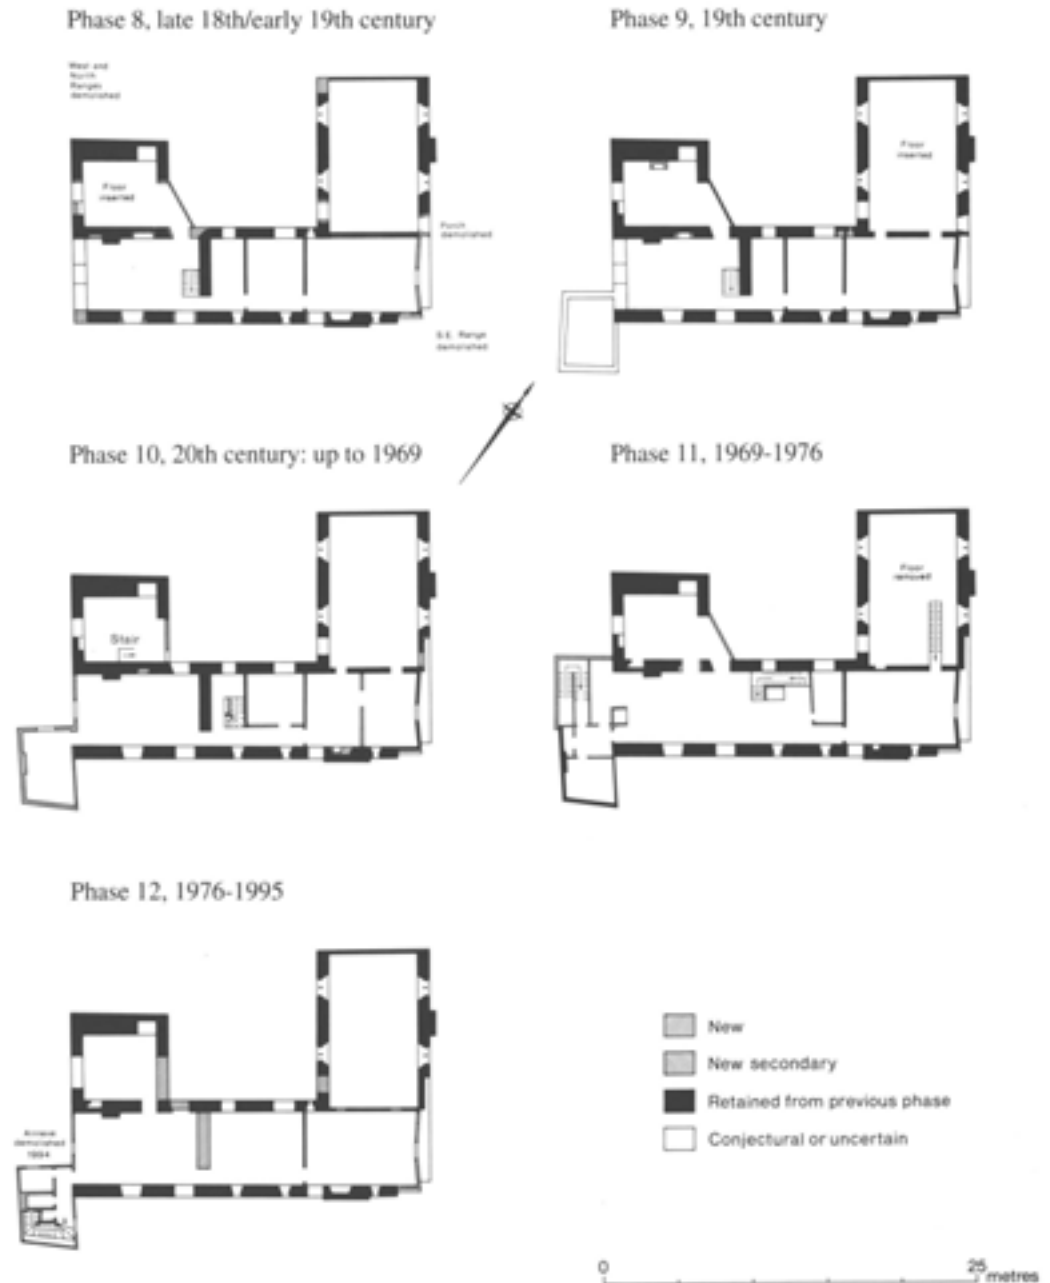
Figure 12.4  
Phased plans to illustrate  
the development of the site:  
first floor, phases 8–12  
(scale 1:500) (line drawing  
by Tony Ives).

the south wall before 1969. The position below truss VI only became enclosed on the insertion of the stair in bays 6 and 7 in the restaurant period (phase 11) alterations (see Fig 12.4, phases 10 and 11). Although there is no direct evidence for the assumption that the pre-1969 screen below truss VII was the one placed beneath truss VI post-1969, the structure has to have come from somewhere in the building at that point. Certainly the architect's plans show that the central bays of the south range were the part of the building most heavily affected by the alterations of that time (the plans make no mention of an ancient screen in this position, but it may have been covered over and unrecognised until it was dismantled). The planks filling the apex of truss VII (Chapter 7 and see Fig 7.27) also suggested a partition on this line. Sockets in both north and south walls of the inner chamber showed where the headbeam had been

seen in the south wall (see Fig 6.22, 125) extending into bay 7 (perhaps because the passage at the head of the stairs was also ceiled while the stair well, occupying the northern part of bay 7, remained open; see Fig 12.4). The north side of bay 5 contained a portion of a brick-lined flue against the west face of truss V (see Fig 6.25, 155), representing the provision of heating in the subdivided bedroom in the 19th century. A chimney is visible in this position in Stockdale's drawing of the courtyard (see Fig 2.5) and presumably served a fireplace or a free-standing stove in the corner of the room that had been removed by the time Everett came to draw his plan in the 1950s. Last in the sequence of alterations was the construction of staircases in bays 7 and 6–7. The first (phase 10)<sup>83</sup> rose against the west side of the partition beneath truss VII and must have entailed the removal of some floor joists in ground-floor bay 6. The depredations of the second (of 1969, phase 11) on the ground floor have been described above (see above, p 120), but also involved the removal of part of main beam 6 and areas of joists in ground-floor bays 5 and 6.

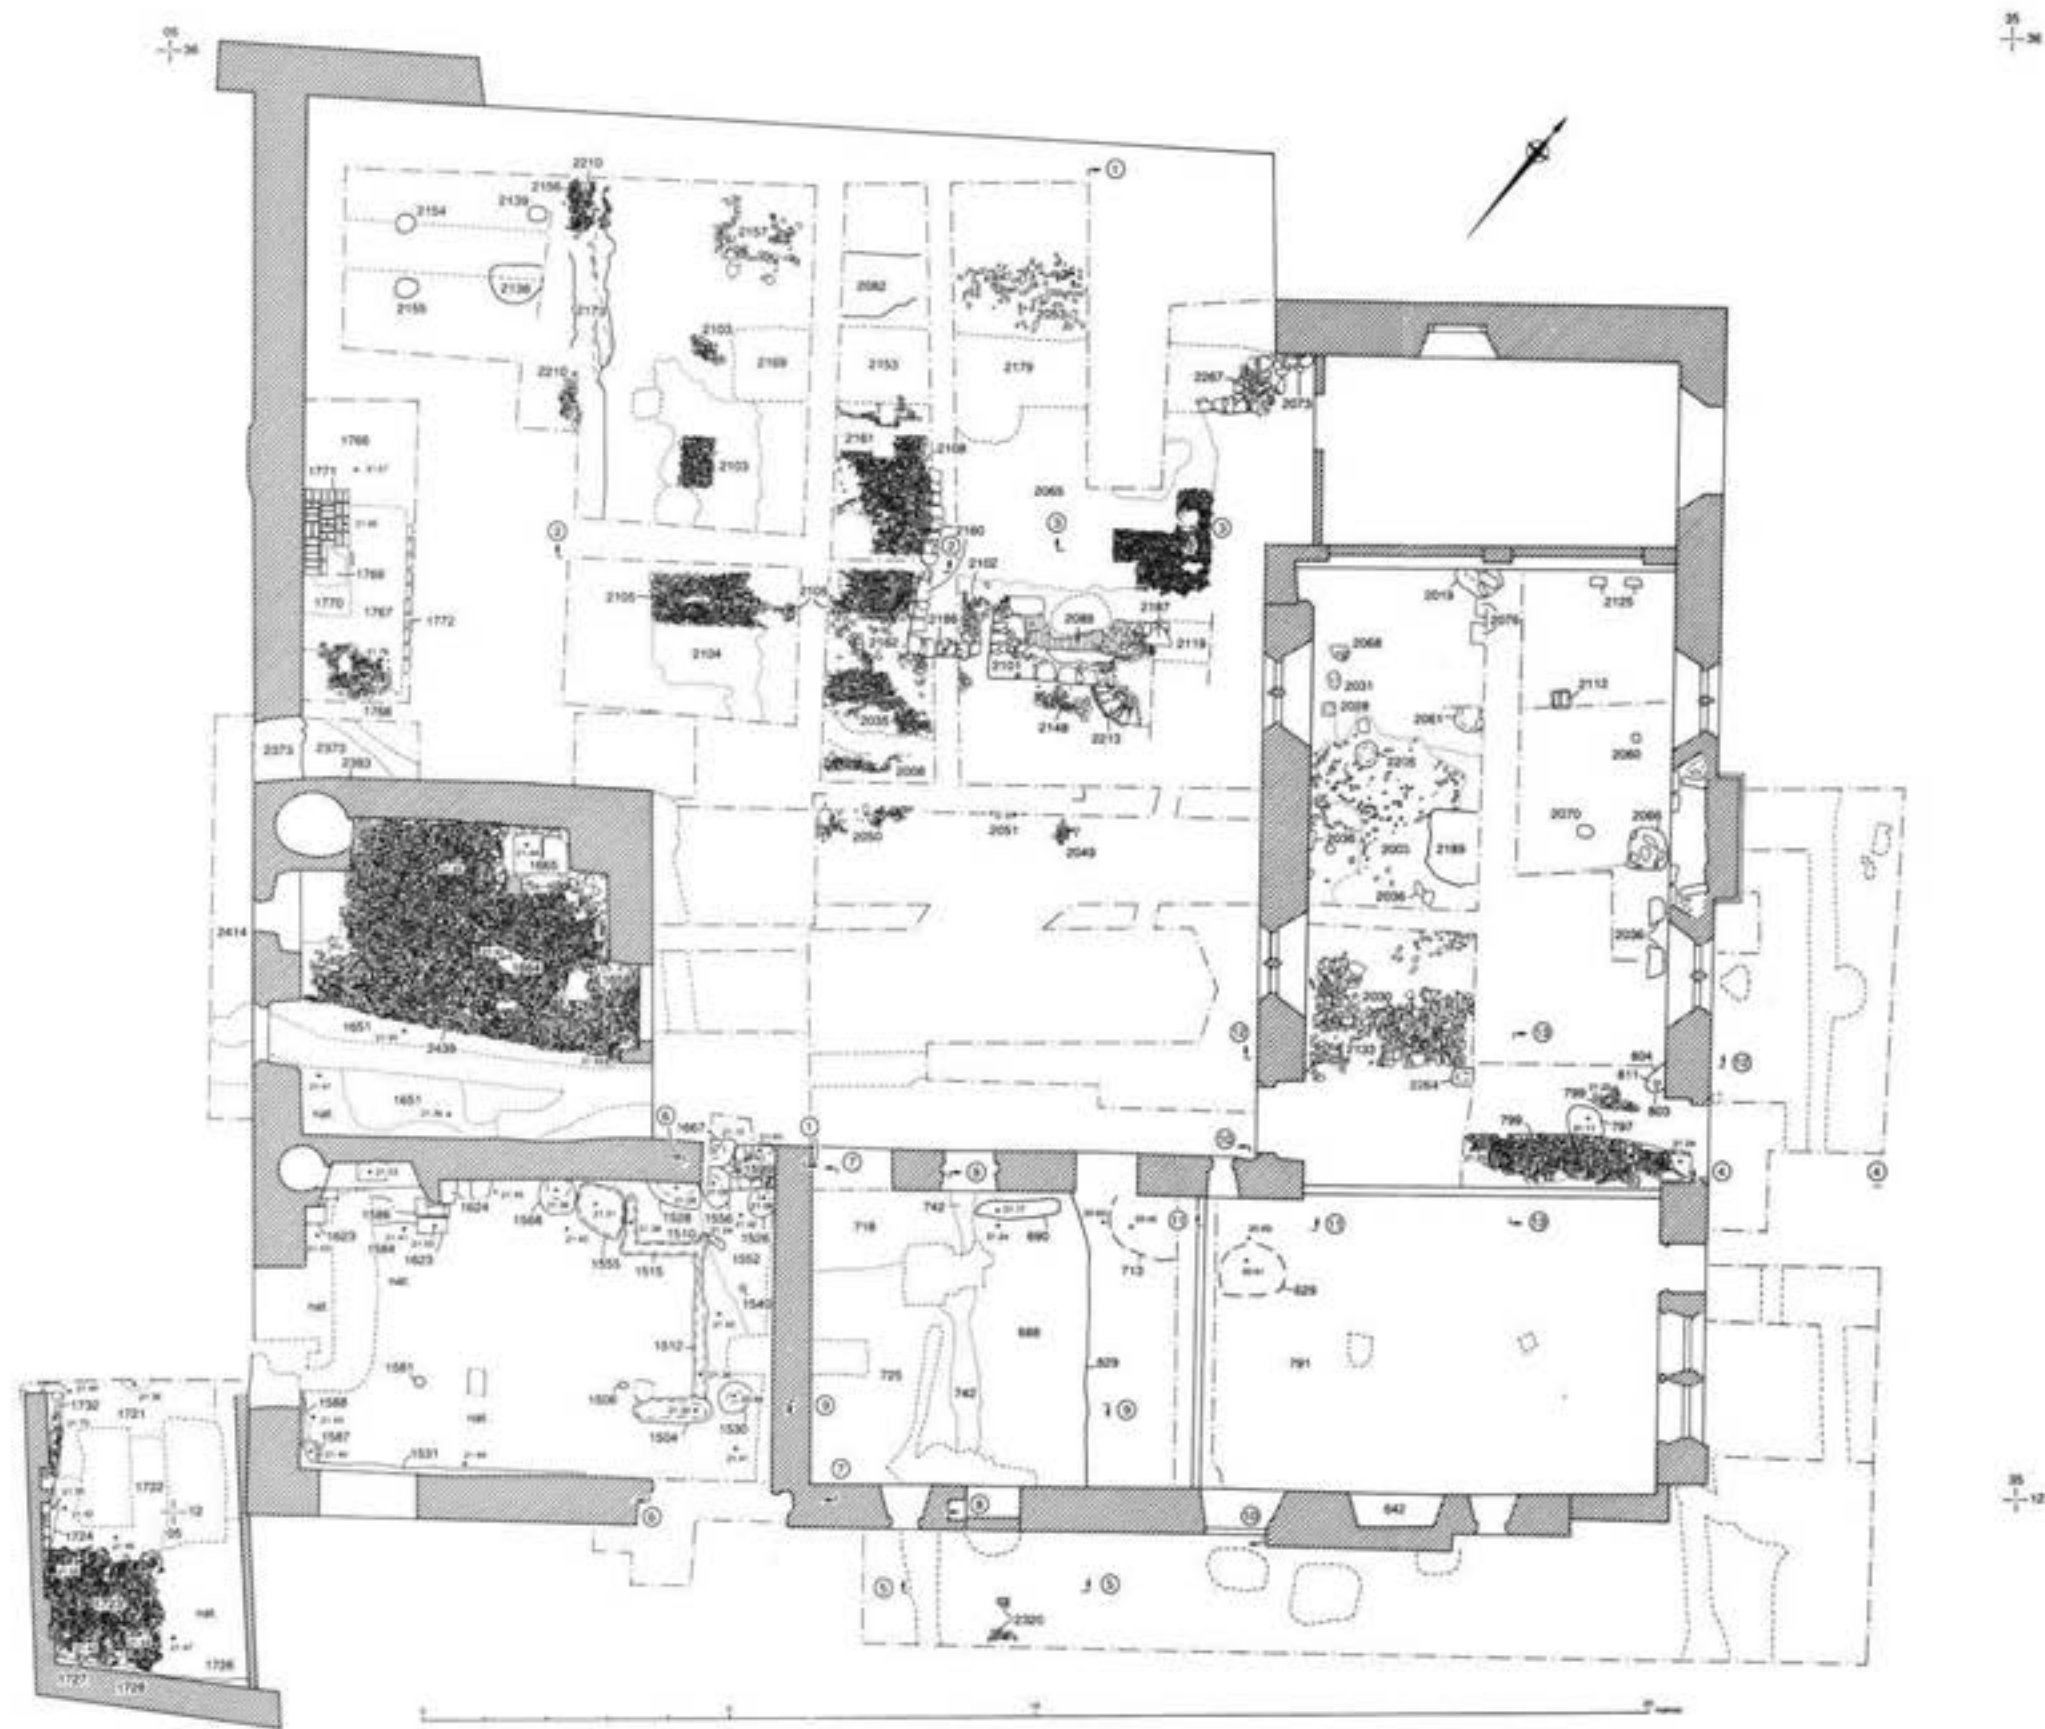
Figure 4.7  
 Plan of excavated features associated with the primary building, phase 3 (scale 1:100) (line drawing by Tony Ives).
