RAUNDS FURNELLS

The Anglo-Saxon church and churchyard

RAUNDS AREA PROJECT

ARCHAEOLOGICAL REPORT 7

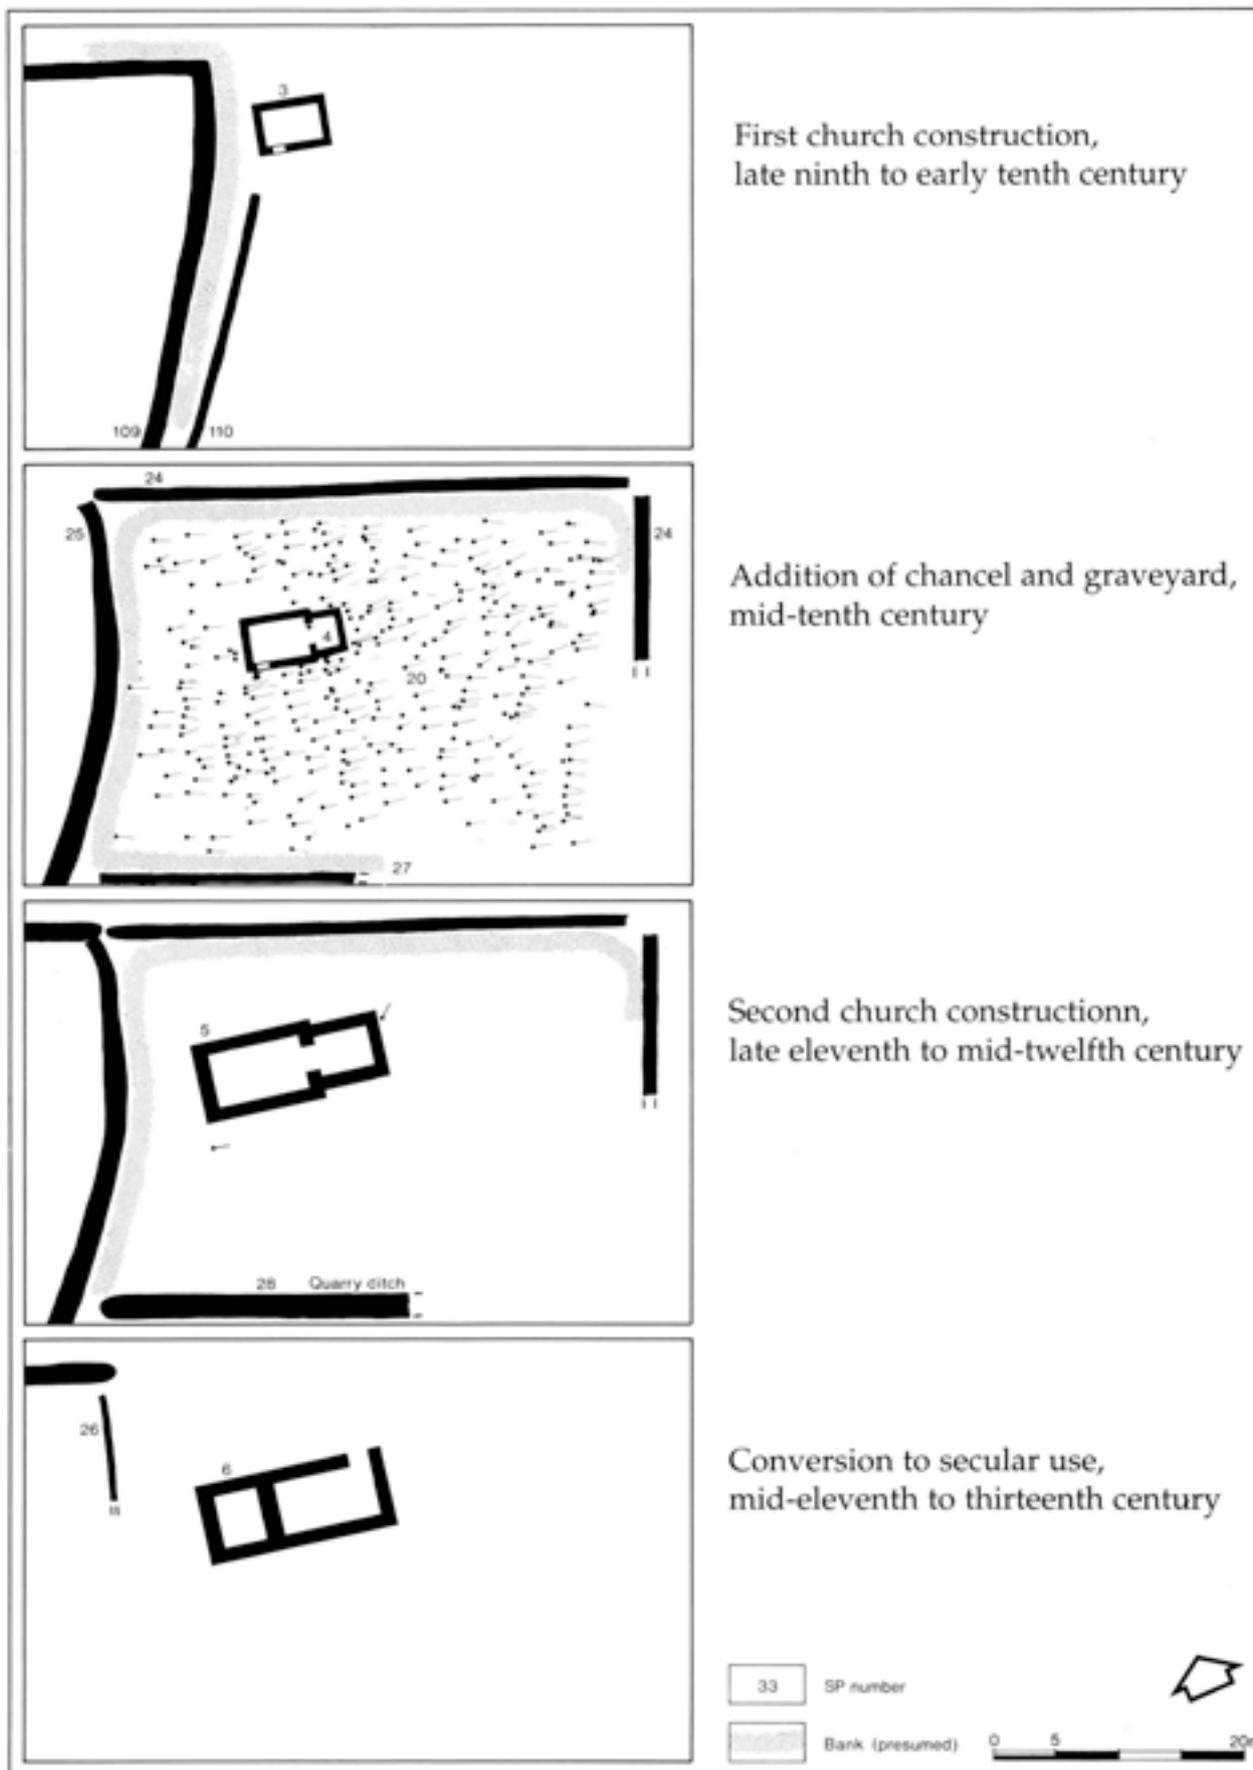
Fig 5 The church construction sequence

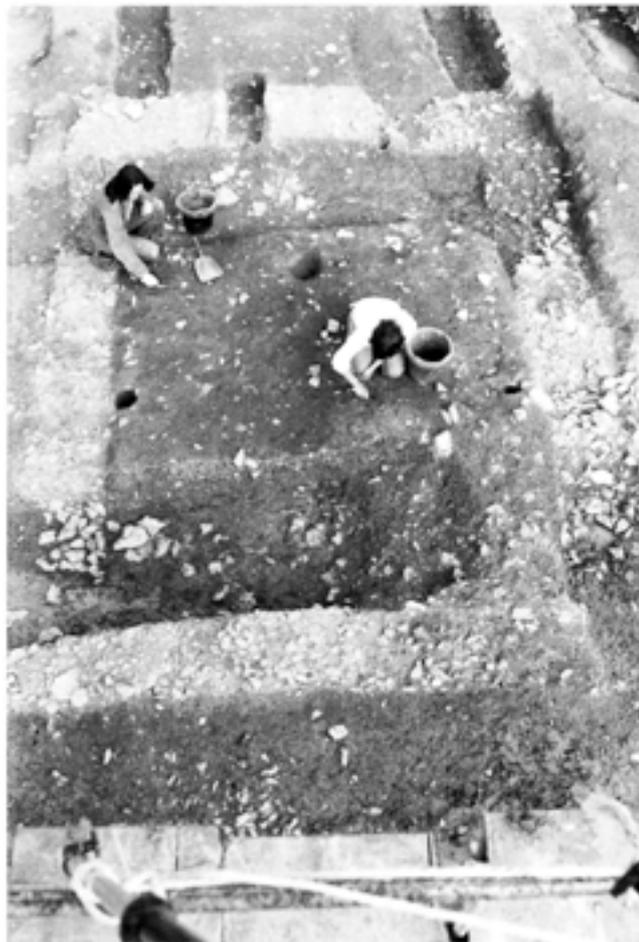
Fig 12 The first church viewed from the west

The foundation of the building was 0.35–0.43m wide and was set in a narrow, vertical-sided, flat-based construction trench (G1344). The south side of this trench was generally lower, reflecting the lower ground level on that side. The foundation was composed of two layers of cornbrash limestone. The lower layer was constructed of two or three rough courses of cornbrash limestone rubble, the stones of which were generally 0.06–0.20m across and set in clay (G1344, 1621). In contrast (Fig 15) the overlying and thicker layer – 0.3m deep compared to 0.1m – is constructed of quite small cornbrash limestone fragments, rather less than 0.12m across, in a matrix of sand and clay (G1344, 1481). The top of the south foundation was 0.15m lower than the top of the north foundation, reflecting the slope of the pre-construction levelling. At the south-west corner of the foundation an additional layer of larger cornbrash limestone fragments reinforced the surface in the area of the doorway.

The lowest course of the walls survived along the entire length of the west side (G105) and along much of the north side (G139), but barely at all on the south side (G1414). Here it had been removed by the south nave wall foundations of the second church (SP5). The walls were built of medium to large flat cornbrash limestone fragments which were up to 0.25m across in the core of the wall face, with generally larger stones up to 0.4m across at the face. Throughout, the cornbrash limestone was rough hewn, without tool marks and bonded with a ginger mortar (for details of the mortar, see p 100). Only the north-east external angle of the nave survived (G139). There was no quoining evident, though quoinstones were recovered from the second church foundations and these no doubt derived from this building (p 98). The walls survived to a maximum height of 0.18m. Their original height could not be determined, though the quantity of mortar debris associated with the demolition of the church suggests they were probably more than mere dwarf walls (p 21).

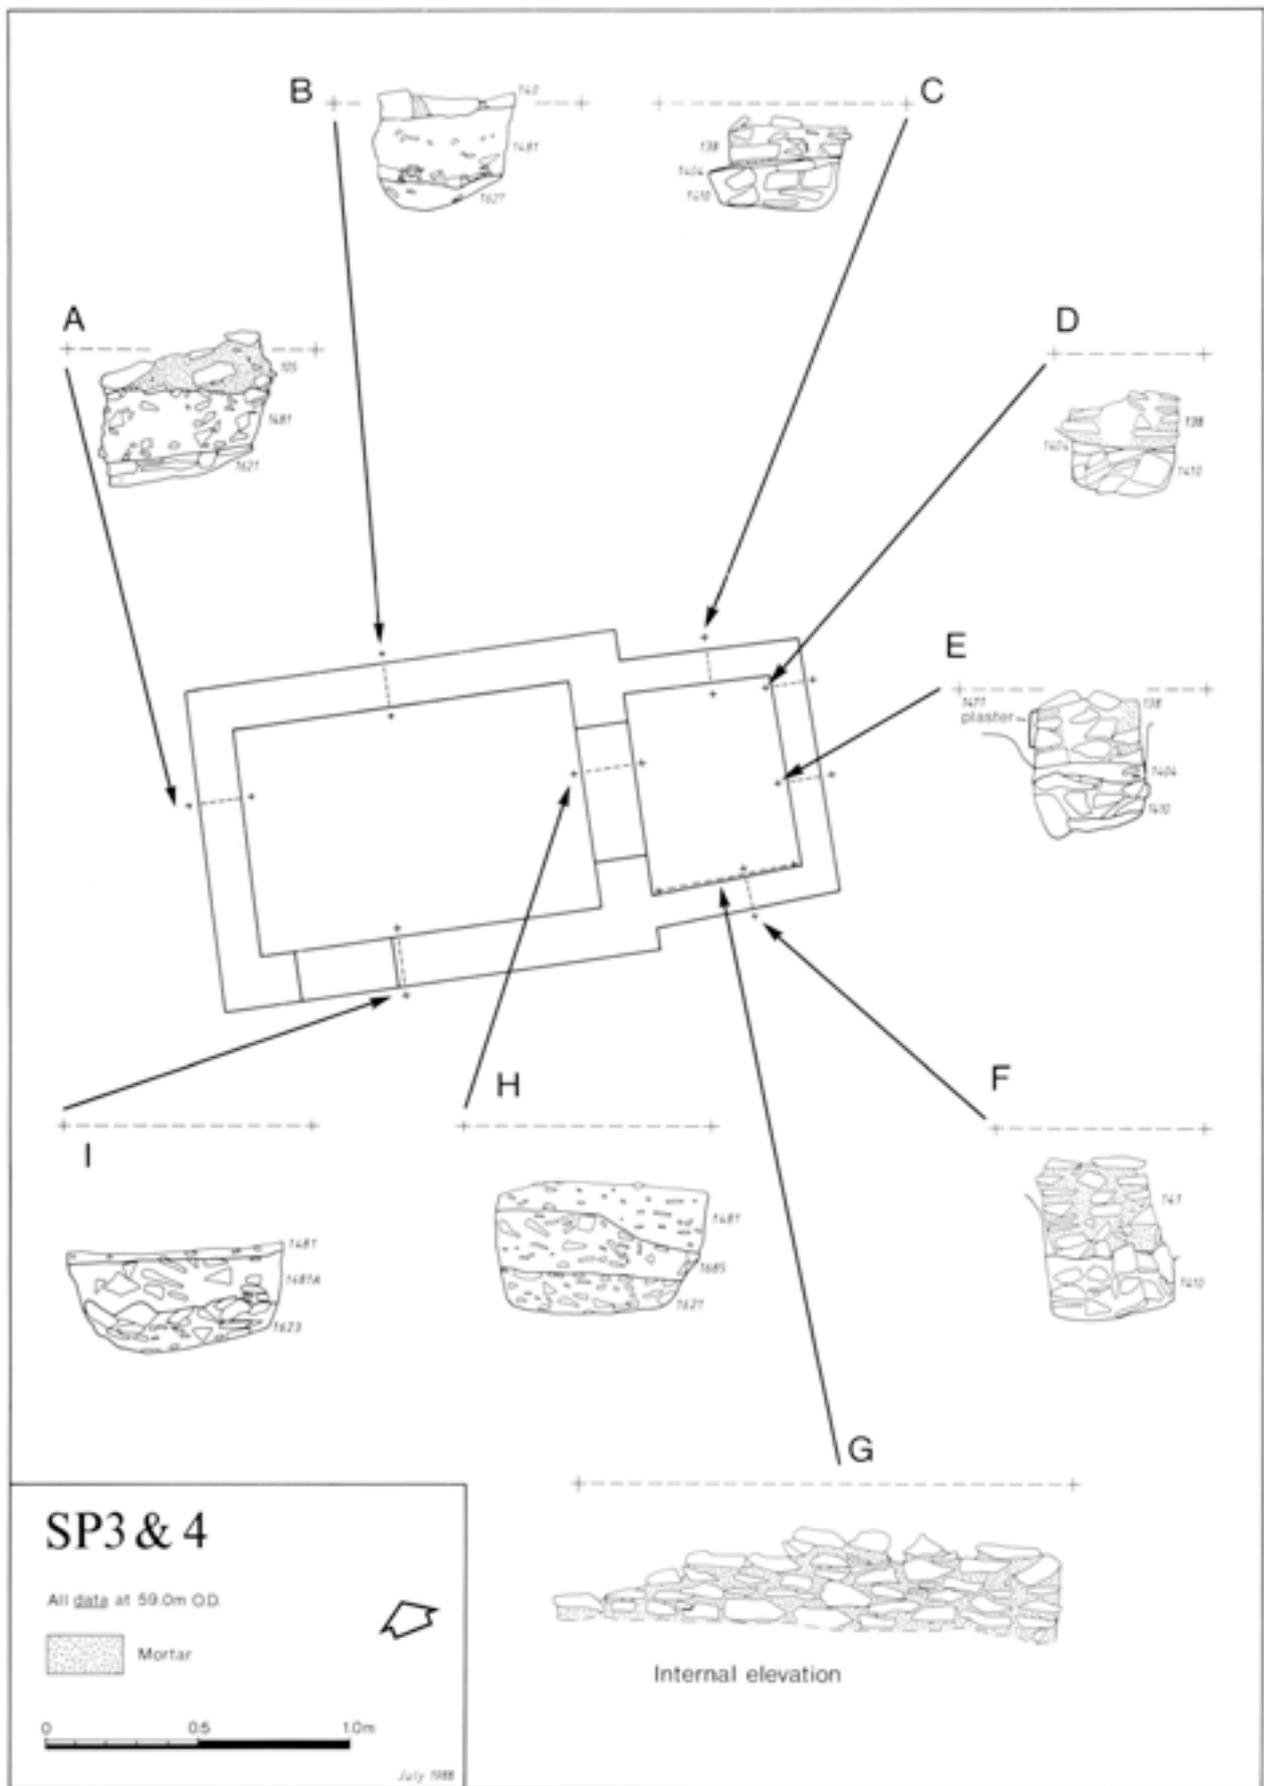
Fig 13 Sections of walls and foundations of the first church

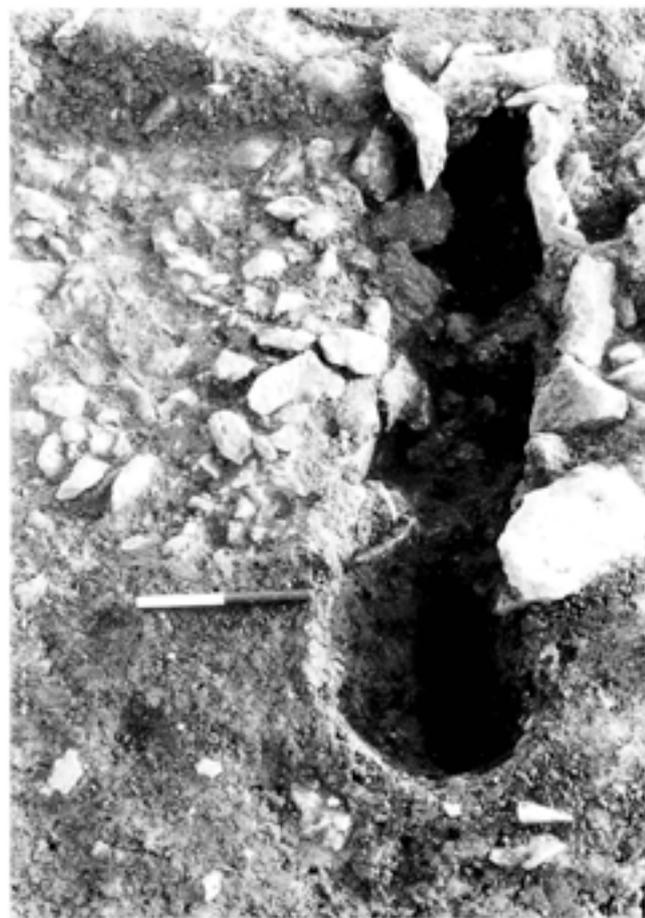
Fig 14 The first church doorway viewed from the north

There was clear evidence for a door in the south wall. It was hung on a large post set in a posthole (G1413) cut into the foundations; in contrast the opposite side of the door was relatively slight (Figs 10 and 14). A slot cutting into the south wall of the church evidently held three upright posts (G1529). The form of the slot and the arrangement of packing stones suggests that this side of the door frame was formed by two rectangular posts, each c 0.1m by 0.2m. The third post lay within the interior of the church and had a circular postpipe, 0.12m in diameter. This may have been part of a non-structural frame to the doorway or of a short internal screen.

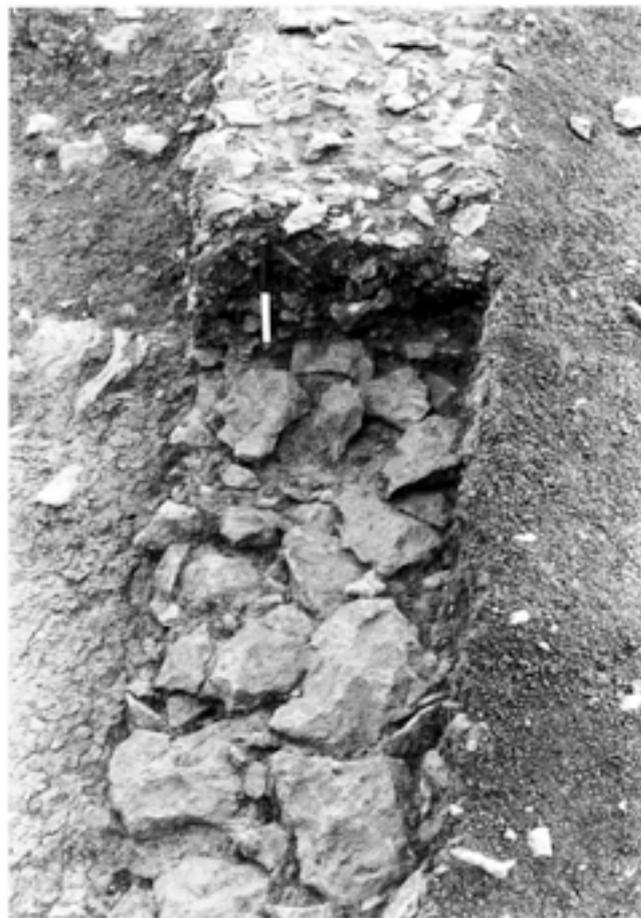
Fig 15 The first church foundation, showing difference in construction between top and lower courses of foundation

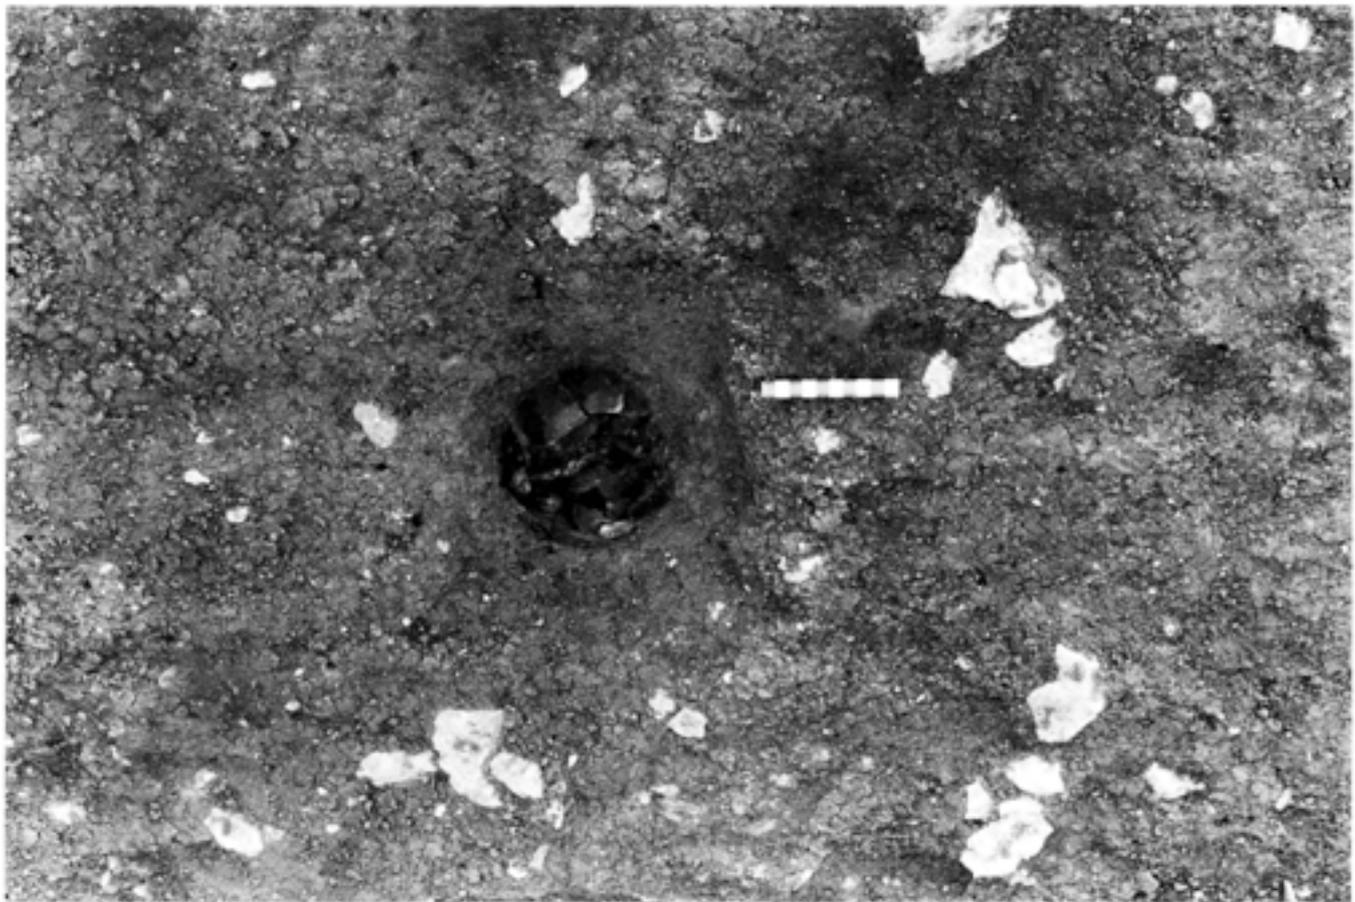
Fig 16 *The sacrarium pottery vessel in situ*

In the east part of the nave a layer of burnt soil with ash, 2–10mm thick, spread across the central axis. At the centre of the burning a complete pottery vessel of St Neots type ware was set in a small pit (G745, diameter 0.3m, depth 0.12m; Fig 10). The lack of fire damage to the upper part of the pot indicates that it was placed in this position after the fire. A dark grey silty-clay deposit with c 15–20% charcoal filled the lower two-thirds of the vessel. This was of a similar character to the burnt deposit around the vessel (for analysis see p 97) and may have been scraped from the burnt area. The internal base of the pot was covered with a burnt residue containing honey, sugars, and tartaric acid (see p 96). The charcoal and silt fill was sealed by the broken fragments

of the top of the pot which were covered with a light brown clay. This clay was present on the broken edges of the pot and had filtered into the fill below, so that the clay formed about 70% of the deposit at the top of the fill top but only 5% at its base. The burnt layer (G742) surrounding the vessel comprised the incinerated top of the pre-construction levelling layer (G2294) with some additional ash. This suggests that the burning predated any church floor and it seems probable that the fire was contemporary with the construction of the church. Of course, any floor may have been removed prior to the burning but this seems unlikely. The small areas of surviving stone floor (G763 and G765) may have originally extended over the burnt area to the lip of the pot which protruded 65mm above the surface. These stone areas are potential fragments of the first floor of the first church.

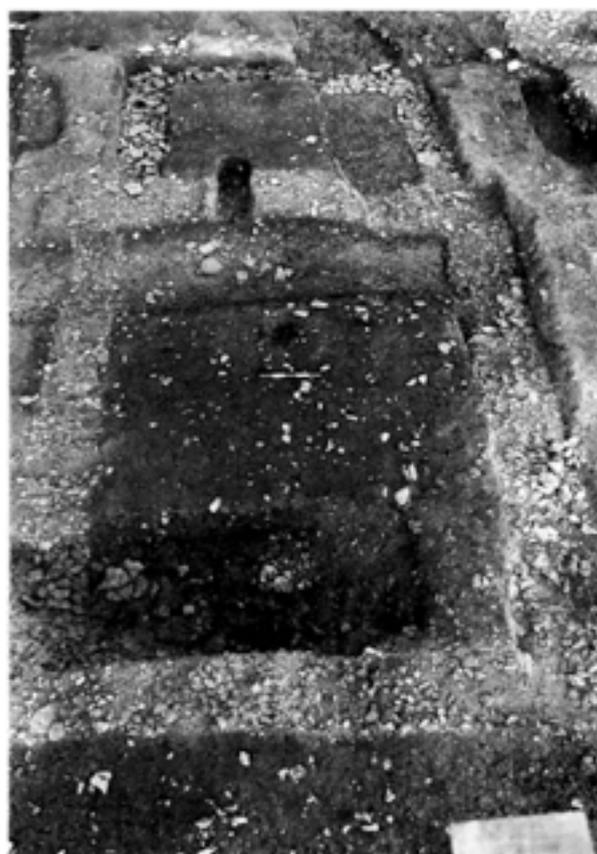
Fig 17 (top left) The first church after addition of the chancel, foundations viewed from the west: the difference in construction of the foundations can be seen

In common with the first phase of the church, the chancel survived remarkably well (Figs 11, 17, 18, and 19). It was disturbed along its south side only by the south chancel wall foundation of the second church (SP5); this removed about 40% of the floor area.

The construction cut was similar to that of the first phase with vertical sides and with the same general slope from north to south (G1491). The foundation construction was, however, of a different character. No formal courses occurred in the foundation which was constructed of fragments of cornbrash limestone up to 0.26m across (G1491, 1410; Fig 13, C, D, E, and F). Small patches of ginger mortar clung to the limestone. This was of the same character as that which bonded the walls of the nave, demonstrating that the foundation layer was laid with stones removed from the east wall of the nave during the cutting of the chancel arch. The thickness of the foundation varied from 0.18–0.24m; it was overlaid by a levelling layer of clay with smaller fragments of cornbrash limestone forming a levelling layer 0.02–0.07m thick (G1491, 1404). The wall itself was constructed of rough-hewn fragments of cornbrash limestone, 0.10–0.20m across (G1491, 138). In contrast to the walls of the nave, the wall was bonded with mortar at the face only and had sandy clay as the matrix for the core.

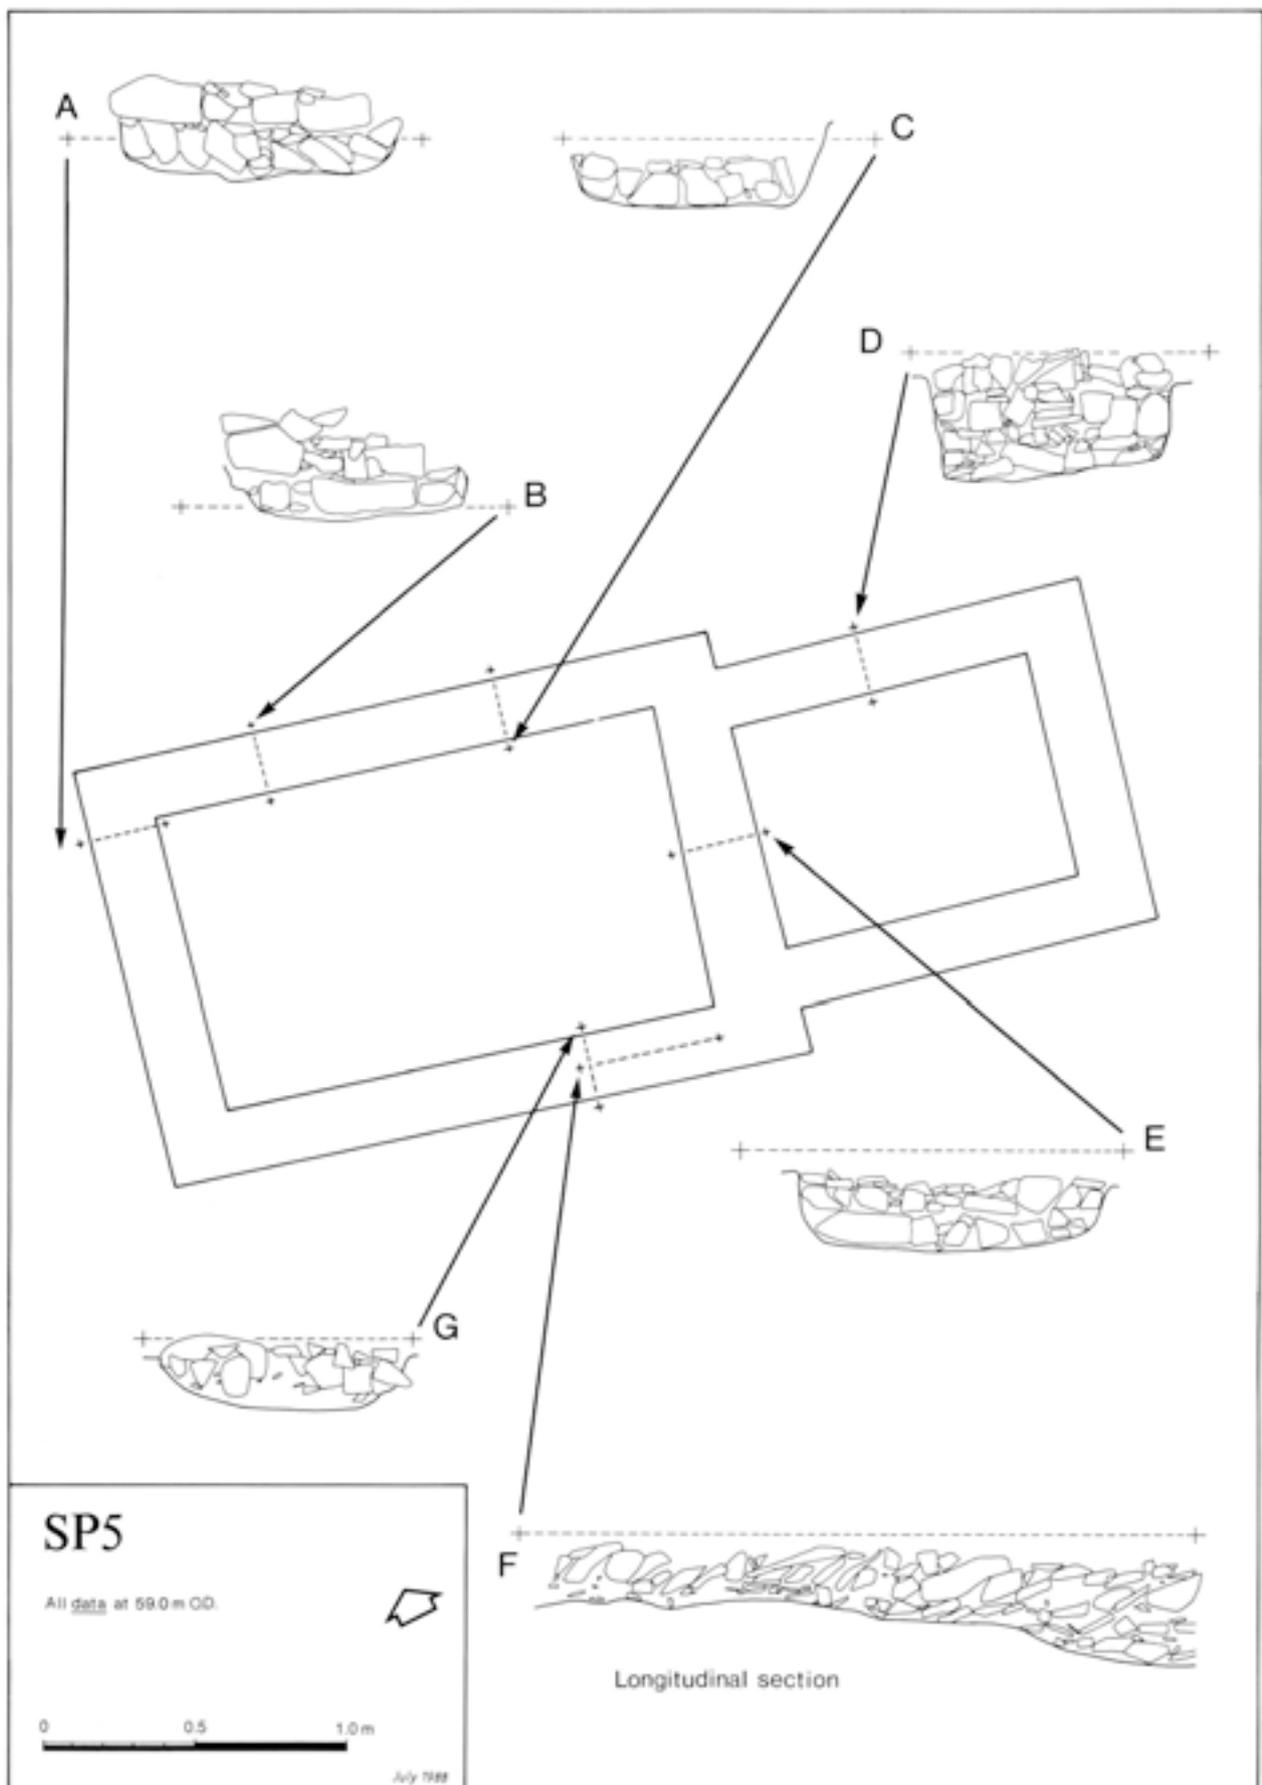
Fig 23 Sections of the foundations of the second church

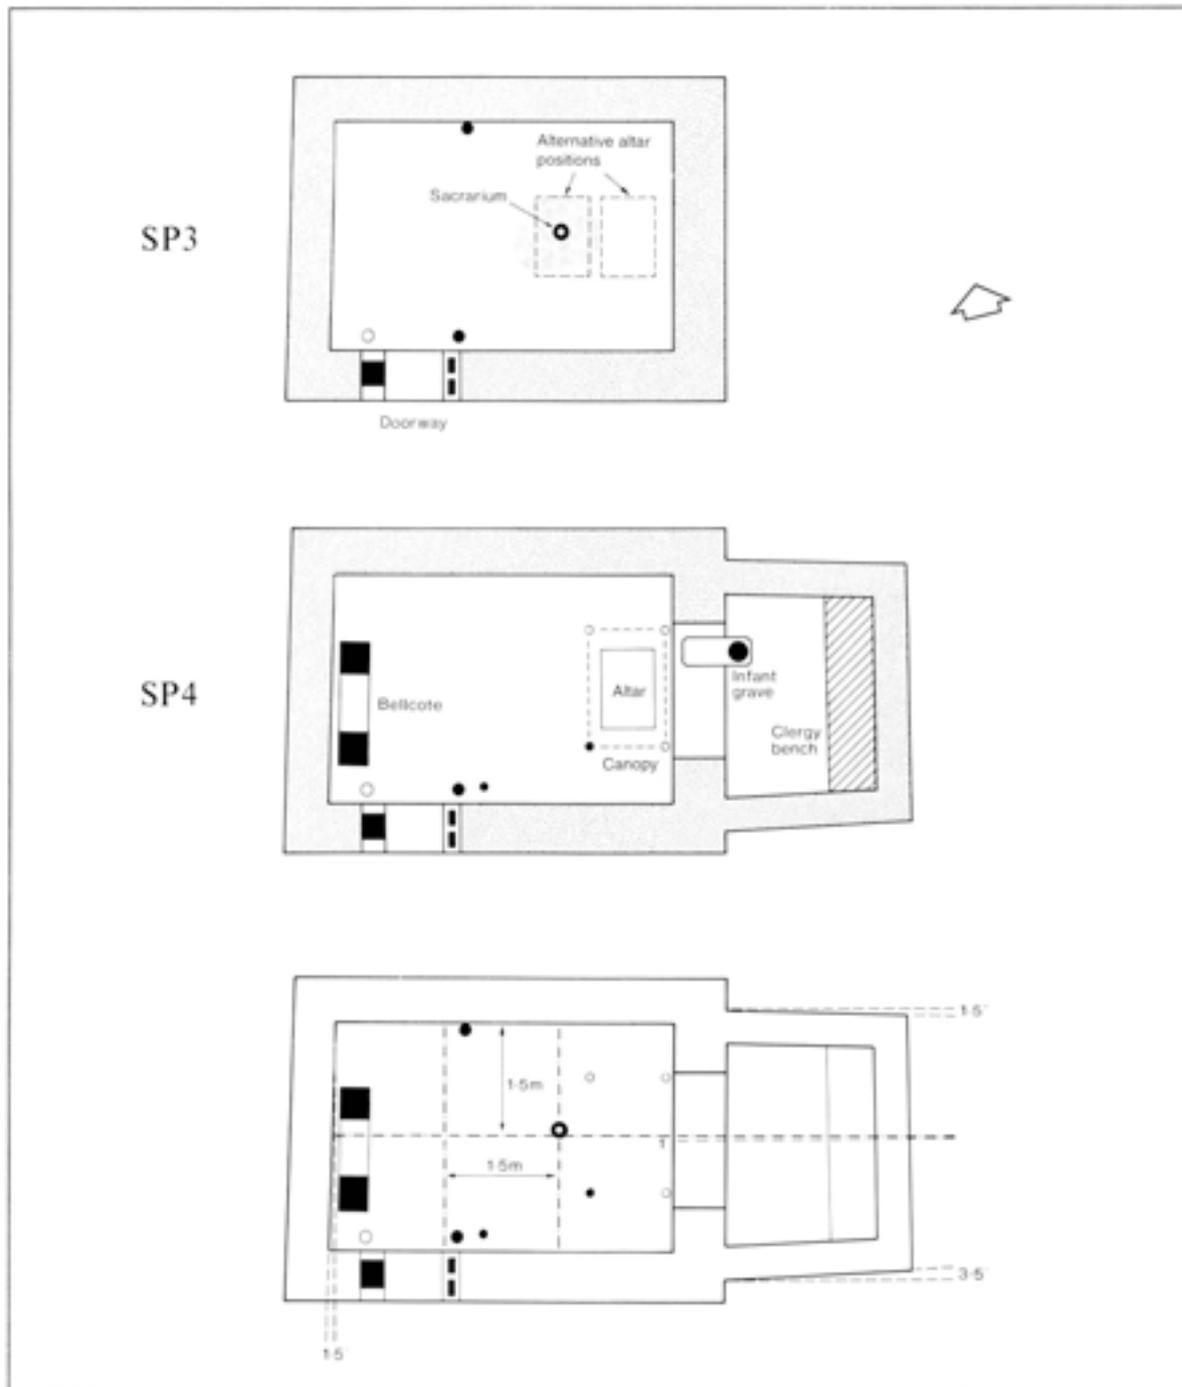
Fig 24 Interpretation and layout of the first church

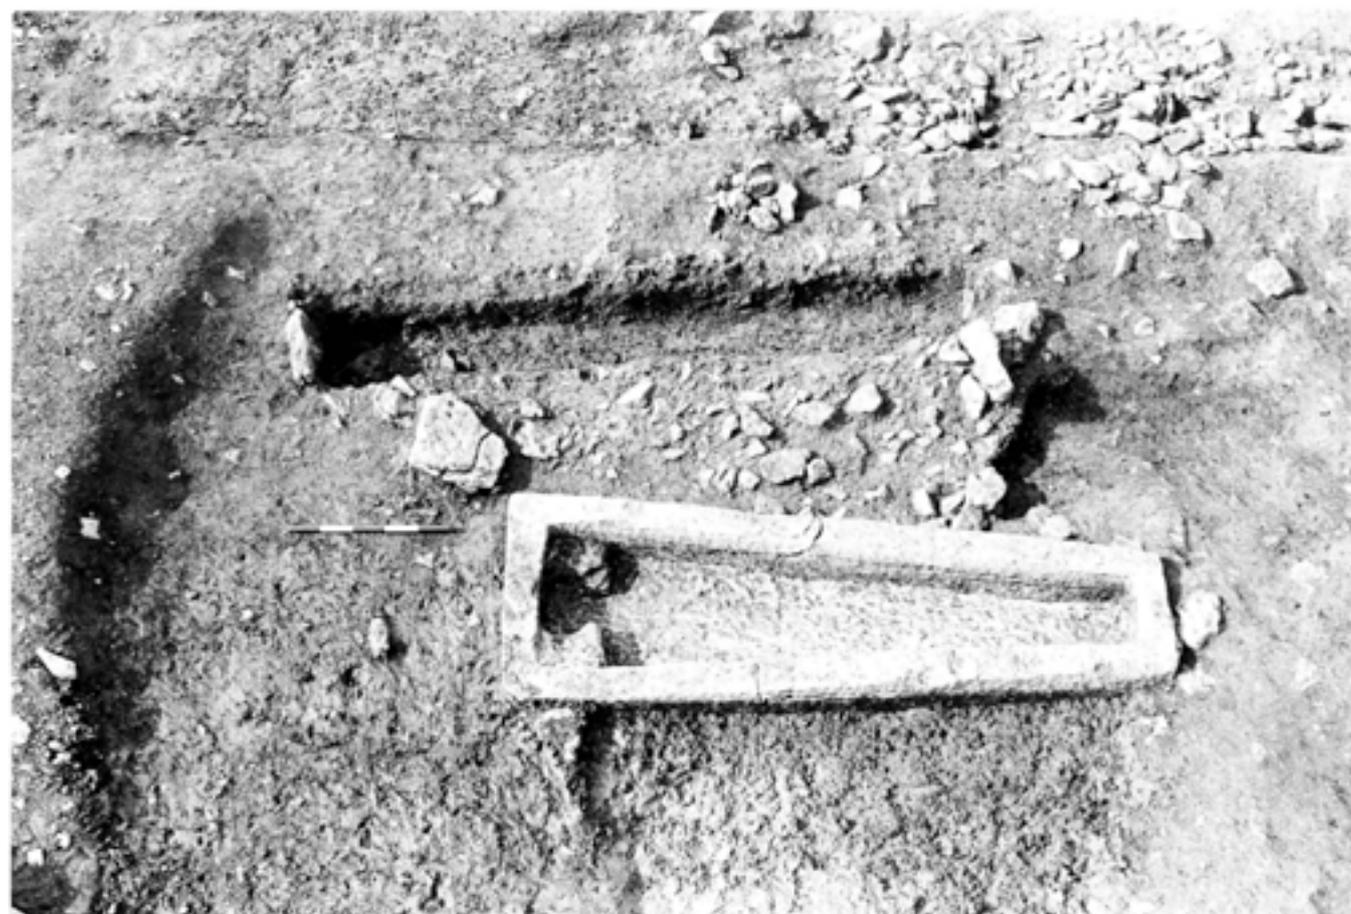
Fig 56 Stone coffin [1117] and slot 'marker' for adjacent grave (5282/M/45+; 5207/F/25-35)

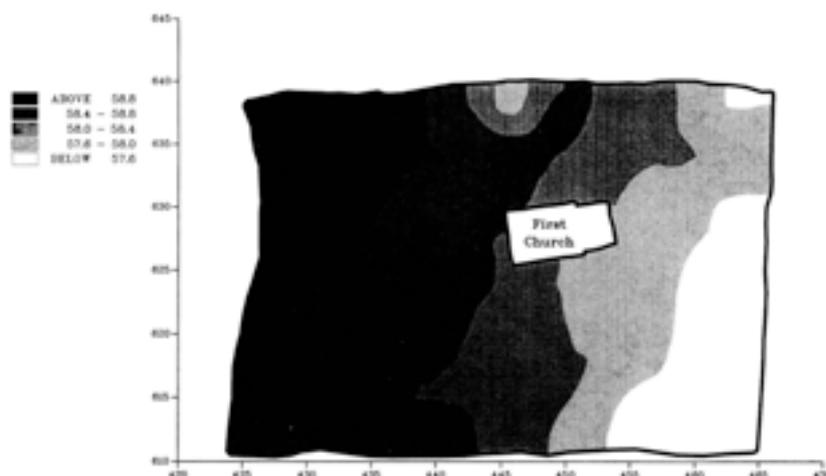
Fig 59 The contours of the churchyard

The graveyard surface sloped from west to east and more steeply from the church to the south boundary (Fig 59). The surface was not severely eroded except in the south-east corner and here only by an estimated 0.14m (p 46). Its original surface survived only adjacent to the church. For the first church, a small area of pitched limestone rubble abutted the east chancel wall. For the second church, limestone rubble was found in most of the graves adjacent to the church. The rubble sealed an extensive spread of mortar which derived from the demolition of the first church and filled several hollows created where the backfill of graves had subsided. At least three grave markers had been uprooted and the postholes left empty, to be filled by demolition material.

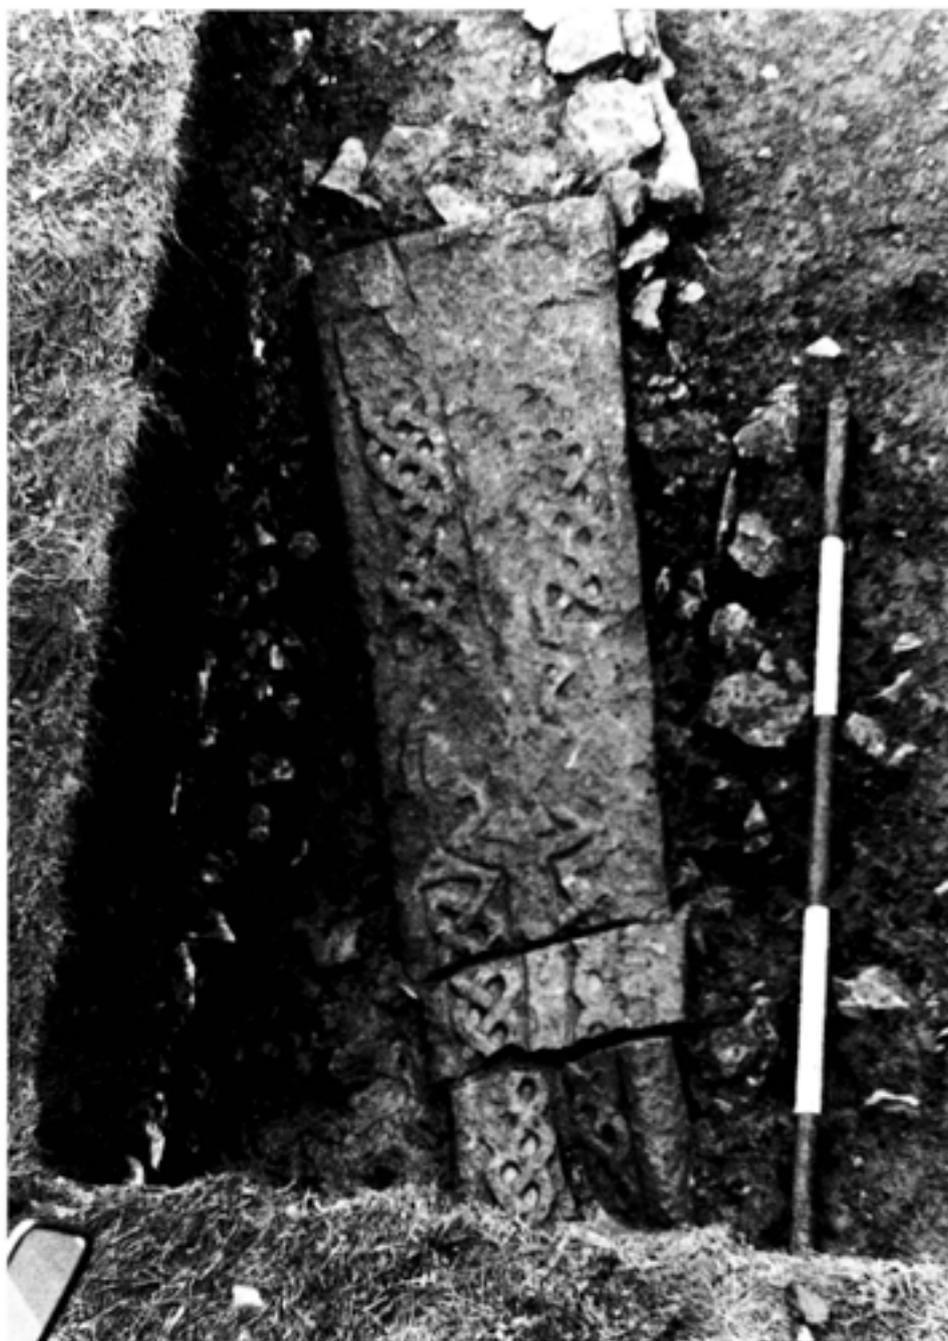
Fig 62 Grave cover [300] in situ showing setting of stones at the head

([300], Fig 62, p 106). It was set in the centre of an area measuring 1.6m north–south by 1.5m east–west, empty of other graves except for one infant (5171) and one infant or child (5342?/0–6). These youngsters need not have been related to the adult. Rather, these insertions into this otherwise vacant plot reflect the special treatment of infants in the same way as the concentration of infant burials against the church walls. No photographs survive of the burial, which was excavated during the 1975 trial season. The site notes, however, show that it was in an earth grave without stone arrangements. Possibly it was in a wood coffin, or at least had a wood cover, as the site notes record what seems to have been bone tumble – ‘some disturbance to the pelvic area and feet; one heel bone at the patella, the other at the pelvis’.

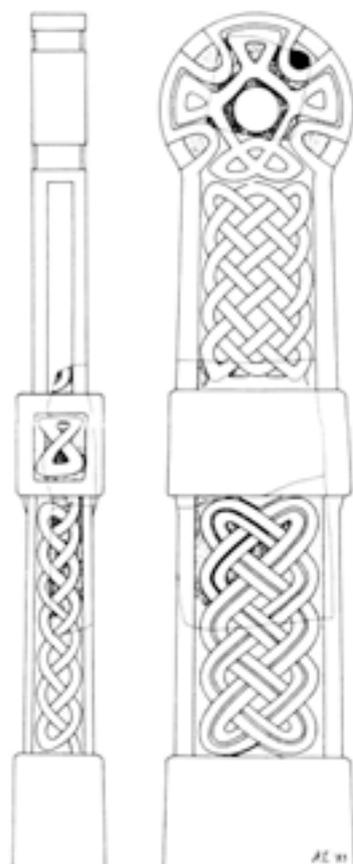
Fig 63 Reconstruction of cross ([164], [302/7])

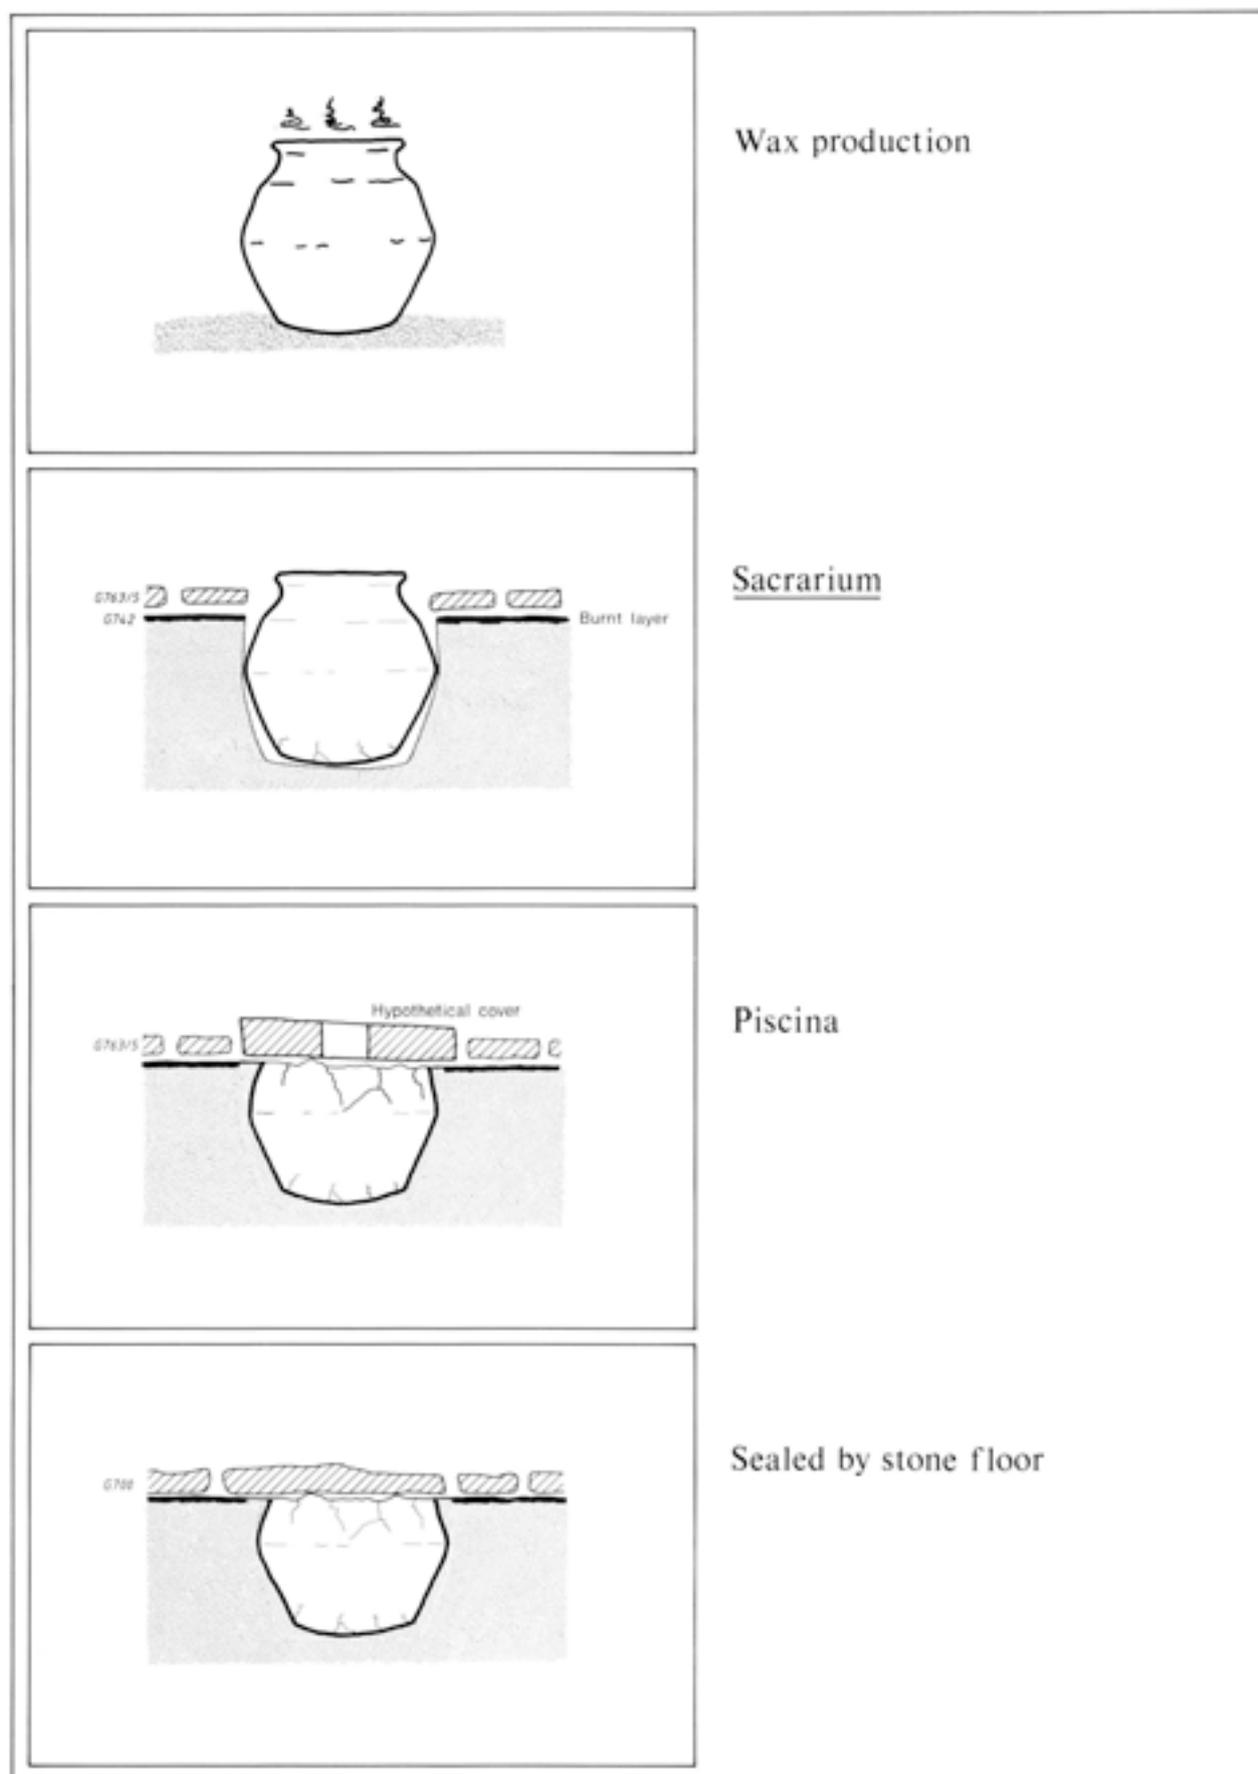
Fig 69 Sequence of use of the pottery vessel

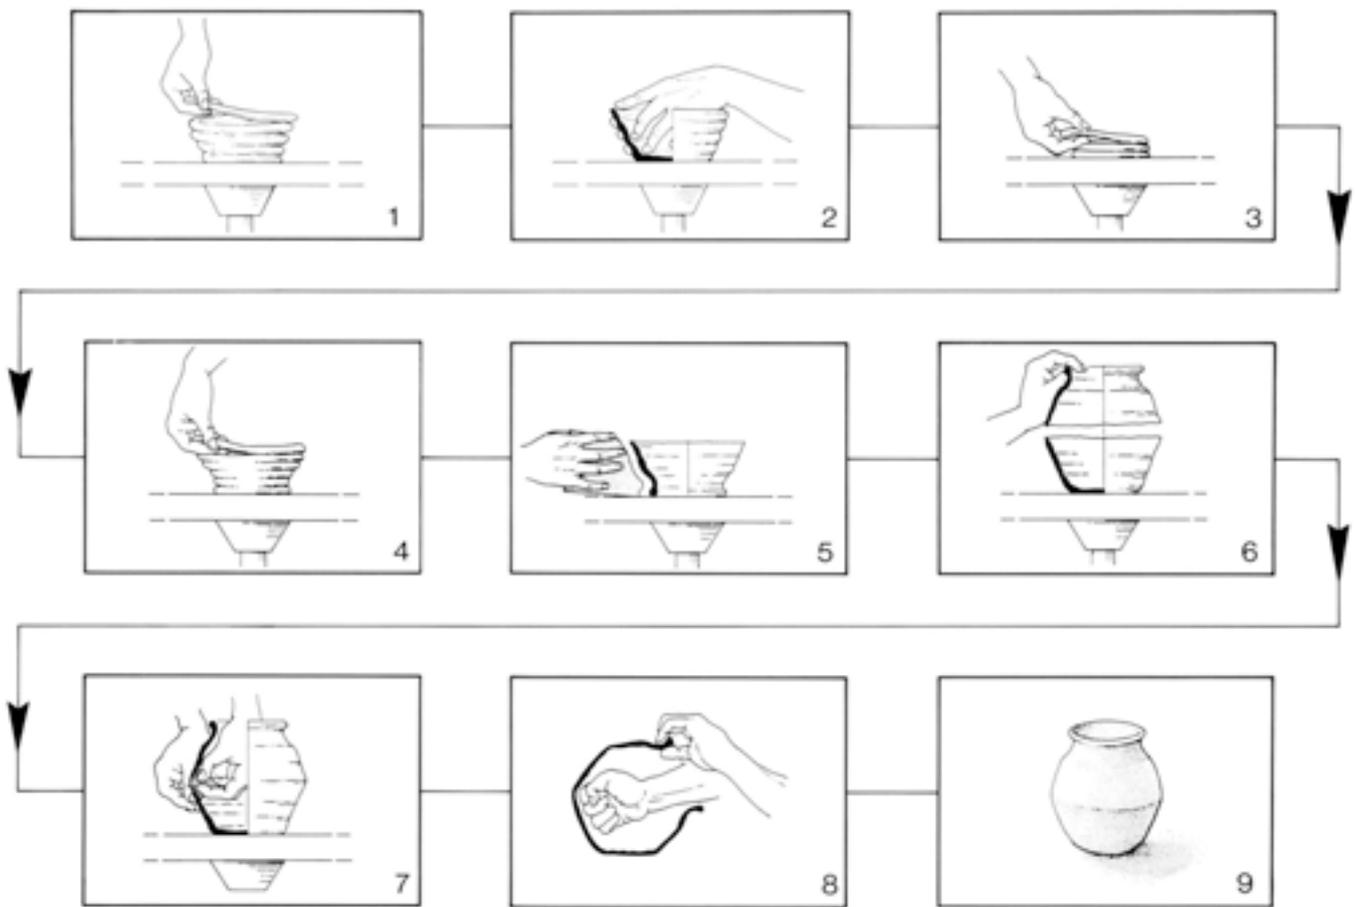
Fig 78 Construction method of the St Neots type ware small jars and bowls (types R031 and R055); the base and lower body were made in the same way for both forms [1 and 2], additional coils being added to form the bowl rim, which was then smoothed and finished. The rim and upper body of the small jar was coiled on a turntable [3 and 4] and probably finished with a template [5]. The upper body was then fitted to the lower body and base [6] and the join reinforced with a clay coil applied to the inside [7]: the jar was then inverted and the rounded base profile formed [8].

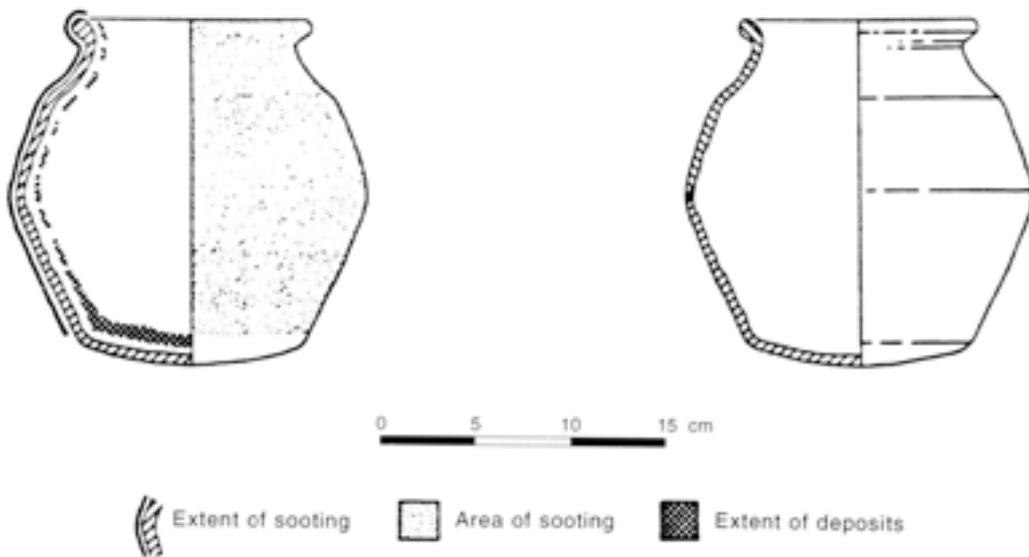
Fig 81 Drawing of the sacrarium pottery vessel

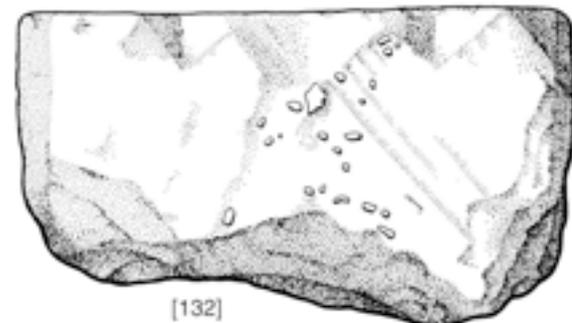
Fig 83 Hood moulding [132], possibly from conversion phase (SP6; scale 1:4)

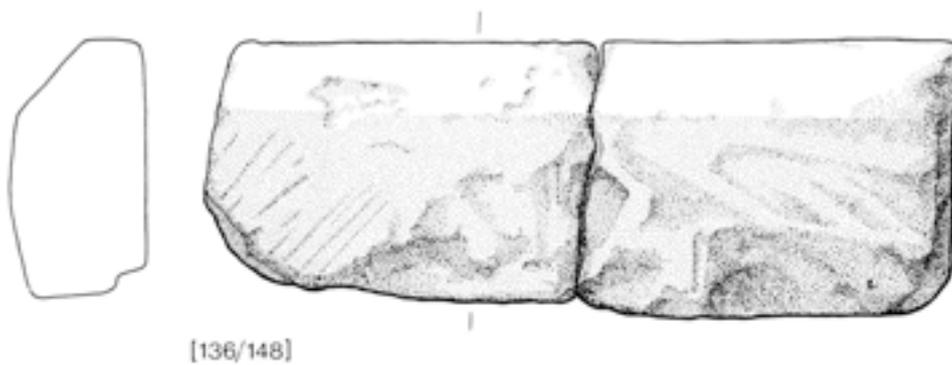
Fig 85 Possible architrave fragments from the first church, viewed from below ([136/148]; scale 1:4)
