RAUNDS FURNELLS

The Anglo-Saxon church and churchyard

RAUNDS AREA PROJECT

ARCHAEOLOGICAL REPORT 7

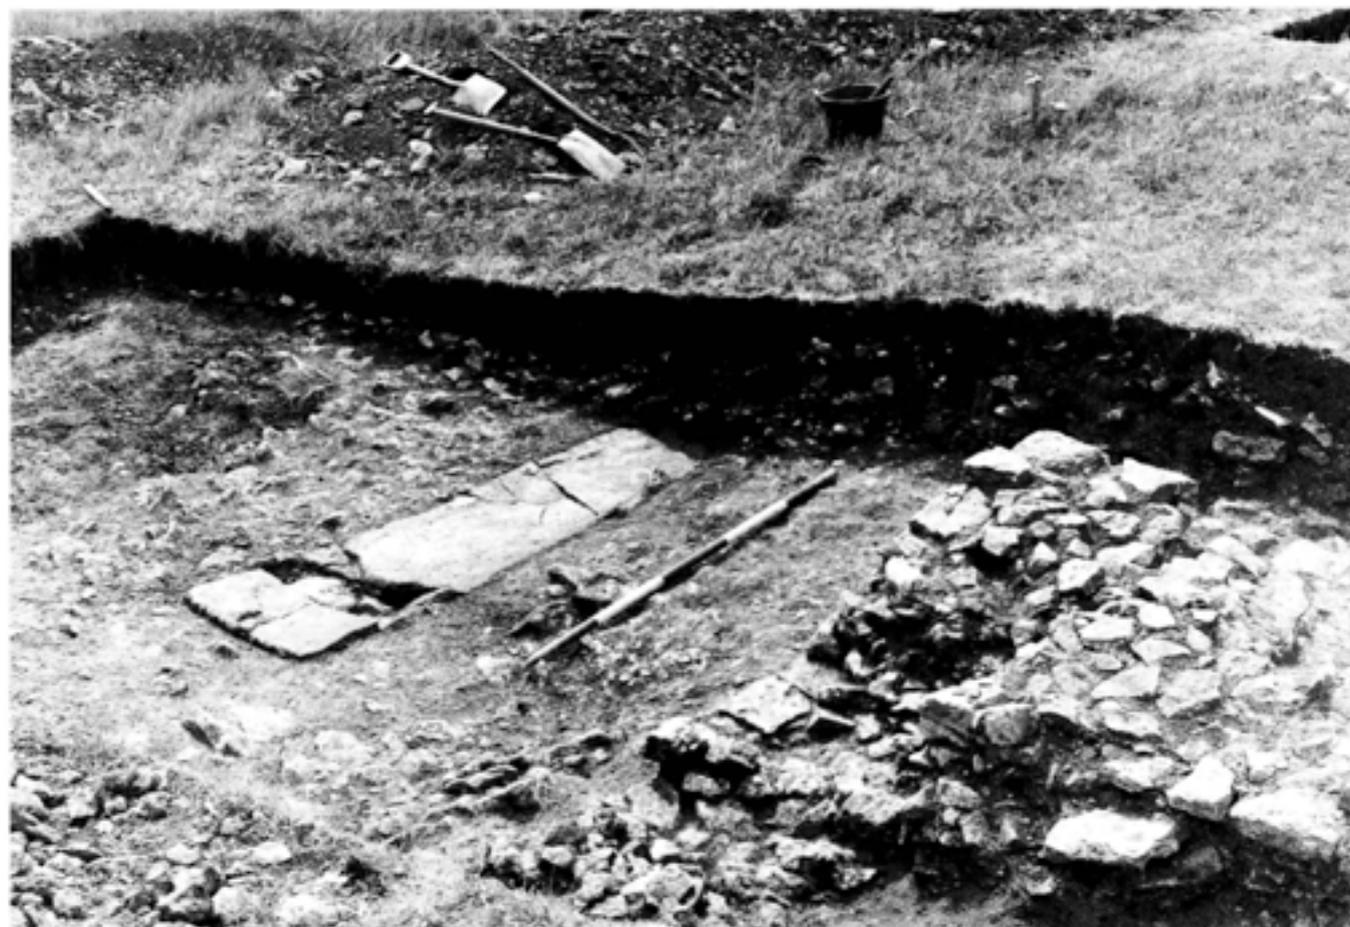
Fig 89 Stone coffin with cover in position as found ([1117])

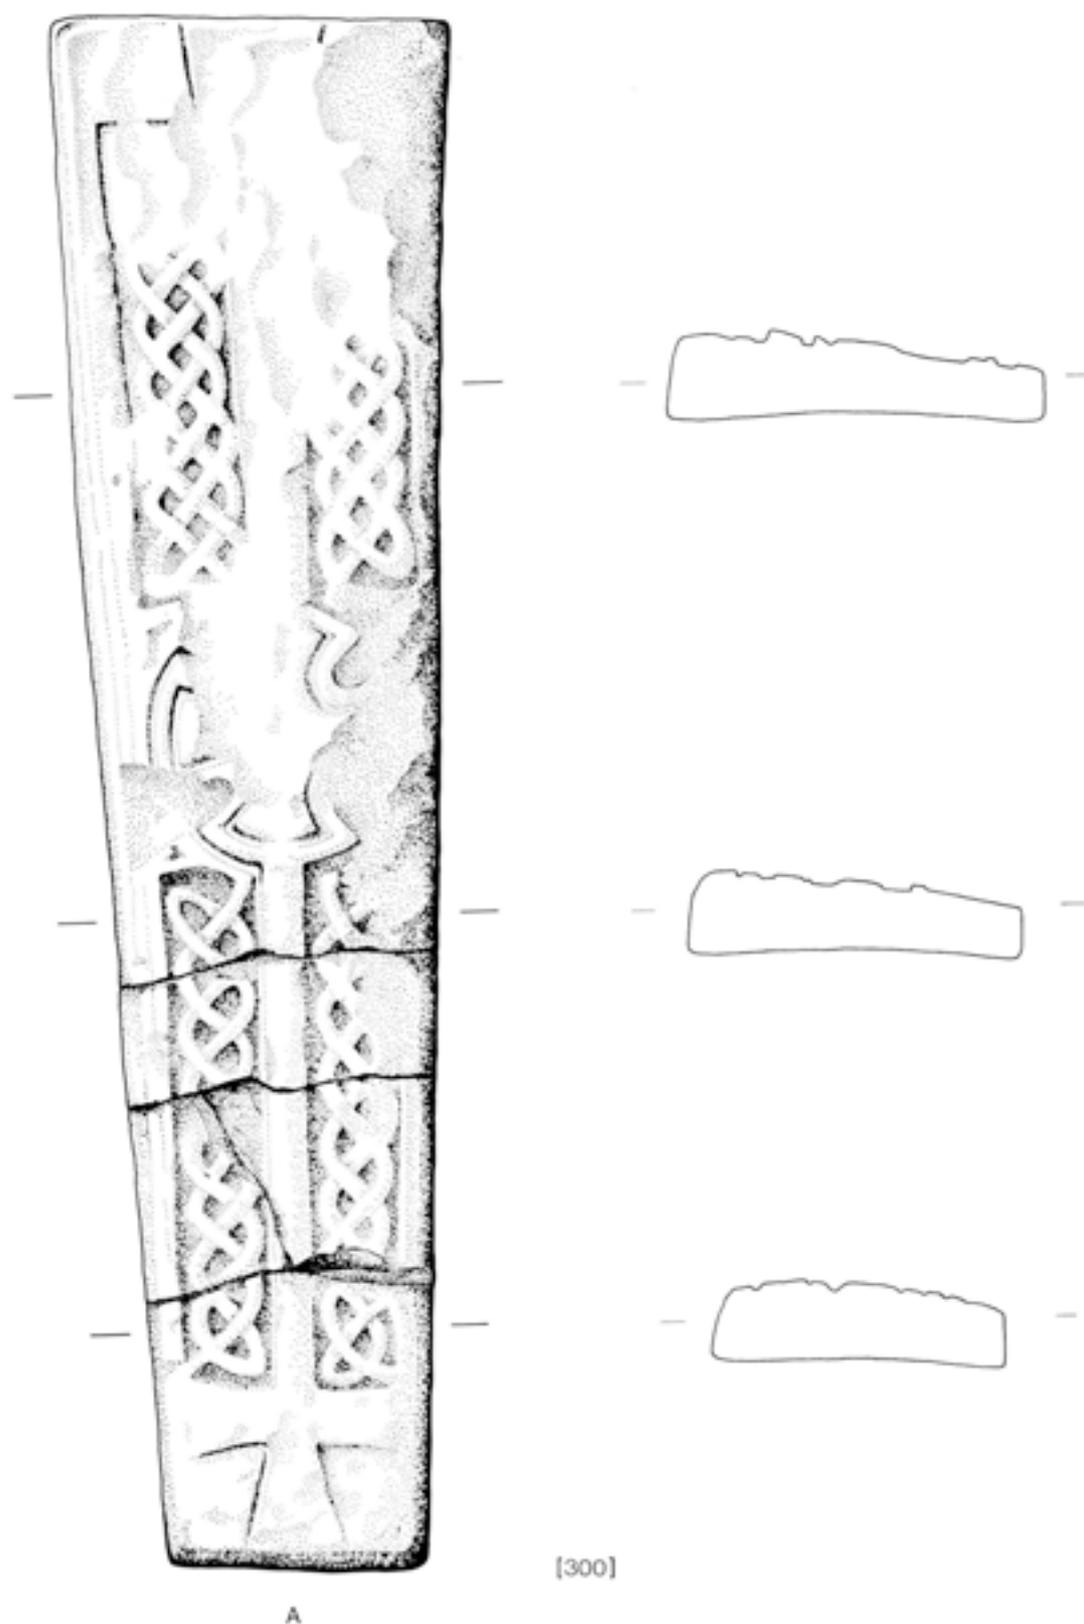
Fig 94 Carved limestone grave cover ([300]; scale 1:10)

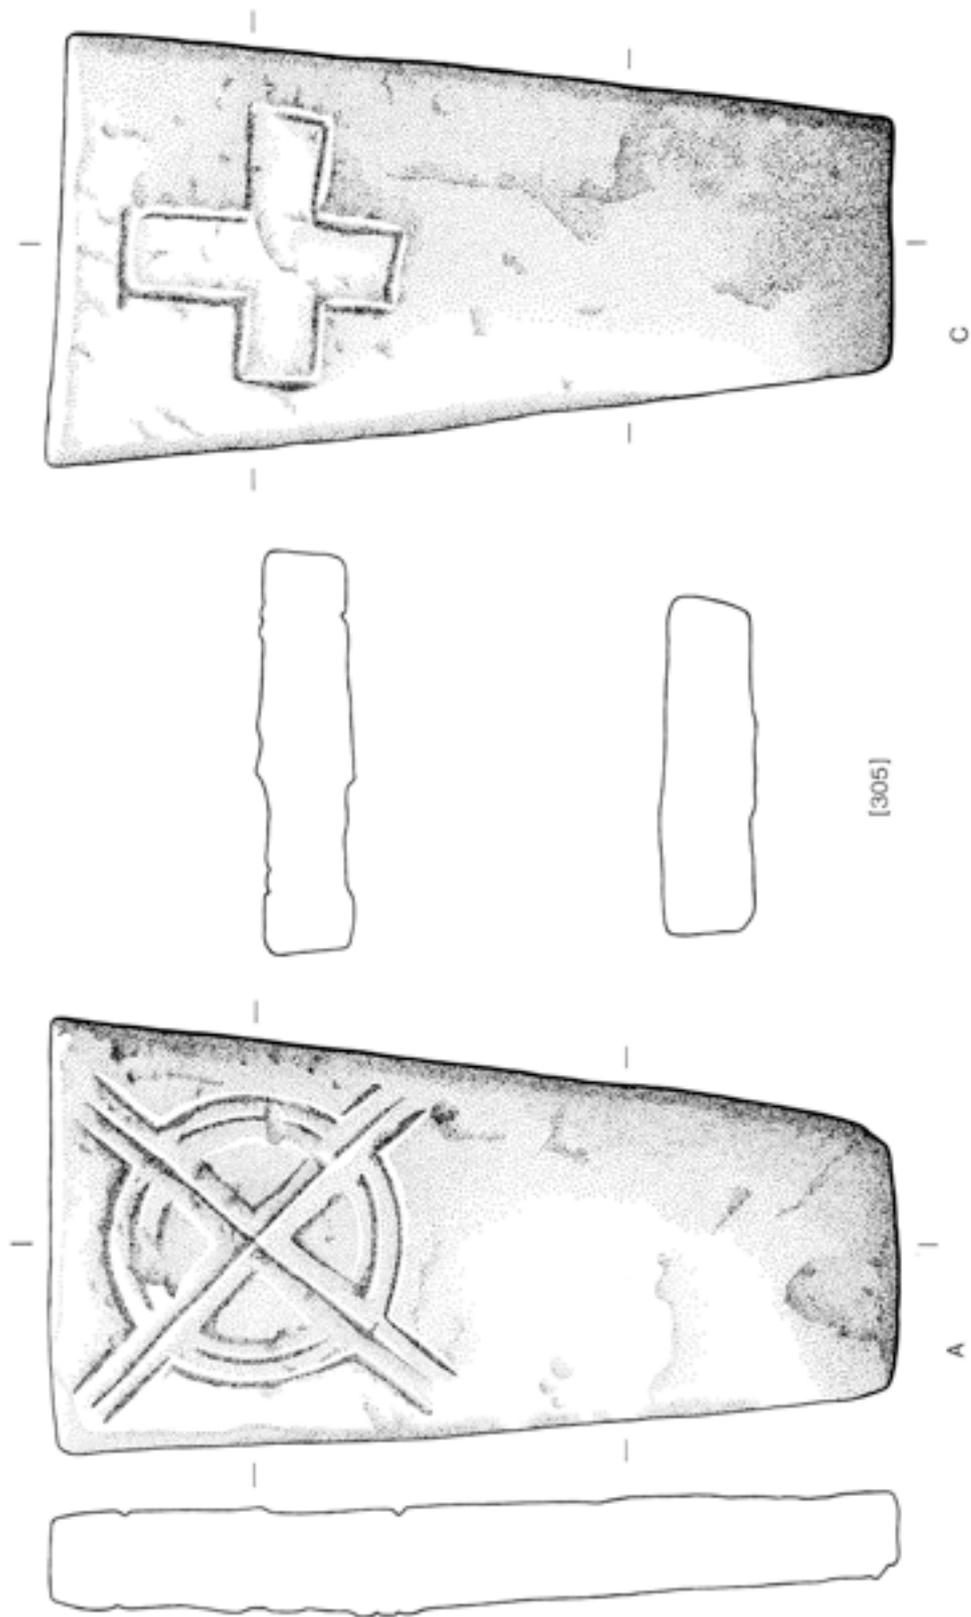
Fig 97 Carved limestone grave cover or marker ([305]; scale 1:10)

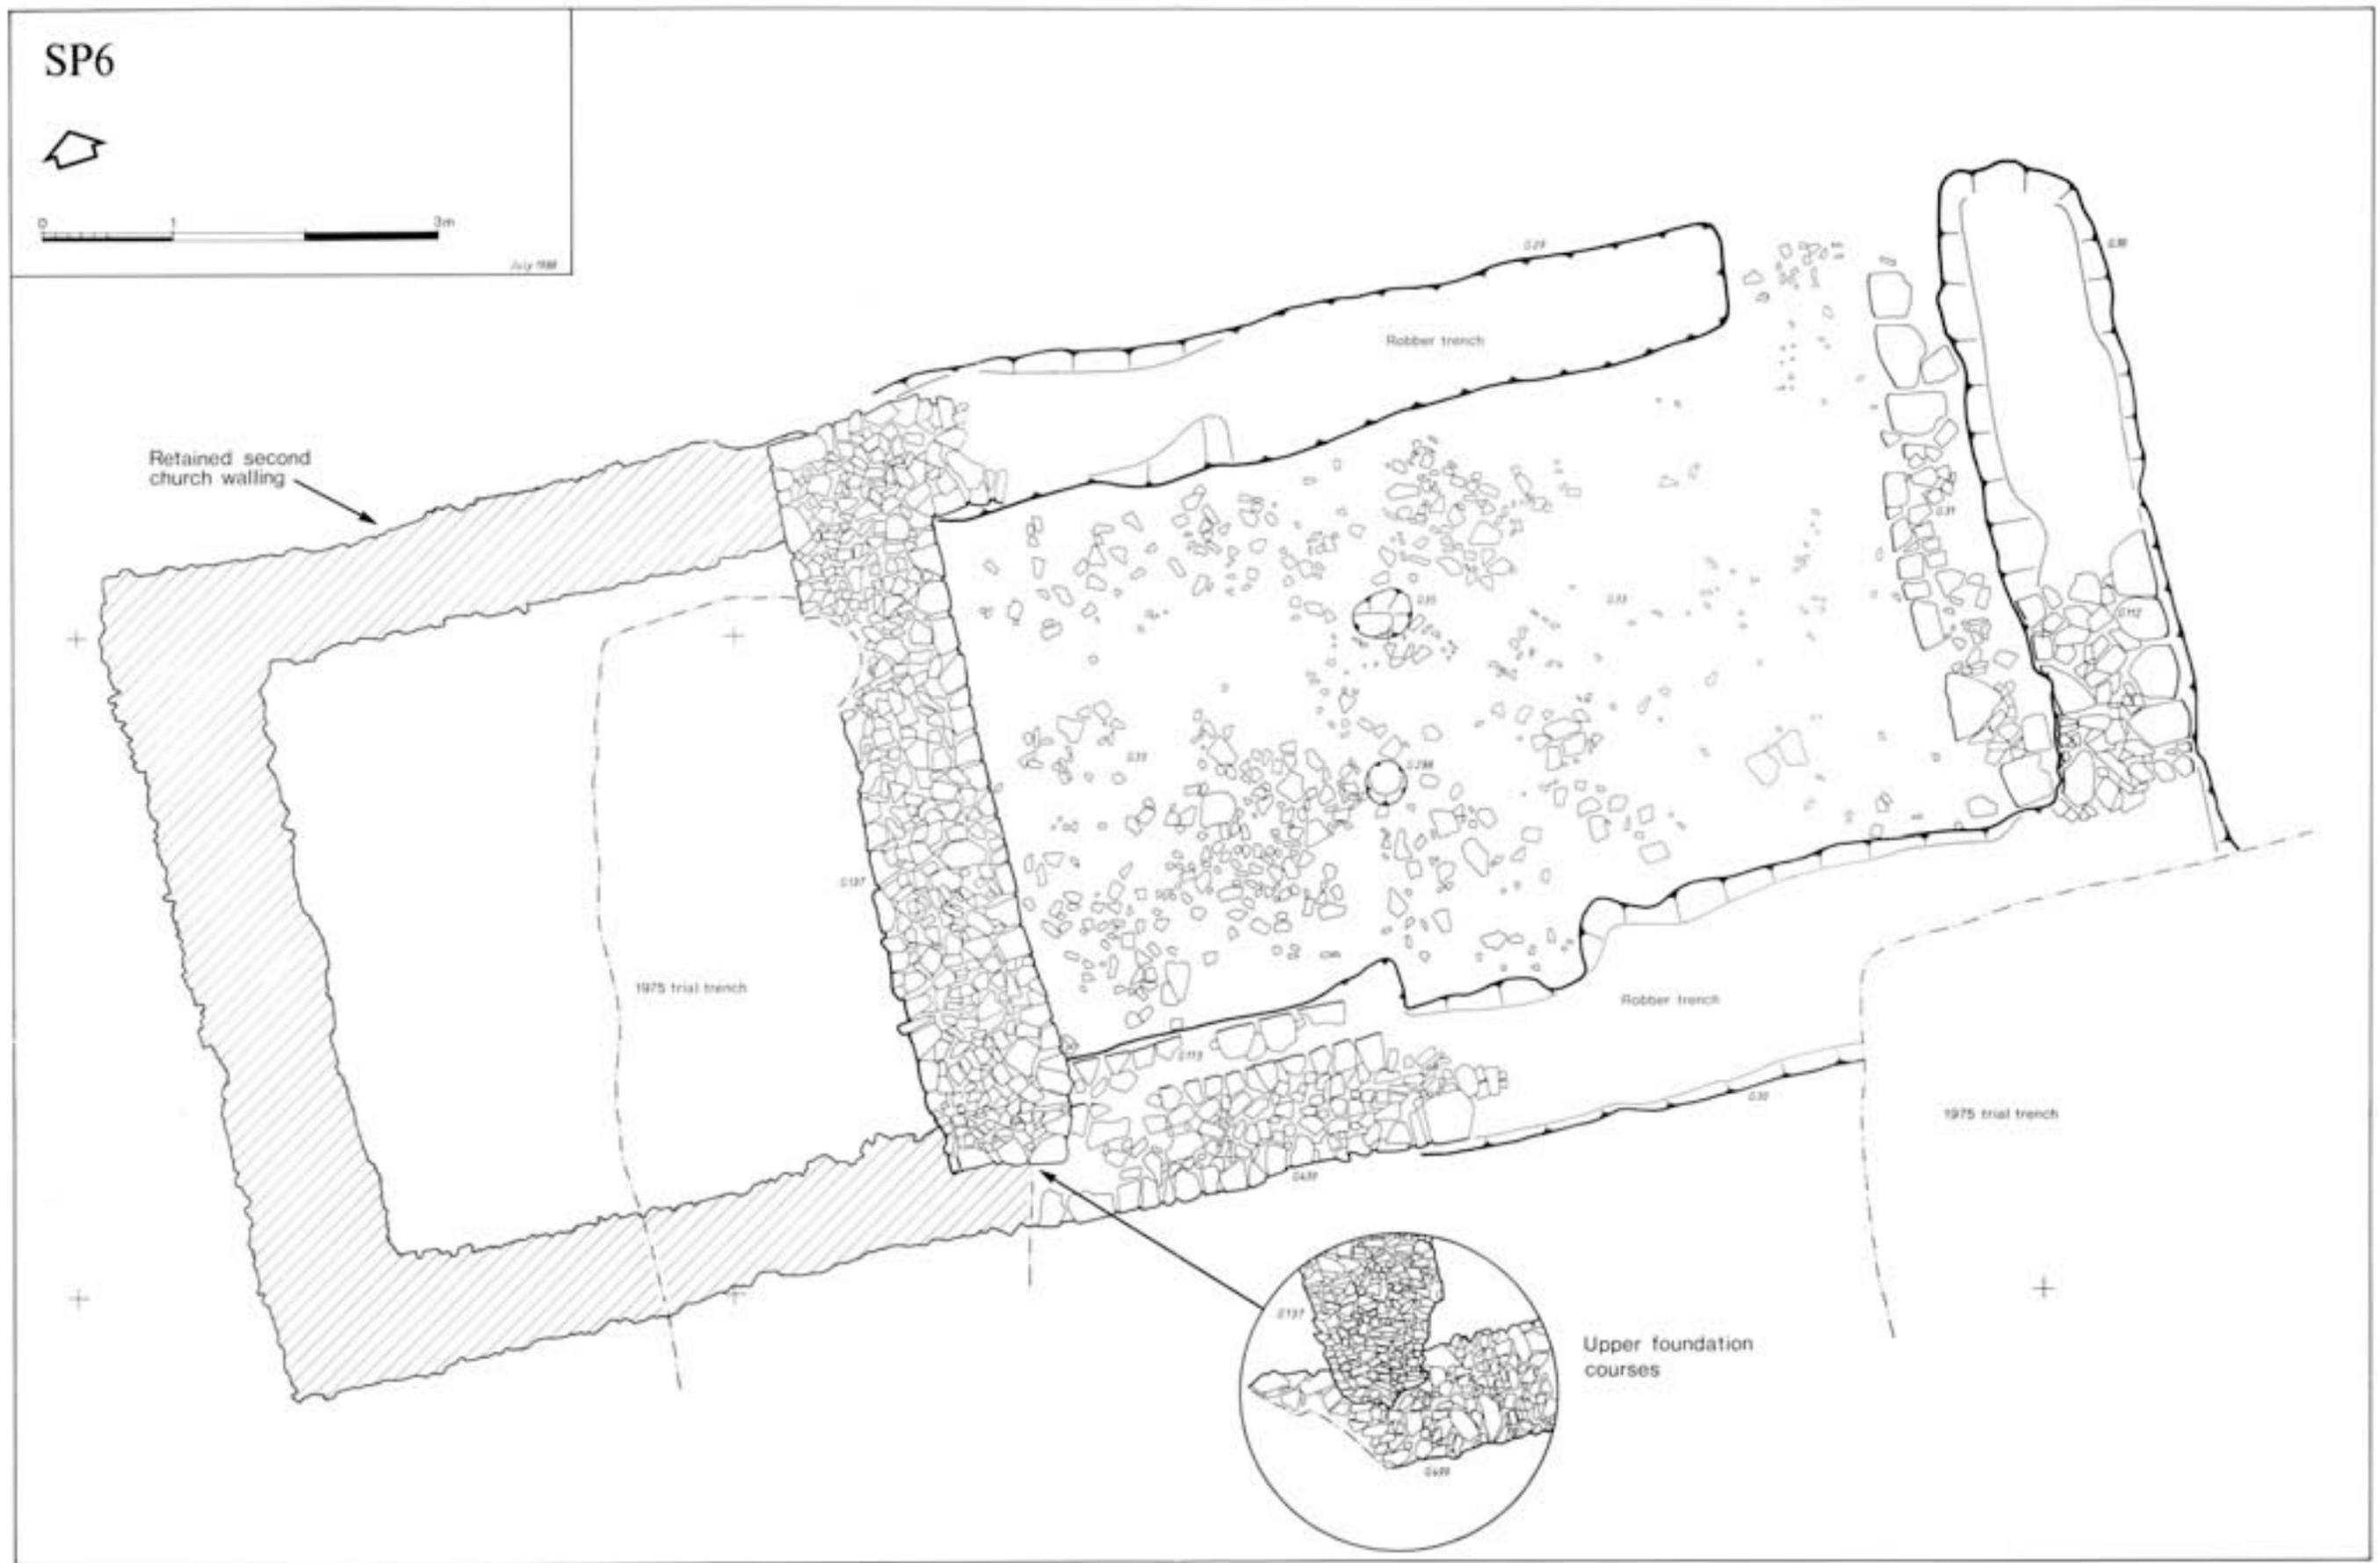
Fig 22 Conversion of the church to secular use

The conversion of the second church entailed the demolition of the chancel and the extension of the nave walls eastwards to meet the line of the east chancel wall. Later robbing removed all the east wall, except its foundations, hence it is not possible to determine whether the east wall of the chancel was retained or completely rebuilt. A new wall was built across the original nave, 4.2m from its west end. This created two rooms 4.6m wide, the east room being 8.0m long.
