SHIPS OF THE PORT OF LONDON

First to eleventh centuries AD

Peter Marsden

ARCHAEOLOGICAL REPORT 3

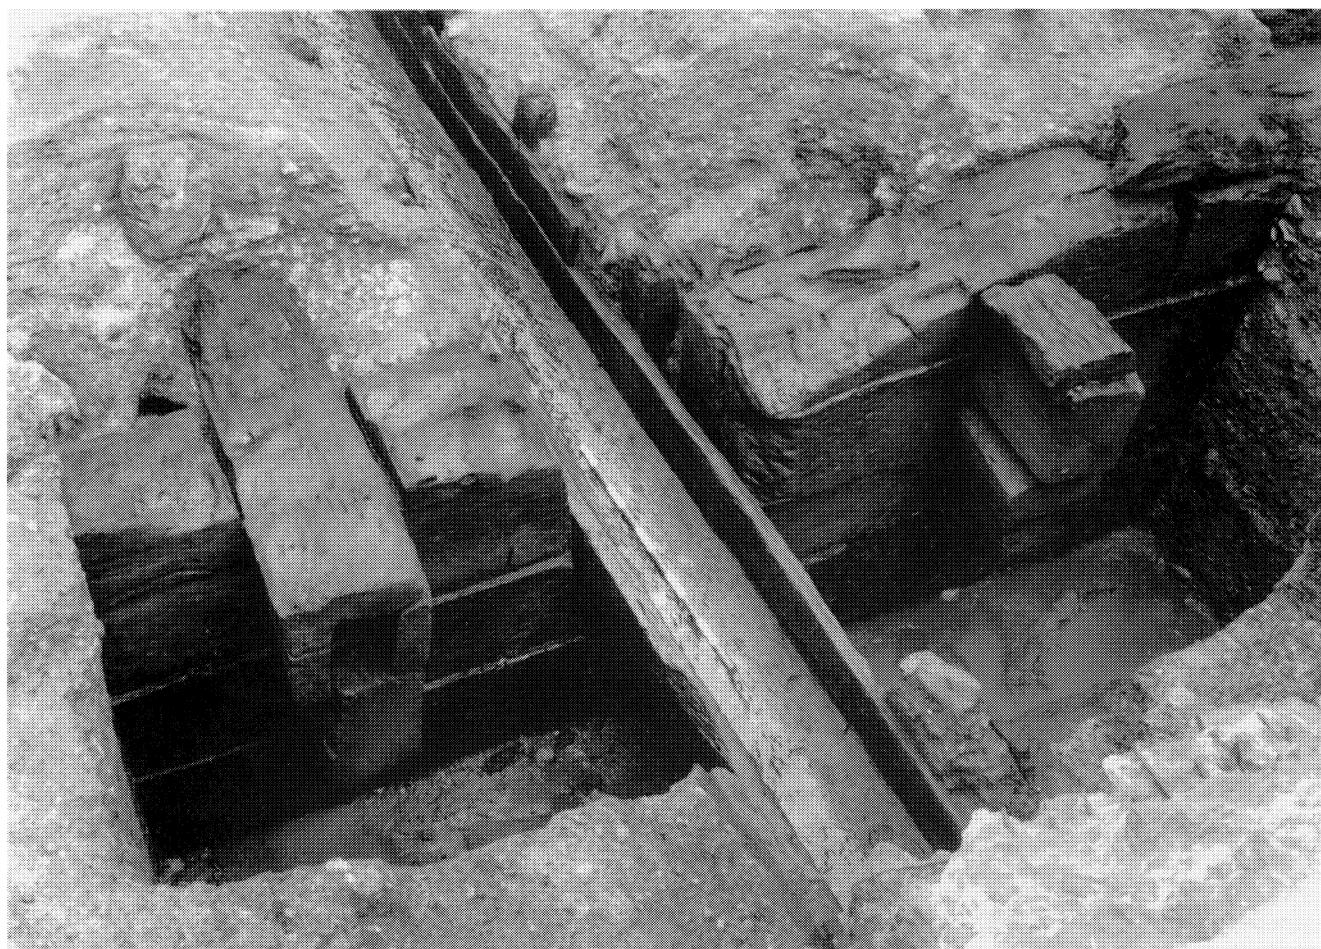
Fig 12 Late first-century timber quay, with a later Roman timber drain, found in Pudding Lane, London.

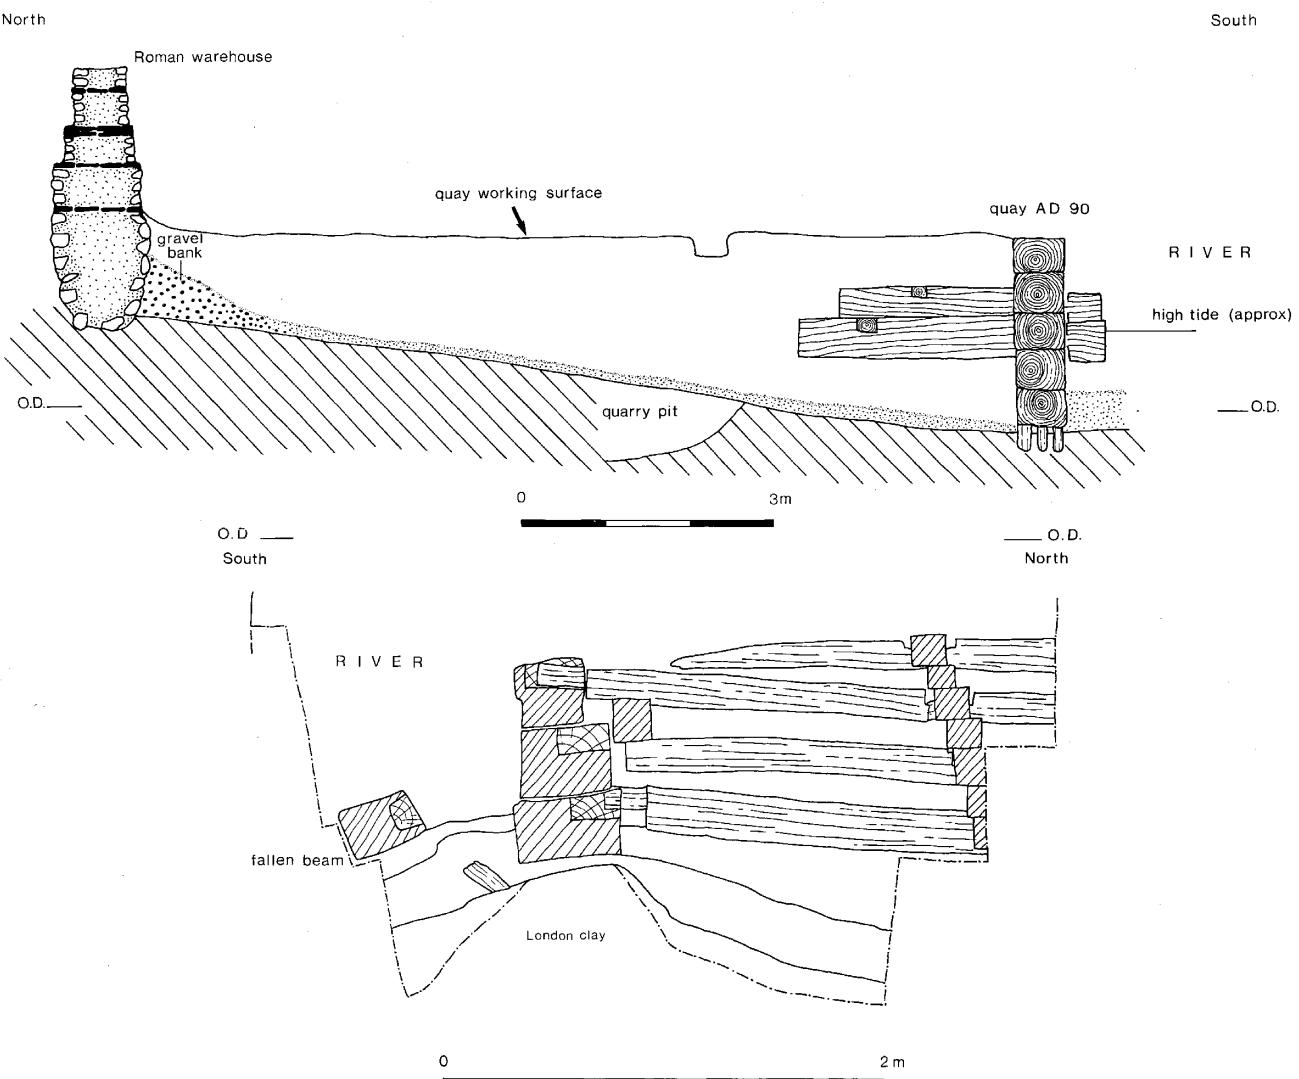
Fig 13 Section through a quay, late second century AD, at Custom House, Lower Thames Street.

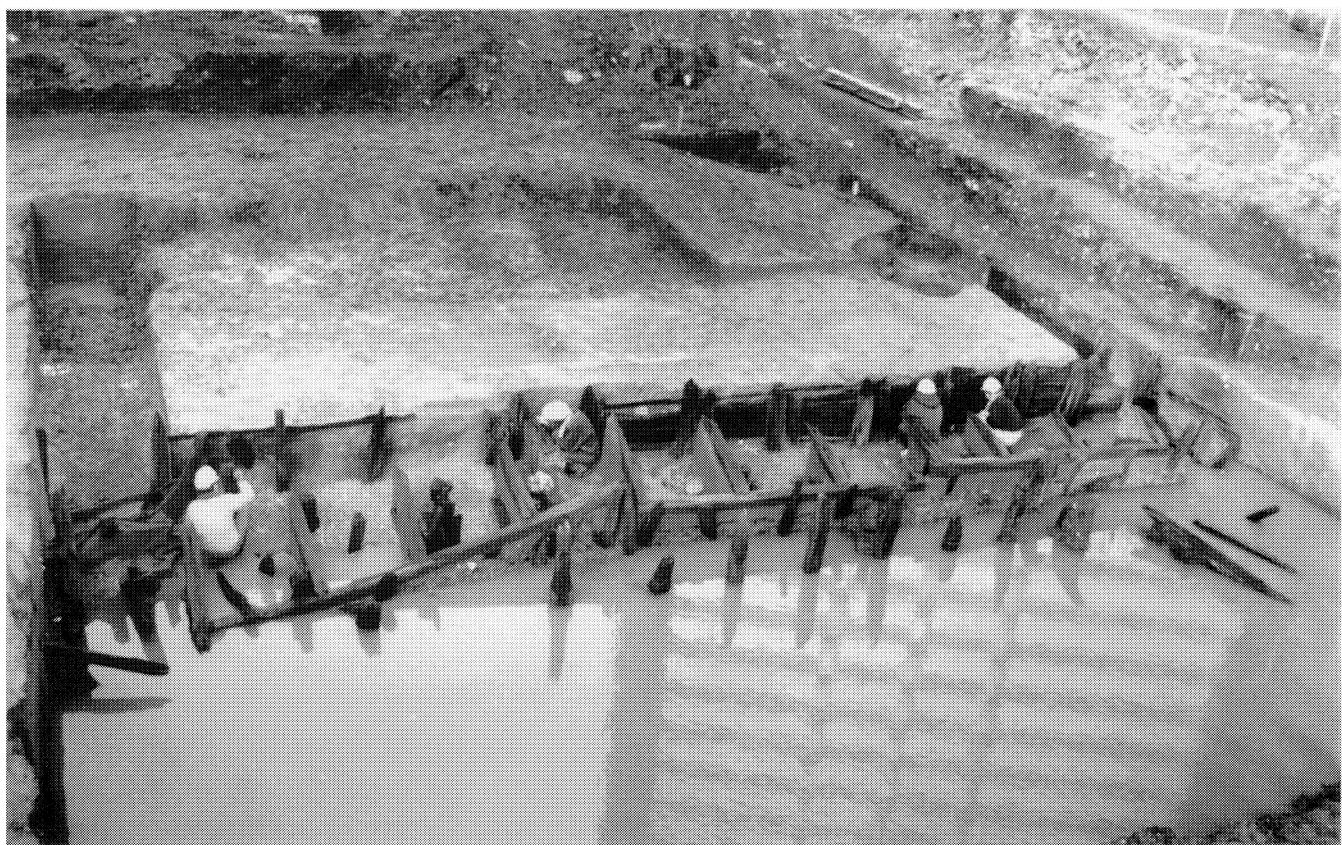
Fig 17 Second century timber quay found beside an inlet of the River Thames, Guy's Hospital, Southwark.

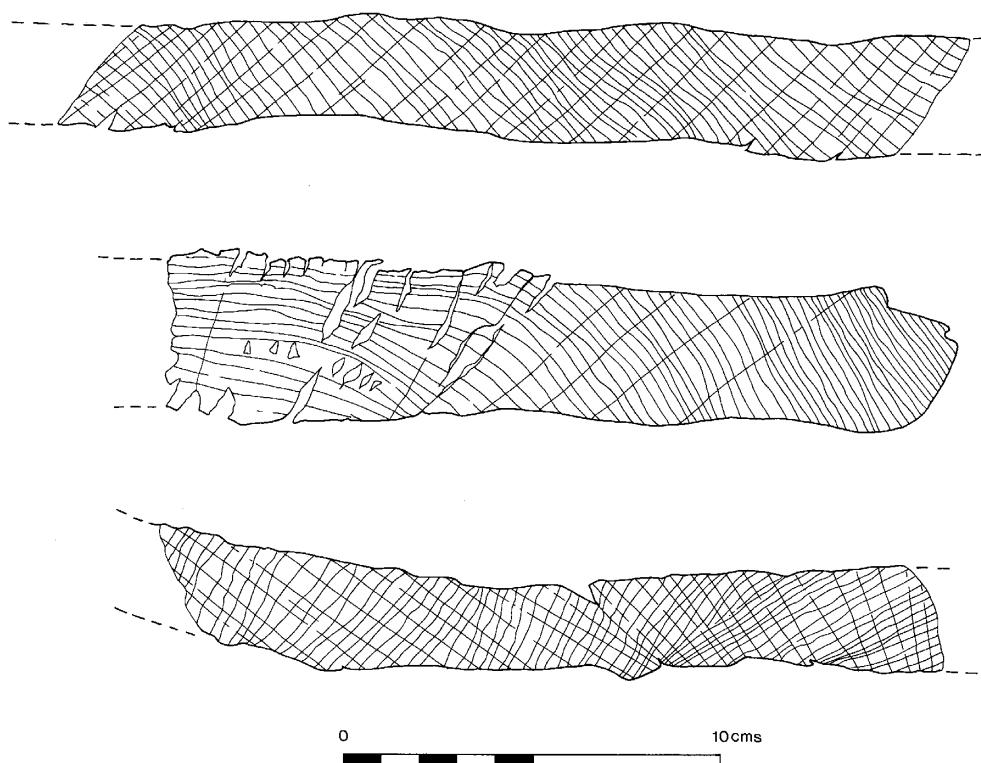
Fig 24 Sections through plank fragments showing the tree-ring patterns.

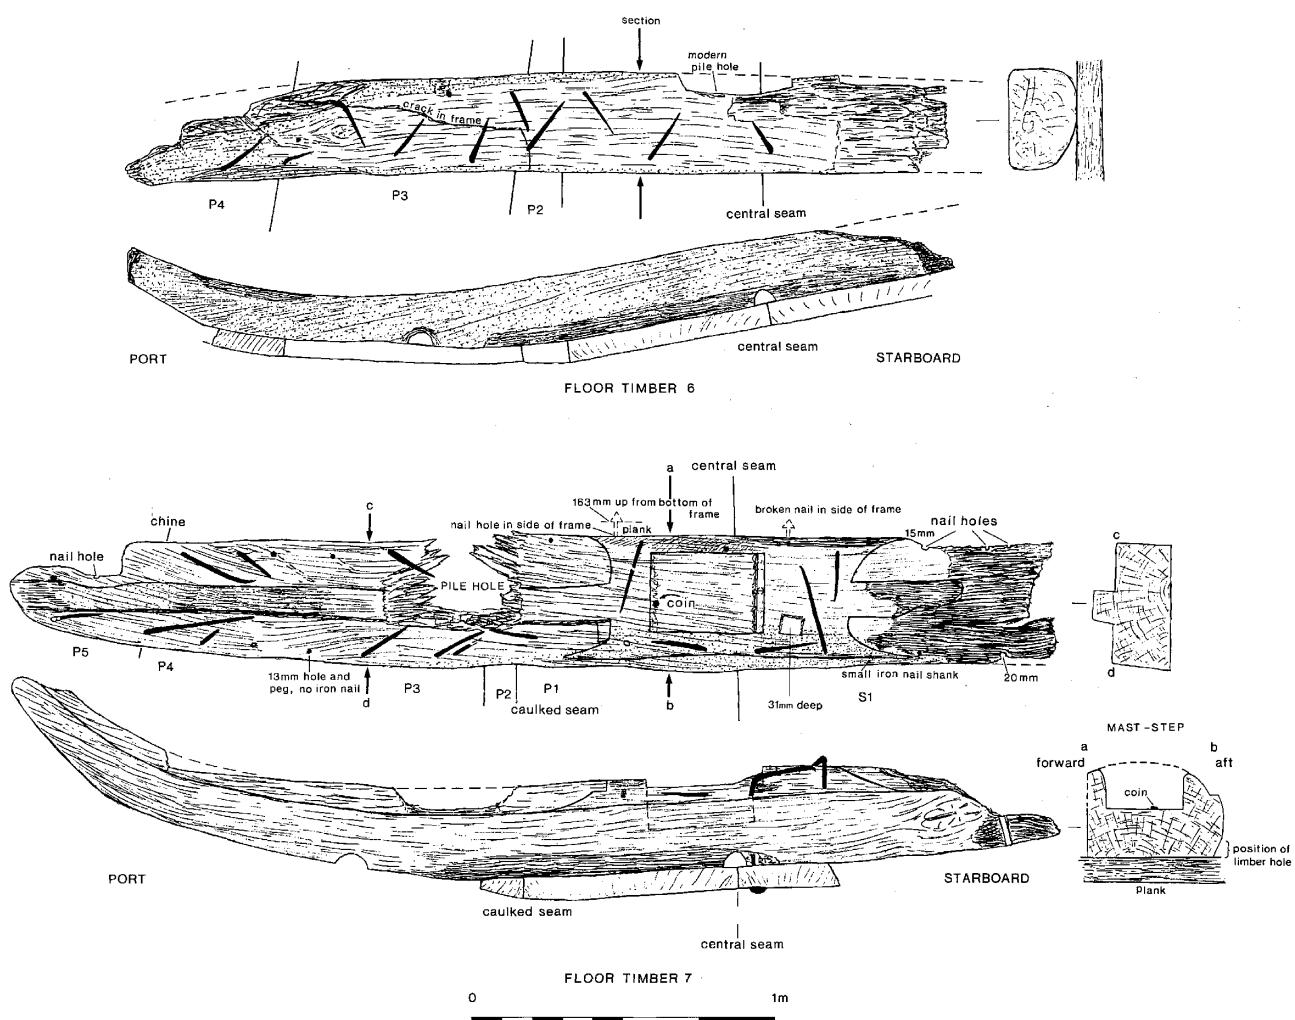
Fig 33 Floor-timbers 6 and 7 as recorded in 1963. The stippling represents sapwood.

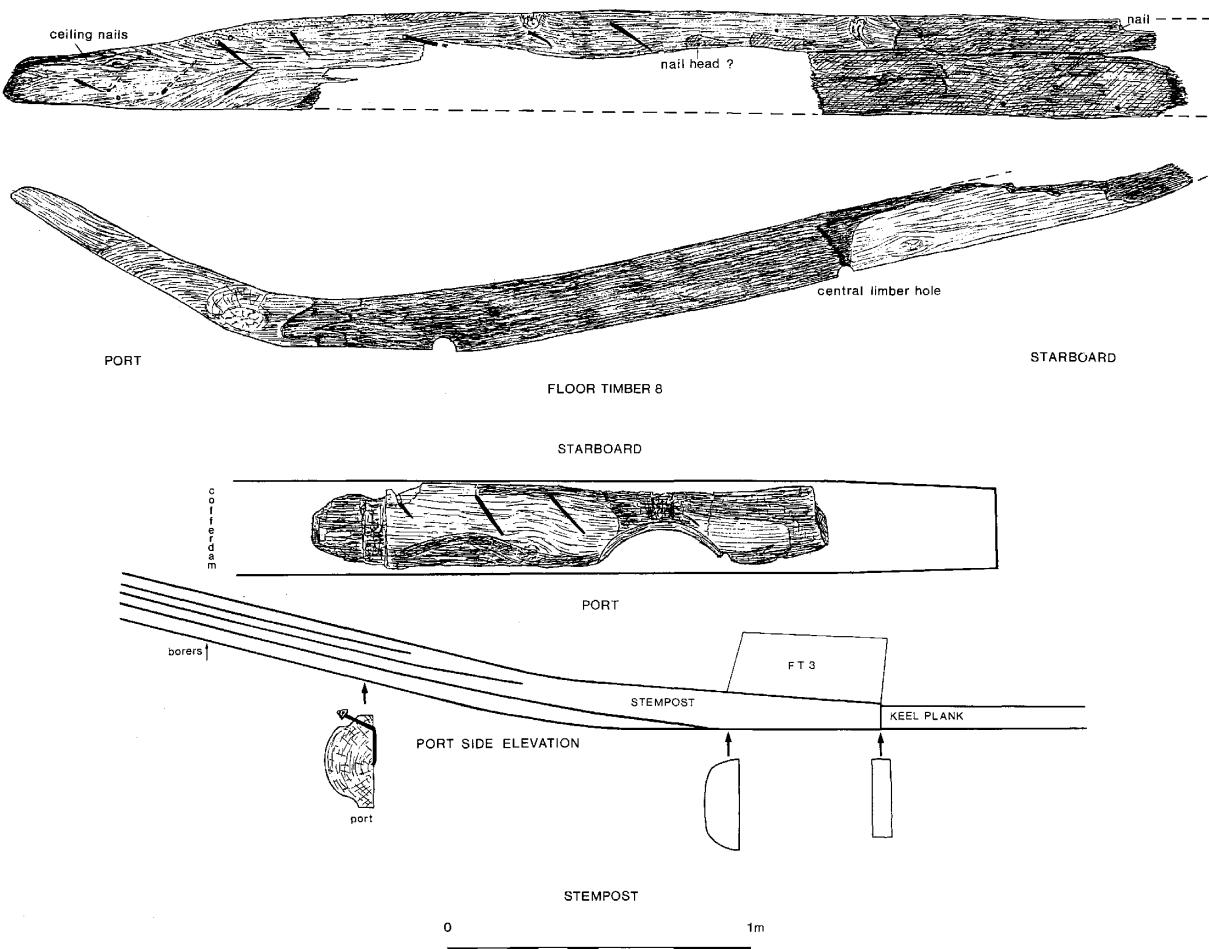
Fig 34 Floor-timber 8 and the stempost, as recorded in 1963. Stippling represents sapwood. Note that the whole outlined area of the stempost was found, but the drawn fragment was all that was saved for detailed recording.

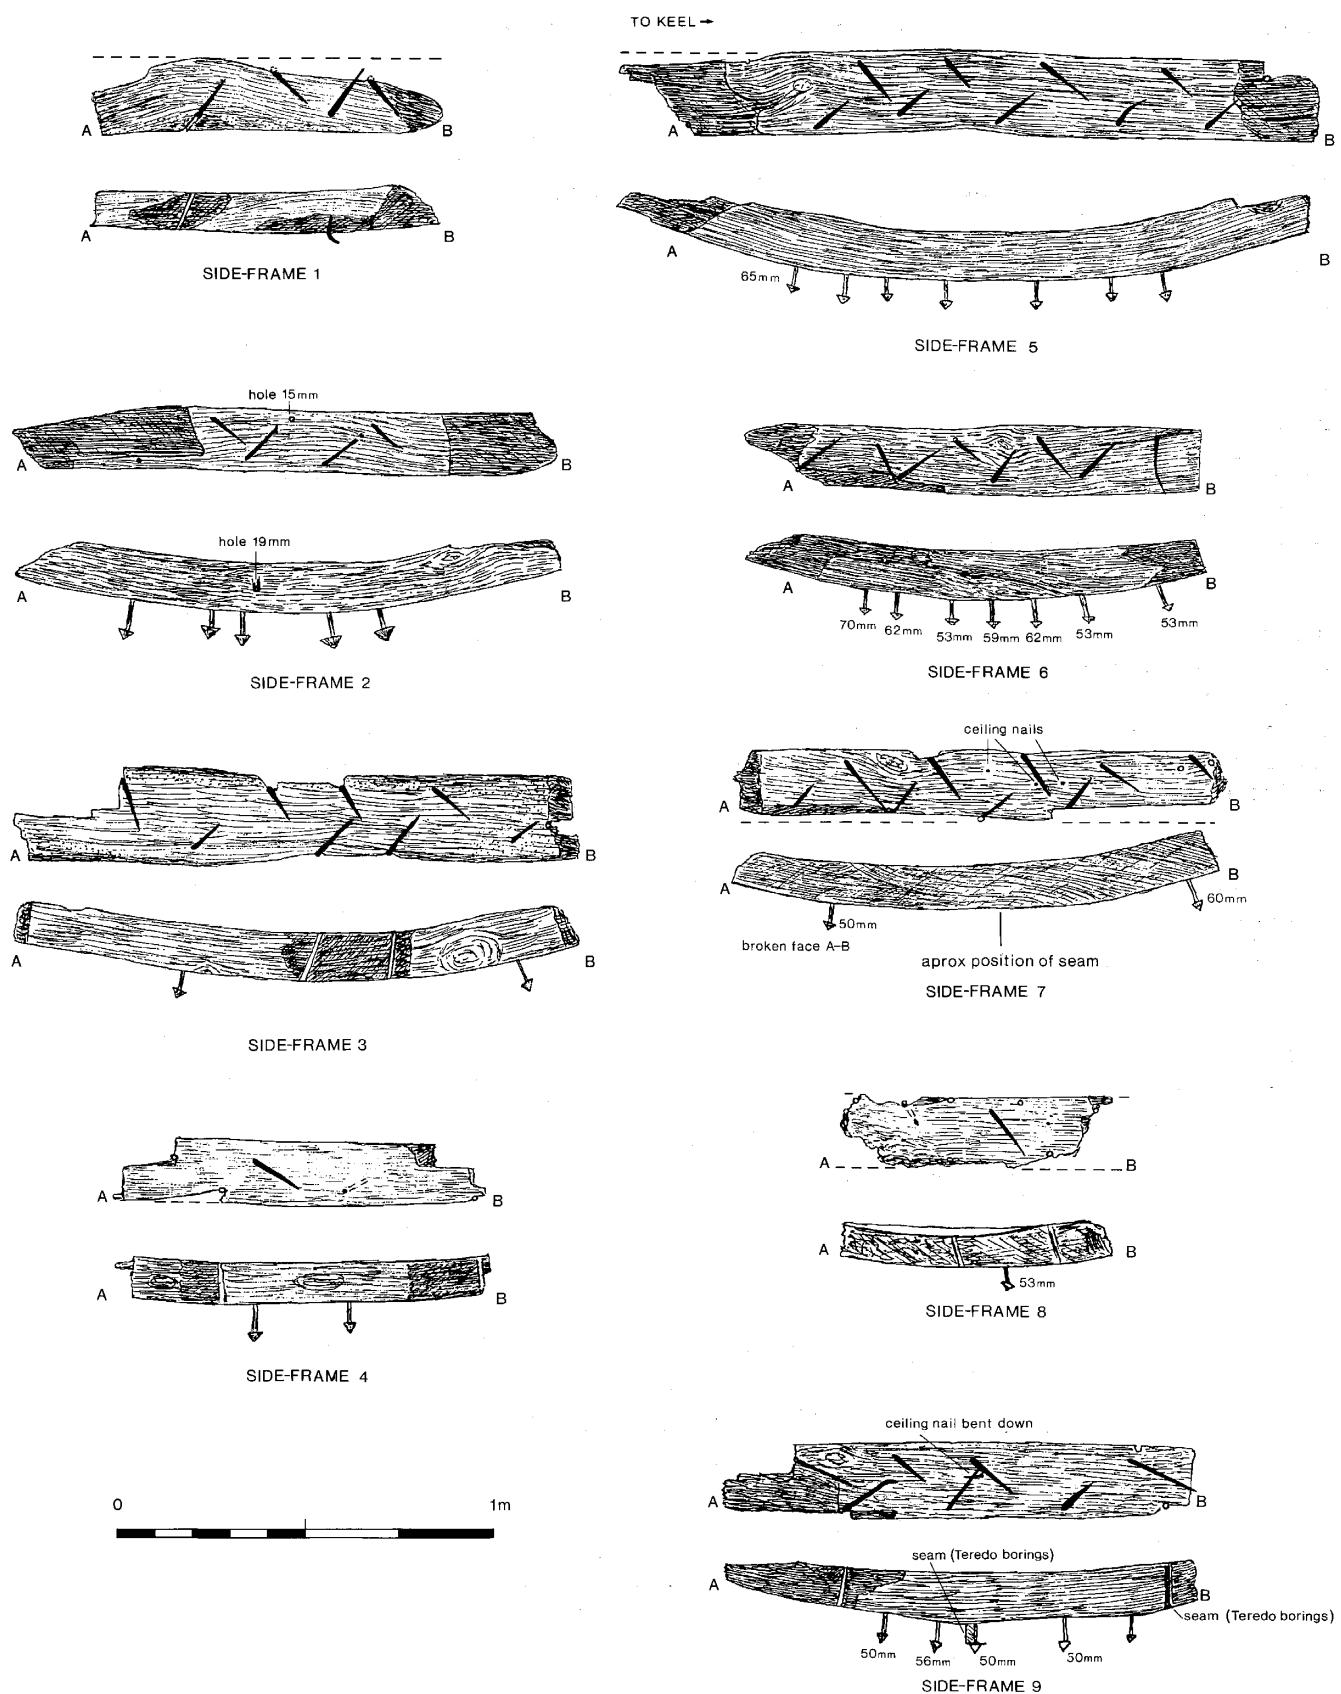
Fig 35 Side-frames 1–9 as recorded in 1963. Stippling represents sapwood. Note that these were only parts of the frames found and recorded on site.

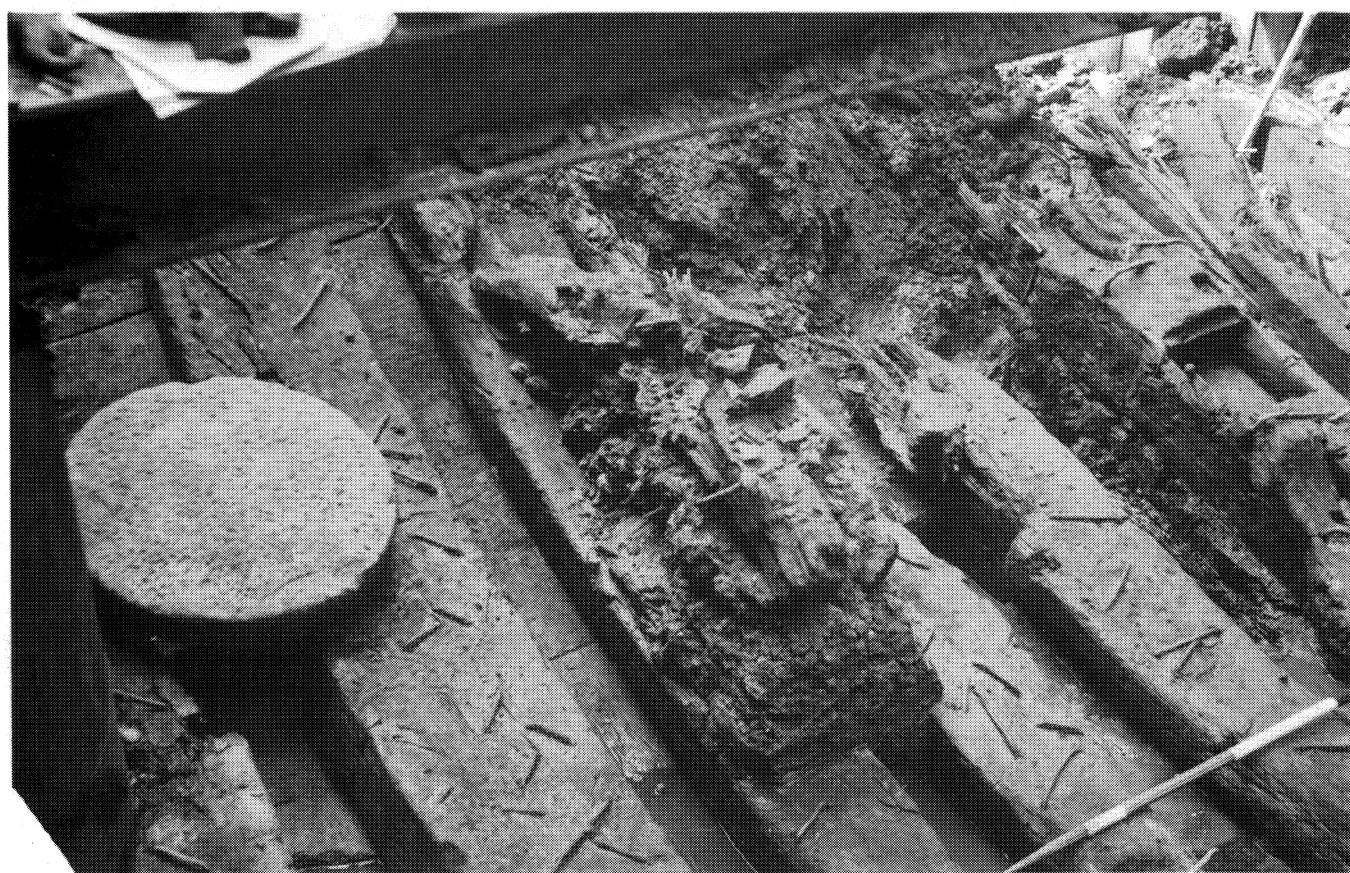
Fig 36 General view of the forward side of Blackfriars ship 1, showing the unfinished millstone in situ (left) and the mast-step (right).

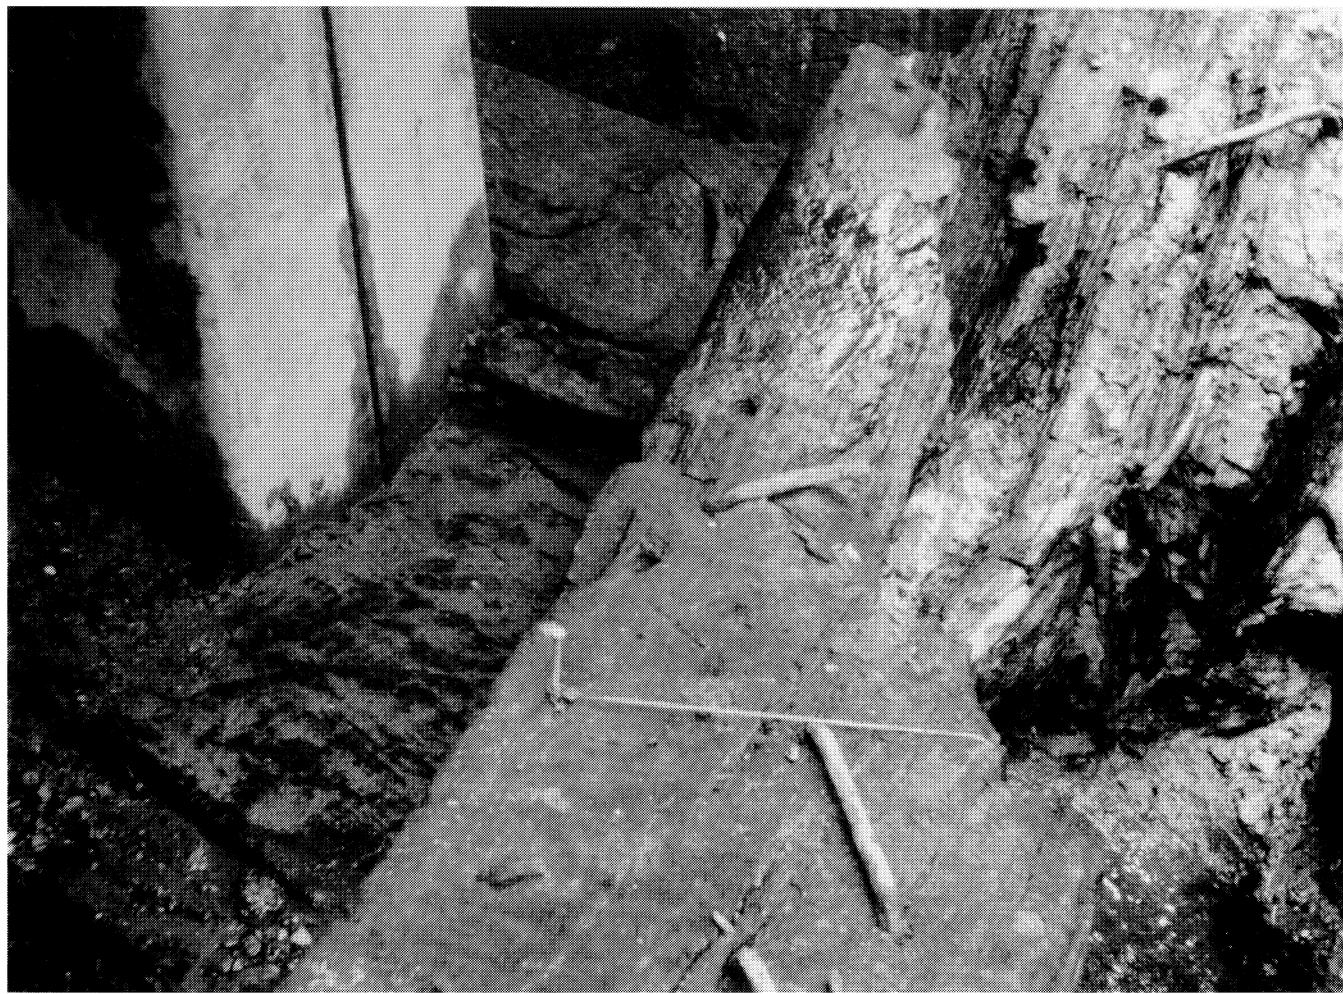
Fig 37 Floor-timber 1 overlying the stempost and adjacent planks.

Along the upper faces of floor-timbers 1 and 3 (Figs 37 and 38) were rows of empty vertical holes 19mm in diameter, extending through the thickness of the frames, but not into the strakes beneath (Fig 30). As two of these holes were exposed in the forward face of floor-timber 3,

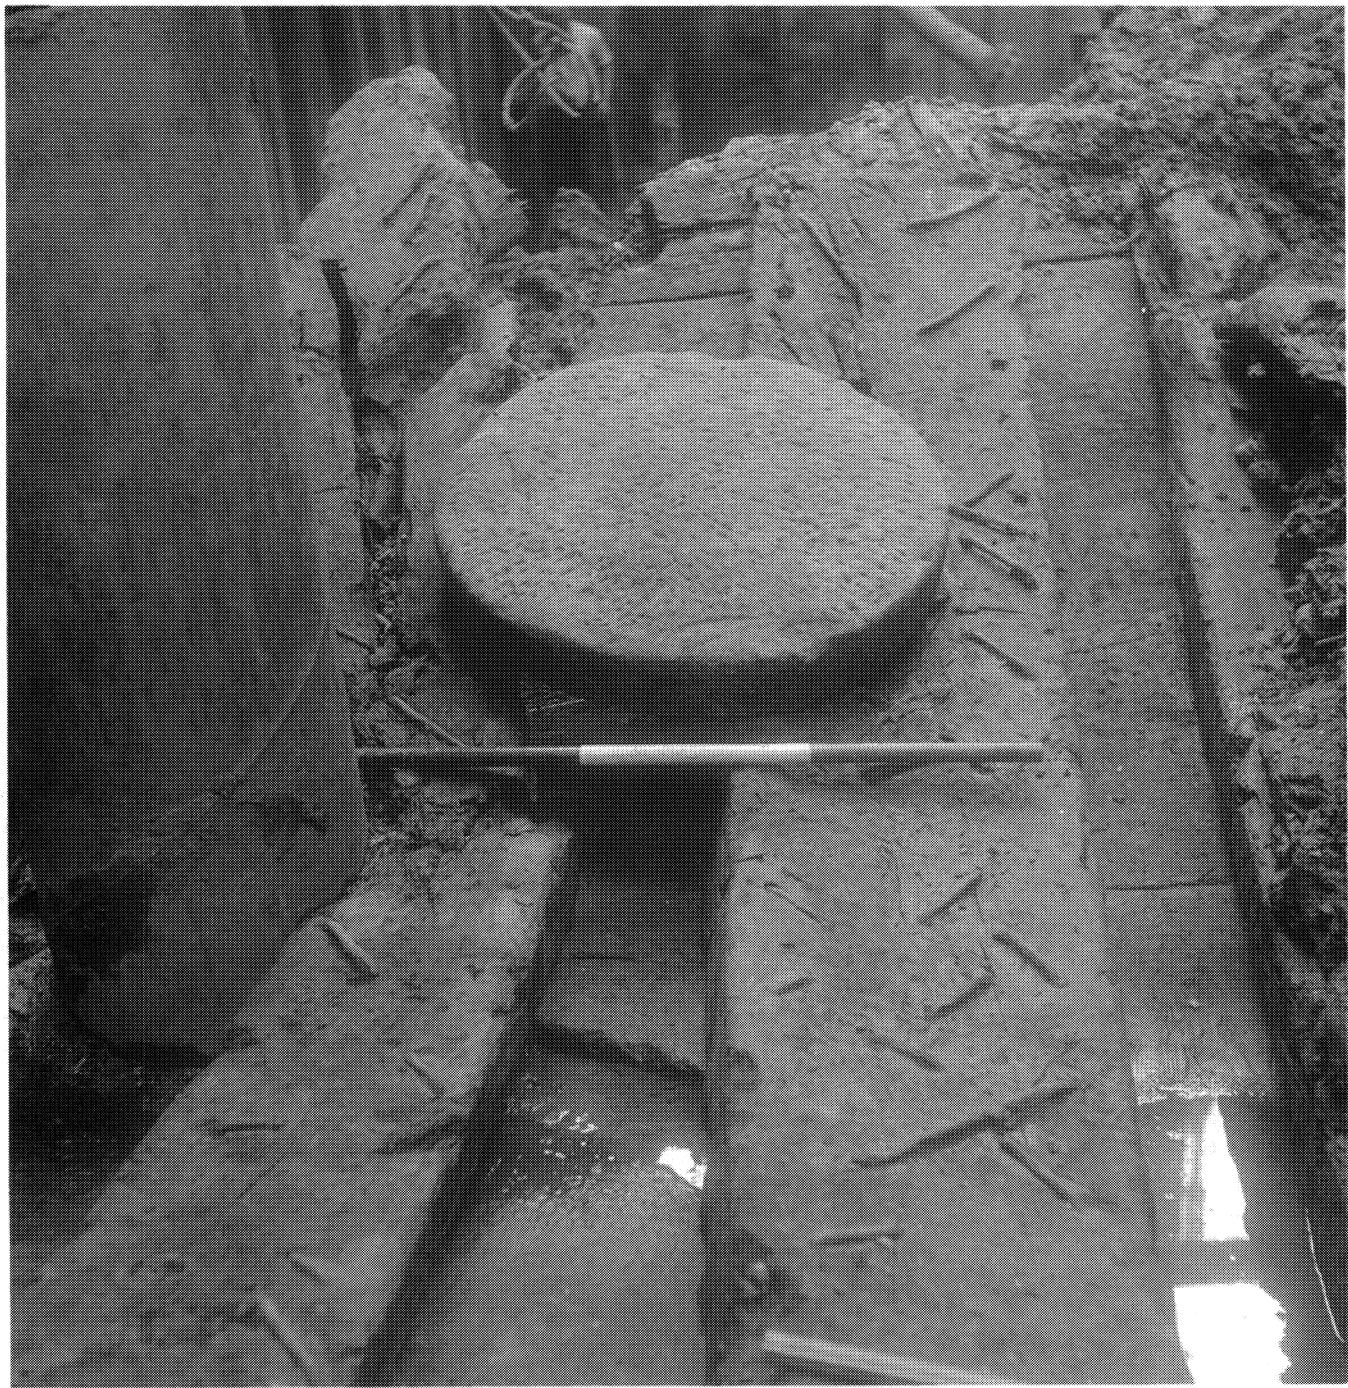
Fig 38 Floor-timbers 2–4, with the millstone in situ. Floor-timber 2 (left) has been broken and displaced by a modern steel pile. Scale in feet.

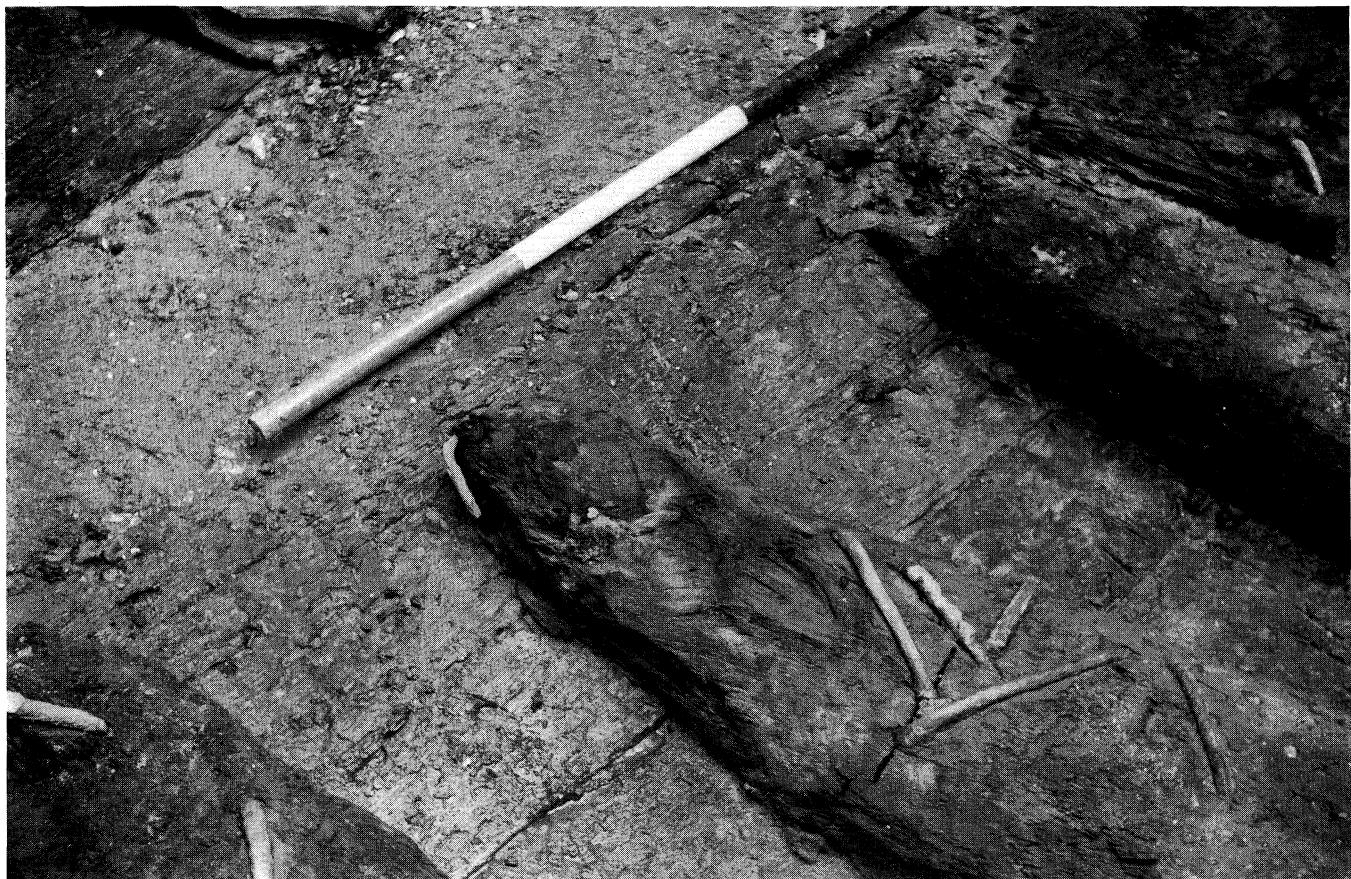
Fig 41 The port ends of floor-timbers 3 (top right) to 5. The bottom of the collapsed side is top left. Note the broken end of a nail in the plank between floor-timbers 4 and 5. This originally held the lower end of a side-frame. Scale in feet.

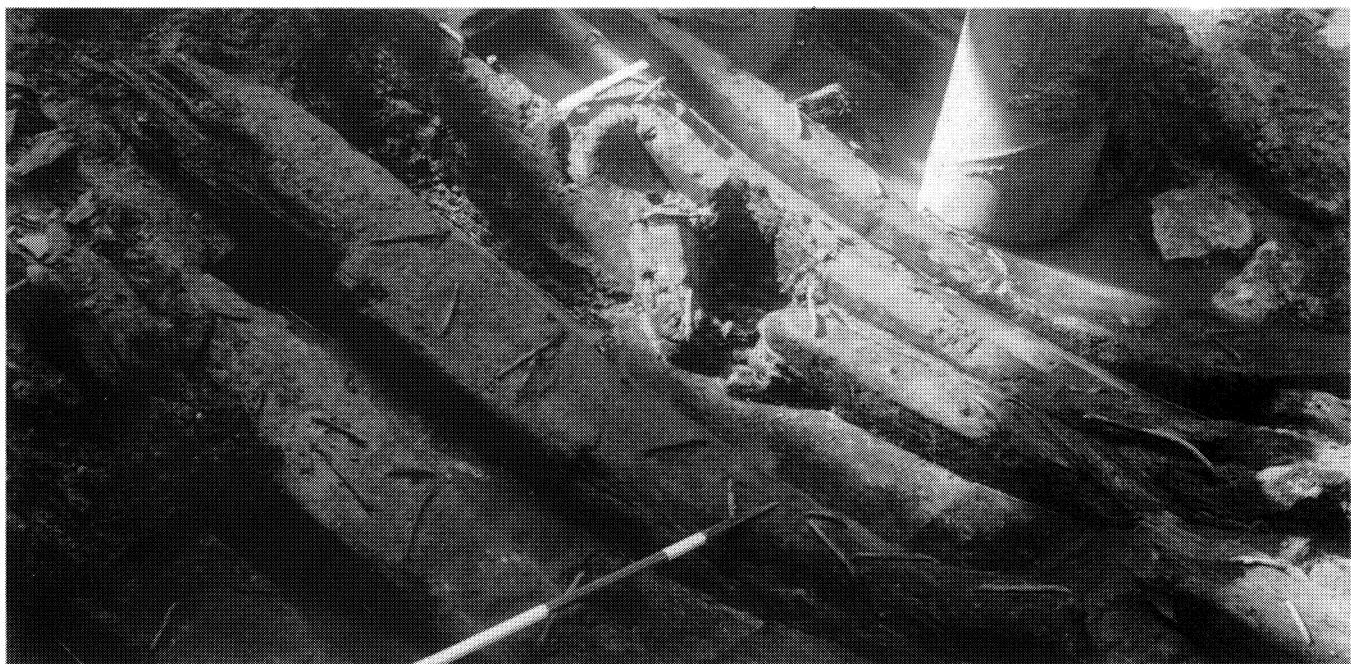
Fig 42 Blackfriars ship 1 looking aft, showing the mast-step. Scale in feet.

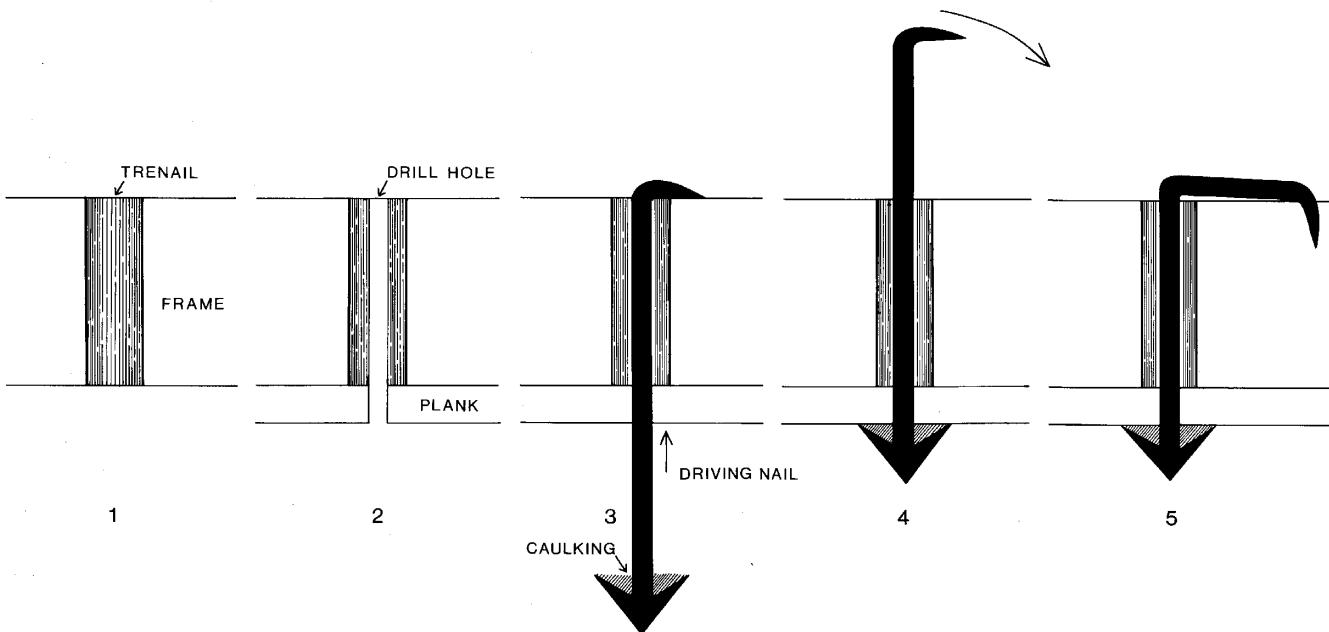
Fig 48 Reconstruction of the stages in fastening the hooked nails in Blackfriars ship 1. Not to scale.

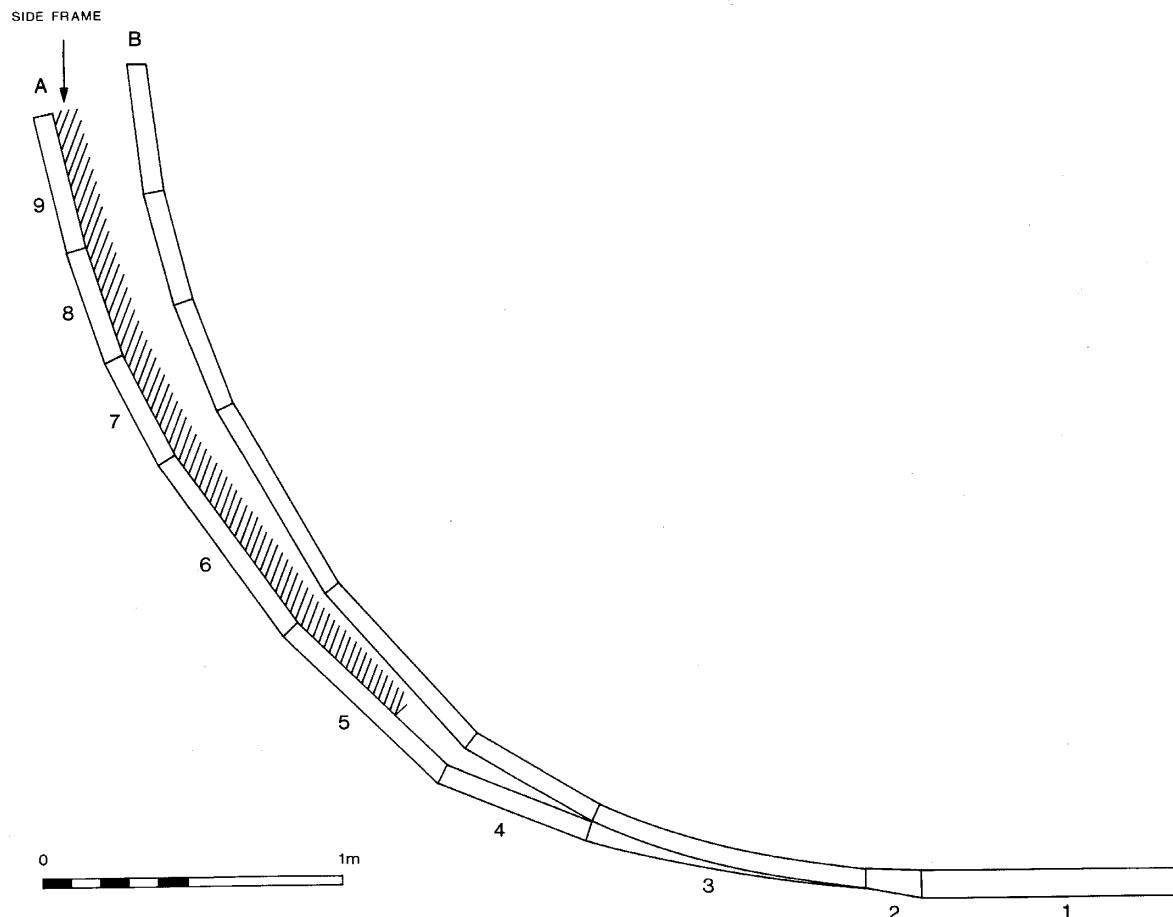
Fig 56 (A) Port side profile of the ship from the shape of the frames as found. (B) Adjusted profile of the ship to allow for a little flattening of the hull.

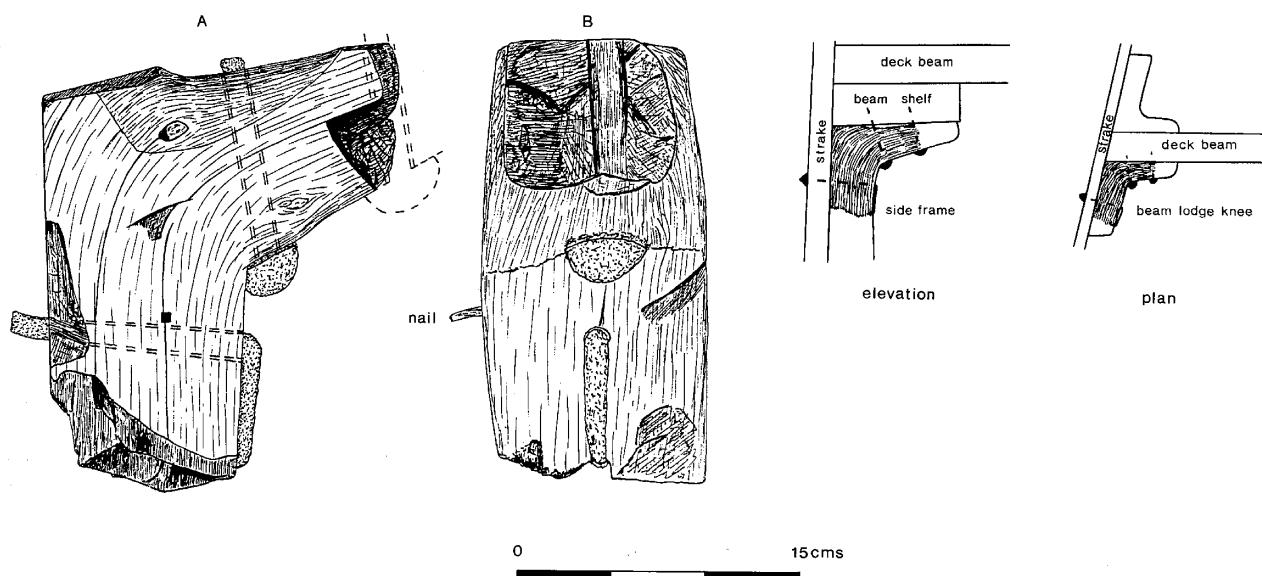
Fig 57 A knee-timber found loose in the wreck, with two possible alternative reconstructions of its use.

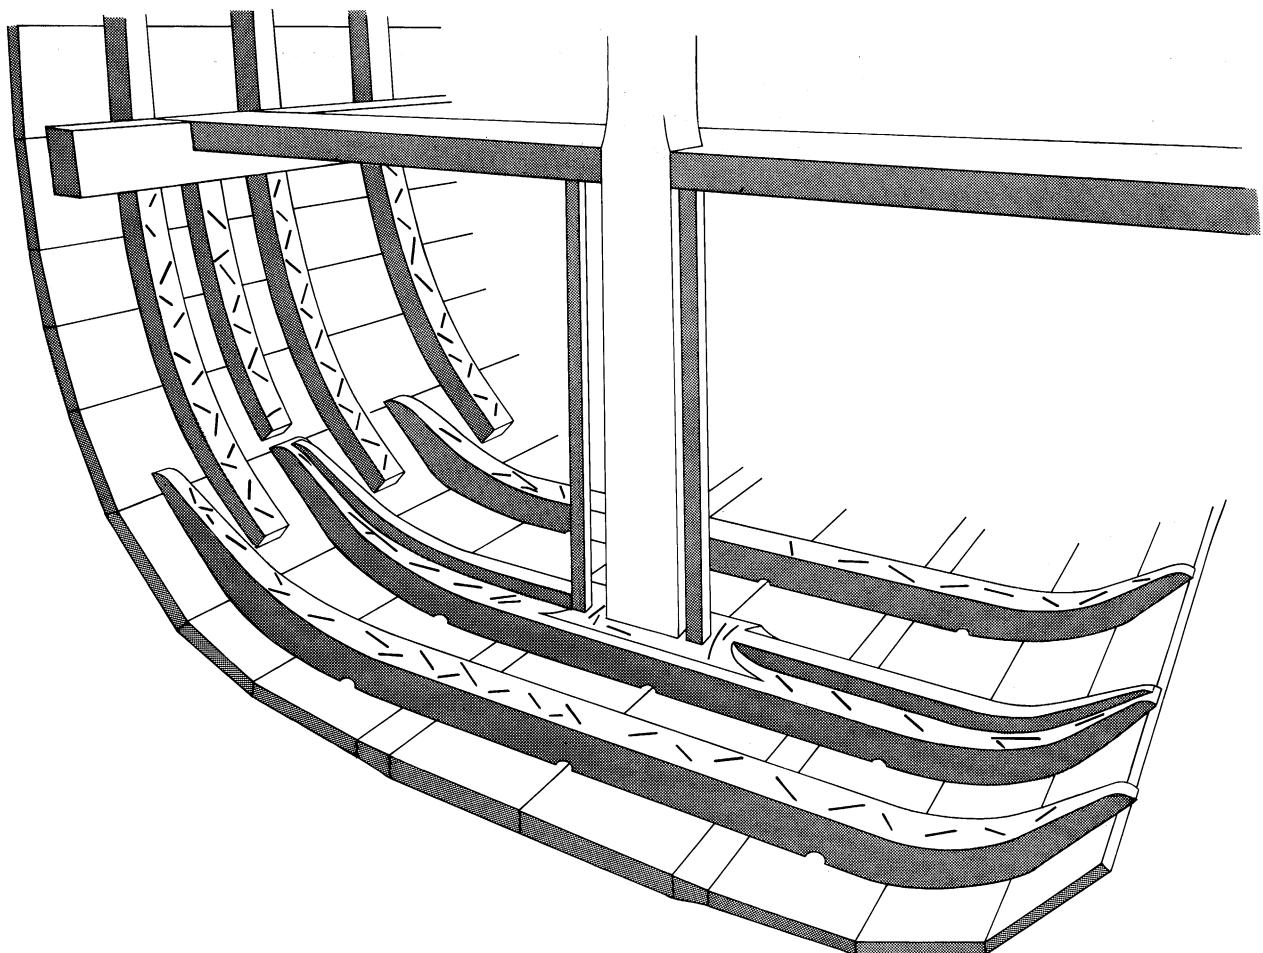
Fig 58 Reconstruction of the interior of Blackfriars ship 1 at the mast-step. The 'ceiling' planking (the boards in the hold that covered the frames) have been omitted, but they lay in the foreground up to the mast frame.

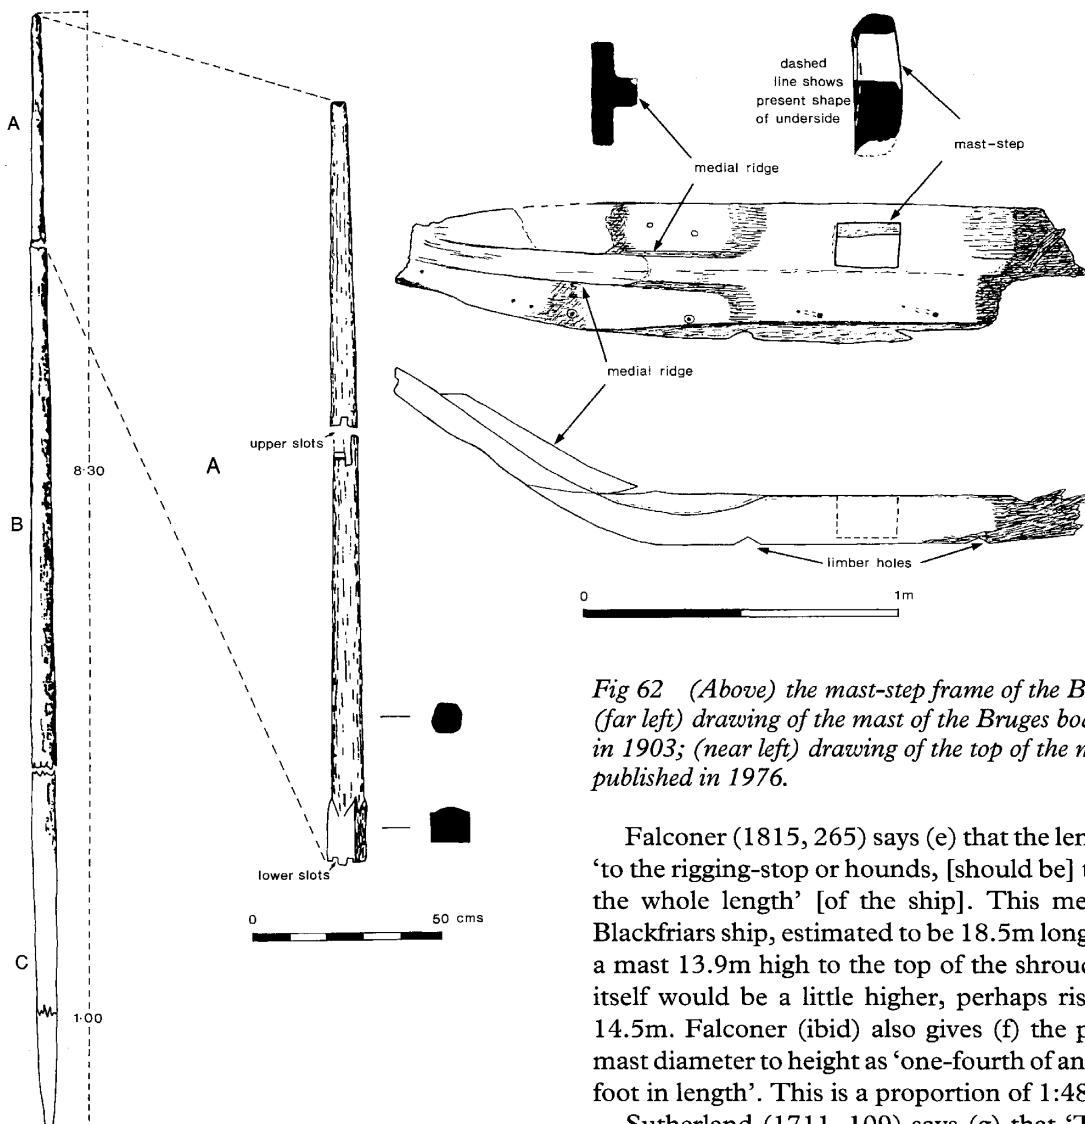
Fig 62 (Above) the mast-step frame of the Bruges boat; (far left) drawing of the mast of the Bruges boat published in 1903; (near left) drawing of the top of the mast published in 1976.

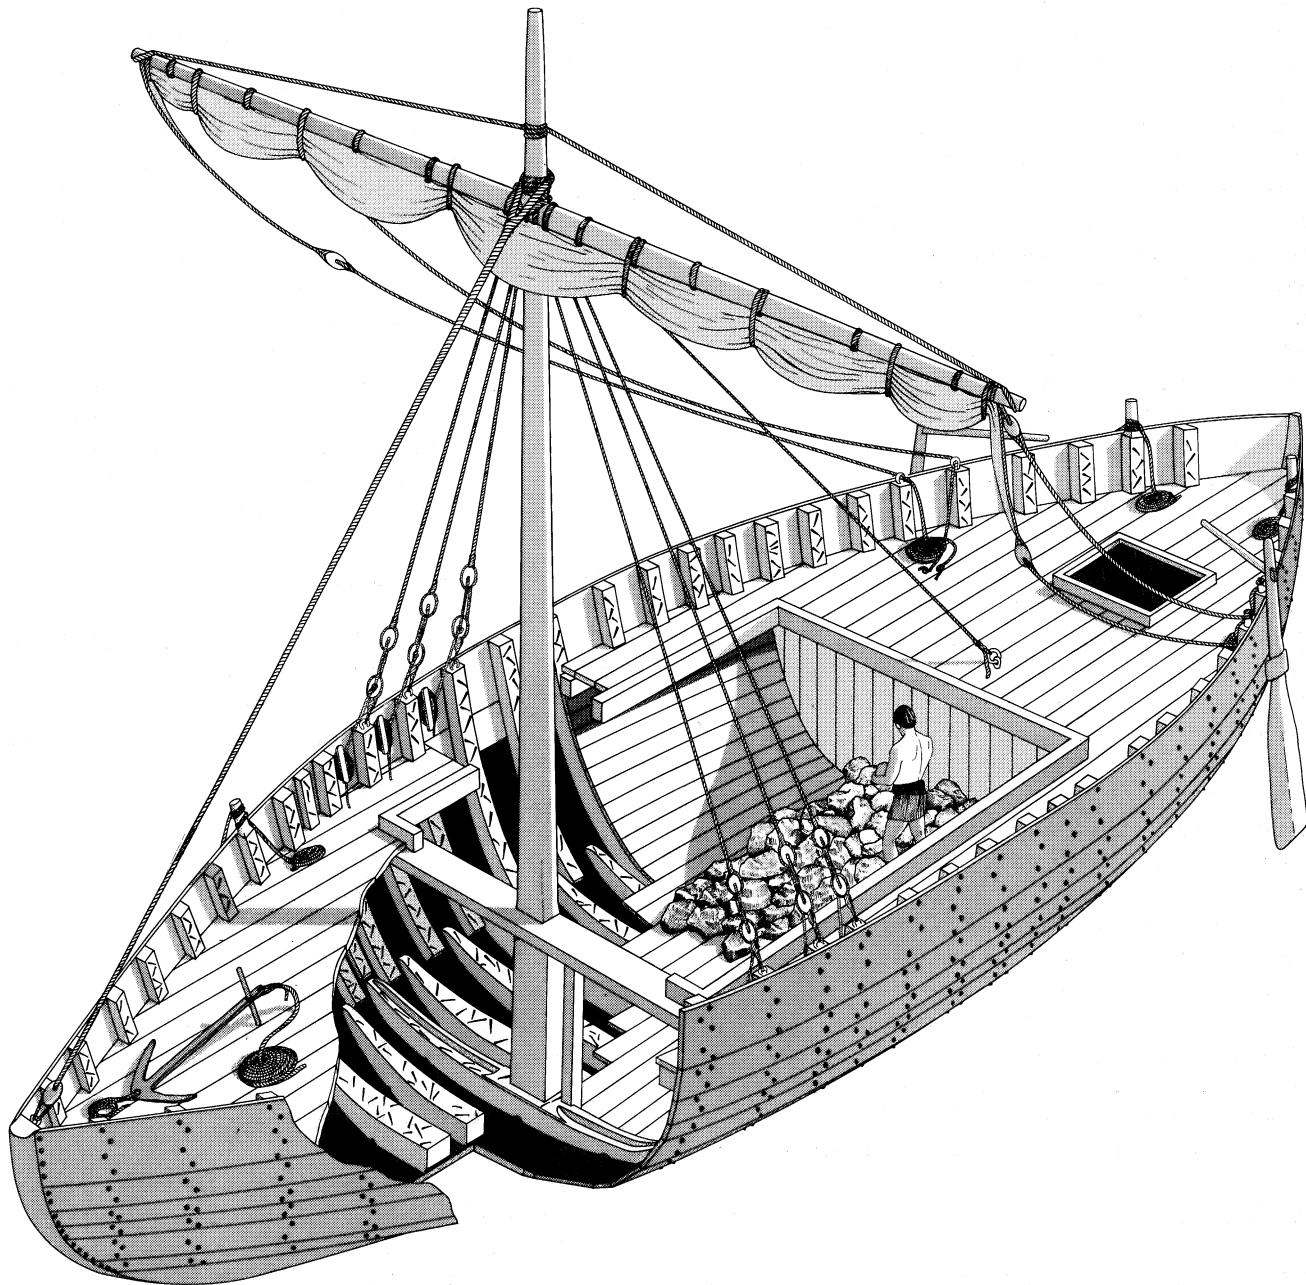
Fig 69 Cut-away reconstruction of Blackfriars ship 1, to show construction.
