SHIPS OF THE PORT OF LONDON

First to eleventh centuries AD

Peter Marsden

ARCHAEOLOGICAL REPORT 3

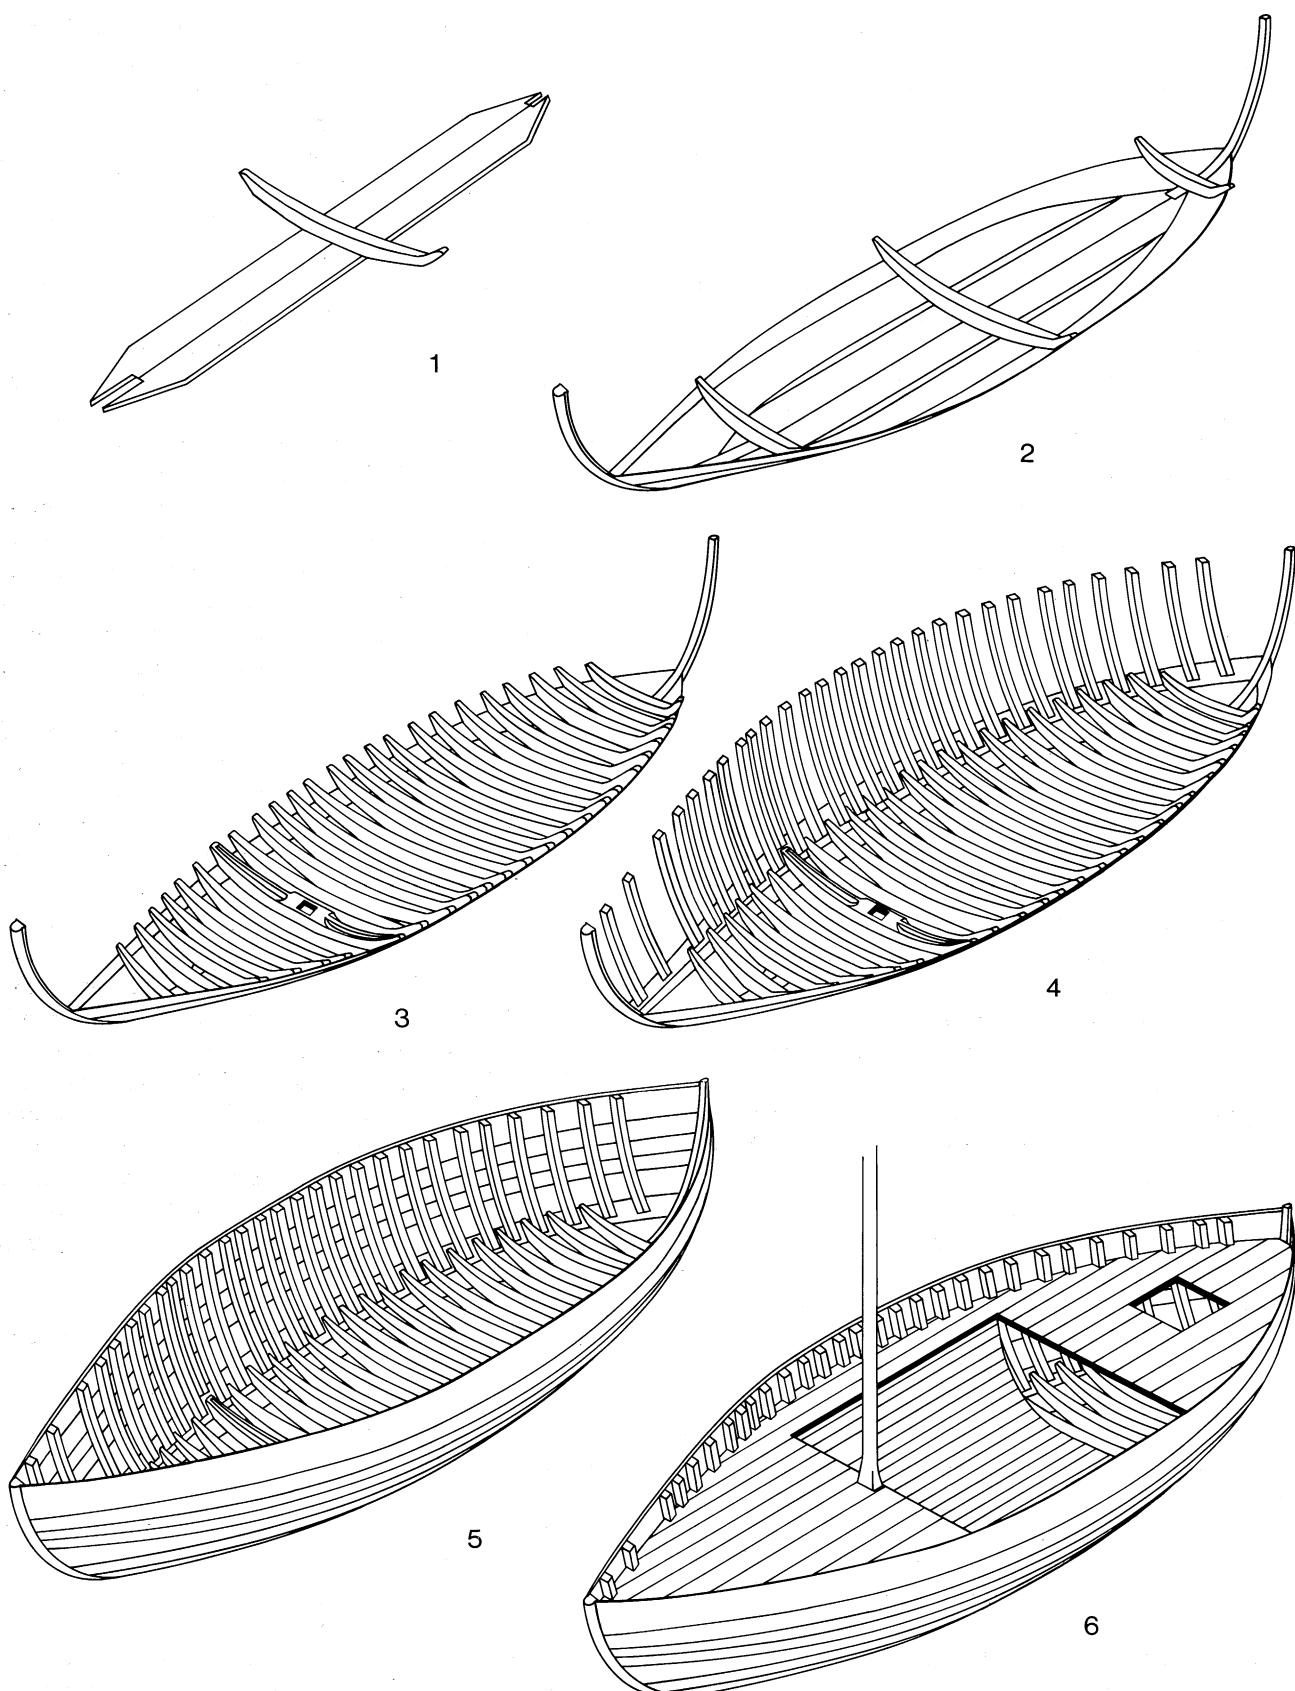
Fig 70 Reconstructed stages in building Blackfriars ship 1.

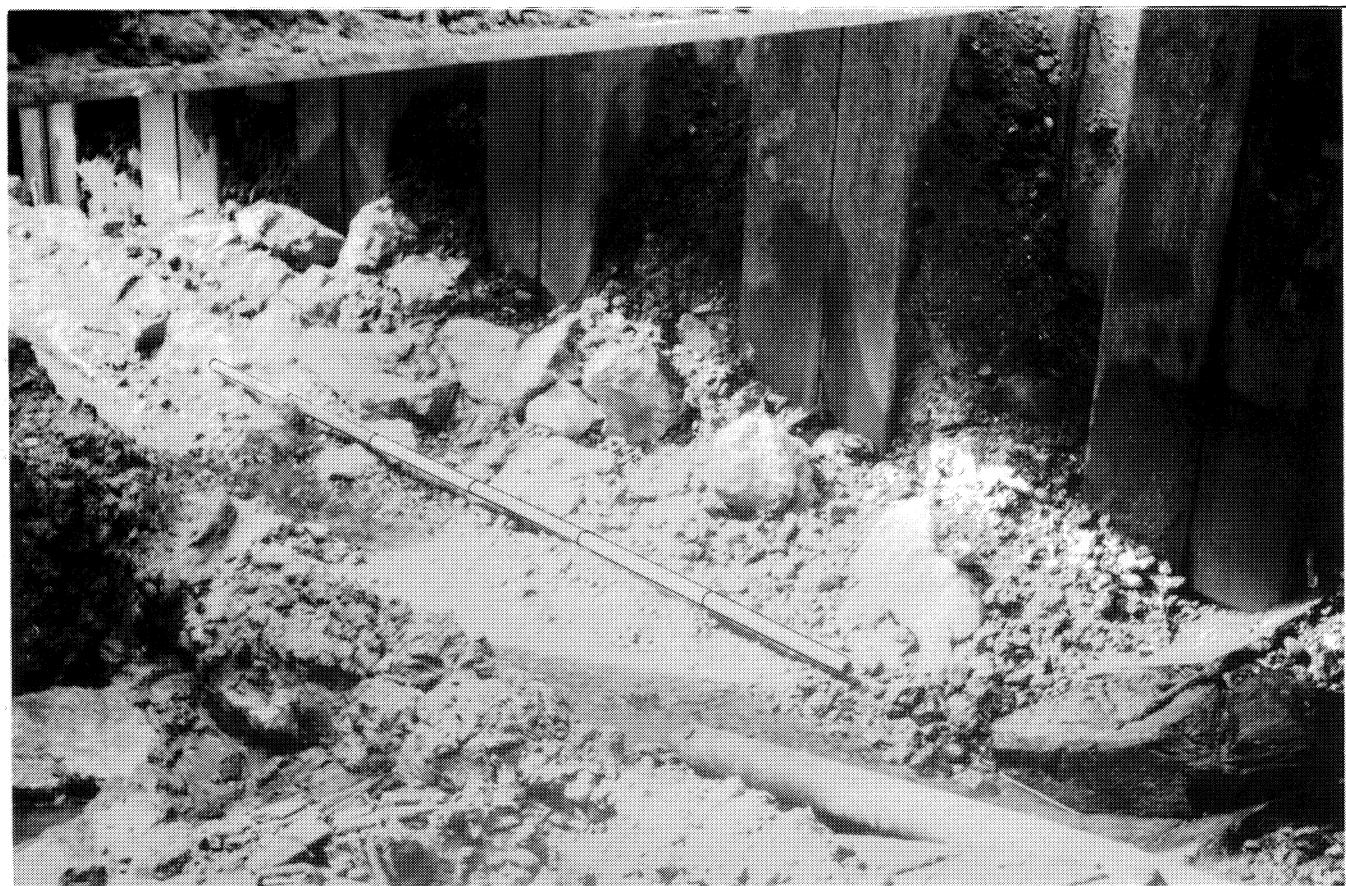
Fig 72 The cargo of Kentish ragstone in the hold of Blackfriars ship 1. The size of this load had been reduced by the site contractor in 1963 before it was photographed. Scale in feet.

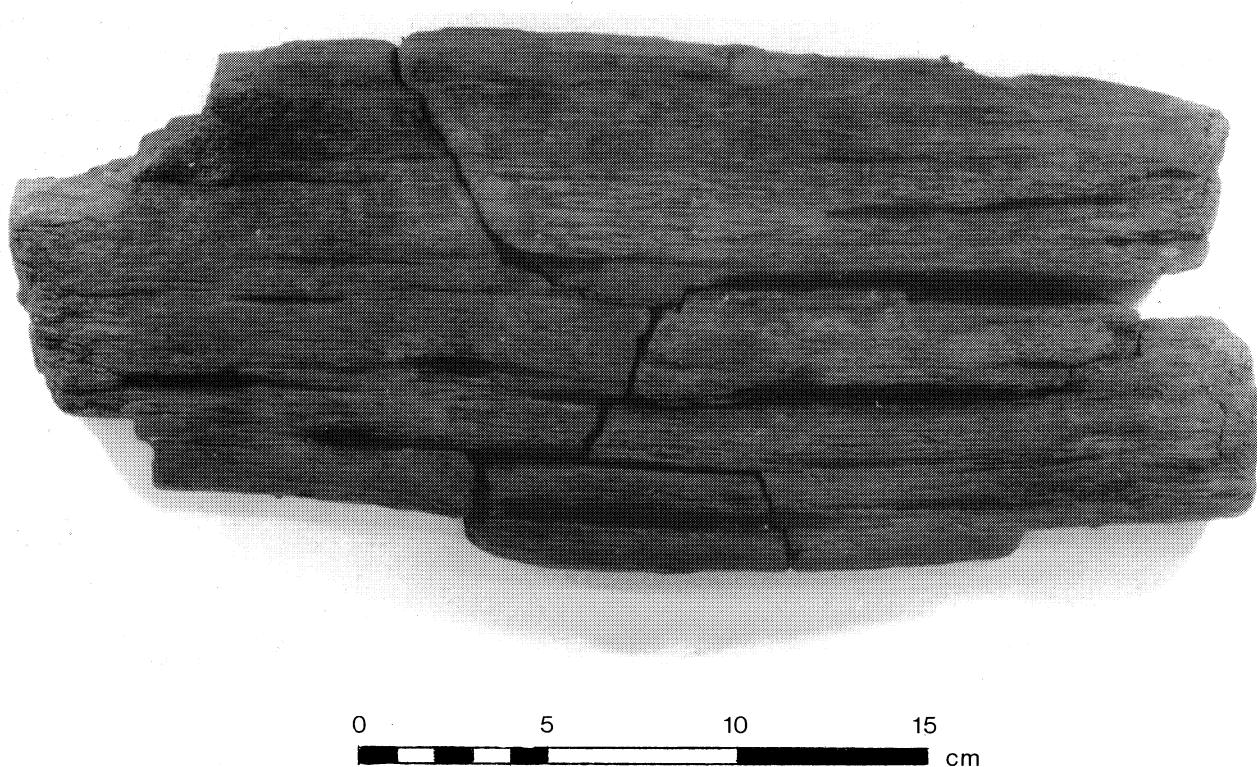
Fig 78 Eroded *Teredo* borings in the planking of Blackfriars ship 1.

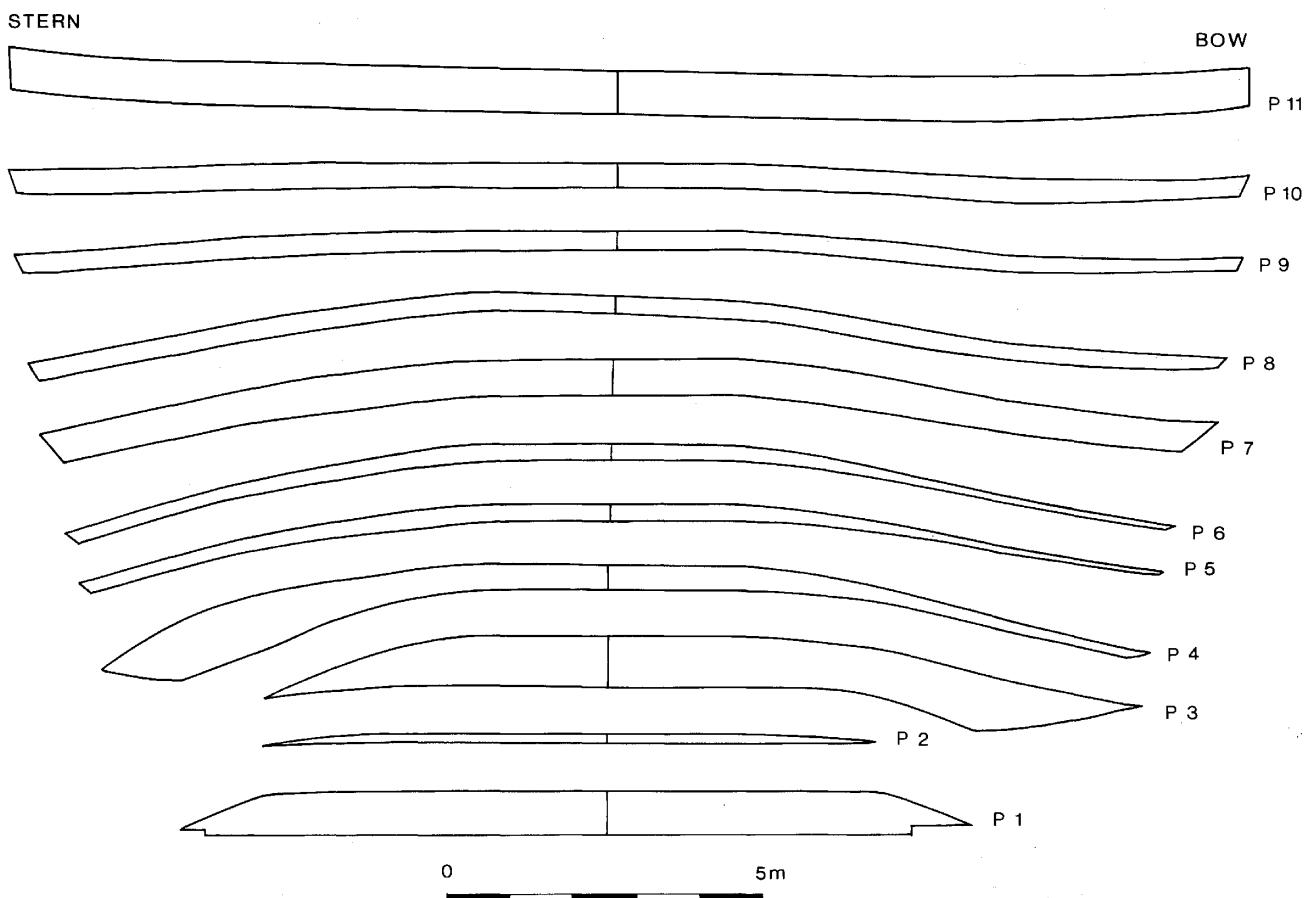
Fig 85 The shape of each stave when laid flat, from the computer reconstruction of Blackfriars ship 1.

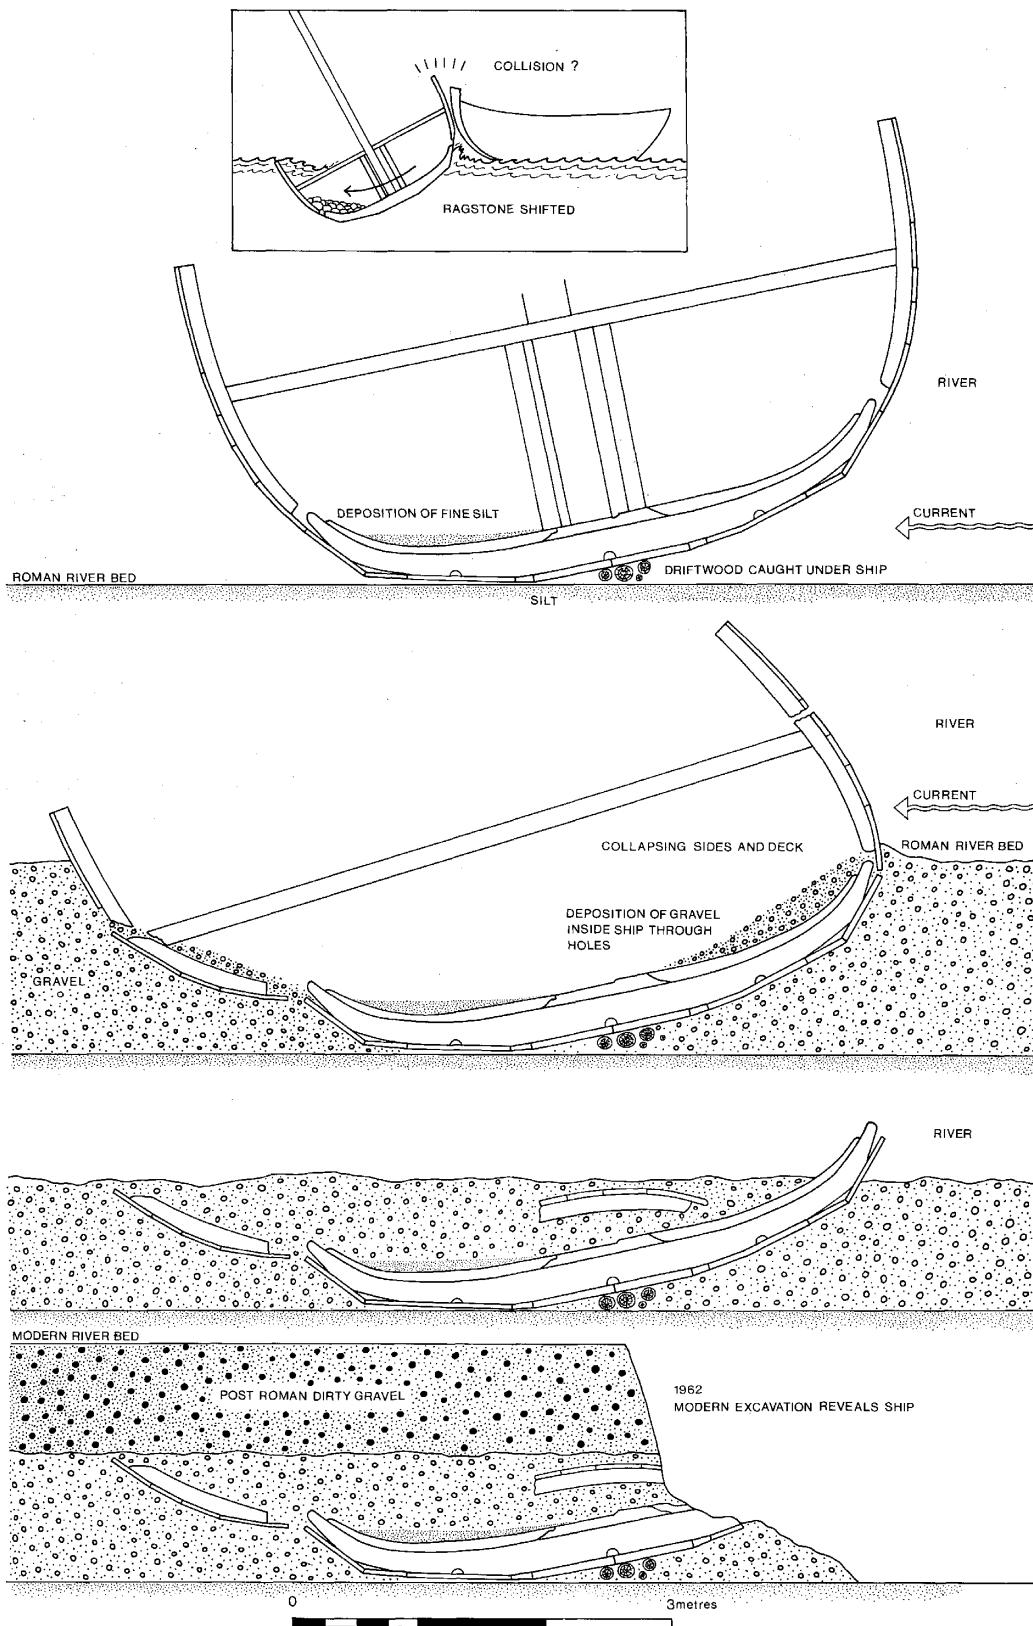
Fig 86 Suggested stages in the loss of Blackfriars ship 1.

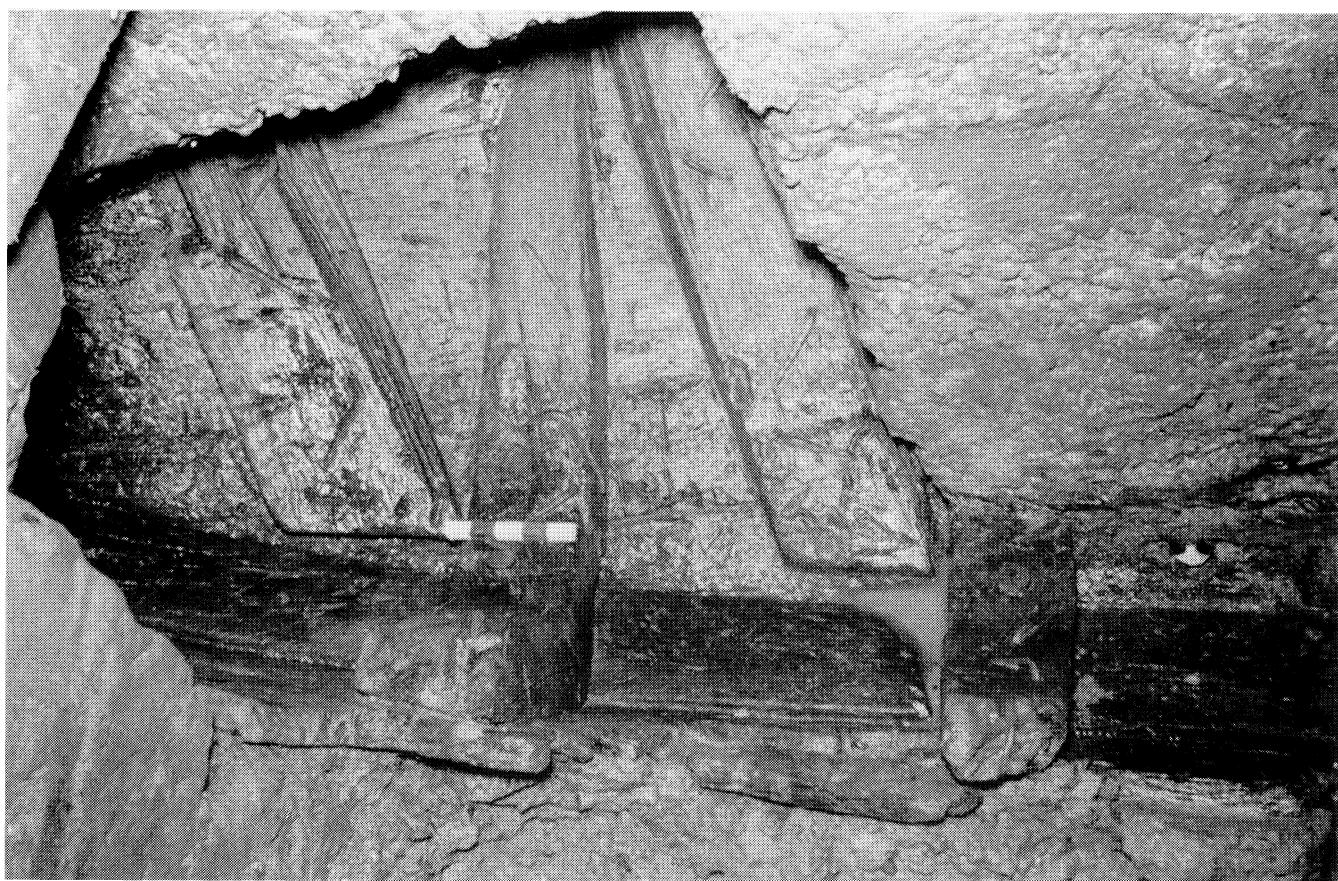
Fig 90 Frames on the east side of the north end of New Guy's House boat.

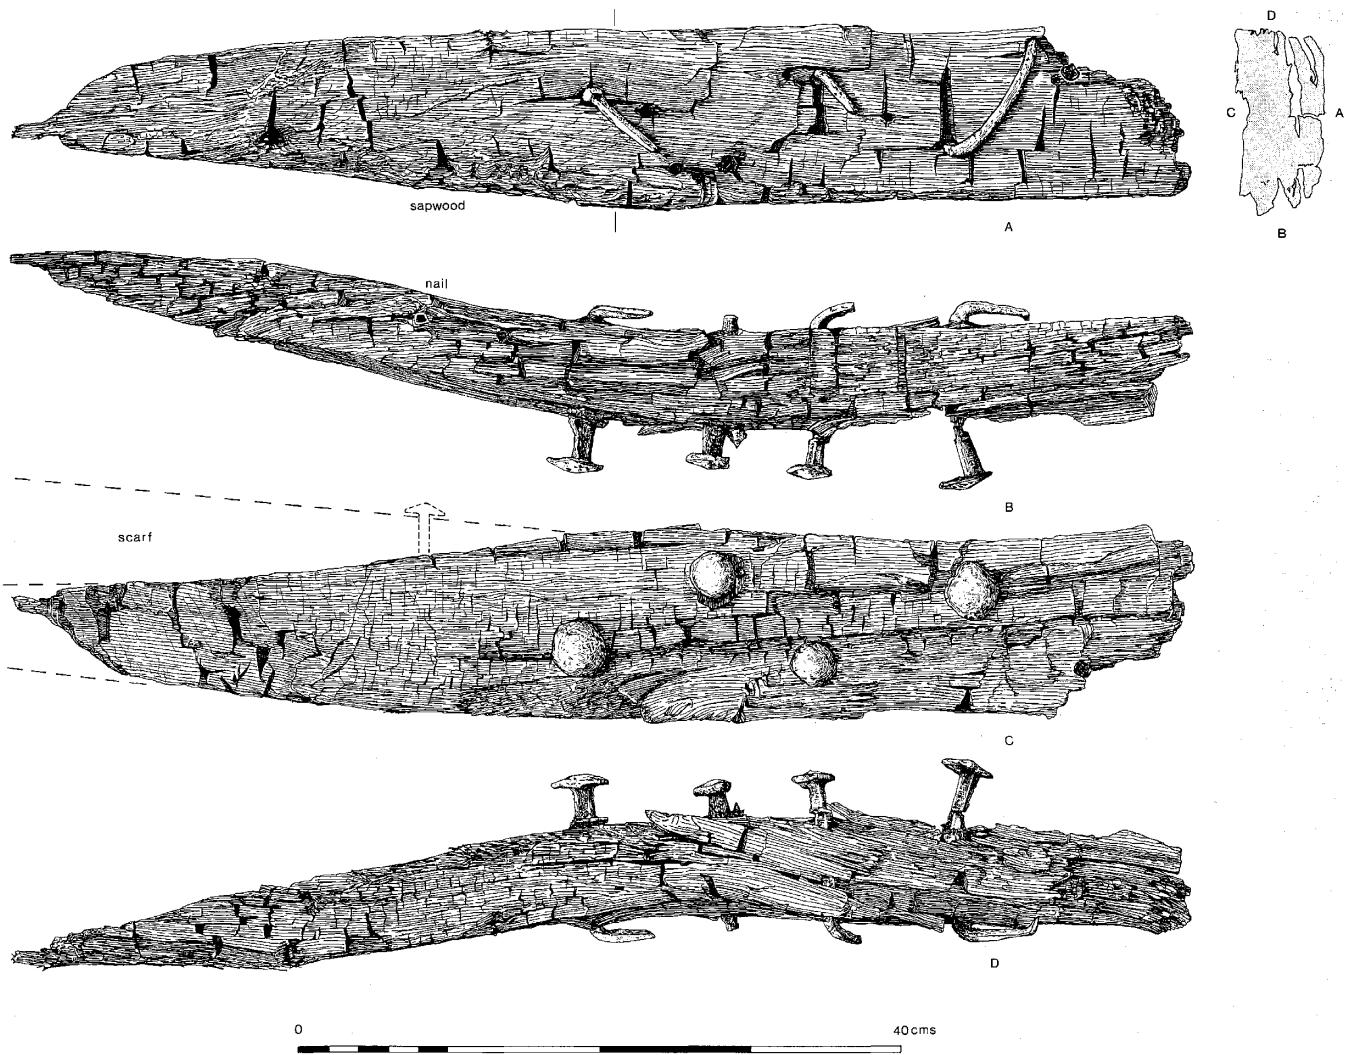
Fig 91 Drawing of a scarfed frame of the New Guy's House boat, found in trench 1. This timber was drawn in its dried and shrunken state.

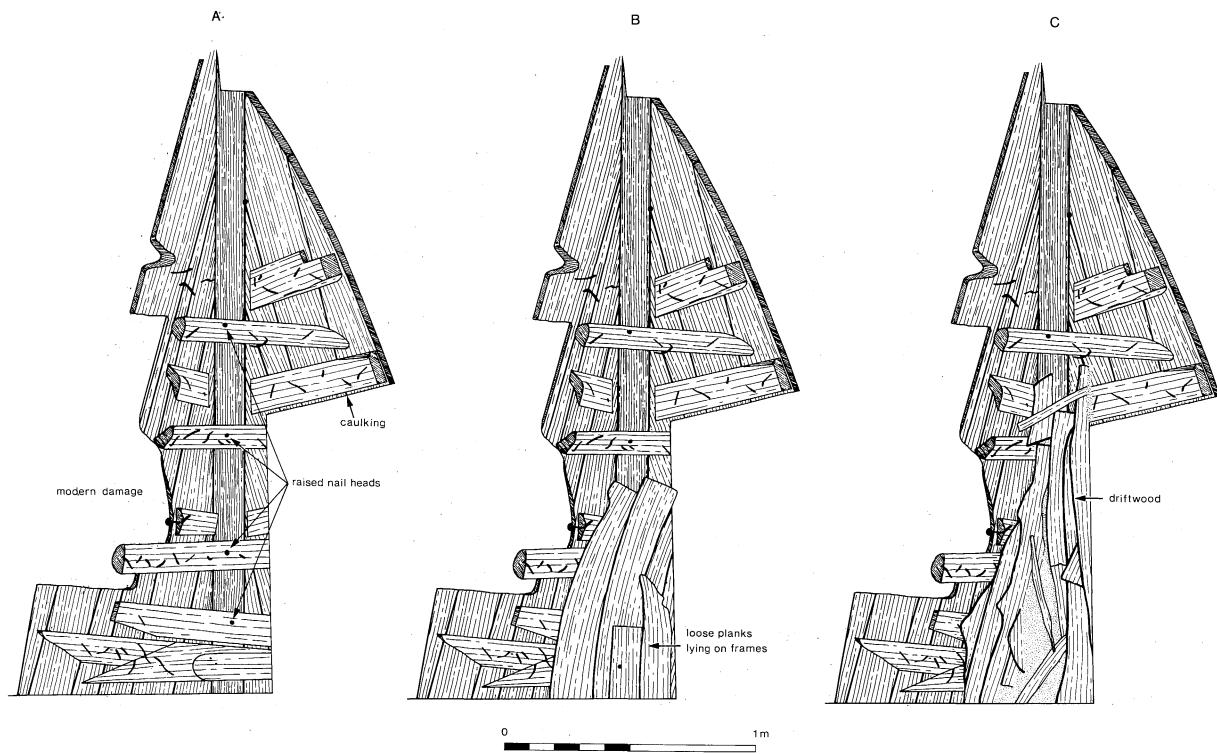
Fig 93 The construction of the north end of the New Guy's House boat: (A) raised nail heads indicate the position of a (missing) central plank; (B) loose planks on the frames; (C) driftwood that had accumulated in the boat.

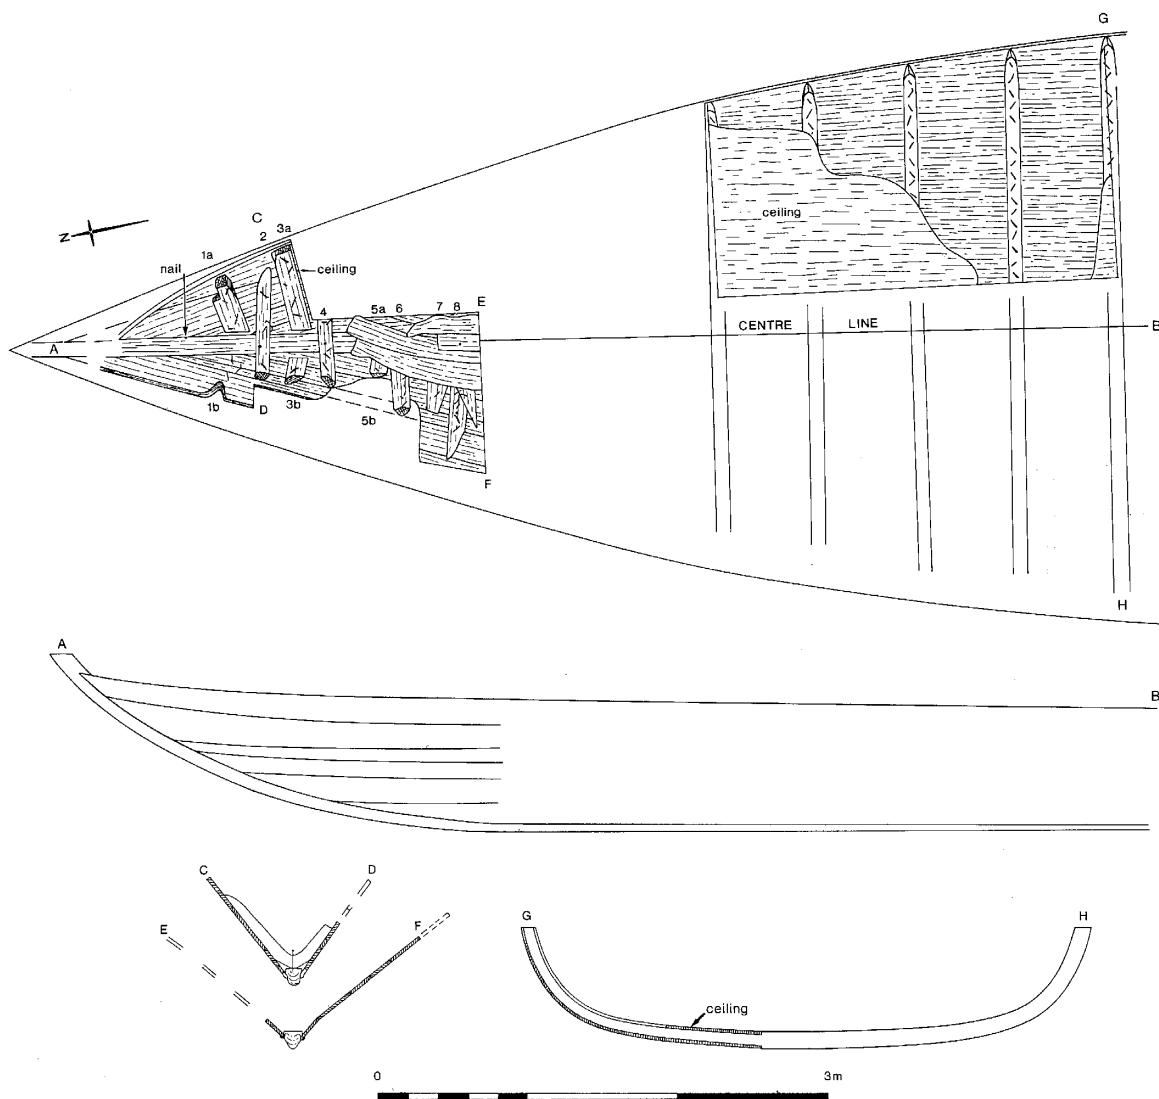
Fig 94 Reconstruction plan, side elevation, and cross-sections of the New Guy's House boat.

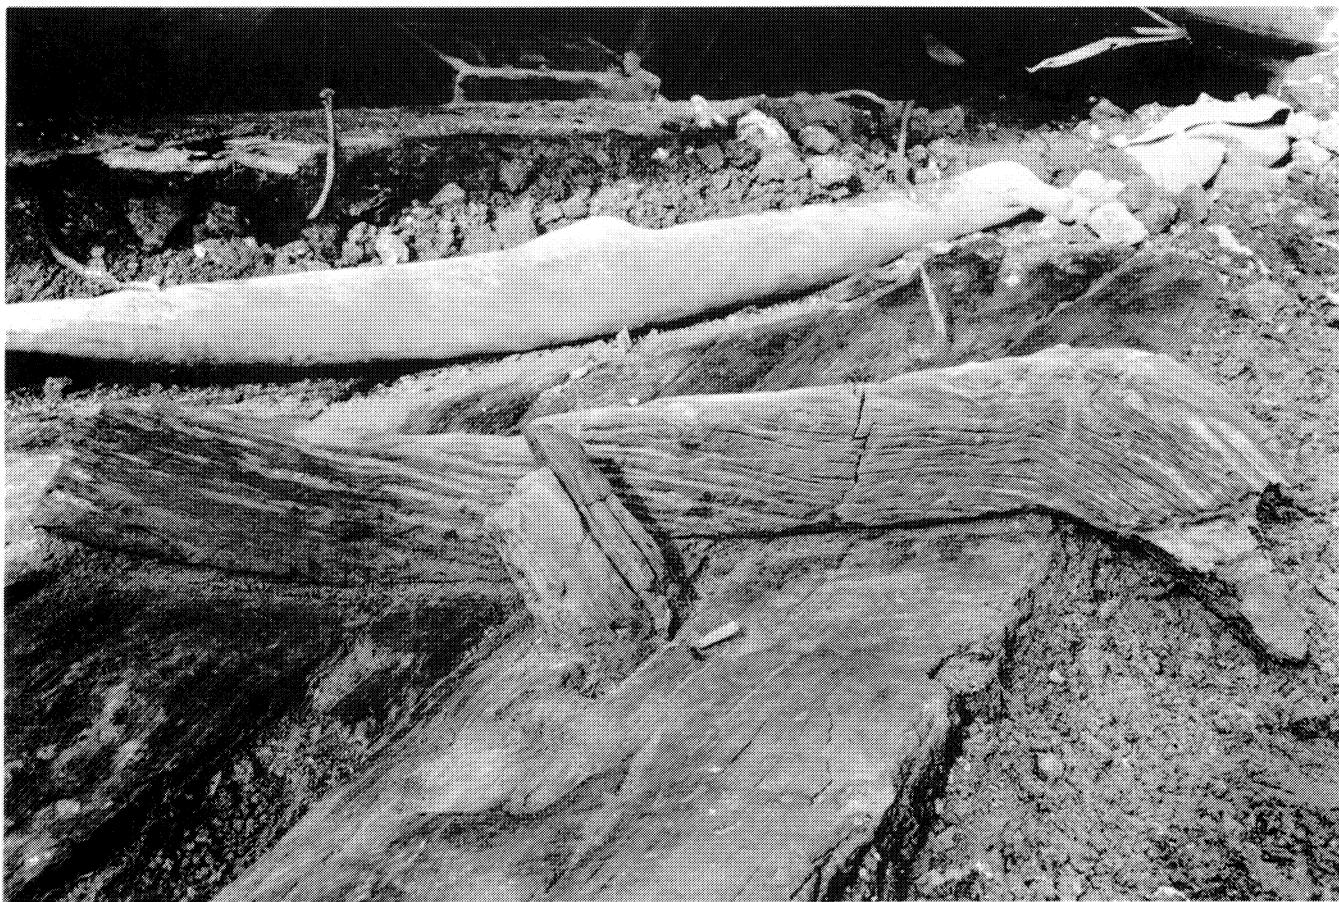
Fig 112 The loose upper end of a frame found in 1910. Note the end of a deck beam.

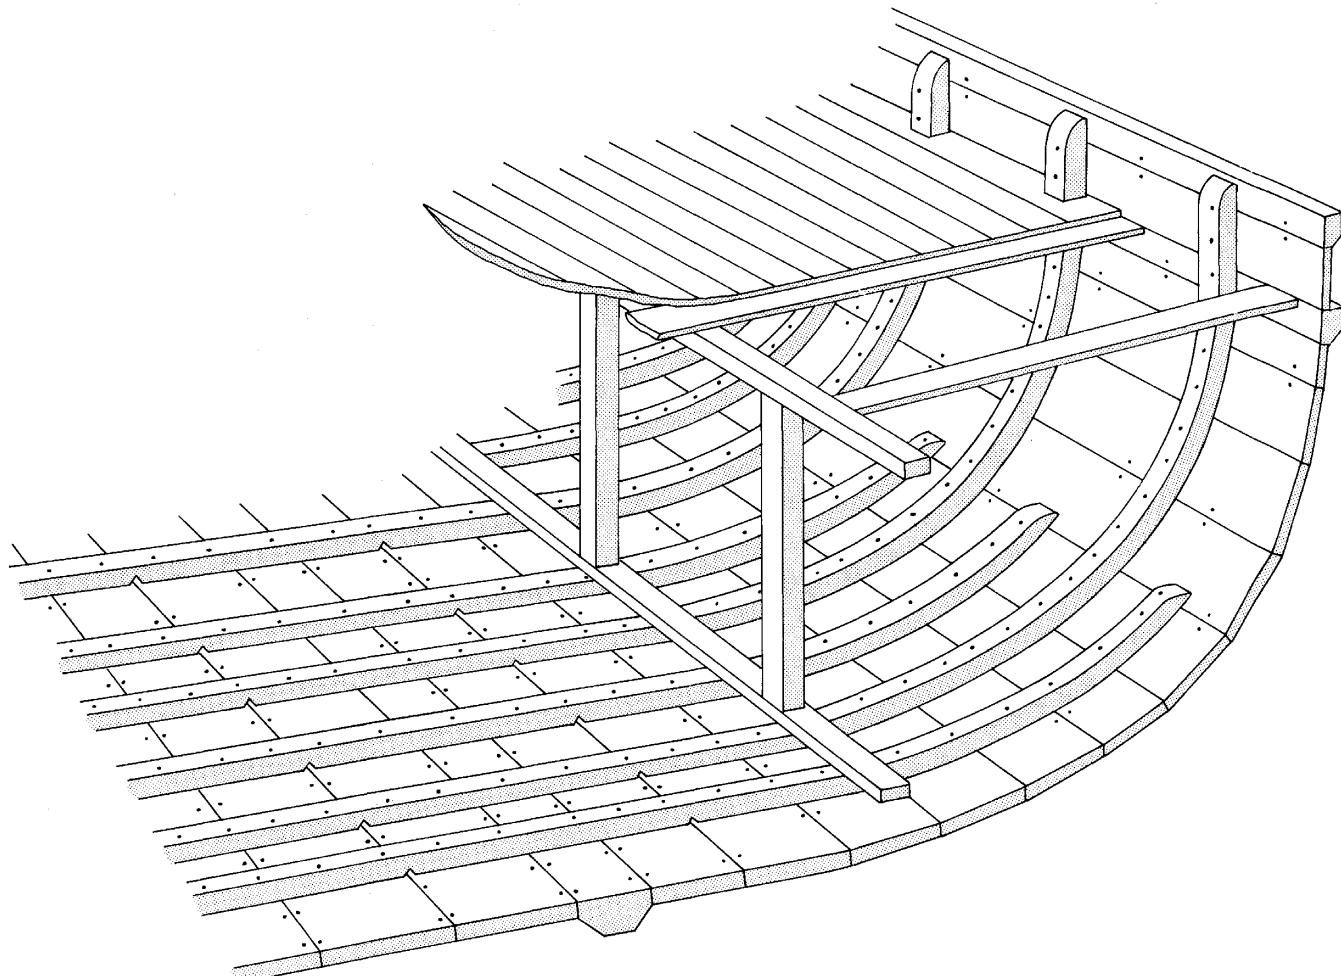
Fig 115 Reconstruction of the structural elements of the County Hall ship.

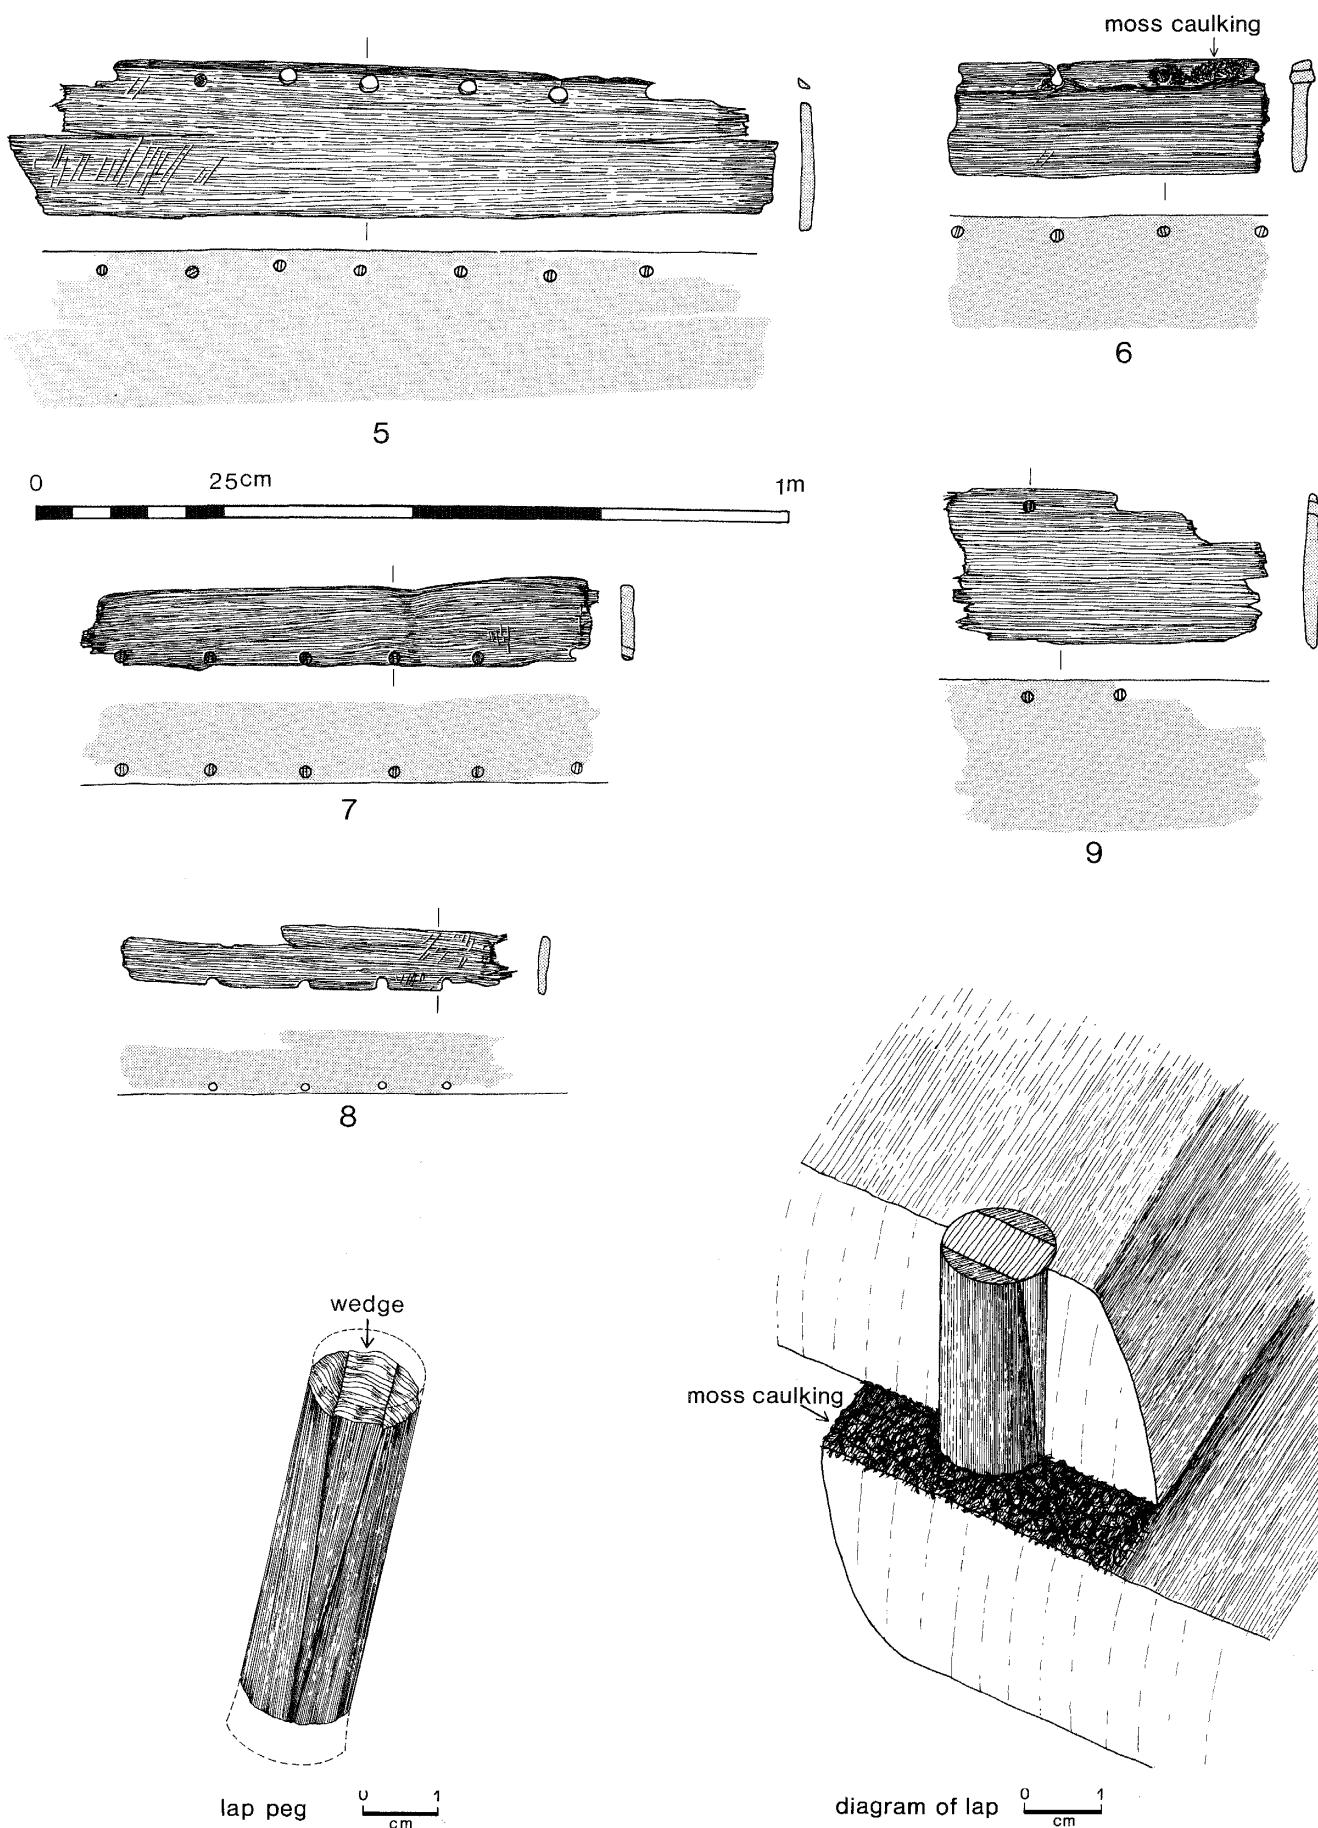
Fig 129 New Fresh Wharf: plank fragments, 5–9, also the lap construction.

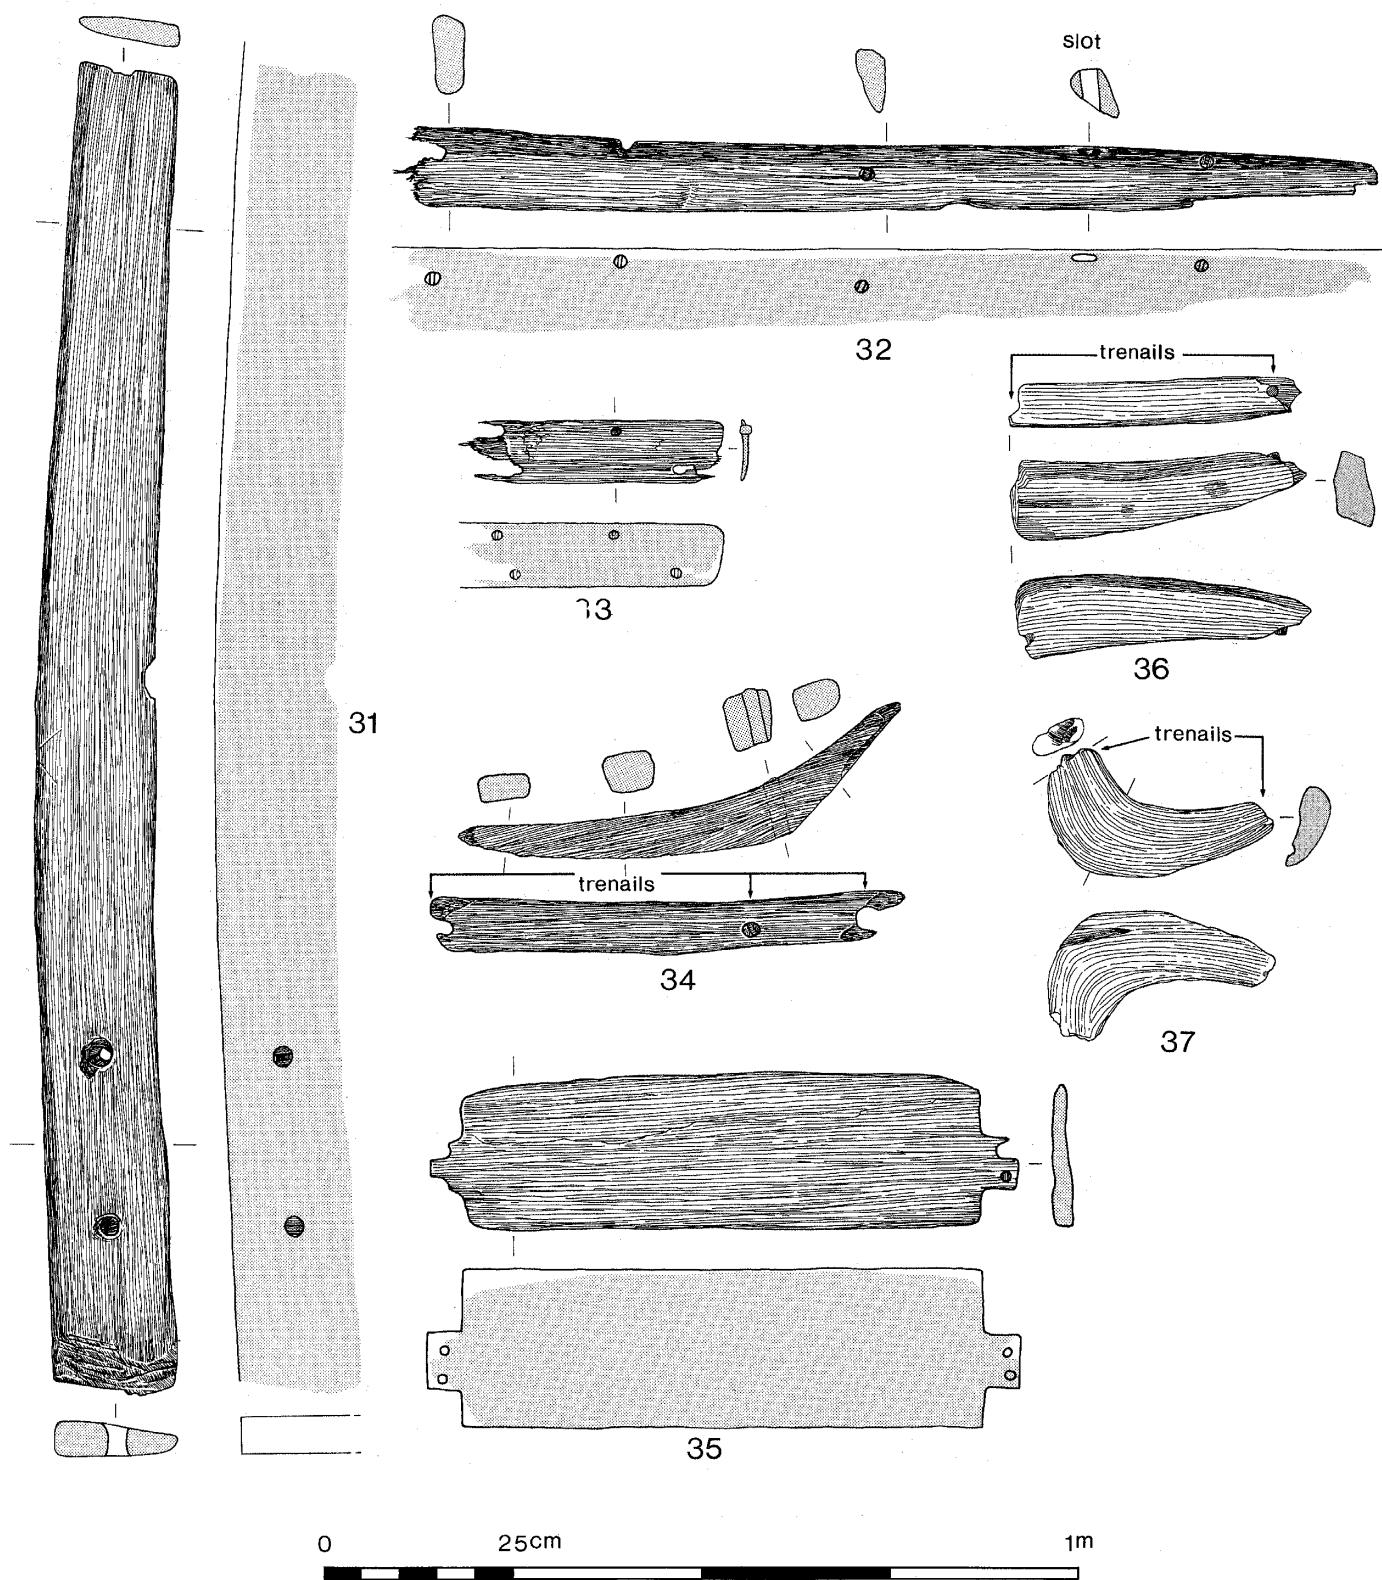
Fig 134 New Fresh Wharf: miscellaneous timbers as found and reconstructed.

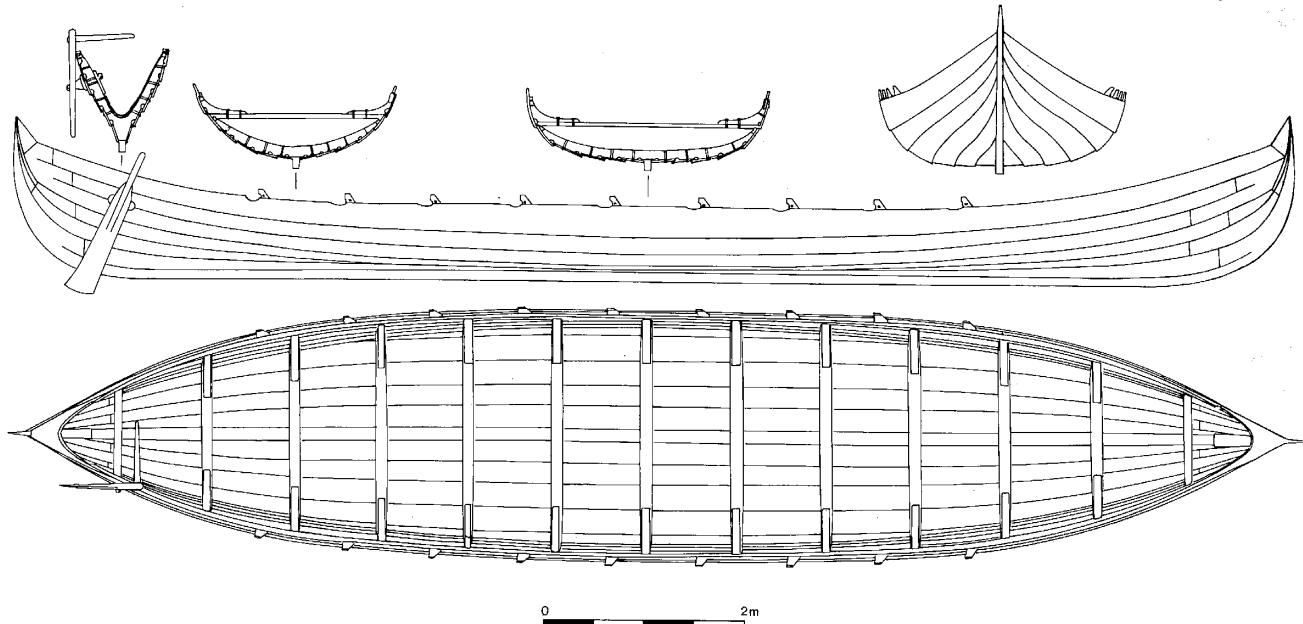
Fig 135 Reconstruction of boat 1 from Danzig Ohra (Gdansk), Poland.

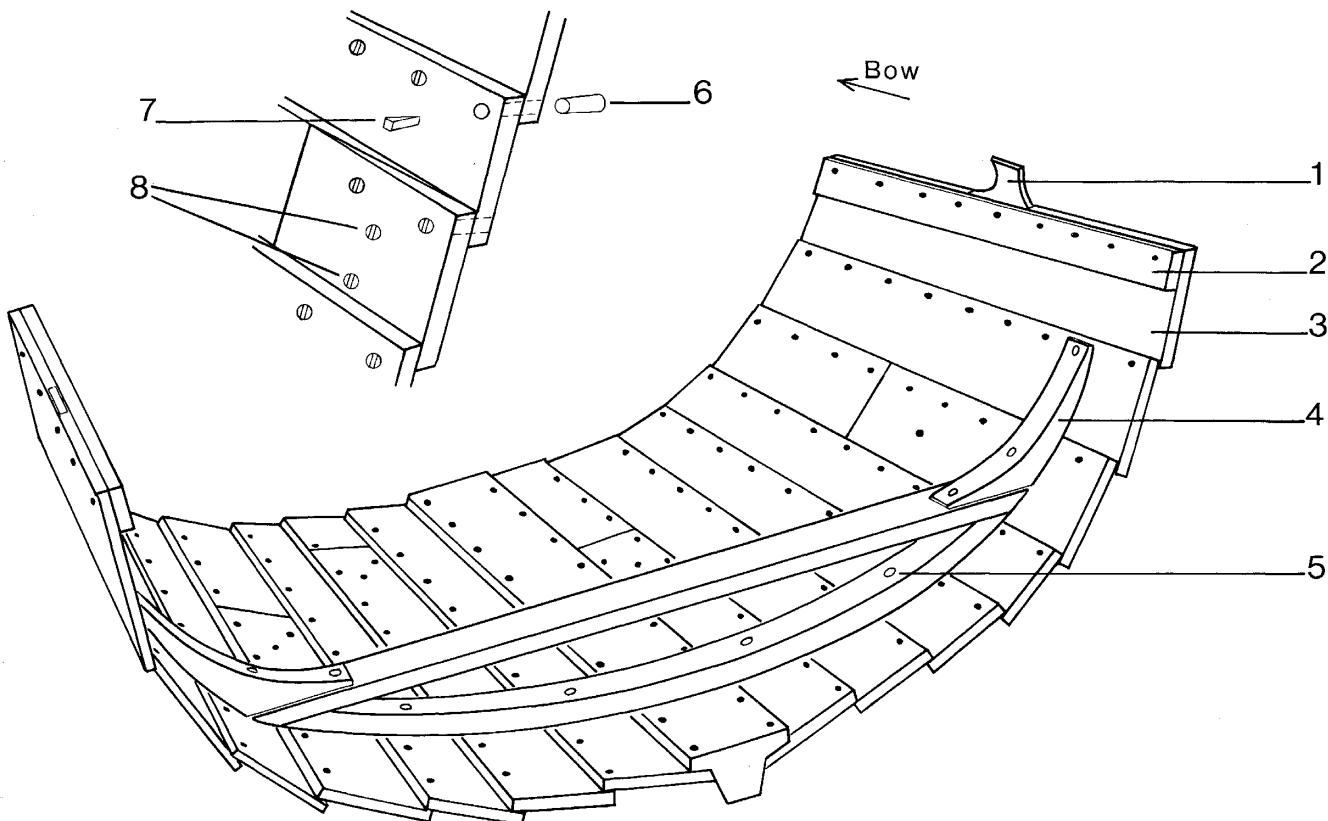
Fig 136 Possible reconstruction of the New Fresh Wharf timbers to include all known features: (1) oar pivot; (2) inwale; (3) gunwale/sheerstrake; (4) standing knee; (5) frame held to planks by trenails; (6) lap peg; (7) wedge of peg, inboard; (8) pegs wedged inboard holding a plank scarf.

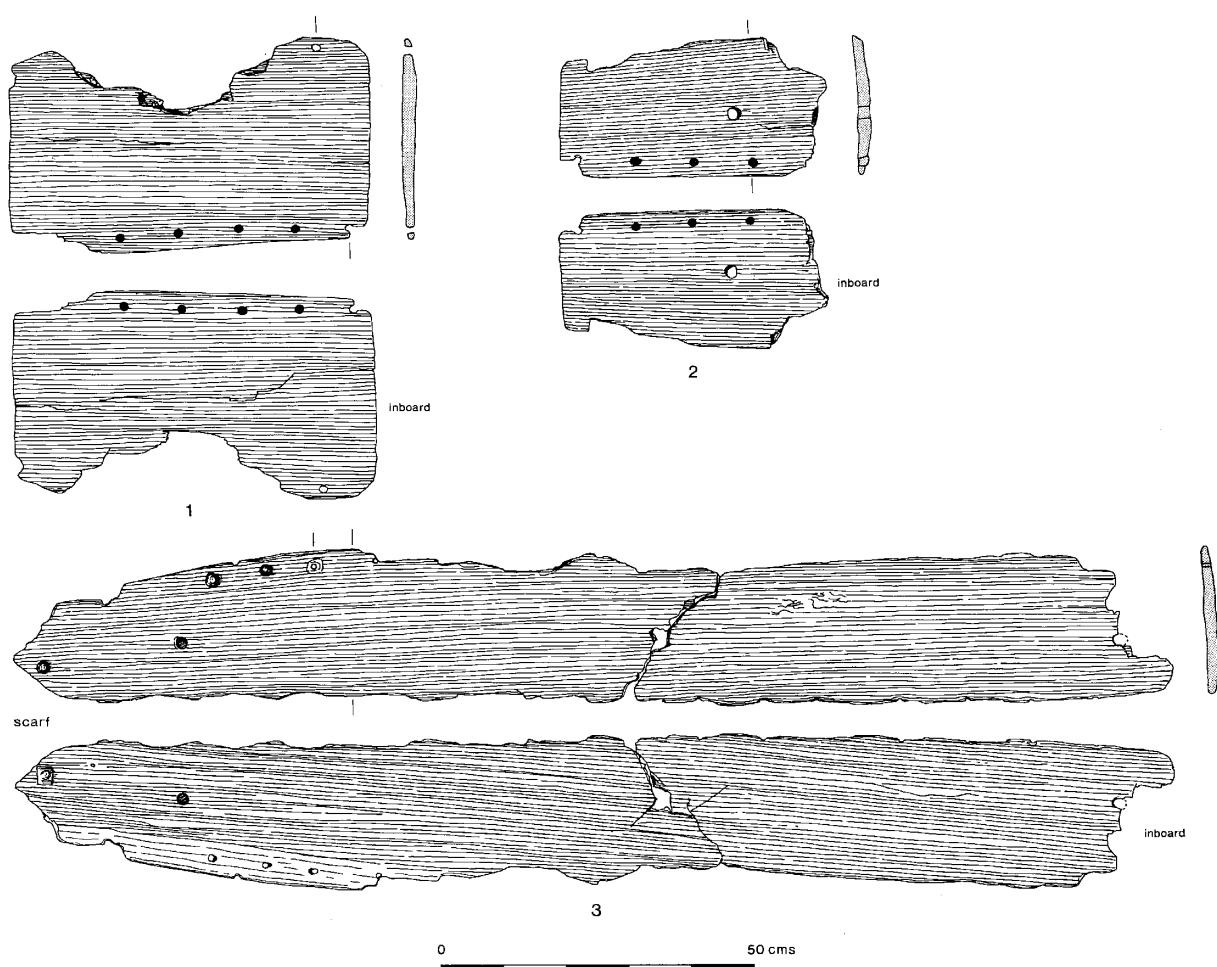
Fig 137 Billingsgate: (1), (2) pegged planking; (3) riveted plank; tenth to eleventh centuries.
