SHIPS OF THE PORT OF LONDON

First to eleventh centuries AD

Peter Marsden

ARCHAEOLOGICAL REPORT 3

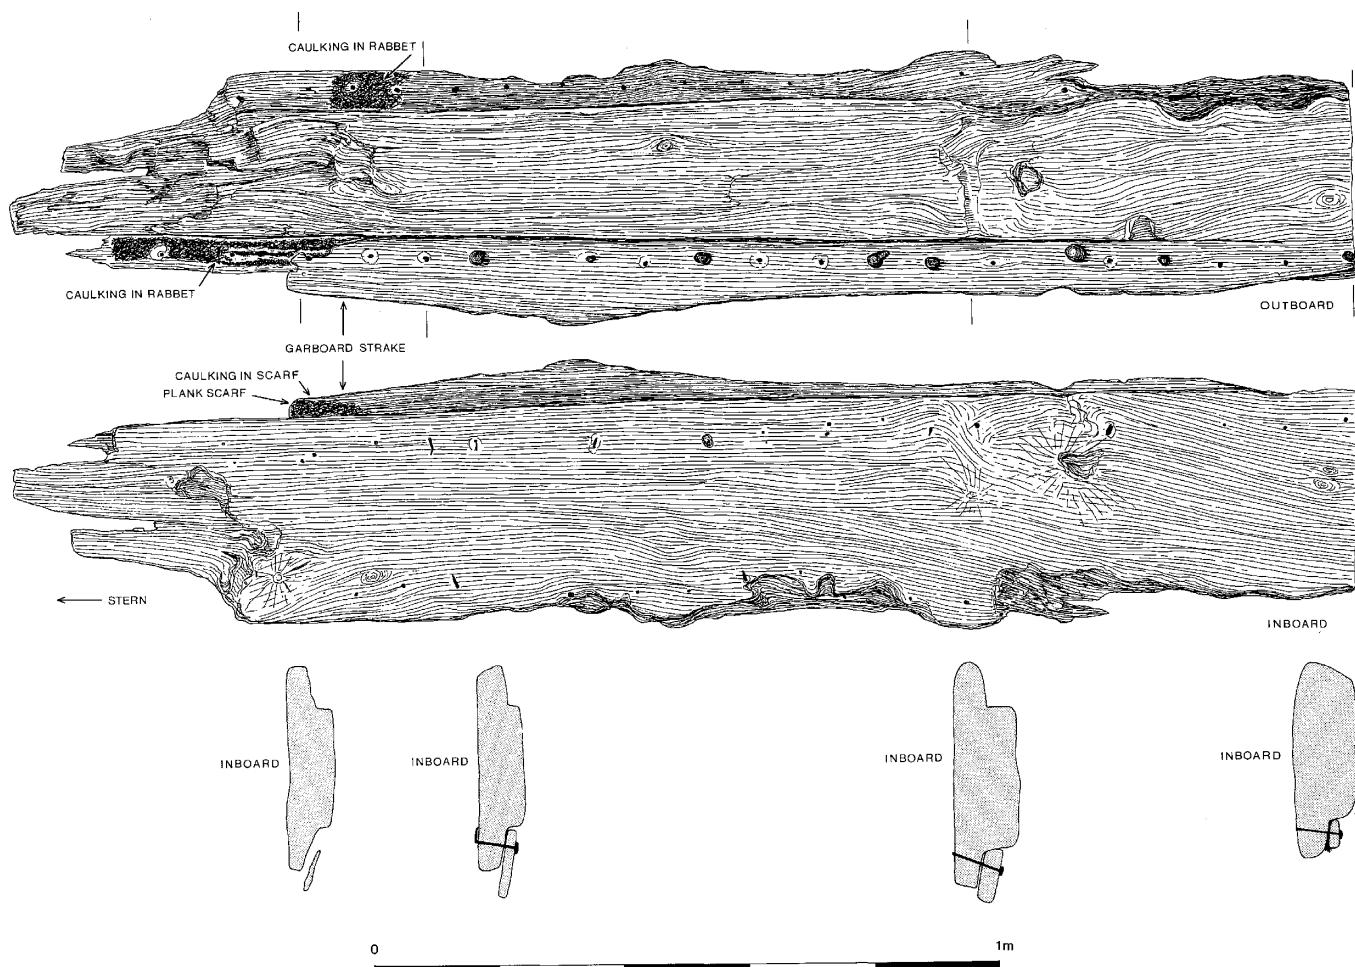
Fig 139 Keel from Fennings Wharf, probably late eleventh century AD. The garboard strakes were held by hooked nails.

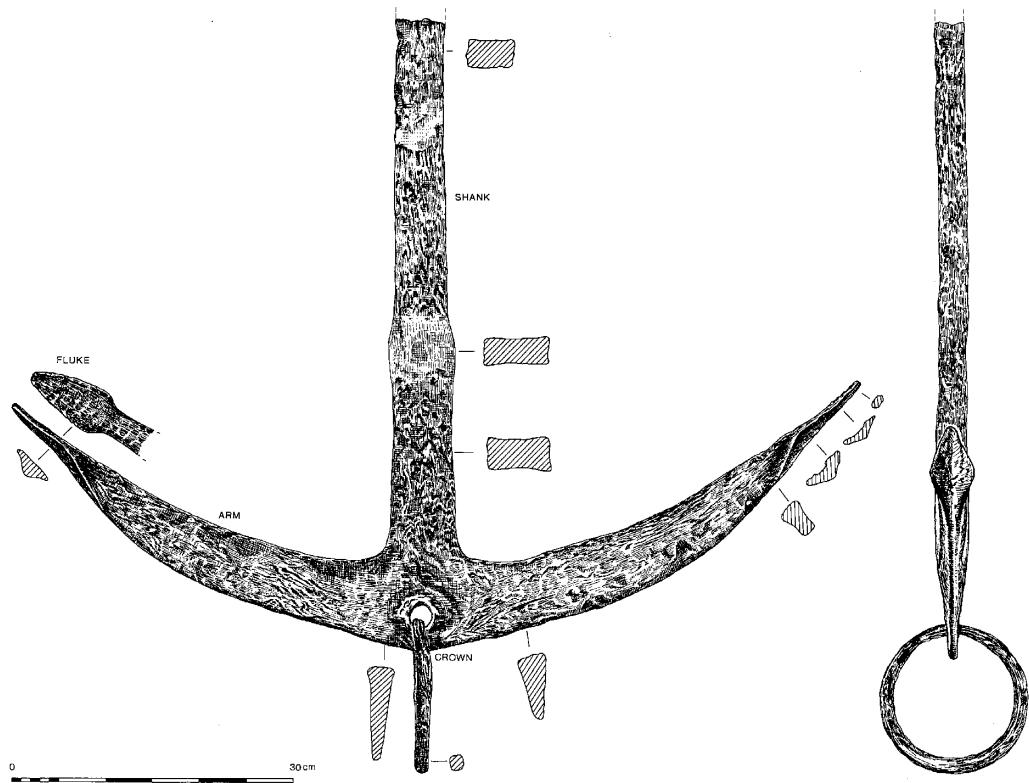
Fig 142 Iron anchor of Viking type, Blackfriars.

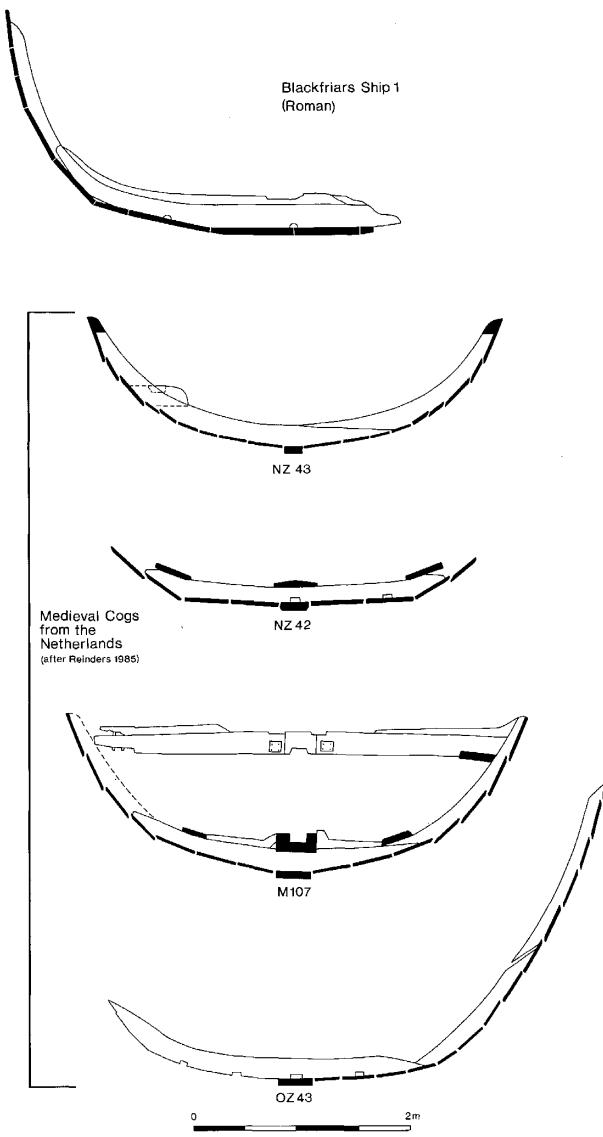
Fig 152 Cross-section of the Romano-Celtic ship from Blackfriars compared with cross-sections of medieval 'cogs'. It is possible that the Blackfriars type of vessel was the ancestor of the 'cog'.

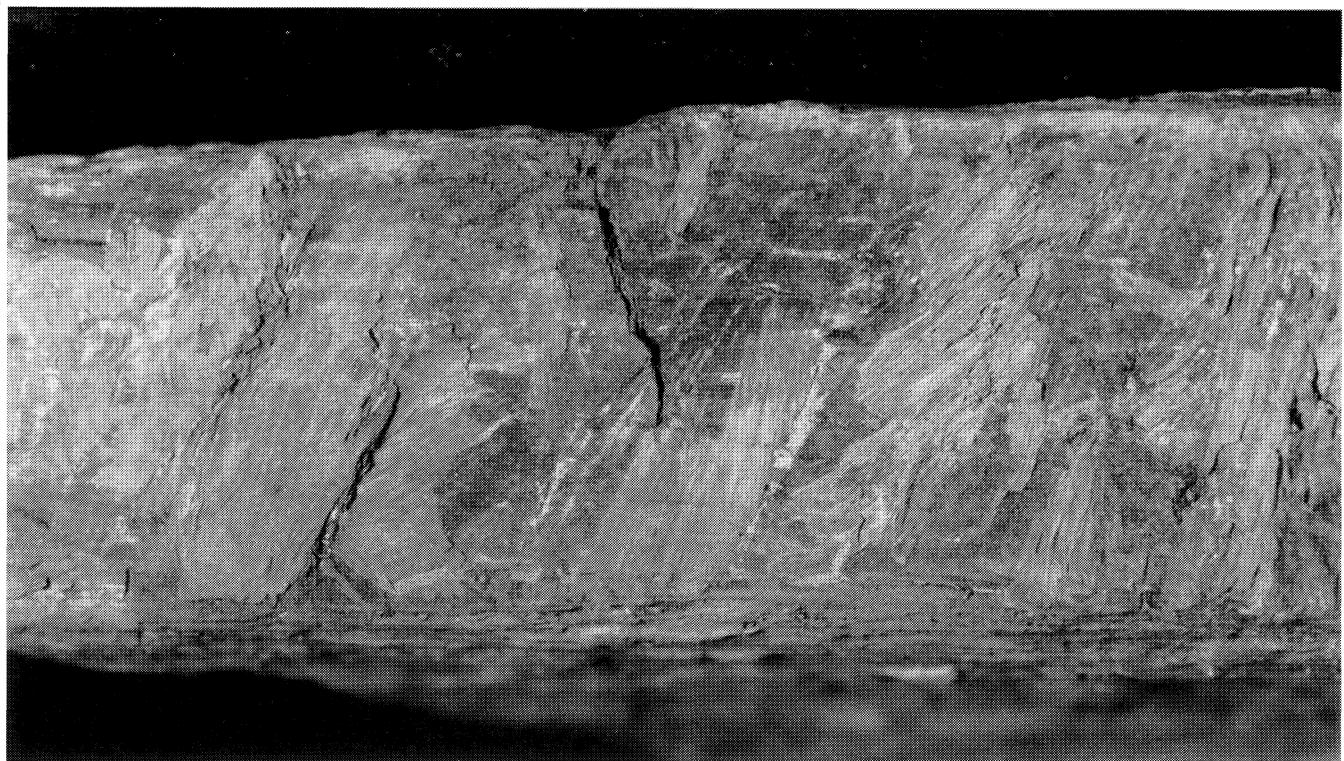
Fig 163 View of hazel wood shavings applied to the edge of a plank in the New Guy's House boat.

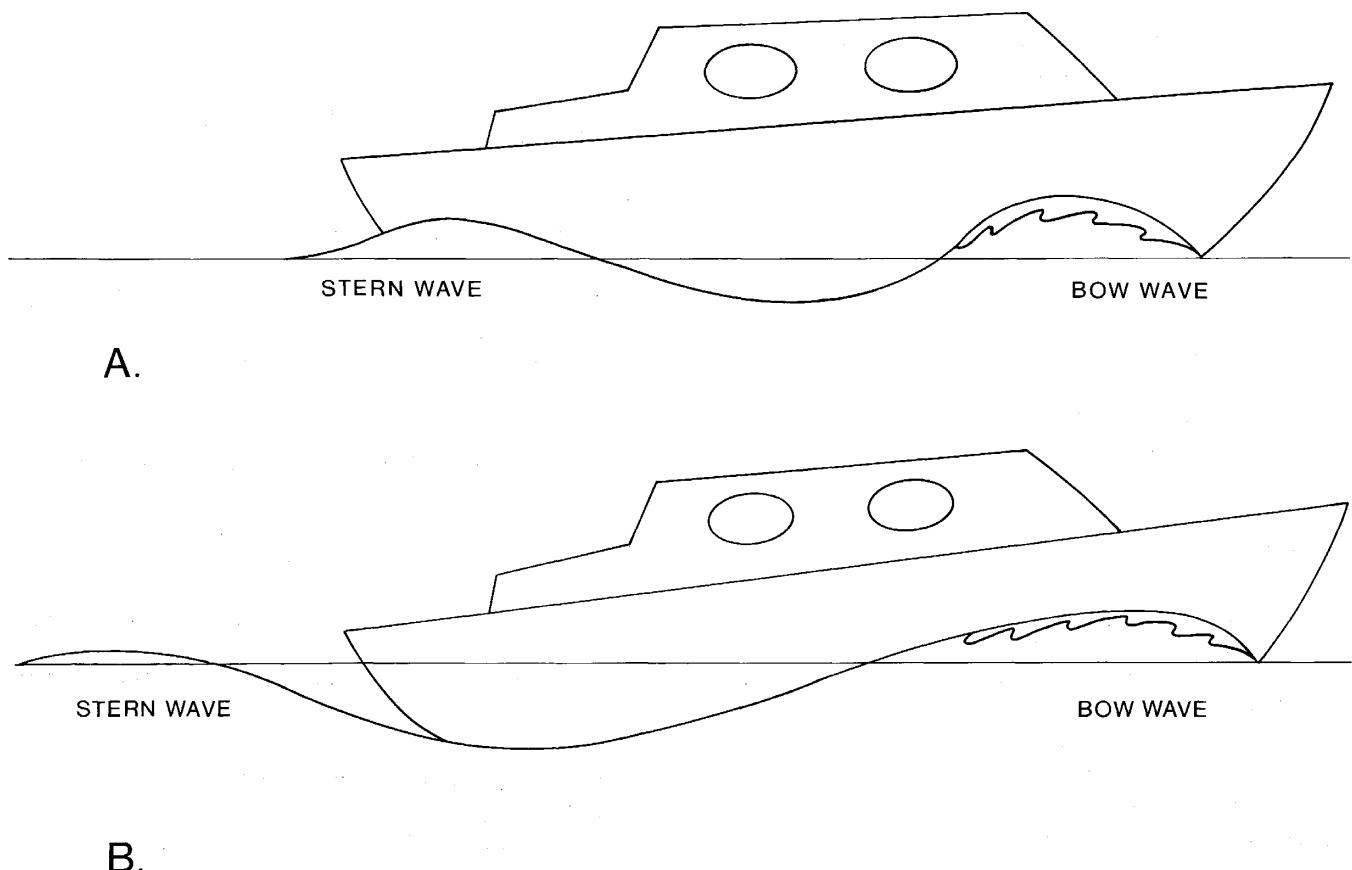
Fig 169 One wave speed. At a slow speed (A) the wave resistance is small, but at a fast speed (B) the stern sinks into the trough behind the bow wave and the vessel has to increase its propulsion power to climb the bow wave. Consequently the wave resistance has increased. This is shown in graph form for Blackfriars ship 1 in Fig 170.

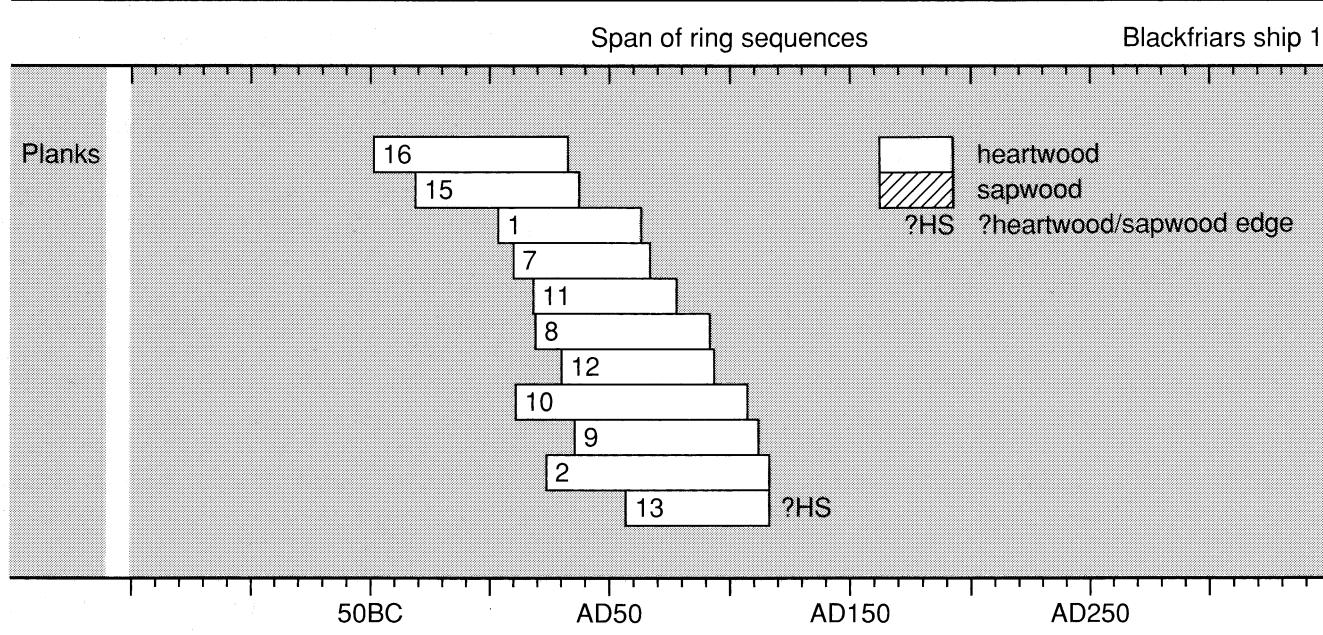
Fig 171 The relative positions of dated tree-ring samples from Blackfriars ship 1.

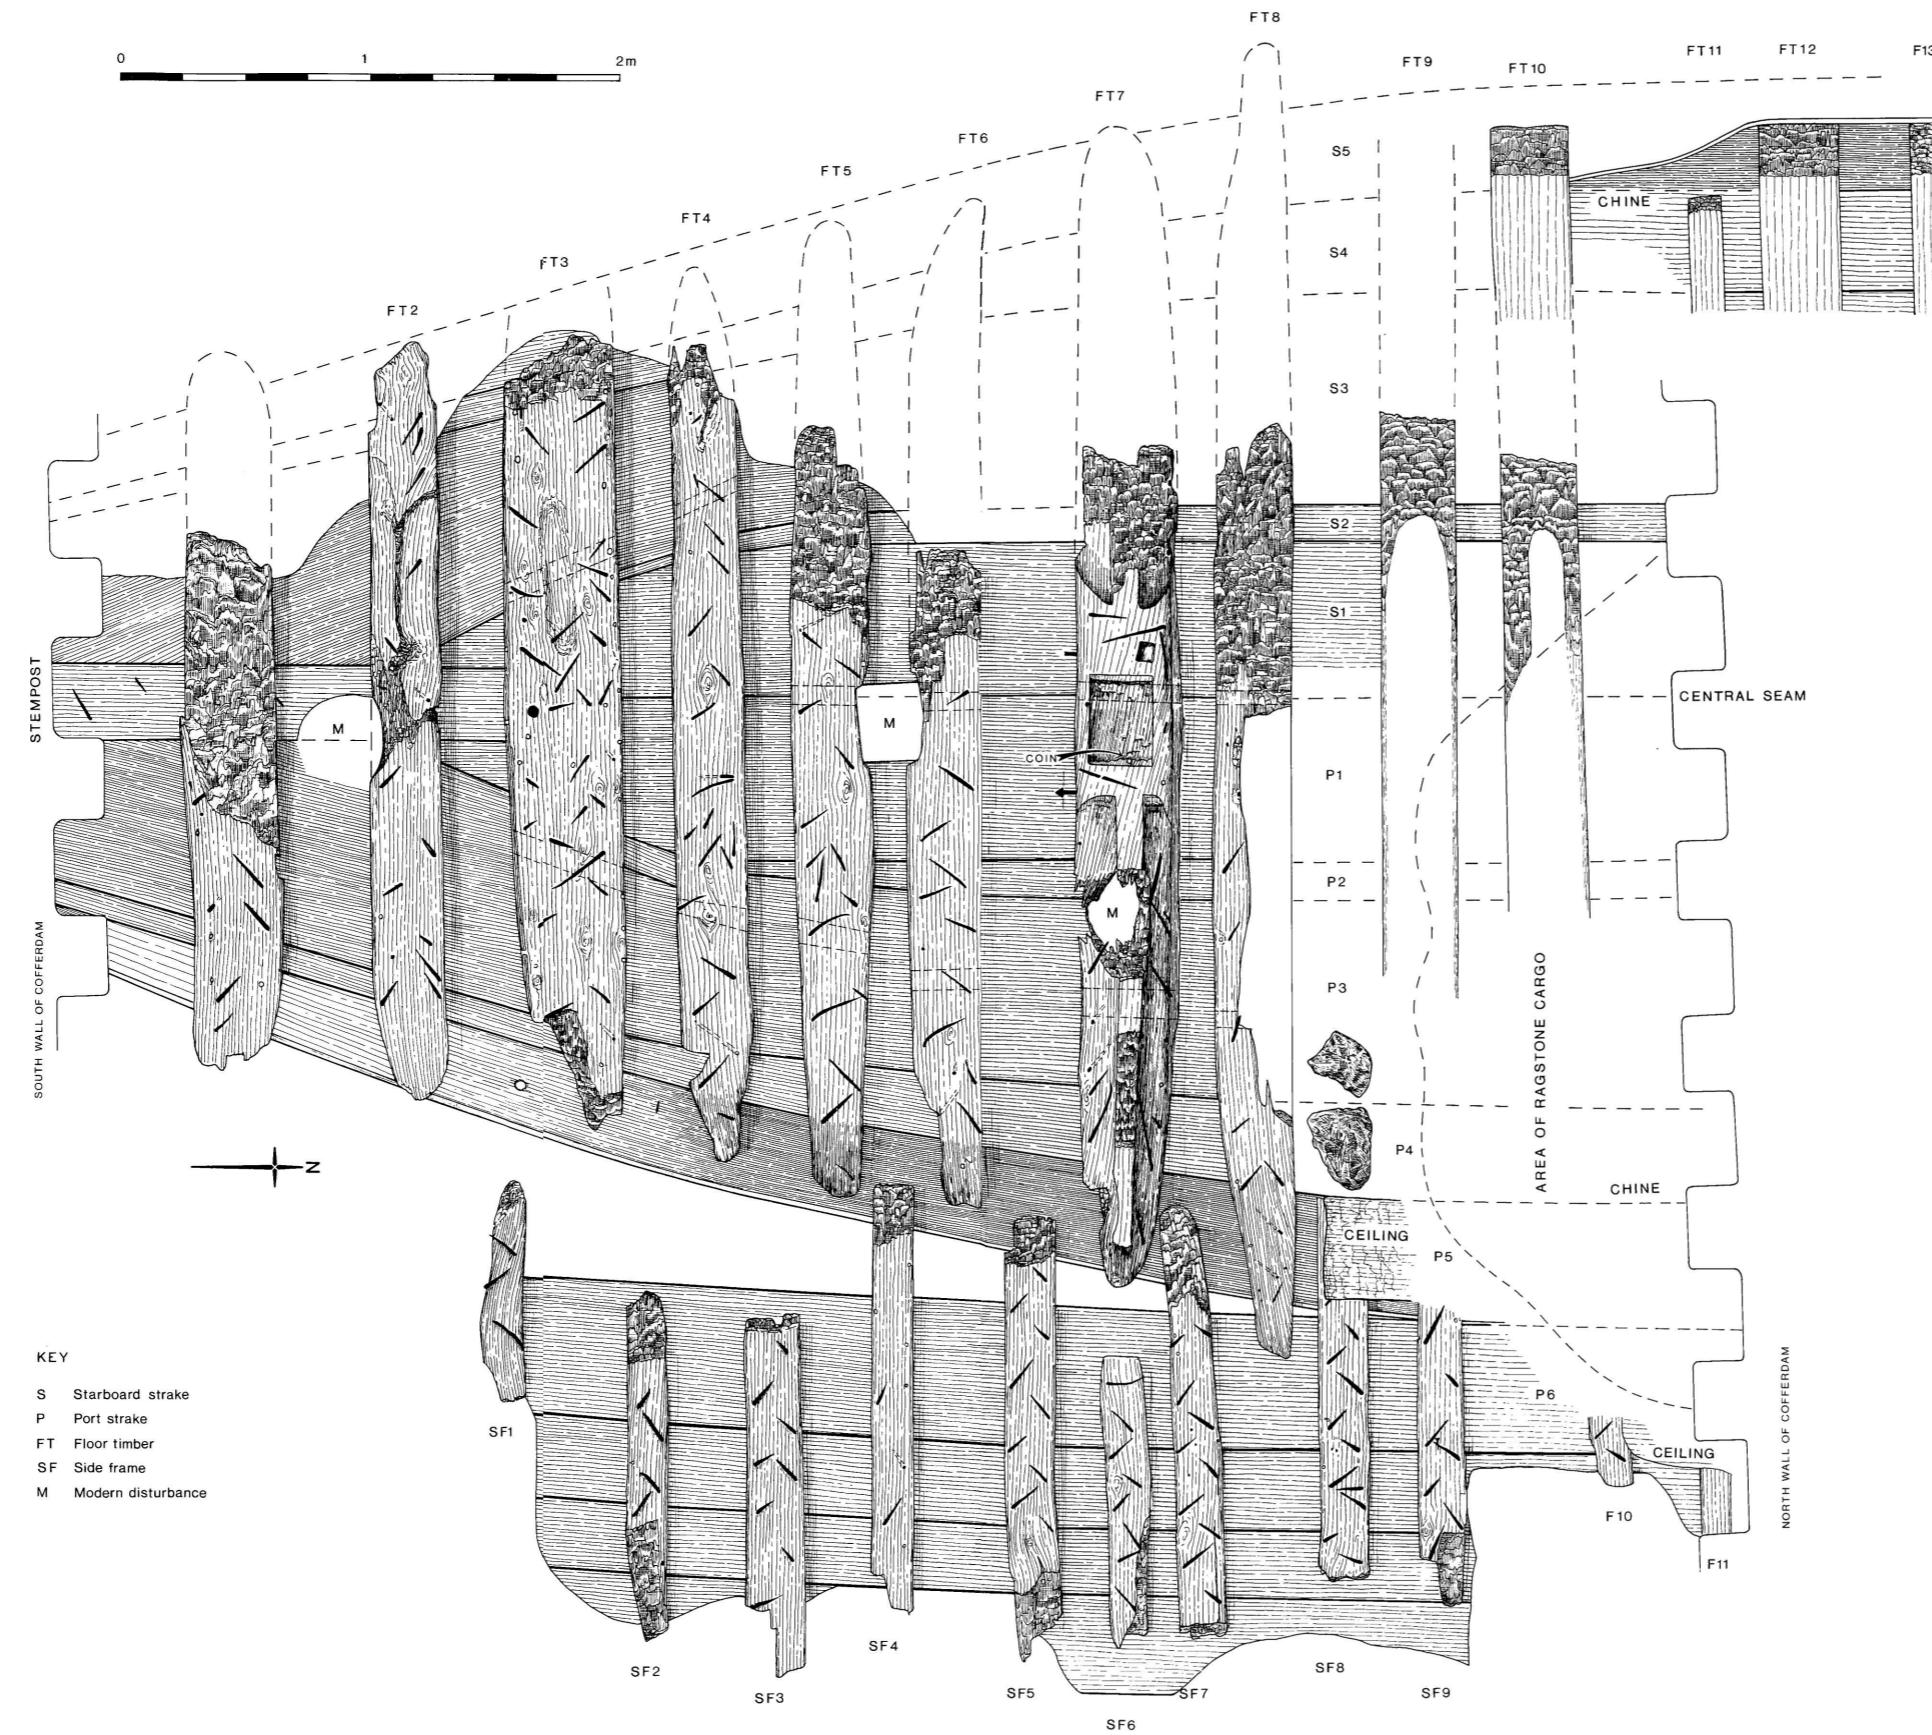
Fig 25 The forward half of Blackfriars ship 1 as excavated in the coffer-dam in 1963.
