JUSTICE STREET ABERDEEN

- Archaeological Watching Brief -

Carried out 18TH – 20TH October 2010

Report No: MAS 2010-22

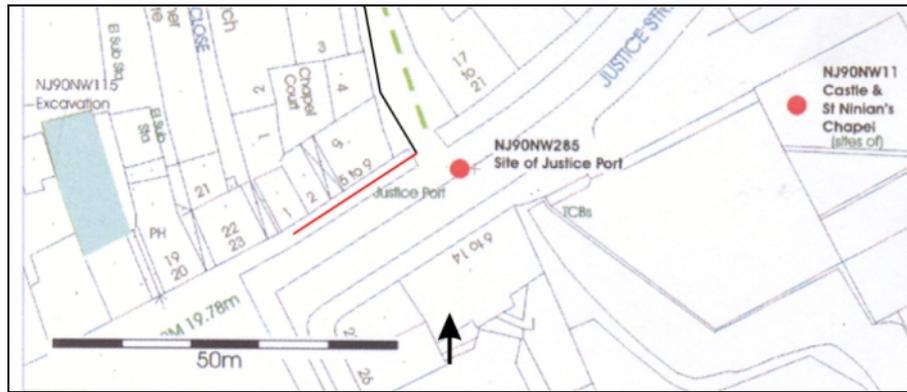
Illus. 1: Location plan. The cable trench is shown in red, connecting with the previous service trench in black.

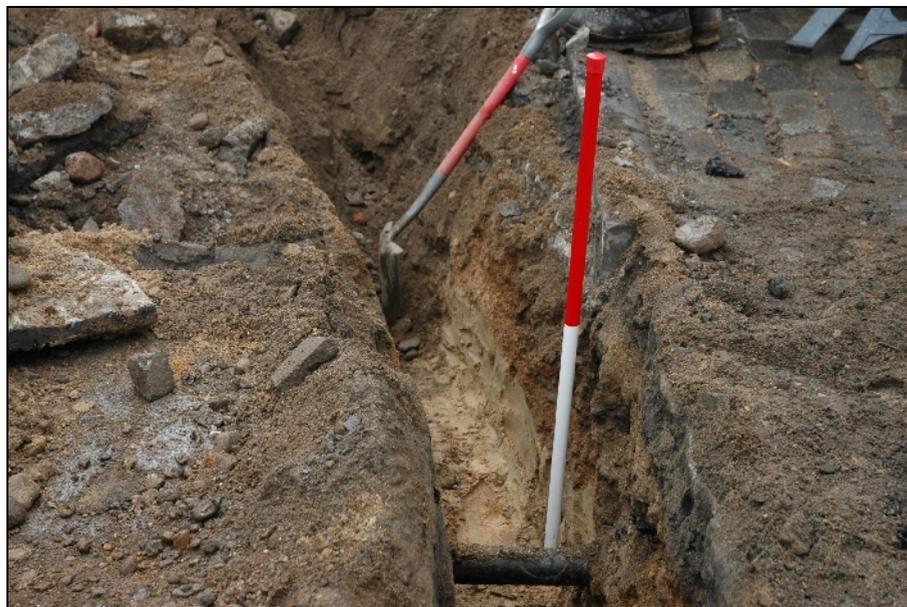
- 3.2 The slow rate of progress was due to the fact that after the excavation of each short stretch of trench, the conduit for the cable had to be laid, the trench backfilled and the surface pavement re-laid.
- 3.3 At its E end, the trench connected with a service trench running N-S from the new development in the Timmer Market site and which had been archaeologically evaluated in 2009 (Murray & Murray, 2009): no archaeological features or finds were observed at that time. The trench continued W to No.22-23 Justice Street.
- 3.4 At the E end of the trench a layer of fine beige natural sand underlay the pavement and sub-base material. Cutting through this was a sequence of modern service pipes [see Illus.2, below].

Illus. 2: Disused service pipe, looking W.

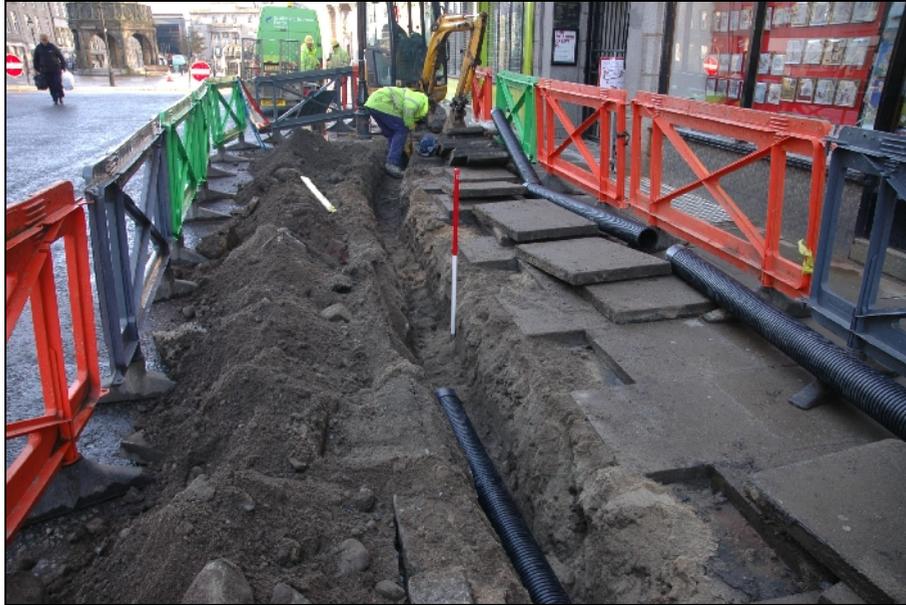
- 3.5 At 2.2m to the W a disused lead water supply pipe was uncovered c.450mm below pavement level. After a gap of c.1.7m a water cistern and stopcock and a sewer pipe lay at depths of 200mm and 300mm, respectively, below the surface.

Illus. 3: View, looking W, at the disturbance in the cable trench.

- 3.6 At c.17m W of the E end of the trench the density of services was such that the cable conduit was being laid at c.450mm below pavement level. At this point the watching brief was discontinued as it was evident that no medieval levels or finds survived the modern service disturbances.
