**SALMON STATION
PORT ERROLL
CRUDEN BAY
ABERDEENSHIRE**

**- Standing Building Survey -
Carried out 21ST October 2010
by
Murray Archaeological Services Ltd**

**Report No: MAS 2010-23
by
H K Murray**

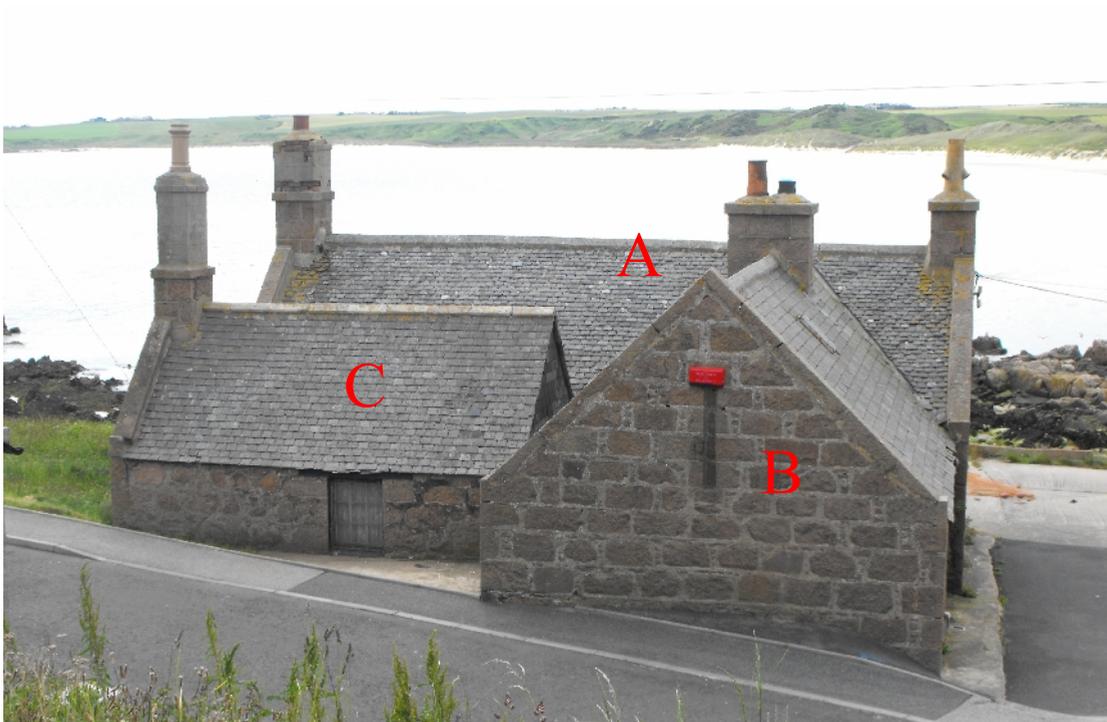
By 1868 the bothy was an L-shaped building, the longer and possibly earlier arm of the L (A) lying parallel to the shore with the shorter arm of the L (B) abutting the N end of the E wall. A third element (C), parallel to and abutting A is secondary; this used the E wall of A as an internal wall and a central door flanked by two windows had been blocked (pers comm Stephen Brown. These could not be planned as behind new cladding.)

Illus 1 The bothy - looking W from across the road

Walls The external walls of all three elements of the building are of roughly squared pink granite rubble set in very even courses with small stacked pinnings between the blocks. It was originally lime mortared.

Roof Each element has a separate pitched roof with slate cladding and ceramic ridge tiles. Both gables of structure A, the S gable of structure C and the E gable of structure C have stone skewes. Originally there were stone chimney stacks with single ceramic pots at either gable of structure A, a stone chimney stack with

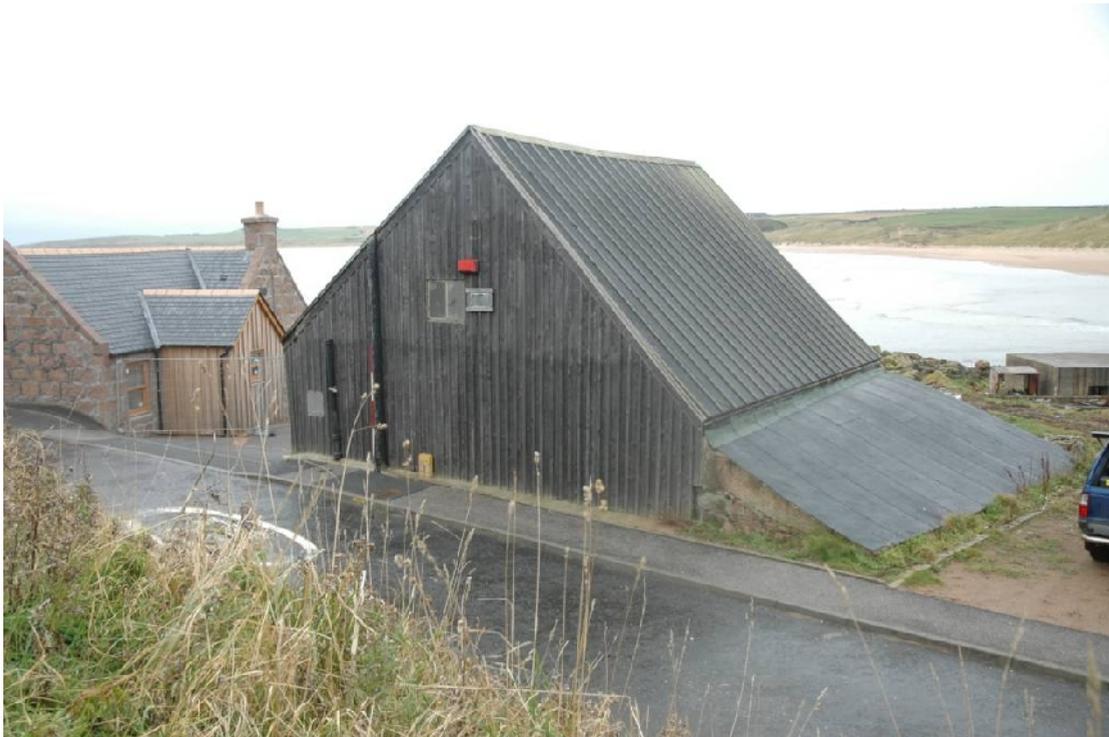
Illus 2 Workshop/store from across the road, showing extension of roof covering the roof of ice-house

Roof The roof is sarked and has tarred felt cladding which continues down over a secondary concrete cladding over the ice-house roof (Illus 2).

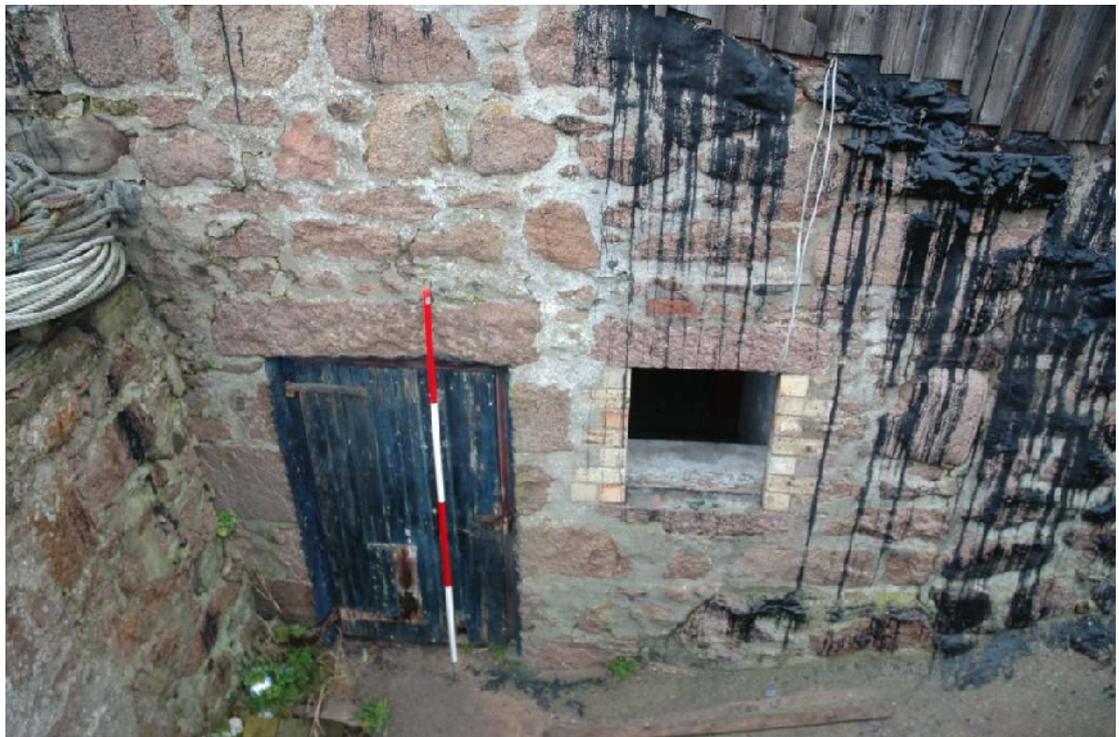
Illus 3 W wall of ice-house

Structure The W wall facing the ramp is of pink granite rubble. The size of the stones are variable and it is distinctly different from the even stonework of the bothy and also lacks the stacked pinnings; this may suggest that it was built

before the bothy or at the least built by a different person (cf illus 3 & 4). The wall is c 650mm thick with a door and a small window. The window (620 wide x 700 high) appears to have been enlarged or replaced, with some modern yellow bricks around the window opening. The sill is however original being of pink granite as is the lintel over the door. The door (1.05 wide x 1.77m high) is planked.

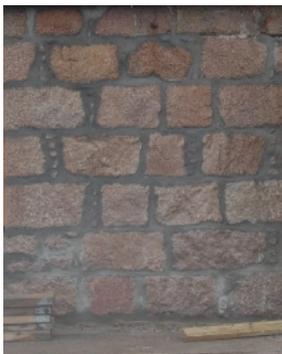
Illus 4 detail of W wall of bothy for comparison of stonework

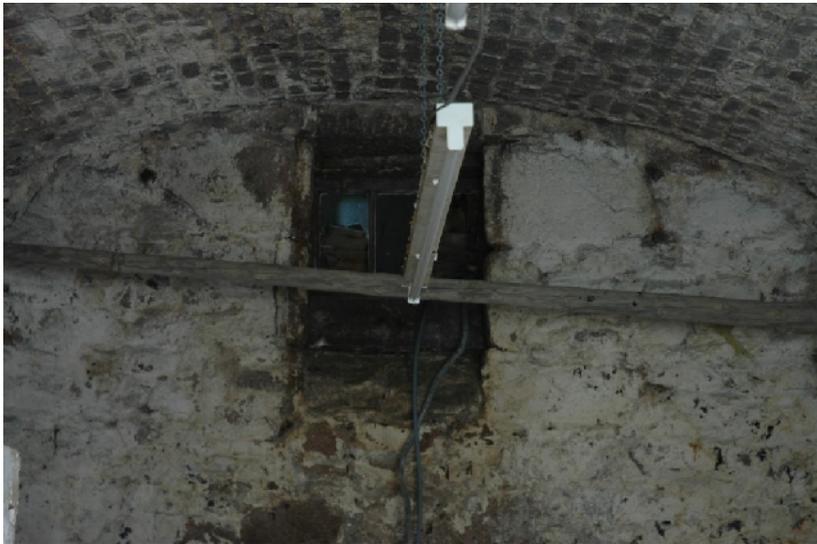
The E wall is now totally obscured on the outside, but has a single high level hatch which would have opened at ground level beside the road for ice to be tipped in from above (Illus 5).

Illus 5 Ice hatch

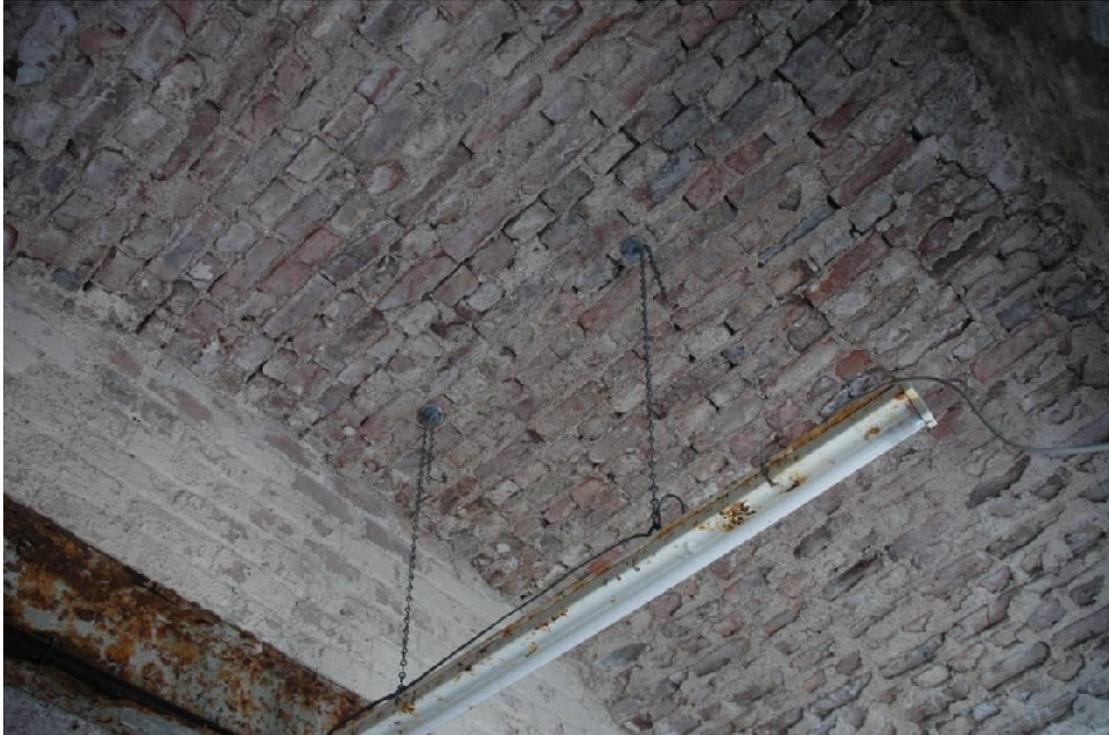
The arch of the roof is of brick with a double row of end-on (header) bricks at the centre and then alternating rows of headers and stretchers. The bricks are hand made irregular bricks orange/red in colour (Illus 6). Externally a secondary angle of concrete has been built up over the arch and the tarred felt roof of the workshop/store extended down over it.

Illus 6 Detail of brick arch of ice-house

The bricks of the ice-house are clearly hand-made early bricks. There was a brickworks in Cruden Bay from 1882 but this is clearly too late for the ice house (which certainly existed in 1868). The nearest known contemporary brickworks at Tippetty (12 miles away) was in production from c 1850 – or perhaps as likely would be the Blackpotts brickworks at Whitehills which was in production from the late 18th century and the products of which could have come by boat.

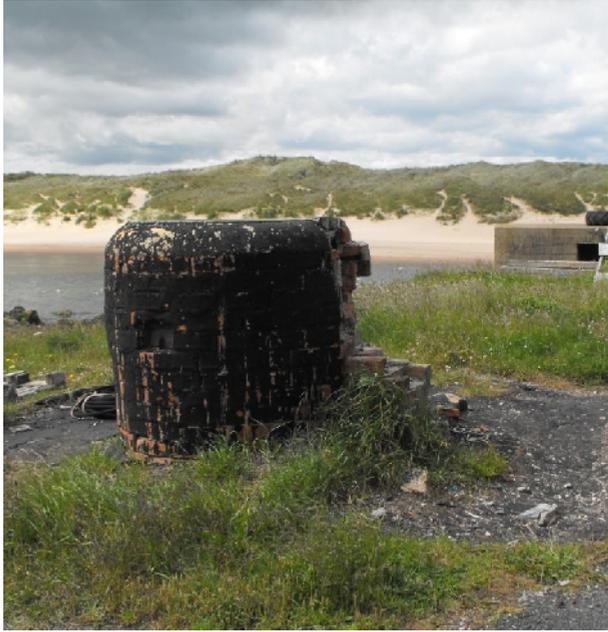
Photographs of the fishing station in the 1970s (RCAHMS John Hume Collection of Industrial Archaeological Images of Scotland. SCRAN id 000-000-187-641-C) show net drying poles and a net boiling tub with a brick chimney and a tripod and block and tackle for lifting. This tar boiler was extant until recently when it was stolen for scrap.

Illus 7 Remains of tar boiler (photograph Stephen Brown)

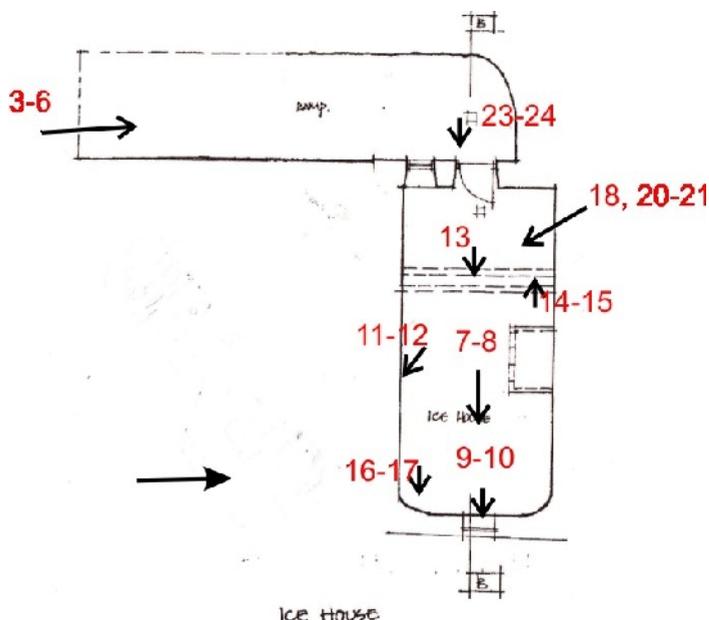
Illus 8 Key to digital photographs of ice-house

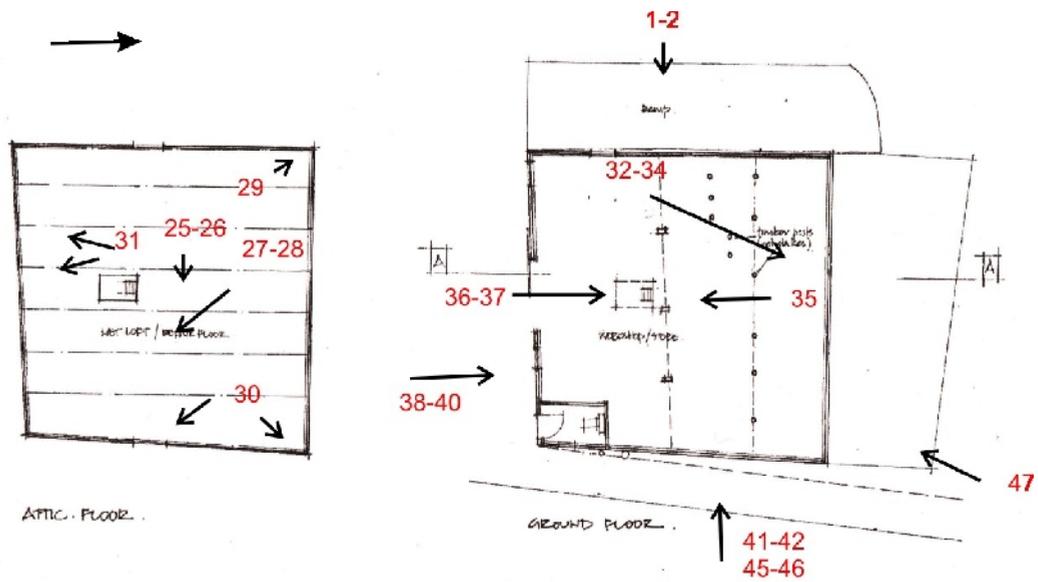
Illus 9 Key to digital photographs of workshop/store

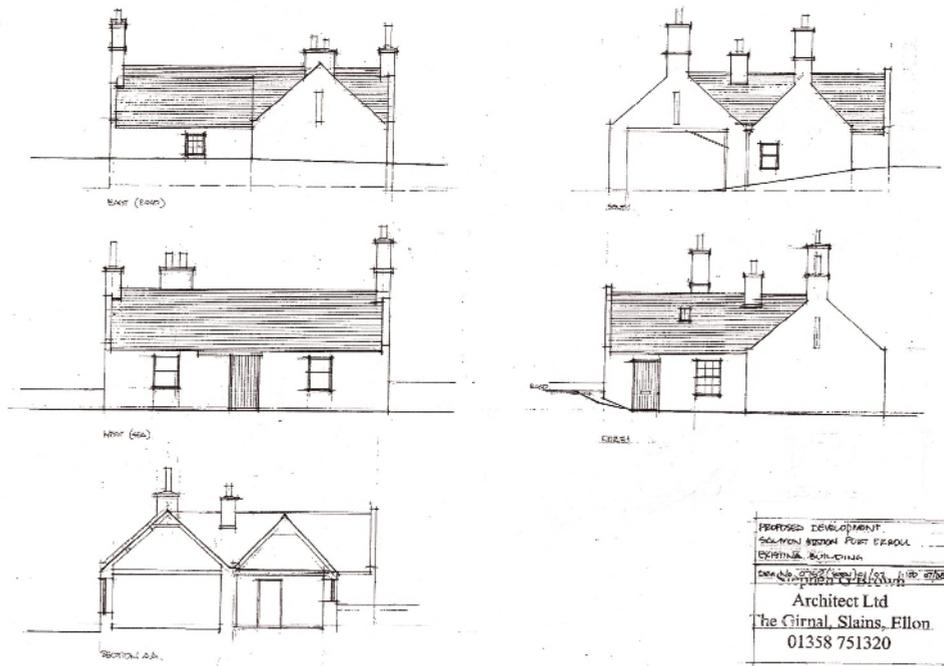
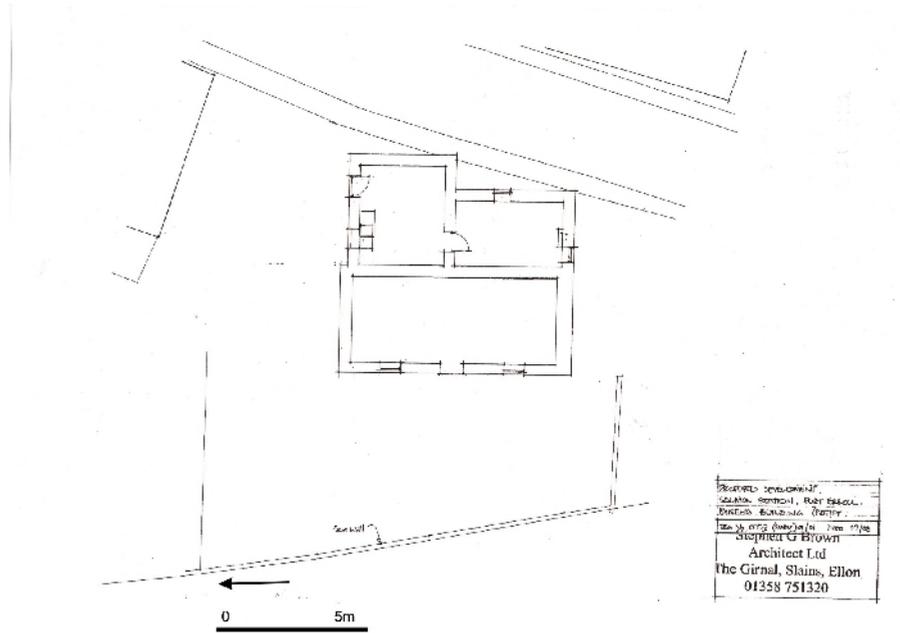
Illus 10 Elevations and plan of bothy before renovation. 2008. Courtesy of Stephen Brown

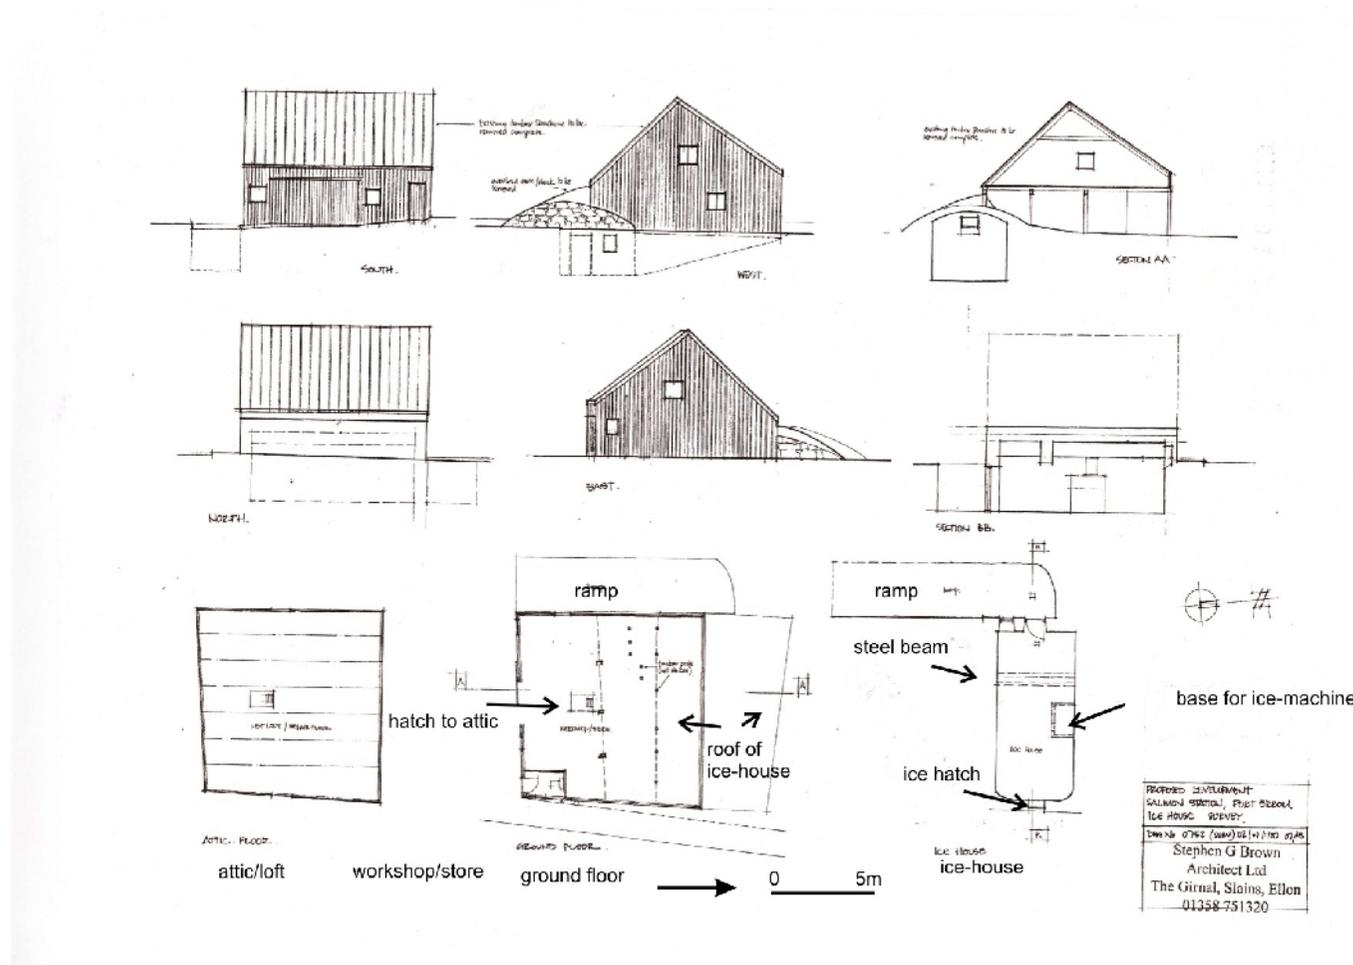
Illus 11 Plan and elevations of workshop/store/store and ice-house. 2008. Courtesy of Stephen Brown Annotated by MAS Ltd
