CASTLE FRASER COURTYARD CLUNY

REPAVING PROJECT 2011

- Archaeological Excavation -
Carried out 14th-18th March 2011
by
Murray Archaeological Services Ltd

Report No: MAS 2010-3
by
H K Murray and J C Murray

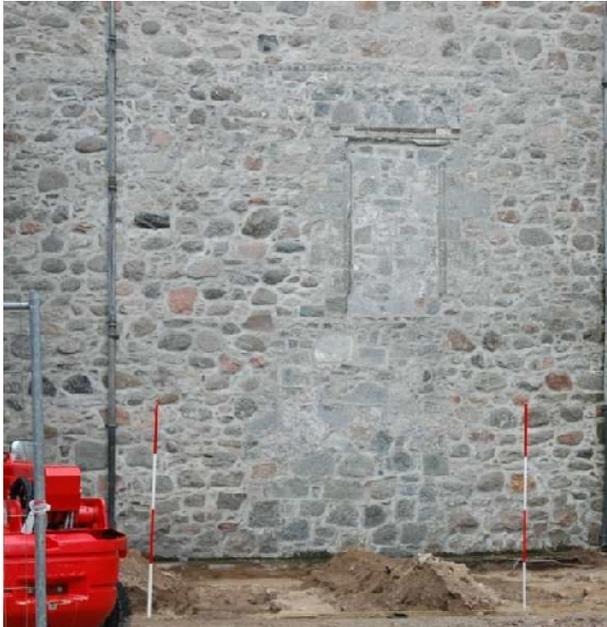
Illus 2 North wall of the castle showing the blocked first floor entrance which related to the stairs shown on 1788 plan

1788 The earliest estate plan of Castle Fraser dating to 1788 shows a central staircase leading up to the now blocked first floor entry in the north wall of the castle which seems to have formed part of major modifications to the building c1615-35.

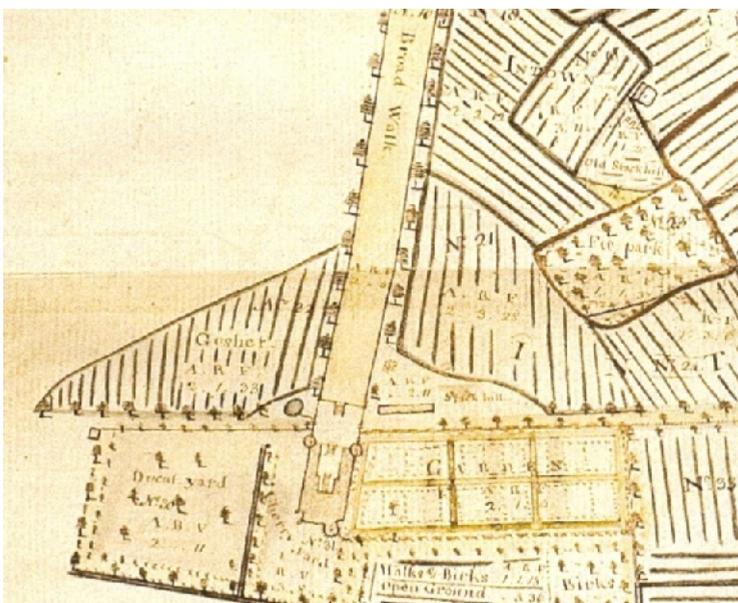
Illus 3 Detail of 1788 plan. Courtesy of Aberdeen University Library

The line of the stair is framed by the 17th century east and west wings and is the focus of the Broad Walk leading towards the castle. This stair is shown extending just beyond the north end of the original stable and kitchen blocks; this would coincide with the northern limit of the paving.

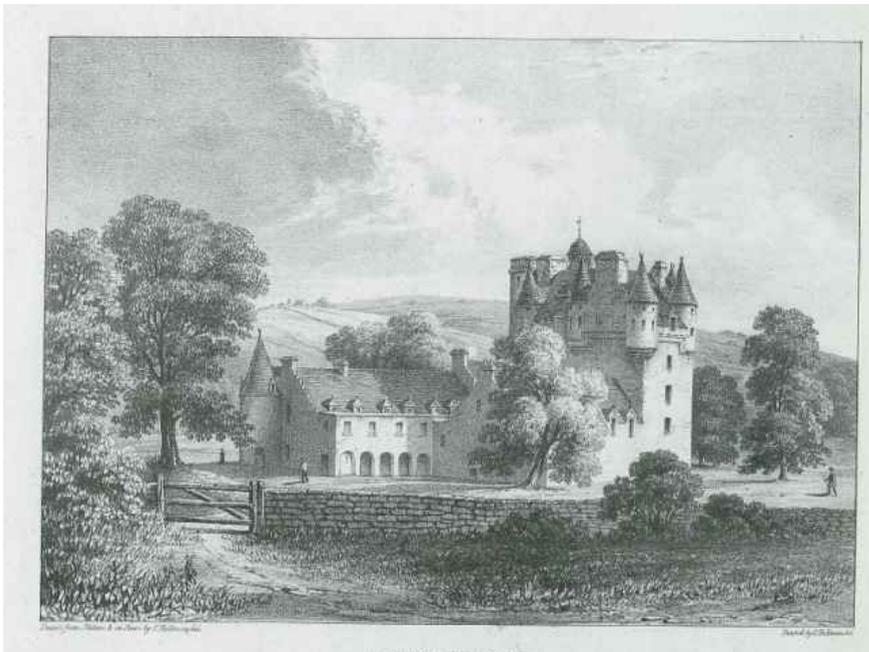
Illus 4 Castle Fraser from north early 1820s by C J Hullmandel

Early 1820s A lithograph of the castle from the north by C. J. Hullmandel shows the castle after the main entrance has been moved to the south face of the castle and a two-storied building which housed the internal stair to the first floor has replaced the external northern stair. This clearly shows the central block with a flat roof and a cupola; it has a crescent-shaped window at ground floor level and a large window with three lights at first floor level. This central block is flanked by archways at ground floor level giving access to the ground floor and at first floor level a landing or passage with a small rectangular window; this is shown clearly on the eastern side but is somewhat masked by shadow on the western side.

A painting probably of the early 1820s by C J Hullmandel shows that to the E and W there were arched passageways at ground level with the first floor extending over them; mortared block 17 may be the base of the E side of the W arch (illus 17); the equivalent area of the E arch was not excavated. It should be noted that the W passage was only c 1.5m wide internally, whereas the E passage was c 2.25m wide. This asymmetry can be seen on the 1923 plan (illus 12).

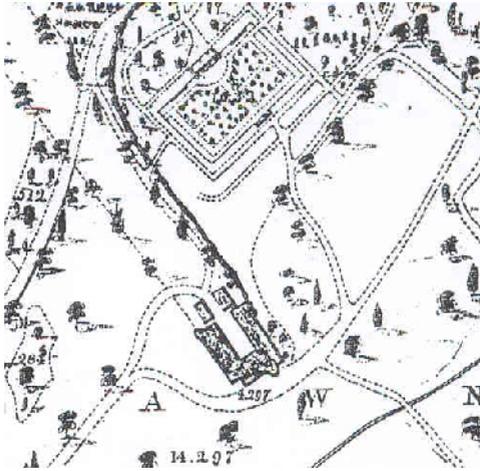
Illus 5 Detail from estate plan of 1816/1846, possibly c 1830

The lodges are clearly shown on an estate map variously dated between 1816 and 1846 and which may be the plan referred to in the accounts for 1830.

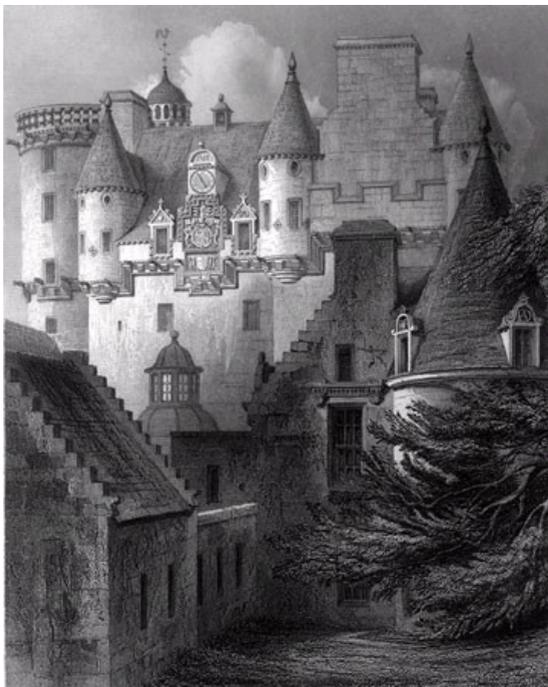
Illus 6 NTS Archive (1852) R W Billing (Redaway Engraver)

1852 An engraving by R W Billing of 1852 shows the cupola from the north-west but adds no additional structural detail. A James Giles painting (NLS:GB233/MS.20346) confirms the detail of the central block but the side wings are obscured by the lodges.

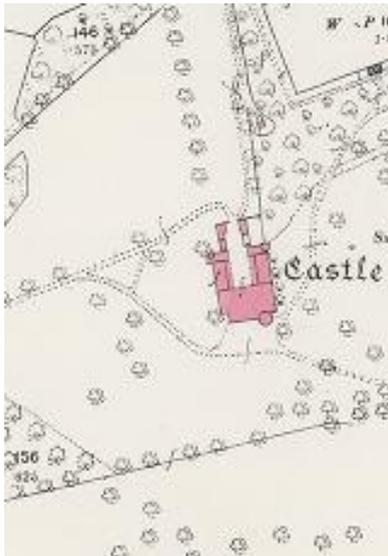
Illus 7 Detail from 1st edition Ordnance Survey map surveyed 1864-7, published 1869

1864-7 The 1st edition Ordnance survey map surveyed in 1864-7, published in 1869 is shows the arcades clearly and shows new structures between the lodges and the wings and arcades. However the small western turret of the stair block has not been added by this stage.

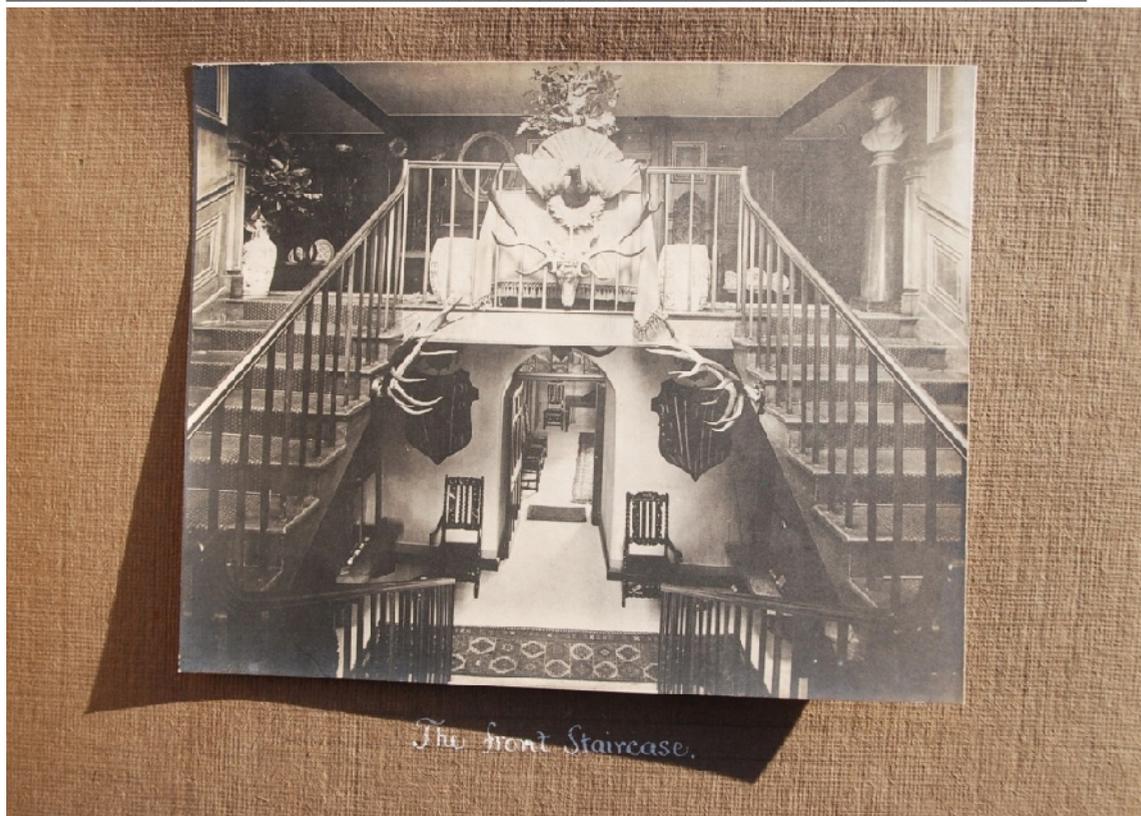
Illus 10 Castle Fraser internal view looking south 1920s NTS archive

An interior view of the same date, taken from the landing of the late 18th century stair looking south, shows the corner of the blocked 17th century first floor entrance into the hall. At ground floor level it shows the doorway into the laigh hall

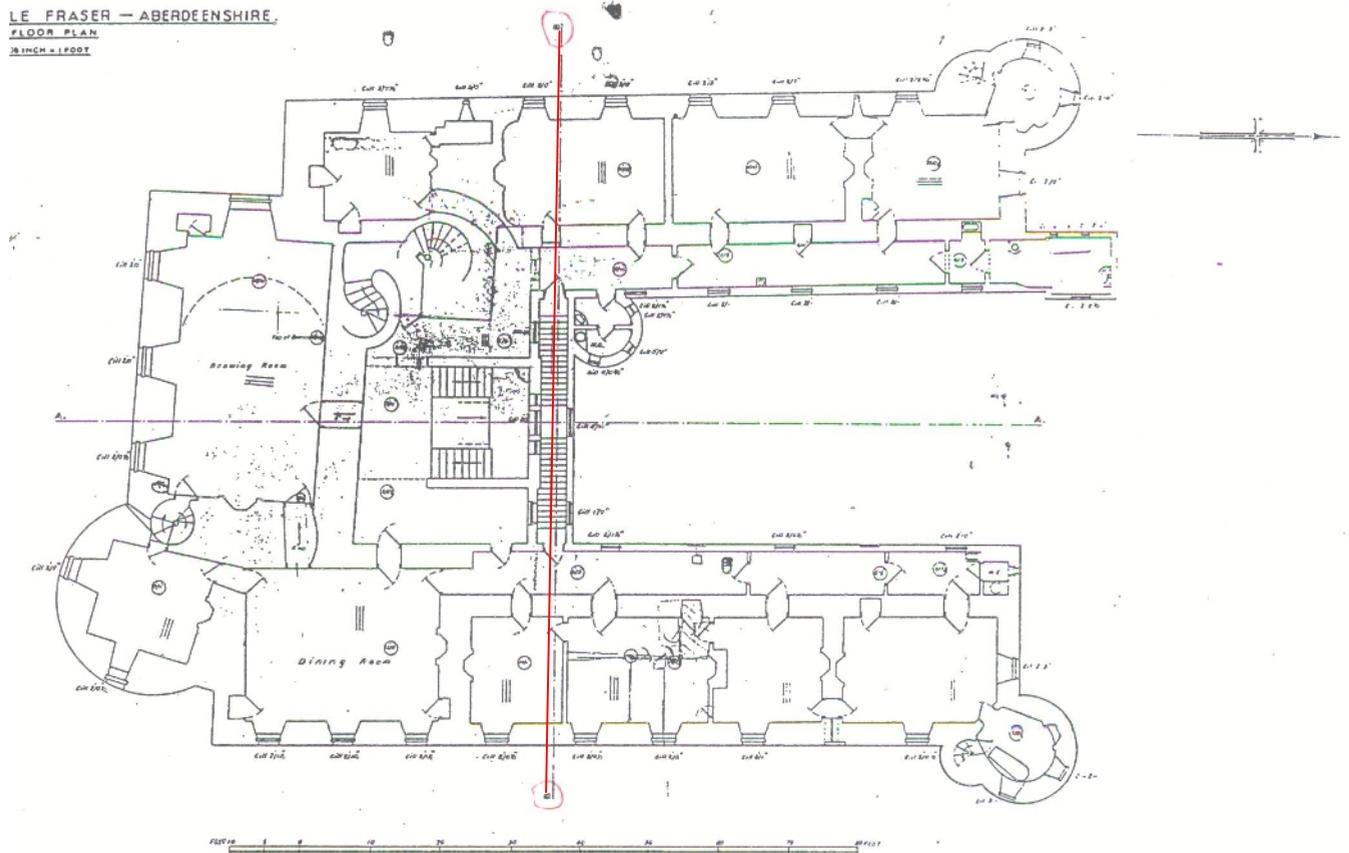
**Illus 13 Castle Fraser first floor plan (Red emphasises the line B-B of the section in illus 11)
(copyright RCAHMS)**

1923 Plans and elevations of the castle in RCAHMS (ABD 18/13) by Robert Lorimer. The elevation is slightly confusing as it is in part elevation but also a section through the east and west wings of the castle and through the outer stairway, between the north wall of the stairway and the north wall of the original stairway block. This gives a detailed view of the structure that is shown in the 1920s photographs and as it appears to have been after the changes that took place c.1864-1880. At ground floor level in the original stair block the crescent window has been replaced by a doorway and at first floor level the central window with three lights and the flanking single windows remain. The secondary outer stair and new external north wall are drawn. This outer wall is shown on the first floor plan as having a central window with a single light, a narrower window to the east and the small turret to the west. Stairways run up to the east and west from either side of the central doorway into the original stair block, giving access to the rooms

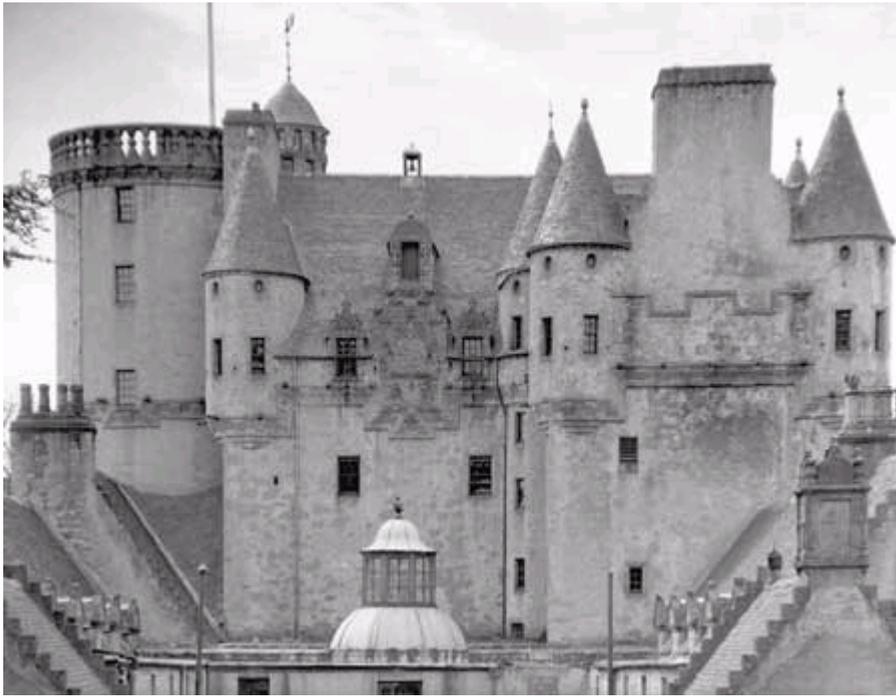
Illus 14 RCAHMS 1942 (copyright RCAHMS)

c1942 A RCAHMS photograph of c 1942 shows the cupola and the central first floor window of the outer stairway but the western turret has been removed (This date is given to the photograph in SCRAN Scran ref:000-000-596-241-C RCAHMS ref: AB/1328 and digital ref SC802386)

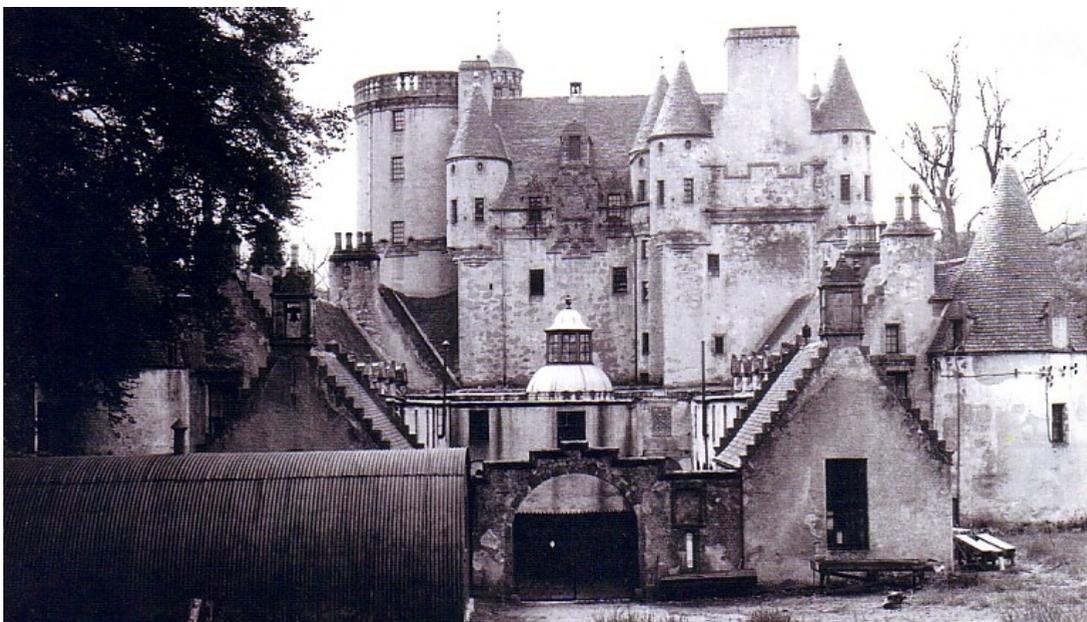
Illus 15 Castle Fraser from the north. *c 1948* NTS archive

c 1948 A photograph of *c 1948* showing the WW2 Nissen hut outside the courtyard gives a clearer view showing the cupola and central window of the outer stairway. The first floor window on the eastern side is visible. The western first floor window is shown blocked and the small turret removed.

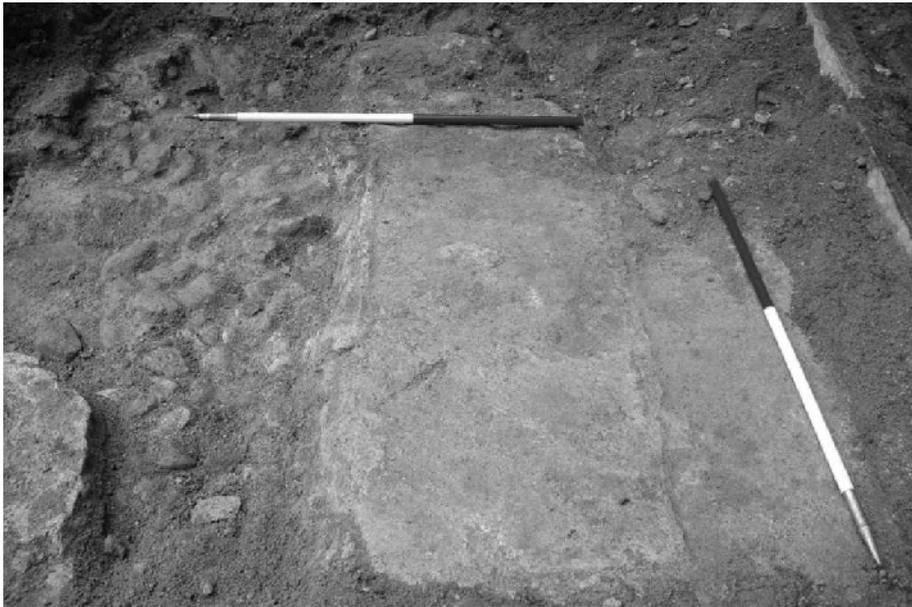
Illus 16 Mortar layer 8 with slab impressions

In the central area between walls 9 and 11, the rubble lay over a compact mortar surface which had the outlines of large rectangular stone flags (illus 16); it is suggested that the paving (1) being replaced in 2011 had been taken off this mortar bedding and that it had formerly been used as the flooring at ground floor level within the earlier phase of the stair block.

The mortar (8) layer lay over a very rough pebbly layer (12); this was originally thought to be an earlier cobbled surface but it was very rough and it may simply have been sub-base for the mortar.

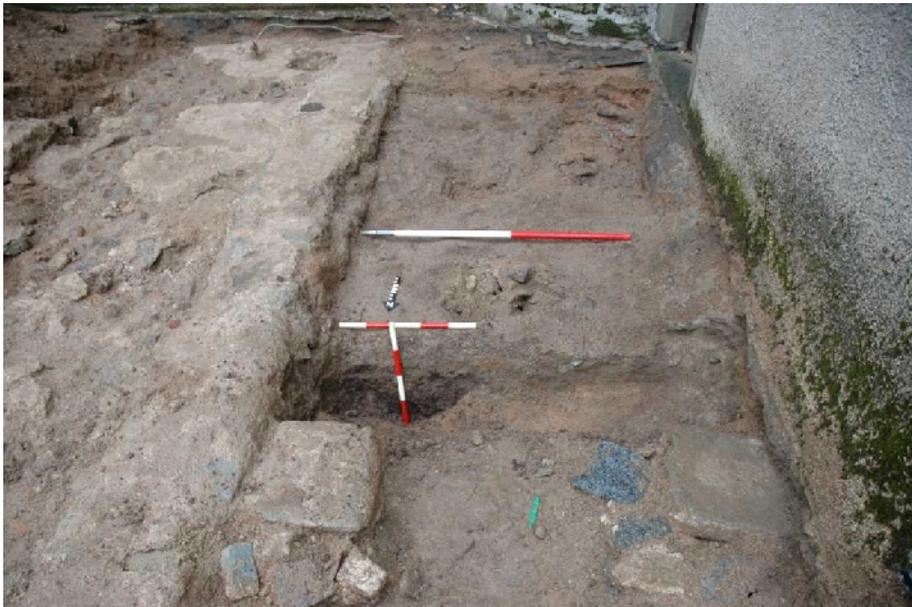
Illus 17 Wall 9 and arch block 17 looking S

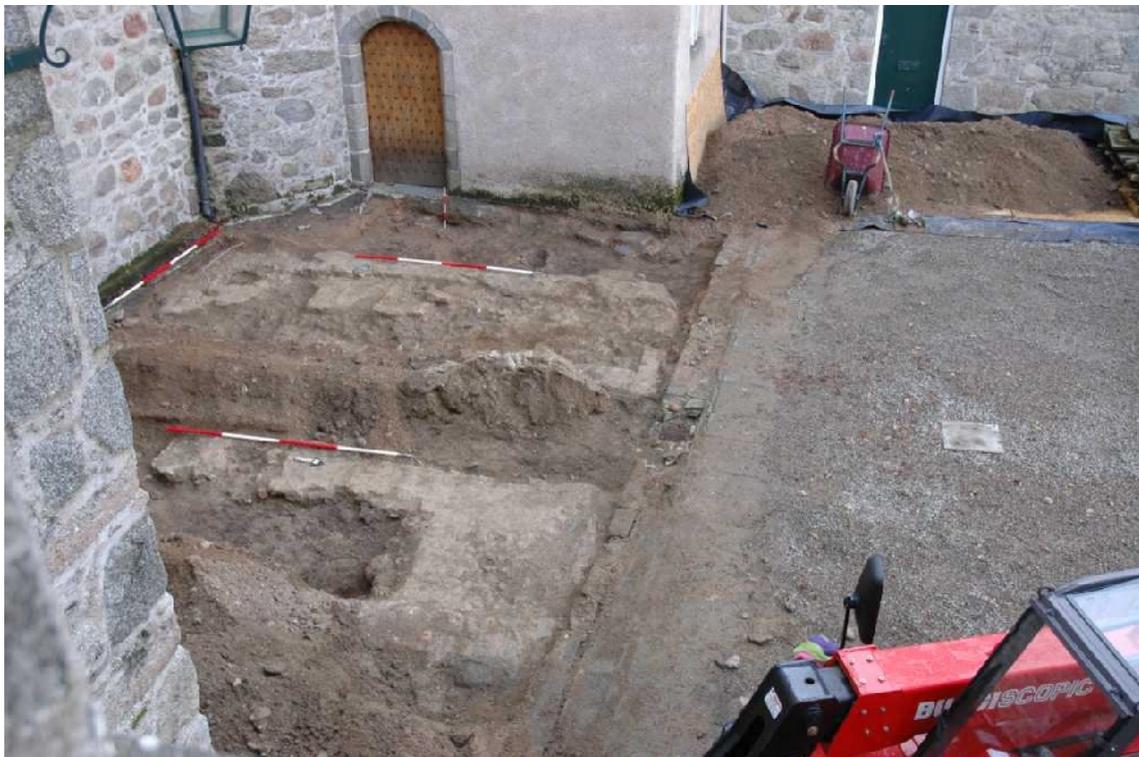
Illus 18 Looking SW from first floor office, showing walls 9,10,11,13 and mortar surface 8

The two thicker walls (9 and 11) were both at right angles to the N wall of the castle and enclosed an area 4.75m wide (E/W) and 5.5m N/S up to the face of the only E/W wall (13). These appear to be the foundations of the main block that held the rotunda.

The E/W wall 13, which is truncated on the N side by the drain, is interpreted as the front wall of the first phase of the new internal stair. Later, when the stairs to the rooms on the first floors of the wings were added, this became an internal wall and a central door was broken through.

The third, narrower N/S wall (illus 19: 10) and traces of stonework observed on the E side of the cable trench in 2004 (illus 23: context 22) appear to extend only c 3.4m S from the inner face of wall 13. These are interpreted as the bases for the flight of stairs leading from the castle S entrance (Laigh Hall) to the first landing.

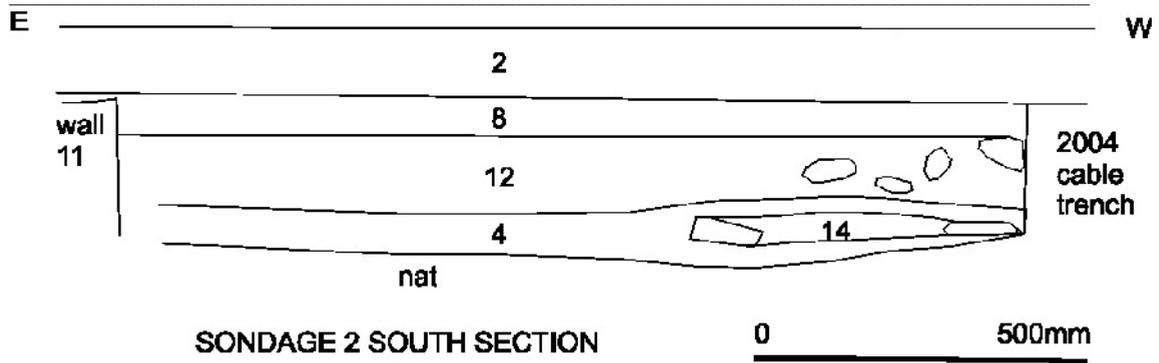
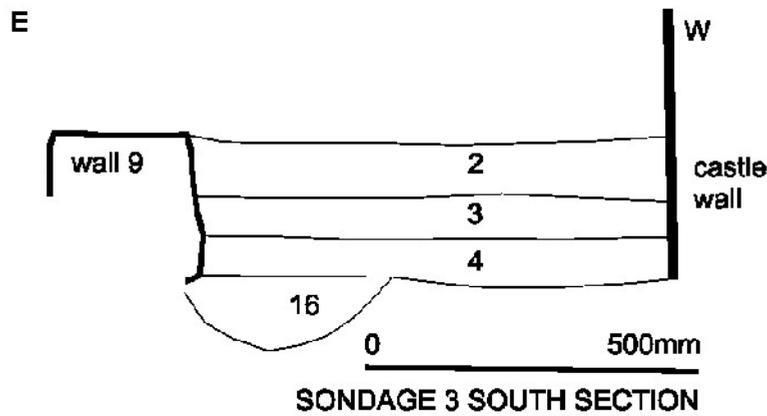
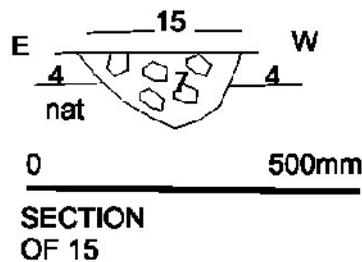
Illus 20 Sections of sondages 2 and 3 and context 15

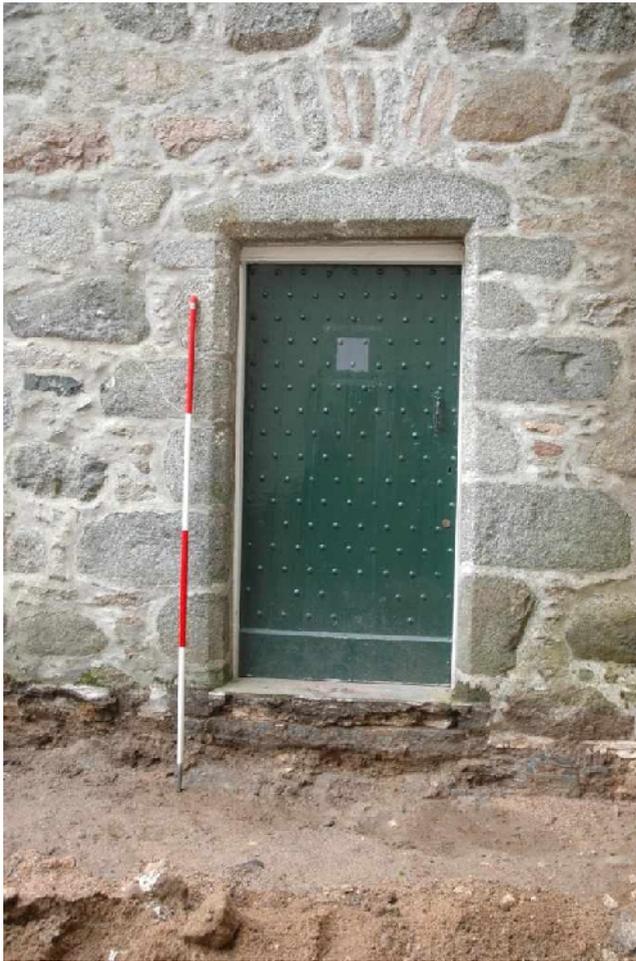
Illus 21 Kitchen door showing earlier threshold below present threshold

The excavation also revealed that doorway of the present kitchen and possible original stable was originally slightly taller as the present threshold is a replacement some 140-150mm above the top of the earlier threshold (Illus 21, 22). The original door height was 2.10m.

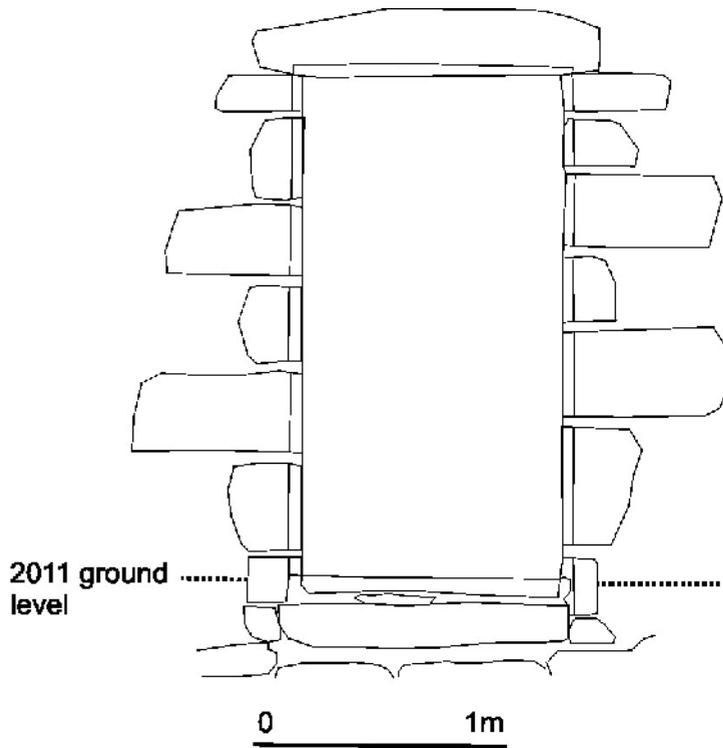
Illus 22 Elevation of kitchen doorway

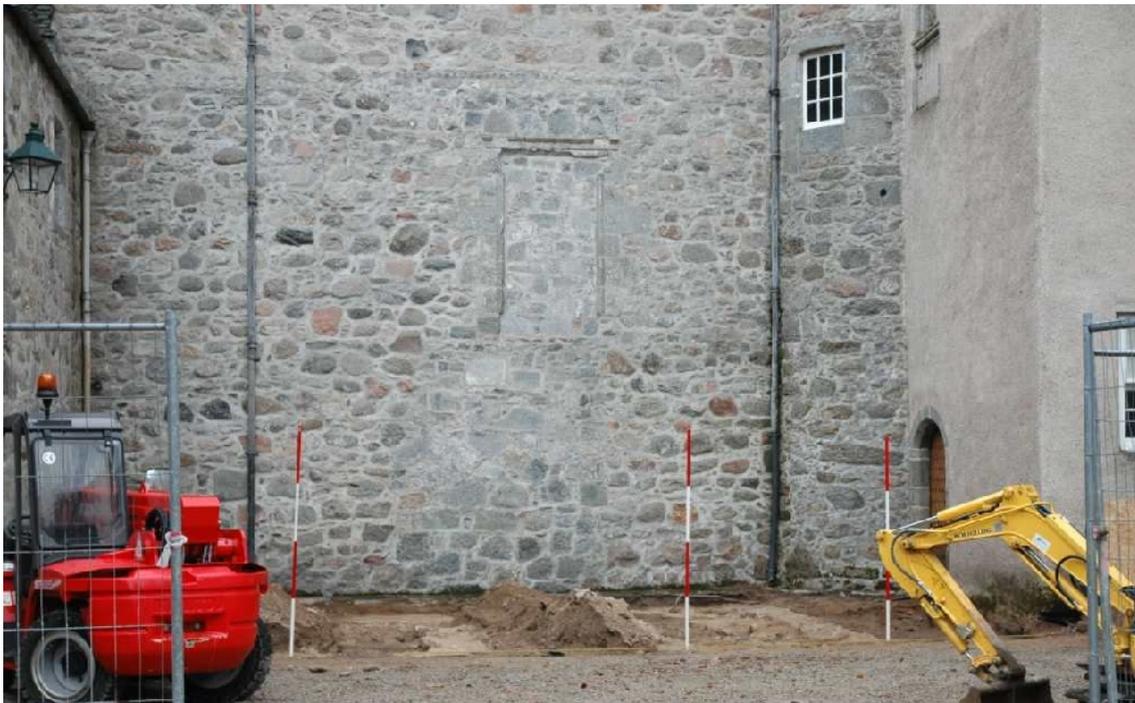
Illus 23 Excavation in relation to blocked doorways in N wall of castle. Ranging rods indicate position of walls 9, 10, 11 (R to L)

The excavation revealed and confirmed much of the ground plan of the late 18th and 19th century stair block which had been removed in the mid 20th century. There is no positive evidence of the 17th- century stair but it should be noted that the asymmetry of the late 18th and 19th century plan places the wall 10 and the possible wall 2004 context 22 in line with the sides of the now blocked 17th- century first floor entrance in the north wall of the castle; it is possible but not provable that some of the fabric of these walls dates to the 17th-century stair.

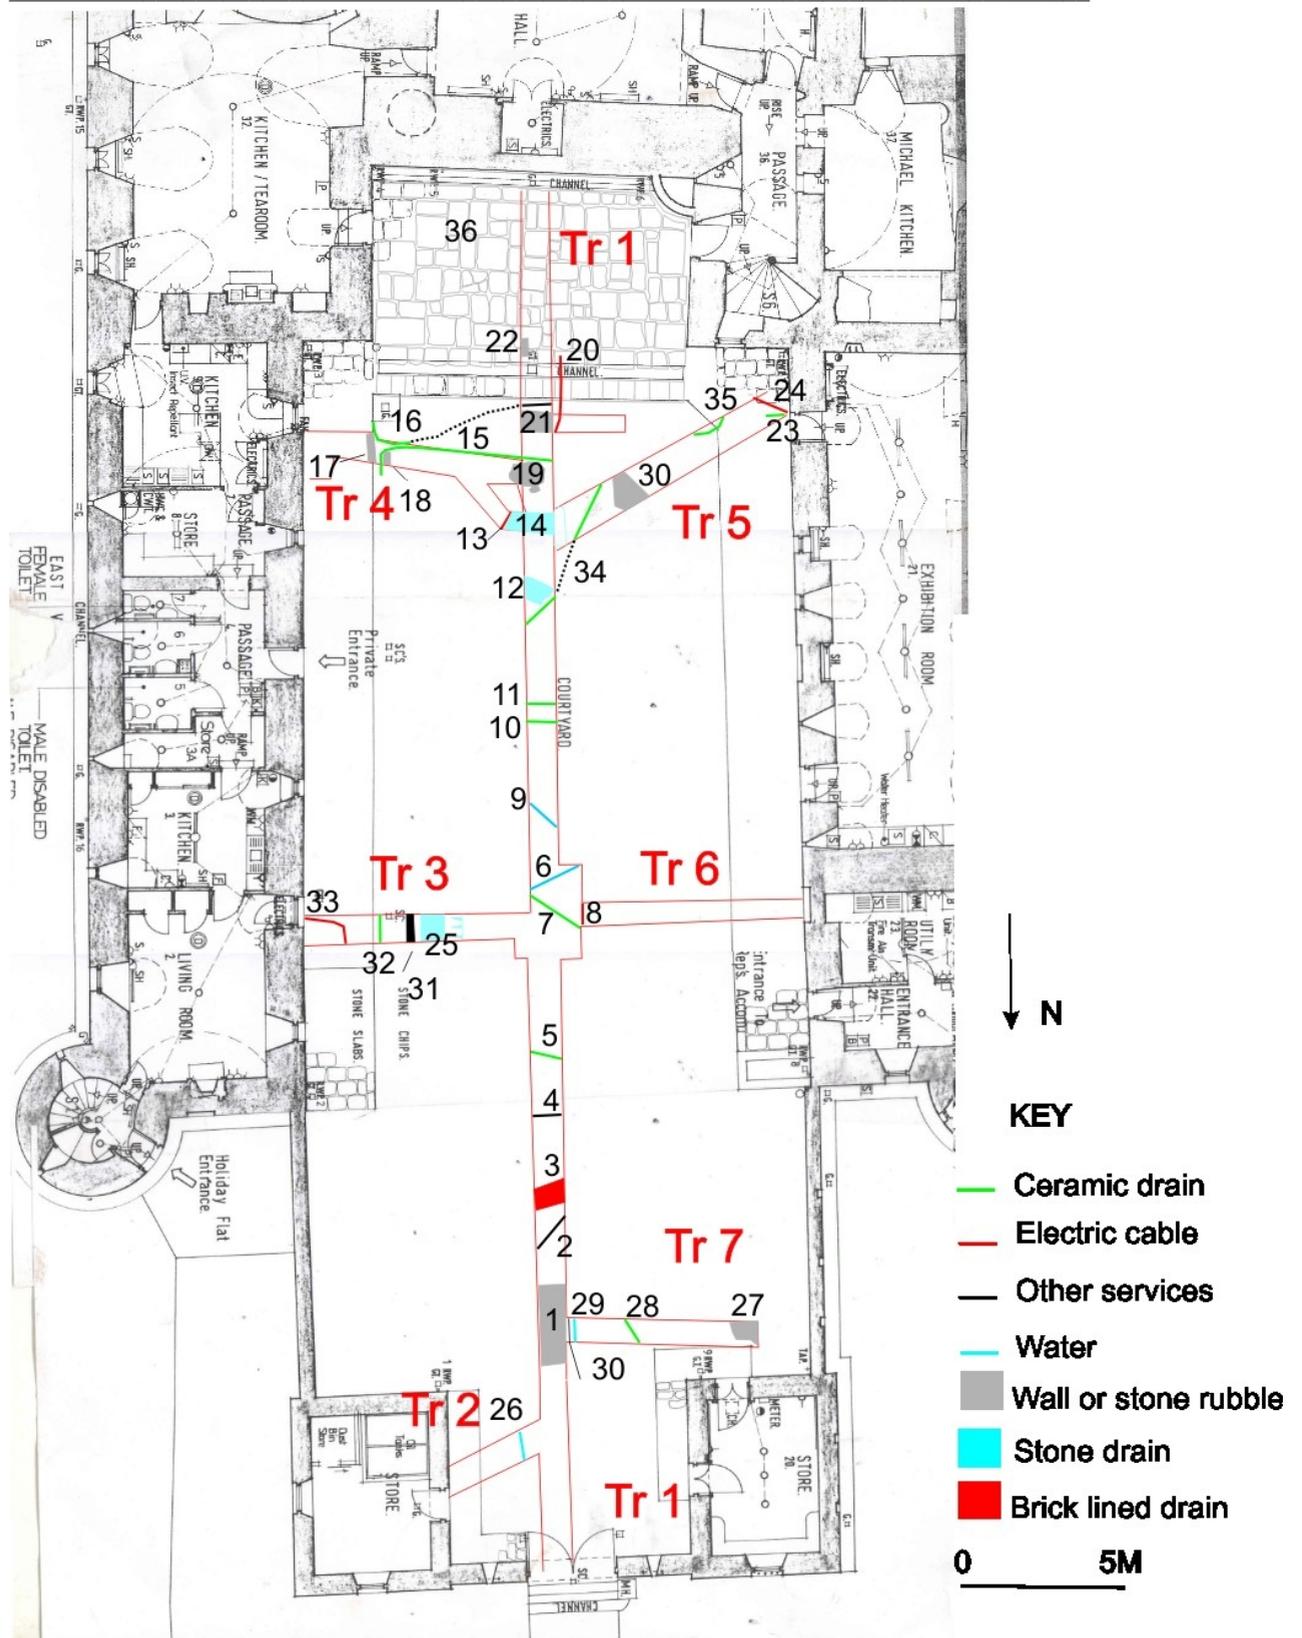
Illus 24 2004 plan showing paving removed in 2011

- 1.3 In January 2004 archaeological observation of the narrow cable trench N/S across the paving during the re-wiring project revealed that an existing N/S drain had cut through a substantial mortared stone foundation (Illus 24: context 22) c 900mm wide at a point c 5m from the face of the north wall of the hall; it was considered possible that this was part of the stair foundation. The top of the foundation was 150-200mm below the paving.

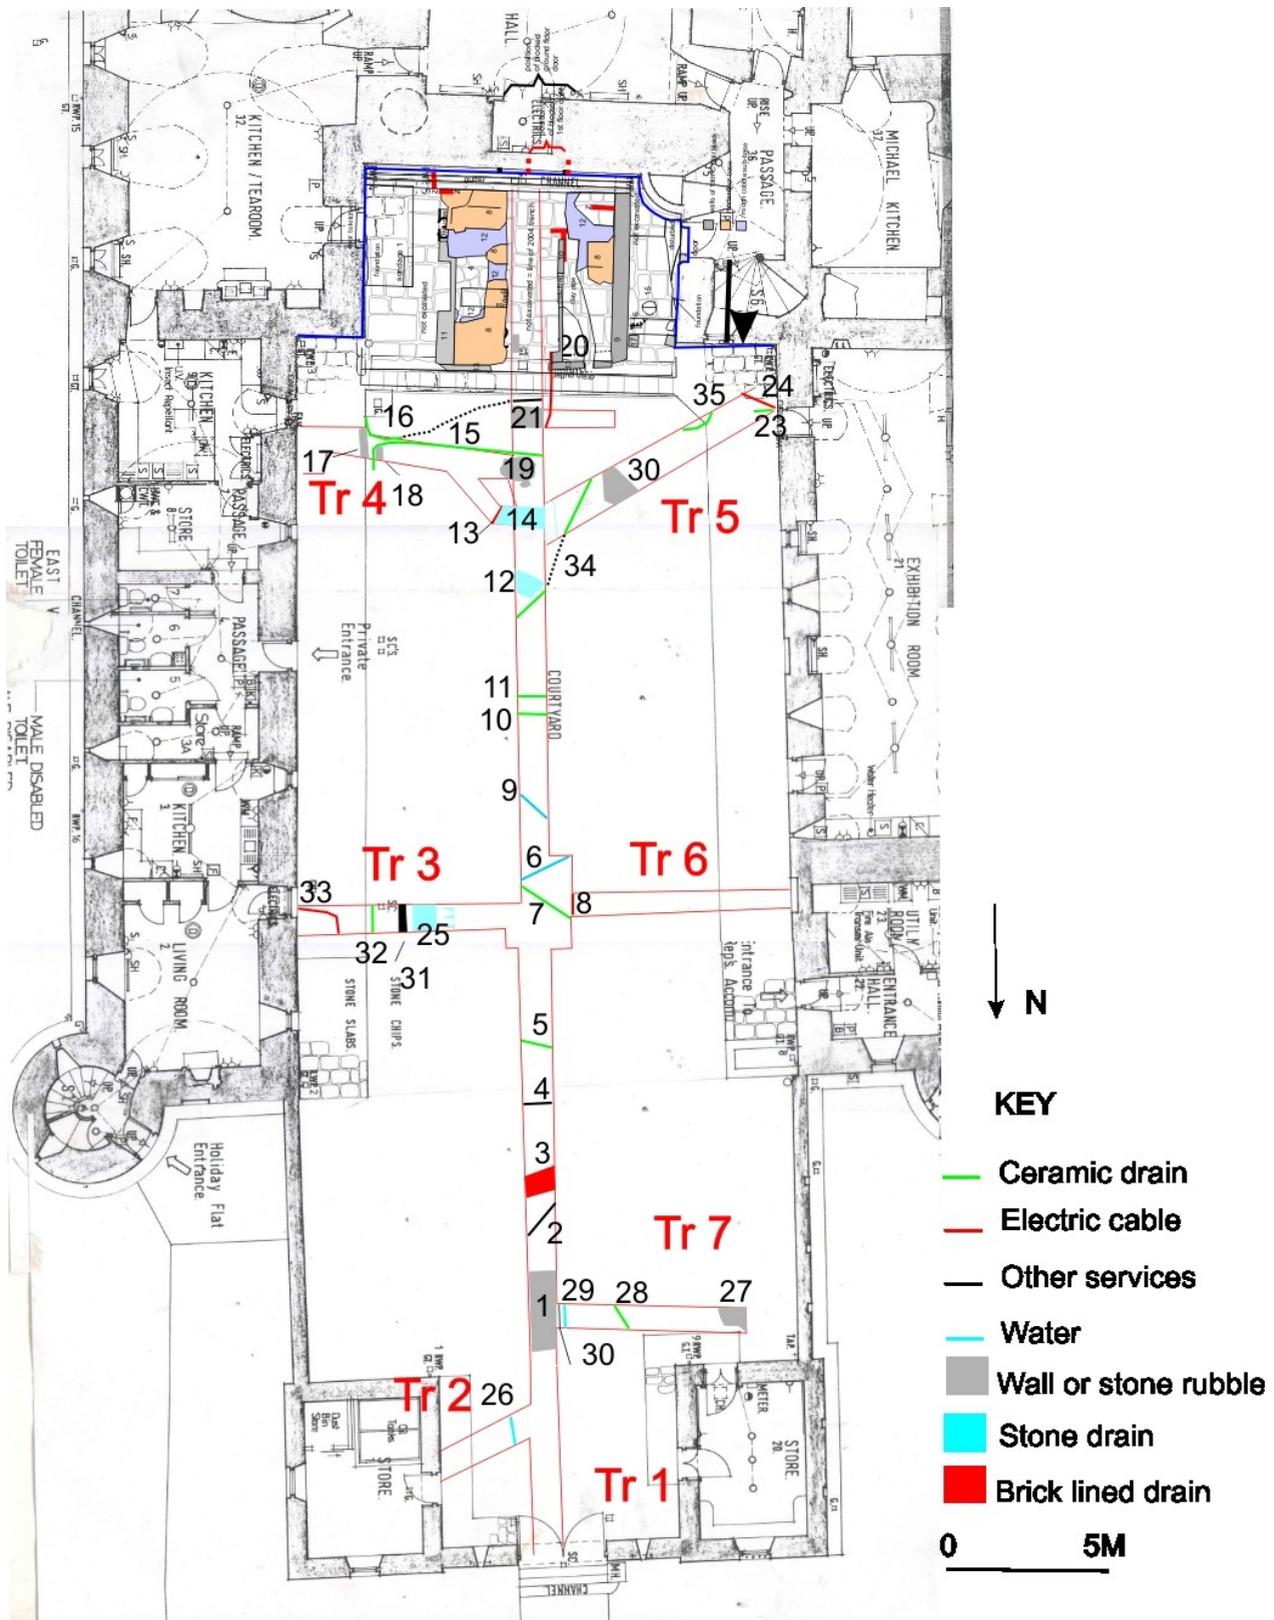
Illus 25 2004 plan with 2011 plan superimposed

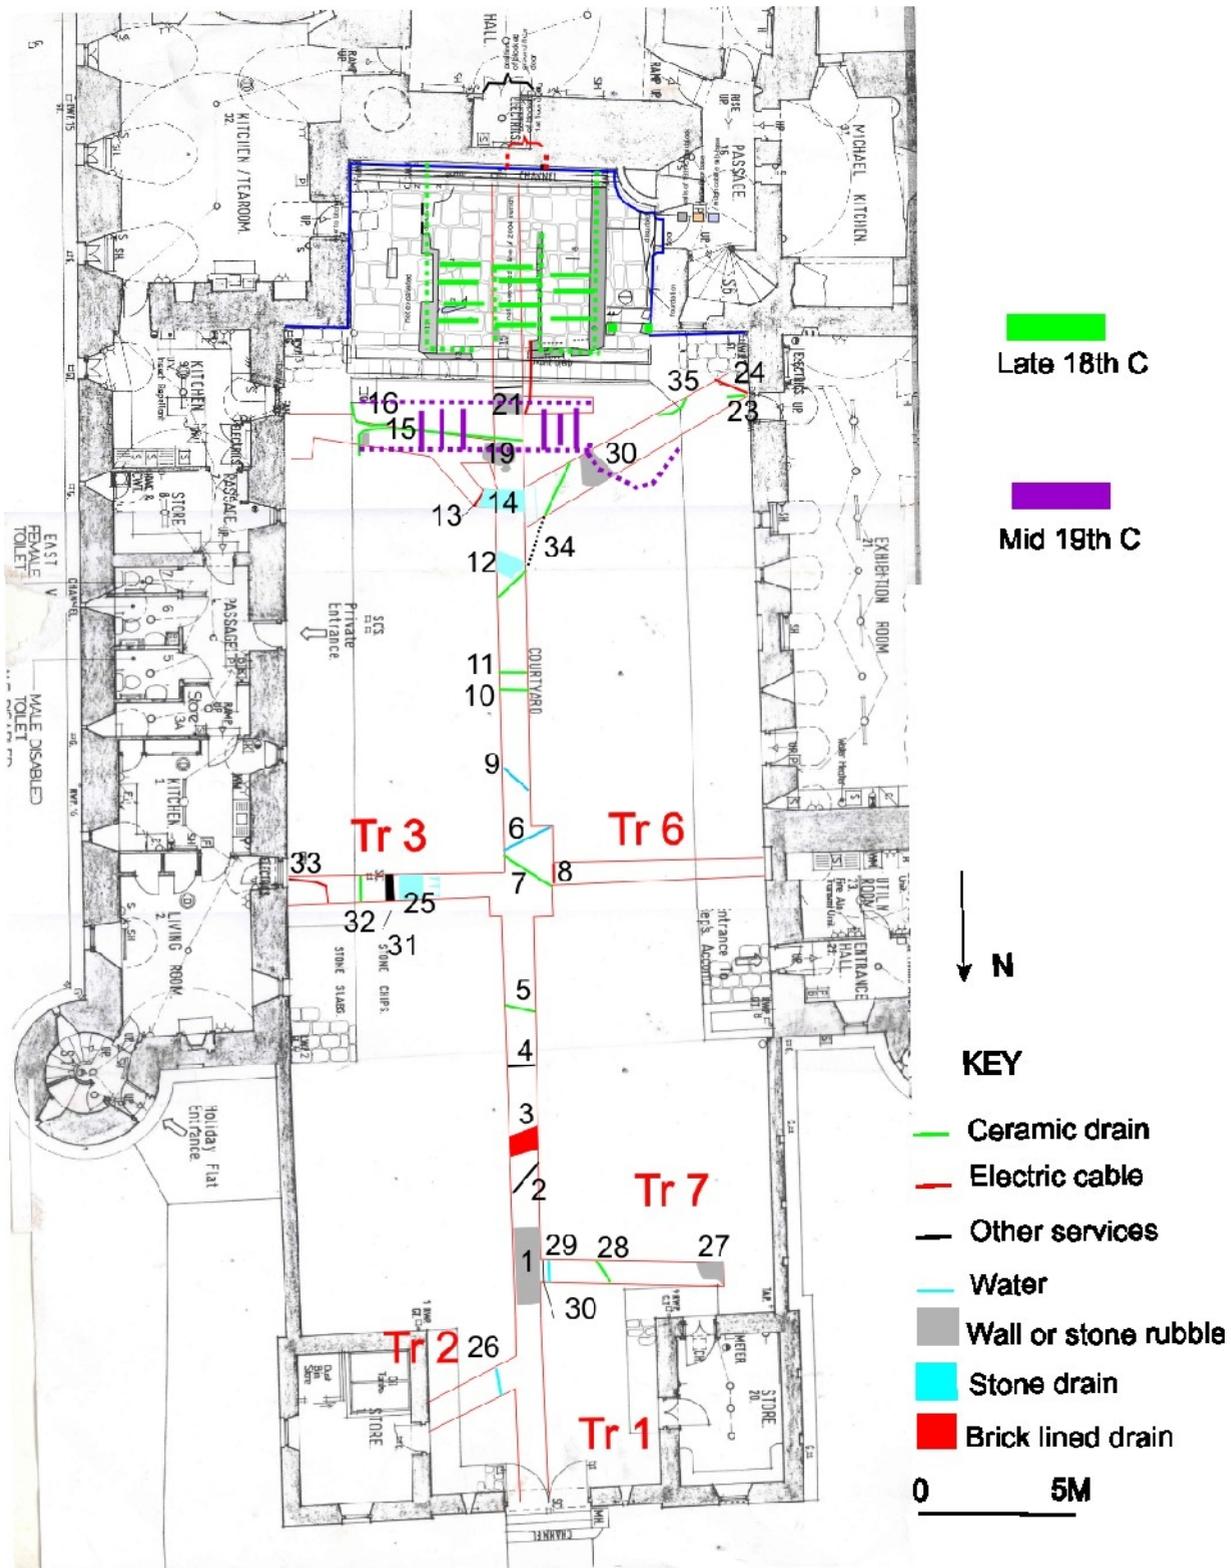
Illus 26 Detail of 2004 and 2011 plans with interpretation of traces of 18th and 19th-century struct

The 2011 excavation did not extend N beyond wall 13 into the footprint of the second phase of the works in the mid 19th century which comprised internal stairs to the E and W wings. However the 2004 observation of the cable trench revealed wall traces (Illus 24: 21, possibly 19, Illus 26) which may have been remnants of the N wall of this later
