Phoenix Art Centre
Harelaw
County Durham
NZ 416142 552836

Archaeological Building Recording
for
Anderson and Metcalf

084-14-HS | January 2014

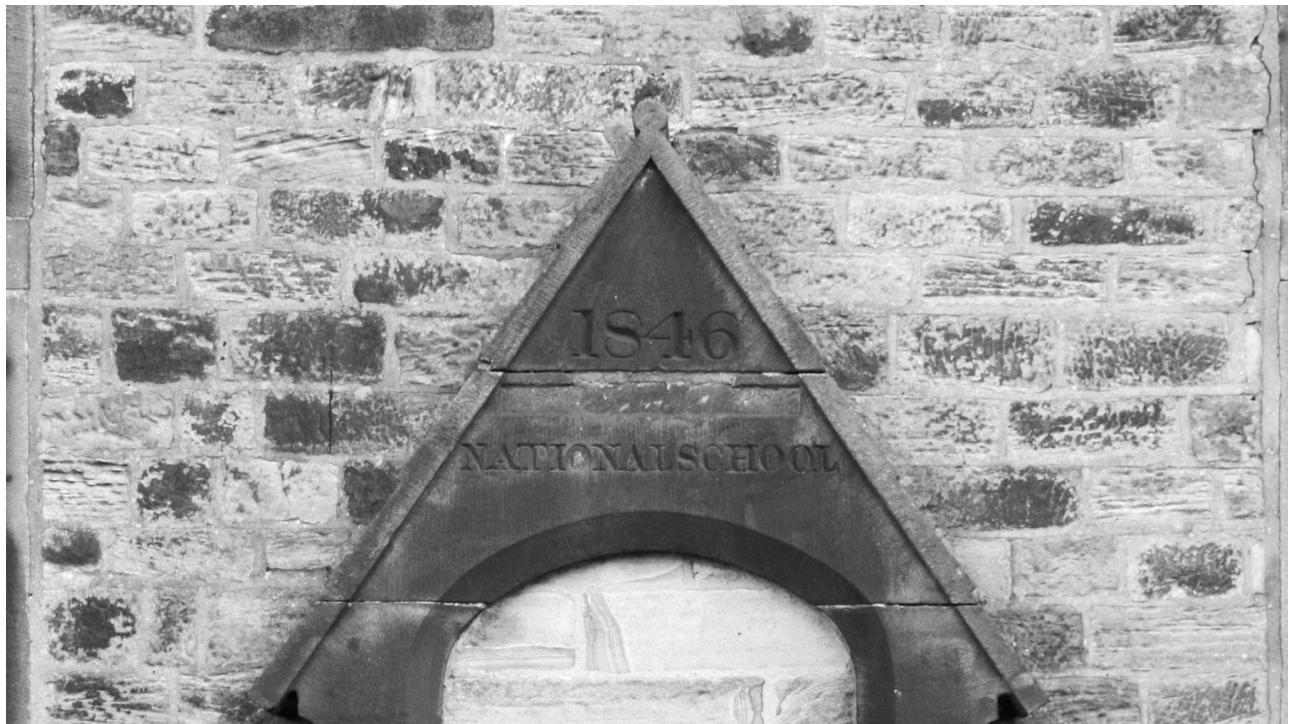
Plate 1. The inscription over the door of the school (frame PAH14003)

- 2.1.2 In 1846, Dorothea Clayton donated a large area of land to the Church of England. The Church's National Society for Promoting Religious Education then constructed Collierley National School (the focus of this development scheme) in 1846. The architect was George Walton. The inscription over the original eastern porchway reads '1846 NATIONAL SCHOOL' and can be seen on the plate below:

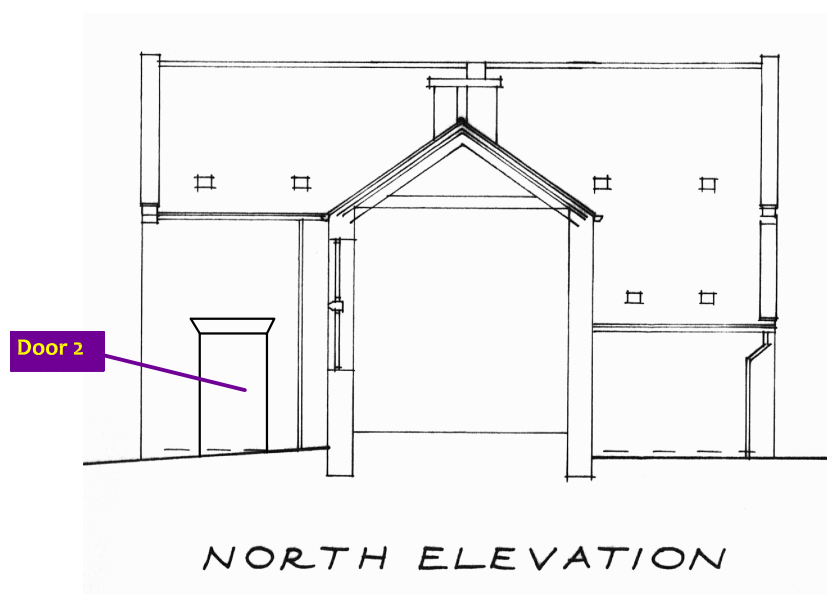
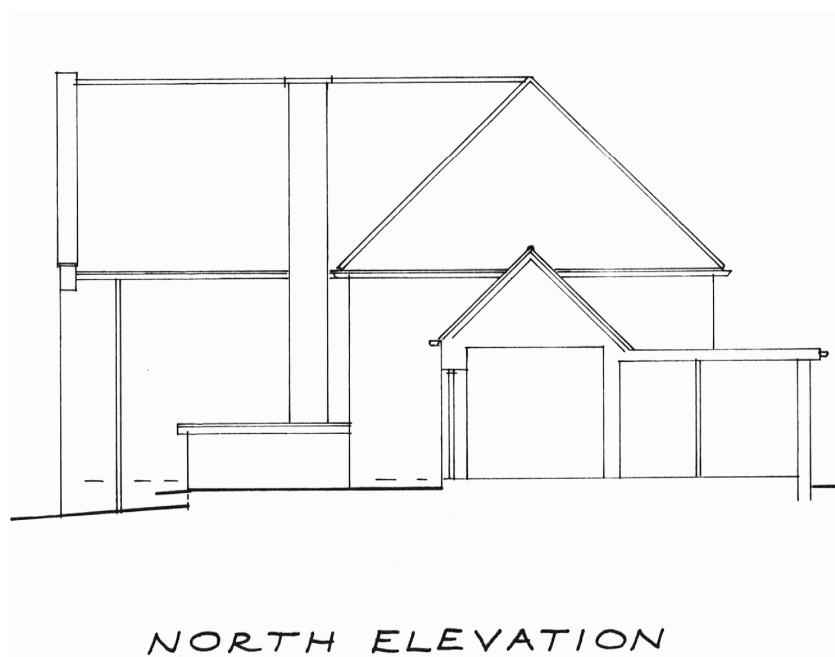
Figure 9. Elevations 2 and 3 - northern elevations

- 3.2.4 The master's house is attached to the original schoolroom, a projecting double-height cross wing. The northern elevation of the projection (Figure 9) holds the blocked original boys' entrance (Door 2) to the schoolroom, blocked with coursed sandstone and marked by the door's original wedge lintel still *in-situ*.

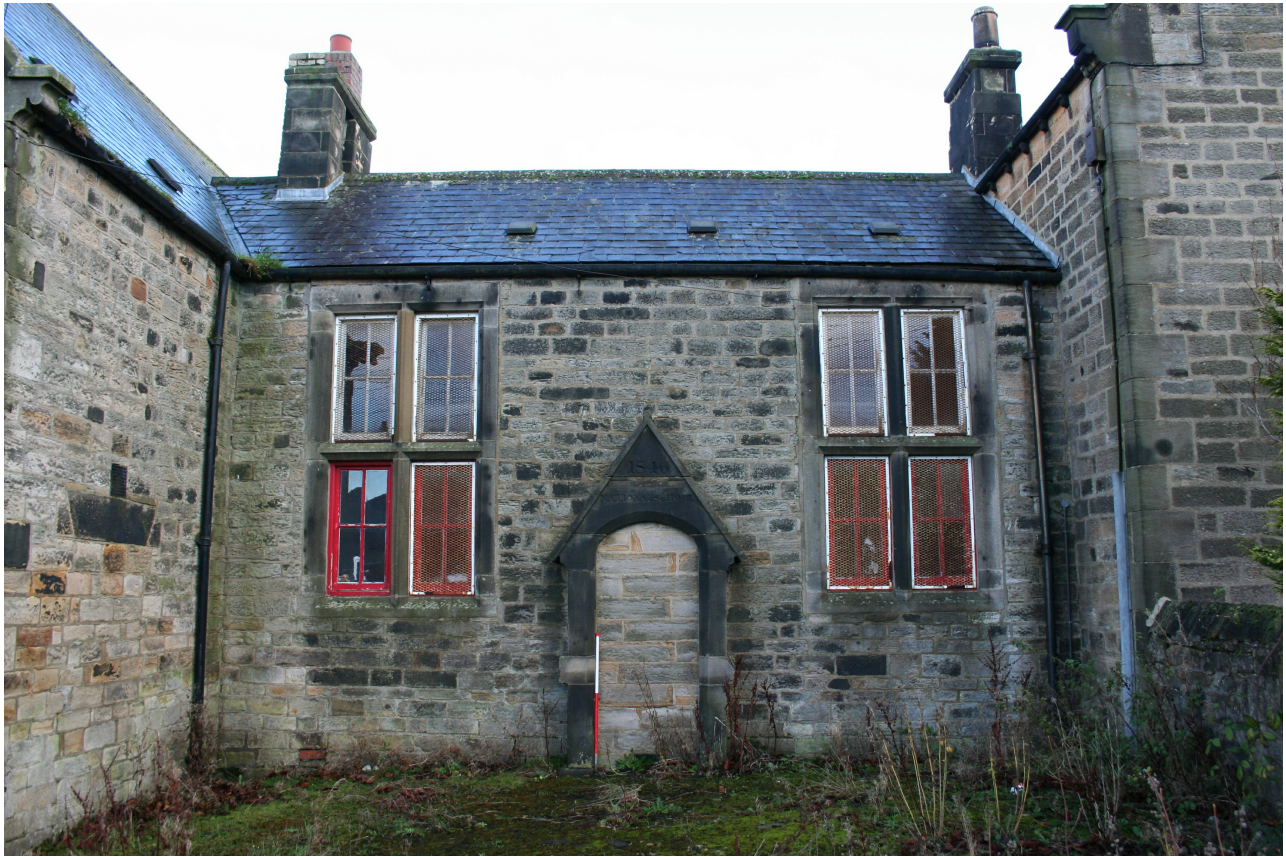
Plate 2. The northeastern elevation of the school, looking west (frame PAH14002)

3.2.3 The northeastern elevation consists of a three-bay master's house (*Plate 2*) with a central doorway, now blocked with coursed sandstone. This building belongs to Phase 1 of the school's development (see Section 4.1.4). The doorway, *Door 1*, is set within a gabled segmental-headed stone porch, inscribed with '1846 NATIONAL SCHOOL'. To the north of *Door 1* is *Window 1*, with *Window 2* to

the south. Both of these windows are double-height cross windows complete with stone transom and mullion. Each window contains sixteen lights.

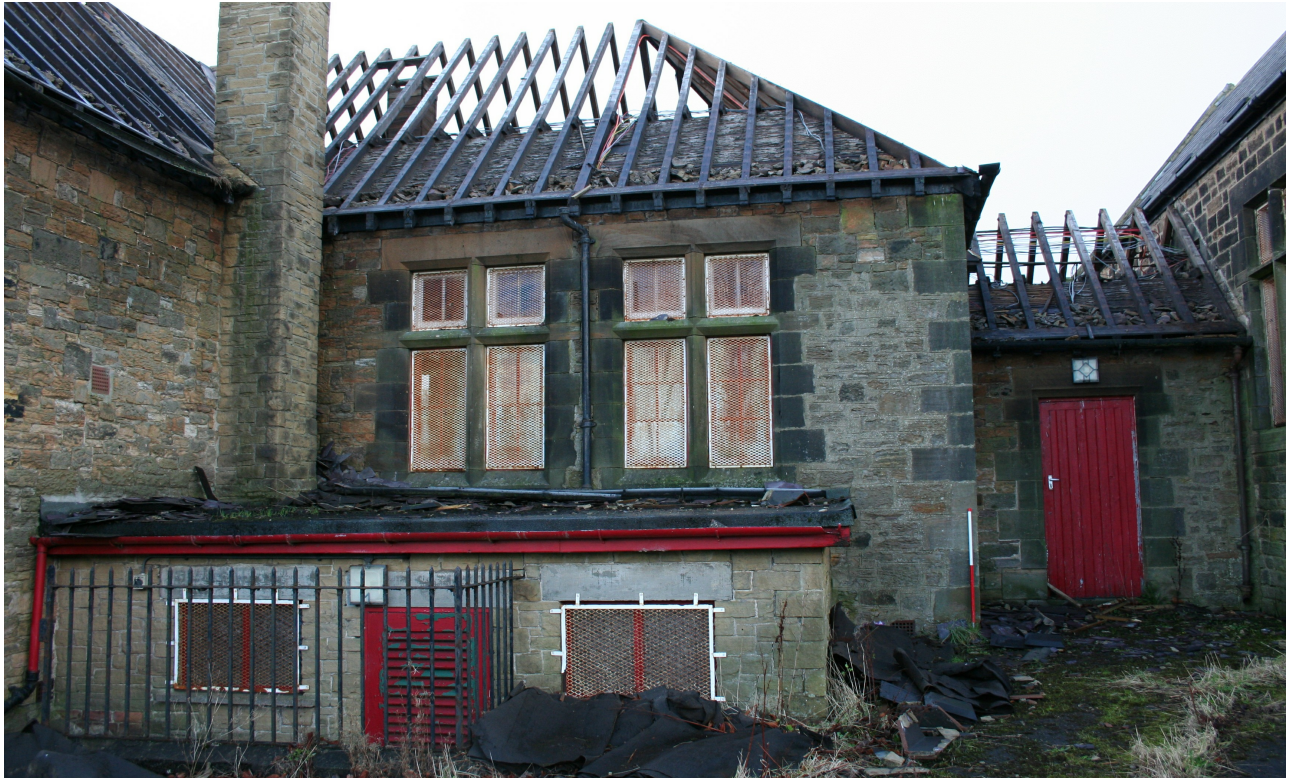
Plate 5. Eastern elevation showing Doors 2 and 16 and Windows 6, 7, 24 and 25 (frame PAH14015)

- 3.2.8 The joining block marks the northern entrance into the extended late 19th century school, with the mid-20th century red painted vertical panelled door (Door 2) set in a surround of ashlar stonework. This door was the girls' entrance to the school, leading into the girls' cloakroom (Area 5).

- 3.2.9 The stone wall makes a short return east before returning south again. This elevation holds two stone mullioned and transomed cross windows of late 19th century date, Windows 6 and 7. Each window holds sixteen lights. The ground floor level of this elevation has been obscured by a modern boiler room (Plate 5), built with a flat felt roof and holding two small windows, Windows 24 and 25, as well as a modern framed door set centrally in the northern elevation of the boiler room and accessed down a short flight of stone steps.

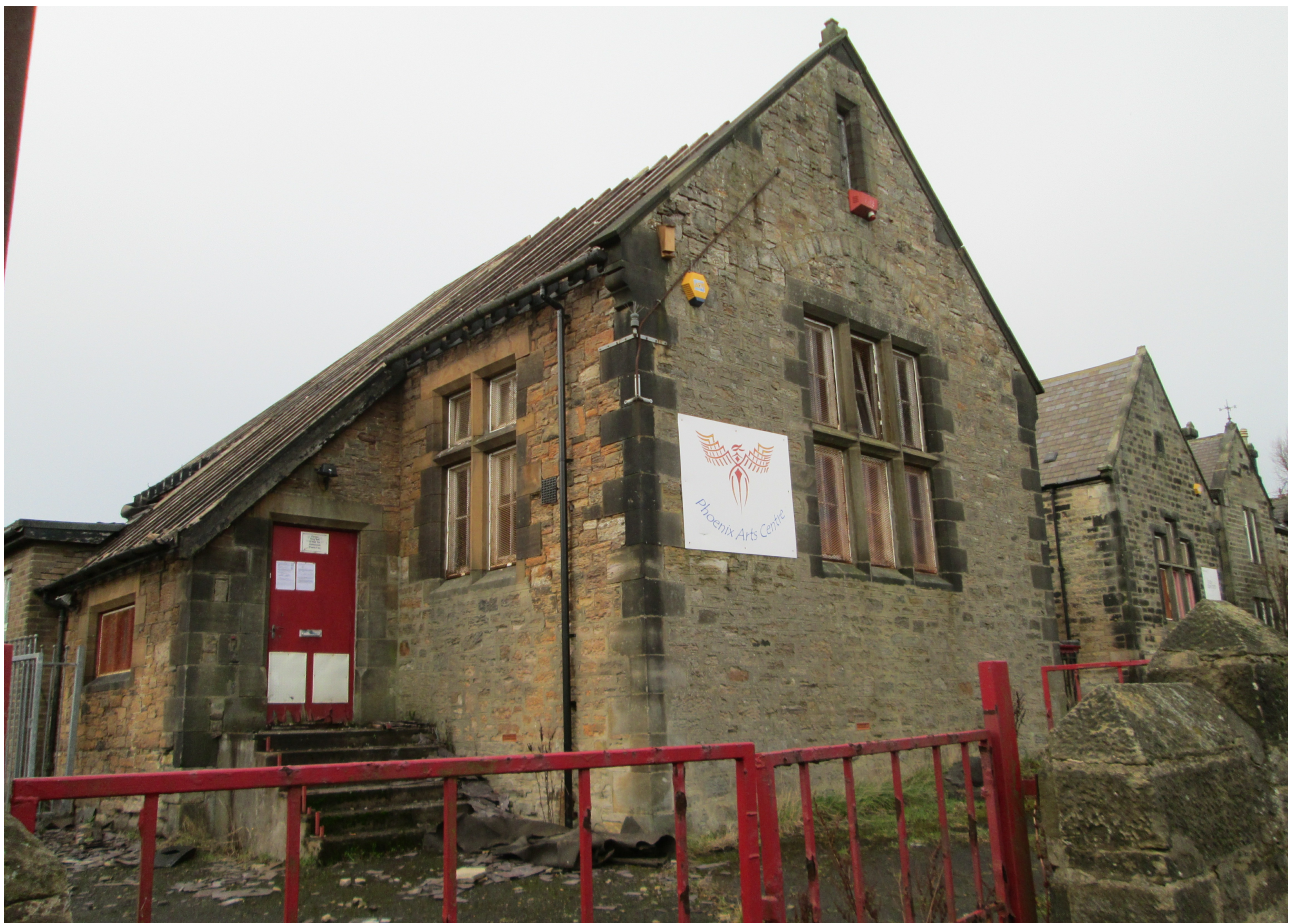
Plate 7. Southern elevation of the school (Frame PAH14022)

- 3.2.13 The brick structure returns north for a further 2.6m and holds a small three-light modern frosted window (*Window 12*). The brick butts against the stone southern elevation of the late 19th century school building. The stone wall returns west for 1m before turning north again. This elevation forms the main west wall of the main school hall, and holds four early 20th century windows (*Windows 13-16*), likely replacing the original late 19th century structures. The wooden frames are set in a stone lintel and sill.

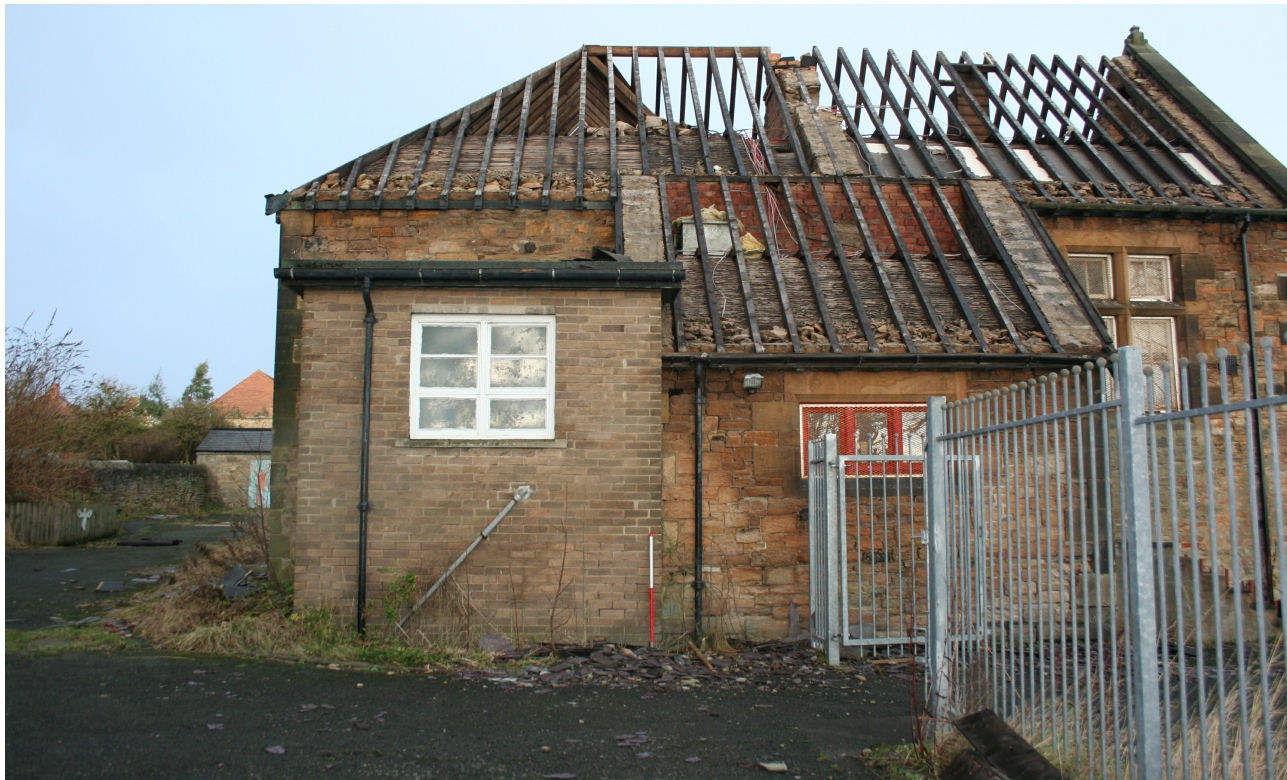
- 3.2.11 The classroom projection returns west revealing a height-and-a-half transomed and mullioned cross window, with stone lintel and chamfered sill (*Window 9*). The wall then returns south into a small entranceway. This door (*Door 4*) is a modern MDF door set in an ashlar surround, and acts as a southern entrance providing access to the boys' cloakroom (*Area 1*).

- 3.2.12 The wall returns west and holds a small three-light modern-framed window (*Window 10*) set in a stone surround. The stone wall then returns north, where the original southwest corner of the building is obscured by a modern flat-roofed brick building (belonging to Phase 3 of the school's development, see Section 4.1.6) has been built to house the male toilets and bathroom. It is unknown if the modern toilet block obscures any 19th century windows. The modern brick structure holds one six-light modern window (*Window 11*) on the southern elevation.

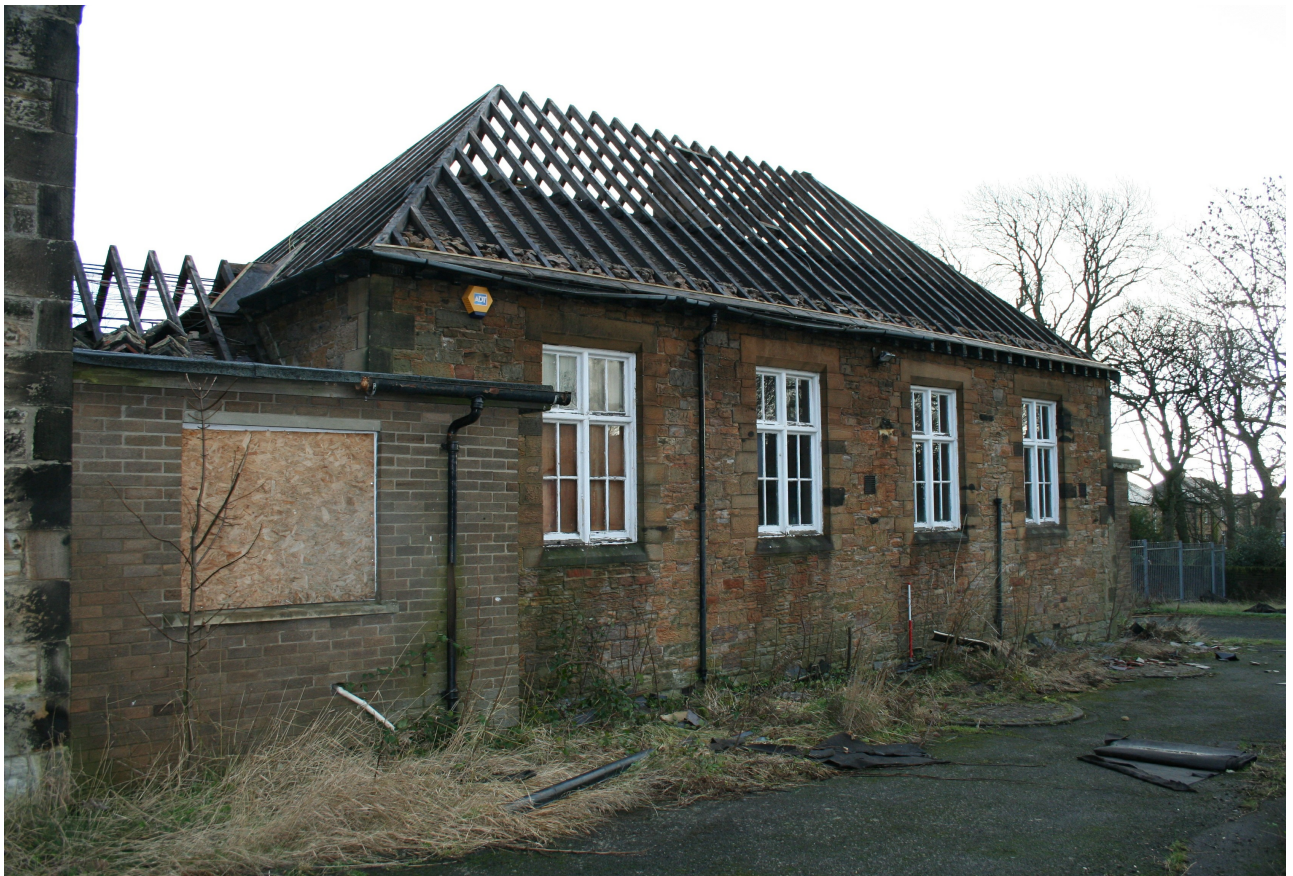
Plate 10. The late 19th century addition to the northwest of the original schoolroom (Frame PAH14028)

- 3.2.15 This wall forms the western gable end of the original schoolroom, and mirrors the features on the eastern gable, with a stepped tripartite mullioned and transomed window (Window 18) holding twenty lights, over which is a small ventilation duct in a stone surround (Window 26). The elevation was extended a further 5m north during the late 19th century. The division between these two phases of building can be clearly seen in the fabric of the building, and can be seen in Plate 10. The extension holds a nine-light window (Window 19) with stone lintel and sill, as well as Door 5, now blocked and boarded.

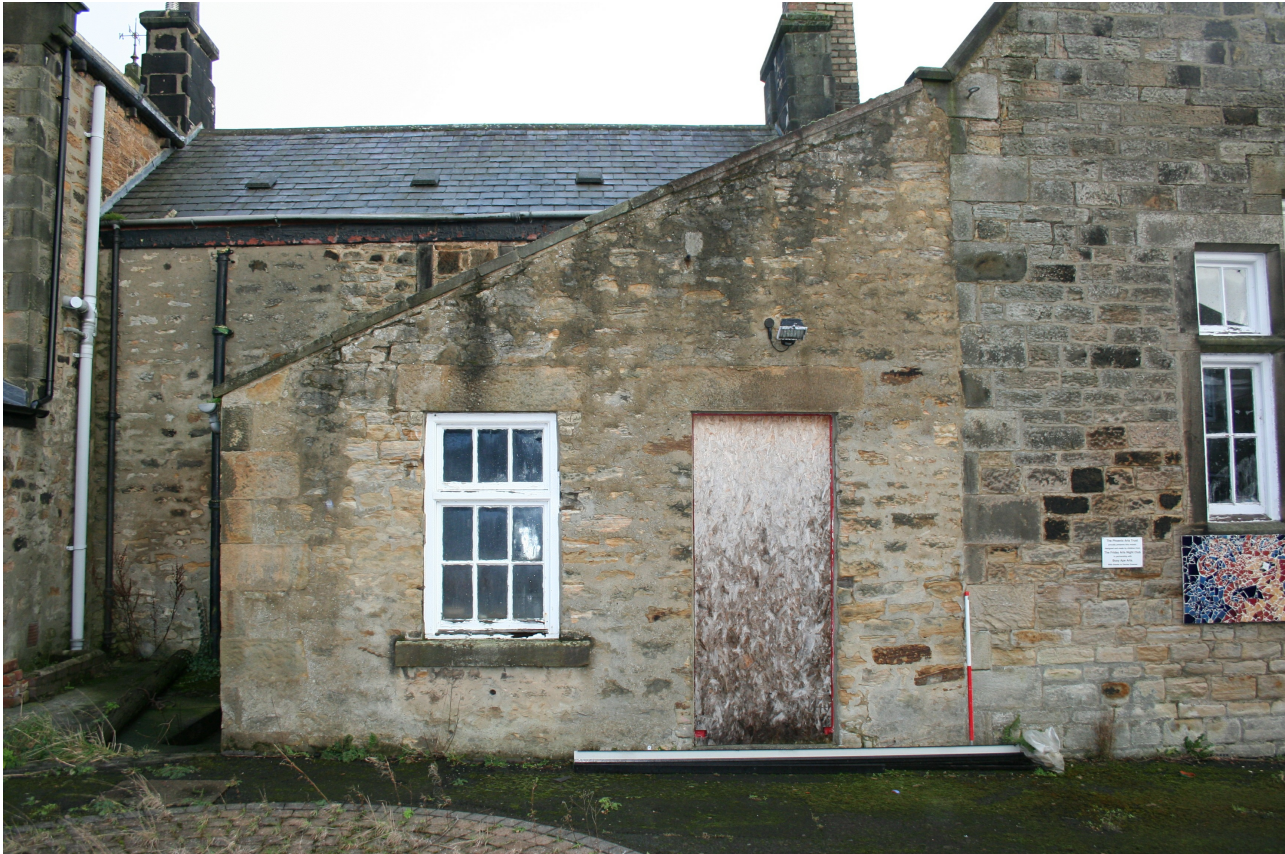
- 3.2.16 The extension returns east and butts against the western wall of the original master's house before returning north again to meet with the southern wall of the north-adjointing property. The wall holds a blocked window (Window 26) centrally in the upper storey of the wall, set within a stone surround and against the roof flashing.

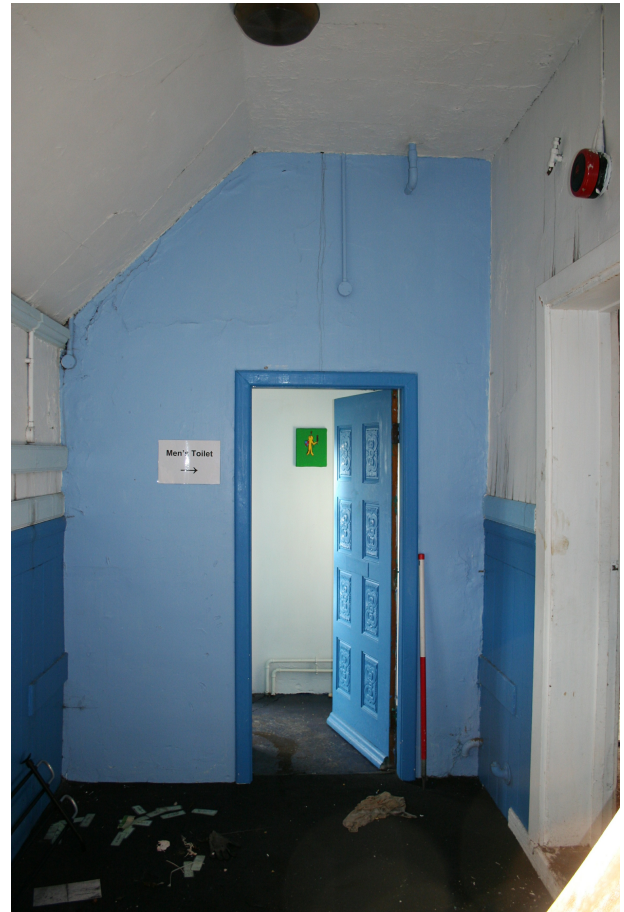
Plate 11. The boys' cloakroom looking west (Frame PAH14034)

- 3.3.3 This area originally belongs to the late 19th century extension (Phase 2) of the school build. The lower 1.10m of the walls are clad in wooden vertical wainscoting panelling, on top of which is a modern electrical cable conduit.

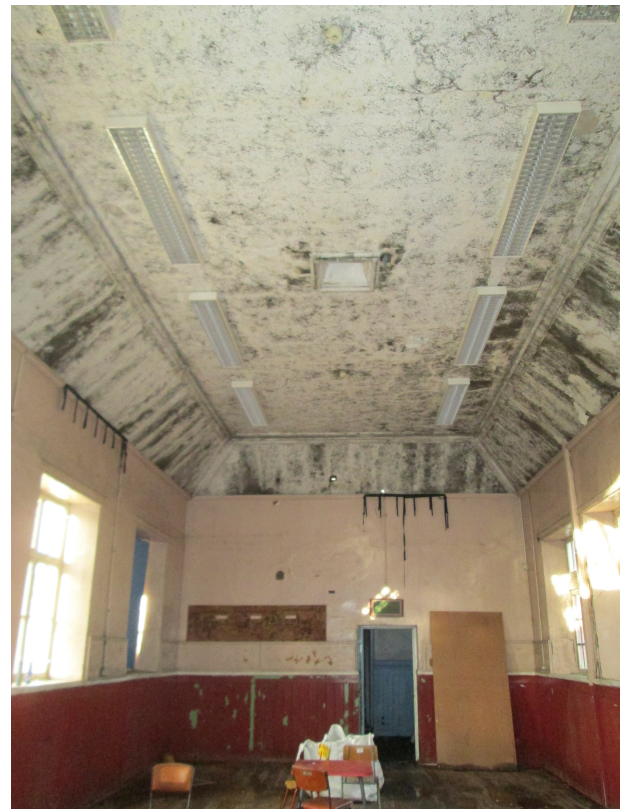
Plate 12. The main hall looking north (Frame PAH13045)

- 3.3.6 Area 3 (12.70m x 6.0m): *Main hall*. The main hall forms the core of the late 19th century extension (Phase 2). At the time of the survey, the ceiling was in poor condition due to the prior removal of the roofing structure, with localised flooding on the floor due to ceiling breaches.

- 3.3.7 The western wall holds four windows (Windows 13-16), with two external windows set in the eastern wall (Windows 6-7). A further internal window (Window 22) lies in the eastern wall and holds nine lights.

- 3.3.9 The lower walls are clad in wooden vertical wainscoting panelling, with plain plaster above. The floor comprises wooden floorboards, and the ceiling is vaulted and plastered, lit by striplights.

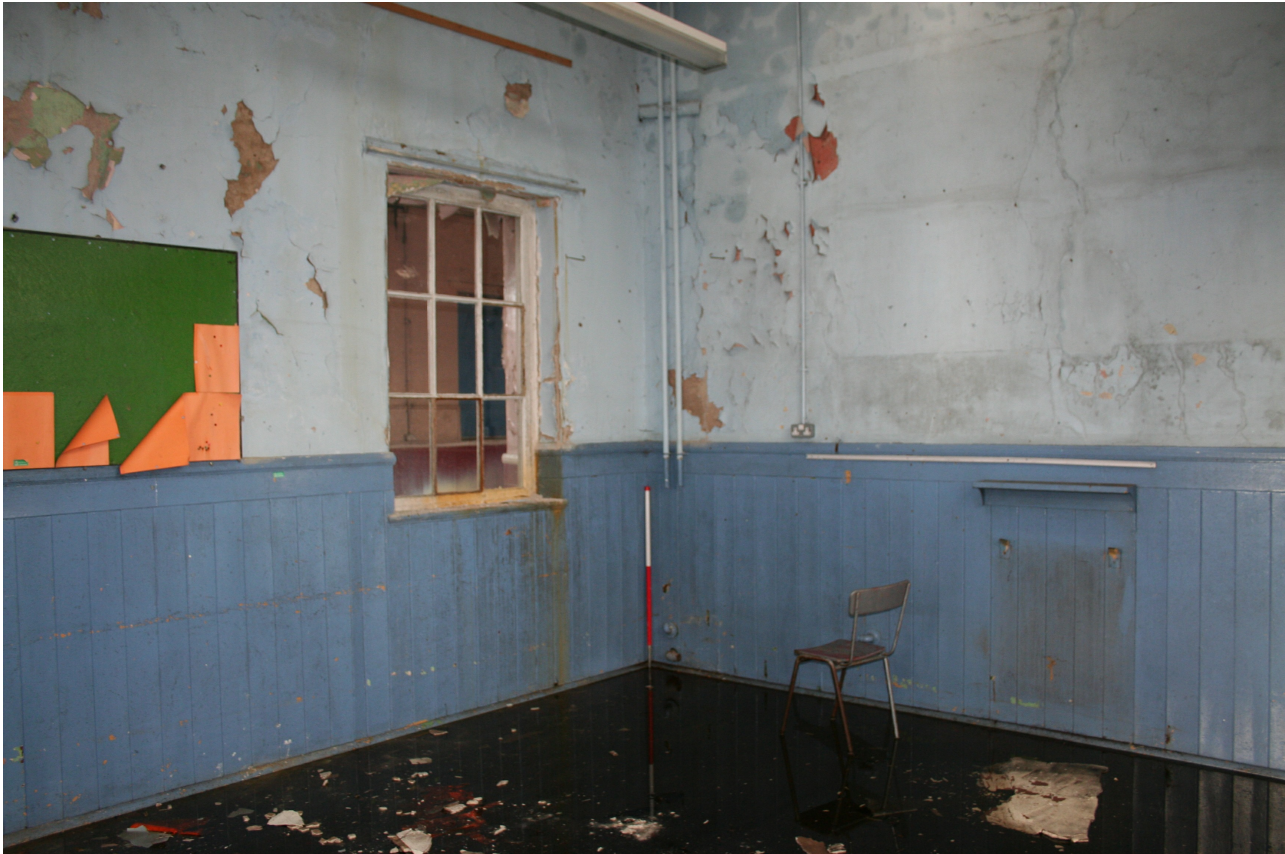
Plate 13. View of the classroom, looking northwest (frame PAH14052)

- 3.3.10 Area 4 (6.0m x 5.14m): *Classroom*. This is a basic square classroom entered through a door (Door 9) in the southwest corner. The classroom's ceiling is in very poor condition

with a number of breaches, with the floor flooded over the majority. The lower half of the classroom's walls are clad in wooden vertical wainscoting panelling, with plain plaster above. Light was introduced externally via Window 8 in the east wall and Window 9 in the south wall, with the internal Window 22 overlooking the Hall.

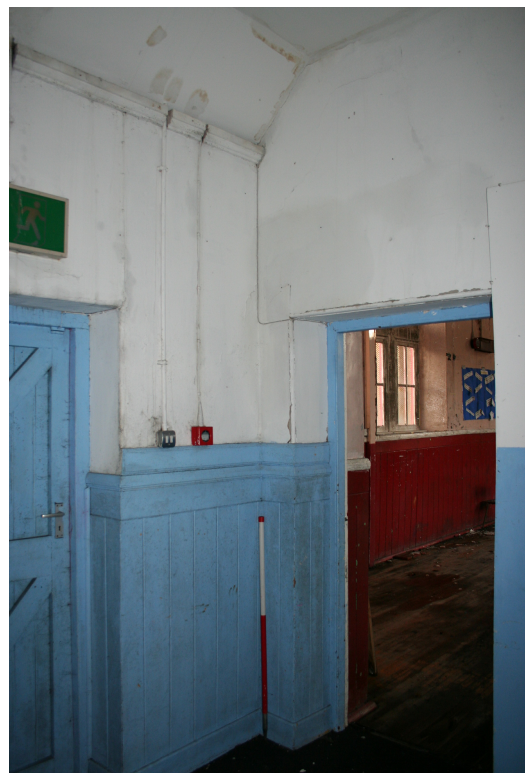
Plate 14. View of Area 5 looking southeast (frame PAH14060)

- 3.3.11 The classroom belongs to the late 19th century extension to the school, contemporary with the Hall.
- 3.3.12 Area 5 (3.0m x 2.65m): *Girls' entrance and cloakroom*. This small vaulted room was accessed externally through Door 3 in the east wall, a modern wooden door. In the south wall is a door through to the main hall; in the north wall is a door through to the original schoolroom (Area 7) and likely marks the original entrance to the schoolroom building. In the western wall is the entrance to the female bathroom, Area 6.

- 3.3.13 The area's walls are plain plaster, with the lower half clad with wooden vertical wainscoting panelling. The room is part of the late 19th century extension.

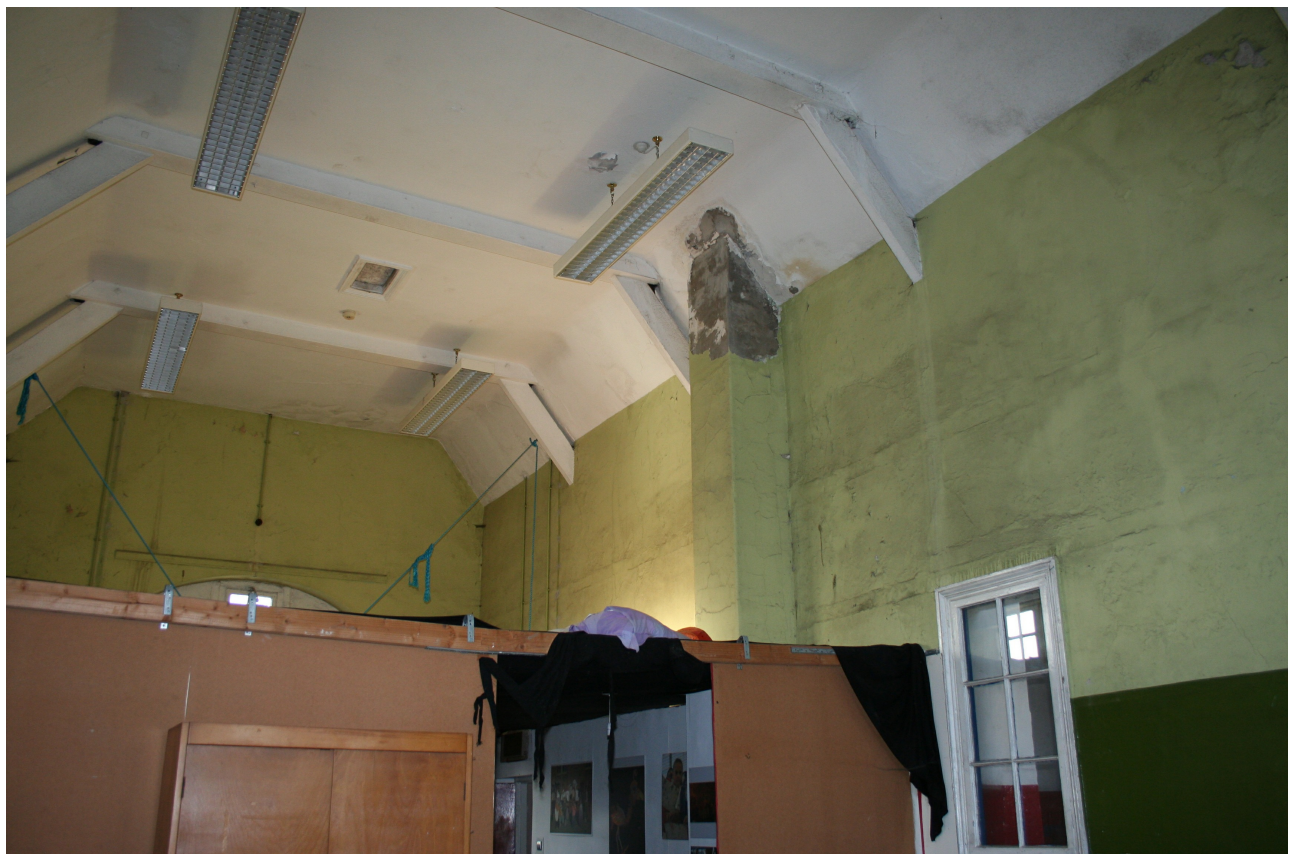
Plate 16. The original schoolroom, looking west (frame PAH14073)

- 3.3.15 Area 7 (11.4m x 4.75m): *Original schoolroom*. The 1846 schoolroom is structurally a single space at the full height of the building. In the east and west gable ends are *Windows 4* and *18*, both stepped cross-windows. In the north wall, *Window 21*, a six-light window looks into the parlour of the original master's house (*Area 10*), with *Window 5* set in the south wall overlooking *Door 3*. In the western extent of the southern wall, *Window 20* is set which overlooks the roof of the female bathroom, *Area 6*.

- 3.3.17 At the time of the survey, the room had been divided into two sections by a modern ply partition, the ceiling of which lies level half way up the window in the western gable. The room is clad in plain plaster with a vaulted ceiling containing striplights. Unlike the rest of the building, this room does not sport any timber wainscotting.

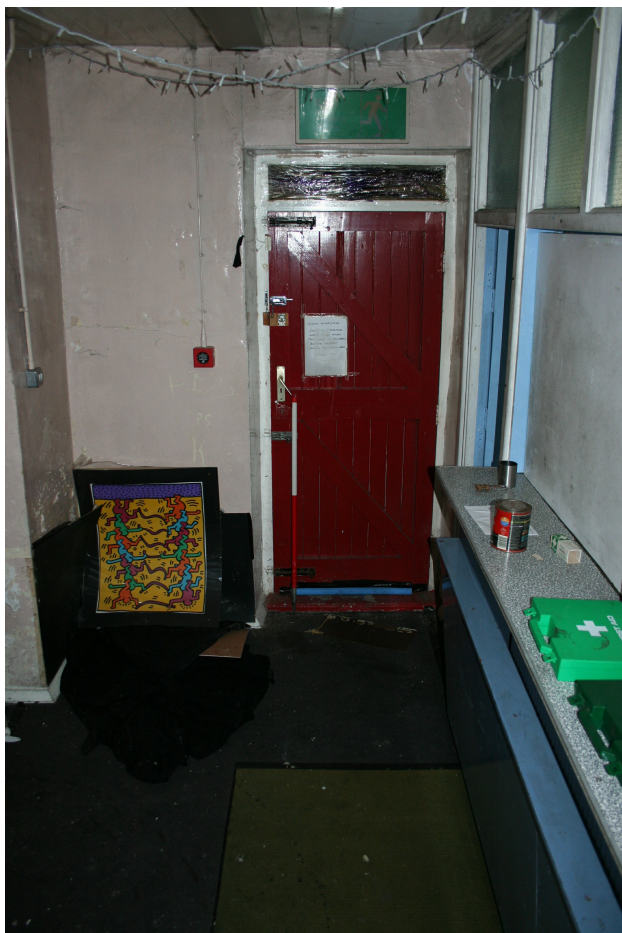
Plate 17. View of the back lobby, looking west (frame PAH14079)

- 3.3.18 Area 8 (3.06m x 1.84m): *Back lobby*. The back lobby is part of the late 19th century lean-to extension and gives access to the kitchen to the north through *Door 14*, the original master's room through *Door 15* to the east (up two steps), the original schoolroom through *Door 13* to the south and out to the back yard through *Door 5* in the west wall. Its likely that the external back door is original, with new locks fitted.

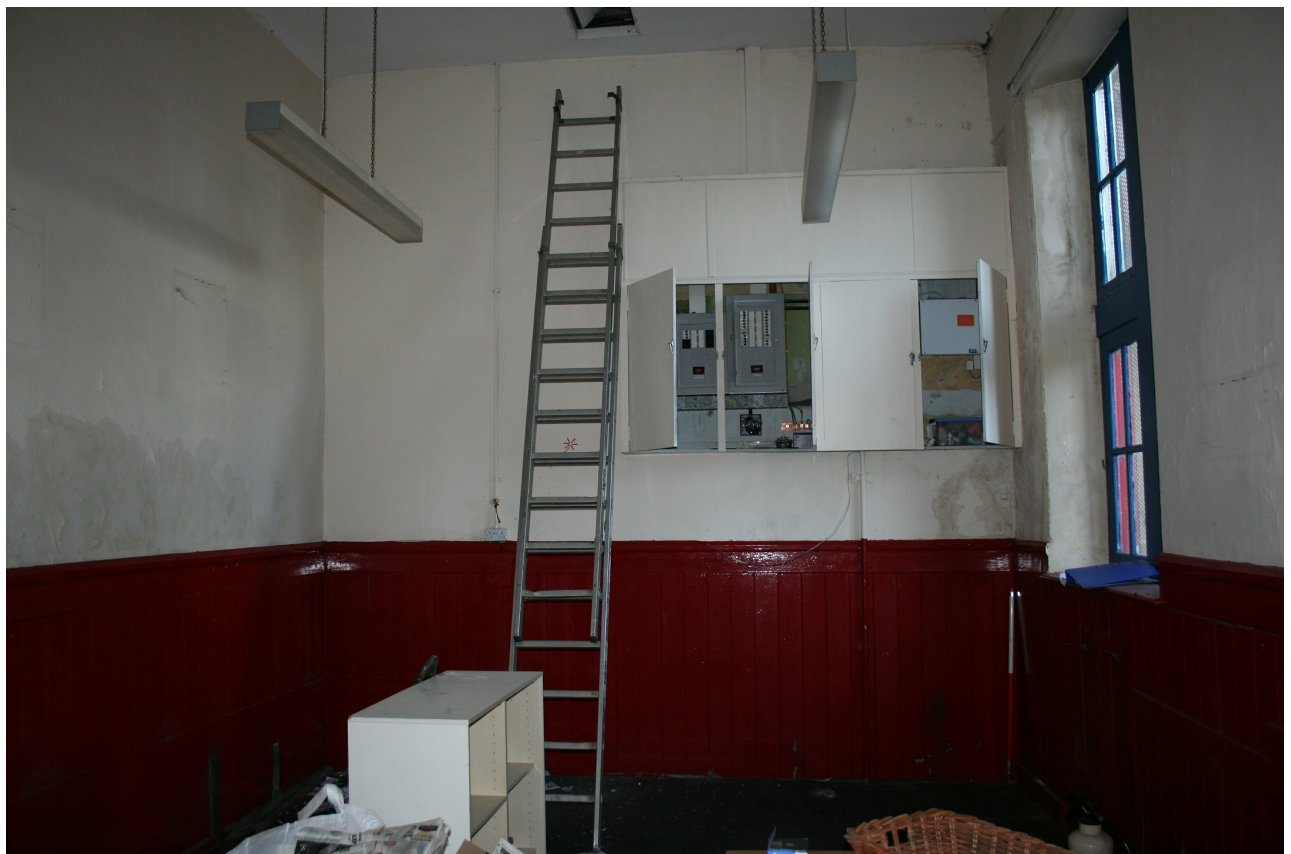
Plate 21. The fireplace in the south wall of the master's room (frame PAH14095)

- 3.3.25 In the south wall, the original chimney stack remains in-situ, converted to hold a gas fire. However, the outline of the 19th century fire surround can be seen beneath the paint of the stack, showing a lintel set above the modern fireplace. This can be seen in *Plates 21 and 22*.
- 3.3.26 Area 11 (5.34m x 3.14m): *Boiler room*. No access was available into the boiler room at the time of the survey, as the client didn't have a key. From the external construction this room likely dates to Phase 4.

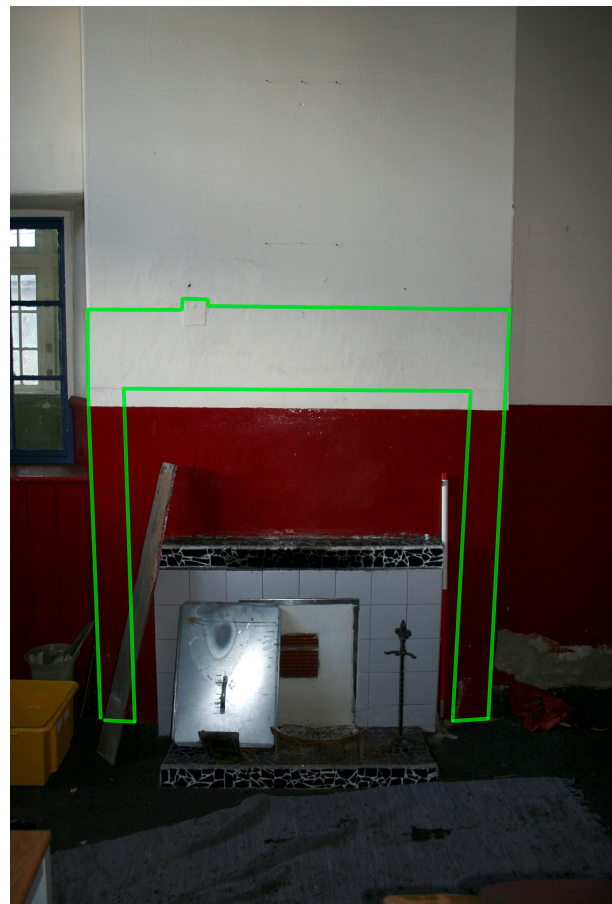
Plate 22. The outline of the original fire surround, marked in green.
