CPAT Report No 1173

St Michael's Church, West Felton, Shropshire ARCHAEOLOGICAL WATCHING BRIEF

Project Name: West Felton Church

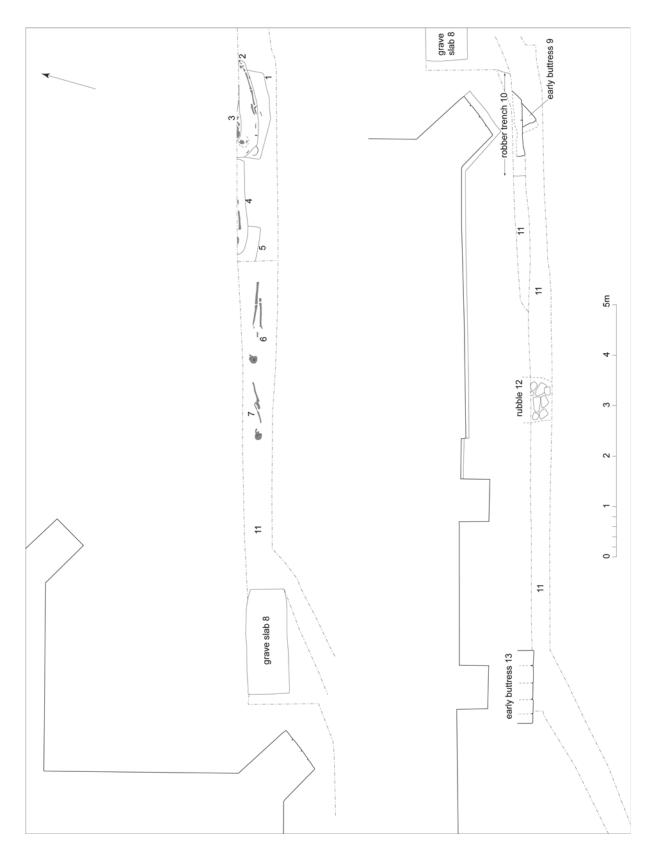
Fig. 3 Detailed plan showing the location of burials and features relating to earlier phases of the church

2.3 Evidence for the foundations of a presumed medieval church, predating the present structure, consisted of robbed buttresses and wall footings, which in some cases were associated with general demolition debris. The basal courses of two earlier buttresses (9 and 13) were recorded adjacent to existing buttresses along the 19th-century south aisle, (Fig. 3), each around 1.4m wide and surviving to a height of at least 0.45m. In both cases the surviving walling consisted of two courses of lime-mortared, dressed red sandstone blocks, although additional, unexcavated, courses of stonework were visible at the base of each buttress. One of the buttresses (9) was revealed at the base of an obvious robber trench, and was sealed by a demolition layer (10) consisting of degraded red sandstone, slate and river rounded cobbles (Fig. 4) which contained fragments of medieval floor tile and pottery. There was also evidence for a third buttress located between the other two, comprising an isolated band of sandstone rubble (12).

- 2.8 In total, eight graves were identified within the service trench to the east of the church, all orientated roughly east to west, and seemingly representing three periods of burial (Figs 3 and 9). Skeletal remains were partially exposed in all but two of the graves (5 and 8), and most also contained coffin nails. The two earliest graves (1 and 5) were cut into the natural subsoil at around 1m below the present ground surface. Both graves had been truncated by later burials (2 and 4), one of which (2) was itself truncated by a subsequent burial (3), recorded at a depth of 0.55m. The only dating evidence came from a single sherd of medieval pottery recovered from the fill of grave 1. All of the later burials, including graves 6 and 7, were sealed by the cemetery soil deposit (11) and were located at a depth between 0.65m 0.8m below the present ground surface.

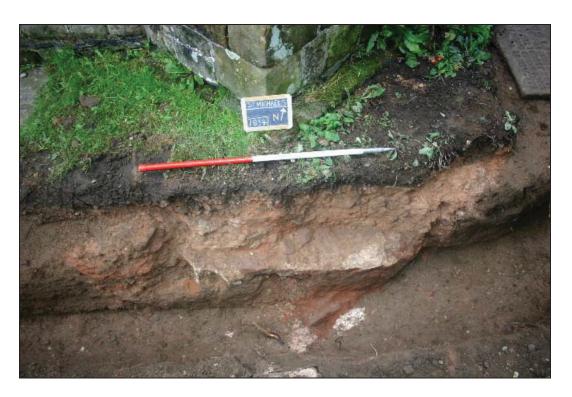
Fig. 4 The remains of an early buttress (9) along the south wall, sealed by demolition rubble (10). Photo CPAT 3535-0029

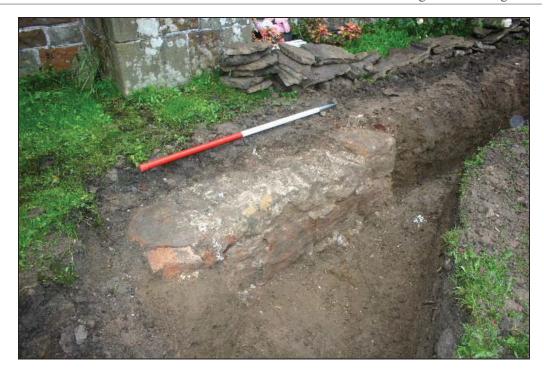
Fig. 5 The remains of a second early buttress (13) along the south wall. Photo CPAT 3535-0038

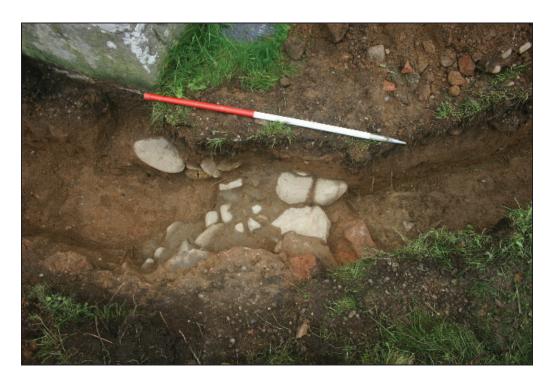
Fig. 6 The remains of an earlier wall (14) at the base of the church tower, viewed from the south-west. Photo CPAT 3535-0052

2.5 The rubble, the extent of which continued along the west side of the tower, sealed the remains of two walls (14, 15) aligned roughly east to west and about 5m apart (Fig. 6). Both walls were c. 1.3m wide, survived to a height of 0.4m, and were constructed from red sandstone and river cobbles, bonded with fine brown sand. A similar deposit of cobbles and sand (16, 17) was recorded immediately adjacent to the walls (Figs 6-8). The upper courses of stonework were later carefully removed from the southern wall (14) revealing a foundation trench containing further courses of red sandstone and yellowish buff sand (20).

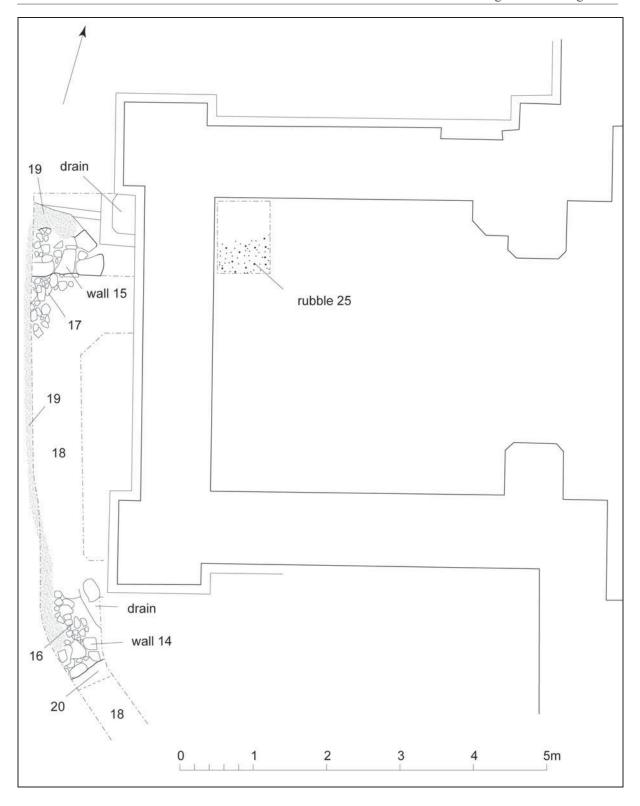
Fig. 7 Features revealed during the watching brief around and within the tower

2.6 The installation of the new services also required the hand excavation of a small trench, 1m by 0.7m and 0.5m deep, internally within the north-west corner of the church tower (see Fig. 7). A band of large river cobbles in a matrix of fine, buff-coloured sand (26), was recorded at the base of the trench. The cobbles, which appeared to lie within a feature orientated east to west, were similar to the stony layers (16 and 17) located outside the tower. The cobbles were

sealed by a layer of fragmented medieval tile (25) and charcoal (24) and degraded red sandstone (23), the latter containing numerous fragments of medieval and later floor tile and post-medieval pottery. A thin (80mm) skim of concrete mortar sealed the rubble, forming a base for the 19th-century tiled floor.

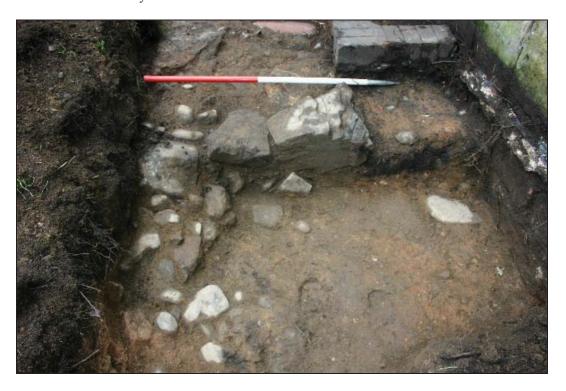
Fig. 8 The more northerly (15) of two earlier walls alongside the tower, viewed from the south. Photo CPAT 3535-0061

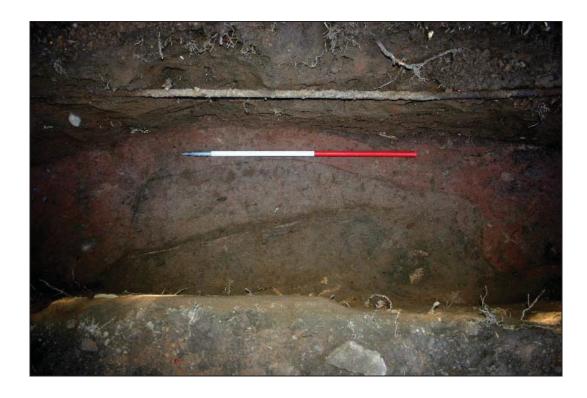
Fig. 9 Three successive phases of burial are indicated by grave 1, at the top of the view, which was cut by grave 2, with the latest grave (3) just protruding from the northern section of the service trench. Photo CPAT 3535-0006

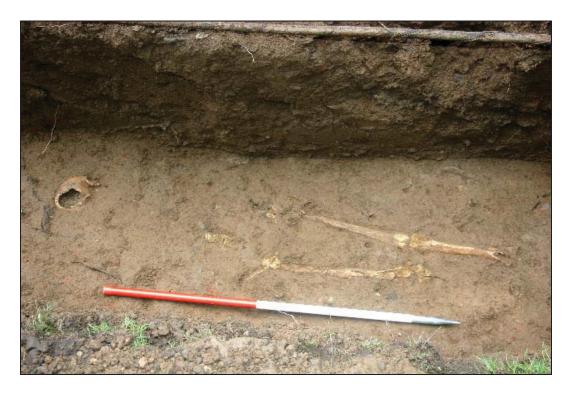
Fig. 10 Skeletal remains within a grave 6, viewed from the south.

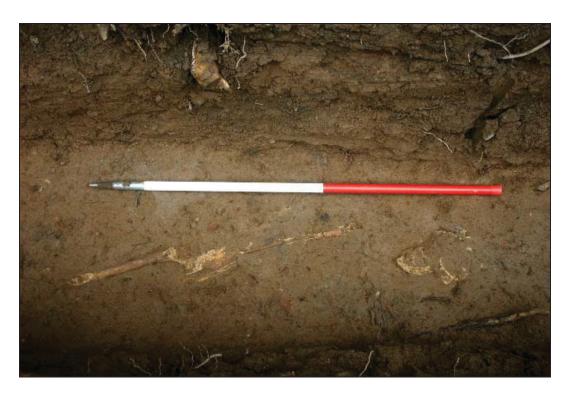
Fig. 11 Skeletal remains within grave 7, viewed from the north. Photo CPAT 3535-0021

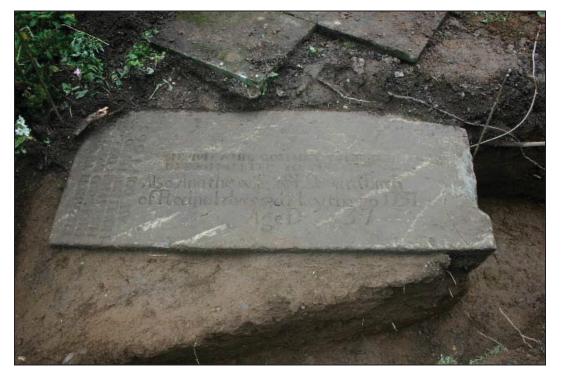
Fig. 12 The memorial stone for the Birch family, viewed from the south, records both 17^{th} -and 18^{th} -century burials. Photo CPAT 3535-0026

An in-situ memorial stone was uncovered on the south-east side of the 19th-century chancel (Fig. 12). The memorial, constructed from a large sandstone slab, is inscribed in three sections, one of which is illegible but in the same style as the earliest which reads 'Elizabeth the wife of Richard Burch of Haughton deceased November 30th AN DOM 1663'. The later inscription reads 'Also Ann the wife of Edward Birch Rednal deceased May the 20 1731 aged 37'.

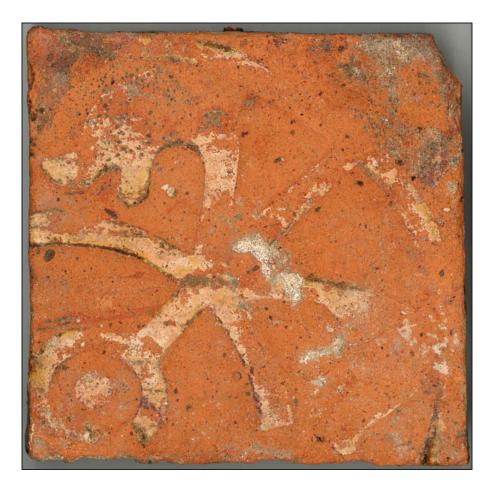
Fig. 13 The complete medieval floor tile, scale 1:1

2.13 A significant quantity of fragmented medieval floor tiles was recovered from the excavation within the church tower, all of which had been re-used as levelling material. The tiles were all in a sandy red fabric, most having an olive green glaze which often extended onto the underside of the tile, and some retained traces of lime mortar. Some tiles retained parts of impressed and slipped decoration, while others appeared to have been plain. Only one complete tile was recovered, measuring 113mm by 113mm and 22mm thick. This had a very worn surface but retained part of a zoomorphic design which evidently formed one quadrant of a pattern made up of four identical tiles (Figs 13 and 14). It has not been possible to identify comparable tiles from the sources immediately available to us.

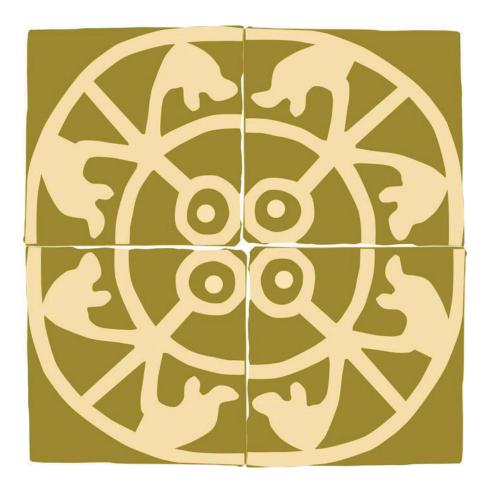
Fig. 14 A reconstruction of the zoomorphic pattern formed by four of the medieval floor tiles
