Cow Tag 118 Function Code 5 5.7

Brief Description: [timber element, p/s, condition, fragments]
GOOD CONDITION

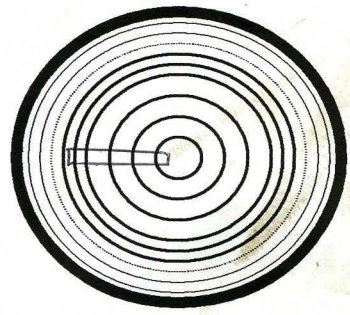
COWTAG
118

Notable Features: [tool marks, scribed lines, decoration, repairs] POINTS TO LOOK OUT FOR WHEN RECORDING ufos
INBOARD:- LINES c 0.3m FROM FOR EDGE OF AFF SCARE, UPPER EDGE OF PLANK
Numerous wood nails along lower land (5) Possible Type 3 on each
OUTBOARD:- LINE TO FORE SIDE OF SAMPLE
4 INSCRIBED LINES ON LAND c 1.5m FROM AFF END OF PLANK
Type 3 on upper land but not on eroded exposed on B face -

Wood Science: [rings, ARW, knots, sapwood, conversion]
Some wavy grain. c 60H. Possible N/S at lower edge? ARW=185/60
Radial
