Cow Tag 126 Function Code S25.3

Brief Description: [timber element, p/s, condition, fragments] complete plank, solid condition.

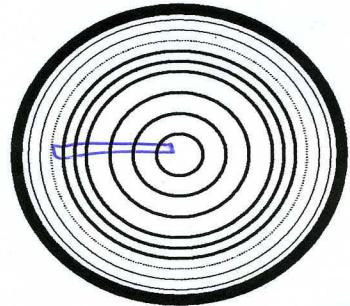
Notable Features: [tool marks, scribed lines, decoration, repairs] POINTS TO LOOK OUT FOR WHEN RECORDING ufos
IB: inscribed lines; type 4 ^{no} next to scarf also type 1. ← many of these
OB inscribed lines next to trenail 2 aft of scarf
IB: - LOTS OF STEEP + DEEP AXEMARKS (NO STRIATIONS) ON FACE OF PLANK

Radial but very knotty which might partially explain heavy chipping.
Pith beyond upper edge in growth ring
C 100 H ARW = 205/50.
50

Recommended action: [samples, additional photos, moulding, queries and problems] Photos of type 4 lines?
