DB 11/2/8

Cow Tag	Function Code	
136	S27-4A	
Brief Description: [timber element, p/s, condition, fragments]		
long, wide plank. incomplete aft		
Notable Features: [tool marks, scribed lines, decoration, repairs] POINTS TO LOOK OUT FOR WHEN RECORDING ufos		
<p>3/4" of scribed line on inboard face</p> <p>2 nails have left <u>apparent</u> rect holes (split away) on upper edge.</p> <p>Blind inboard nail hole.</p>		
Wood Science: [rings, ARW, knots, sapwood, conversion]		
<p>One major knot near central upper edge inboard.</p> <p>Radial <math>\approx 100 \text{ H} + 10 \text{ S}</math> ARW = 202/110</p> <p>Centre of parent tree beyond upper edge.</p>

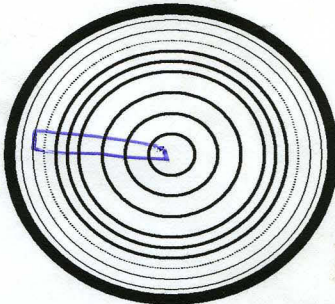
136 S2F-4A

HPM thinks this is a possible mail hole

bind with hole  
wall hole

wall hole

Recommended action: [samples, additional photos, moulding, queries and problems]		
<p>Photo inboard scribed line. Row <u>in</u> with</p> <p><u>DEND</u> - sampled for dendro. 1/2/7</p> <p>sample = 2293</p> <p>organ = 2294</p>		
Cleaned:	Recorded:	Photos:
	TNS 14.6.5 LE ACCO 25/10/06	17/05/05 - CLINKER NAIL WITH ROVE - INTENTIONAL MARS.

Checked: [corrections needed]	Initials & Date:	
Photo blind inboard nail hole	NN 11/10/5.	
Corrections Done [desktop, Faro Arm?]:	Initials & Date:

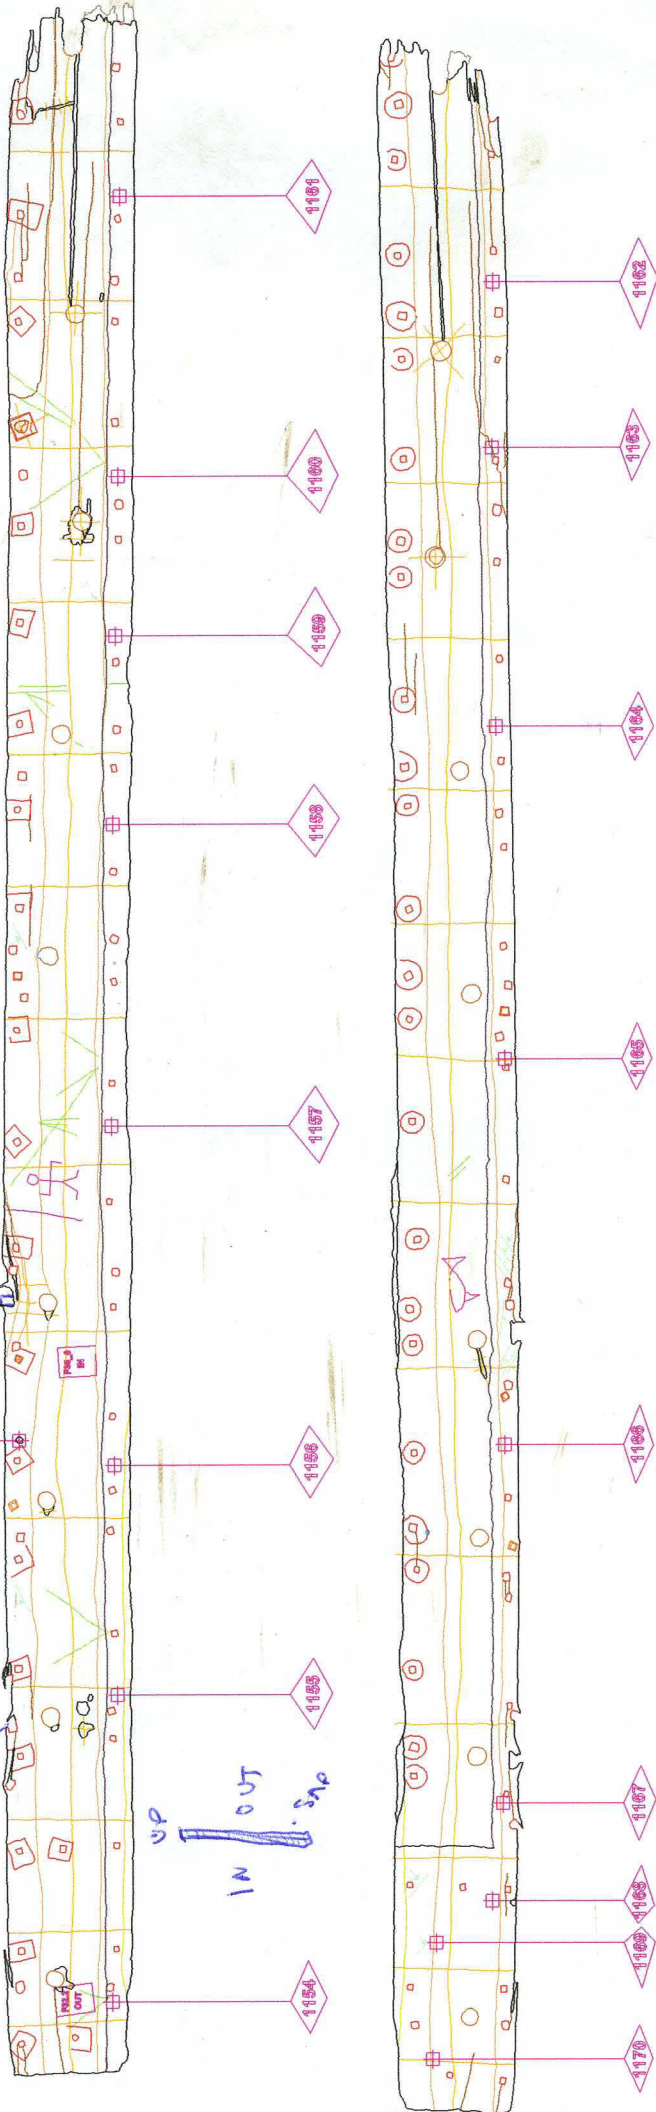
UP  
IN OUT  
SAP
