| Cow Tag <u>164</u> | | Function Code <u>P75</u> |
| Brief Description: [timber element, p/s, condition, fragments] <u>VERY WELL PRESERVED PLANK, AFT. END SLIGHTLY DAMAGED</u> | | |

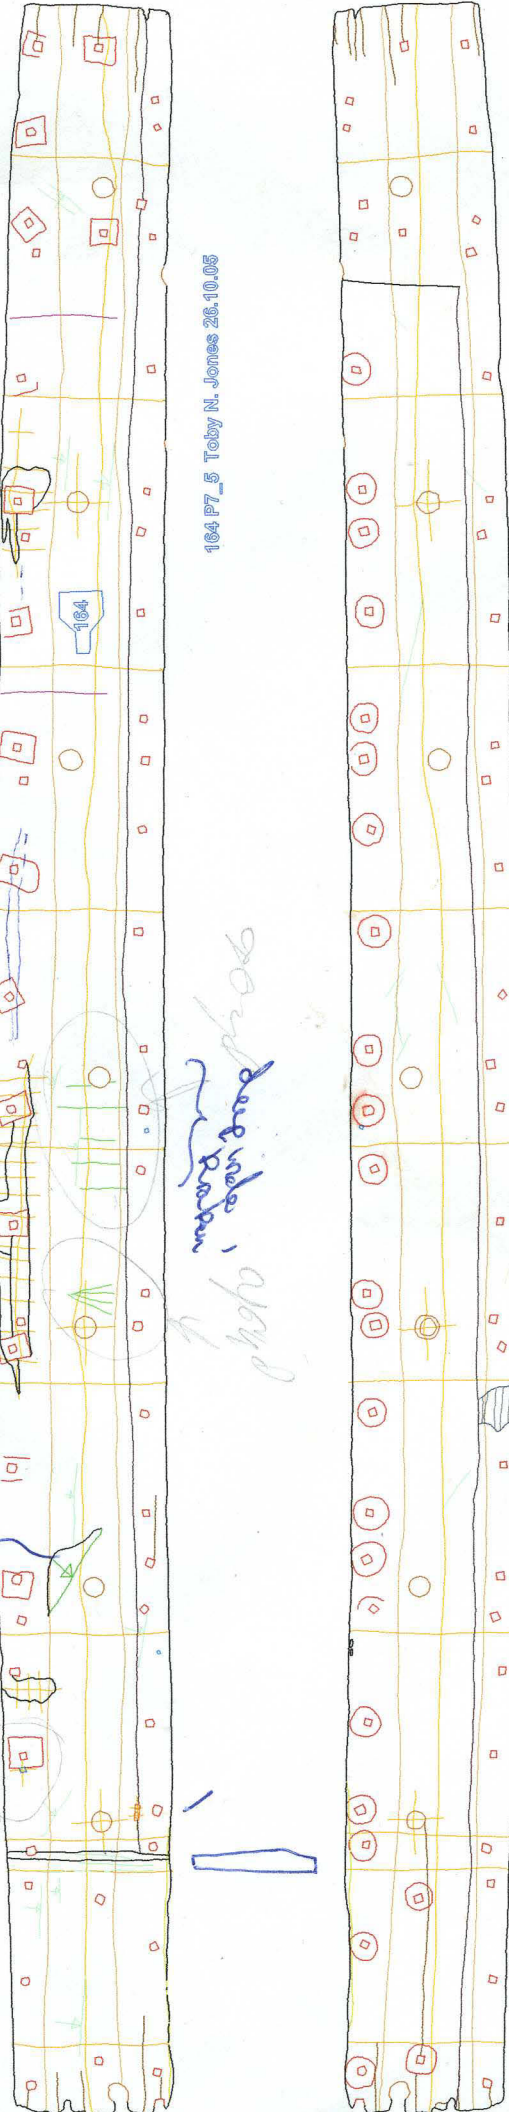
164 P7_5 Toby N. Jones 26.10.05

| Notable Features: [tool marks, scribed lines, decoration, repairs] POINTS TO LOOK OUT FOR WHEN RECORDING ufos <ul style="list-style-type: none"> - BLIND HOLE NEXT TO SCARF, INBD. - ADDITIONAL NAIL LAND, NEXT 2 SCARF, INBD. - 4 INSCRIBED LINES AND ANOTHER 5 LINES ON INBOARD FACE | | |

Wash
damage

| Recommended action: [samples, additional photos, moulding, queries and problems] <u>Photos of 2 groups of lines on inboard face.</u> | | |
