DB 12/2/8

Cow Tag 168 Function Code P 15-2

PERFORATED PLANK - damaged aft (pib?)

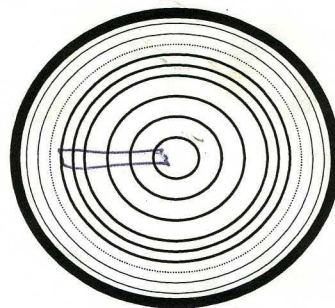
Generally straight grained but
'runs away' at forward scarf. Pith
layed lower edge on growth trend
c. 05 H at forward scarf. ARW
= 228/105.
Radial.
