DB 13/2/8

Cow Tag 208

Tingle at P9.4 - P9.5,

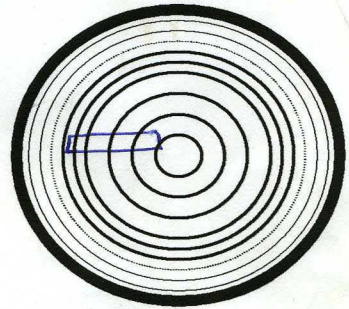
Intermediate - see drawing.
C85H. ARW = 170/85. Bright grained.

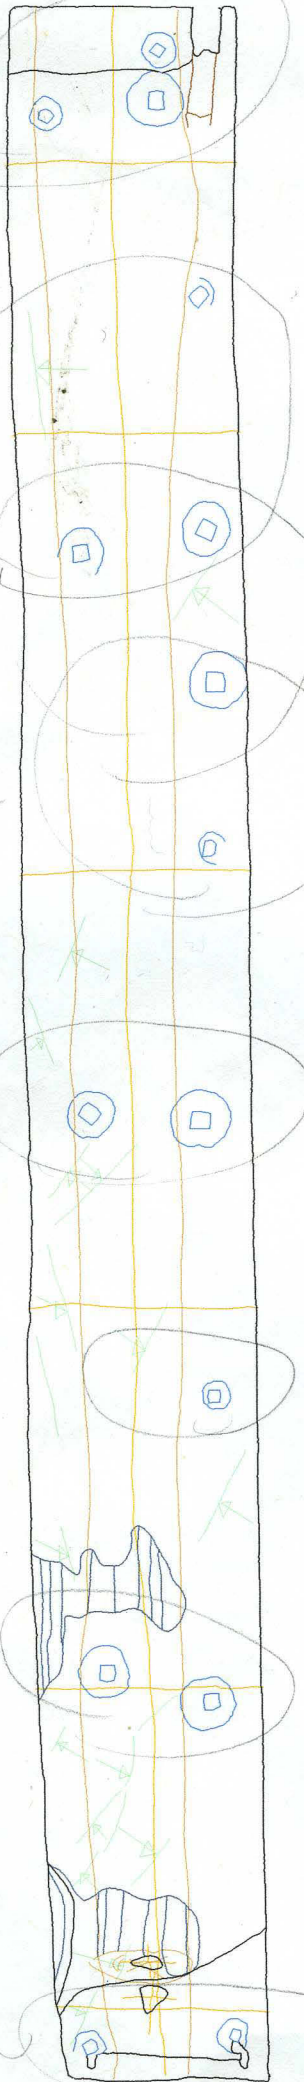
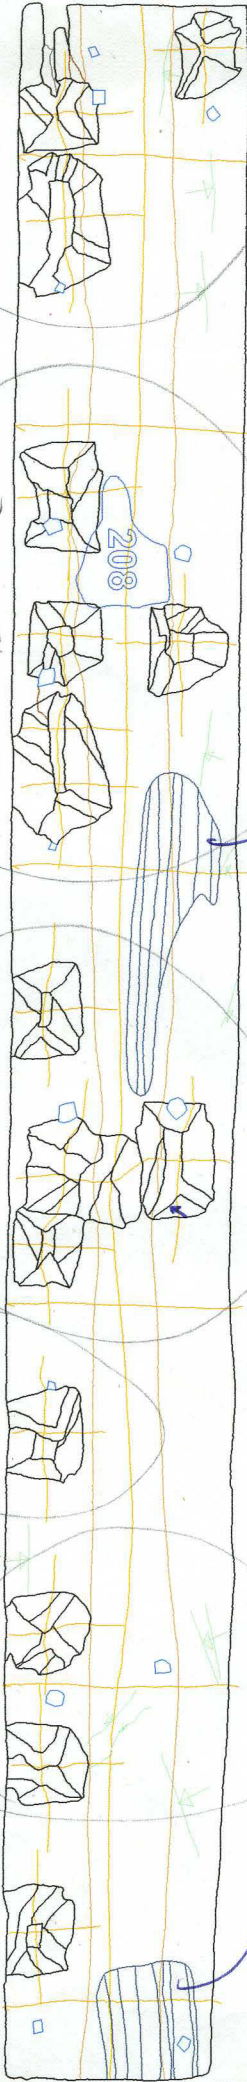
208 Tingle P9_4/5 Toby N. Jones 12.10.05

Tool signatures on 1B + 0B faces same tool - cf P9.4 + P9.5.

No barnacles found on outboard face. Co Tool signatures -
photo, mould, compare?
