DB 13/2/8

209 Tingle P12_4 or 5 Toby N. Jones 01.10.05

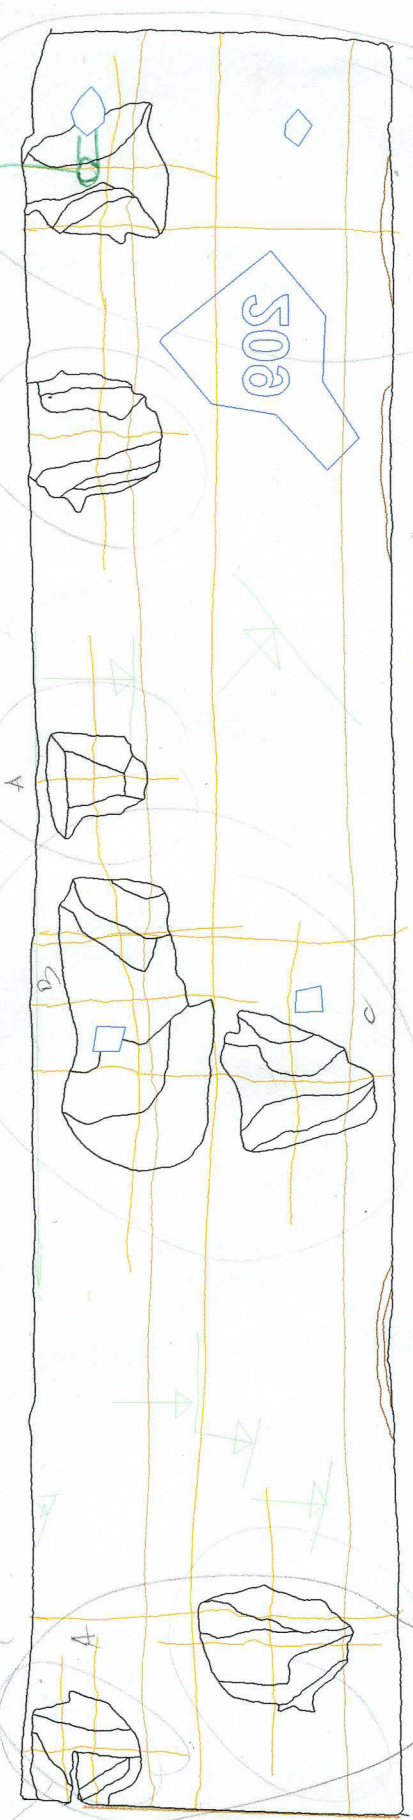
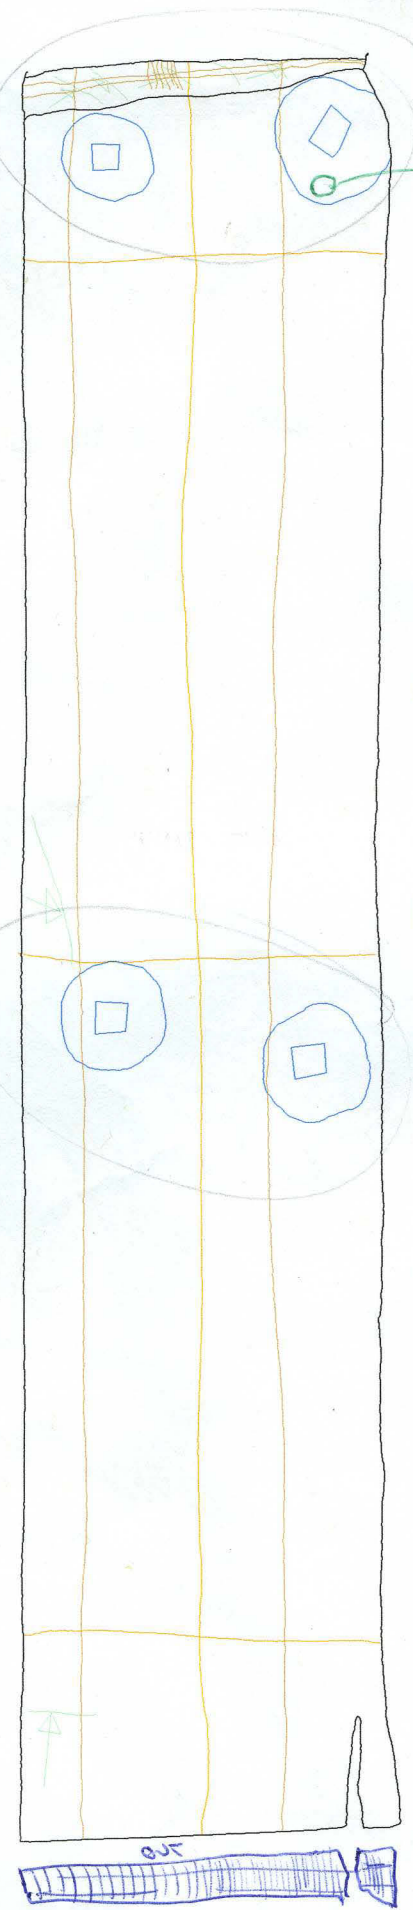
Cow Tag: 209		Function Code: P12-4/5 Tingle
Brief Description: [timber element, p/s, condition, fragments] Tingle		
Notable Features: [tool marks, scribed lines, decoration, repairs] POINTS TO LOOK OUT FOR WHEN RECORDING ufos Sawn on one end Excellent striations on toolmarks - see on inboard face and outboard face - probably same tool based on repeated signature and direction. - TNJ ✓ MM		
Wood Science: [rings, ARW, knots, sapwood, conversion] radial, slow growth - cf DEND		
Recommended action: [samples, additional photos, moulding, queries and problems] Need to check for sample taken for dendro, → FARO Marked tool signatures - cf adjoining plank + other tingles. Photos also.		
Cleaned: TNJ 31.10.05	Recorded: TNJ 01.11.05	Photos: 16/02/06 MMRD IN: TOOL SIGNATURE REBAID FOR NAILS OUT: TOOL SIGNATURE + NAILS
Checked: [corrections needed] Need to add wooden nail!		Initials & Date: MM-4/11/5
Corrections Done [desktop, Faro Arm?]:		Initials & Date:

modern, new
42

Modern Sawm Edger?
