Cow Tag <b>321</b>	Function Code <b>5/6.24</b>	
<b>Brief Description: [timber element, p/s, condition, fragments]</b> TRUNCATED PLANK - 95% of aft scarf missing INBOLDED surface v. soft		
<b>Notable Features: [tool marks, scribed lines, decoration, repairs] POINTS TO LOOK OUT FOR WHEN RECORDING ufos</b> INBOLDED :- T.1 1m of aft (5-10m) of 2nd T.N from aft end (v. joint) LINES 1m of 2nd T.N from aft end (v. joint) Line 1m of 3rd T.N from aft end T.1 1m between 3rd + 4th T.N from aft end Age lines on level between 4th + 5th T.N from aft end V. joint remains of 1m 5cm from aft 5th T.N from aft end, towards upper edge of plank, also @ 10 + 15 cm from middle of plank Marked cut at aft scarf: ↓ P.T.O		
<b>Wood Science: [rings, ARW, knots, sapwood, conversion]</b> 115H + 55. Radial. ARW = 220/120 Pith beyond lower edge. Straight grained.		
<b>Recommended action: [samples, additional photos, moulding, queries and problems]</b>

321 S10\_2A Yardeni Forest 22 August 2006

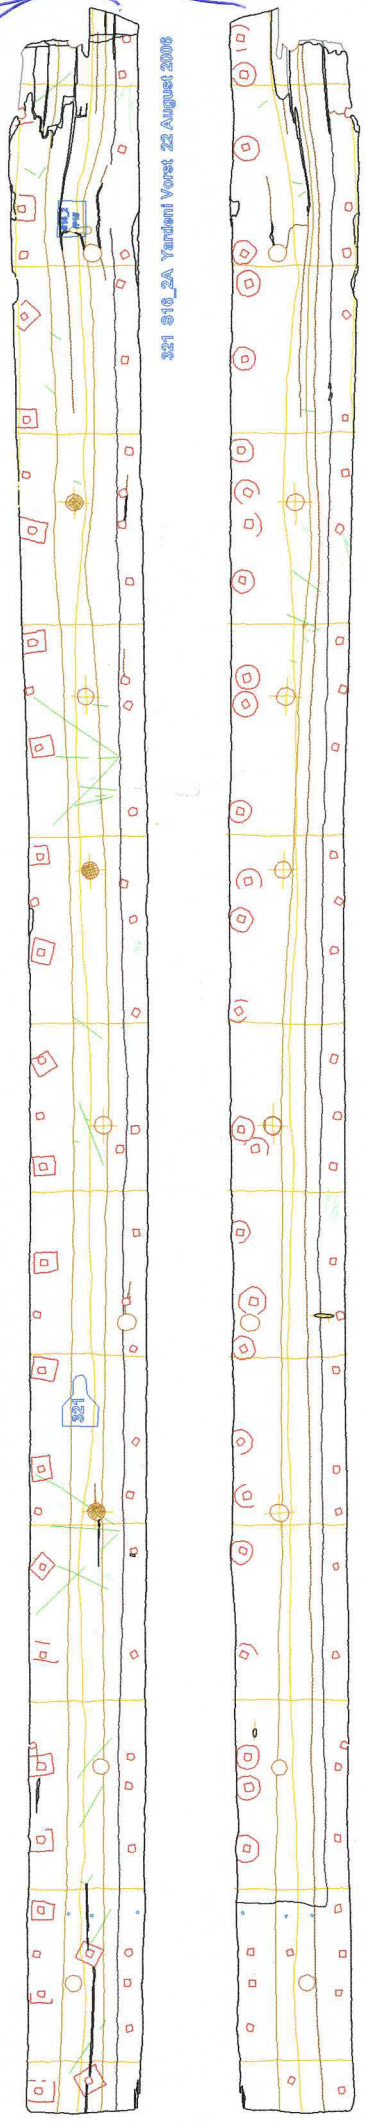
- T. 1. Lines for of 3rd T.N from for end,
- Line 5cm aft of 3rd T.N from for end
- Line 15 cm for of 3rd T.N from for end, crossing above T. 1
- Line mid for of 2nd T.N from for end
- Line 10cm aft of for edge of plate

- T. 1. mid way between 2nd & 3rd T.N.
- from aft end - nice and sharp lines
- Small vertical or marks? aft of 3rd T.N from
- aft end?

outboard: animal size holes between 7th & 8th keel near land.
