Cow Tag <u>423</u>		Function Code <u>TINOLE OB/18?</u>
Brief Description: [timber element, p/s, condition, fragments]		<u>S16.6 - 16.7</u> <u>TINOLE</u>
Notable Features: [tool marks, scribed lines, decoration, repairs] POINTS TO LOOK OUT FOR WHEN RECORDING <u>ufos</u> <u>N.N.17</u> <u>IB: compression mark from tenon?</u>		
Wood Science: [rings, ARW, knots, sapwood, conversion]		<u>Reeded. c 75 H ARW = 170 / 75</u> <u>P.A. beyond upper edge</u>

423 OB Tingle S19\_5 or 19\_6?? Yardeni Vorst 12 September 2006

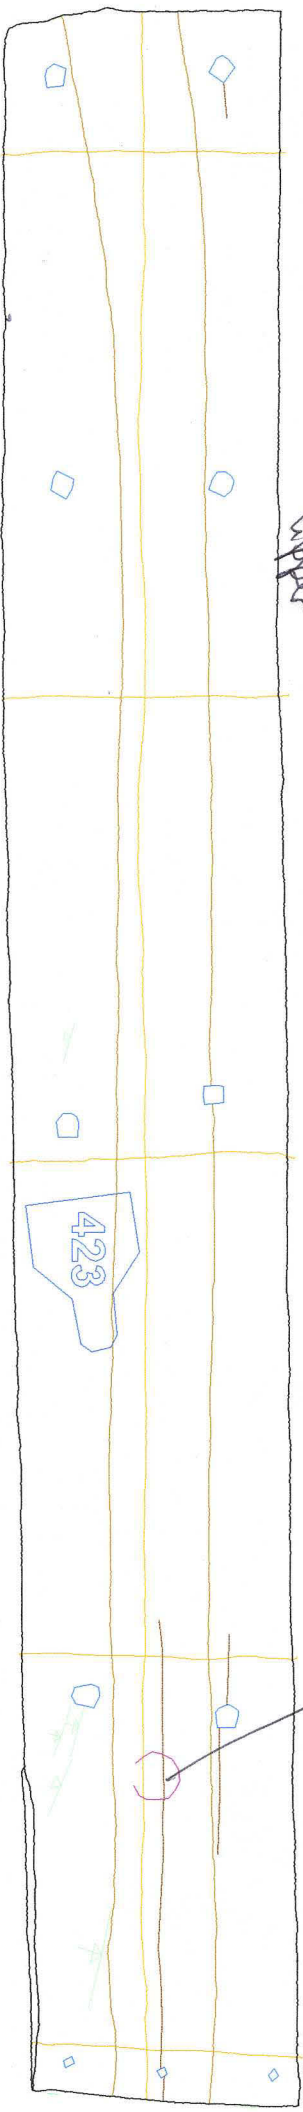
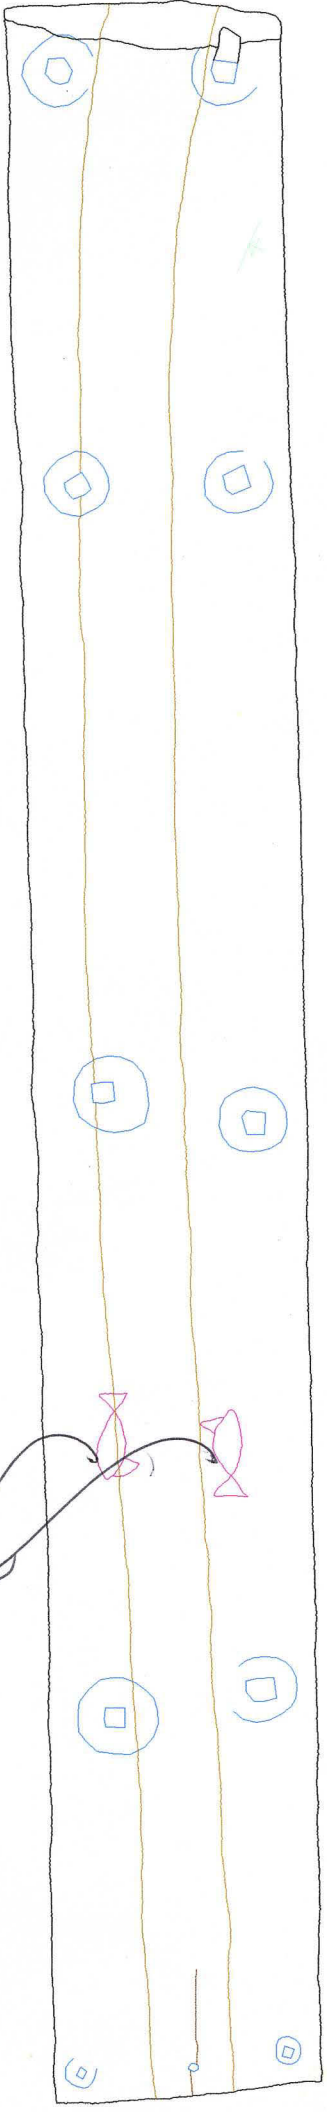
Recommended action: [samples, additional photos, moulding, queries and problems] <u>problem: not clear where timber goes: (is it 08?) and on which plank(s)</u> <u>original number = 2152 -&gt; (goes between S19.5 &amp; S19.6 -&gt; S19.5 doesn't seem to have a tingle) S19.6 isn't drawn yet.</u> <u>re schematic S16.6 / S16.7. sorted. DEAD</u>		
Cleaned: <u>11/09/06</u> <u>EV JLF JS</u>	Recorded: <u>12/09/06</u> <u>DV</u>	Photos:
Checked: [corrections needed] <u>✓</u>	Initials & Date: <u>NN18/10/6</u>

upper

compensation  
RHid

inward

sorted  
-see  
Dense file.
