Cow Tag 465	Function Code 515.4	
Brief Description: [timber element, p/s, condition, fragments] Large plank, <u>deformed</u> otherwise good condition		
Notable Features: [tool marks, scribed lines, decoration, repairs] POINTS TO LOOK OUT FOR WHEN RECORDING ufos Inboard: inscribed lines next to cow tag (type 1). Tool marks (axe) on upper side. Outboard: inscribed lines. 2 additional marks		
Wood Science: [rings, ARW, knots, sapwood, conversion] Several distinct knots (epicormic?) Radial 80H+5S. ARW = 250/85 Pith beyond upper edge.

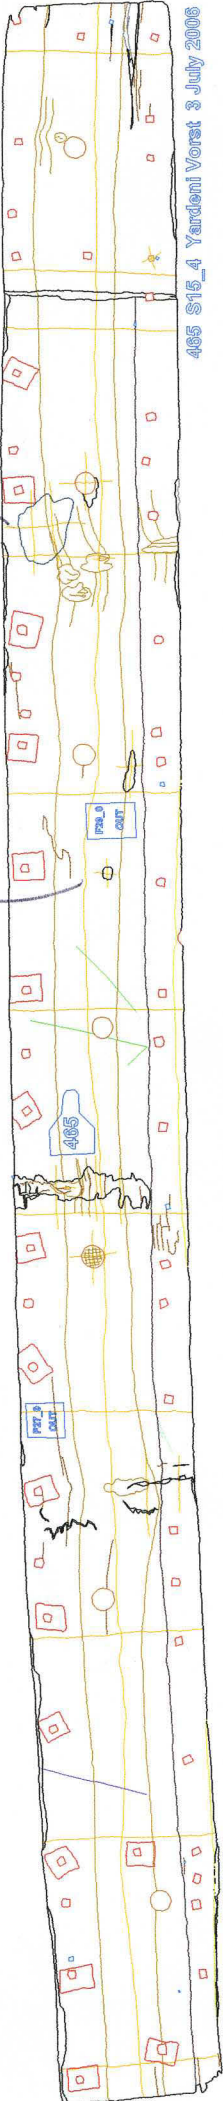
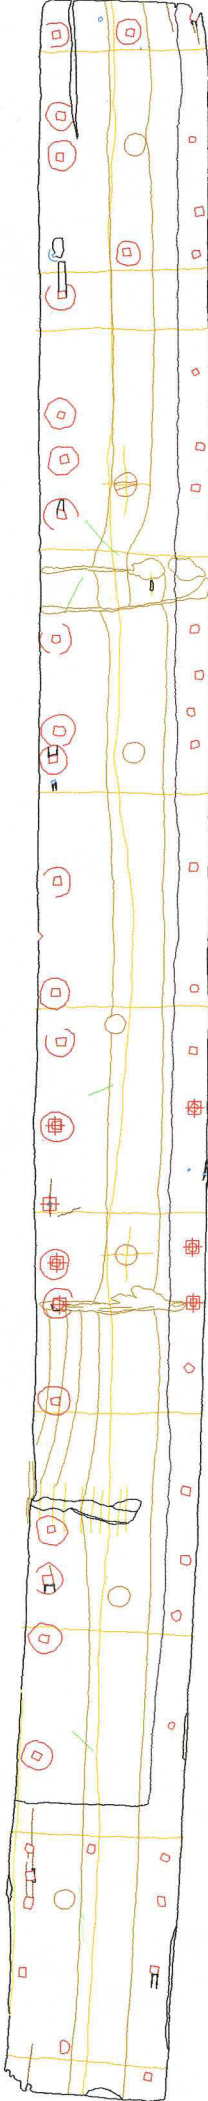
485 S15_4 Yardeni Vorst 3 July 2006

Recommended action: [samples, additional photos, moulding, queries and problems] <ul style="list-style-type: none"> inboard: possible clamp-mark next to label F29 cut but recorded as limit of original edge nail angles of small additional nails <u>not</u> taken with 15cm rod outboard: between 3rd & 4th treenail outboard: wedge in 6th treenail inboard: inscribed lines type 1 inboard: line recorded as wear (purple) looks like a compression mark but unlikely to be of a frame because of the angle. <div style="text-align: right; margin-top: 10px;"> + ③ type 2 mark between trees with 5&6 followed by a type 1 mark </div>

more likely
with bar
outer

clump neck
