Cow Tag 466		Function Code 5 14- 3 3	
Brief Description: [timber element, p/s, condition, fragments] SOLID PLANK, SEVERELY MARKED. Near complete.			
Notable Features: [tool marks, scribed lines, decoration, repairs] POINTS TO LOOK OUT FOR WHEN RECORDING ufos			
<p>IN BOARDS:- DEEP IMPRESSION OTV LINES 15 cm AFF OF COW TAG - Yes but forward of center.</p> <p>SEMI CIRCULAR IMPRESSION LINE FROM 60 cm FROM AFF TO 1 m FROM OF AFF LINE 20 cm FROM OF COW TAG LINE 2 m AFF OF FROM END</p> <p>OUTBOARDS:- POSSIBLE INSCRIBED LINES TOWARDS THE AFF END OF TIMBER</p> <p>STRANGE MOULDINGS C. L. 6 m FROM AFF END OF PLANK - PRES POST DEP - NIGEL</p> <p>- Inboard: limits with lots of snits over it over the width of the plank are compressed areas</p> <p>- Inboard: two small elongated additional (nails) holes on & just under the land one near aft end, one near forward end. (drawn as limits, but put an angle on it)</p>

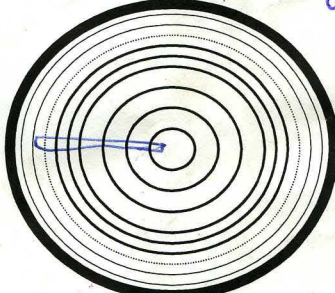
<p>Radial, p/s beyond lower edge 90W45S. ARW = 24S/AS. Numerous epicormic? branches.</p>			
Recommended action: [samples, additional photos, moulding, queries and problems]			
<p>→ Check on coding for SH4.</p>			
Cleaned: KM BJ 20/06/06 LB MJ VT	Recorded: 13/07/06 DV	Photos:	
Checked: [corrections needed] ✓		Initials & Date: NN 26/7/6.	
Corrections Done [desktop, Faro Arm?]:		Initials & Date:

- Inboard: two possible clamp marks
- NB forward end of plank does have normal end, therefore no ring of 90W45S!
Wrong!
