Report 846

### Archaeological watching brief at 150-156 Fratton Road, Portsmouth, 2007/12

Client: Rok

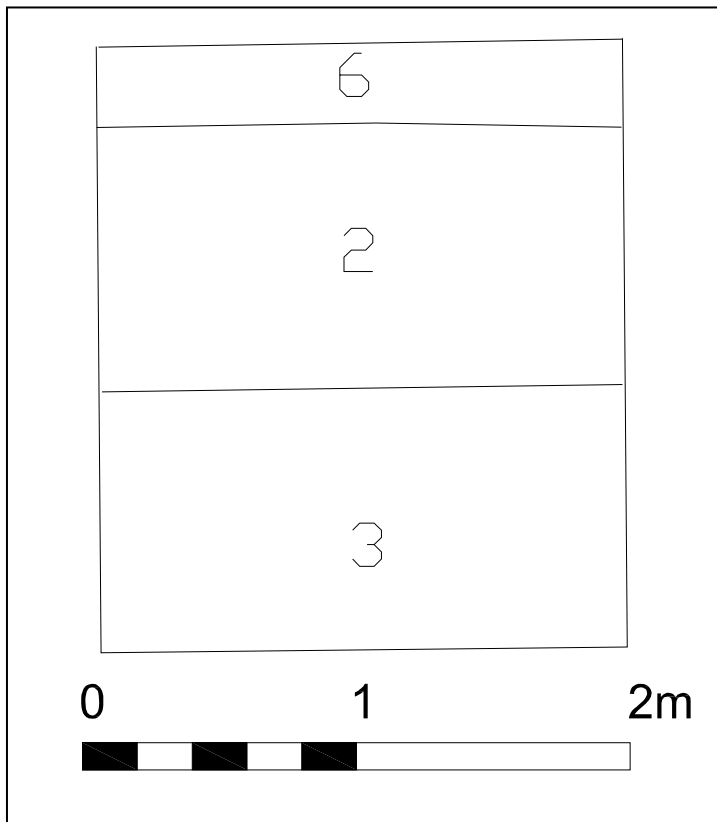
Figure 3: East-facing section of trench 1.

The earliest deposits encountered were layers 2 and 3 (Fig 3). A sandy loam, layer 3, was observed in trenches 1, 2 and 4, in the north of the site. It was yellowish brown in colour (10YR 5/4), was at least 1 m thick, and was situated 1.3m below the surface. A clay loam layer, context

2, was situated 200mm from the surface. It was observed in the majority of trenches. It was yellowish brown in colour (10YR 5/8) and was up to 1.3m thick in places.

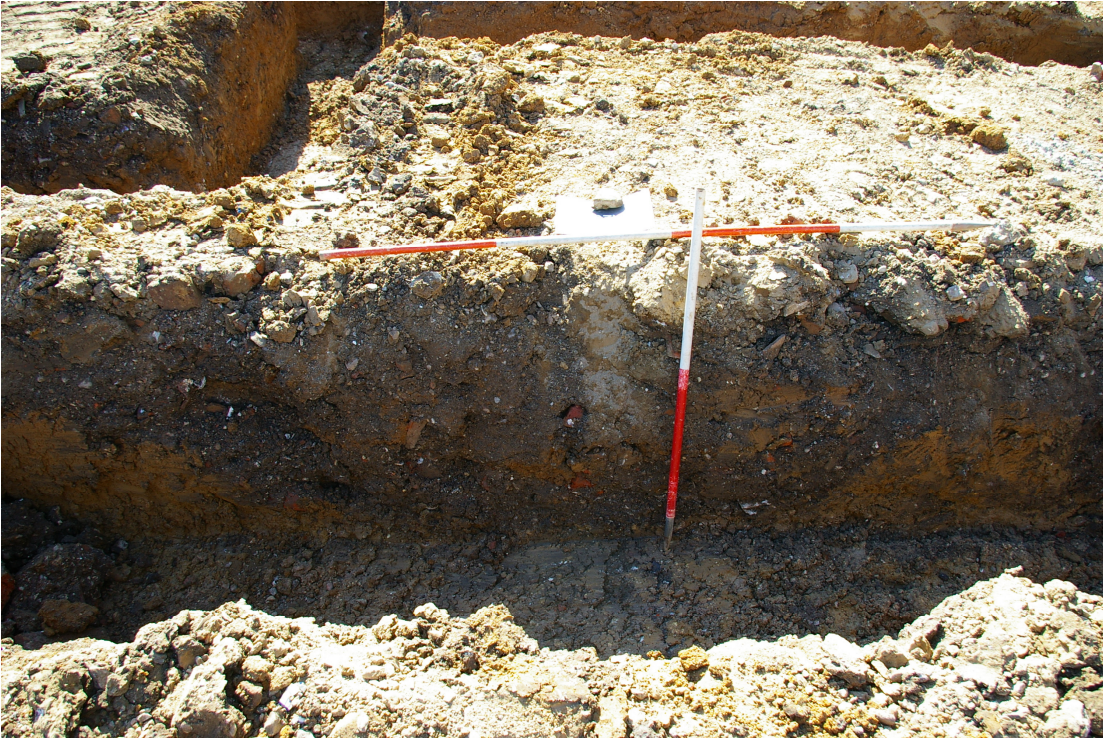
Figure 4: East-facing section of trench 7, showing pit 14 cutting 2.

A pit, context 14, was observed in trench 7 in the northern part of the site. It cut through natural, context 2, and was sealed below a clay loam layer, context 16 (Fig 5). The eastern and western edges of this pit were not observed as they continued outside the boundary of the trench. It was not bottomed, so its full dimensions were not observed. It was 2.07m wide, at least 1 m long and 500mm deep. The sides sloped at a 30 degree angle from vertical.

Pit 14 was filled with a very dark grey (10YR 3/1) clay loam, context 15, which included fragments of oyster shell, brick, roof tile and pot. The pottery consisted of a 16-17<sup>th</sup> century fragment of red earthenware. The internal glaze, and burning on the outside suggest it was a cooking pot. The roof tile fragment had mortar on all sides including a broken edge showing it may have been re-used in later building work.

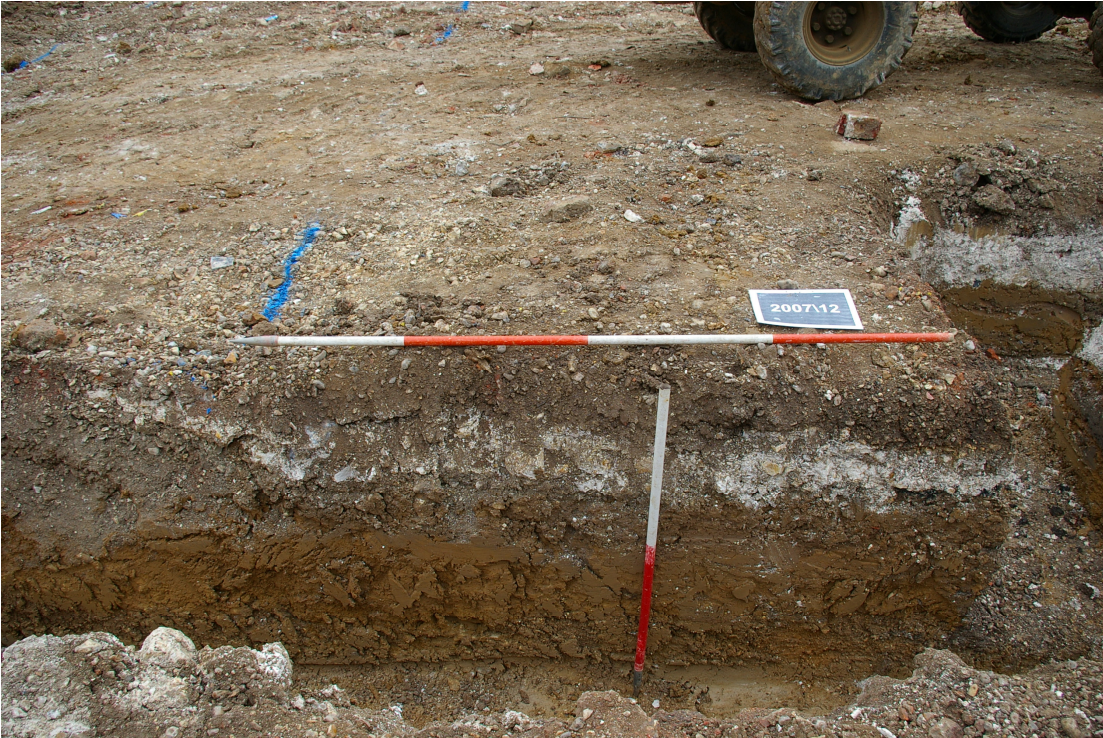
Figure 6: East-facing section of trench 12, showing pit 19 and chalky fill 21.

A large, irregular, shallow pit, context 19, was found in trenches 4, 11, 12, 13, 16, 17 and 18 in the centre of the site. It cut through the natural, context 2, and was sealed below clay loam layer 16. It

was 9.9m long, 8.5m wide and 0.8m deep. The sides sloped at a 30 degree angle from vertical and the base was near flat.

Pit 19 had two fills, contexts 20 and 21. Fill 20 was a dark greyish brown (10YR 4/2) clay loam, which included flint nodules and a few fragments of brick and tile. The roof tile was dated to the 16-17<sup>th</sup> century and not local to Portsmouth but was from the south Hampshire area. The brick was local and was dated to the post-medieval period.

Fill 21 was above 20 and was a light grey (10YR 7/1) chalky fill (Fig 6). It contained very few fragments of brick and pot. One fragment of pot was a small sherd of red earthenware with an internal glaze, dated to the early post-medieval period.

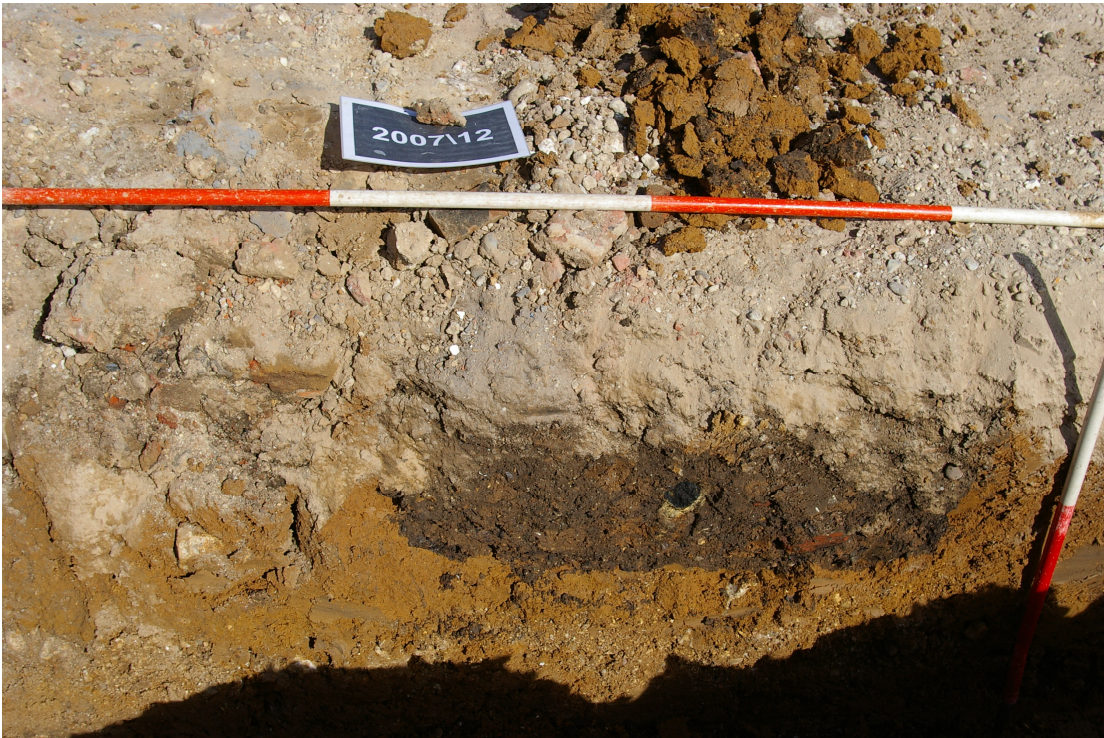
Figure 9: West-facing section of trench 21, contexts 25 and 26

A pit, context 25, was found in the west-facing section in trench 21 in the east of the site. It cut through the natural, context 2, and was sealed below overburden 1. It was 1.1m wide and 280mm

deep. The sides sloped at a 20 degree angle from vertical and the base was near flat (Figs 9 and 10).

Pit 25 was filled with a very dark grey (10YR 3/1) clay loam, context 26, which included fragments of coal, early 19<sup>th</sup> century brick and pot. The pottery was a residual fragment of early verwood which had a green internal glaze dated 17-18<sup>th</sup> century.

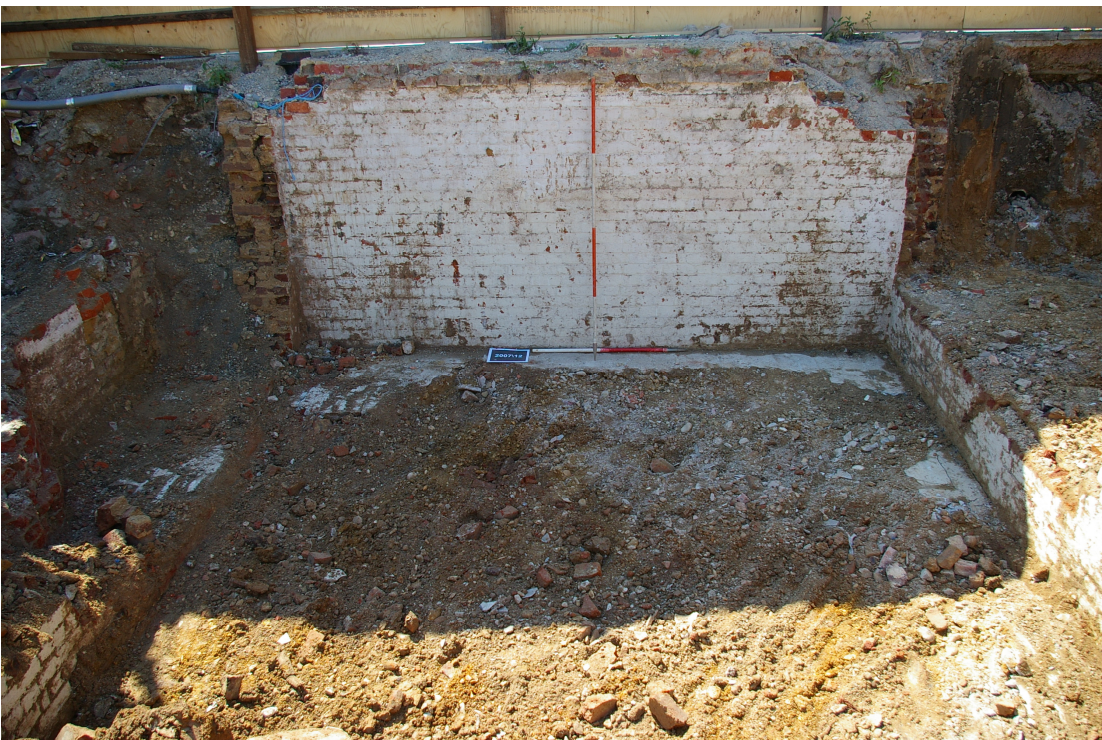
Figure 11: East-facing section of trench 9, contexts 17 and 18

Construction trench 17 was observed in trench 9. It was 7m in length, 4.4m wide and 2m deep. It cut contexts 2 and 3 and contained the brick cellar walls, context 18. The bricks from this wall were dated 19<sup>th</sup> century.
