ARCHAEOLOGICAL WATCHING BRIEF
DURING GROUNDWORKS AT
STONE HOUSE, CORVE STREET,
LUDLOW,
SHROPSHIRE

Archaeological watching brief during groundworks at Stone House, Corve Street, Ludlow, Shropshire

Mike Napthan MIFA
5th March, 2012

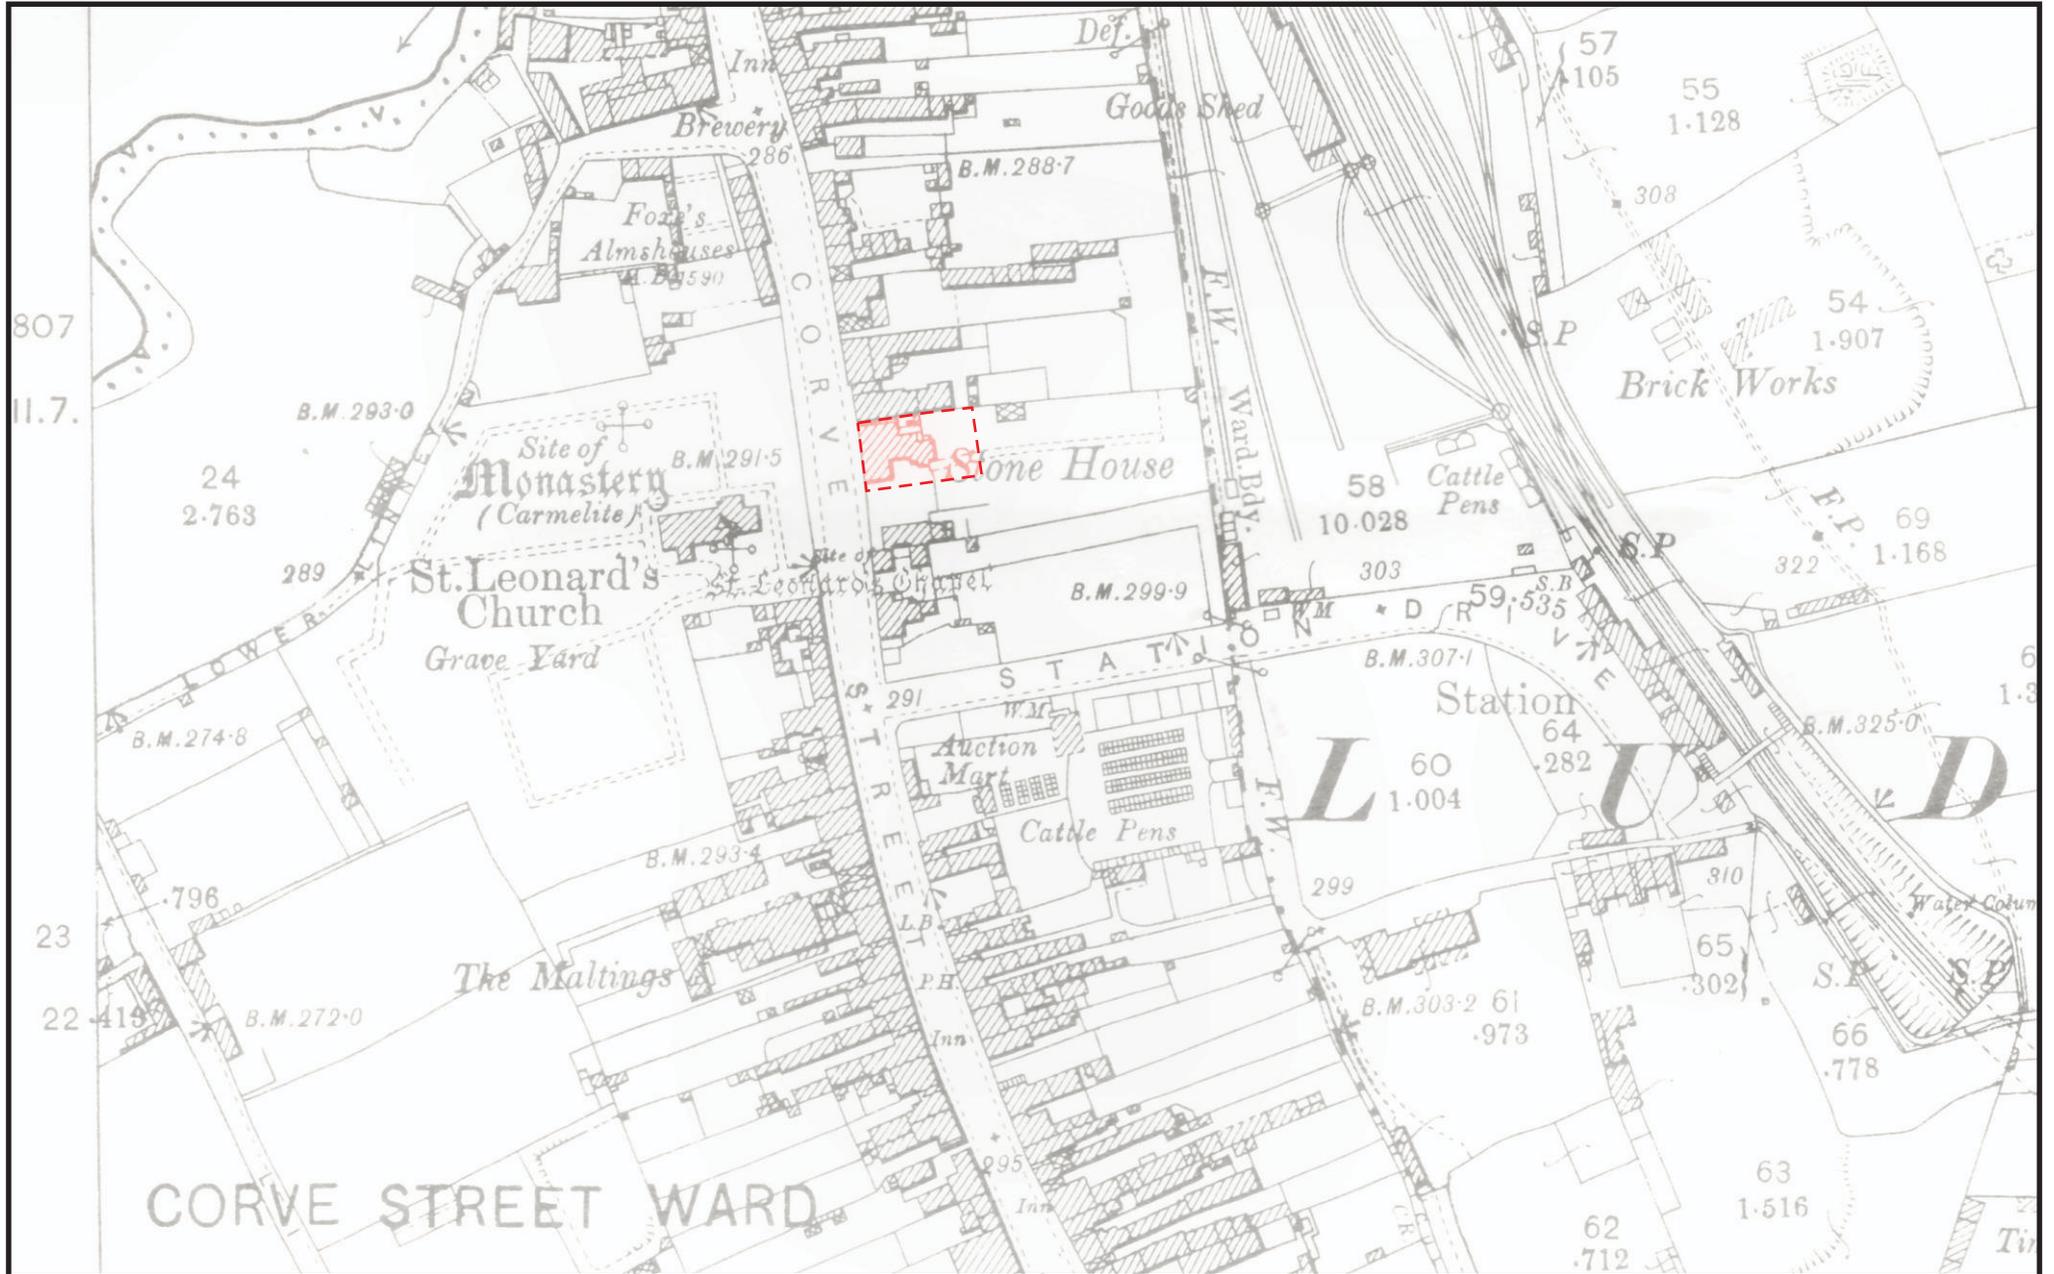
Figure 2: Site location overlaid on 1903 Ordnance Survey mapping

openings to sides; 2-panel, imitation 2-leaf, door. Returned sides: returned cornice, frieze and parapet; 1st floor storey band. Wing to rear has lantern and half hipped roof, with further hipped roof to rear gable with kneelers to coped parapet on enriched corbels; stone segmental flat arch over 15/10 sash. Stone stack, with brick above roof level. Interior: open well staircase with stick balusters; rear winder stair with stick balusters; ornamental plasterwork, including panelled light-well; fireplaces. (Ludlow Historical Research Group; Clifton-Taylor, 1978 p166). The house is little changed in plan since the mid 19th C, and early Ordnance Survey mapping (Fig 2) shows no earlier buildings within the intended rear garden area.

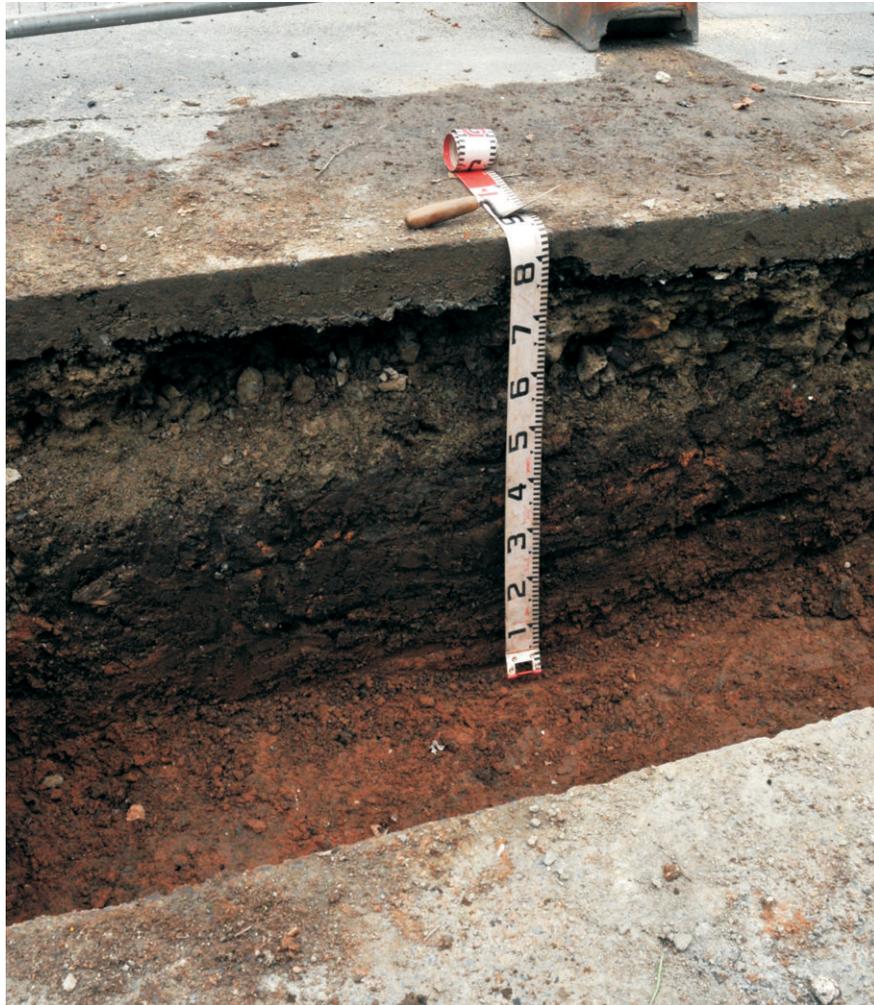
East side of north-west leg of trench - showing typical sequence of deposits - scale in 10cm divisions.

- 5.4 The predominant material excavated from the trench was a layer (Layer 4) -averaging 0.35m deep, of mixed reddish grey brown friable clay loam, containing frequent charcoal flecks, occasional clay tobacco pipe stems and very occasional blue decorated white china, with occasional small animal bone. At the base of the layer were several fragments of stone roofing tile (Fig 5). The nature of the artefacts indicate a very late 18th or more probably early-mid 19th C date for this horizon.

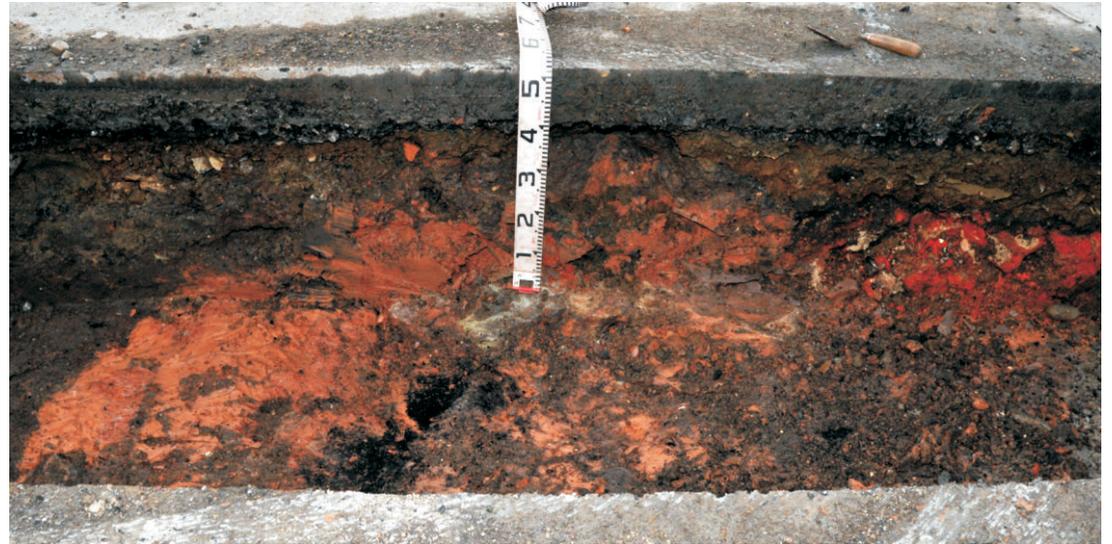
Patch of red clay, marl, soot and brick rubble on south side of east-west leg of trench - apparently of recent (mid 20th C) date

- 5.5 In the southern arm of the trench there was a large amorphous patch of red clay and reddish marl intermixed with a little brick rubble (see Figs 3,4 and 5)). The patch was not fully exposed within the limits of the trench, but was approximately 2.4m across, and at least 0.15m deep. It lay within a cut that was clearly later than Layer 4, but that pre-dated the roadstone of the carpark (Layer 3). The patch of clay may represent a large backfilled feature which lies mostly to the south of the trench, or simply levelling up of the site prior to car-park construction. The nature of the red clay is reminiscent of the raw material of brick making, and it is possibly derived from one of the several nearby former brickyards which survived into the mid 20th C.

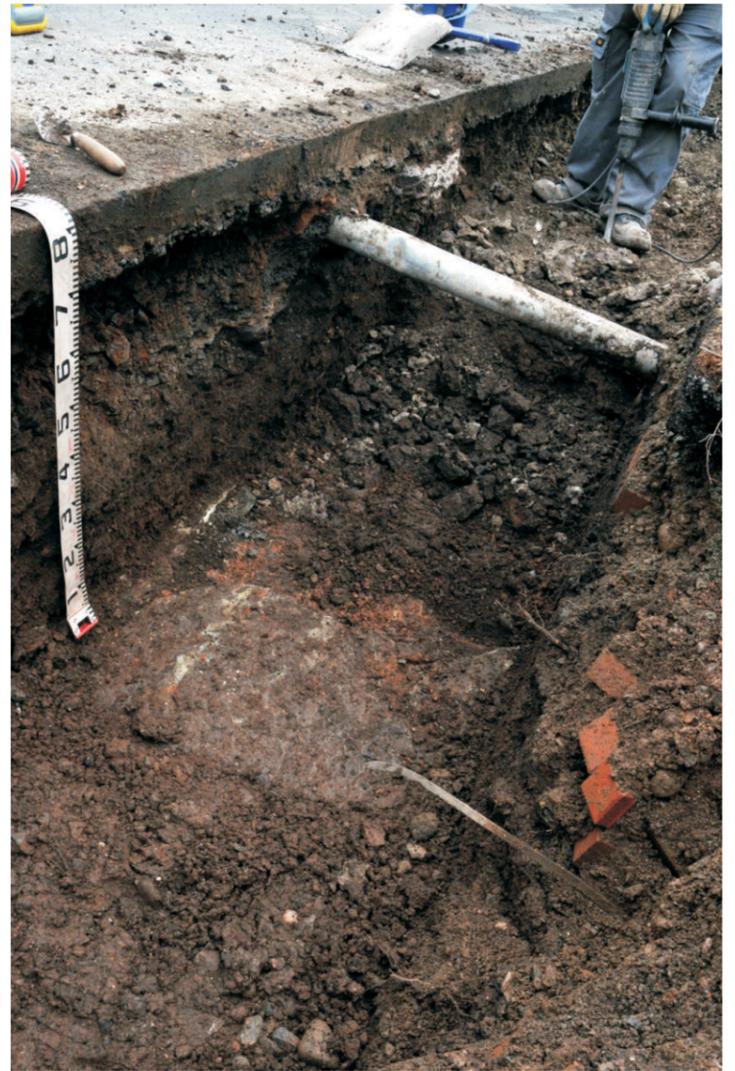
Possible stone foundation "F1" exposed in base of trench

- 5.3 Two possible sections of vestigial stone wall foundation (F1 and F2) were observed crossing the eastern arm of the trench (Figs 3 and 5). Of the two the northernmost (F1) was the most convincing, consisting of several large flat stones directly overlying Layer 5, and in some places overlapped (Fig 5). The line of stones was a maximum of 0.7m wide, and apparently aligned at a right angle to Corve Street (similar to the rear part of Stone House). The surviving stonework was apparently less than 100mm deep, the top being 0.83m below the carpark surface (so at approximately 88.00mAOD according to the supplied survey plans). The stonework was not removed, so it was not certain that the foundation was any deeper, but there was no clear indication of a foundation cut. The possible foundation F2 was less well preserved, but apparently of similar character. It consisted of a linear patch of several smaller flat stones and a little lime mortar bedding. It was aligned as a continuation of the south wall of the rear wing of Stone House, but otherwise might be interpreted as a small patch of demolition rubble, or possibly a pathway.
