BUILDING RECORDING AT
WINNALL LODGE,
LINEHOLT, OMBERSLEY,
WORCESTERSHIRE

WSM 46062

Building recording at Winnall Lodge, Lineholt, Ombersley,

(With a report on the tree-ring dating by A J Arnold and R E Howard)

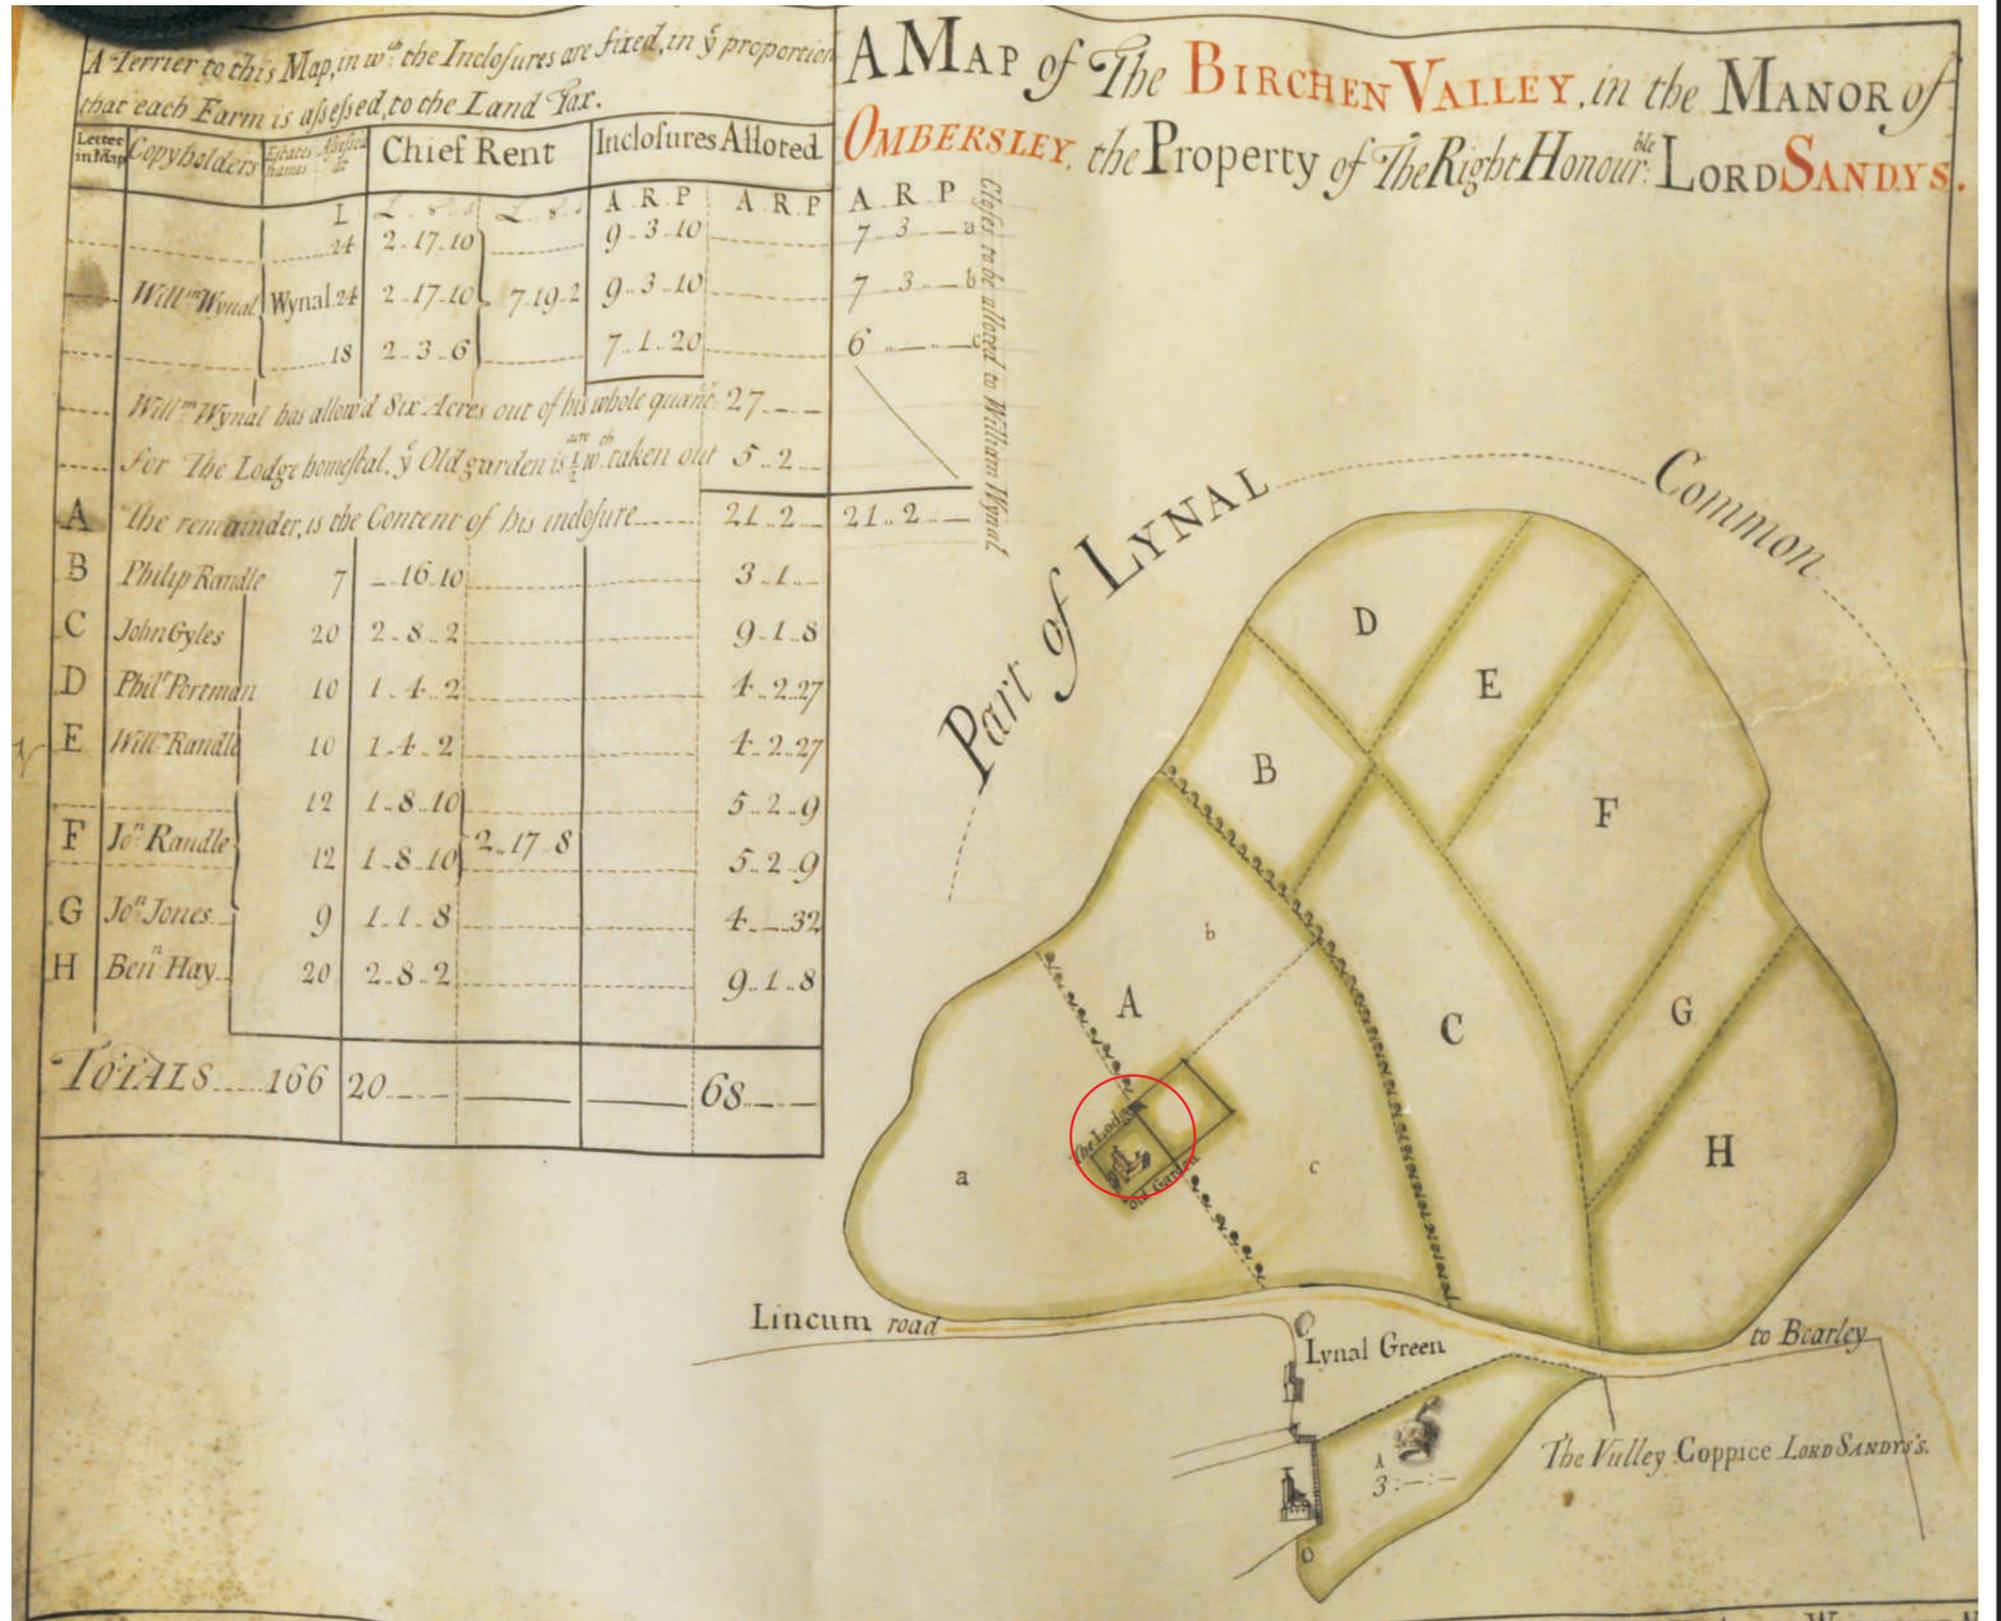
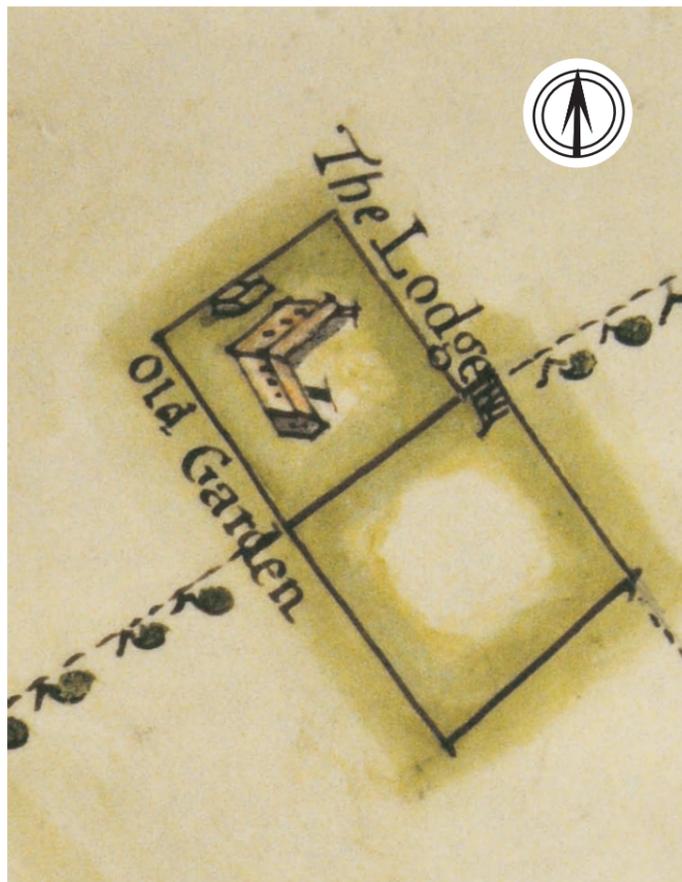
Figure 1: The earliest detailed plan of this part of Ombersley, by John Doharty, November 1751, showing the location of Winnall Lodge (ringed) with inset enlarged detail of the house (WRO BA 3972/17 ref r705:56)

- 7.1 The earliest detailed map or plan of this area is an estate map of 1751 drawn up apparently in respect of the inclosure of the southern end of Birchen Valley. (Fig 1: WRO BA3972/17 ref r705:56 (another copy at BA 3972/18). It is titled “*A map of the Birchen Valley in the Manor of Ombersley, the Property of the Right Honour[a]ble the Lord Sandys, Survey[e]d and Alloted by J Doharty Worcester, Novem[bris] 1751*”. This plan is particularly interesting as it shows a small sketch of the house, then an “L” shaped 1½ or two storey building, probably of three bays in each wing as each has three windows not including those in the gable ends. , In this sketch the east-west range being is at the northern end, the two wings meeting in the NW corner, with a further small, detached outbuilding to the north. Both ranges of the house have chimneys marked, so it would appear that the whole was a domestic building. The plan also indicates that the northern part of Birchen Valley was apparently enclosed first, and by that date was a discrete copy-hold land holding held by William Winnall. Of interest is the fact that the curtailage of the house is shown as “Old Garden”, suggesting that the property was already well established by this date.

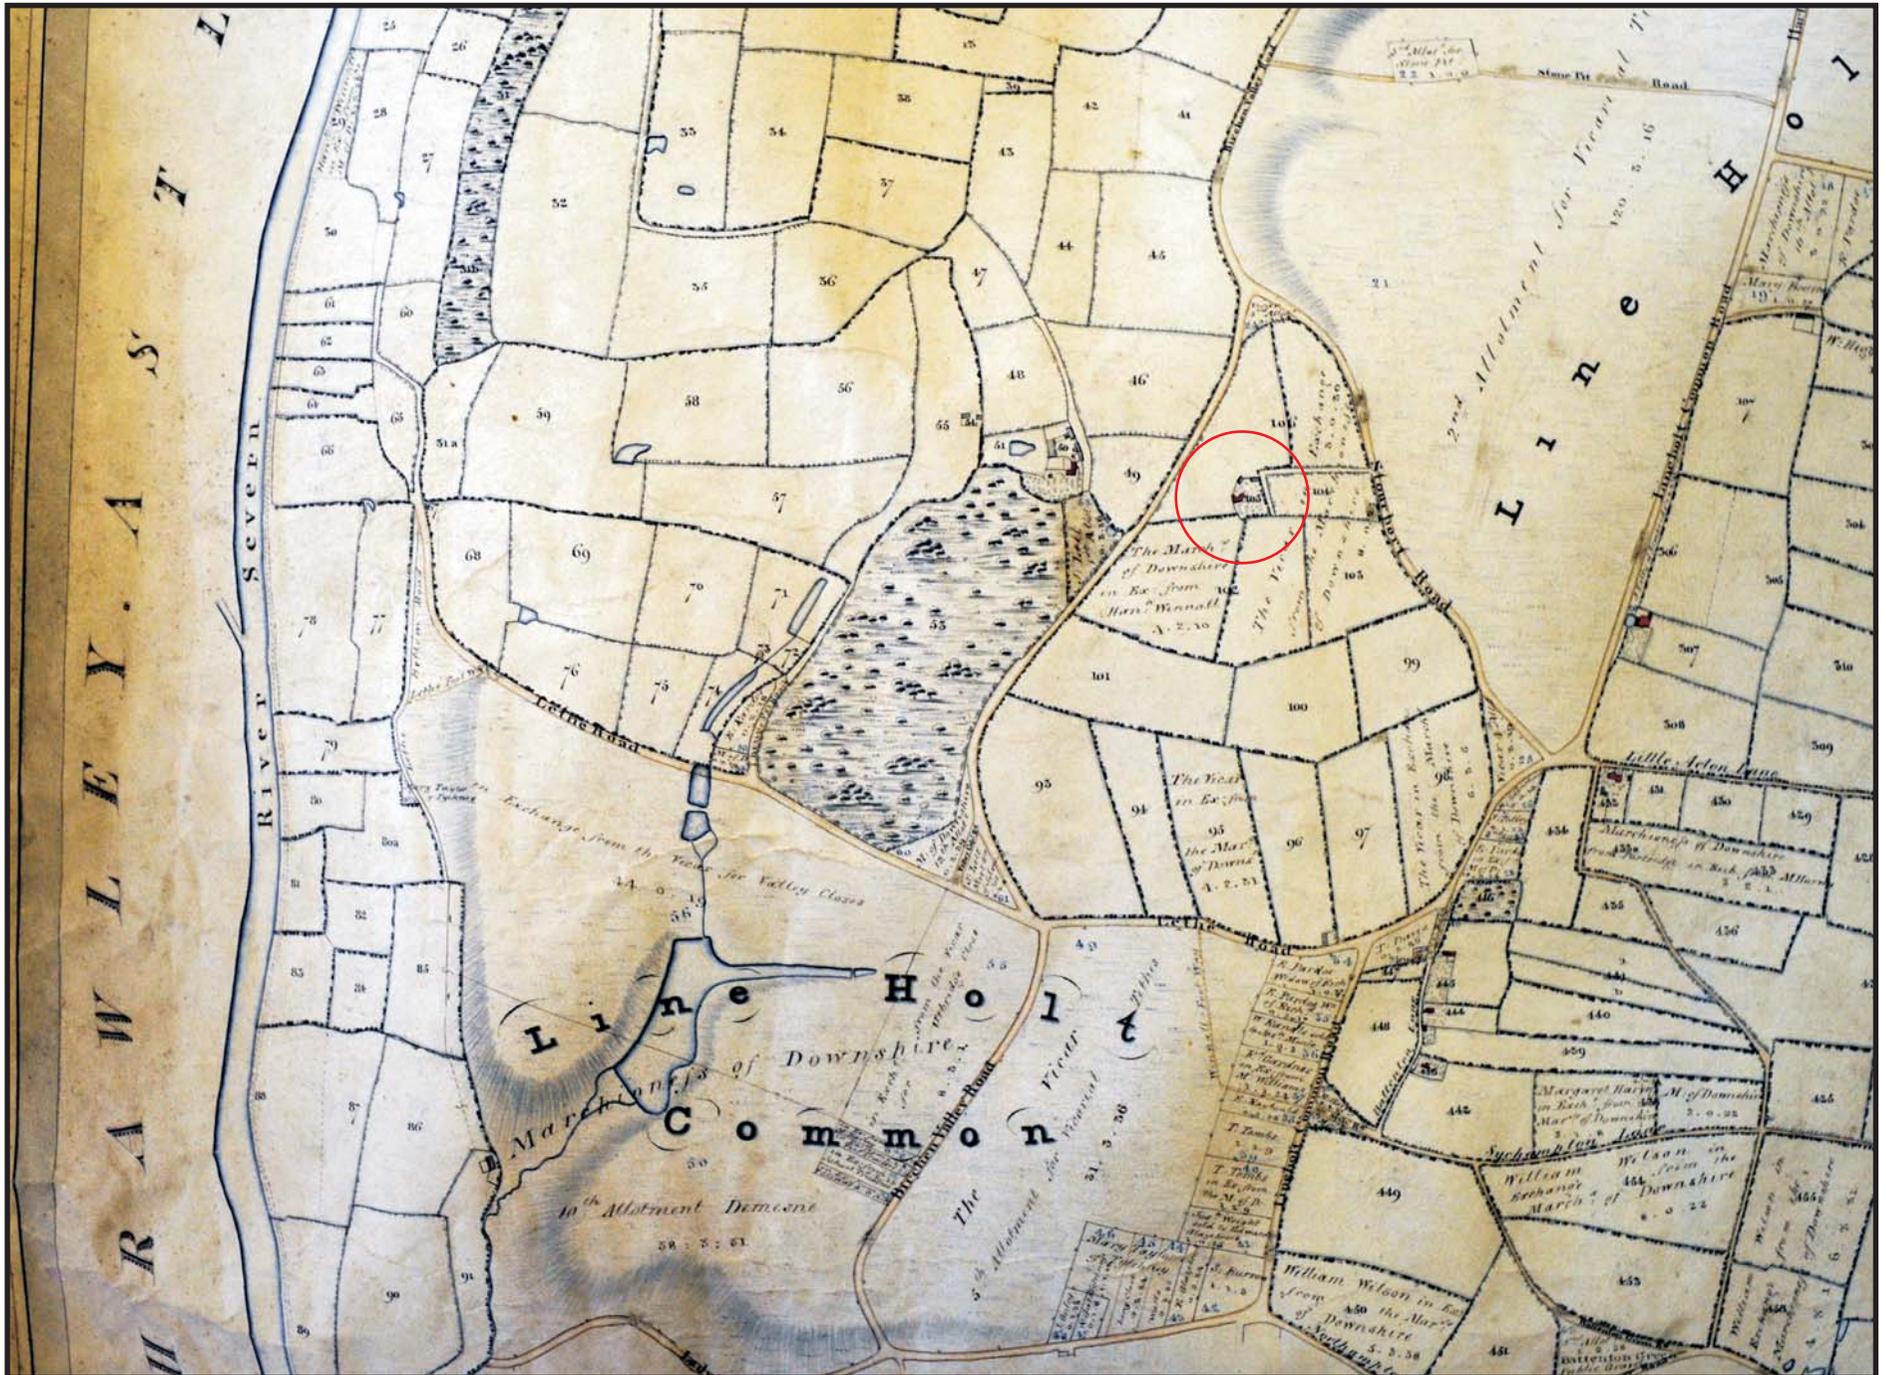
Figure 2: Inclosure Awards plan for Ombersley c.1824, showing the location of Winnalls Lodge (ringed) in relation to the newly inclosed Common

- 7.2 The next plan dates to circa 1800 (WRO BA 1294 ref x705:56) it is titled “Plan of the parish of Ombersley” and is drawn to a scale of 40 chains to half a mile [1: 2391]. It shows a rather different layout of buildings than the Doharty plan, and this cannot all be attributable to cartographic

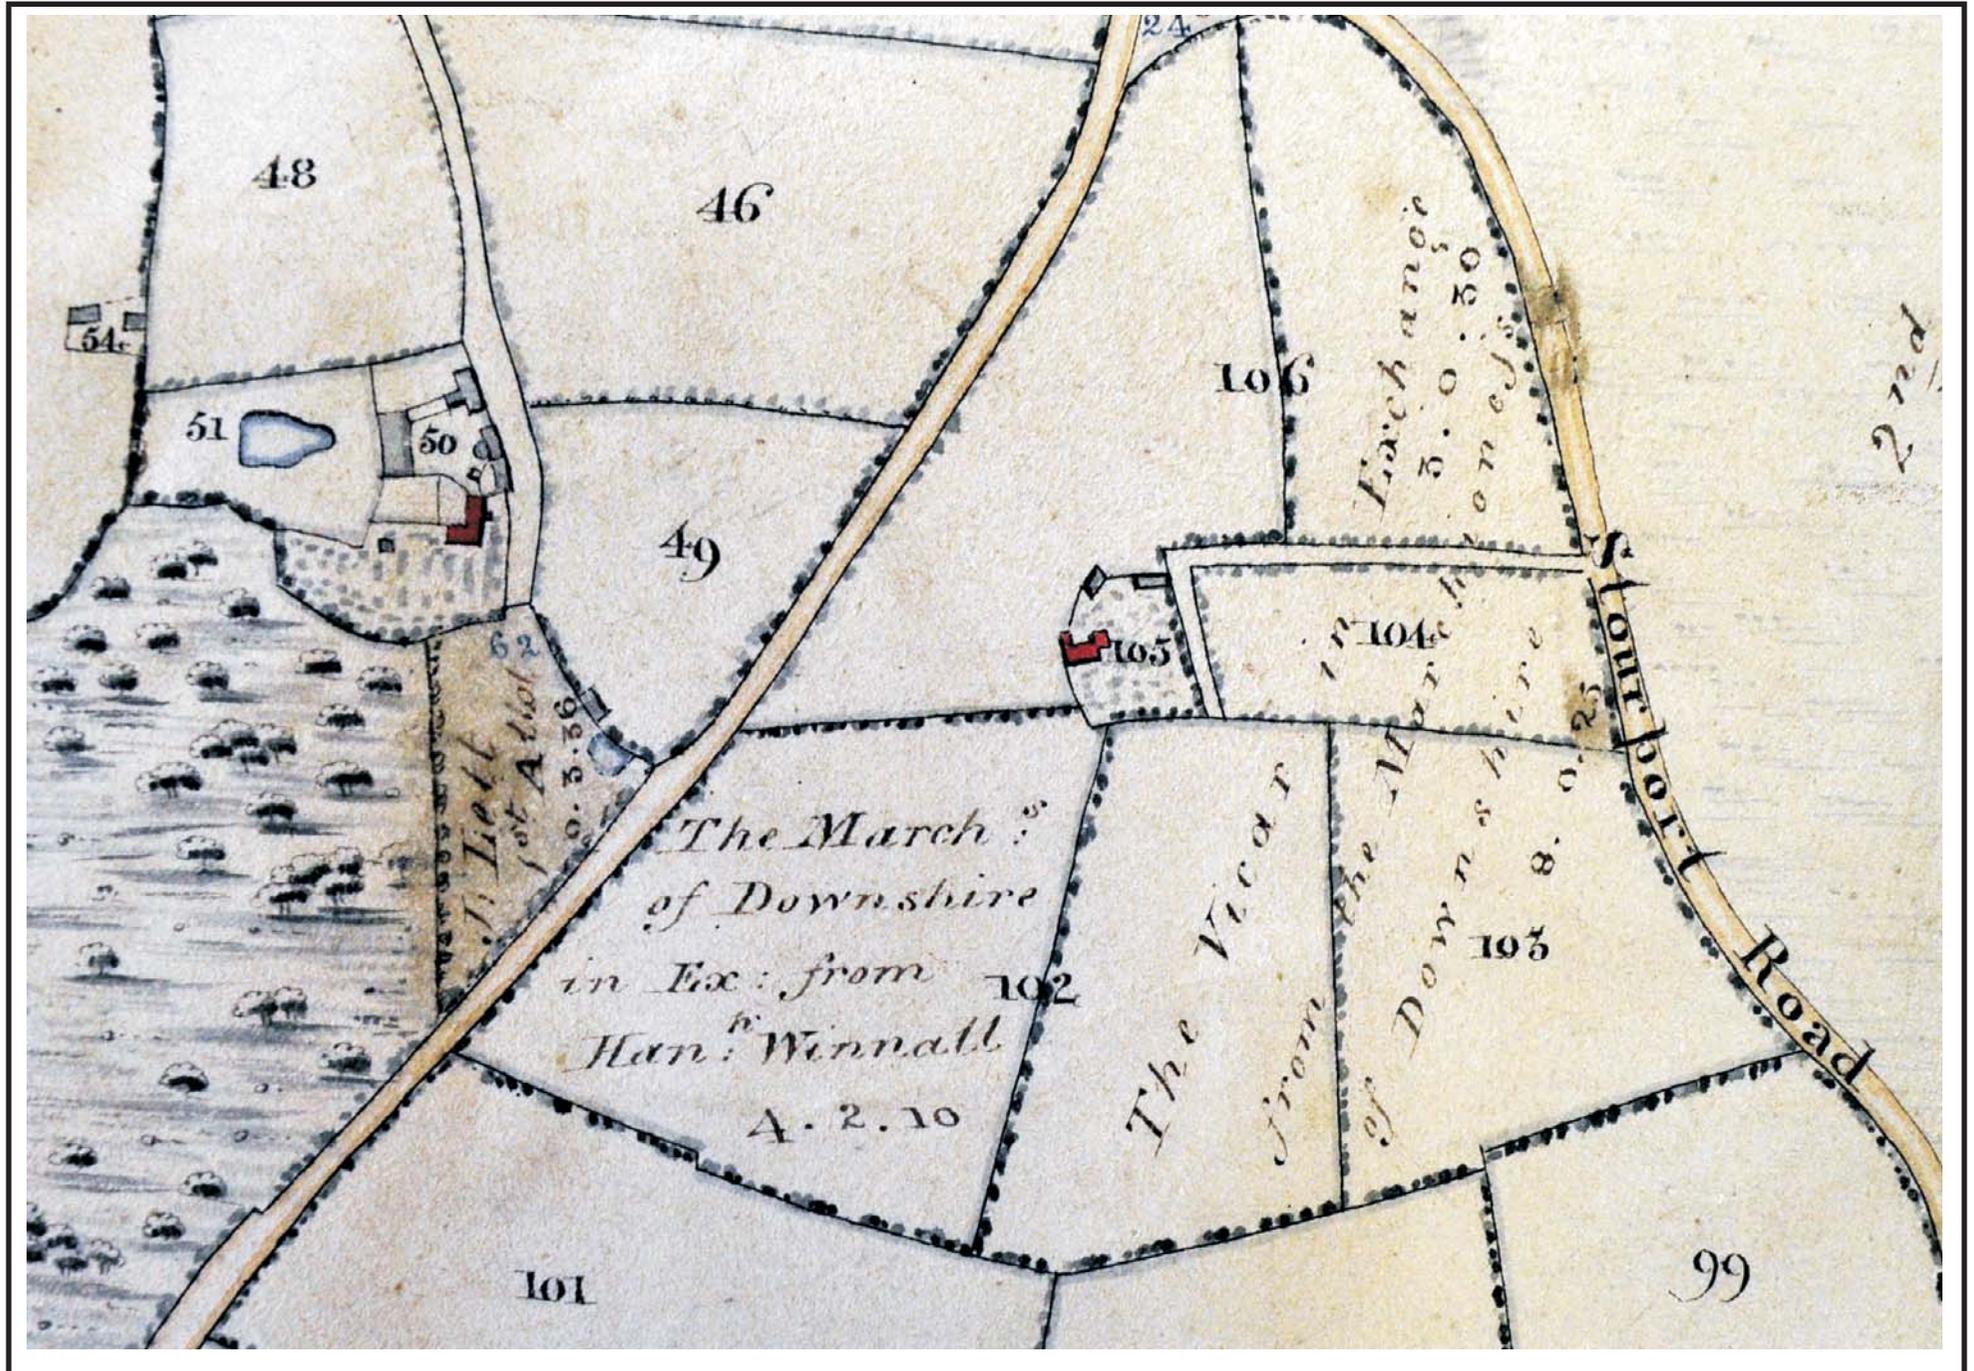
Figure 2: Inclosure Awards plan for Ombersley c.1824, detail of Winnall Lodge (Parcel 105, right of centre)

discrepancies. Most notably the house, although still “L” shaped is orientated very differently, and placed closer to the western boundary. On this plan the east-west leg of the house is at the southern end, and to the east of the north-south range.

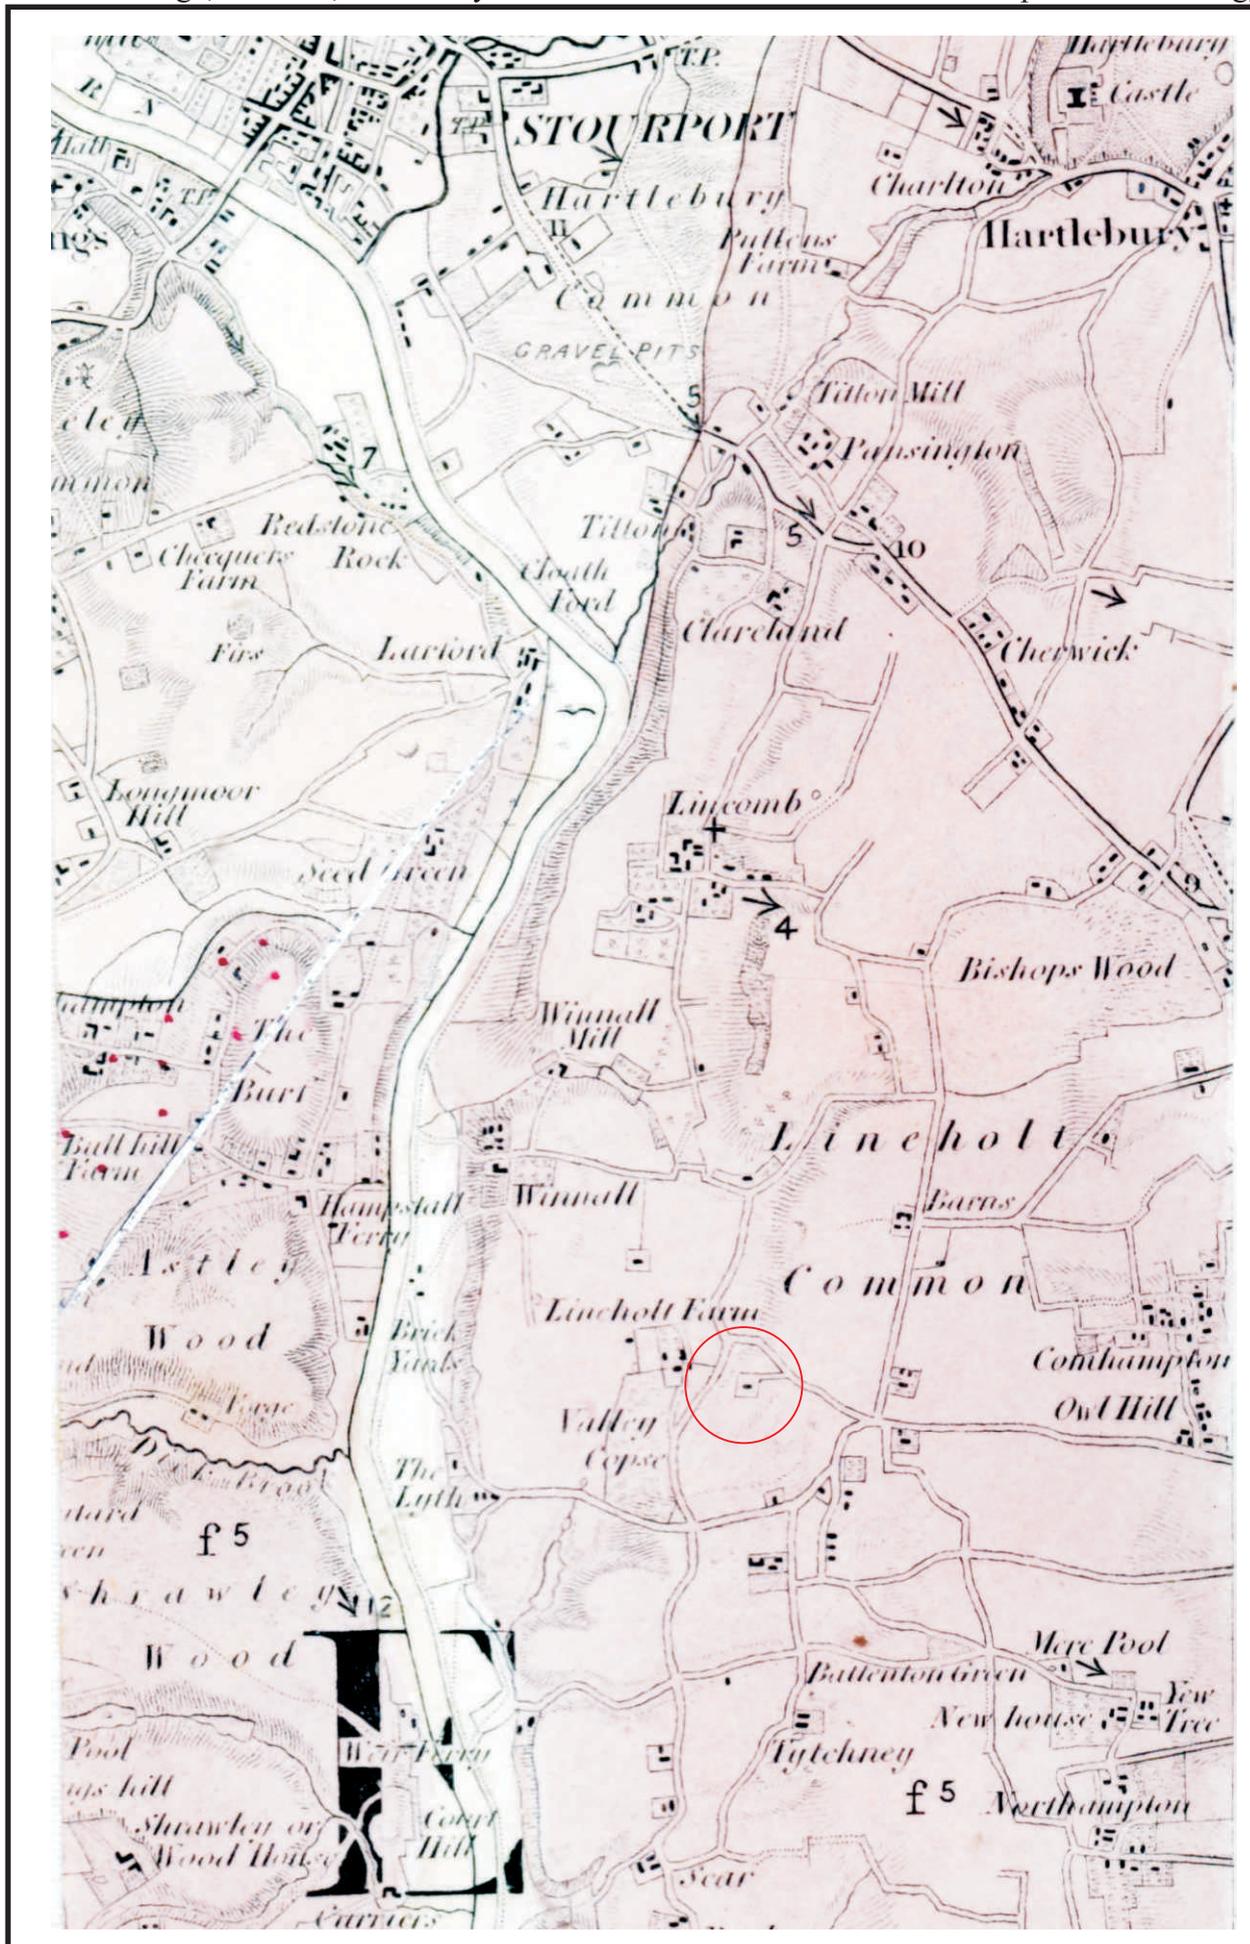
Figure 4: Winnall Lodge was omitted from the 1817-19 first draft of the Ordnance Survey, but appeared on the first printed edition seen here as the “Old Series” (1832) edition hand coloured with 1850 geological survey data - (Source: MNA reference collection).

- 7.3 The earliest Ordnance Surveys of this area were undertaken in 1811-1816, but the surveyors seem to have overlooked the present property completely. This suggests that it was no longer a residence of any significance (WRO BA130359 ref 70.5:1163 microfiche copies of OS draft survey maps of Worcestershire). Greenwood's 1822 map of Worcestershire, is too small a scale to distinguish the buildings clearly. The next plan to show the present property was drawn circa 1827 for the Inclosure Award (WRO BA307/56 ref s143/56 : Figs 2 and 3). This shows a similar site layout to the 1800 plan which was drawn up at the start of the Inclosure process. The first Ordnance Survey printed maps were published for this area in 1832, and do show Winnall Lodge, albeit as little more than a dot (Fig 4). As the land was tithe exempt the property does not appear on the Ombersley Tithe Awards plan. Subsequently in 1841 a sale plan was drawn up for the “Winnalls Estate” but the estate did not include the present property at that time. A further sale of the “Winnall House Estate” in 1907 (WRO BA 4600 ref 705:550), did however include the present property as Lot 3 (see Fig 7). The land formerly attached to the lodge had by that time diminished to only part of the field to the north-west of the house and the trackway to the Stourport Road. There was only one small outbuilding to the north-east of the house (Building 6 in the present report). The other building ranges and extensions to the original building shown on modern mapping (Buildings 4 and 5 of the present report) are therefore all of 20th C century date, mainly relating to the extension of the house and its most recent use of the premises as a kennels.

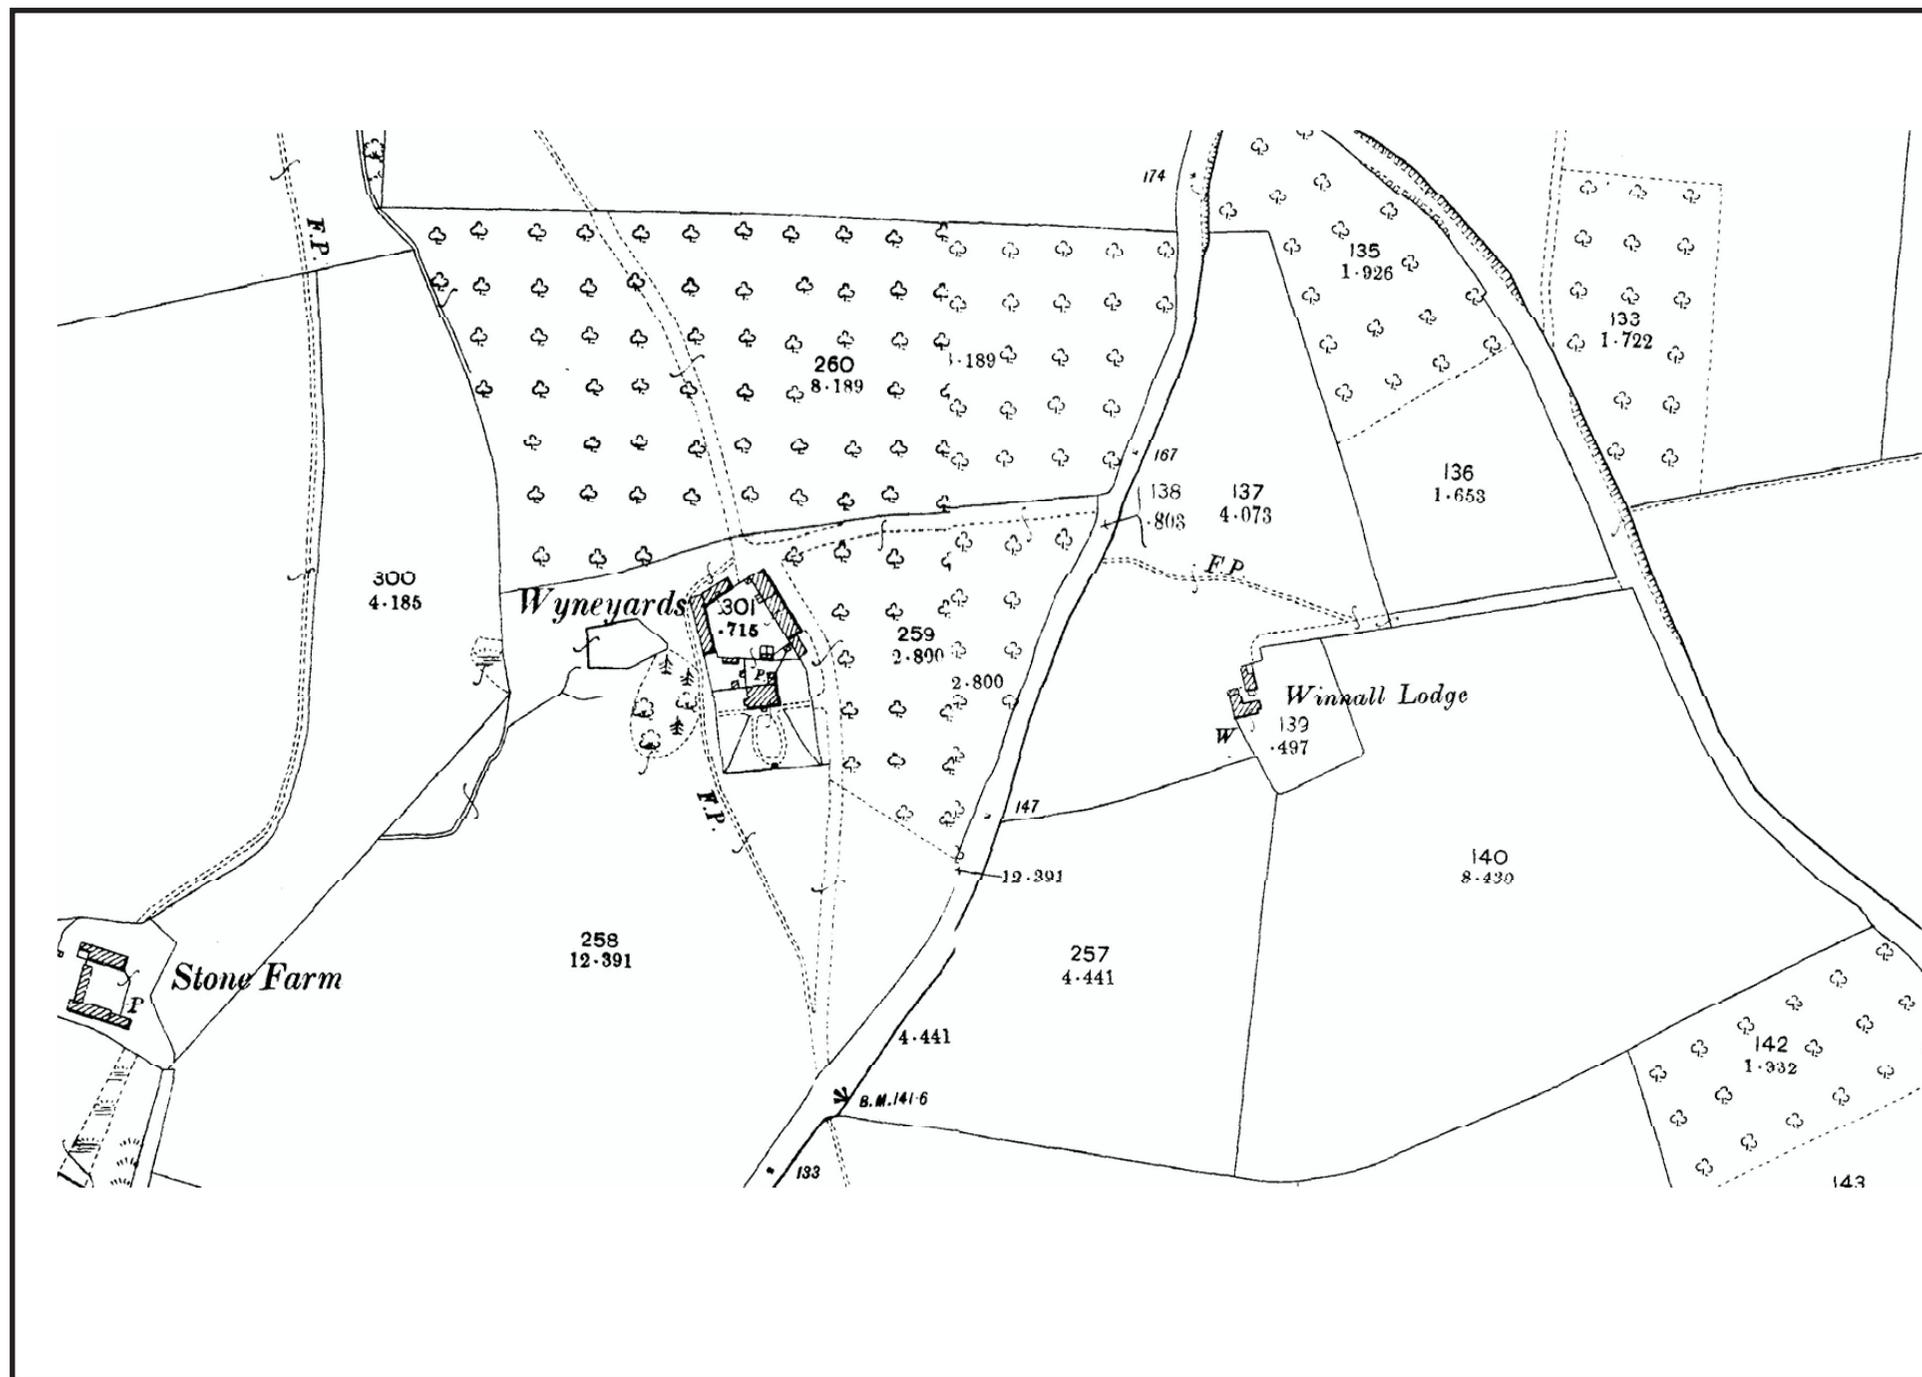
Figure 6: 1880s Ordnance Survey mapping of Winnall Lodge

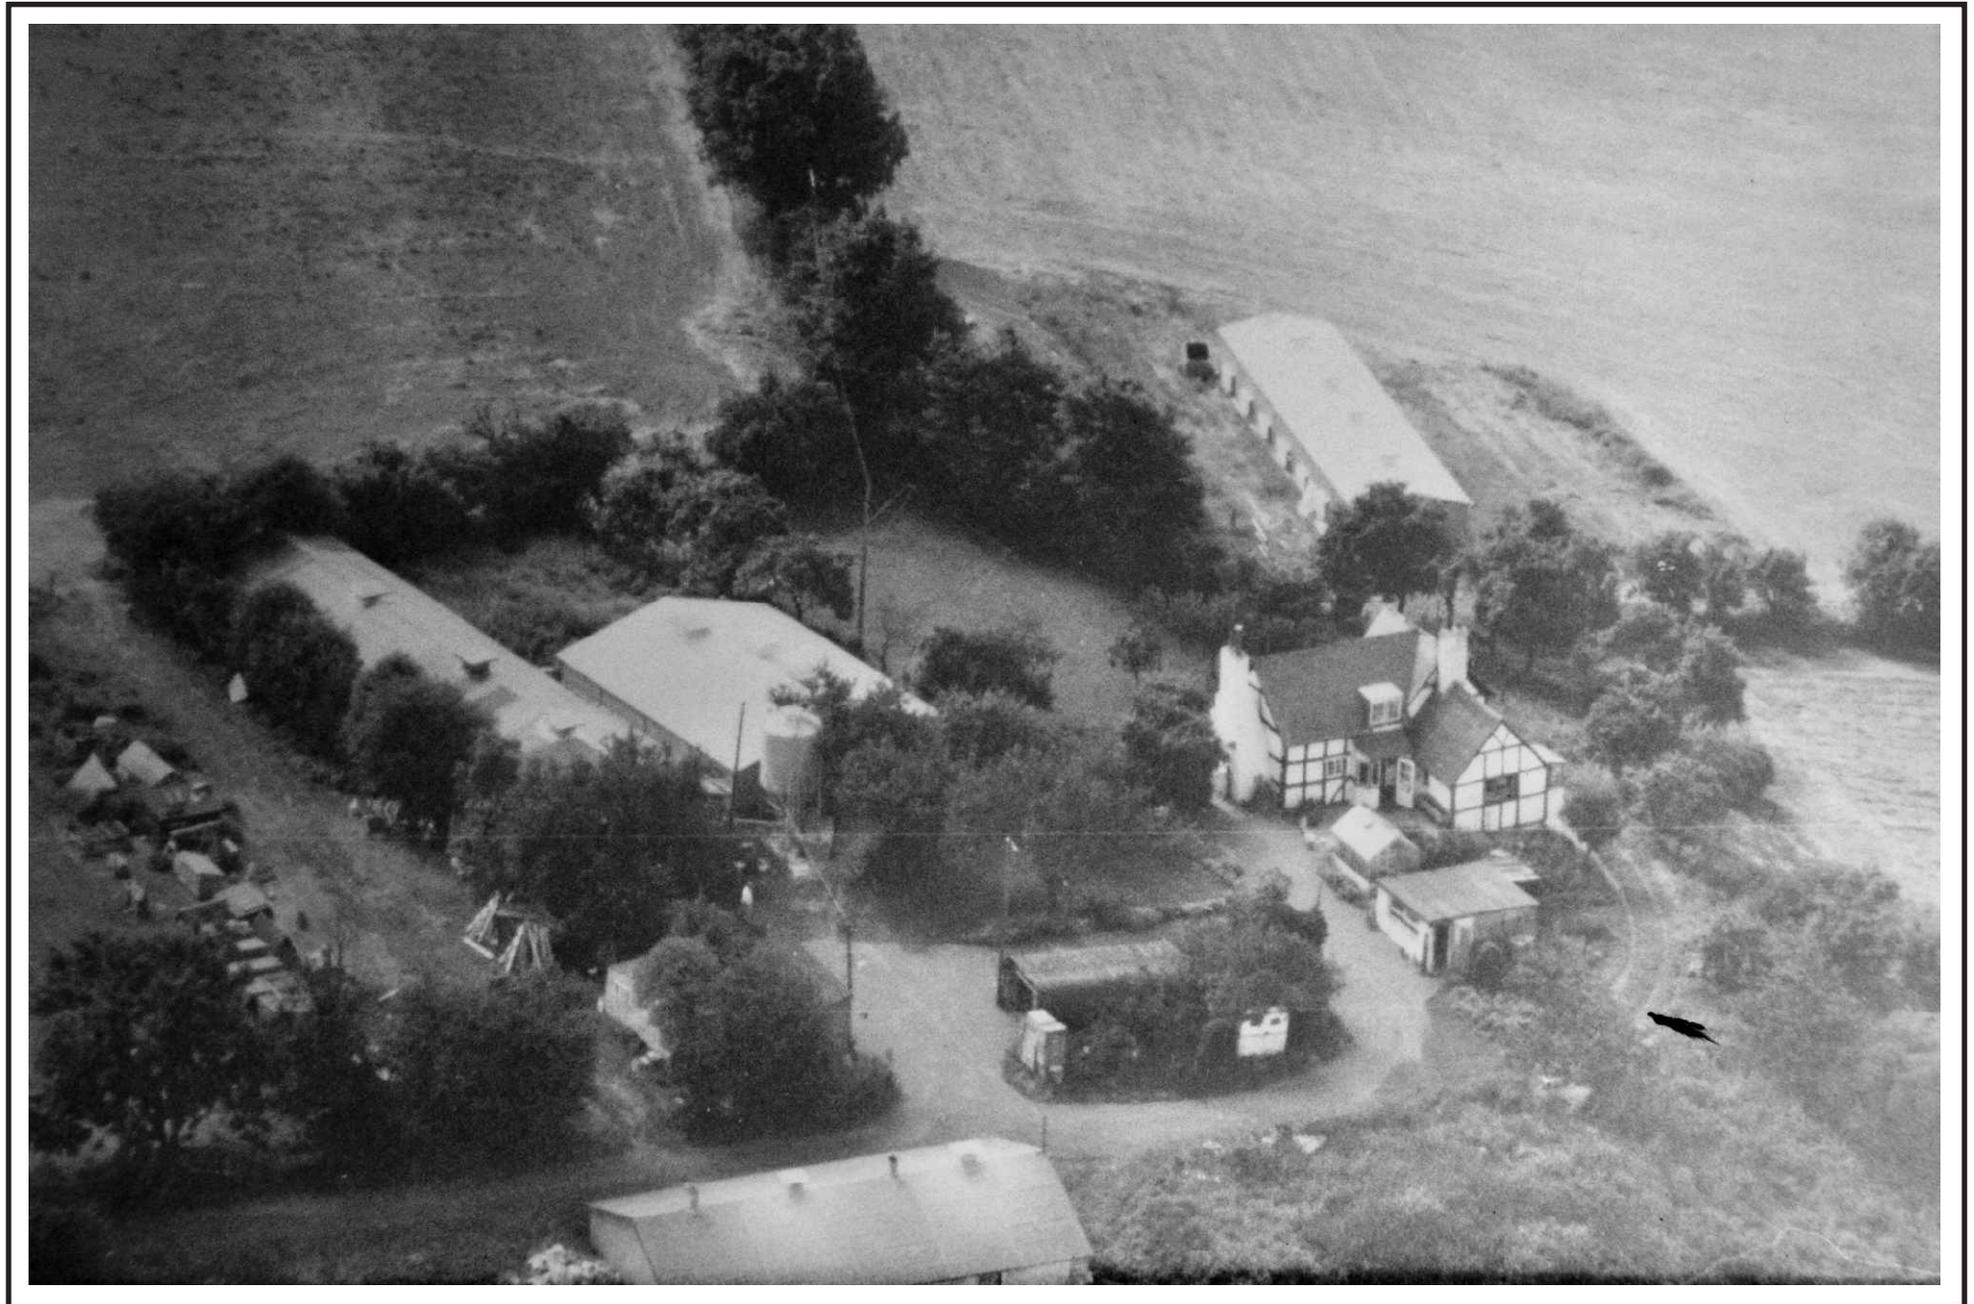
Figure 8: Winnall Lodge farm in 1965 - note chicken houses, and relatively unaltered farm-house. The “framing” of the north wing appears to be painted on for cosmetic effect, as this building is brick. View faces south

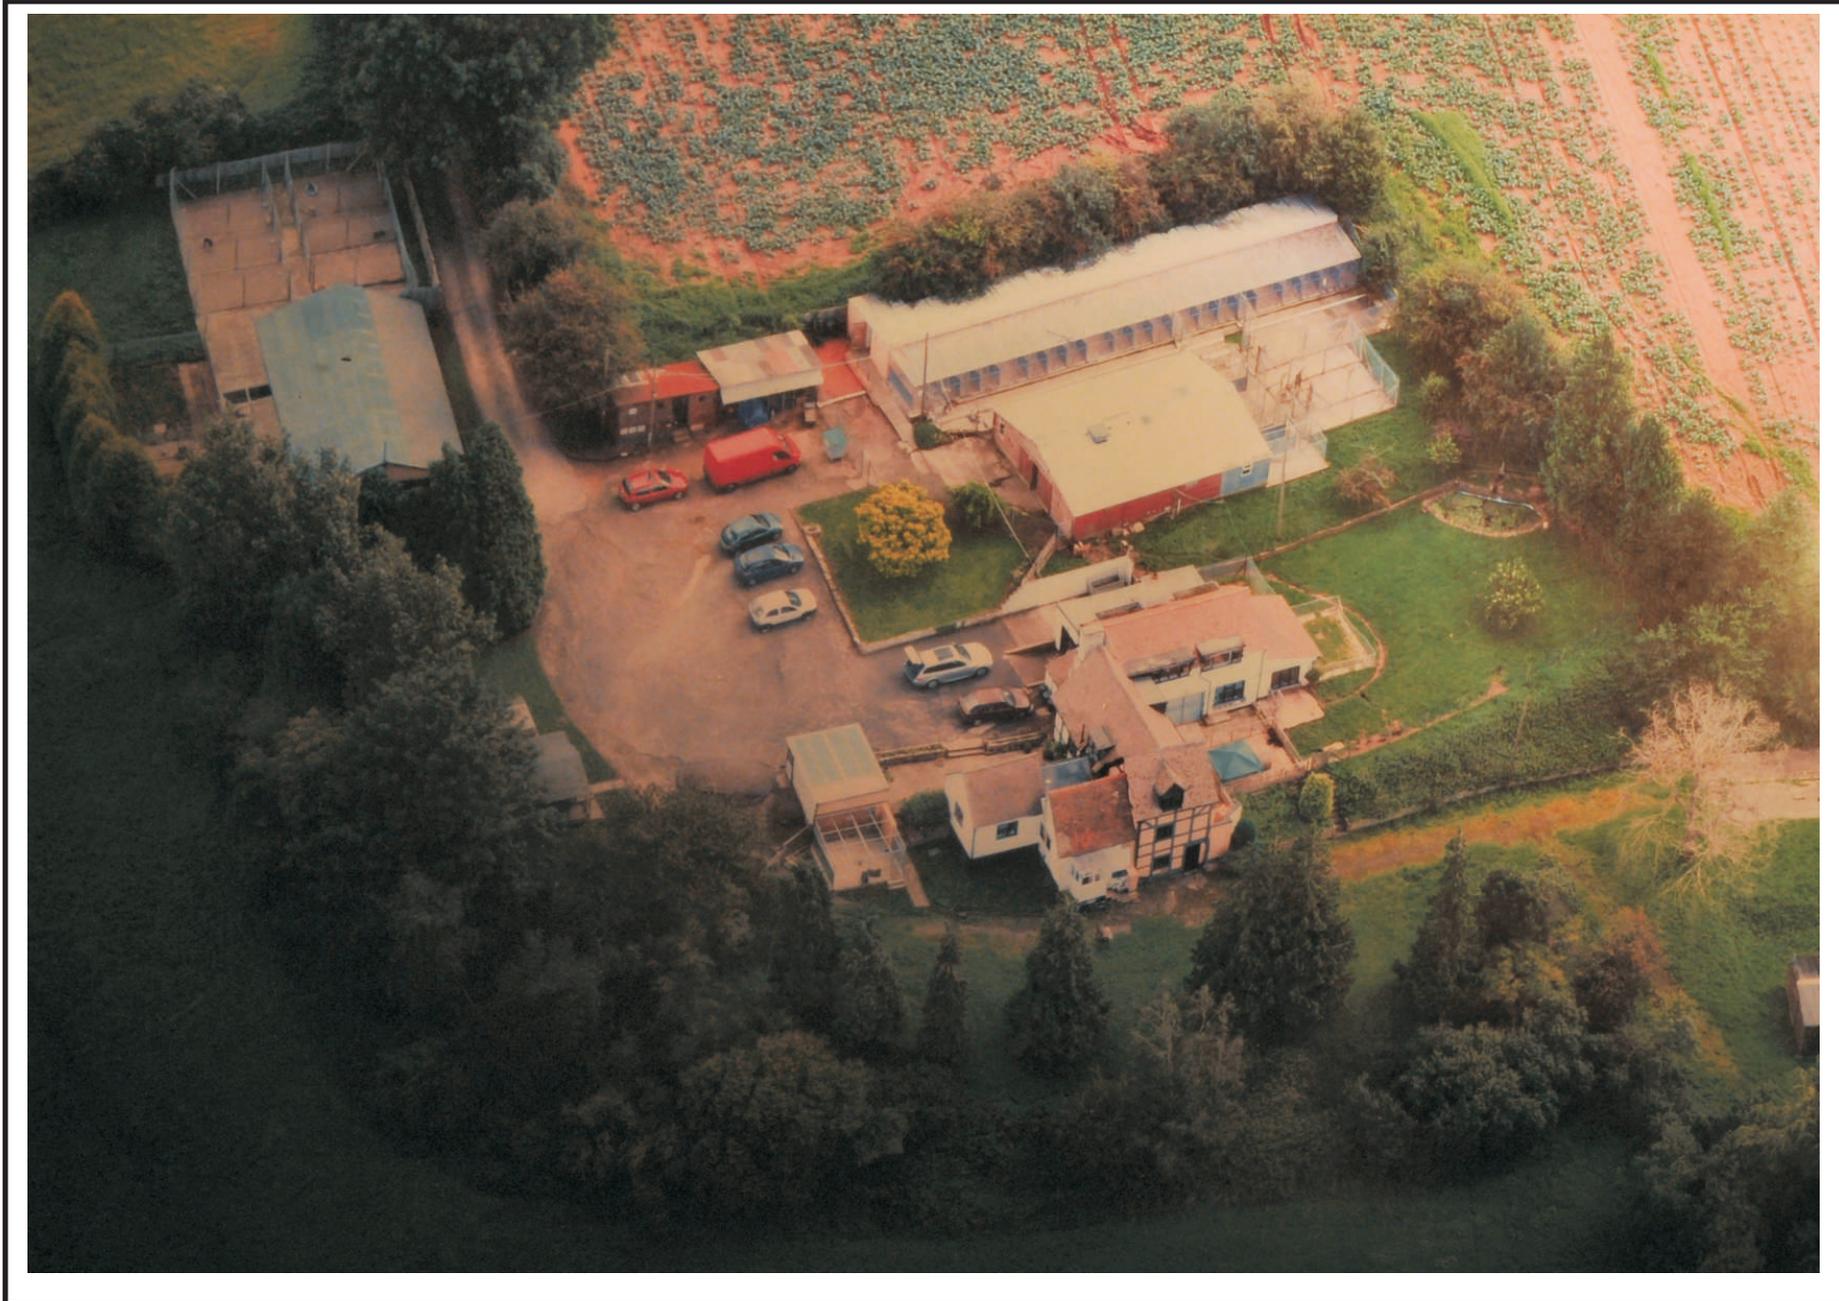
Figure 9: Winnall Lodge farm in 2001 - note substantial extensions of the 1980s and 1990s. View faces east.
