BUILDING RECORDING AT
WINNALL LODGE,
LINEHOLT, OMBERSLEY,
WORCESTERSHIRE

WSM 46062

Building recording at Winnall Lodge, Lineholt, Ombersley,

(With a report on the tree-ring dating by A J Arnold and R E Howard)

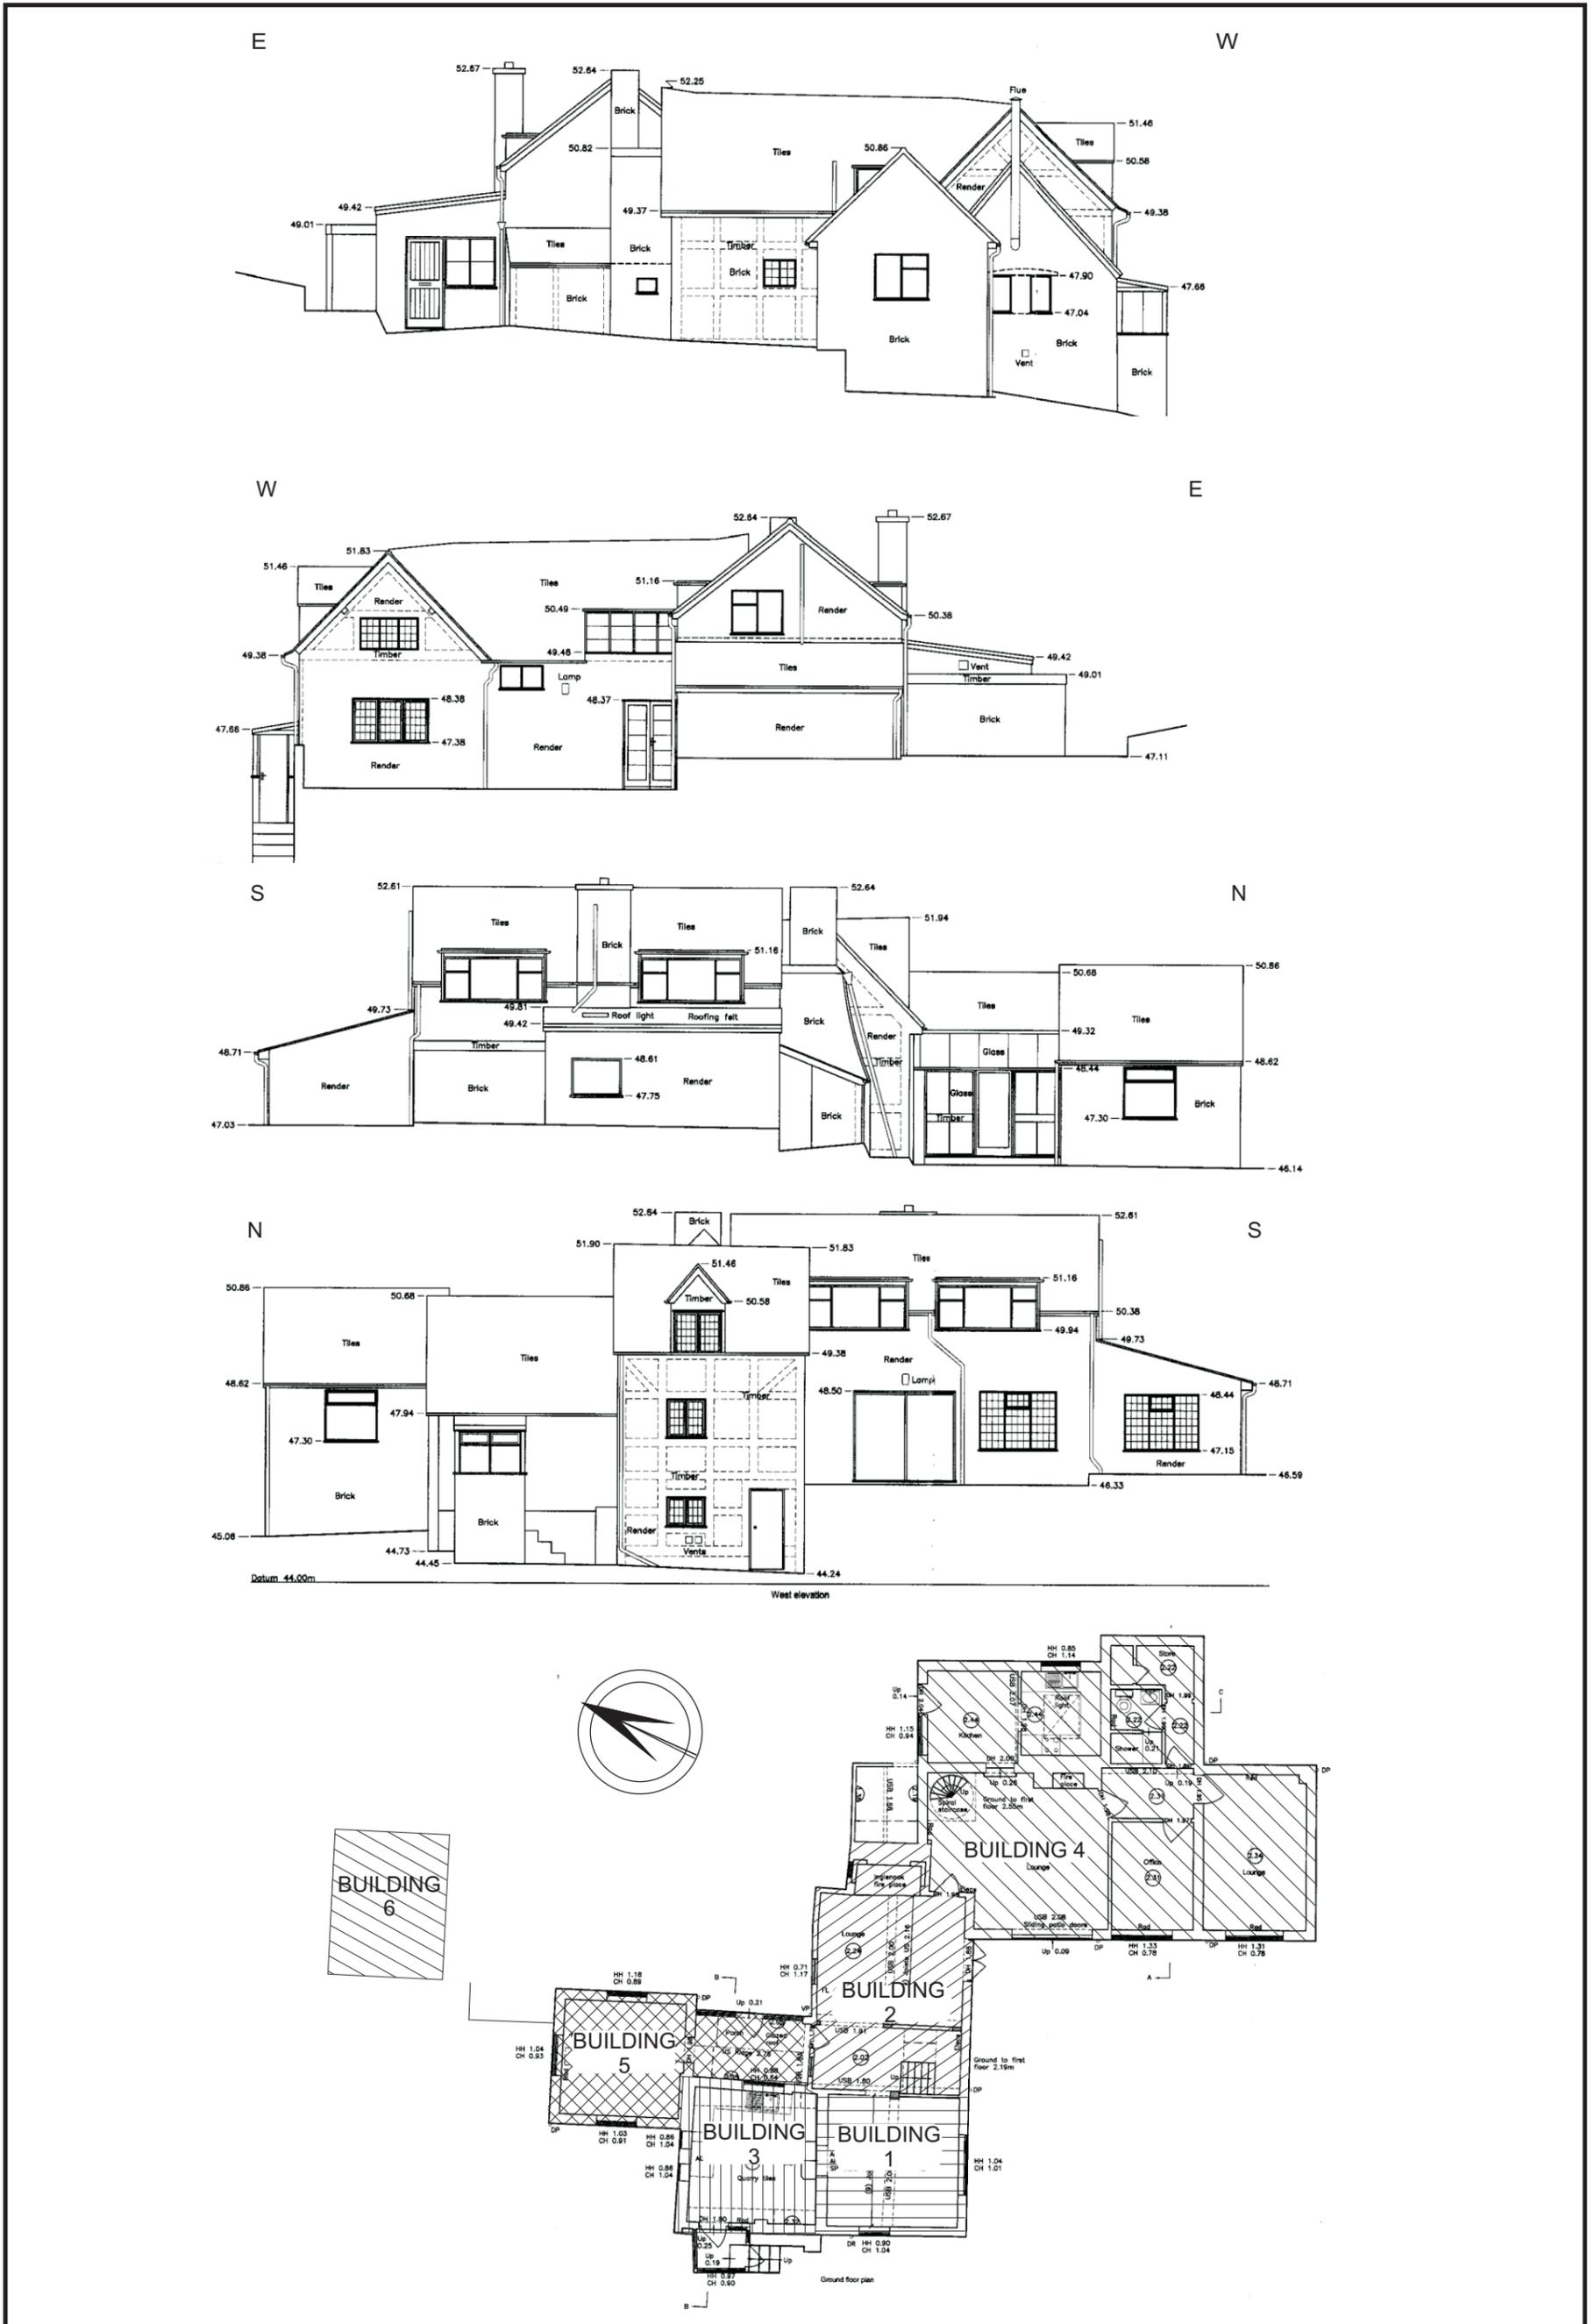
Figure 10: Architects survey drawings and key-plan (nb: only Buildings 1-3 formally surveyed, Buildings 4 and 5 were modern and Building 6 outside requirements of the Brief)

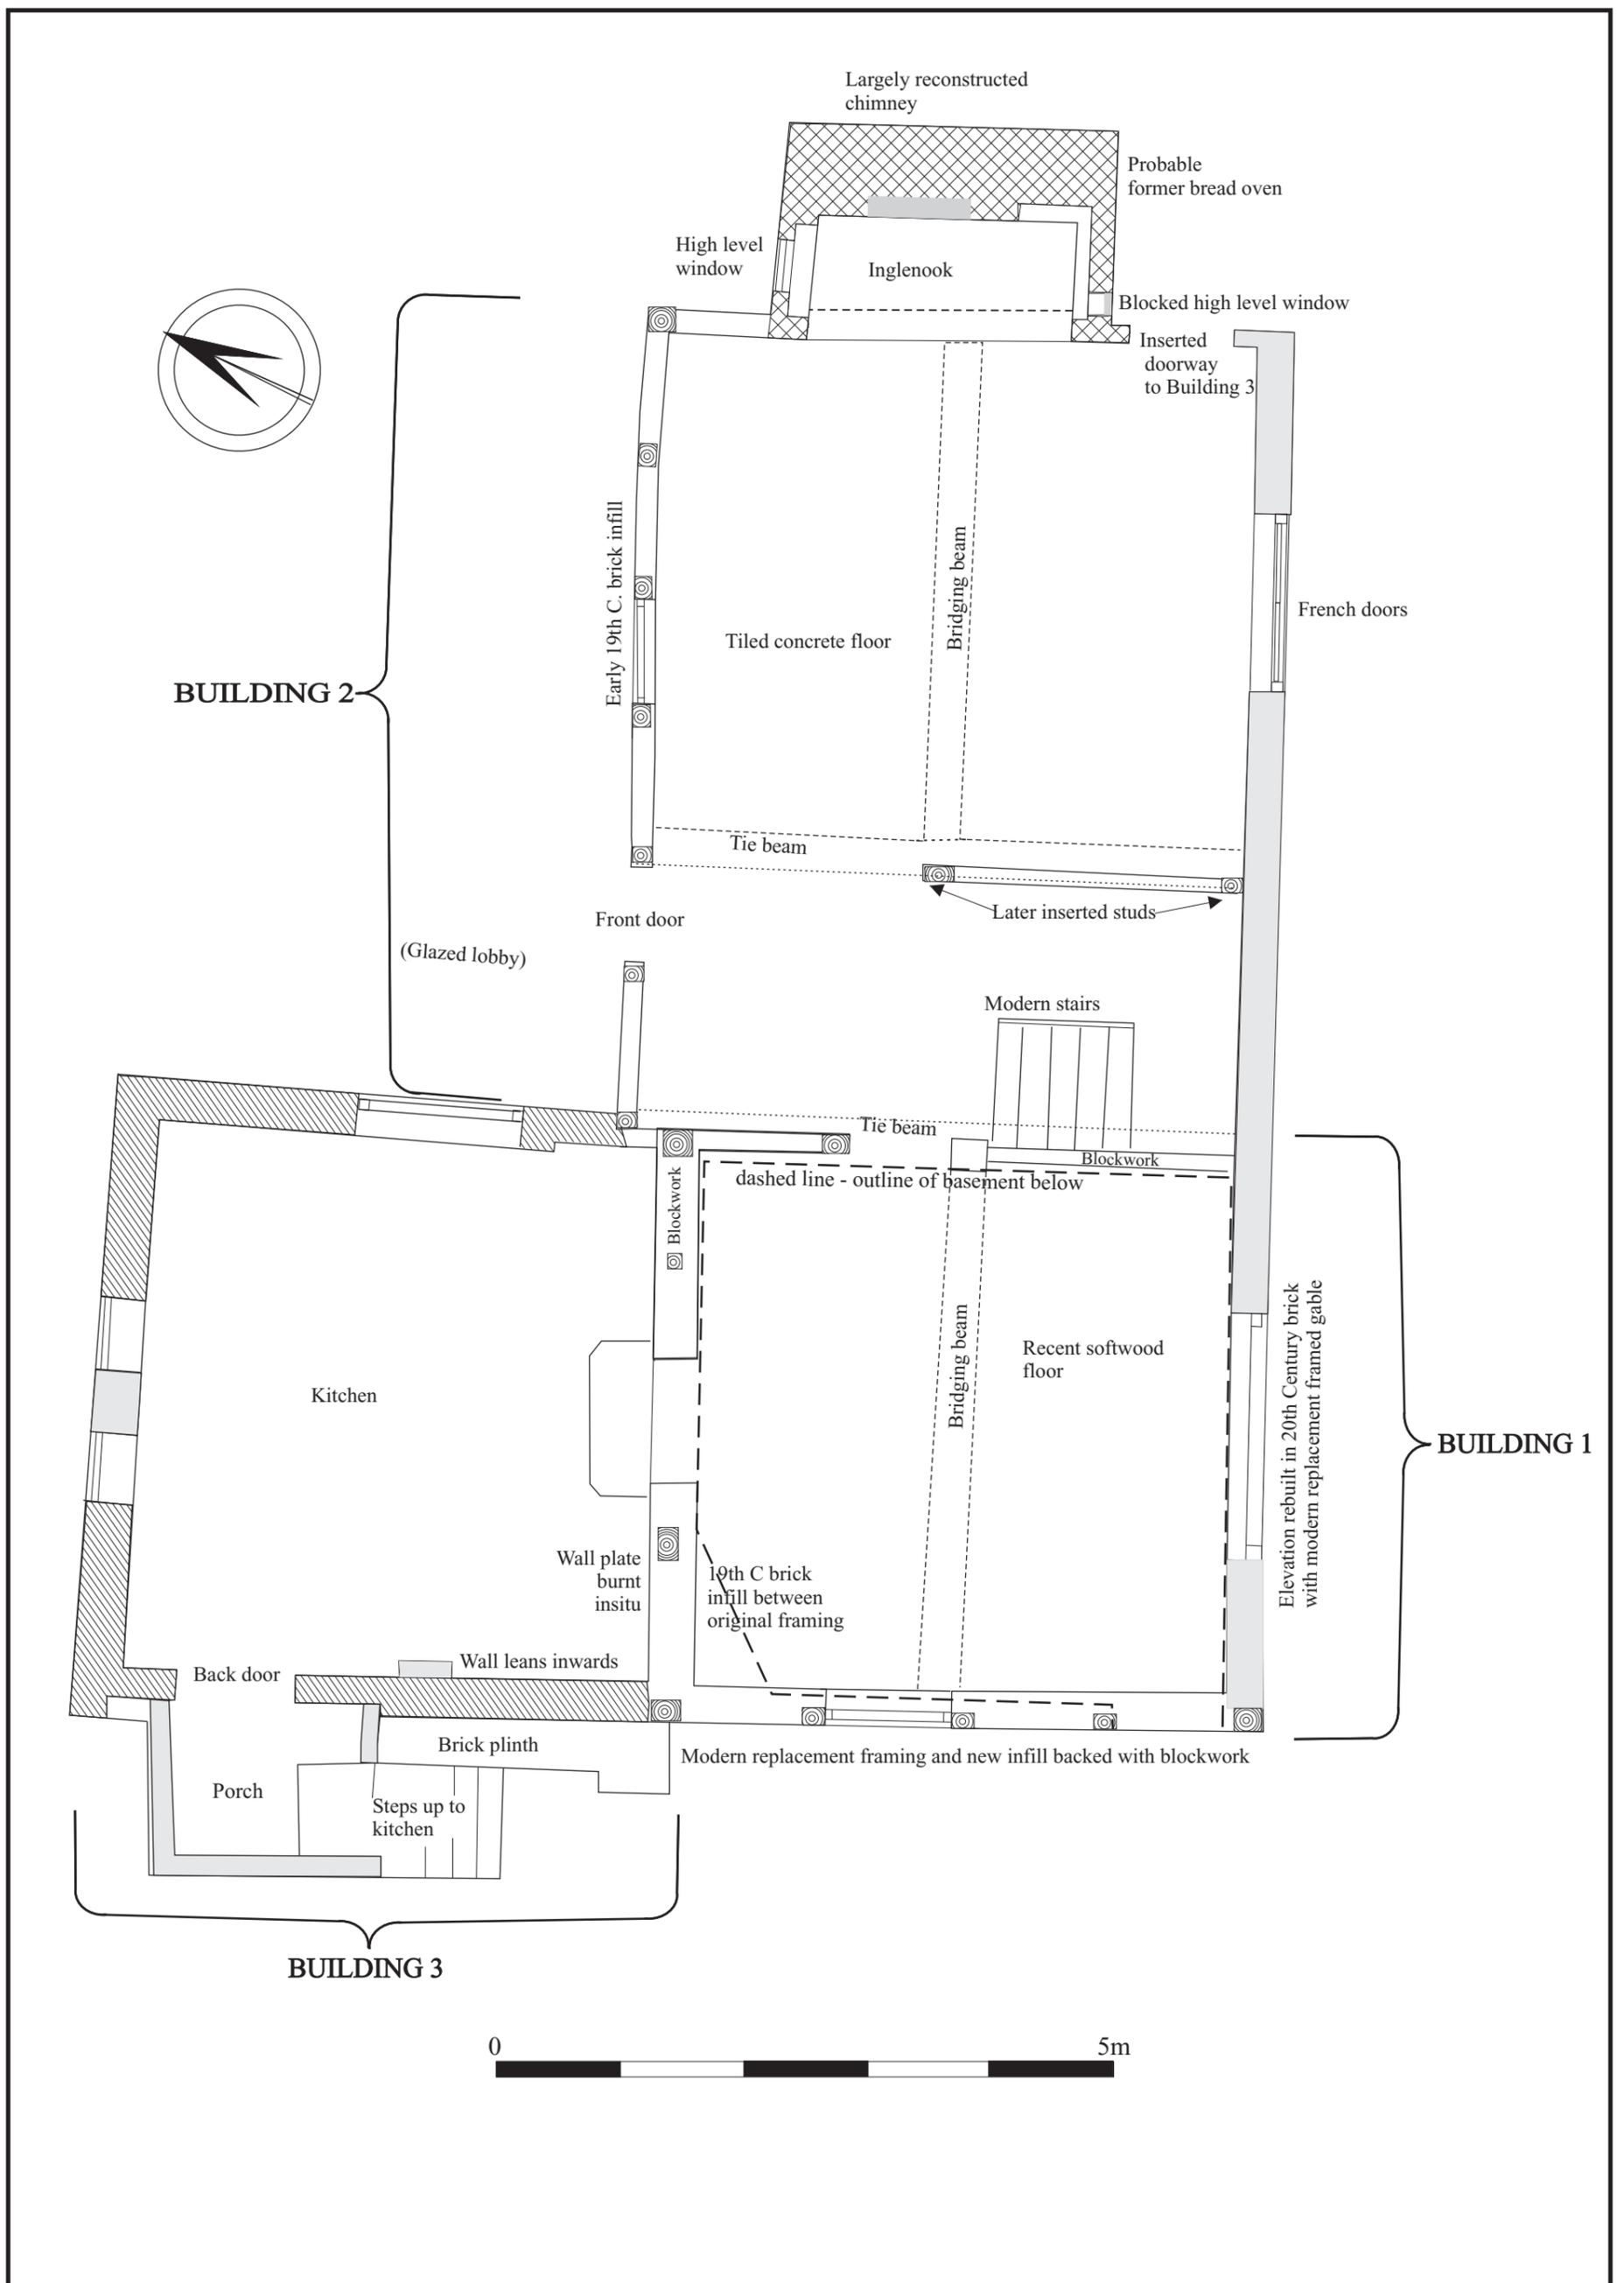
Figure 11: Ground floor plan of historical portion of Winnall Lodge (nb: 20th C extensions largely omitted)

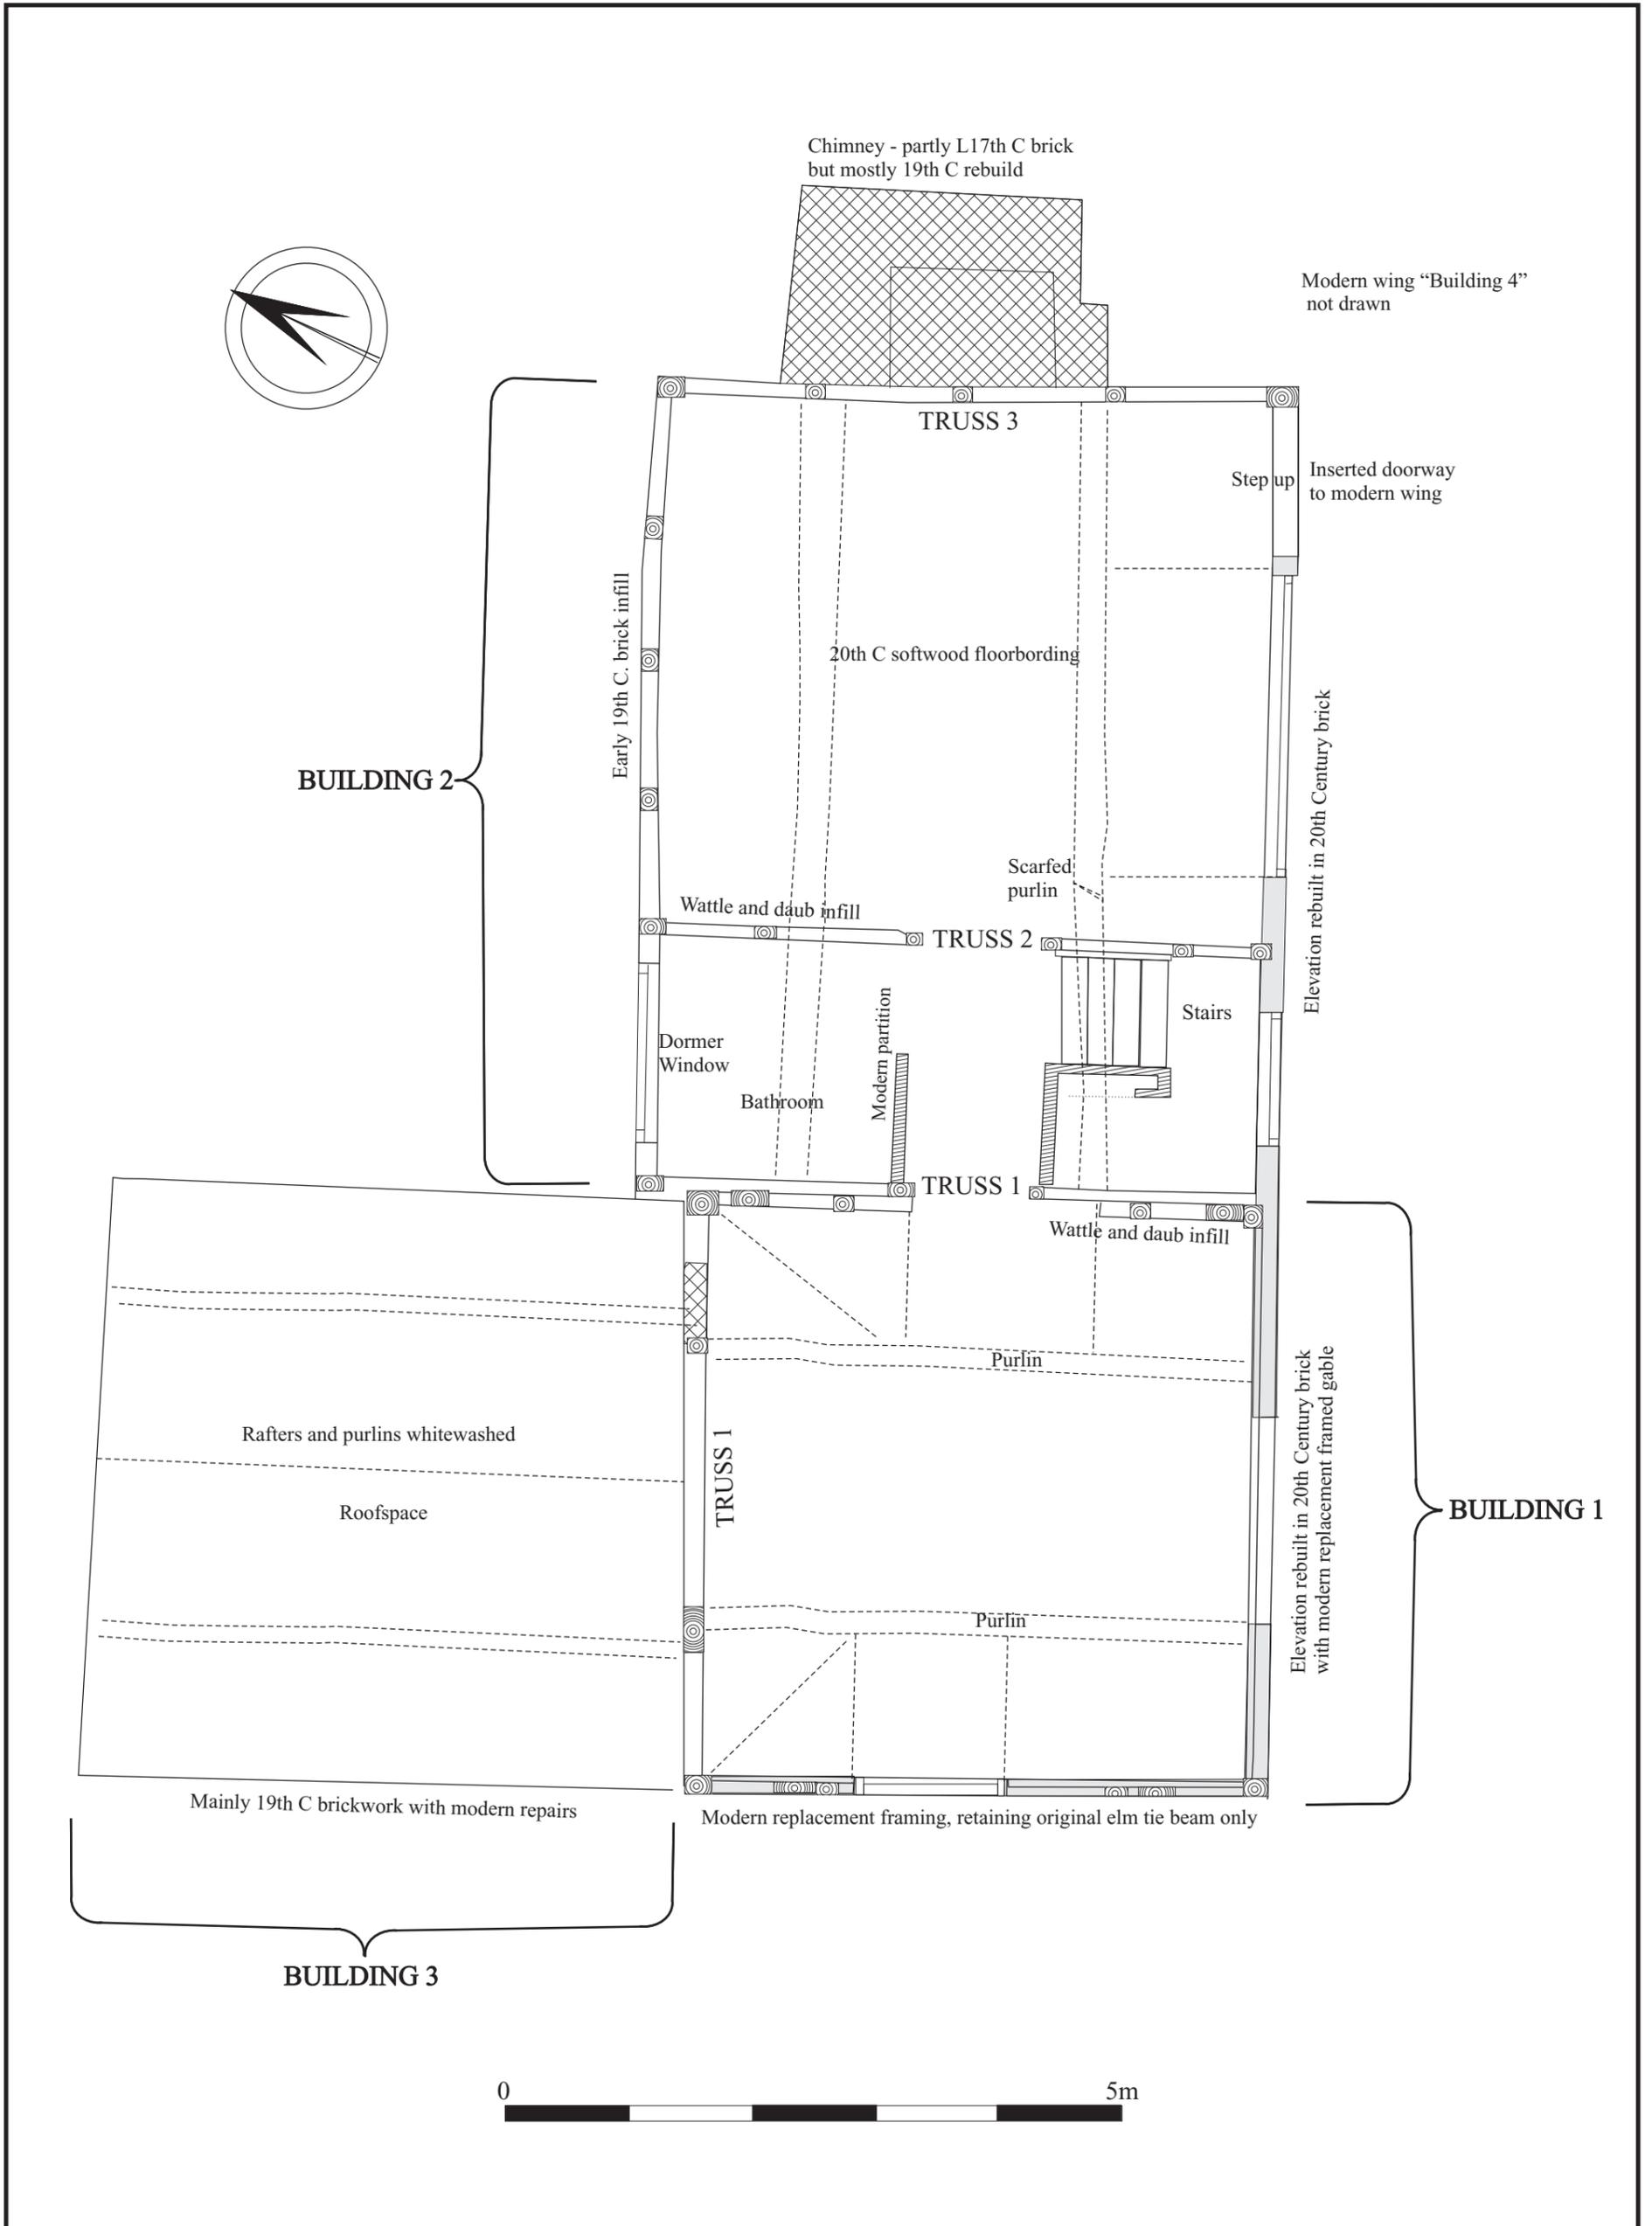
Figure 12: 1st floor plan (later extensions omitted)

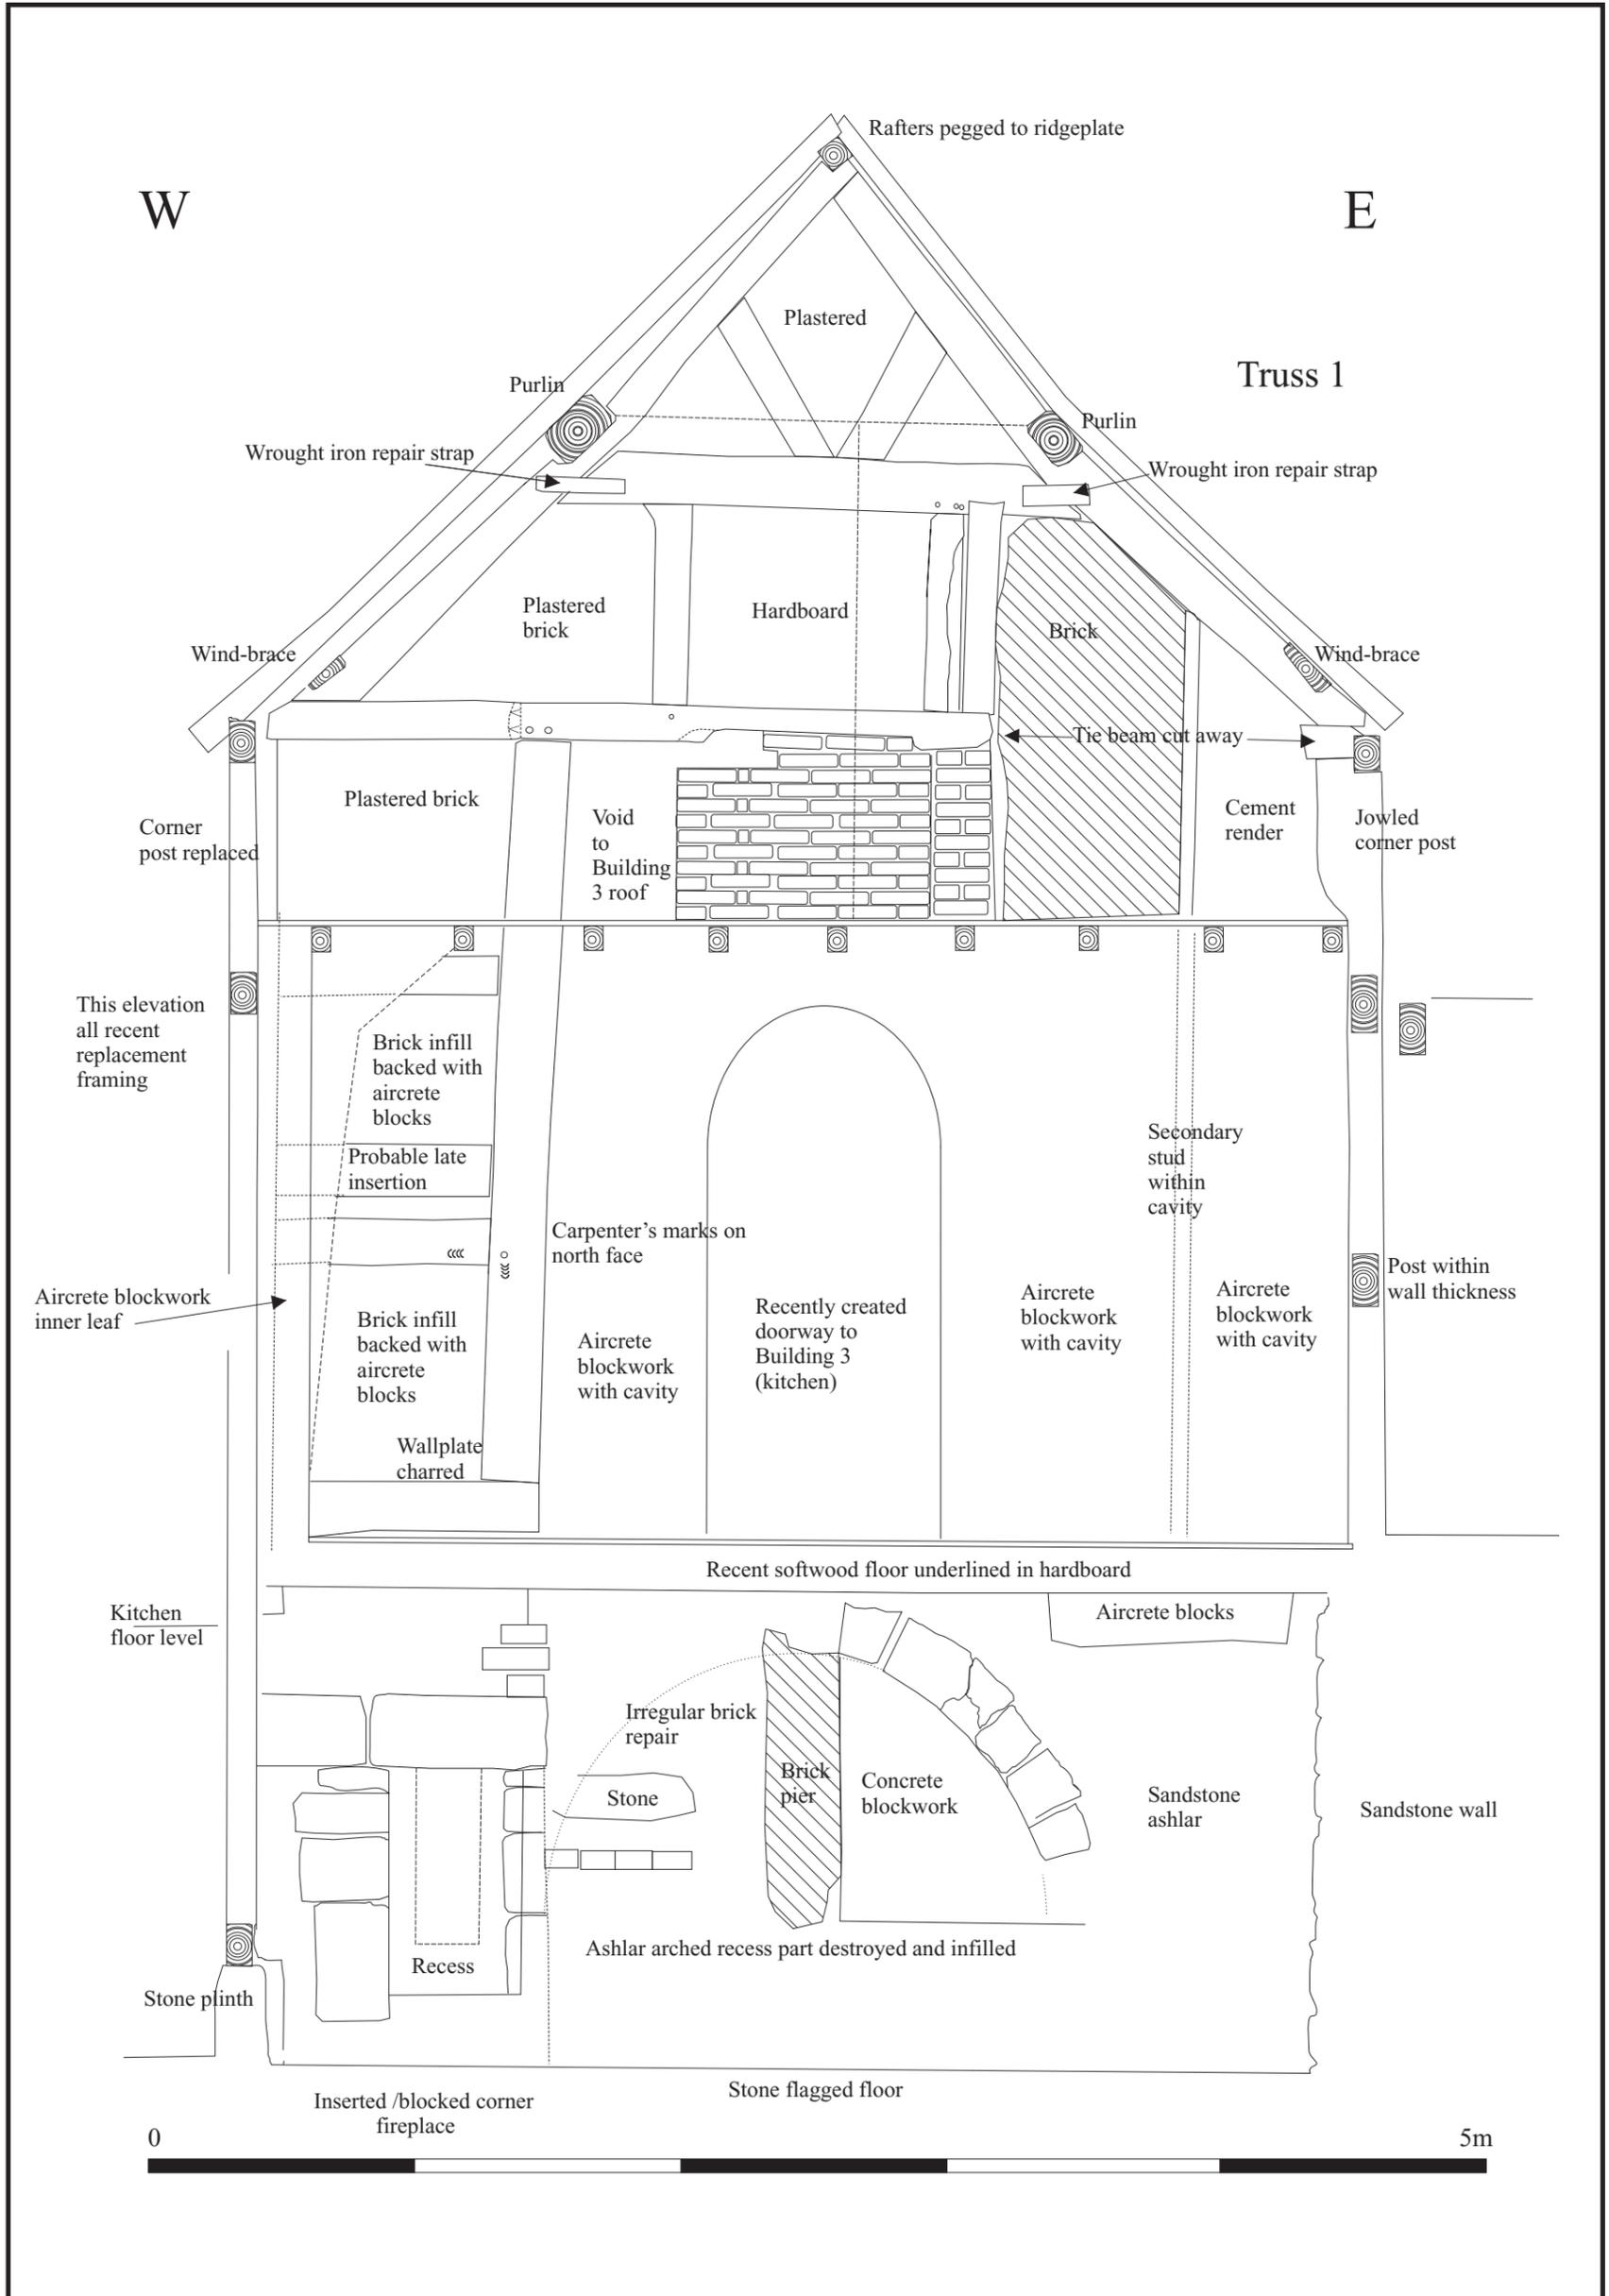
Figure 13: Composite internal elevation of northern wall of Building 1 (nb ground floor framing was only exposed from north)

- 8.1.3 *First-floor* - At first floor level two sides of Building 1 are still relatively recognizable, although the panel infills have been largely replaced, and openings cut through the original framing. The northern wall consists of a gable-end truss of pegged oak, and the head of the principal post (described above) which is jointed into the tie-beam soffit, the NE corner post also survives intact. The corner post has a pronounced jowl (swelling) to support the eastern end of the tie beam, but the latter has subsequently been cut off at the point where it meets the jowl. The cutting of the tie beam seems to have been done in order to facilitate the insertion of a brick chimney, though most of this chimney has been subsequently removed. The central portion of the tie beam has a cut out portion to its soffit. The cut-out is chamfered, and clearly deliberate. It is possible that the chamfered portion served as a fire-place lintel in the postulated central chimney, but it shows no sign of scorching or sooting. A fireplace with a decent draught will not necessarily show any smoking of the lintel, so the absence of such damage does not disprove this interpretation. The area beneath the tie-beam has been infilled with an area of 18th C brickwork, and separate sections of possibly late 17th C brickwork – maybe reused. An alternative possibility is that the tie-beam was cut back to improve head-room over a stair, but there is a lack of supporting evidence which might be expected to survive. The northern truss of Building 1 is otherwise unexceptional, with typically 17th C framing, and small raking queen-struts above the collar. The central opening between the tie beam and collar is rectangular, and might well have once contained a framed window, though no evidence of this was visible. The two purlins both may be original, though the extensive rebuilding of the southern and western walls and western roof-pitch has removed much of the evidence. There are raking straight windbraces between the purlins and the principal rafters of the northern gable end. The eastern wall of Building 1 has been cut through for a central doorway (at the time when Building 2 was constructed, but otherwise is intact, retaining the heads of both NE and SE corner posts, and two out of originally three studs. There are raking braces between the wall-plate soffit and the two corner posts, each double pegged to the wall-plate. The central section of wall plate is lost, but it is highly probable that there was a further stud jointed to it at its' mid-point. Above the wall-plate the framing is all part of Truss 1 of Building 2. Immediately framing the modern doorcase are two studs, also part of the Building 2 framing. The southern elevation is 20th C brick up to the tie-beam soffit, and the whole of the gable-end framing is recent oak framing. The quality of this modern framing is very poor – the studs either side of the window opening are not jointed into the collar soffit, but merely “glued” with mastic. It must be assumed that the present frame broadly resembles the original. The western elevation is almost entirely modern framing – the only exception (at all levels) being the wall-plate/tie beam which is of elm and probably original. The retention of this timber was probably dictated by the fact that keeping it *in situ* avoided the necessity to remove the western roof pitch in its entirety. Due to the otherwise total replacement of the western elevation (including both corner posts) we are forced to assume that the present framing broadly reflects the original arrangement. Some of the roof timbers (rafters) of Building 1 appeared to be original or early replacements, as they were pegged together at the apex. Access to this area was very limited, and so it is not clear how much of the western pitch might have been more recent replacements.

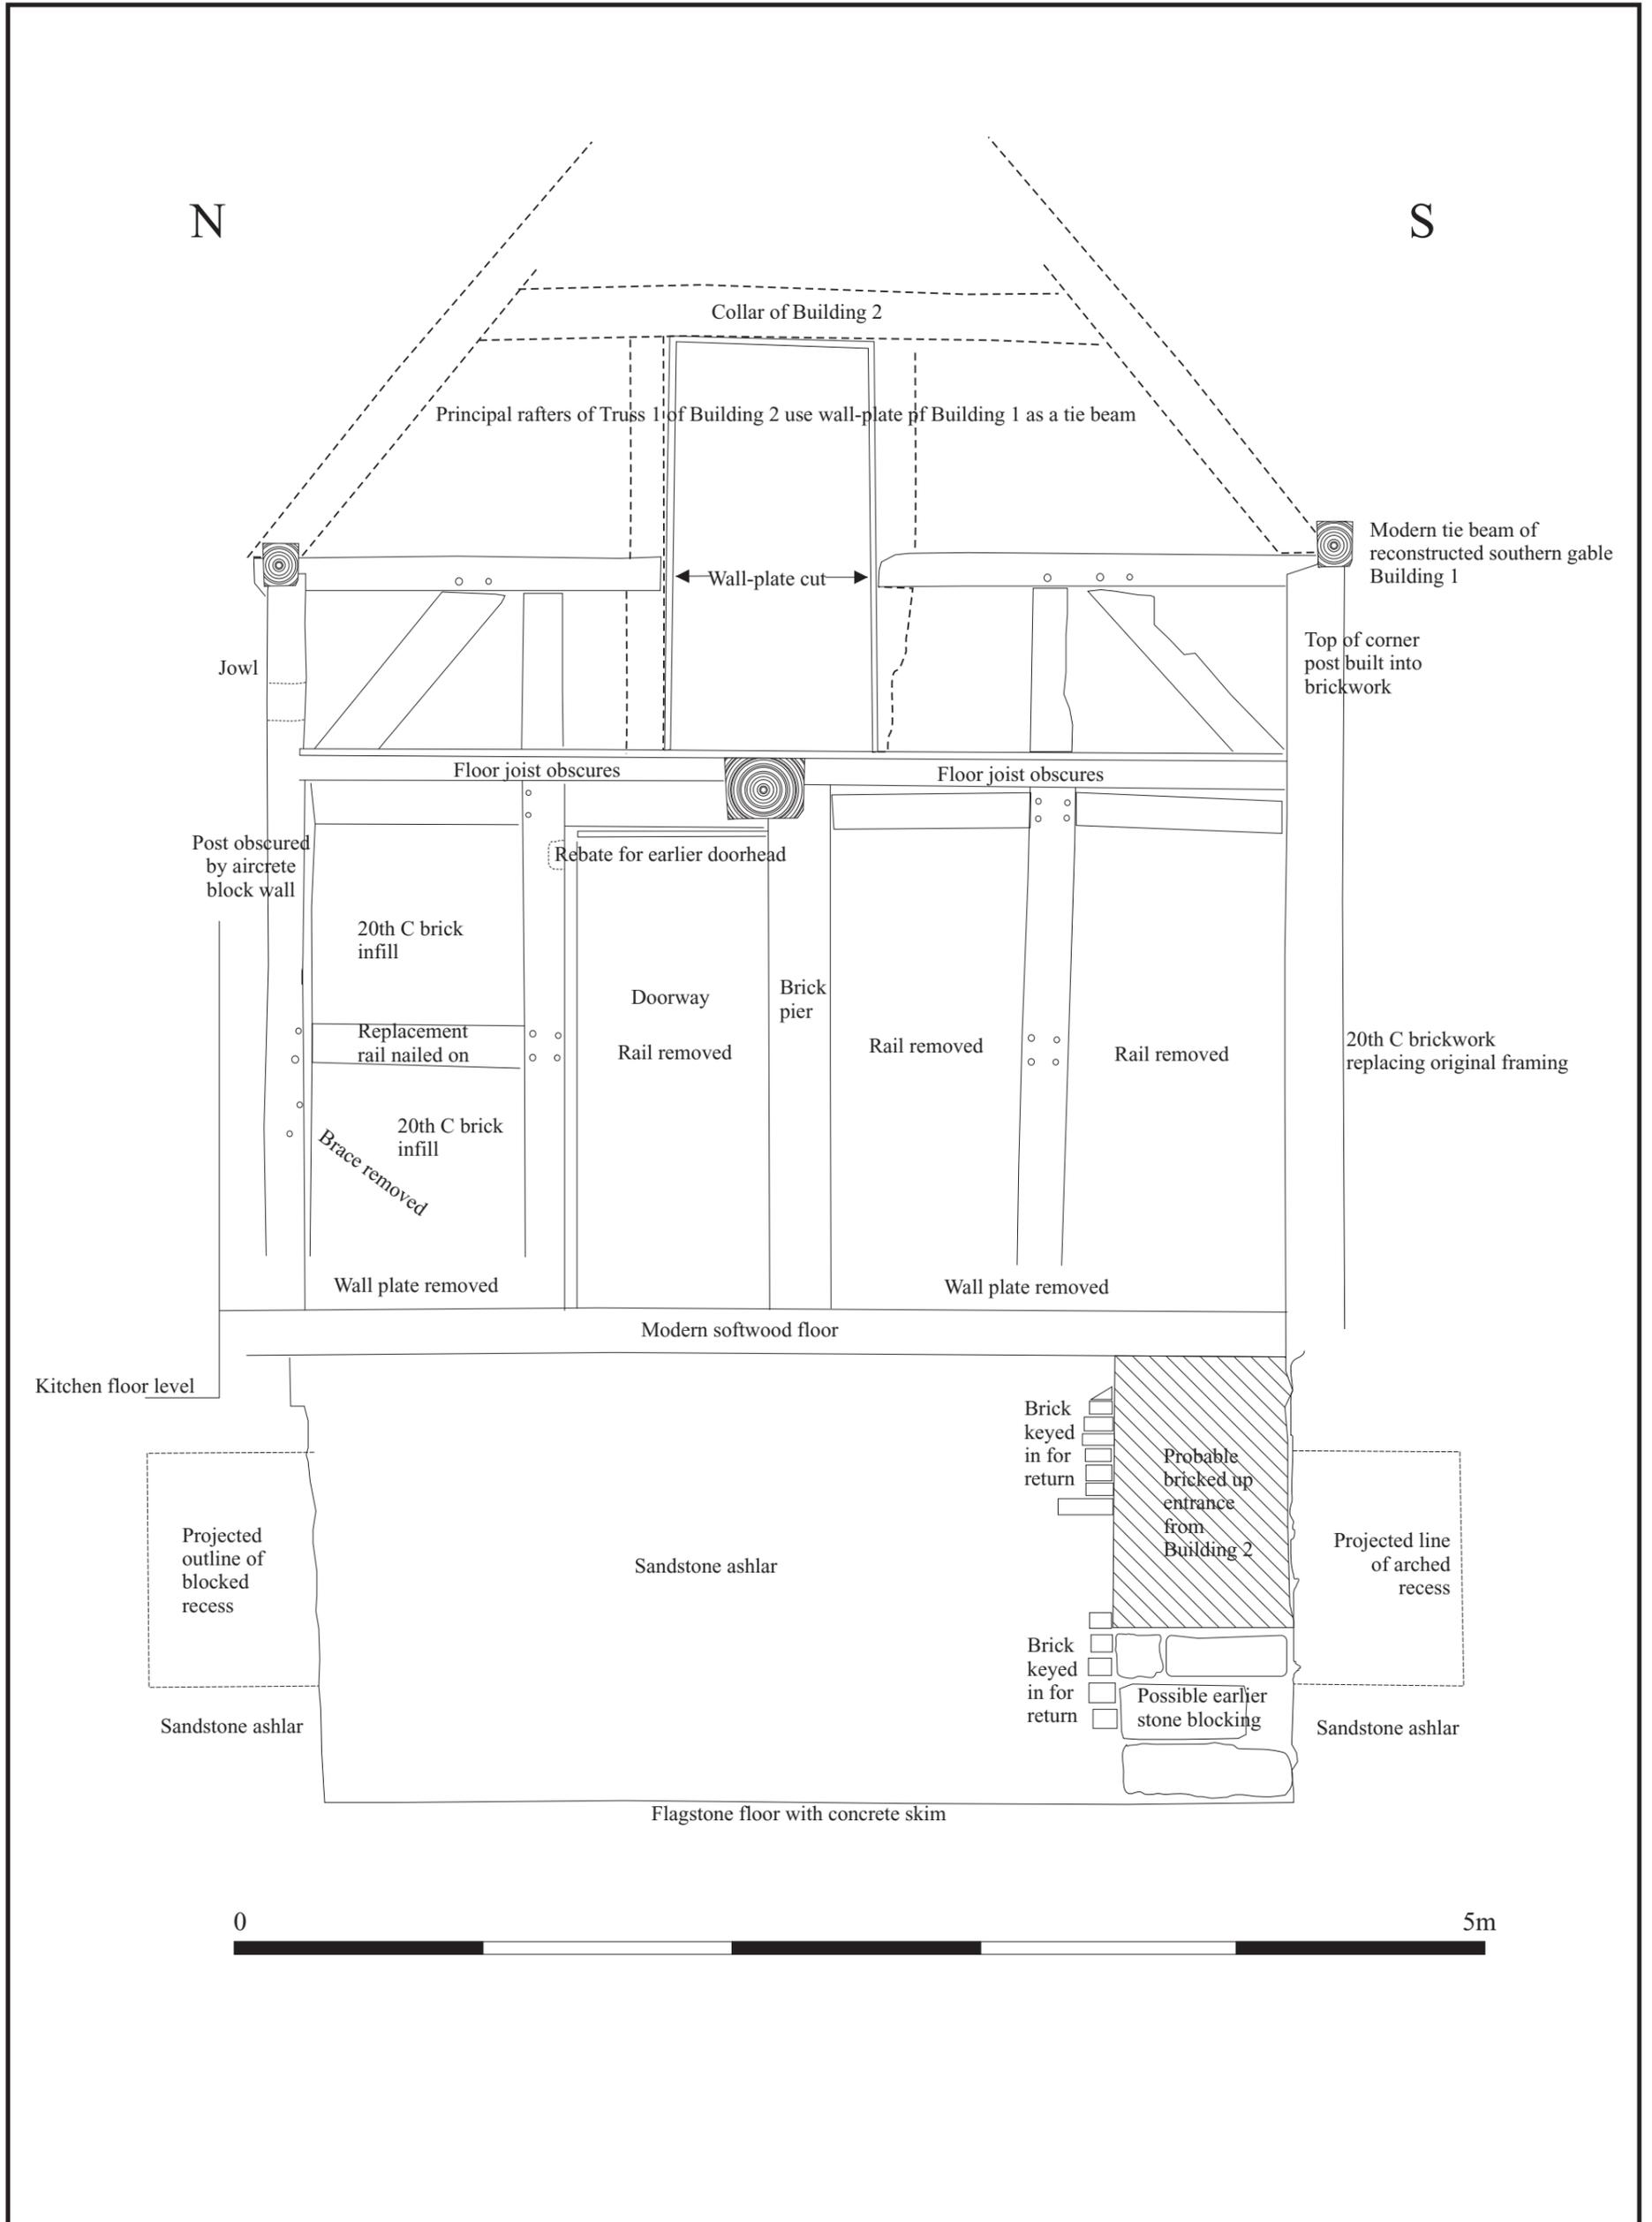
Figure 14: Composite internal elevation of eastern wall of Building 1

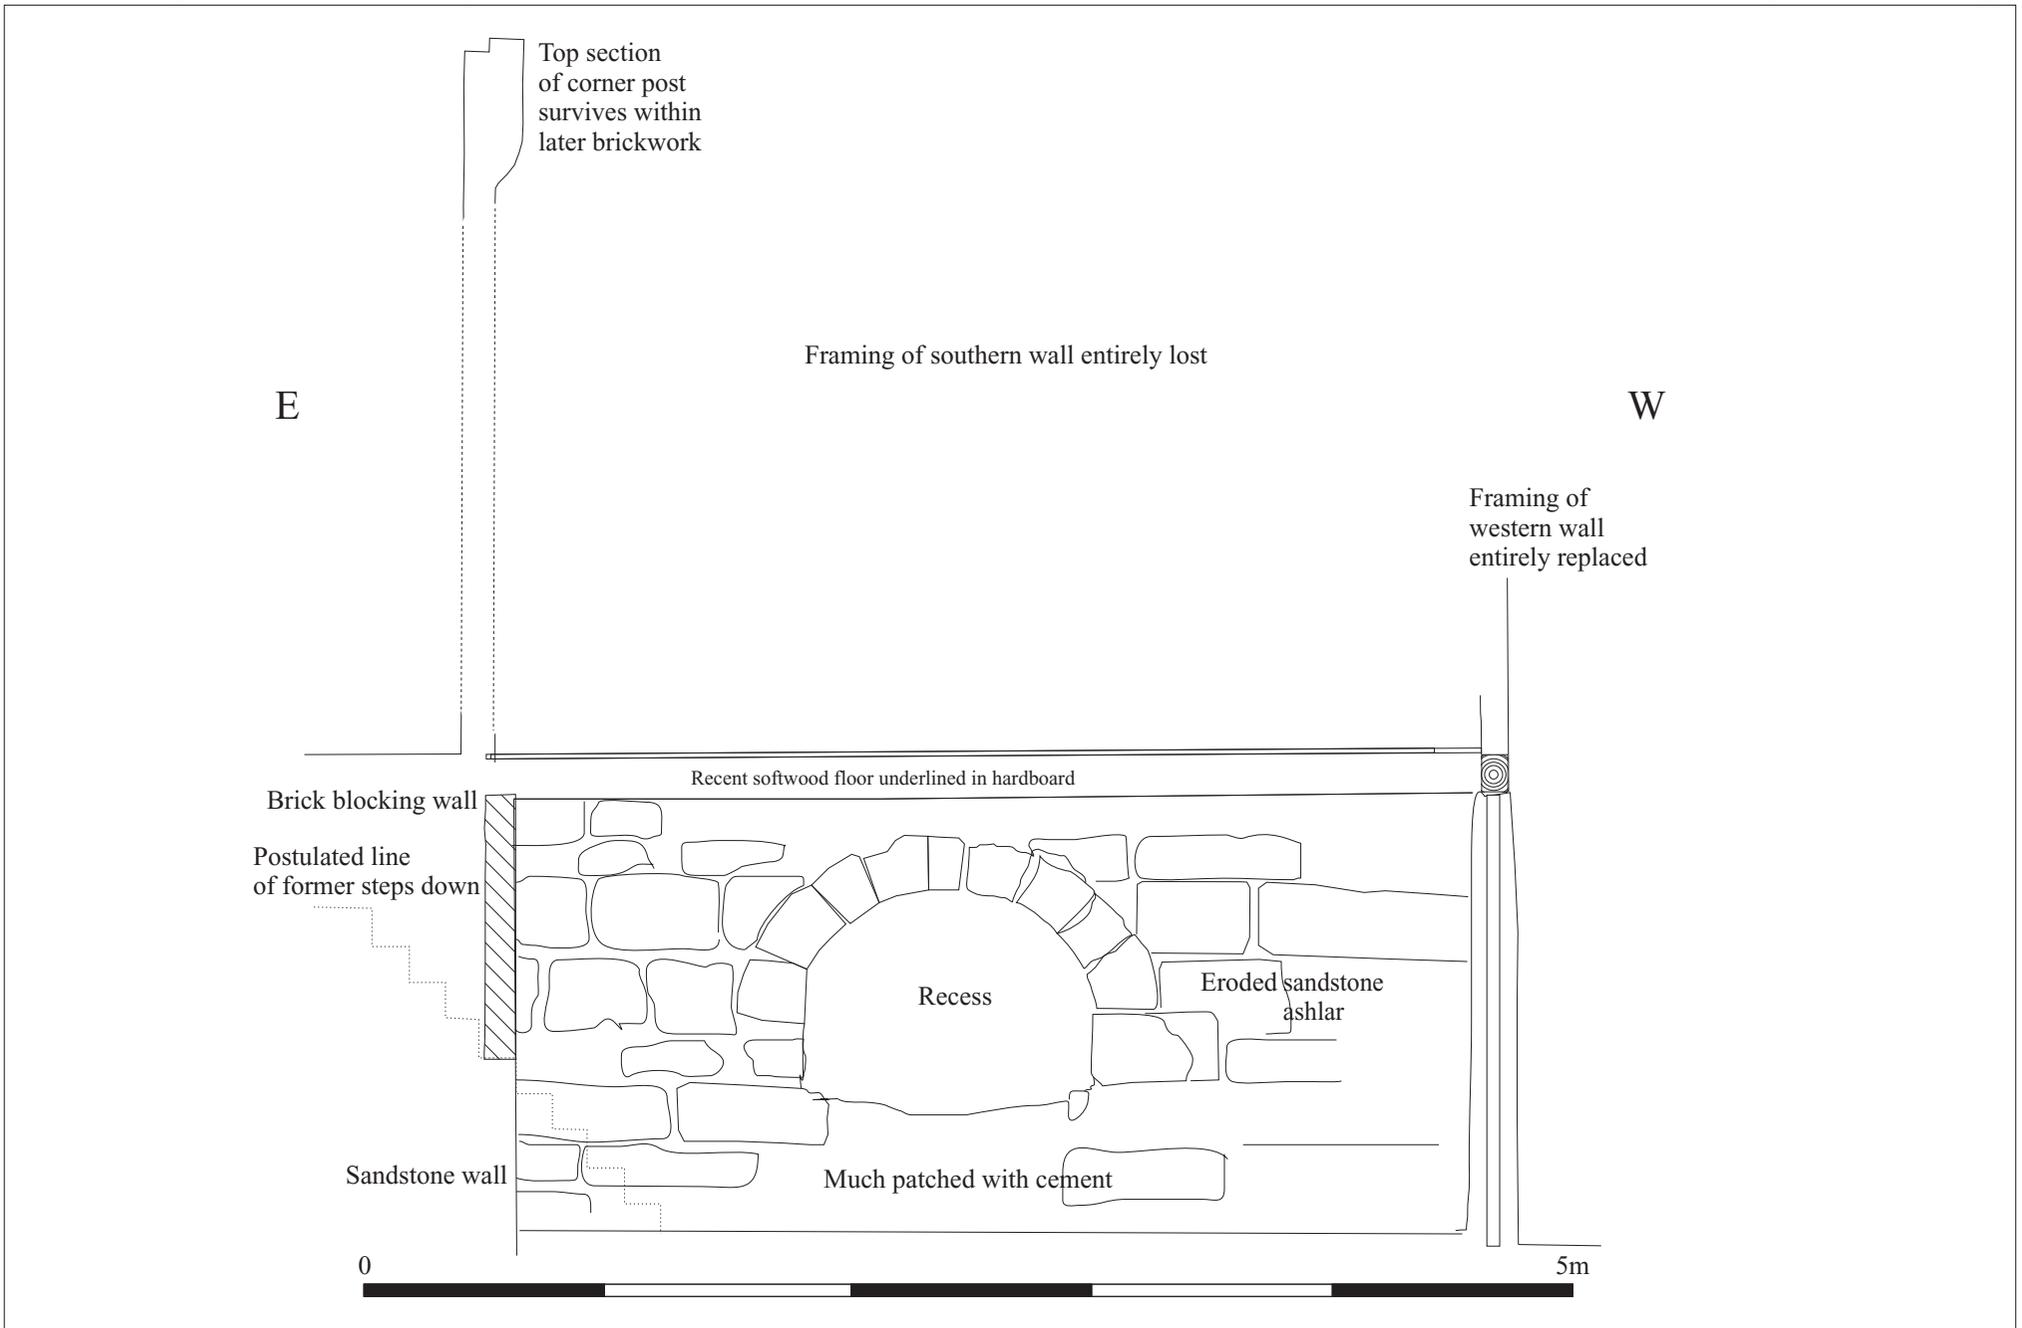
Figure 15: Internal elevation of southern wall of Building 1 basement
