BUILDING RECORDING AT
WINNALL LODGE,
LINEHOLT, OMBERSLEY,
WORCESTERSHIRE

WSM 46062

Building recording at Winnall Lodge, Lineholt, Ombersley,

(With a report on the tree-ring dating by A J Arnold and R E Howard)

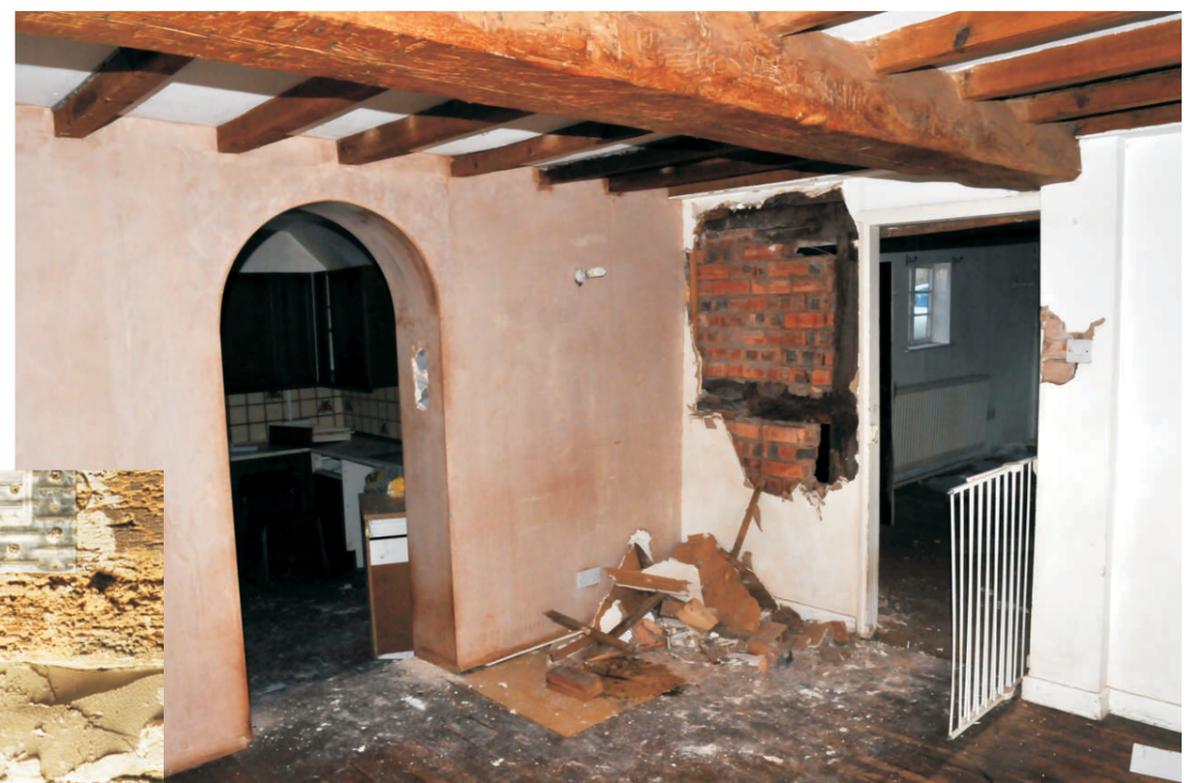
Framing of east wall of Building 1 exposed at ground floor level, note brick infill

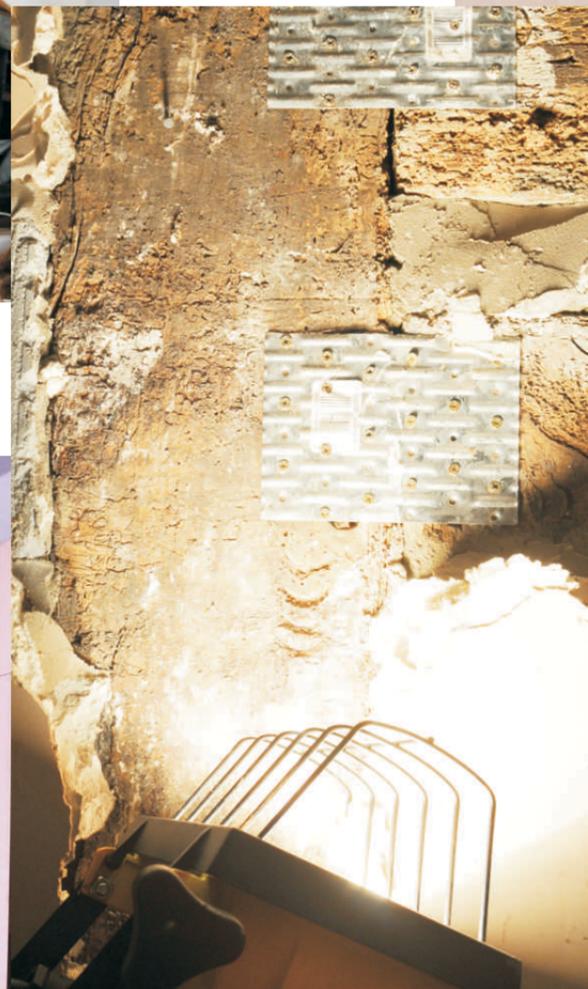
Detail of carpenter's assembly marks as exposed in ground floor kitchen

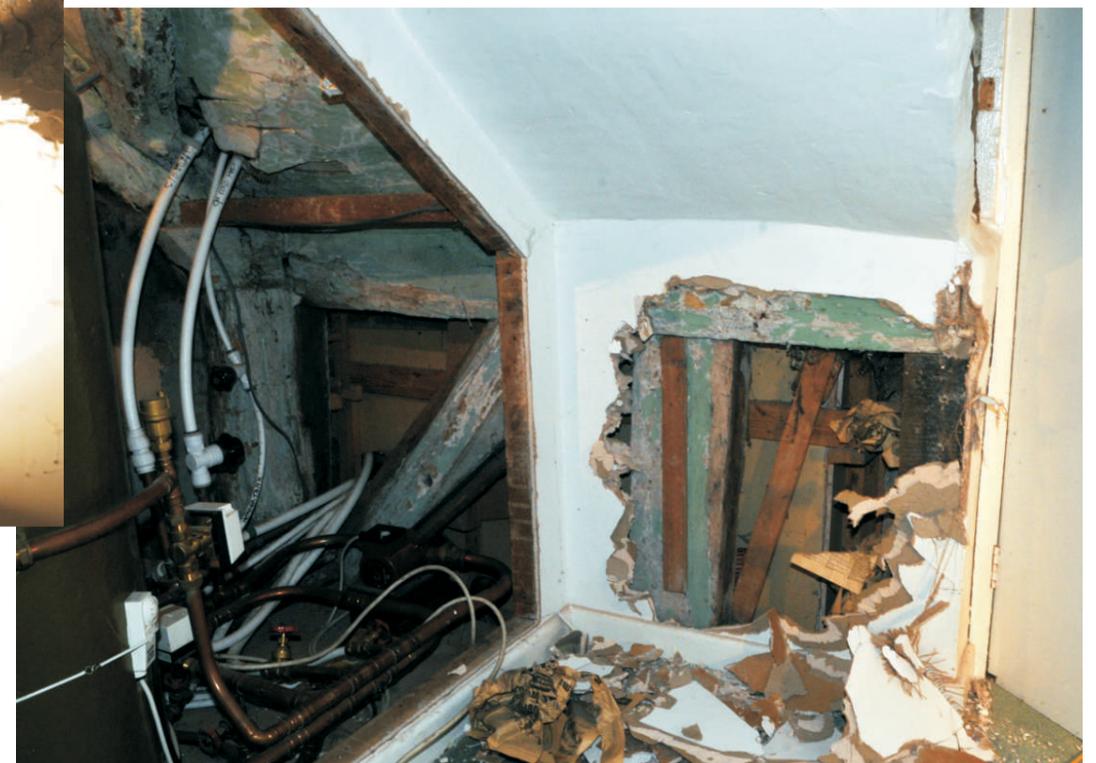
Framing of east wall exposed at 1st floor level, note bracing

Figure 16: The interior of "Building 1" - very little original fabric was exposed, and the surviving timber frame was only revealed by stripping away plasterboard and blockwork. Almost none of the original framing of this building was exposed externally - the western and southern walls having been almost entirely rebuilt.

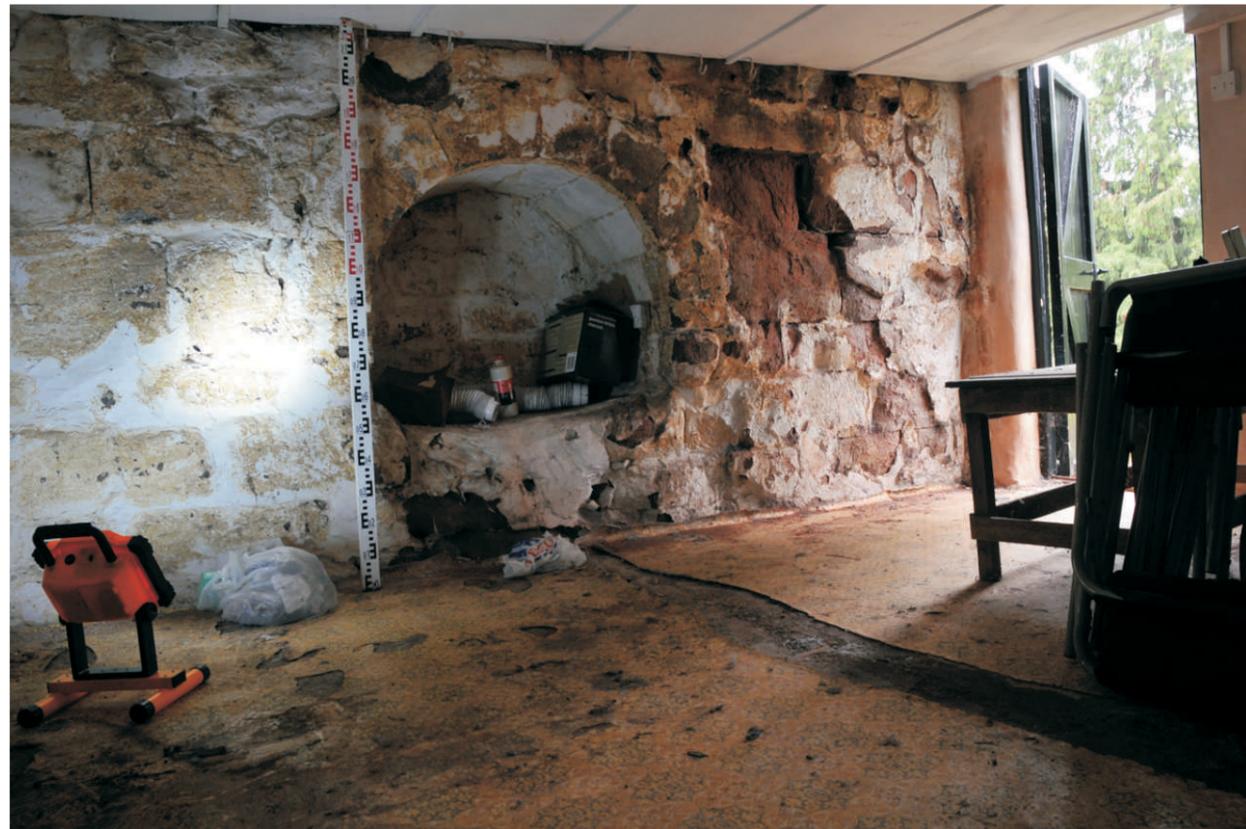
Southern wall of basement - note large arched recess of sandstone ashlar

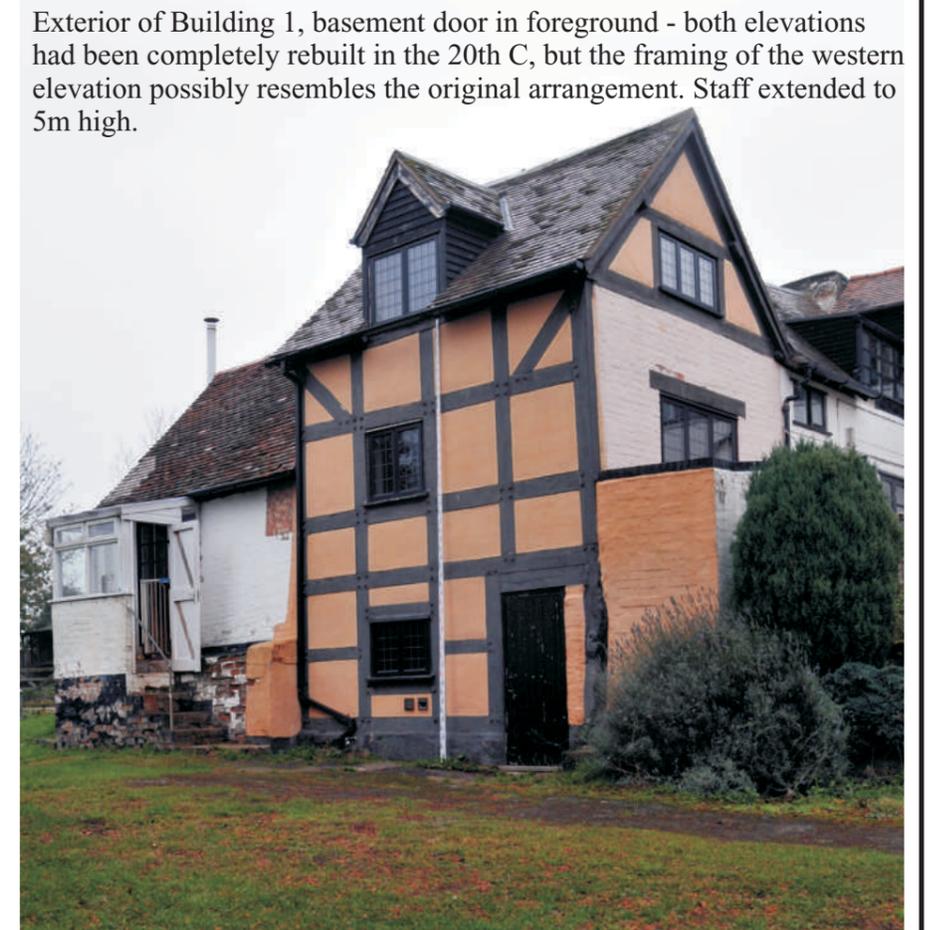
Exterior of Building 1, basement door in foreground - both elevations had been completely rebuilt in the 20th C, but the framing of the western elevation possibly resembles the original arrangement. Staff extended to 5m high.

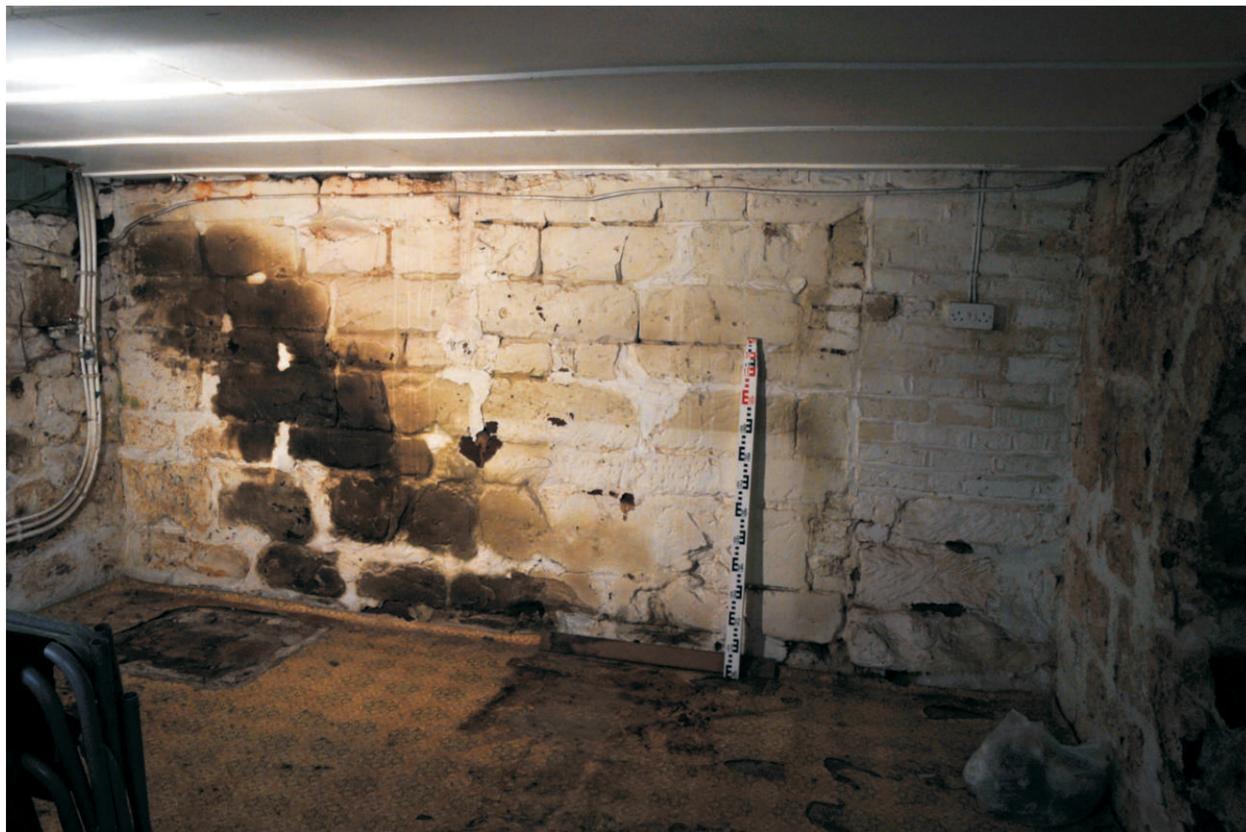
Eastern wall of basement - note bricked up probable stairway to RHS

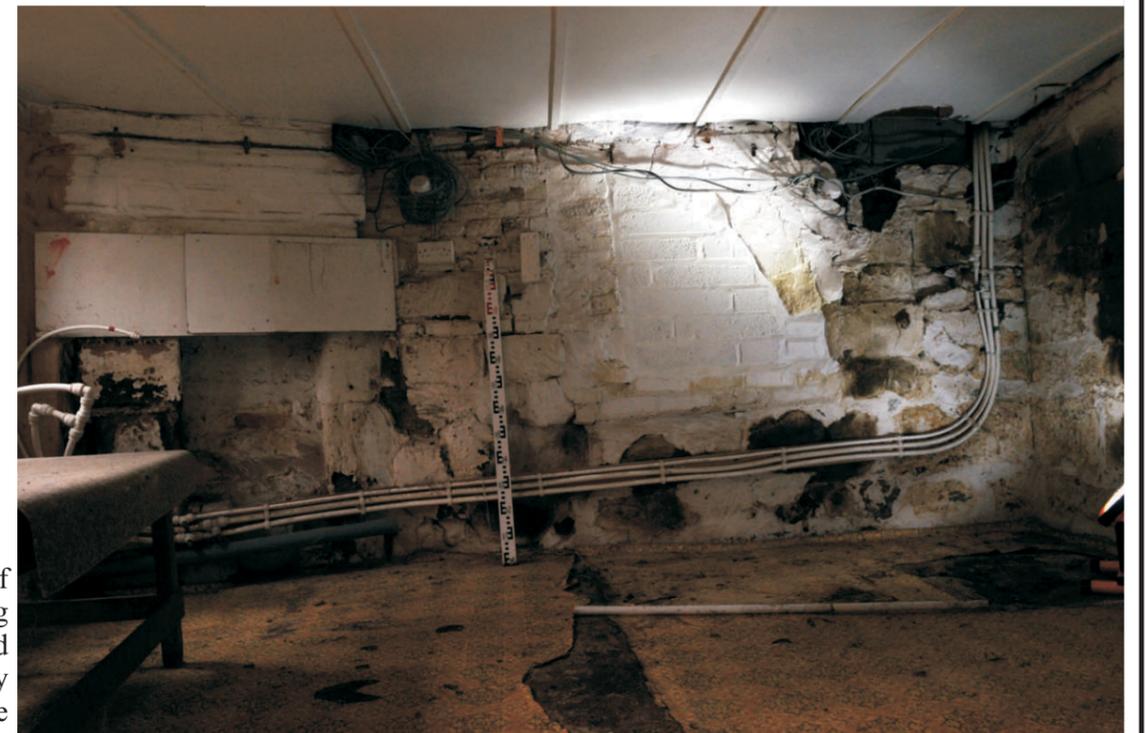
Northern side of basement, showing infilled arched recess, and secondary fireplace

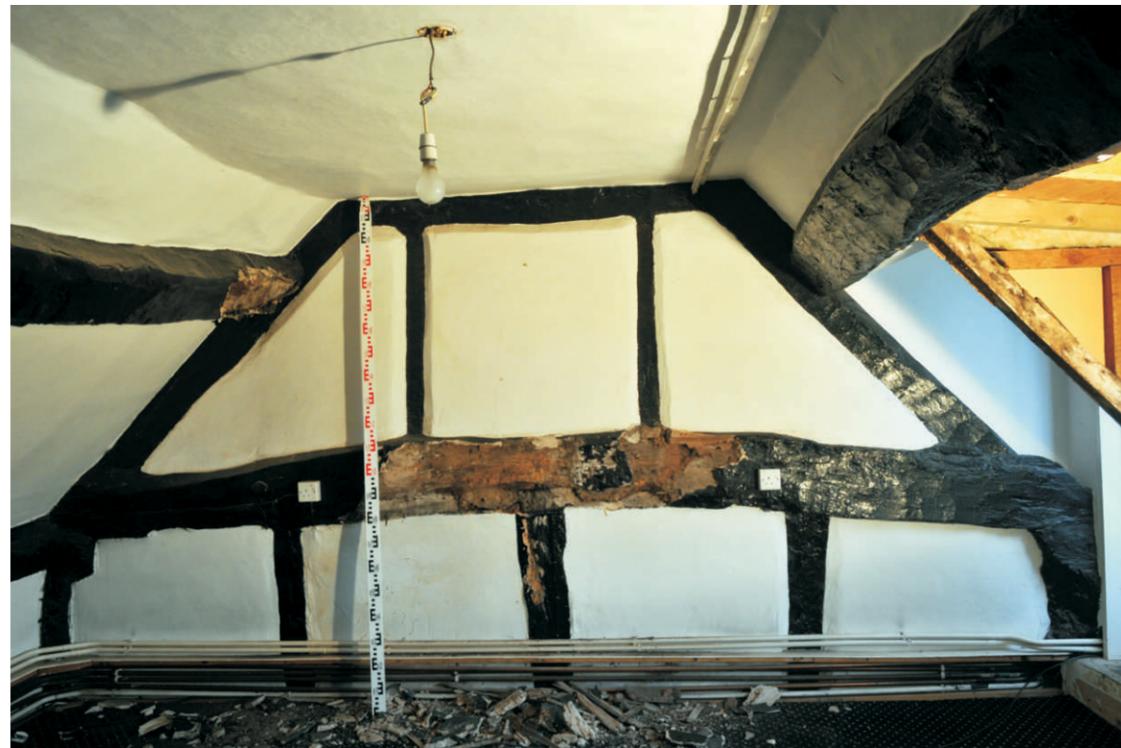
Eastern end of 1st floor - note very irregular tie-beam of Truss 3 patched in plaster

- 8.2.4 At first floor level most of the framing of the eastern bay survives, the only loss being the southern wall. Truss 3, the gable end, is of unusually irregular timber only roughly halved and crudely squared in places. The irregularities of the tie-beam timber have been evened up with lath and lime-plaster to provide a cosmetically more even finish. The crudely rounded purlins have been similarly treated. The gable end infill against the chimney is brick of probably late 17th C date. The majority of the Truss 2 infill appears to be of wattle and a deep reddish brown clayey daub. The ceiling is predominantly lime plaster, with later repairs and a new (unlined) dormer roof.

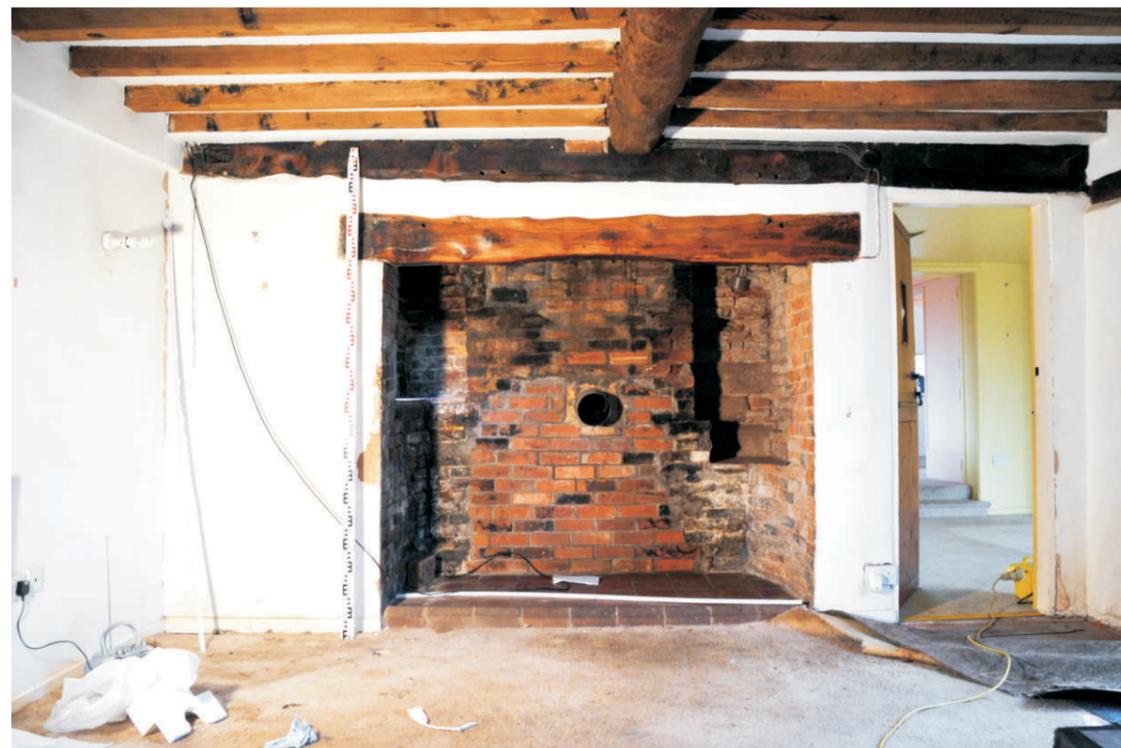
Eastern end of ground floor room showing re-used tie-beam and reconstructed first floor

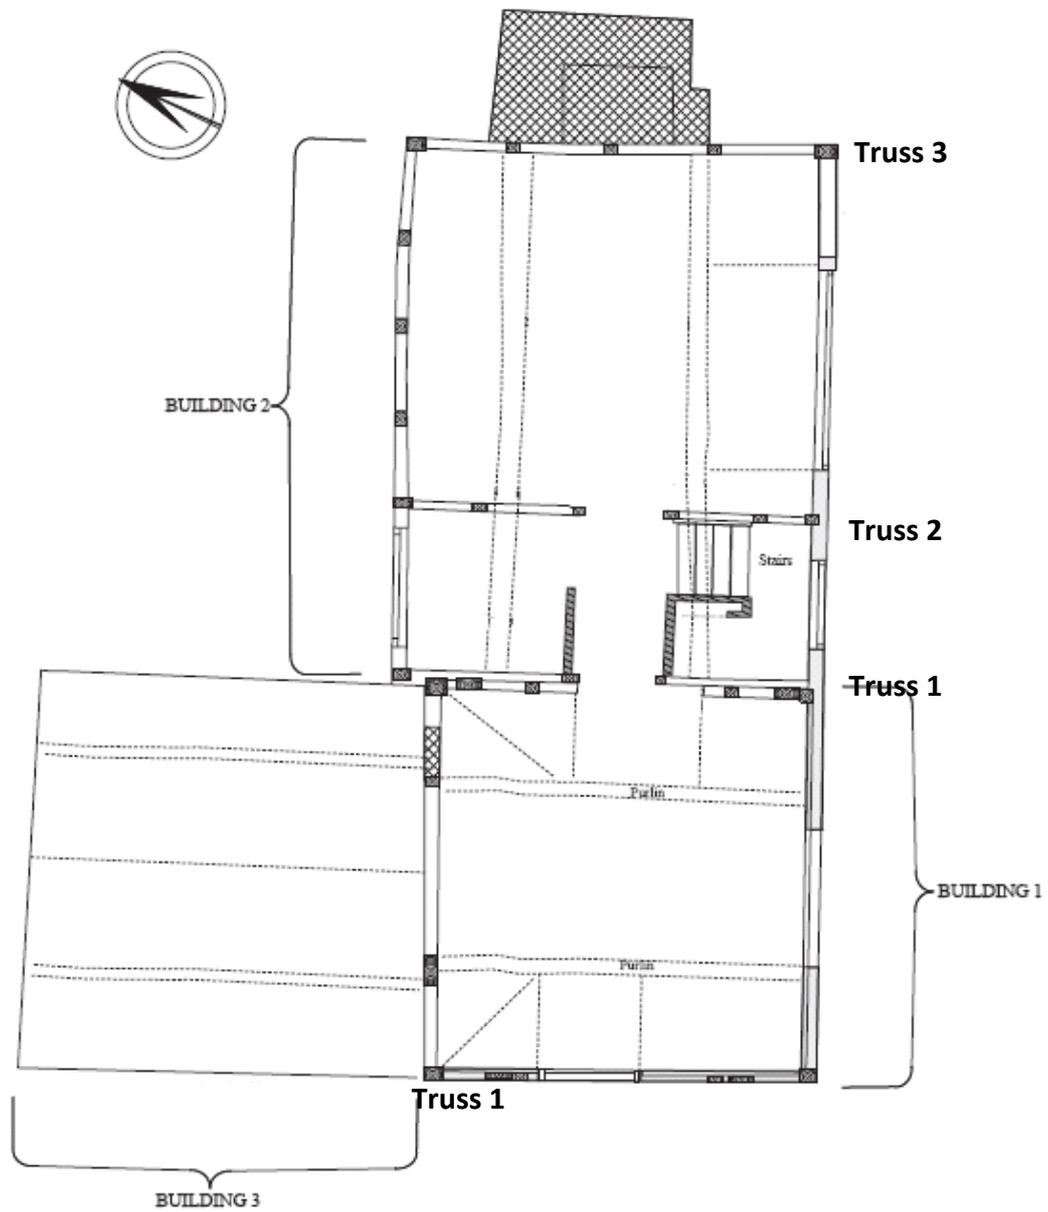
Figure 2: Plan of Winnall Lodge, Lineholt to show layout of buildings 1–3 and the position of the trusses (after Mike Napthan Archaeology)

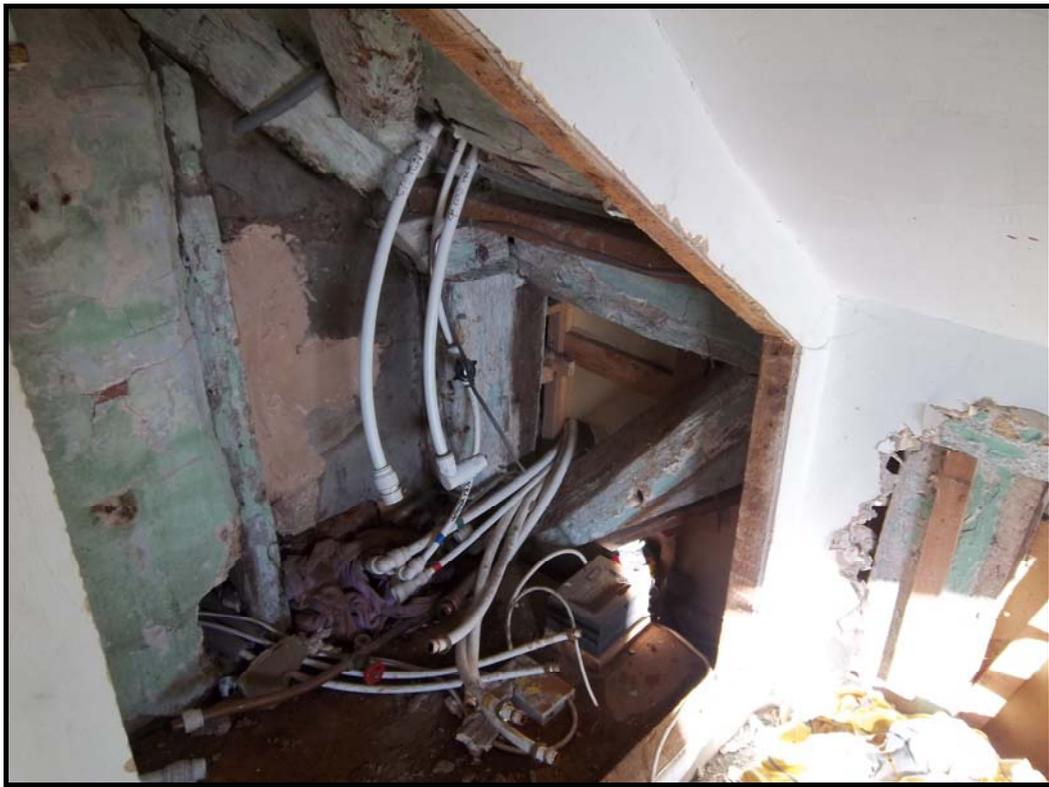
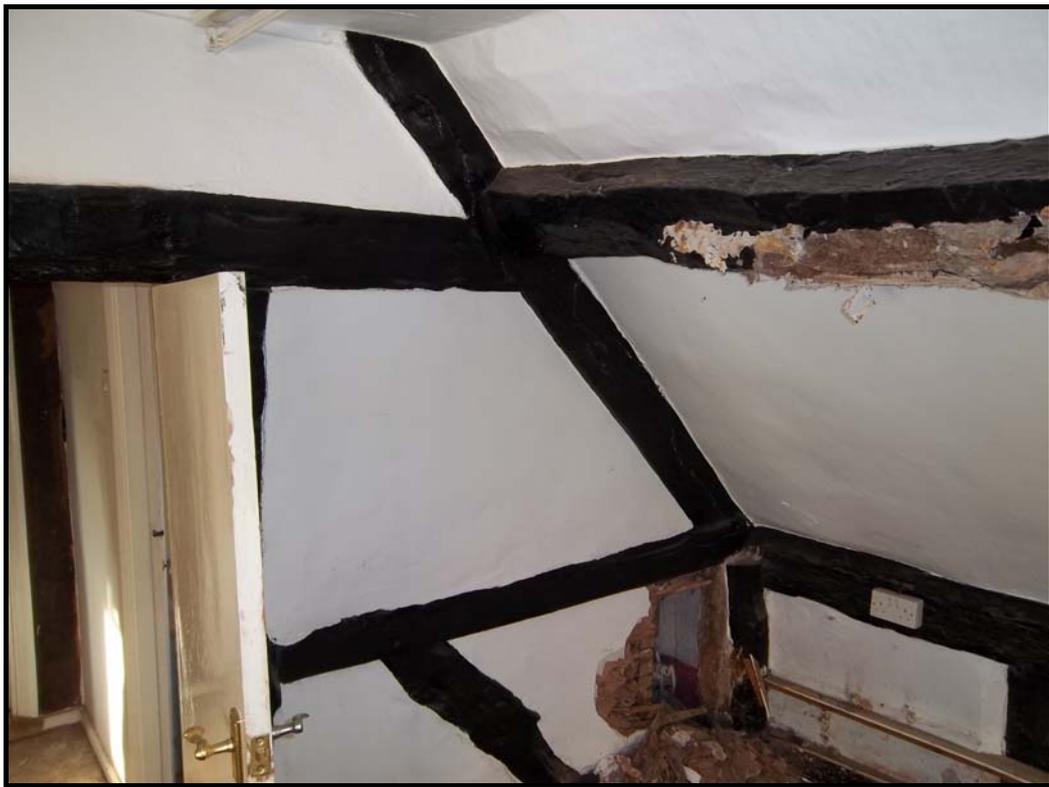
Figure 3a/b: Views of the timbers framing, north-east corner of building 1 (top), and north end of truss 2 in building 2 (bottom)

The greater quantity of remaining timber framing is found within both buildings 1 and 2. The northern truss of building 1 is unexceptional, being typical seventeenth century framing of principal rafters, tiebeam, and collar. The central opening between the tie beam and collar is rectangular, and might well have once contained a framed window, though no evidence of this was visible. Above the collar there are small raking queen-struts. The two purlins both may be original, though the extensive rebuilding of the southern and western walls and western roof-pitch has removed much of the evidence. There are raking straight windbraces between the purlins and the principal rafters of the northern gable end. The eastern wall of building 1 has been cut through for a central doorway (at the time when building 2 was constructed) but otherwise is intact, retaining the heads of both north-east and south-east corner posts, and two out of originally three studs. There are raking braces between the wall-plate soffit and the two corner posts, each double pegged to the wall-plate (Fig 3a). The central section of wall plate is lost, but it is highly probable that there was a further stud jointed to it at its' mid-point. Above the wall-plate the framing is all part of Truss 2 of Building 2.

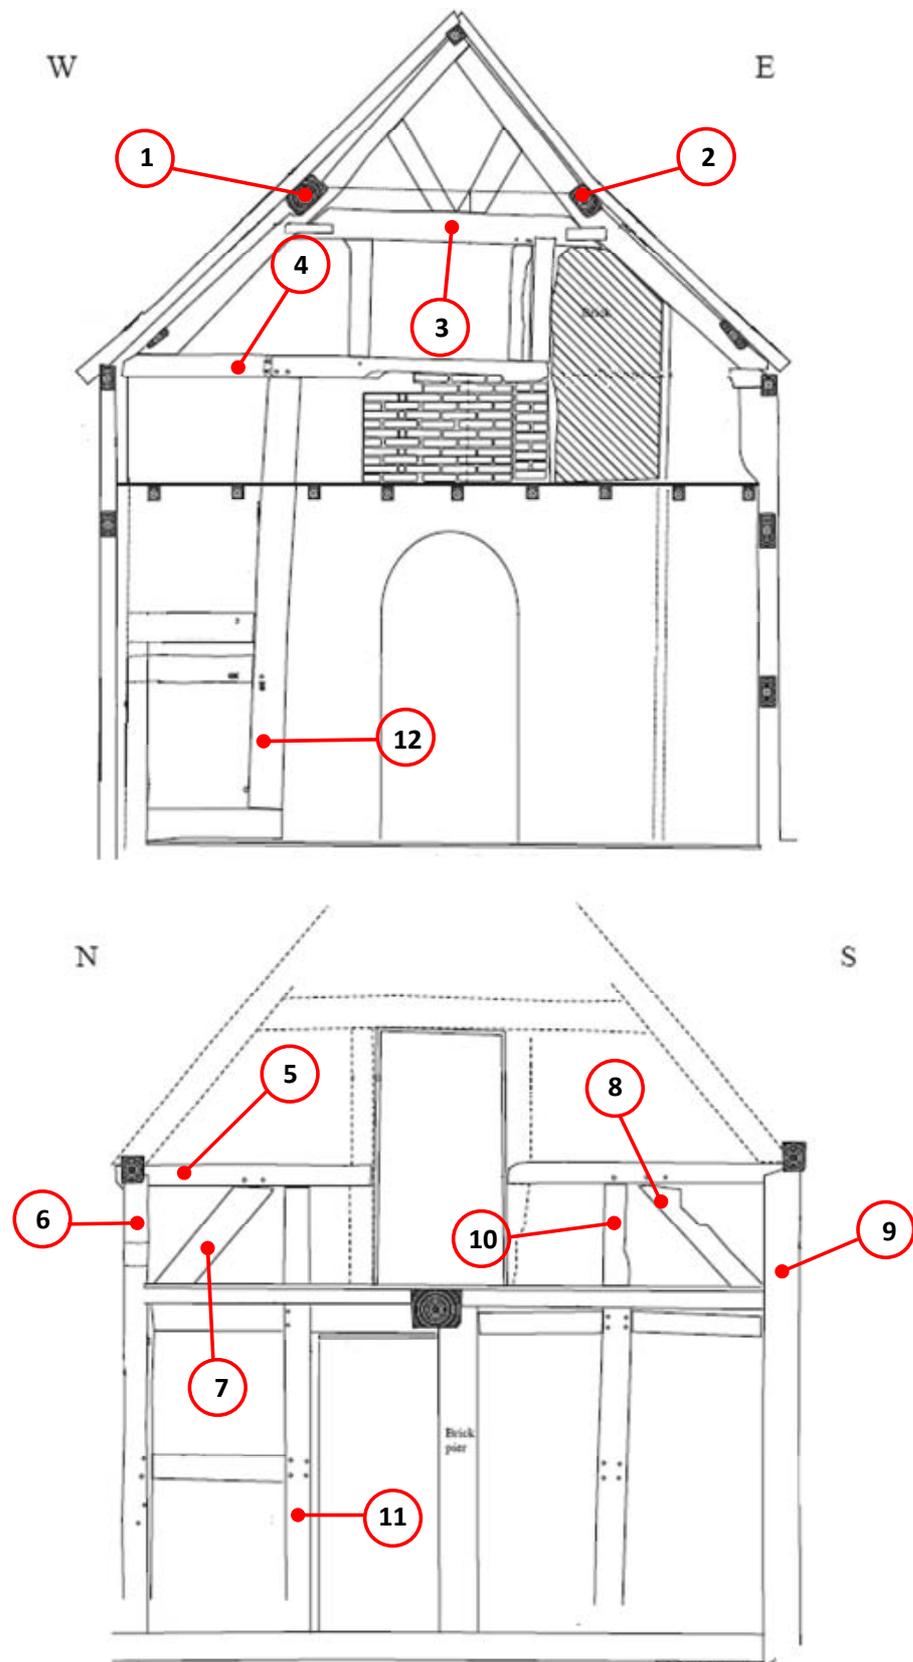
Figure 4a/b: Section through truss 1 (top) and the east wall (bottom) of building 1 to show sampled timbers (after Mike Napthan Archaeology)

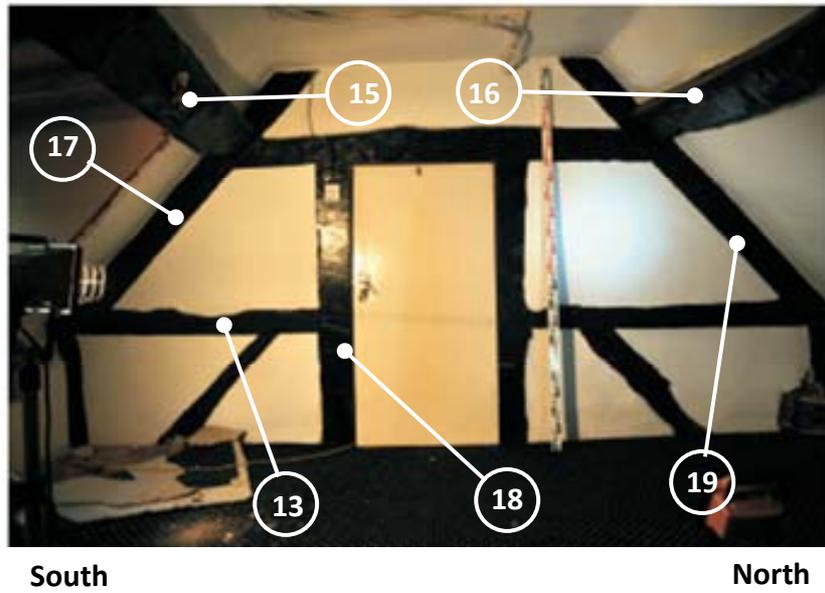
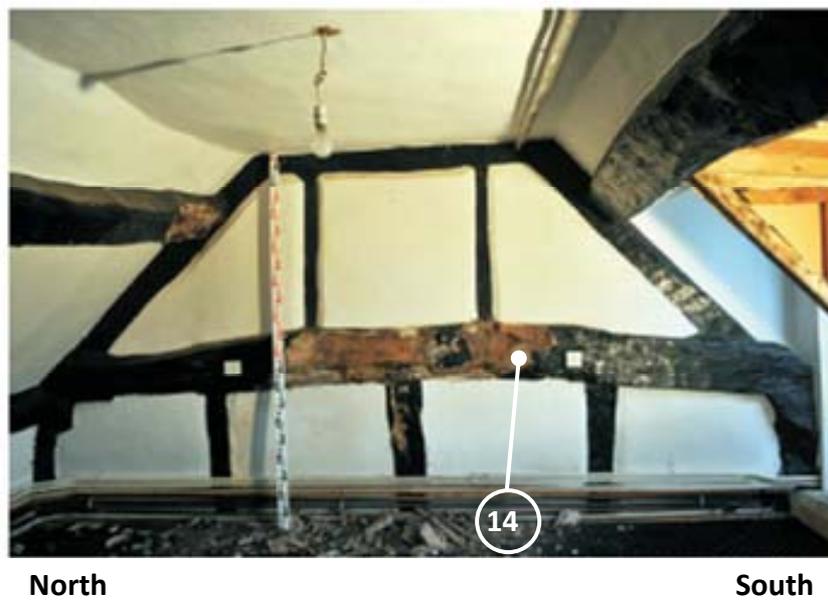
Figure 4c-d: Views of the trusses 2 (top) and 3 (bottom) in building 2 to show sampled timbers (photo by Mike Napthan Archaeology)

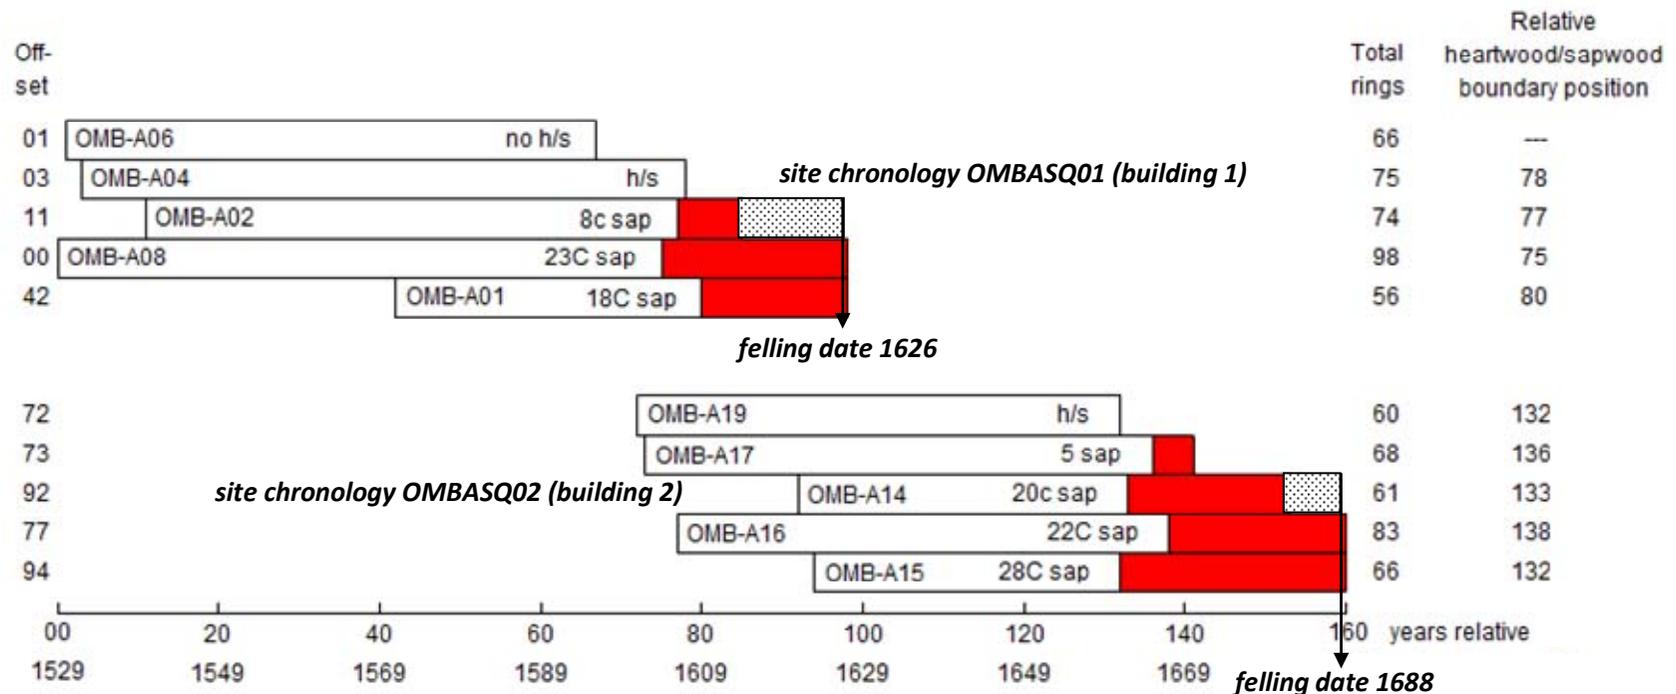
Blank bars = heartwood rings, shaded bars = sapwood rings, hatched bars = estimated lost sapwood rings
 h/s = heartwood/sapwood boundary
 c = complete sapwood is found on the timber but a portion of this has been lost from the sample in coring
 C = complete sapwood is retained on the samples and the last measured ring date is the felling date of the tree represented

Figure 5: Bar diagram of the samples in site chronologies OMBASQ01 and OMBASQ02 at positions indicated by the separate dating of each one. The samples in the two separate site chronologies are shown in the form of bars at positions where the ring variations of the samples in each group cross-match with each other. This similarity is produced by the trees represented by each site chronology growing in the same place, *at the same time* (there is insufficient overlap in date between the two site chronologies for a cross-match to be reliable). The samples are combined to form two ‘site chronologies’, which are compared with the ‘reference’ chronologies. It will be noticed that samples A01 and A08 in group 1, and A15 and A16 in group 2, have the last growth ring produced by the trees before they were cut down, and that each pair stopped growing at the same time. This last growth, and thus their felling, has been dated respectively to 1626 and 1688.

The first site chronology, OMBASQ01, comprises five samples (all from building 1), and has an overall length of 100 rings. These rings were dated as spanning the years 1527–1626. Interpretation of the sapwood on these samples shows that the all the dated timbers of building 1 were felled in 1626.

The second site chronology, OMBASQ02, also comprises five samples (all from building 2), this site chronology having an overall length of 98 rings. These rings were dated as spanning the years 1591–1688. Interpretation of the sapwood on these samples shows that the dated timbers of building 2 were probably all felled in 1688.
