WATCHING BRIEF DURING  
EXCAVATION OF  
REPLACEMENT TREE-PITS,  
HIGH STREET,  
WORCESTER

WCM 101927

# Watching brief during excavation of replacement tree-pits, High Street, Worcester WCM 101927

23<sup>rd</sup> May 2012  
Mike Napthan MIFA

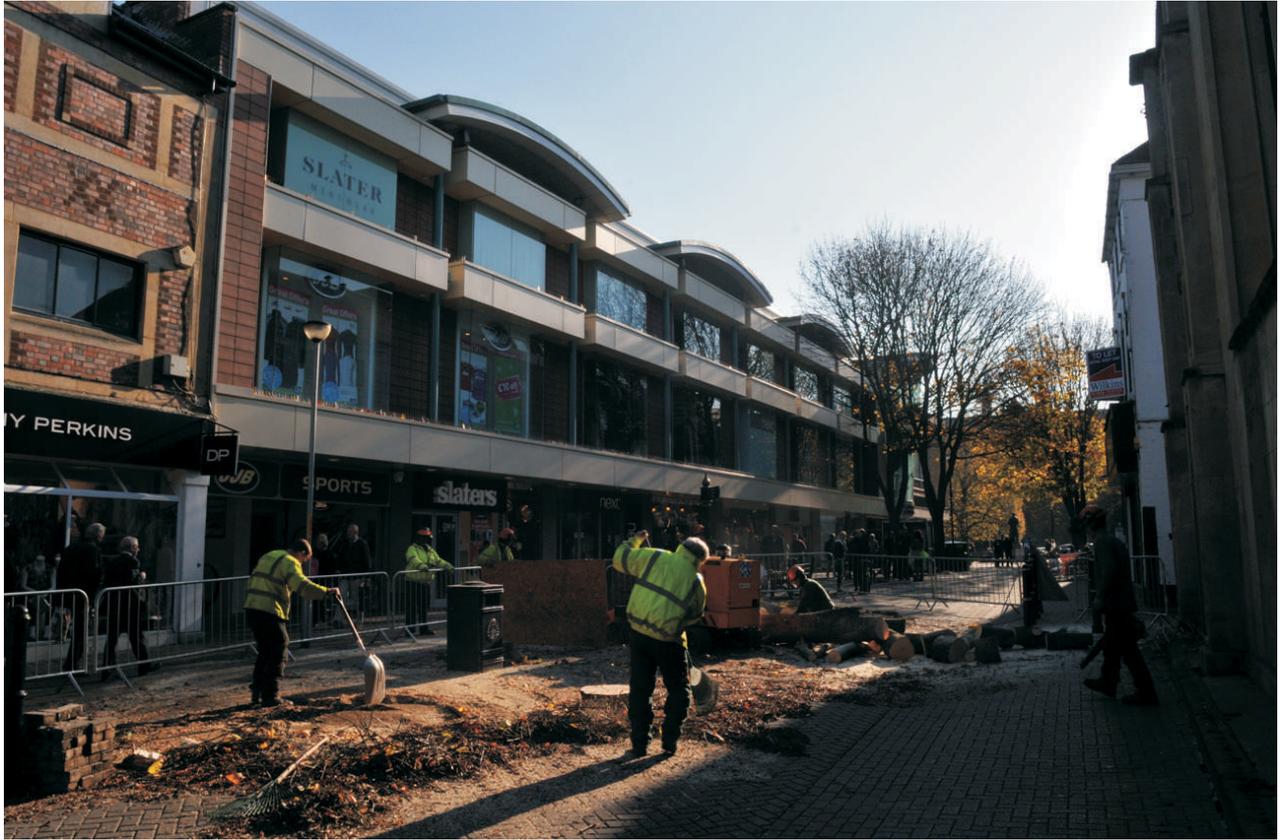
Figure 2: Site photographs

General view facing south during clearance of original trees

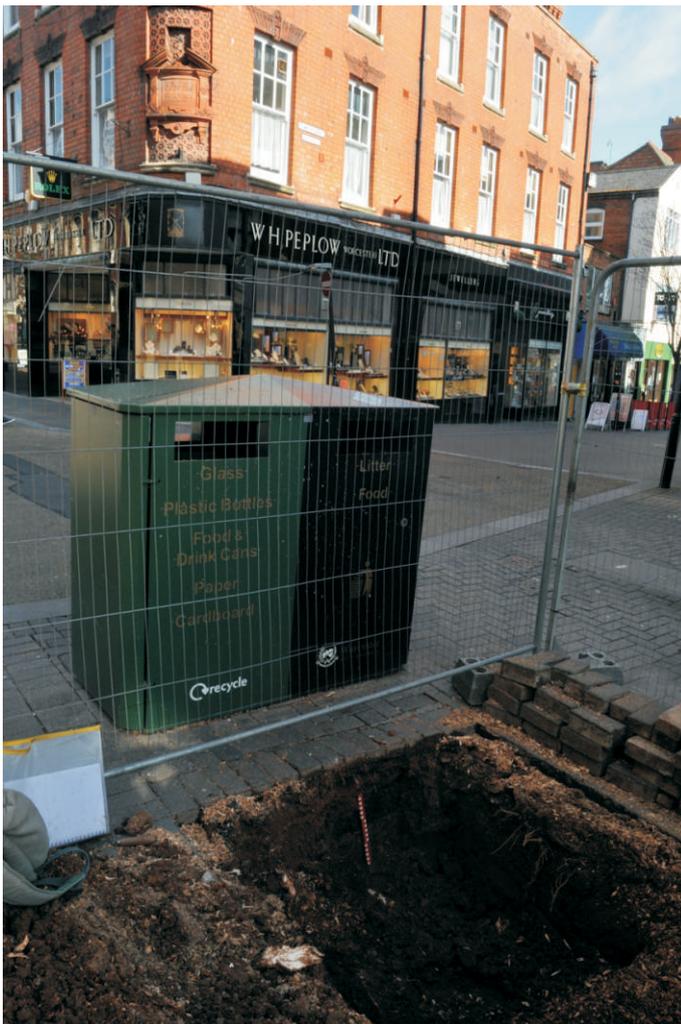
Tree-pit 1 view facing north-east

- 4.2 Tree-pits 1 and 2 were too small for deposits beneath the concrete to be observed, the horizons around the periphery being mixed with the tree planting soil placed around the original trees.

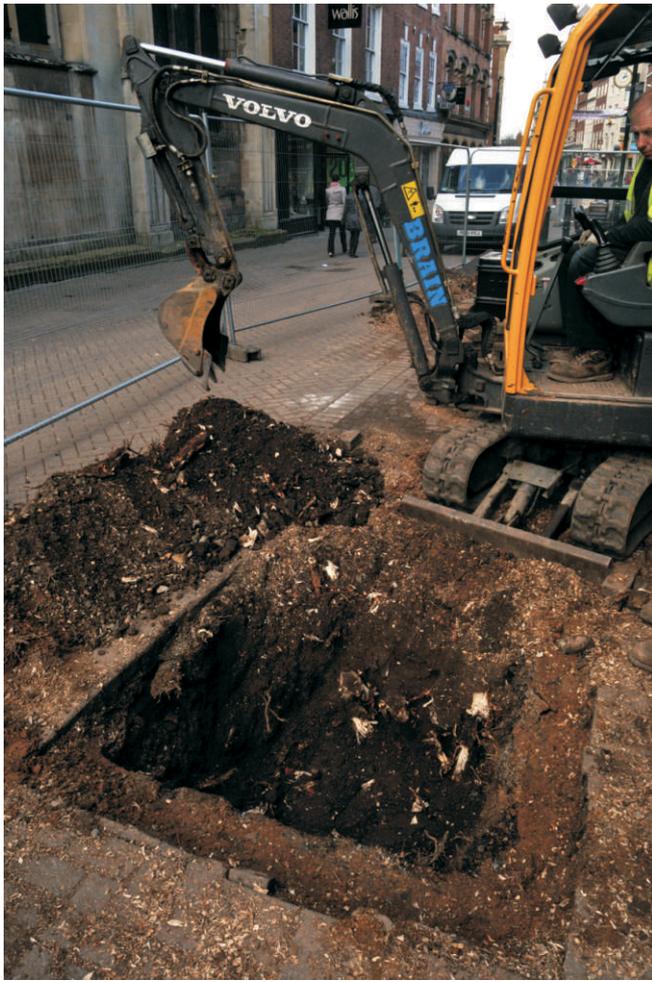
Figure 3: Site photographs

Trench 4 under excavation, view facing north

- 4.3 Tree-pits 3 and 4 had a 200mm deep layer of tree-planting soil mixed with a clayey horizon beneath the concrete. On the eastern side of TP 4 there was a cast iron service pipe and on the western side a small diameter pipe (possibly a cable duct).

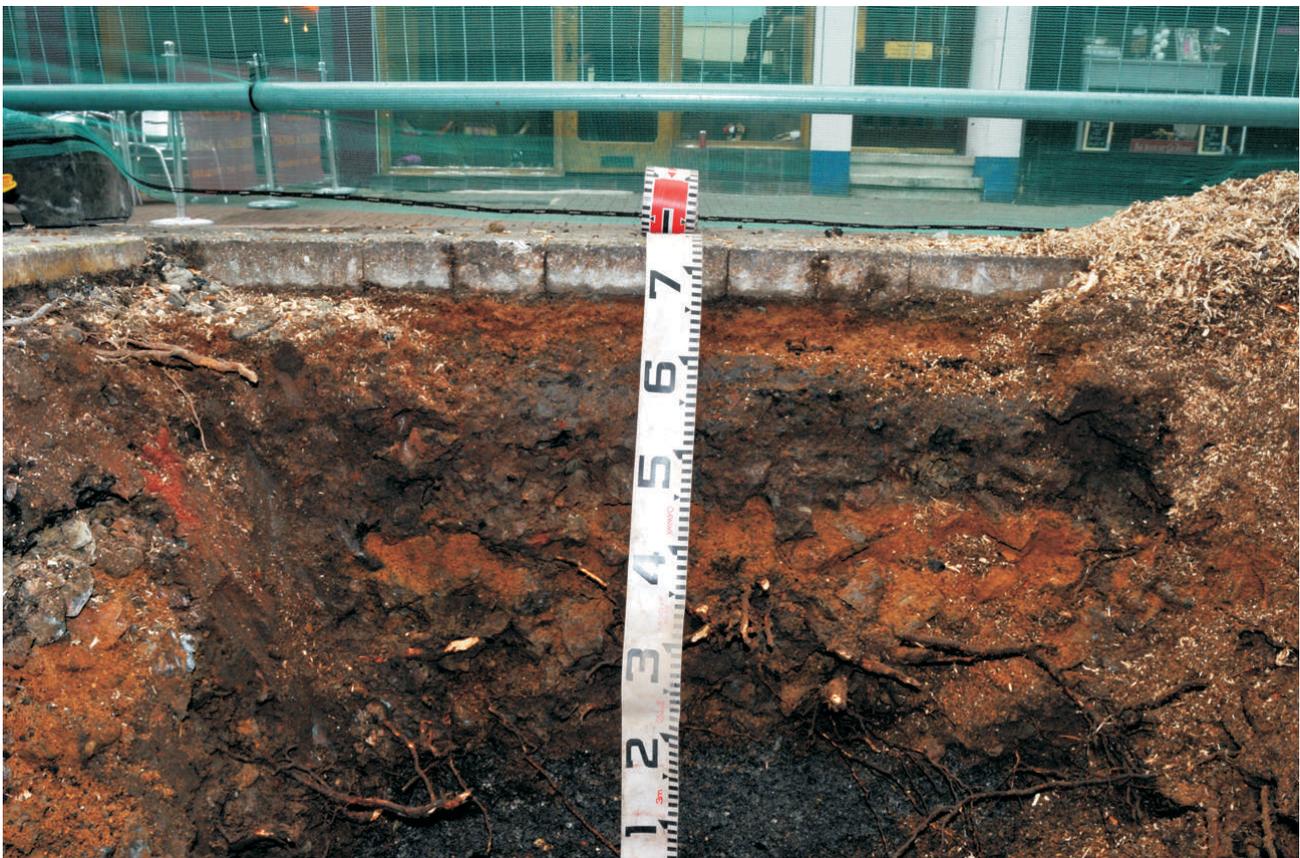
Sequence of deposits on eastern side of TP6

- 4.5 Tree-pit 6 exposed the deepest and clearest sequence of deposits. The concrete here had been replaced with a mixture of roadstone and sand overlying a deposit of finely sifted ashy clinkers at 700-750mm deep.
