BUILDING RECORDING AT
HUDDINGTON HILL FARM,
HUDDINGTON,
WORCESTERSHIRE

WSM 54780

Building recording at Huddington Hill Farm, Huddington, Worcestershire WSM 54780

Mike Napthan MIFA
6th June 2011

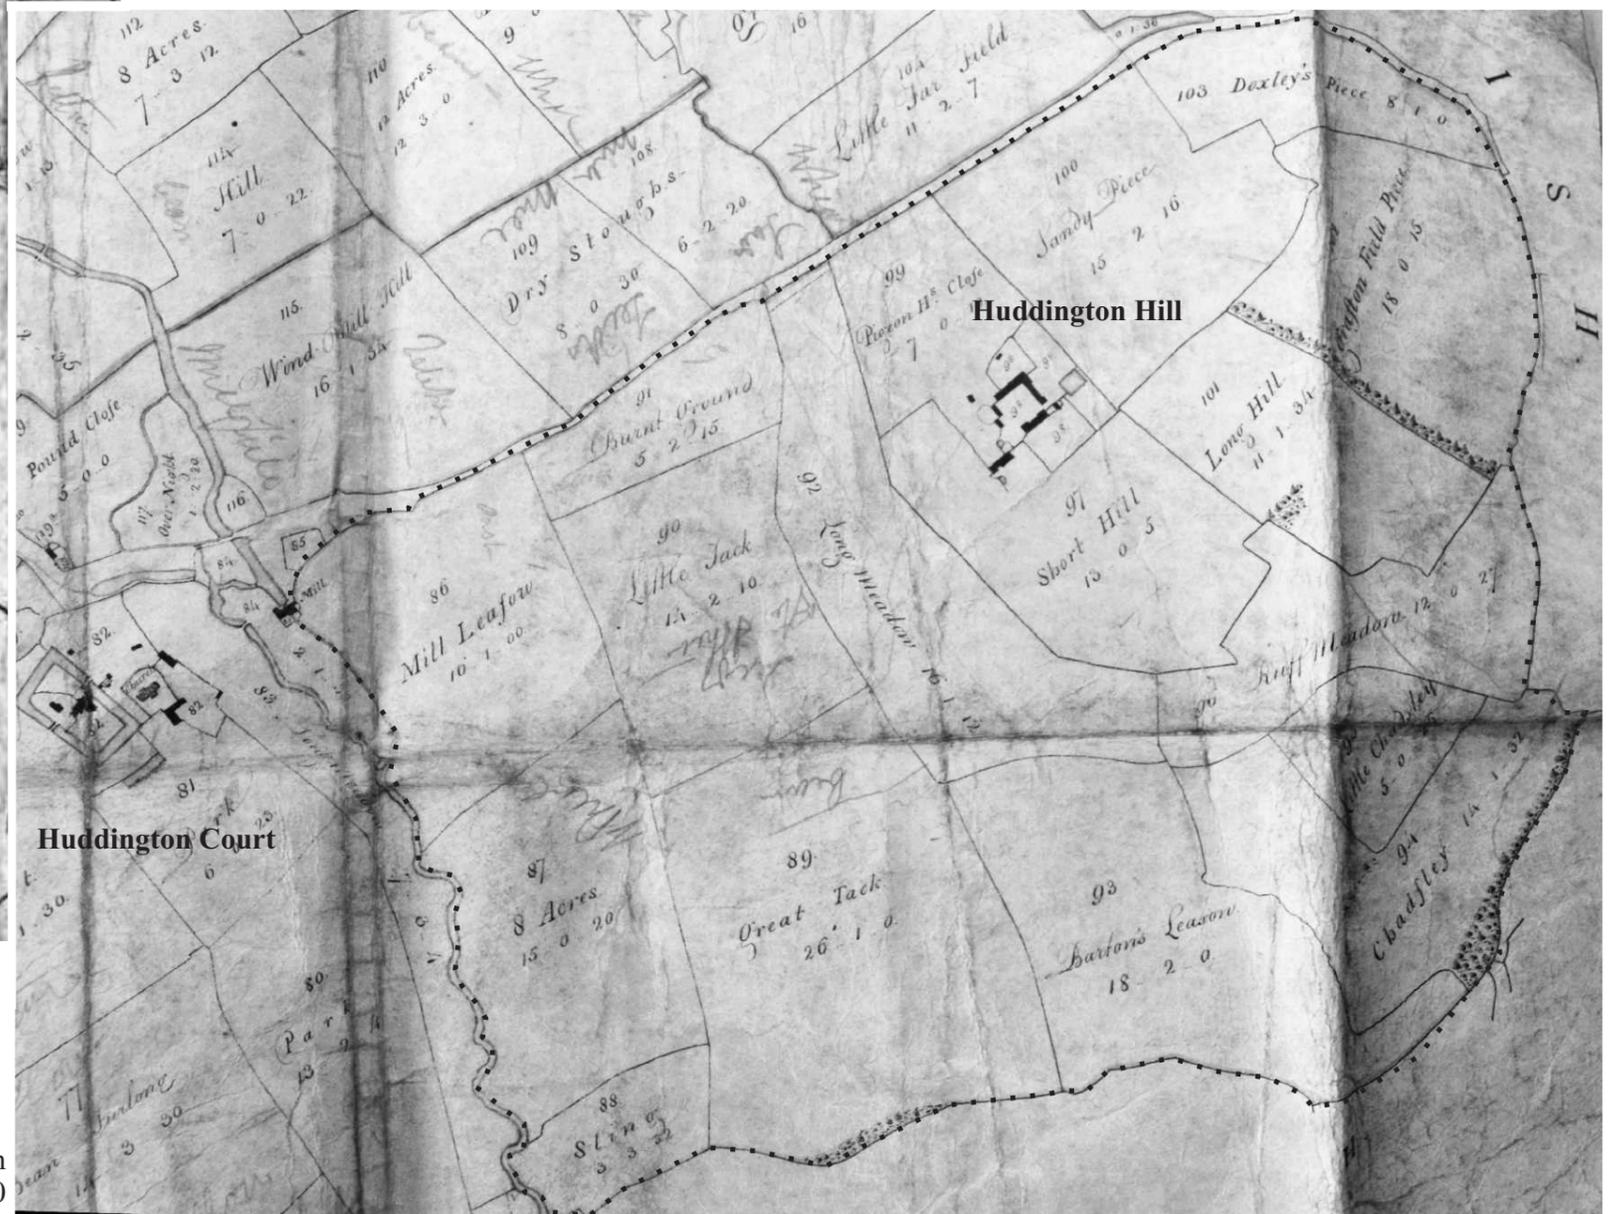
Figure 3: Extracts from an estate plan of 1790, showing Huddington Hill as part of the Huddington Court Estate.

Detail of area around farmstead - note that the western range was incomplete at this date, though there was a building apparently on the site of the present "dairy". The pigeon house is probably the small building to the NW of the farmstead.

Dotted line shows extent of Huddington Hill farm in 1790

- 7.2 The 1790 mapping shows the northern and eastern ranges of the farmyard much as they are now, with the exception that the southern end of the eastern range looks to be a little wider. This may reflect the presence of an earlier building on a similar but not identical footprint to the present stable block, or might be considered as a small lean to shed alongside the present building, the scale of the plan being very small individual structures are not distinguished. The portrayal of the western range shows a clear difference between 1790 and the present day, only the north-eastern

building element being present. There is a further building lying to the west of the present location of the open fronted cattle byre, but the byre itself is not shown. This is intriguing because the physical remains of the byre indicate that it was very probably present pre 1790. It is possible that the building was unroofed at the time of survey and not shown. The cart-house/granary was not built at the time of the survey, and its eventual site remained clear.

- 7.3 The 1790 plan shows at least five buildings that are no longer present – there was a range of two or three buildings (one of barn size) to the SW of the house, a further small building to the NEE. The building west of the byre has already been mentioned – this was approximately the same size as the present byre. The remaining building stood in Pigeon House Close, and therefore may very well have been the pigeon house. Pigeon houses were fairly common agricultural features on wealthier farms of the 17 and 18th Century. No overview of the pigeon-houses of Worcestershire has been drawn up but a recent gazetteer of the pigeon-houses of Herefordshire identified 300 pigeon house sites in the county. Worcestershire has 67 Listed pigeon-houses, but this is not truly representative as a high proportion remain without Listed Building status (Walker, 2010, 17). Walker indicates that the majority of pigeon houses were built after 1619 (when restrictions relating to the manorial prerogative were abolished). The present example appears to be rectangular, which is a fairly uncommon form (the majority being square, and round then octagonal then rectangular in order of frequency). Walker lists only 8 rectangular pigeon houses out of about 50 “square” masonry and timber framed Herefordshire examples for which there are dimensions.

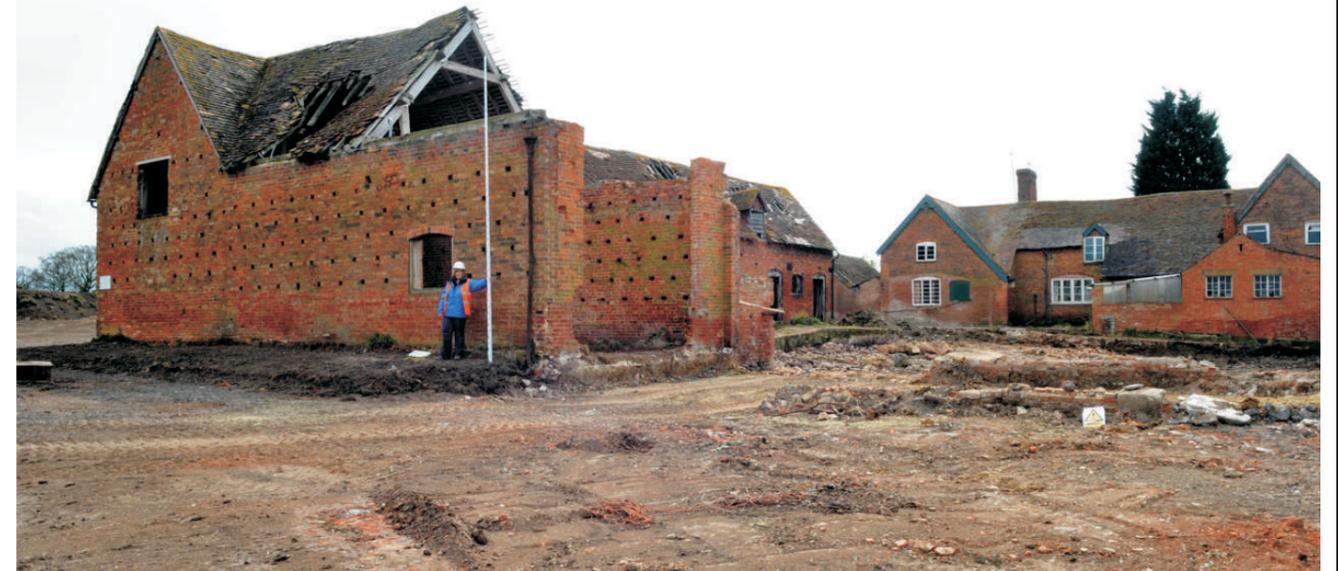
Eastern range, and remains of northern barn range in foreground

Western range, and remnant of timber framed northern range

- 8.4 *Northern Range* (Figs 5, 6, 10 and 11)
- 8.4.1 The northern range formerly consisted of a timber framed barn of four bays, and a two bay continuation of the brickbuilt barn of the eastern range. The timber framed barn survived in a poor state until c2010, when it collapsed. Only the westernmost bay now survives as a roofless condition having lost its gable end. The remainder of the barn is now only traceable as the lower courses of the dwarf walls. The fallen timbers have been cleared from the site and the salvageable elements stored in one of the modern portal framed buildings. The general layout of the barn was recorded on the as existing drawings prepared for the 2007 planning application.

- 8.4.2 Whilst only a fragment of the barn (consisting of the framed gable wall and side walls of the western bay) survives, these together with the retained timbers, tend to indicate an 18th C origin for the building. The structural timbers of the remaining portion are all elm, and the majority are cut from very small scantling timber, with bark and sapwood retained on the interior faces. The box framing is held together with mainly small diameter pegs and some iron spikes, The quality of the framing is extremely poor, and there is no surviving diagonal bracing. The building seems to have been constructed with brick infill in mind as there are no stave mortices or wattle grooves. The southern wall of the surviving bay has been entirely replaced in late 19th or early 20th C brickwork. The brick panels of the framed elements are mid 18th C brick, with patterned vent holes. The dwarf walls are mainly late 18th C brick with some later patching.

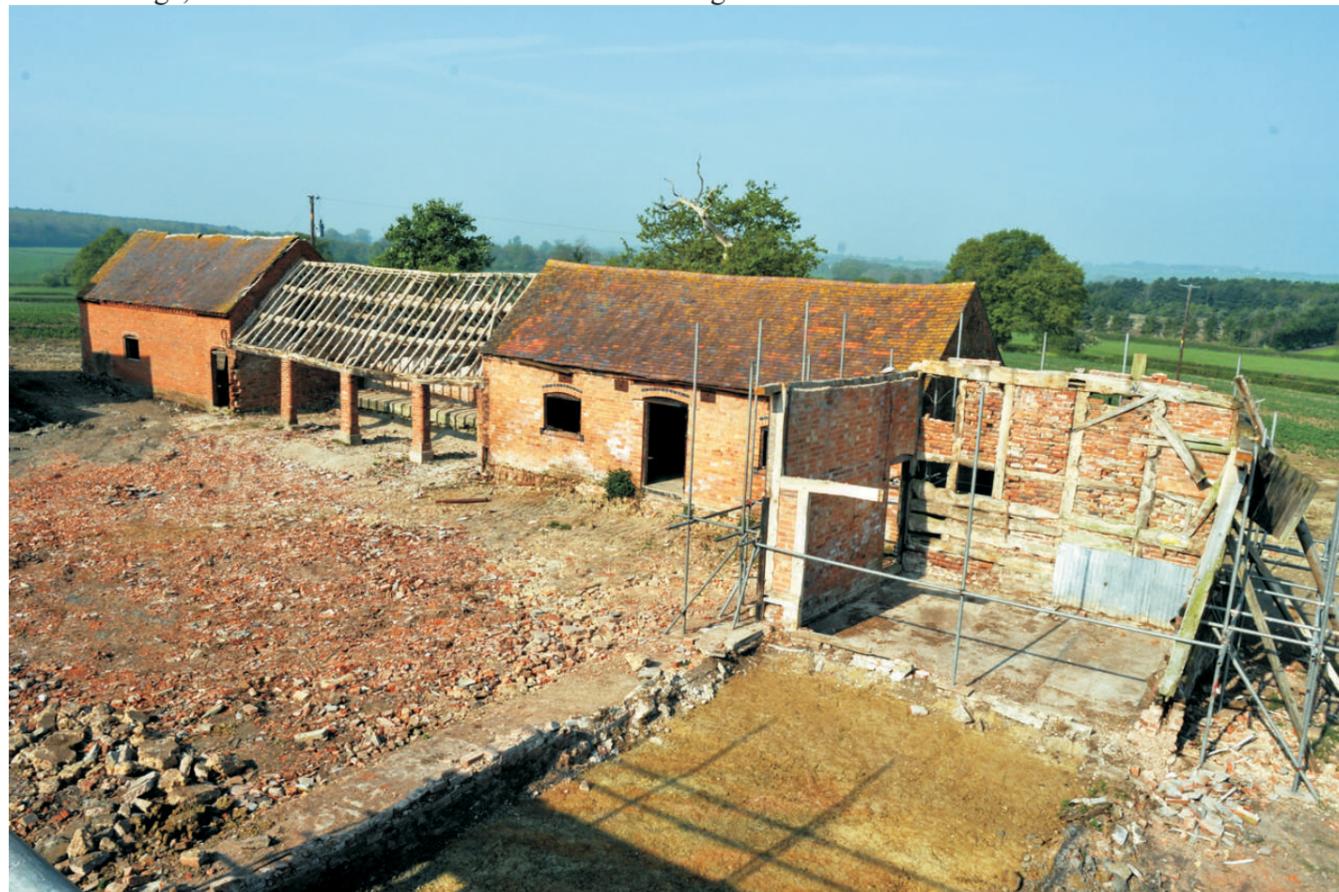
Exterior of eastern range

- 8.2 *Eastern Range* (Figs 5-9)
- 8.2.1 The eastern range consists of a barn at the north end, and a stable/hayloft block at the southern end. The barn is of unusual form as the northern-most bay is linked to a continuation of two bays running along the northern range. Whilst these two bays were constructed separately they appear to have been planned in one with the three bays of barn in the eastern range. The most southerly of the bays is a threshing bay, formerly with large double doors (recently removed). To each side of the threshing bay there is a low brick partition wall. There appears to have been a high level floor within the storage bays of the barn, as there is an internal ledge about 3.7m above floor level, with corresponding loading hatch on the northern gable end. Above the ledge the external walls are only 9”, and have been built over-hand from the exterior only. The walls below are fair faced both sides. All of the walls have frequent ventilation holes, in fairly regular patterns. The second bay has decorative “lozenge” shaped arrangements of vent holes at low level, facing the farmyard only. The fourth bay, lies to the south of the threshing bay, and is clearly an addition to the barn, as there is a clear vertical joint in the brickwork on both elevations 4-5 bricks south of the barn doors. The fourth bay is both slightly lower and narrower than the main barn, following the external dimensions of the stable block to the south. There are slight internal indications of a vertical joint in the brickwork between bay 4 and the stable block, though these are not clear externally. It

would appear that the fourth bay was constructed as infill between the barn and the stable block, however the fabric of both walls and roof is of similar character to the barn, and there is probably no great difference in date. Both the barn and fourth bay appear to be present on the 1790 plan, and would appear to be mid-late 18th C brickwork. The roof structure is of pegged elm trusses, and several of the purlins retain partial bark. The trusses (Fig 9) have small queen struts and a high level collar, leaving a large open area facilitating storage within the roofspace. The trusses have simple short stroke carpenters marks in Roman numerals I-III. The roof contains only small amounts of re-used timber – some of the struts are re-used oak, and one elm purlin of the threshing bay has a disused trench on its underside. The roof is of early-mid 18th C character, and appears to be in generally good condition.

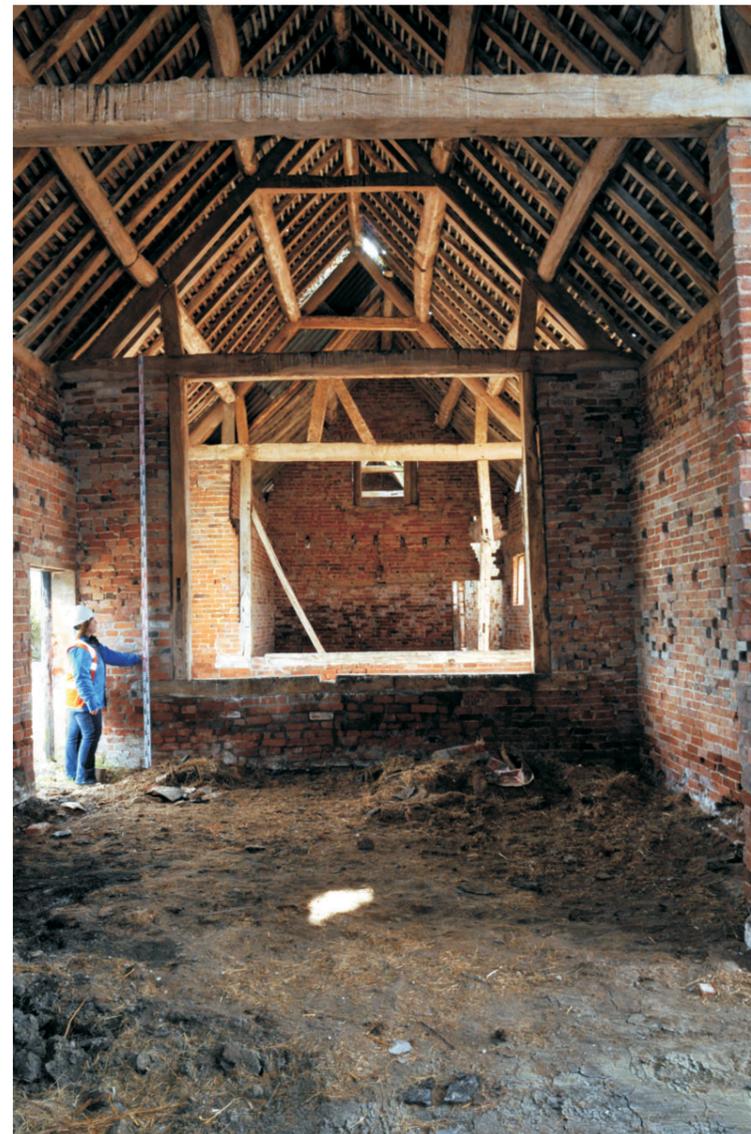
View facing S from NE corner of barn

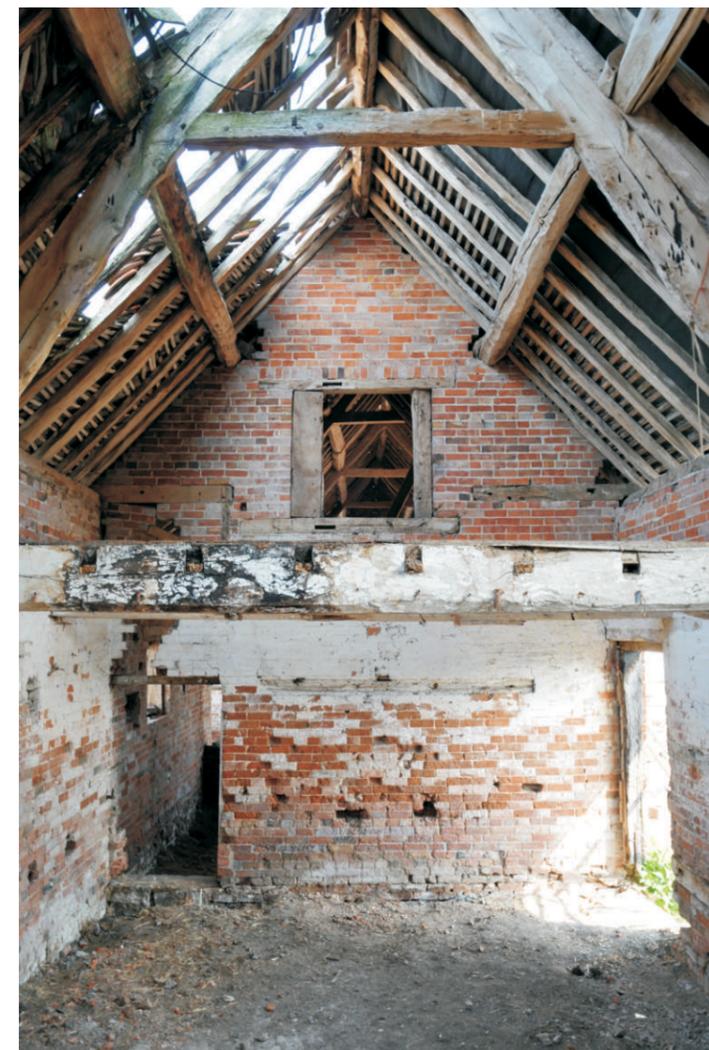
(L) View facing N within stable/
hayloft building (Below R) View
facing south within hayloft

- 8.2.2 The former stable block/hayloft lies at the southern end of the eastern range. At the time of recording the brick floor and floor joists of the upper floor had already been removed. Only faint traces of the former stall partitions were visible in the whitewash of the walls. There were some traces of a manger running the full length of the eastern wall, but no stable fittings remained. The outline of a vertical timber suggests that there was a vertical ladder to the hayloft in the SW corner of the building. The stable doors had also been removed. The stable windows are of pegged oak construction, and the presence of pintles hammered into the frame indicates that they had opening casements. Other provision for ventilation of the stable is very limited, being only three small ventilation brick grilles in the western elevation. At hayloft level there are unusual open “A” framed trusses of elm, with substantial tie beams into which the first floor joists had been lodged (Fig 9). Several of the trusses exhibited localized charring from rush lights or candles. The original hayloft door appears to have been in the southern gable end, where it would be most conveniently accessed from the farm-house. This door had, however been bricked up and partially replaced by a loading hatch. An inserted doorway has been created midway along the eastern elevation, cutting through the wall-plate and covered by a small side roof. This appears to have occurred in the early 20th C. There is a further loading hatchway in the northern end wall of the hayloft, in a position that would have been external prior to the construction of the fourth bay of the barn. There is a further small west facing loading hatch set in a dormer, which appears to be 18th C origin. The hinges of the remaining hayloft hatches are of 18th C date, possibly re-used in the present context. In common with the adjoining barn the roof of the stable block is of common flat tile, the western pitch being of handmade tiles and in poor condition, whilst the eastern pitch has been re-roofed with underfelt and machine made tile. Graffiti on one of the trusses gives a date of 1857, under this is inscribed the date 1972.

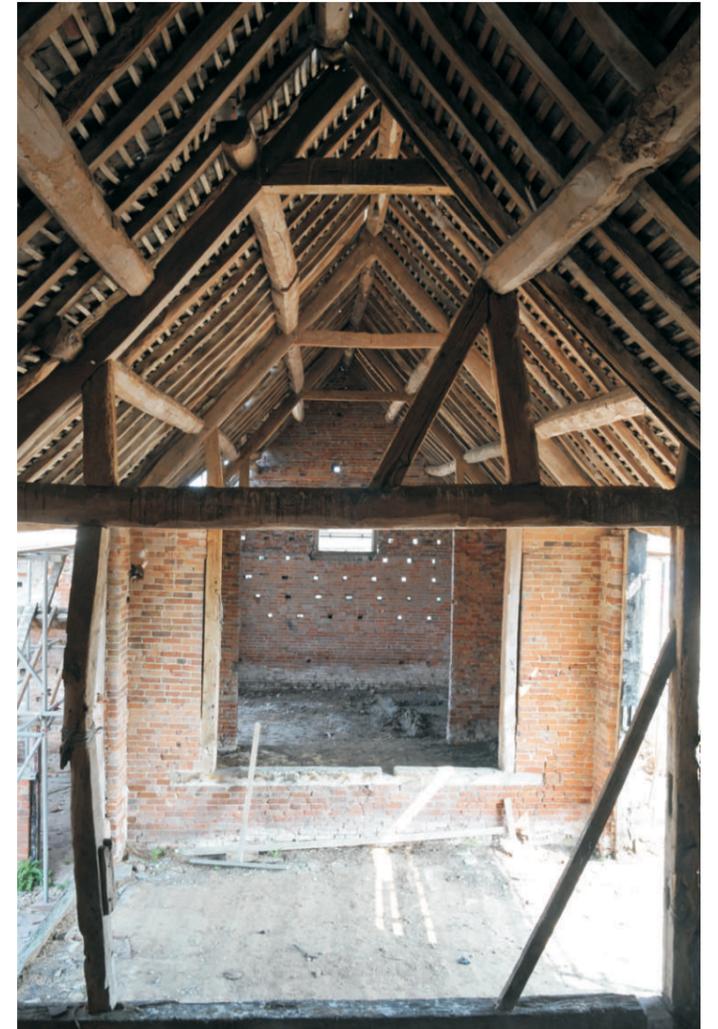
View facing N across former threshing floor of barn
