**Archaeological Watching Brief and Building
Recording at Church Living Cottage,
Branscombe, Devon, 2012–13**

April 2013

This report describes observations made at Church Living Cottage, during repairs and refurbishment in 2012–13. The work to the building included the rebuilding of the present cabin to the north-west of the house, the installation of new French drains in key positions along walls, and of alterations to landscaping, steps and access arrangements. A ‘programme of archaeological work in accordance with a written scheme of investigation’ was a condition of Listed Building Consent (LBC) granted by East Devon District Council under the *Town and Country Planning Act, 1990* (application no: 11/2765/FUL, dated 23rd February 2012, ‘Replacement of existing cabin with building for ancillary accommodation, landscaping works including drainage works, and alterations to parking and access’). This follows current government planning policy as now laid out in *Planning Policy Statement 5: Planning for the Historic Environment* (DCLG 2010a, especially policy HE12) and the associated *Practice Guide* (DCLG 2010b, e.g. paragraphs 126–140). A method statement constituting the ‘Writ

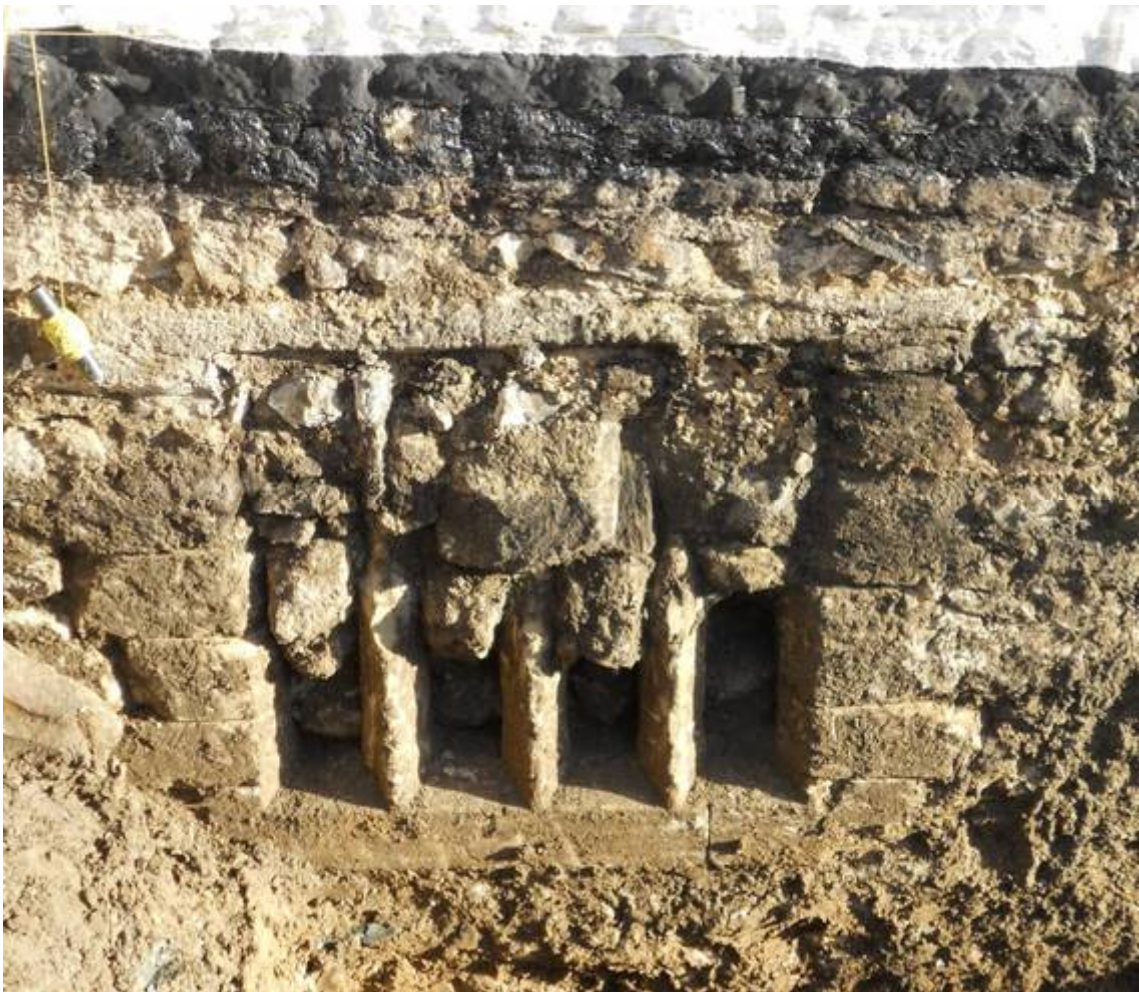
Cover Illustration: The four-light medieval window in the west wall of Church Living Cottage, exposed by excavation on 18th December 2012, just before it was concealed again by the lining of the drain.

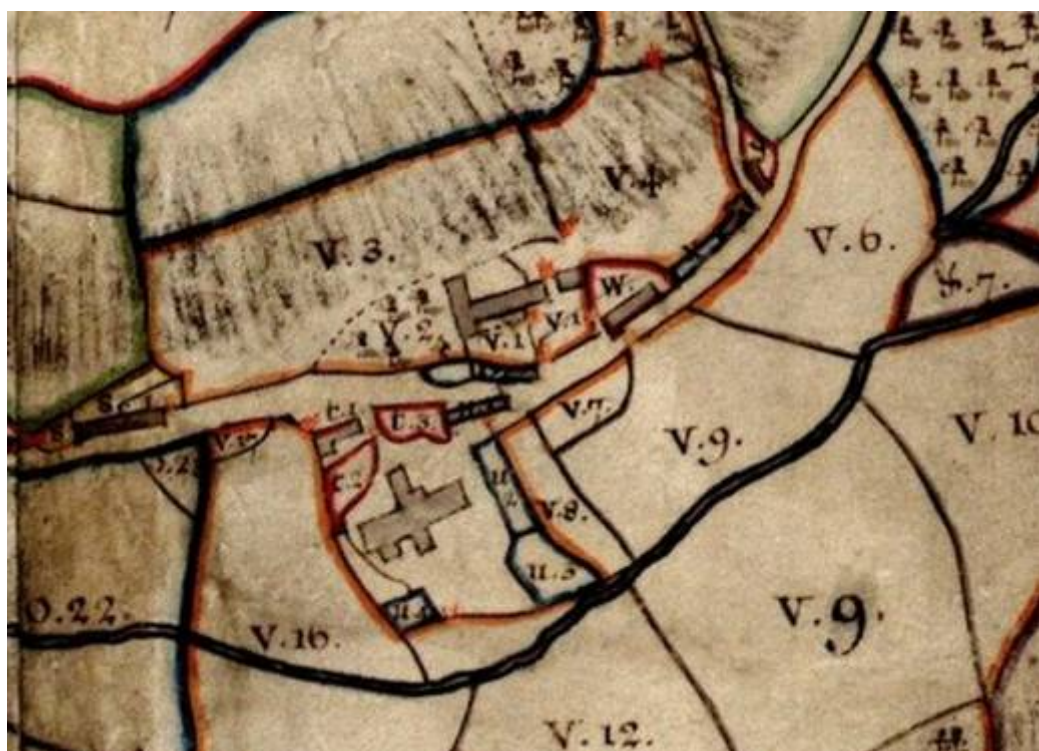
Fig. 2 Detail from Alexander Law's map of Branscombe of 1793 showing the Church and Church Living Cottage (Exeter Dean and Chapter ms. Ch Comm/98/8785).

Two early maps show the footprint of the house in the period 1793–1840. The first, Alexander Law's map of 1793 (Fig. 2) indicates that in the late 18th century the cross range now forming Church Living Cottage extended further north, so that the combined houses formed a T-shaped plan with Church Living Cottage forming the short arm of the 'T'. The apportionment records plot V.1 as 'Farm Houses, Garden, Courtlege and Mowhay', V.2 as 'Orchard', and V.3 as 'Great Winard'. The same basic T-shaped footprint is recorded in the depiction of the house on the Branscombe Tithe map some 50 years later (Fig. 3). The fragment of medieval masonry recorded at the north end of the west elevation of the house presumably represents part of the west wall of this northern extension, and the rather jumbled nature of the masonry of the northern gable is perhaps due to its origin as an internal wall. The nature and preservation of this extension remains uncertain however, since the one other illustration of the house within this period, the anonymous drawing of 1807 (Fig. 8) appears to show the roof line of Church Living Cottage in a similar way to the surviving house, with a gable chimney stack at its northern end. Perhaps the northern extension only survived as a single storey by this time? Neither Law's map nor the Tithe map show any structures to the west of the house at this time. The apportionment accompanying the Tithe map describes plot 600 as 'Farm House and Garden' and 'Great Winnard' as pasture, with no mention of quarry or quarrying, although the approximate extent of the quarry shown by the Ordnance Survey 50 years later is indicated by a dashed line on the map (broadly the same as V.2 'Orchard' on Law's map).

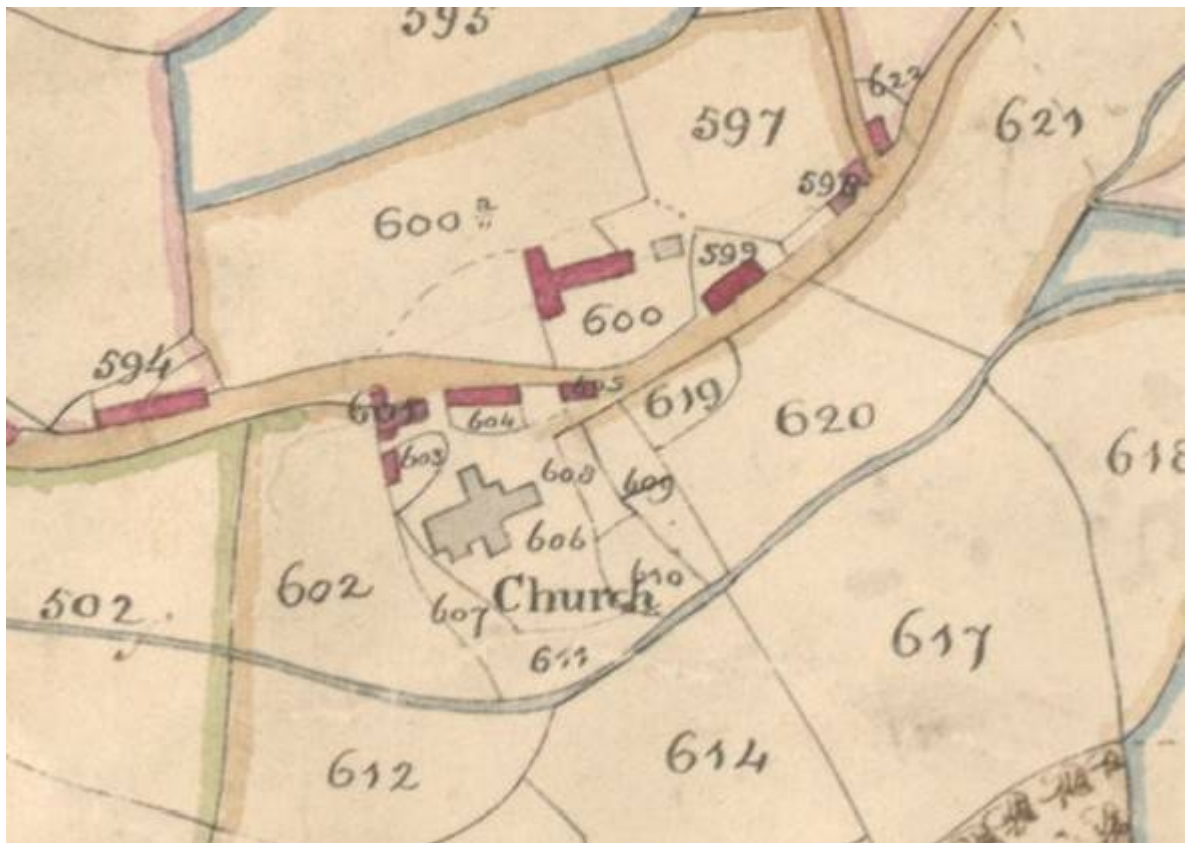
Fig. 3 Detail of the environs of the Church from the Tithe map of 1840.

The early map depictions are consistent in showing the main house as a T-shaped plan (Alexander Law, 1793; Tithe Map, 1840; Figs 2 and 3), and the later maps chart the decline

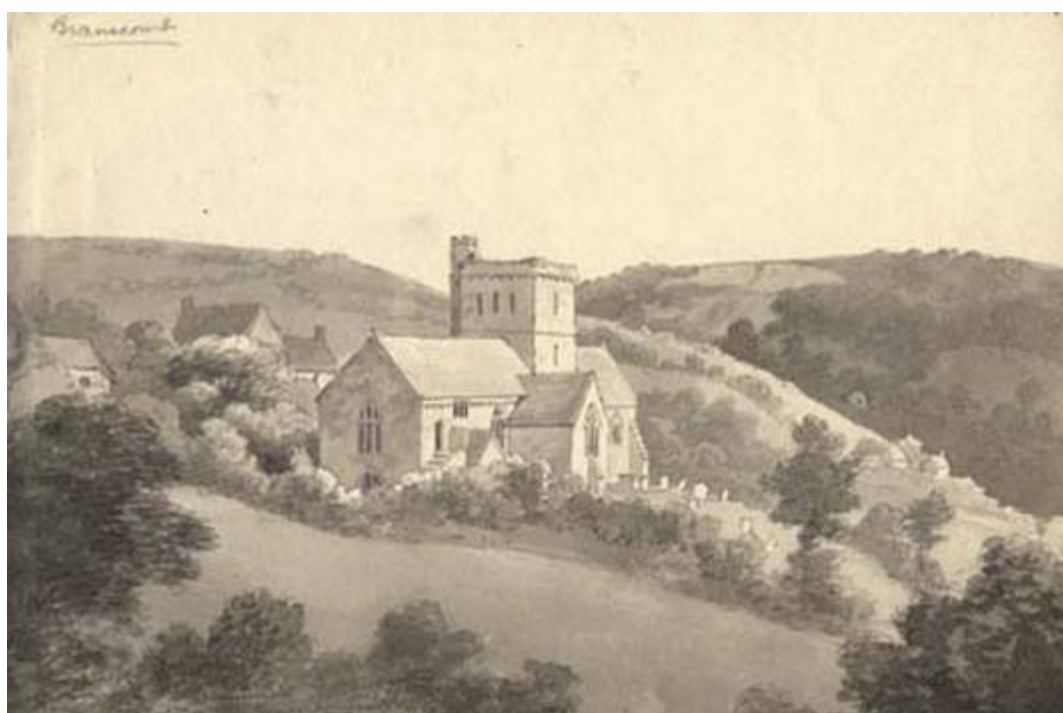
Fig. 8 Anonymous pencil and wash drawing, dated August 1807, of the church from the south-west, showing the roof lines of Church Living behind the church (WSL P&D 08717).

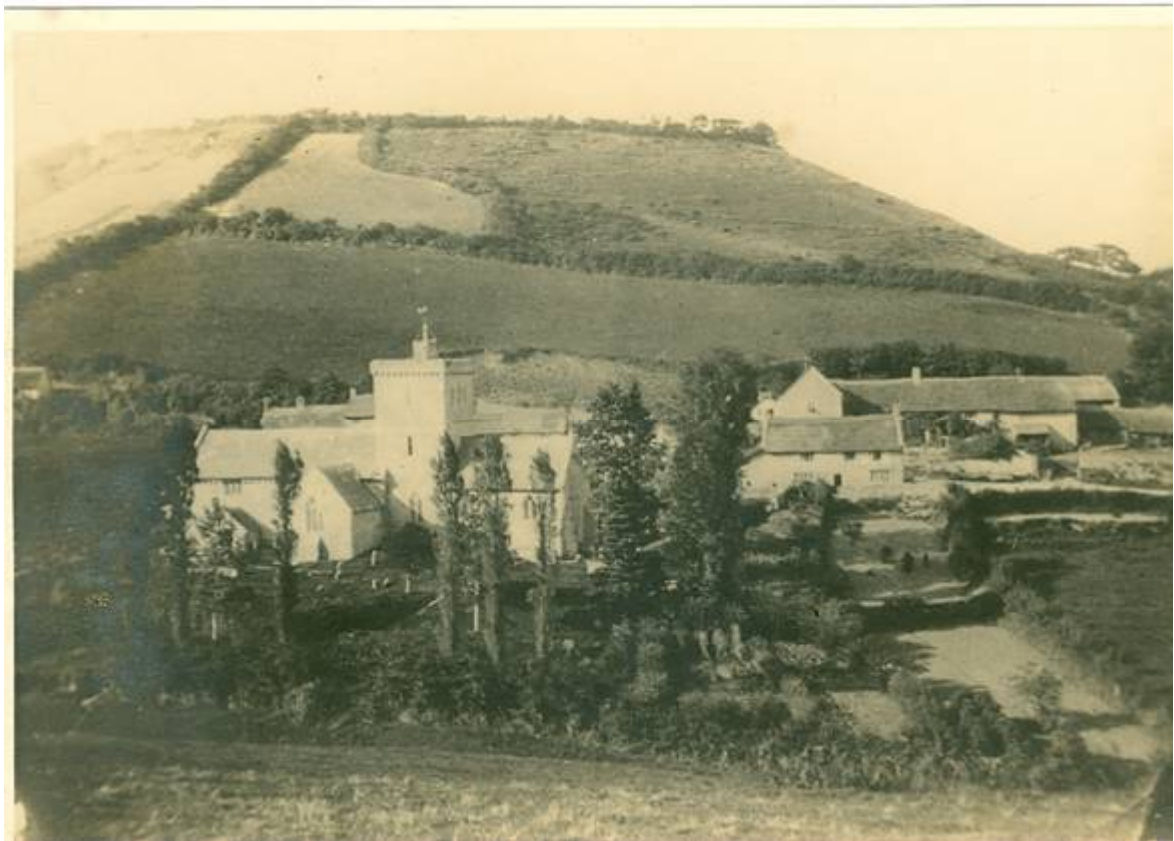
Fig. 9 Photograph of the church and church house, with Church Living and Church Living Cottage to the rear, dating to 1886 or before (the date at which the cottages on the north side of the churchyard were demolished; note also that Church Living was still thatched at this date). Photograph courtesy of The Branscombe Project.

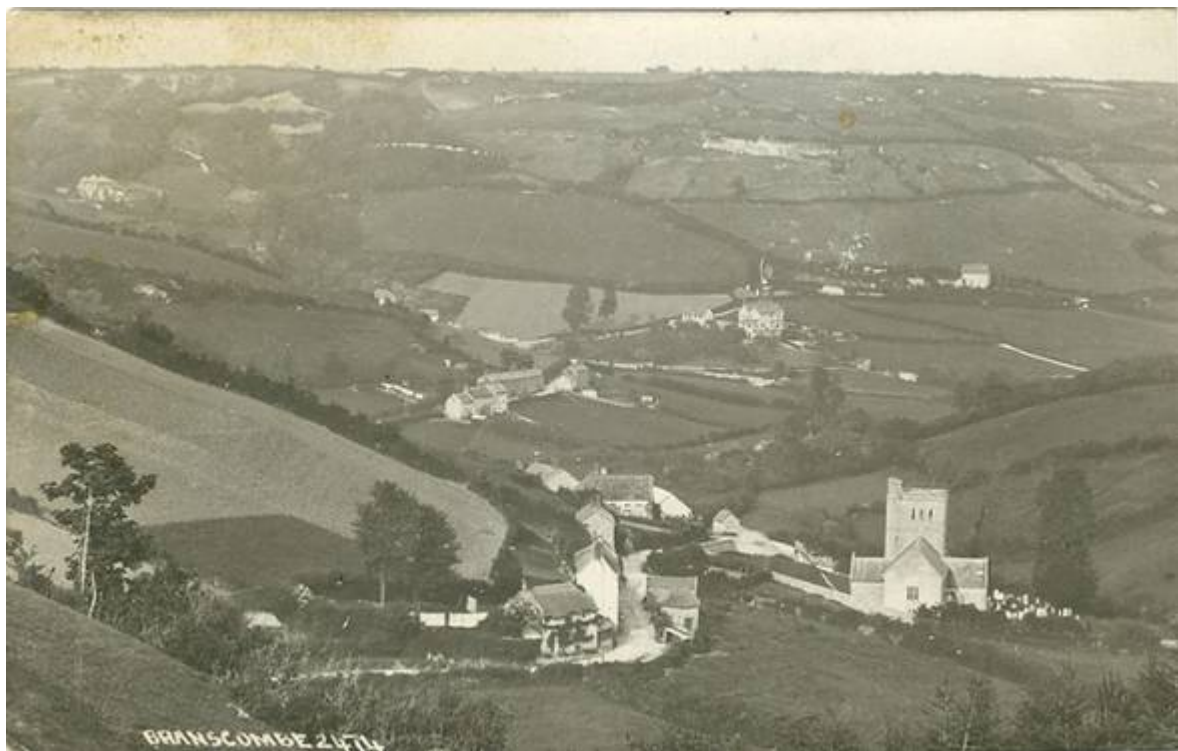
Fig. 10 General view of the church and village, with the west elevation of Church Living Cottage visible in the centre, the slope in front of the house can also be glimpsed, photograph c. 1890, courtesy of The Branscombe Project.

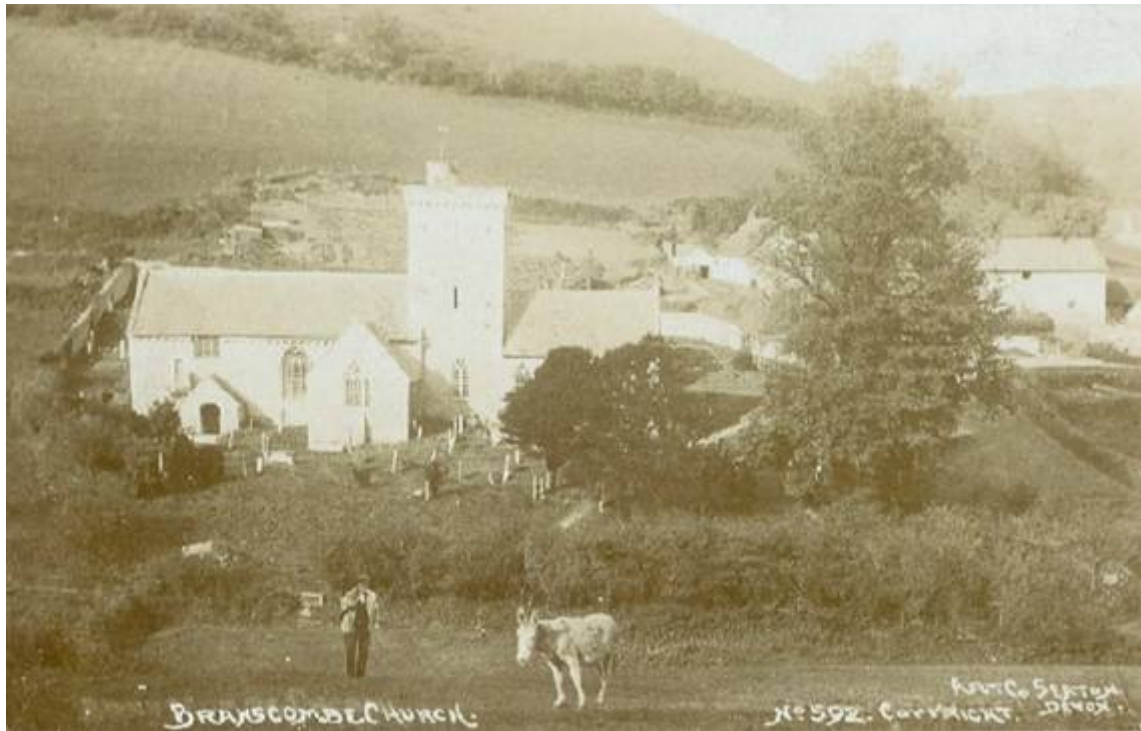
Fig. 11 Postcard view of the church with Church Living Cottage to the rear, the small 19th century shed structure visible to the north-west of the house), perhaps c.1900, certainly before the 1911 restoration of the church. Postcard courtesy of The Branscombe Project.

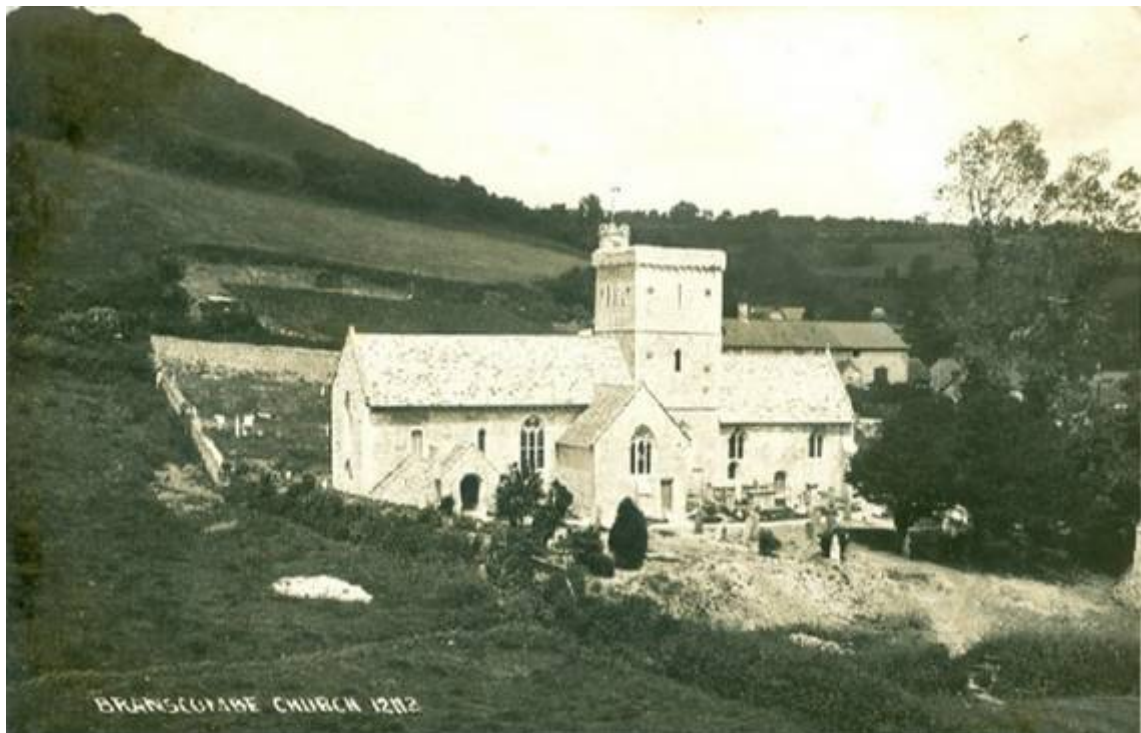
Fig. 12 Postcard view of the church with Church Living partly obscured to the rear, but showing clearly the extent and condition of the quarry to the west of Church Living Cottage, after 1911. Postcard courtesy of The Branscombe Project.

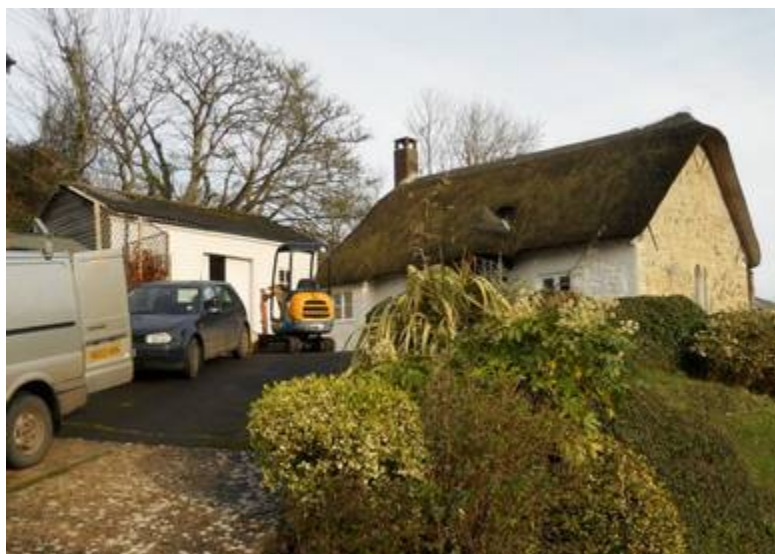
Fig. 17 Church Living Cottage at the start of work, looking NE.

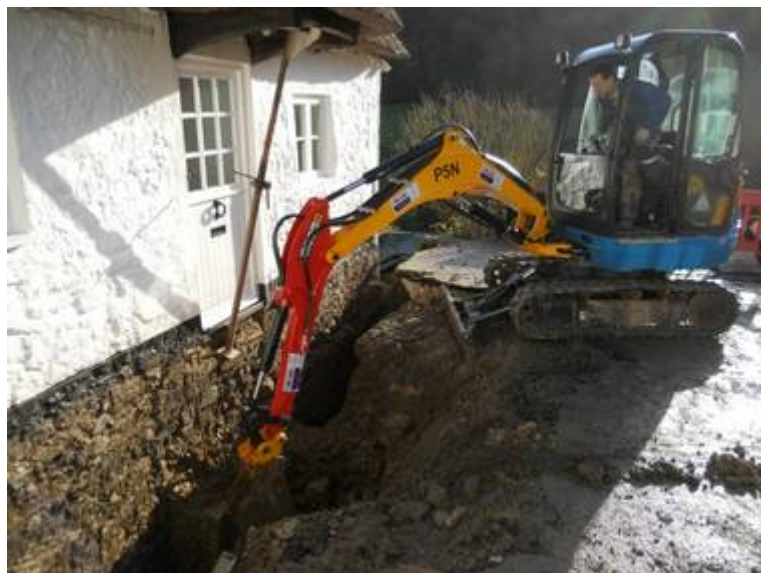
Fig. 19 Work in progress, excavating the French drain, looking SE.

The main below-ground component of the works carried out in 2012–13 was the excavation of a French drain along the west wall of the house. This was an attempt to alleviate internal damp and associated problems caused by the burial of the ground-floor stage of the elevation by the build-up of soil. According to the proposals this was to consist of a trench some 500mm wide excavated along the west wall of the house to a depth below interior floor level (therefore potentially as much as 3–4m deep), to be lined with a membrane and back-filled with permeable fill to allow the passage, but not the retention, of surface drainage and ground water. The simple trench parallel to the wall that was proposed, however, encountered immediate practical difficulties, both in simple physical excavation (which was hampered by restricted access) and by obstacles presented by the addition of the two projecting porches (19th century porch to the north; 20th century porch in the centre of the elevation). Both structures had, of course been constructed after the build-up of exterior ground levels to the west, and thus were seated on top of this backfill, meaning that to excavate the trench as proposed would have entailed undermining the projecting porches. In the case of the late 20th century porch this was managed by temporarily removing the timber supports of the porch, and propping the roof (Fig. 19), but in the case of the masonry structure of the 19th-century porch to the north, whose footings penetrated only some 750mm of the accumulated earth fill, the drain trench ended up having to be dug around the projection, leaving it on a plinth of earth (which was suitably under-pinned) rather than running along the main elevation of the wall (Figs 15; 20). The result of this was that the excavation of the trench was a far-from-straightforward matter, was considerably wider than proposed, and had to be done in stages according to practical considerations, rather than in one continuous excavation. The archaeological recording dimension fitted around this process and resulted in the record elevation drawing presented here (Fig. 16), but in piecemeal recording of the stratification within the trench. A further result of having to leave an earth plinth beneath the projecting porch was that the position of the narrow window, a possible lancet, that is visible on the interior, did not become accessible as expected. Measurement of its position from the inside

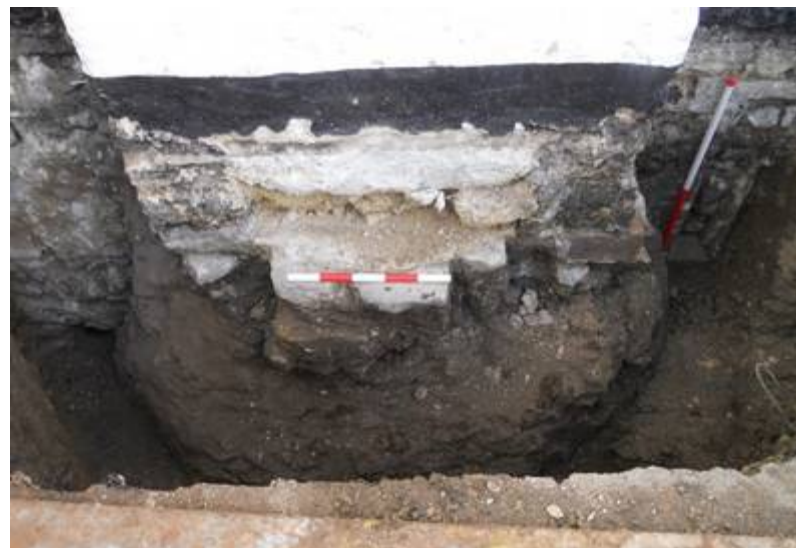
Fig. 20 The threshold of the former porch, showing footings, flagstones and masonry reveals, looking E.

The trench exposed the footings and some earlier surfaces of the projecting porch at the north end of the building (Fig. 20). Until the alterations of the early 1970s this formed the main door of the building, and a structural and stratigraphic sequence was observed to confirm this. The porch was constructed with masonry reveals (which also contained some 19th-century brick), splayed out slightly to north and south, and surfaces with flagstones laid on a rubble base. Laid up to this was a cobbled surface which formed the late 19th century yard surface in this area, and was continuous with the cobbled surface inside the small building to the north. Above the cobbles was a further surface continuous with the mid- 20th century yard surface and the lower drainage gully along the wall, composed variously of gravel, and tarmac (and, elsewhere, concrete). The remaining depth of 420–450mm beneath the present surface was composed of very modern rubble and make-up material, capped off with the tarmac surface as existing in 2012. This was attributed to the refurbishment phase of the early 1970s (1969–74 according to Richard Chadwick). The doorway/porch appears to be glazed to its full height in the 1989 photograph of this elevation illustrating the National Trust's Vernacular Building Survey (National Trust 1989, 21b), so there may have been a further stage of blocking subsequently.

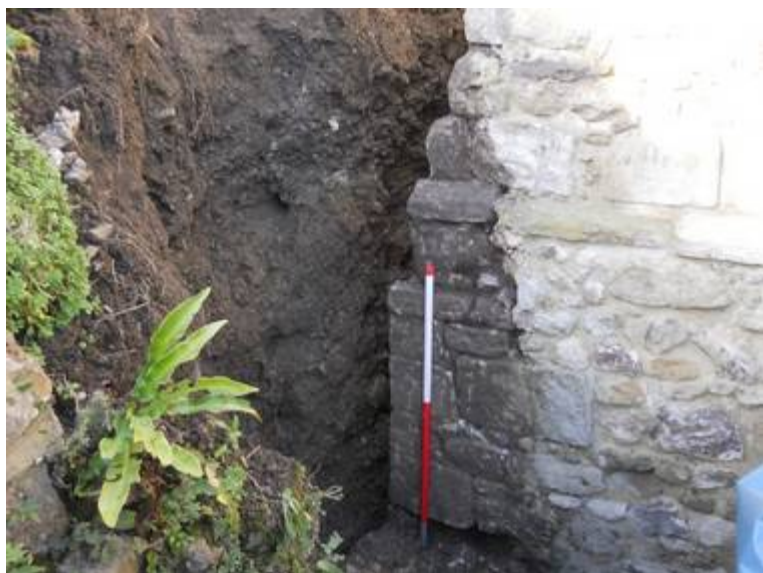
Fig. 21 The ashlar SW quoin of the building, looking NW.

At the base of the quoin, the lowermost ashlar block is supported by a single course of rubble blocks, perhaps representing a below-ground footing, and below this, at a level of c.49.55m a fragment of stony surface was observed, perhaps representing the construction surface from which the house was built. This was seen only in a very small area and could not be traced further.

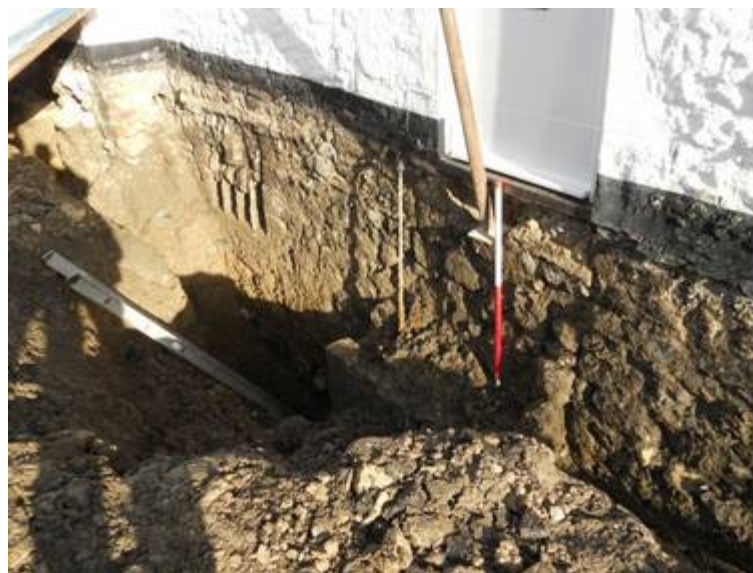
Fig. 22 W elevation: the window and buttress in context, looking NE.

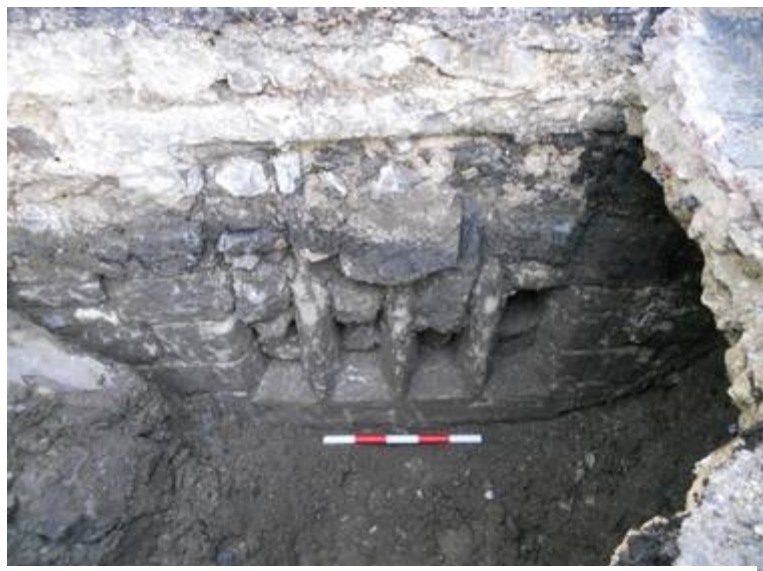
Fig. 23 The window fully exposed, looking E.

The window had been blocked from the inside; at the bottom the tails of mortar-bonded blocks could be seen within the embrasure. Further up blocking had been applied from the exterior as well, first unmortared rubble below, then mortared rubble at the top (Fig. 23). The upper portion of the central (king) mullion was missing and its position filled with a large square block (Fig. 16, detail). The central section of all three mullions displayed substantial weathering of the stone, possibly reflecting the stress point from exposure at or around a former ground level, but the upper parts of the first and third mullions survived intact. In addition to better-mortared rubble filling, which showed that this part of the window stood above ground level at the time it was blocked, the uppermost 400mm or so retained traces of bituminous coating from the splashback at the former ground level (visible as dark discolouration in Fig. 23), presumably the lower yard surface already referred to (discussed above under the stratification of the trench, *q.v.*),

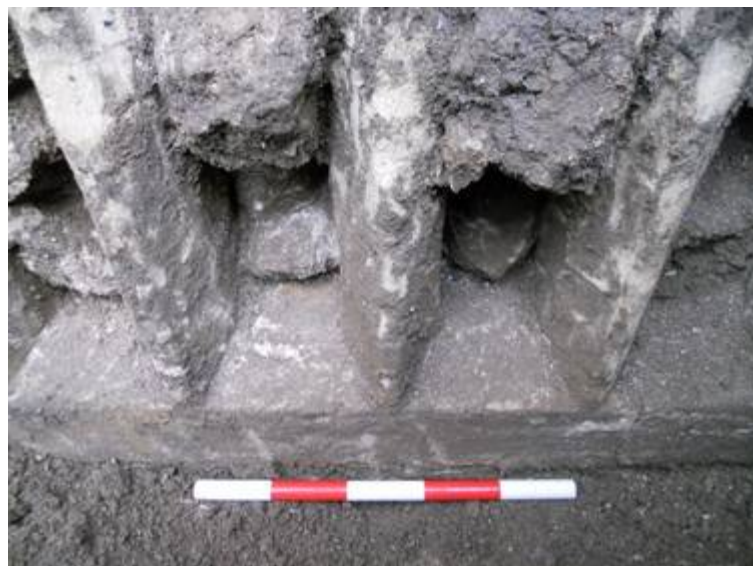
Fig. 24 Detail of the sill and mullions of the window.

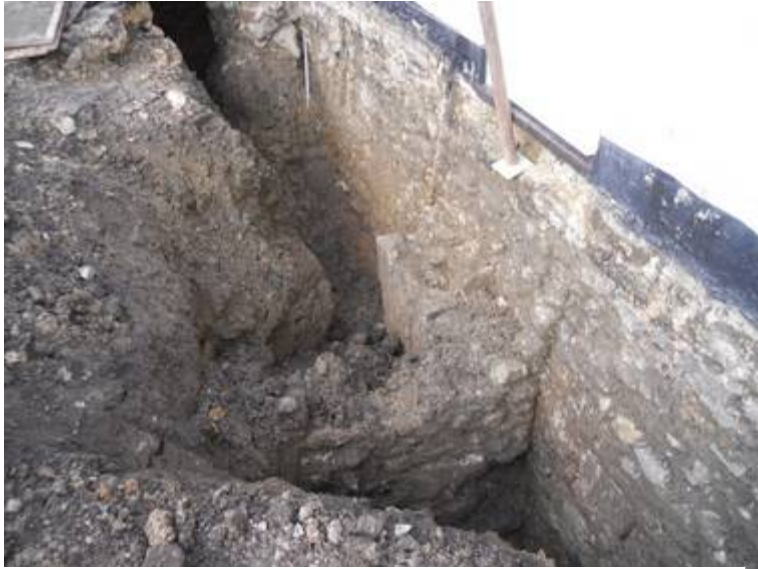
Fig. 25 Buttress with dry-stone terrace wall in front, looking NE.

Just to the south of the buttress in the west wall, a crude dry-stone terrace wall was constructed against the wall and running west beyond the limits of the trench (described in detail below). This was interpreted as a revetment wall or terrace in the garden or yard to the west of the house. It did seem to mark a slight change in the soil deposits: to the south of the wall, i.e. later than it, the soil backfill was loose, very dark clay with building rubble, late sherds plus fragments of 19th century ceramic drain pipes from field drains. To the north the soil fill was a little more solid and compact, although still containing late material, and a sherd of 19th century transfer-printed china was recovered from behind the wall during its removal, conclusively demonstrating its late date.

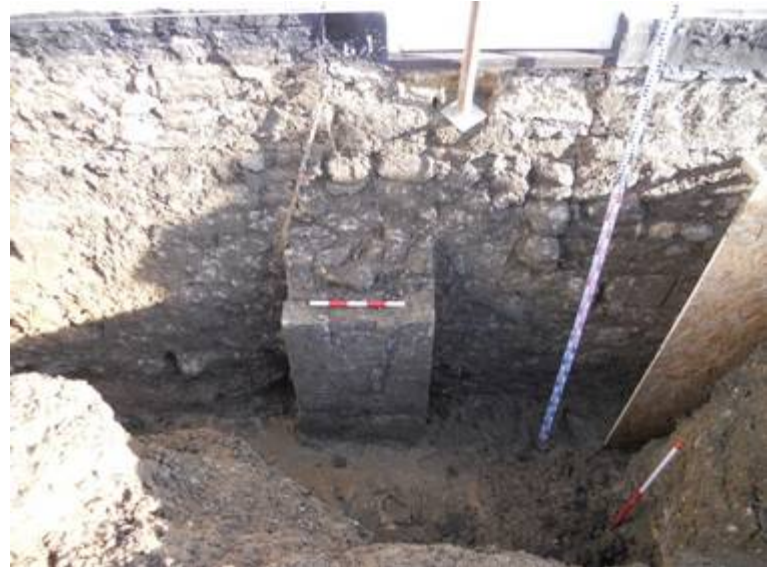
Fig. 26 Buttress fully exposed, with corbel/straight joint to S, looking E.

The evidence for a garderobe projecting at first-floor level from the west elevation adjacent to the buttress is slight, but fairly compelling. According to the interpretation proposed here this evidence belongs to the earliest phase of masonry, and thus may have been removed at the time of the reconstruction of the upper part of the west wall (which, in turn, seems to go with the south gable). But it should be noted that the area above the corbelled stones was very disturbed, by work related to the insertion of the present front door, as well as obscured by remains of the surface treatments of the two 20th-century ground levels, so it is possible that evidence had failed to survive at this point. In view of the reference to two chambers with garderobes in the visitation of 1330 (above), we might expect that this fabric was still standing at that time.

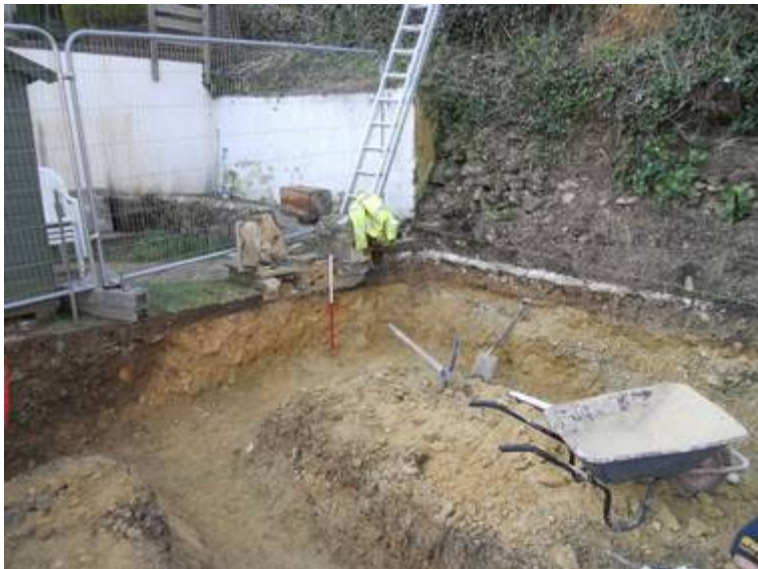
Fig. 27 Footing trenches for the new cabin, looking NW.

The footing trenches for the foundations of the new cabin were at their maximum exposure on the afternoon of 16th January 2013 (Figs 27–28), when I made a brief site visit to observe and record them, just before they were fitted with steel armatures to support the concrete footings, which was delivered the following morning.

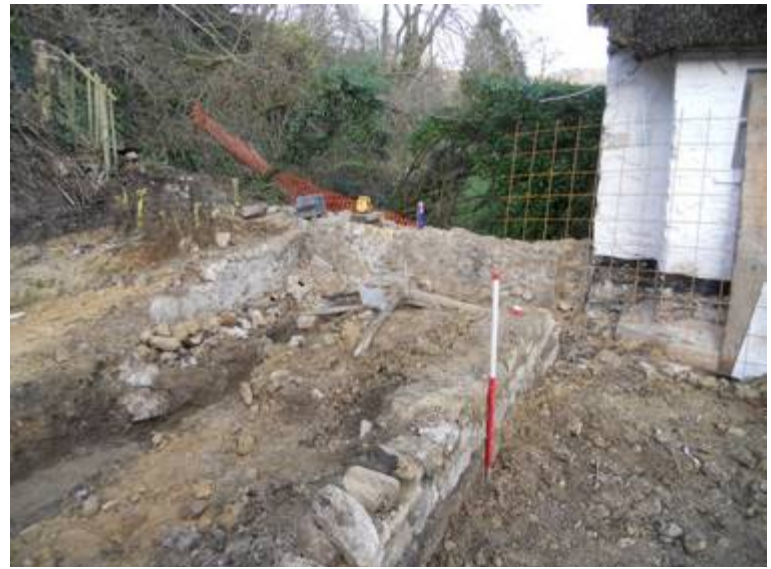
Fig. 28 Footings of the 19th-century outbuilding, looking NE.

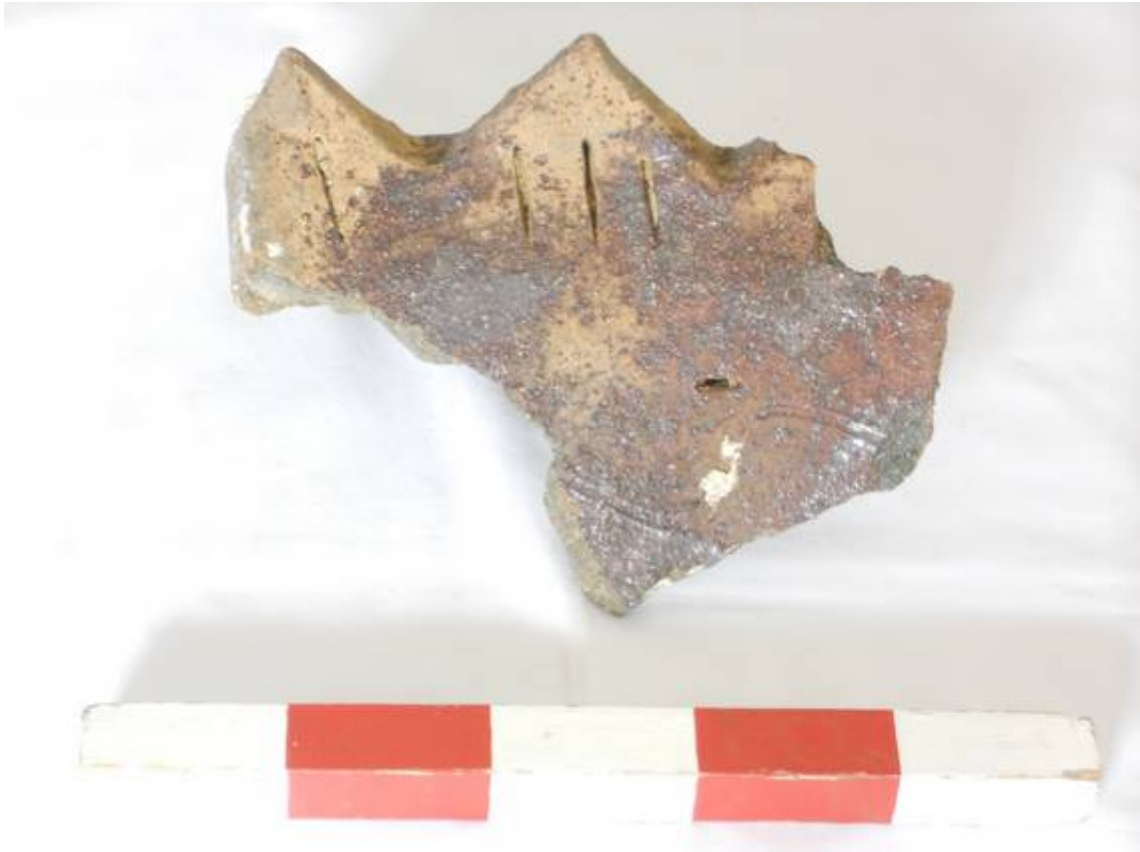
Fig. 29 The large fragment of a Type 'A' ridge tile with triangular, knife-cut peaks.

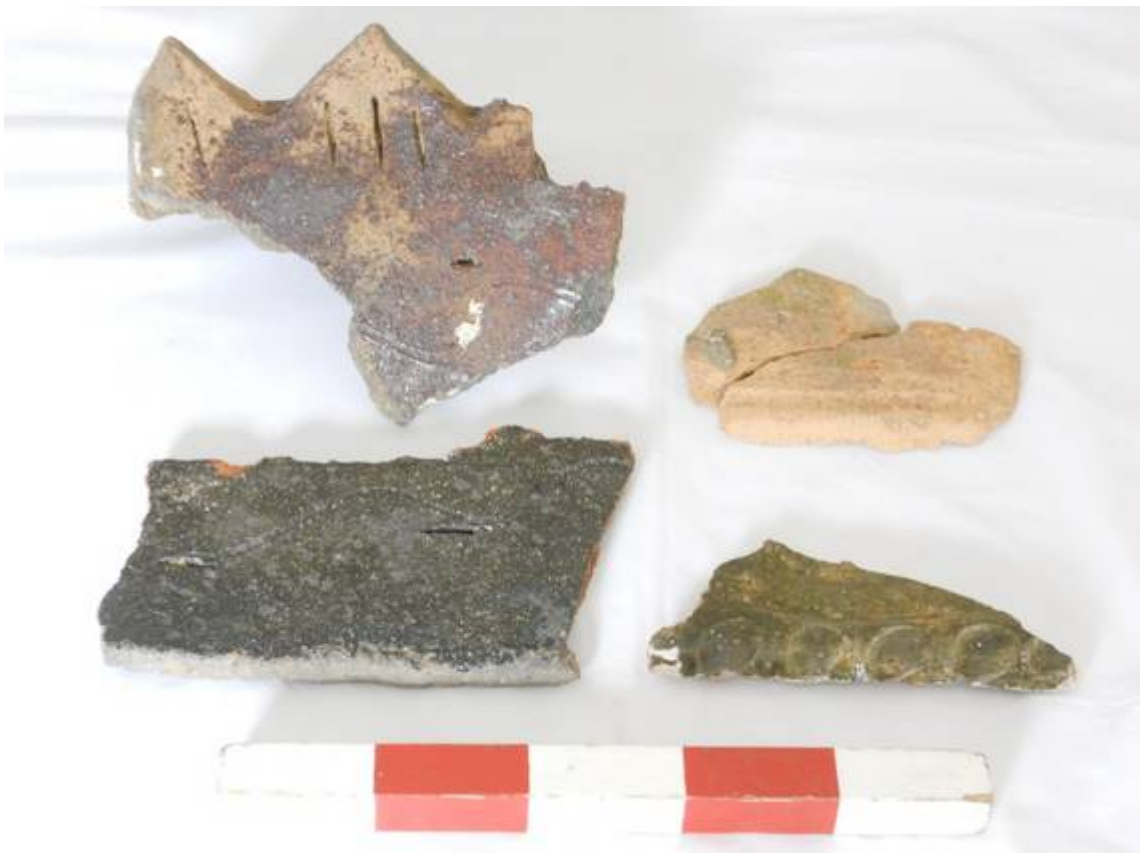
Fig. 30 The four ridge tile fragments: C13th/14th (upper and lower left); C14th/15th (upper right); and post-medieval (bottom right).

Two joining fragments of the side of a ridge tile with a pale gritty fabric, stabbed decoration, and traces of thin mid.-green glaze (Fig. 30, upper right). This is probably a 14th/15th century type. Again the place of manufacture is unknown, although it is certainly not Hemyock (where a substantial ceramic industry has come to light in recent years). The fragments were found in the central section of the trench on 16.xii.12.
