Burnham Manor Stables

Photographic Recording of An Historic Farm Building

National Grid Reference : TA 0556 1707
Planning Reference : 2012/0577
North Lincolnshire Museum Site Code : TCAL

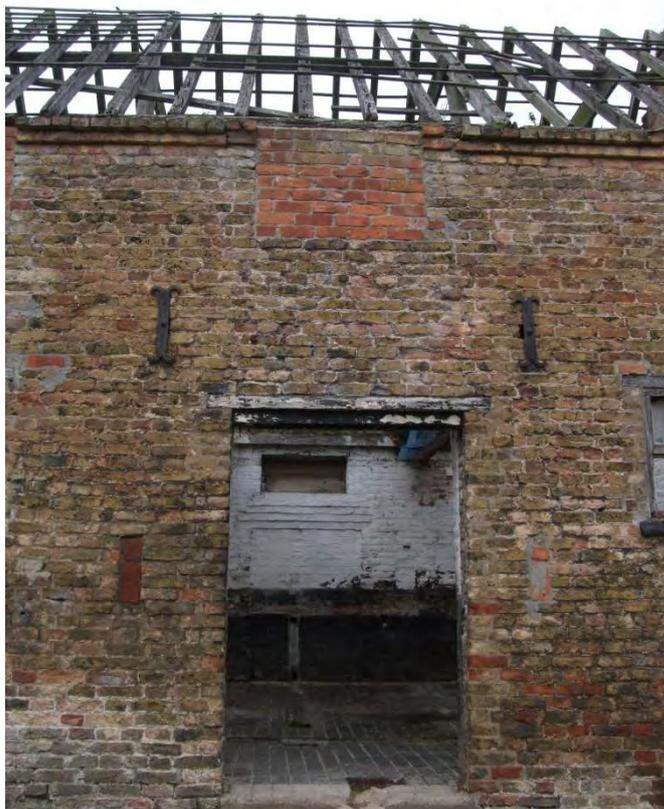
Plate 1 South elevation, east doorway showing altered eastern jamb.

The central and east doorways have been altered, in both cases on their eastern sides, to increase them to the current width of 1.40m. If it is assumed that the flanking slots were symmetrically placed, the doorways would have had a width at construction of approximately 1.25m. New timber lintels were inserted when the openings were made wider.

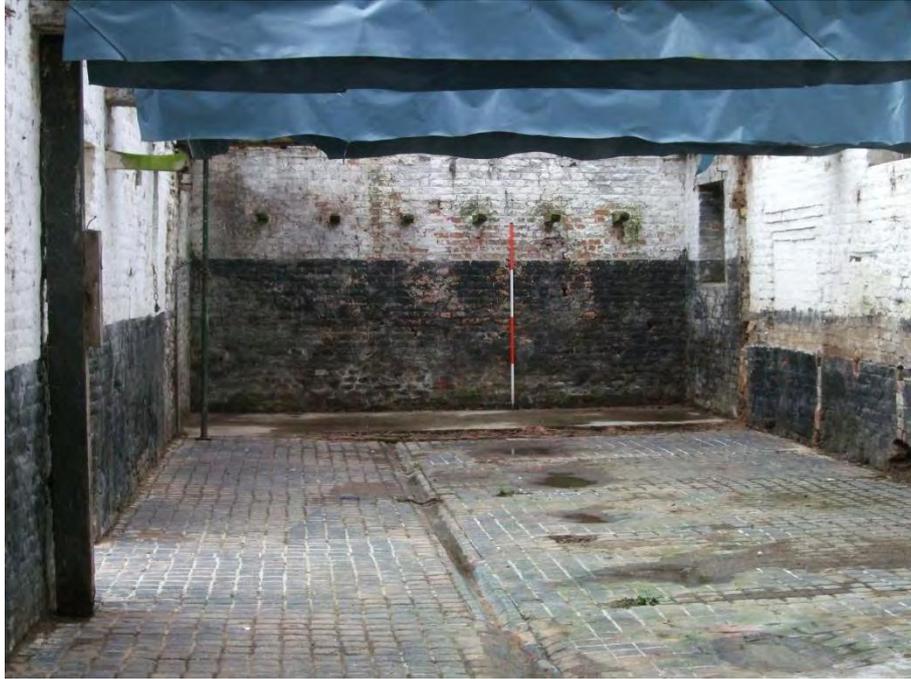
Plate 2 Interior of the stable range, viewed from the east.

The interior of the stable building is open to the sky and retains only its main beams to mark the position of the first floor area, to which there is no fixed access. All ground floor elevations are thickly coated with paint which masks the finer details of the brickwork and obscures minor alterations. The open and blocked doorways and windows are clearly visible but evidence for the original arrangement of internal divisions, fixtures and fittings is all but obliterated. However, the ground floor has been cleaned recently and therefore the footings for a tack room wall near the west end of the space and sockets for stall posts in the remainder are clearly visible.

Approximately 2m east of the west internal elevation of the building there is a 23cm-wide brick footing with a gap at its south end for a doorway. Squared timbers projecting from the west elevation could have held harnesses and therefore the small room was probably a tack room, lit by the window inserted into the north wall. The stalls in the rest of the ground floor area had been divided by timber partitions, now missing, each supported by a post at the south end and one or more horizontal timbers seated in the north wall. Each of the eight stalls would have been 1.80m (2 yds) wide internally. The cut seating for the timbers of a manger was present at the north end of the east wall. All of these internal divisions and structures are demonstrably secondary features, contemporary only with the quadrant-quarry floor.

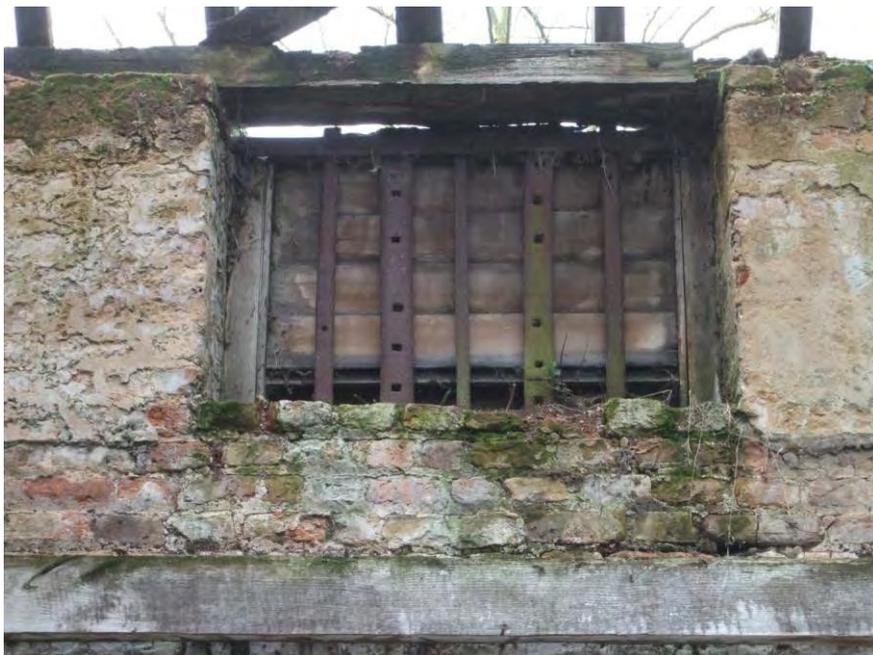
Plate 3 Iron straps reused in the loft windows

The first floor is not accessible for close inspection but is mostly visible from the ground. The openings noted in the exterior elevations are as described above except for the windows in the south wall, which have been blocked by a single external skin of brickwork and internally are visible as recesses, and in the north wall where they have been boarded over externally. The north windows, but not the southern ones, all retain iron grilles made of re-claimed straps.

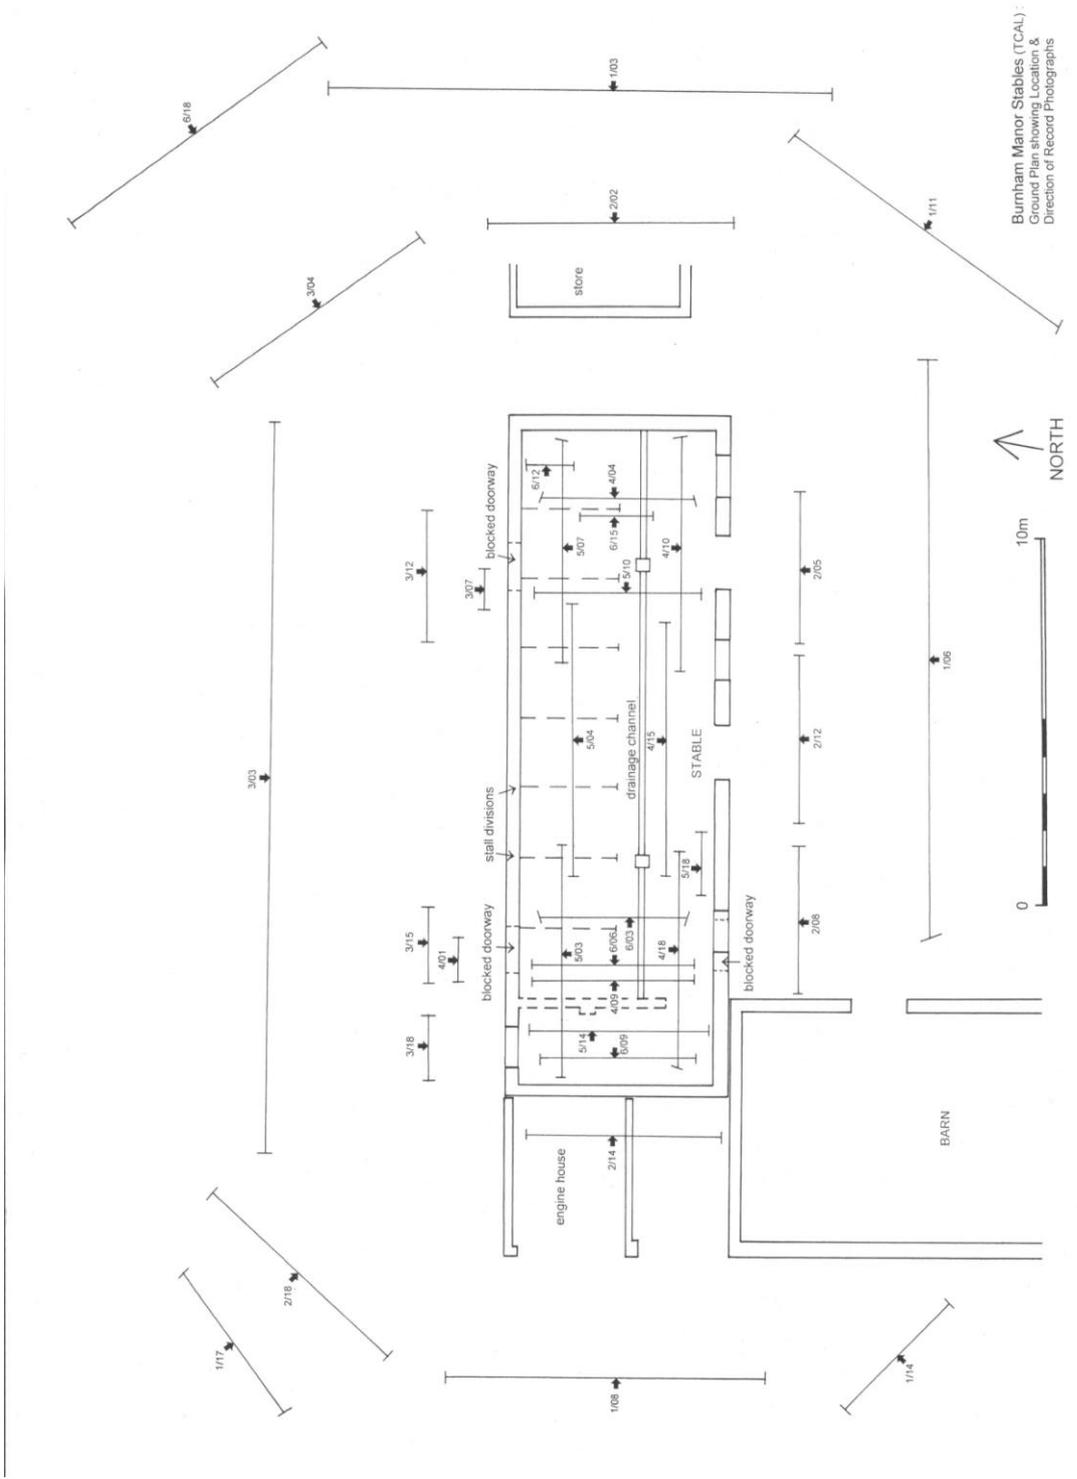
Burnham Manor Stables (TCAL):
Ground Plan showing Location &
Direction of Record Photographs

A re-drafted and amended version of the developers' ground plan (which is the work of J T Brocklehurst), showing the location and direction of each archive photograph, and a catalogue of all the black and white images are appended to this report.
