Ashton House and Mandell House Water Main, The Precincts, Peterborough Cathedral

Scheduled Monument No: SM PE 140

Prepared by Caroline Atkins, and Dr Jackie Hall, Cathedral Archaeologist,
for the Church Commissioners

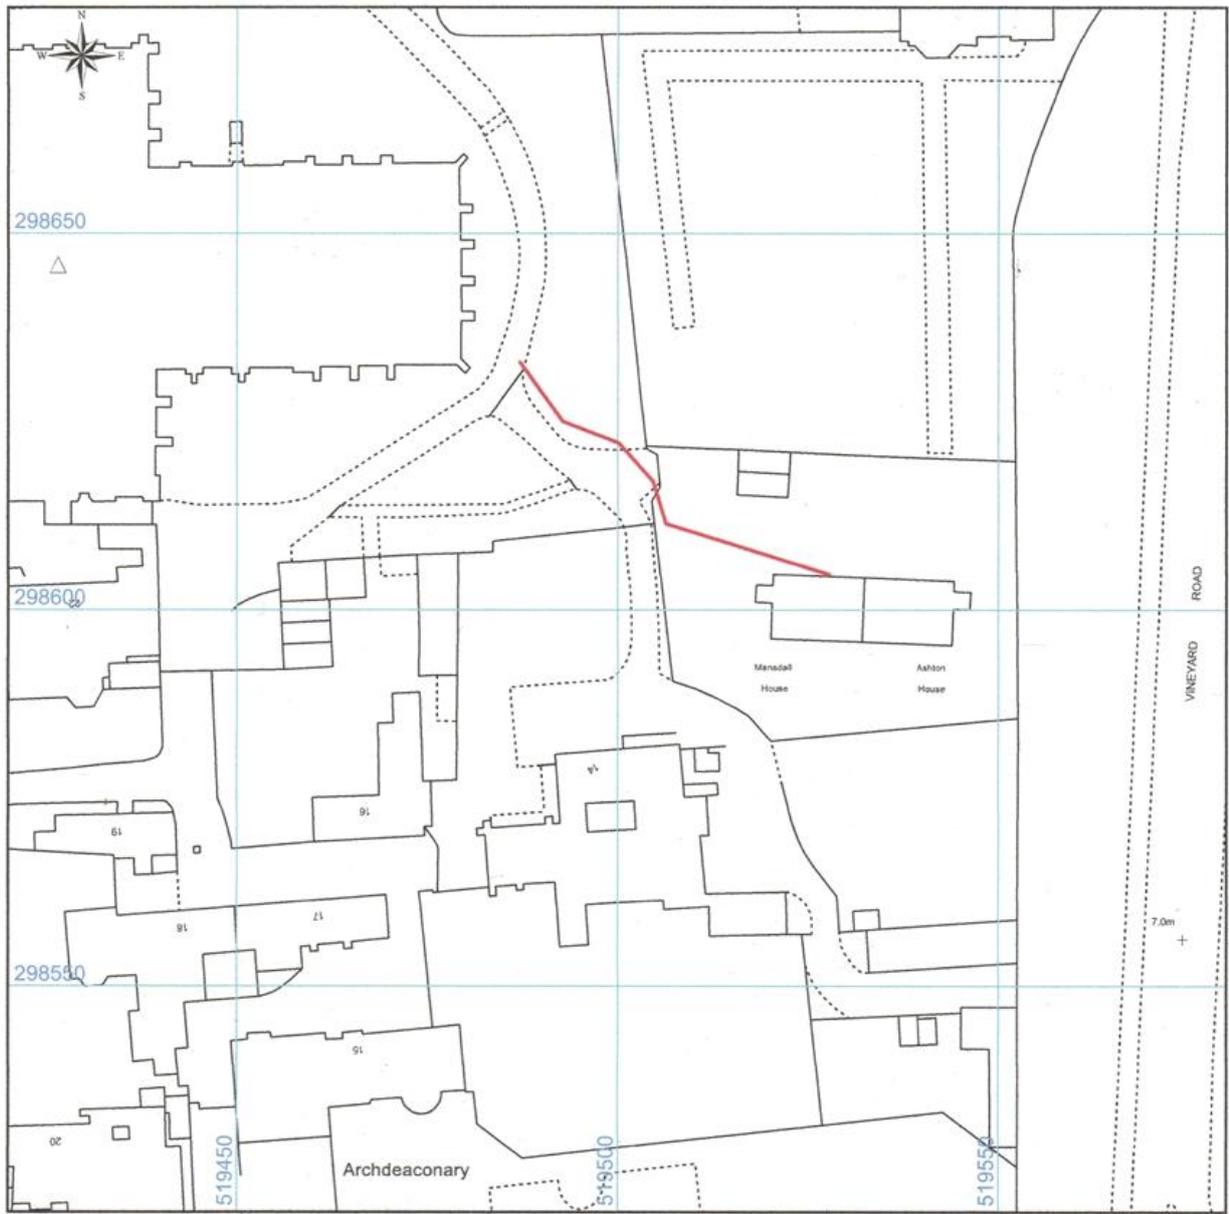
Figure 1
Water Main Replacement Route

The existing and replacement pair of water mains run through this area, from the water meters in the cemetery (at NGR TL 1948 9864) to the domestic properties (NGR TL 1953 9861) to the south-east of it (Figure 1). Between the cathedral and water meters the ground is near-horizontal but to the south-east of the meters the ground slopes gently downwards towards the cobbled entrance to the residential properties and thereafter slopes more markedly down towards the bungalows.

Excavation commenced at the north-west end of the pipe run (Figure 1, Plate 1), at the existing water meters (Plate 2), within the small area previously excavated and reported on in December 2009 (Upex, 2009). The ground level and water meter caps at this point are at 9.176m OD and the bottom of the new excavation 0.85m below that (8.326m OD). The existing water pipes were exposed at this lower limit (Plate 3). Only previously disturbed deposits were exposed in this north-western end of the new trench.

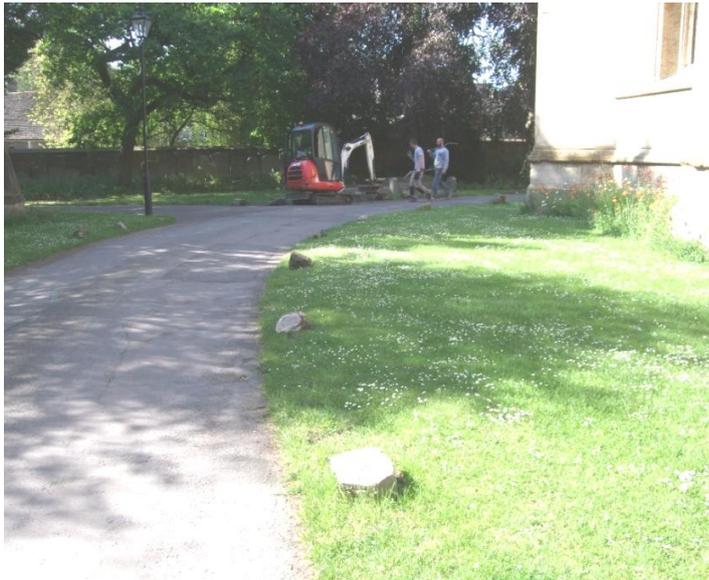
Plate 1
(Archive image PCAMW 001)

The area to the east of the cathedral, viewed from the NNE, showing the lamp post adjacent to the water meters near top left and the buttress on the SE angle of the new building.

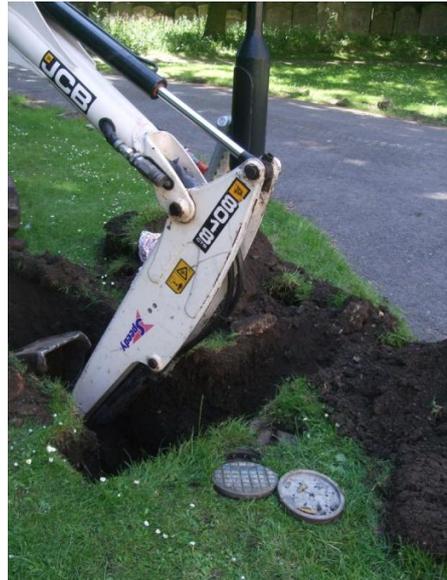
Plate 2
(Archive image PCAMW 006)

The NW end of the new water main trench, adjacent to the lamp post.

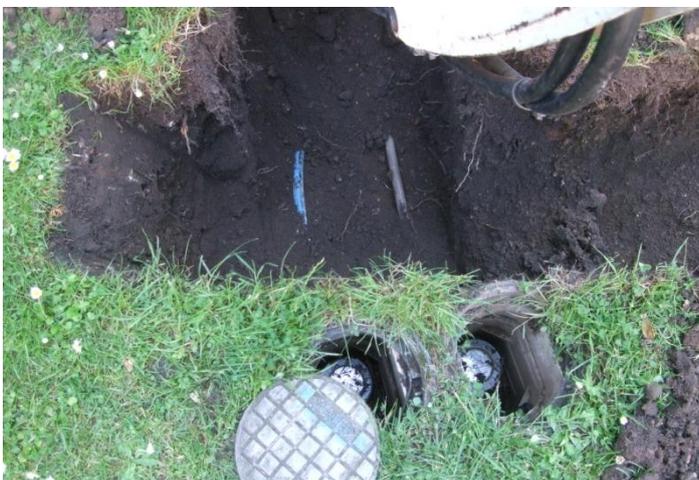
Plate 3
(Archive image PCAMW 007)

The existing water pipes, blue plastic to the north and copper to the south, exposed in the bottom of the 2016 excavation trench, viewed from the NW.

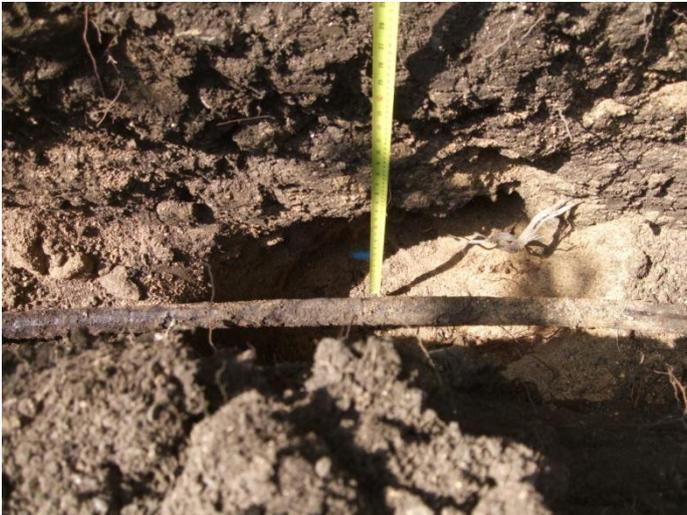
Plate 4
(Archive image PCAMW 025)

Approximately 2m to the south-east of the water meters, an electricity cable was encountered 0.50m below the turf and 0.30m above the two water pipes. The remainder of the new trench followed the route of the electricity cable, at an average depth of 0.60m, and the continued presence of the water pipes on the same route was tested both by CAT scan and trial excavation when practical (Plate 4). At point K, 37.50m (as the crow flies) south-east of the water meters, the ground surface lies at 8.113m; the electricity cable at 7.528m; the general trench bottom at approximately 7.55m; and the existing water pipe at 7.168m OD.

The new trench at point K, viewed from the NE, showing the existing electricity cable and the blue plastic water pipe beneath it.

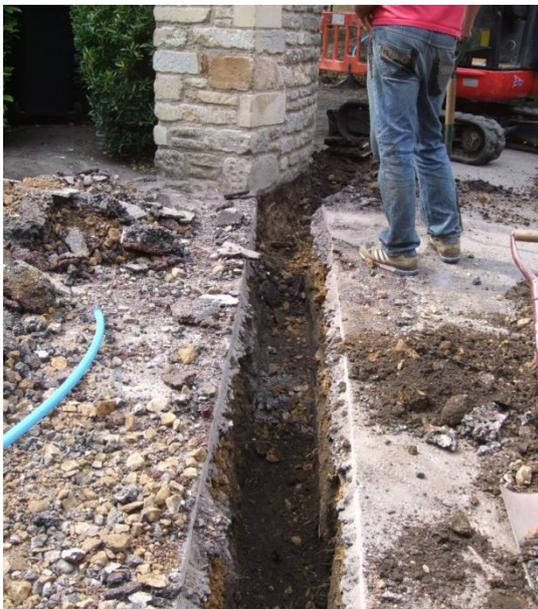
Plate 5
(Archive image PCAMW 037)
The water pipe trench inside the west wall of the property, viewed from the SE.

The progress of pipe trench excavation was essentially north-west to south-east across the turfed areas but the length across the tarmac surface inside the west wall of the property (Plates 5 and 6) was left until almost last and the short length beneath the cement-bedded cobbles across the entrance to the properties (Plate 7) was completed using a tunnelling mole, after the conclusion of archaeological supervision.

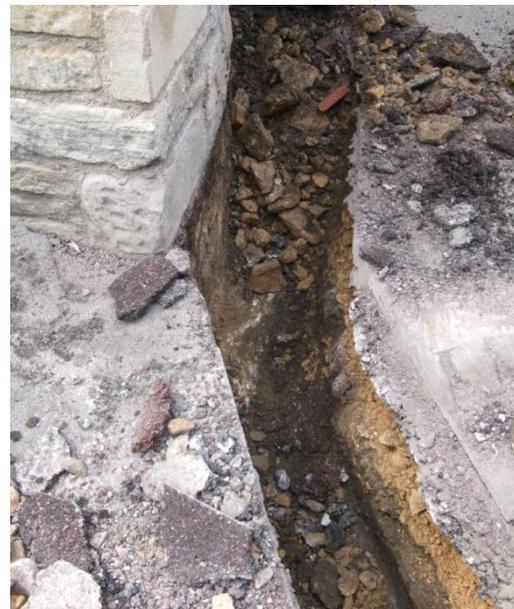
Plate 6
(Archive image PCAMW 038)
The pipe trench abutting the south wall splay, viewed from the SE, showing the splay's substantial footing.

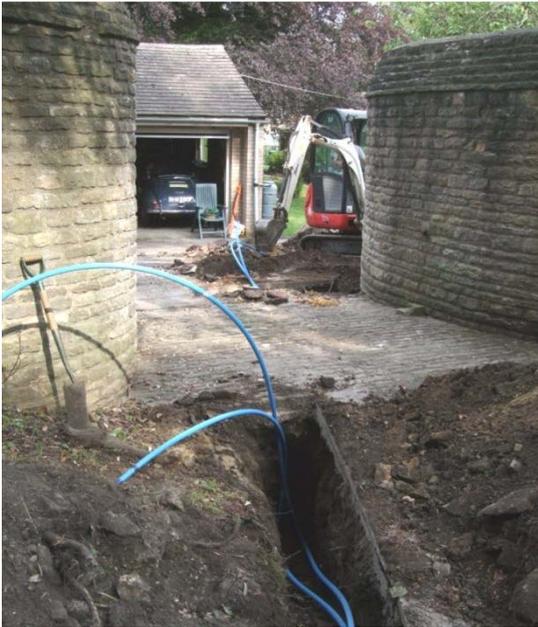
Plate 7
(Archive image PCAMW 42)

The entrance to the residential property, viewed from the WNW, showing the wall splays and cobbled surface and the open water pipe trench.

The other area in which topsoil was not the only deposit was across the entrance into the residential property, at which point the cement-bedded cobble surface lay on a dark loam mixed with pieces of stone (average size 15cm x 12cm x 9cm). Contrary to expectation there was no sign of the lower courses or footing for the boundary wall.

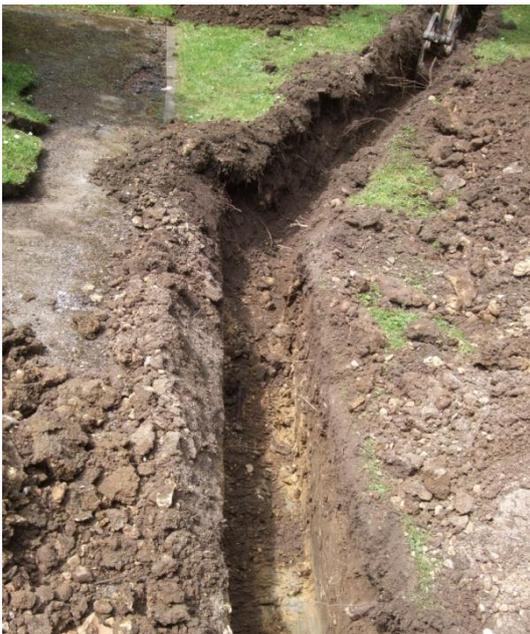
Plate 8
(Archive image PCAMW 031)

One of two exceptions to this norm was in the approximately 2.50m-wide strip along the north side of Mandell House, where the dark loam was sandwiched between the tarmac and hardcore of the path and an unbottomed deposit of dirty yellow clay (Plate 8). The yellow clay contained small fragments of stone and streaks of mid-brown sandy loam, indicating that it was a disturbed deposit, most probably the up-cast material from the excavation of the footings trenches for Mandell House. The upper limit of the yellow clay adjacent to the path was recorded at an average of 7.36m OD.

The new water pipe trench, viewed from the east, showing the trench parallel to the north wall and path of Mandell House, with yellow clay in the trench bottom.

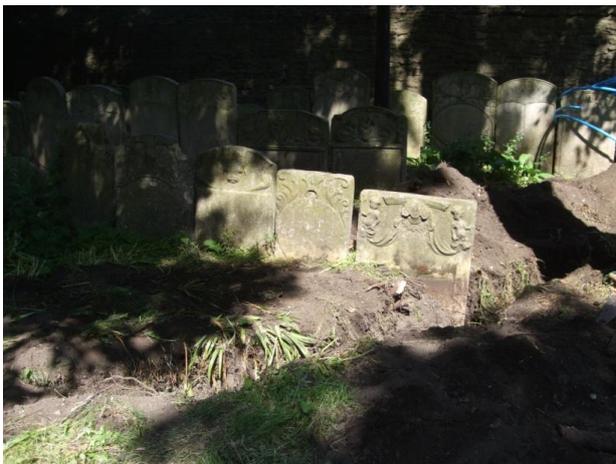
Plate 9

That considerable quantities of soil were imported in the 1820s is documented, but not exactly where it was placed (PCCHER 80082). It is also not clear how much additional material may have been spread over the area during the 1926 landscaping of the cemetery, although the half-buried appearance of the closely set lines of re-positioned headstones close to the cemetery's east boundary wall suggests that 15cm or more of topsoil has built up or has been deposited since they were reset (Plates 9 and 10).

Reset headstones aligned on the east boundary wall of the cemetery, viewed from the west.

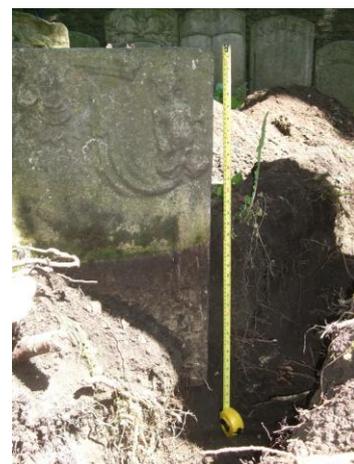
Plate 10

The headstone front right in Plate 9 as exposed by the new trench.
